**ADDITIONAL CONTAMINATION ASSESSMENT
&
REMEDIAL ACTION PLAN**

PROPOSED NARWEE PARKLAND CARE COMMUNITY

**LOTS D & C DP403467, LOT 2 DP518877 AND LOTS 2 & 3 DP16063
59-67 KARNE STREET NORTH, NARWEE**

REPORT NO 20219/6-AA 8 DECEMBER 2022

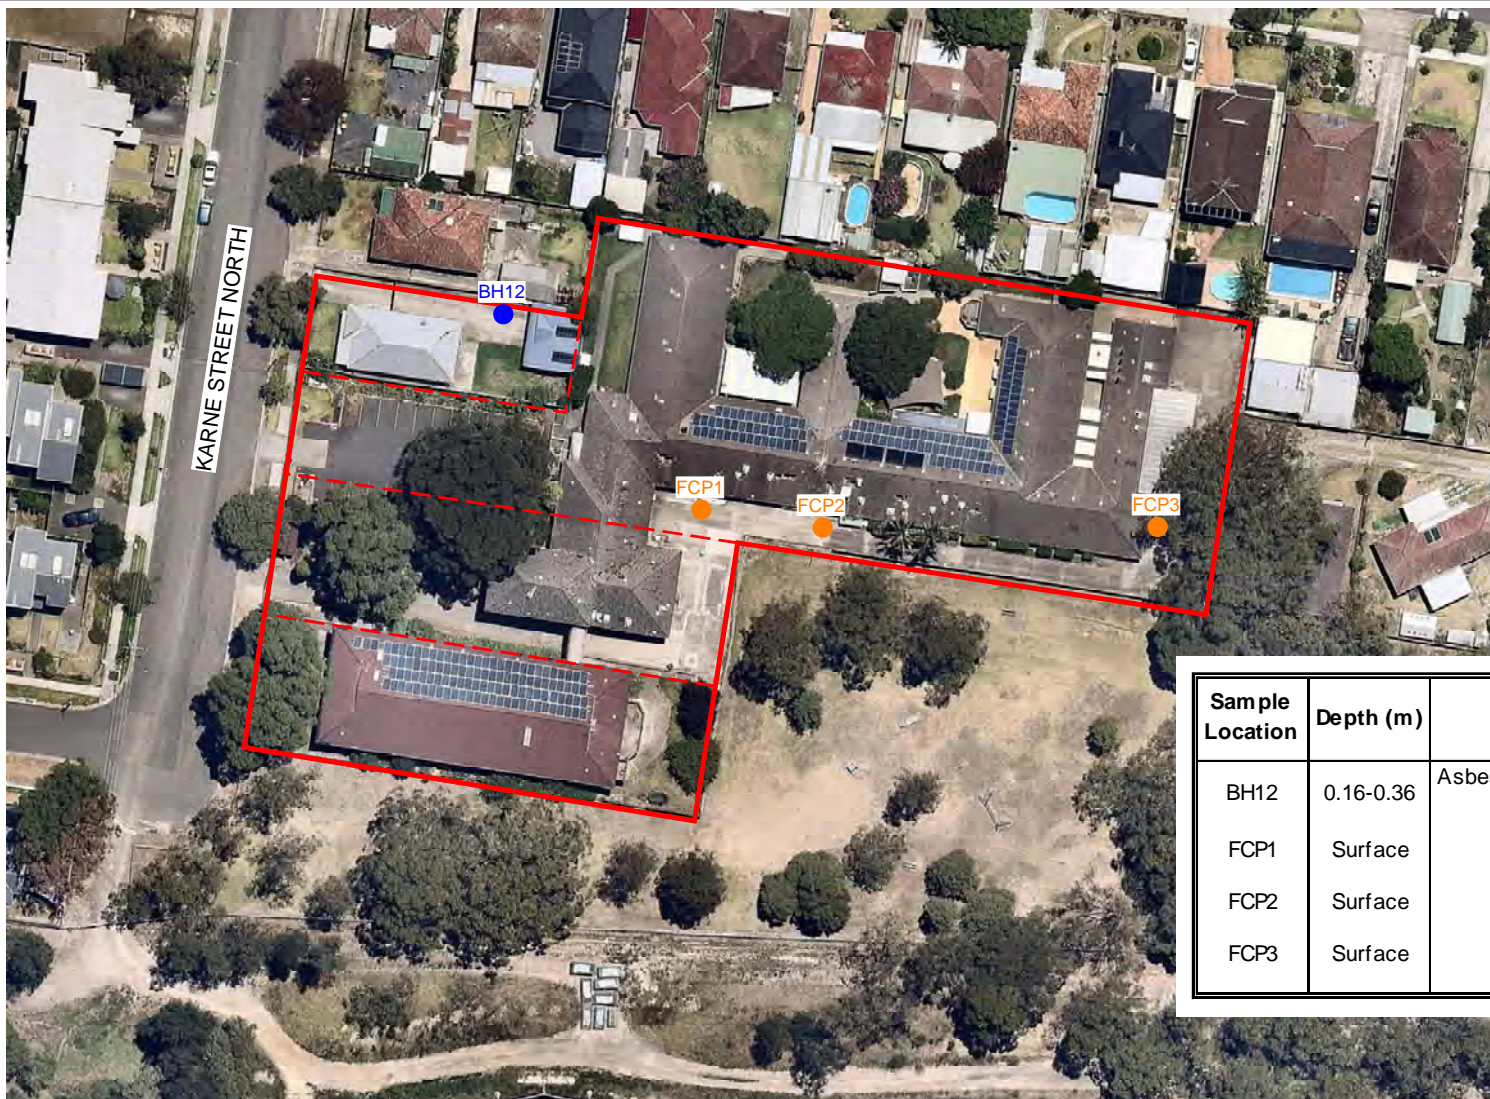
Drawing No: 13977/2-AA2
Job No: 13977/2
Drawn By: MH
Date: 11 April 2017
Checked By: AB

As a part of the updated DSI, detailed sampling in the vicinity of BH12 (BH12a and BH12-1 to BH12-4) was also carried out to delineate the extent of potential asbestos contamination at BH12. During the Phase 2 CA in 2017, one asbestos-cement piece was observed in the fill profile at borehole BH12.

| Sample Location | Depth (m) | Concern |
|---|---|--|
| BH12 | 0.16-0.36 | Asbestos Containing Material (ACM) fragments |

- Detailed sampling and/or testing in the vicinity of BH12 to delineate the extent of potential asbestos contamination.
- Sampling and testing of soils beneath the house, sheds, buildings and concrete covered areas after demolition and removal of site features and hardstand area.
- Development of a remedial action plan (RAP) to remediate potential asbestos contaminated fill and areas with scattered ACM fragments, plus any other contamination identified through the recommended additional sampling and testing, followed by appropriate validation.

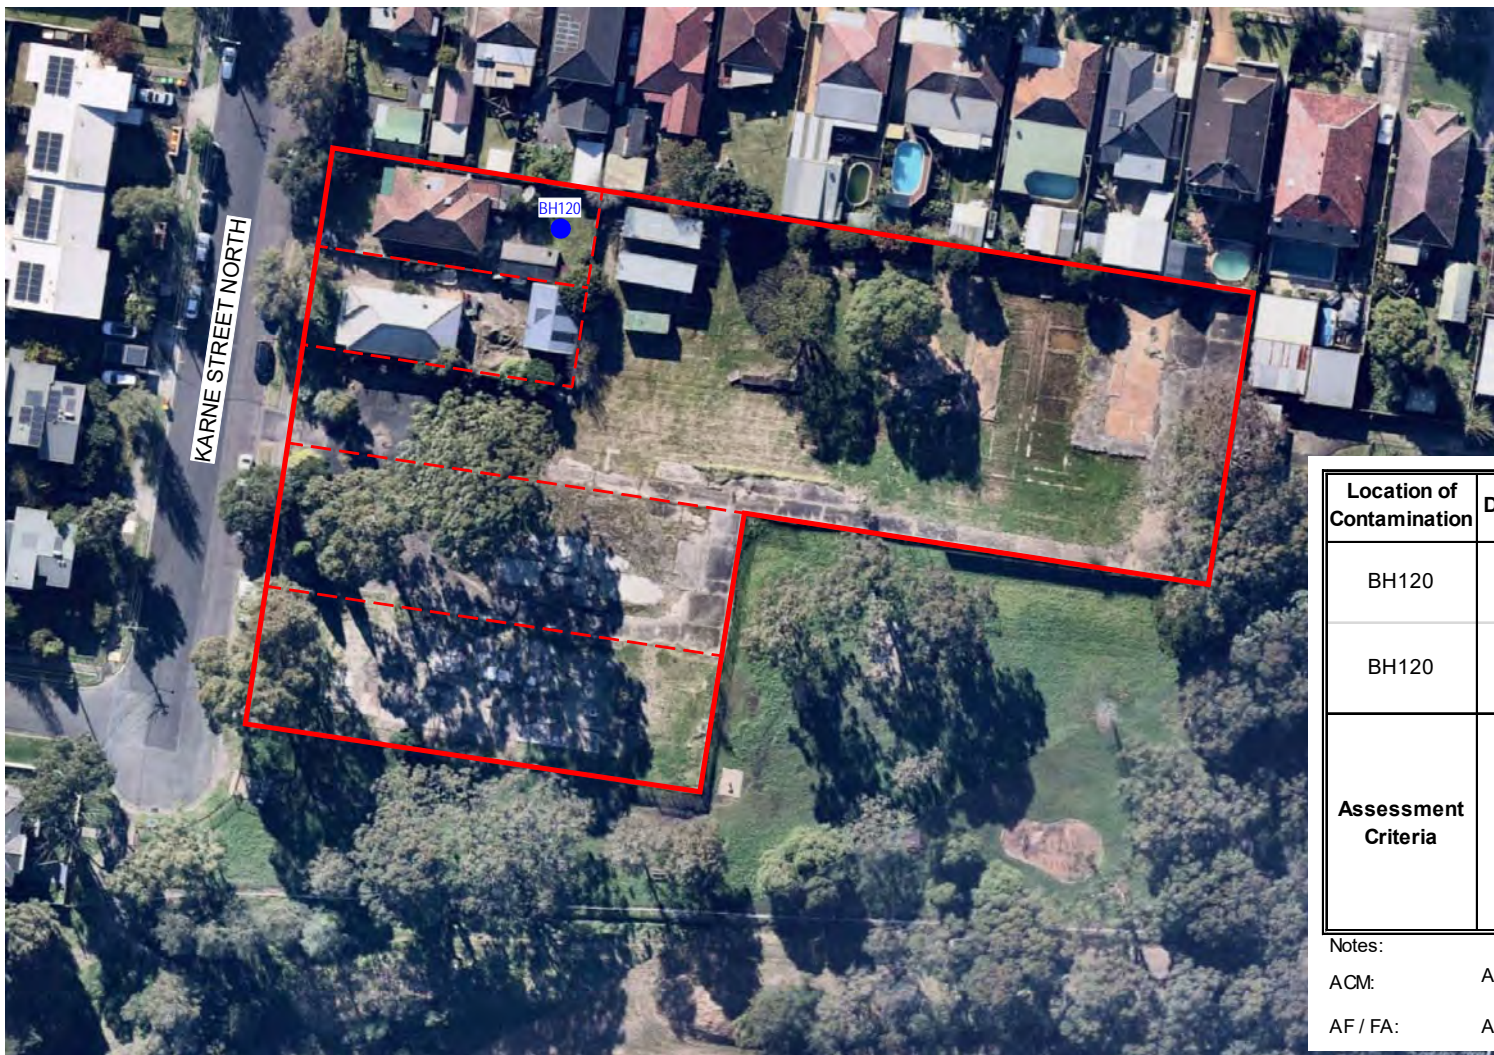
Drawing No: 20219/5-AA3
Job No: 20219/5
Drawn By: MH
Date: 12 August 2022
Checked By: AB

The asbestos test results for the detailed fill samples at and in the vicinity of BH120 are presented in Table C. As indicated, AF and FA in excess of 0.001%w/w were not found in any fill samples. Bonded ACM (>7mm) (ranging from 0.02%w/w to 0.18%w/w) was detected by the laboratory in fill samples TP120-1, TP120-6, TP120-11 and TP120-12.

| Location of Contamination | Depth (m) | Contaminant | Concentration |
|---|--|---|---|
| BH120 | 0-0.15 | Asbestos (bonded ACM fragments) | 0.308% w/w |

- Detailed sampling and/or testing in the vicinity of BH120 to delineate the extent of asbestos contamination.
- Sampling and testing of soils beneath the houses, building, and concrete covered areas after demolition and removal of site features.
- Development of a remedial action plan (RAP) to remediate asbestos contaminated fill, plus any other contamination identified through the recommended additional sampling and testing, followed by appropriate validation.

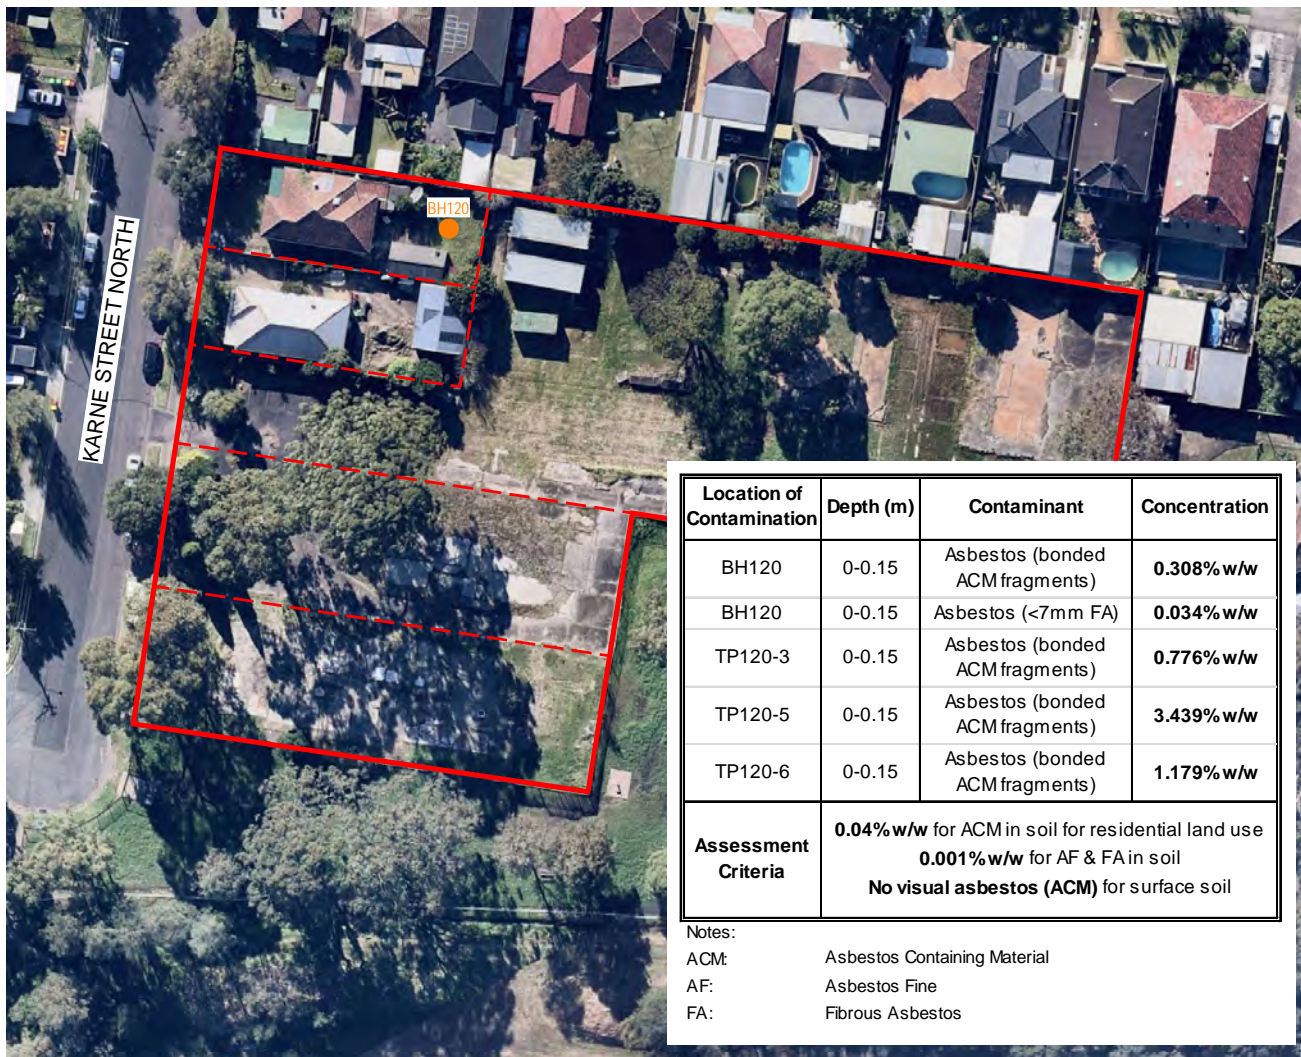
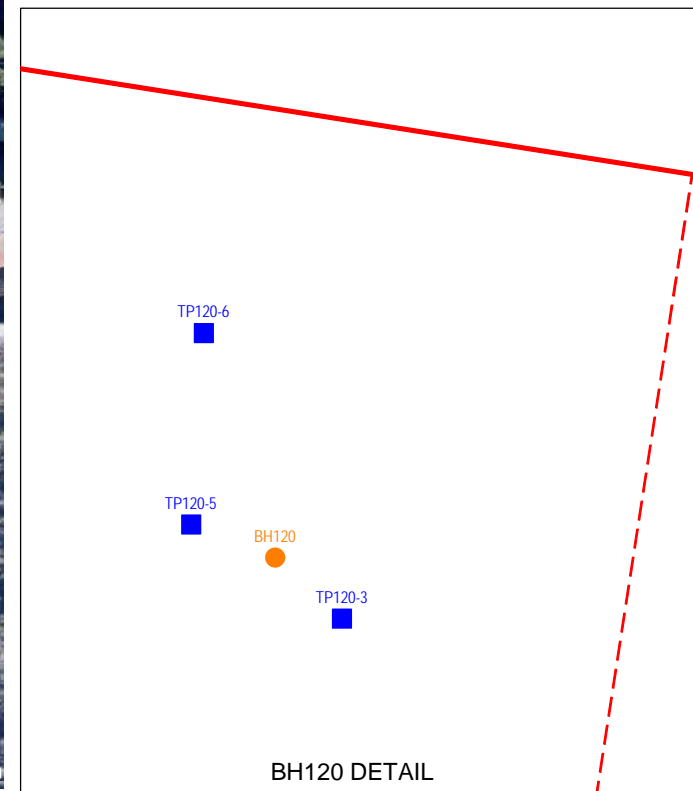
Drawing No: 20219/6-AA2
Job No: 20219/6
Drawn By: MH
Date: 26 October 2022
Checked By: AB

The asbestos test results for the fibro-cement pieces observed in the fill profile at TP120-3, TP120-5 and TP120-6 contained ACM, as also indicated in Table C, which presents a potential risk of harm to human health as these fragments may release asbestos dust or fibres if tooled, cut, etc.

| Location of Contamination | Depth (m) | Contaminant | Concentration |
|---|--|---|---|
| BH120 | 0-0.15 | Asbestos (bonded ACM fragments) | 0.308% w/w |

Due to the presence of FA, a contractor with a Class A Licence for friable asbestos must supervise removal and loading of the asbestos contaminated fill materials from Area 1 in a covered, leak-proof vehicle for transport to an NSW EPA licensed landfill facility.
