# Hazardous Materials Survey

| <b>Prepared for:</b> | CYRE Projects |
| <b>Site</b> | 59-67 Karne St, Narwee NSW 2209 |
| <b>Date:</b> | Monday, 7 November 2022 |

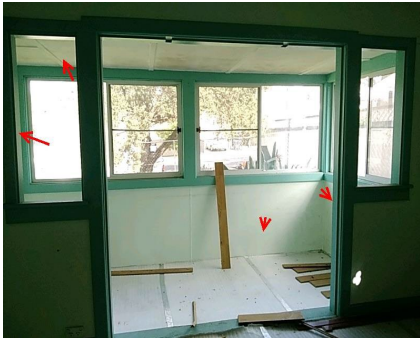
Photo No: 221107-093754  
Result: Asbestos - Positive  
Location-Level: Interior - Ground Floor  
Room-Location: Living area - sun room  
Feature-Material: FC sheeting  
Item No - Risk Rating: 3 - Low

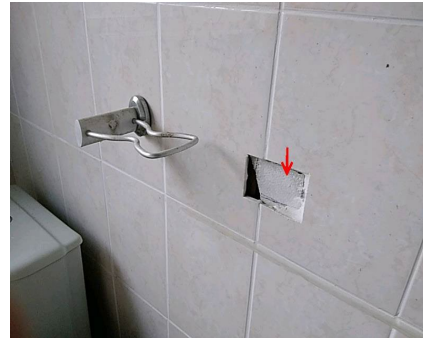
Photo No: 221107-094420  
Result: Asbestos - Positive  
Location-Level: Interior - Ground Floor  
Room-Location: Bathroom - walls (behind tiles)  
Feature-Material: FC sheeting  
Item No - Risk Rating: 5 - Medium

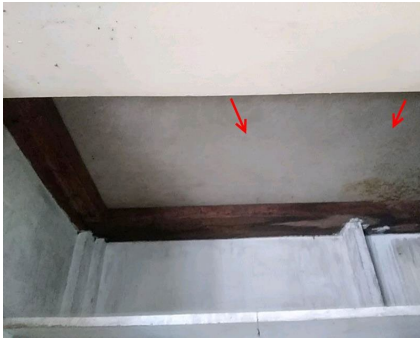
Photo No: 221107-095042  
Result: Asbestos - Presumed Positive  
Location-Level: Interior - Ground Floor  
Room-Location: Kitchen - cupboard ceiling  
Feature-Material: FC sheeting  
Item No - Risk Rating: 8 - Low

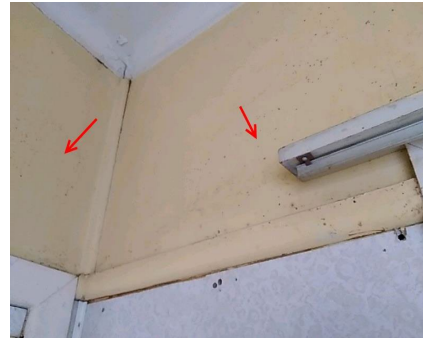
Photo No: 221107-095147  
Result: Asbestos - Presumed Positive  
Location-Level: Interior - Ground Floor  
Room-Location: Kitchen - walls (behind splashback)  
Feature-Material: FC sheeting  
Item No - Risk Rating: 9 - Low

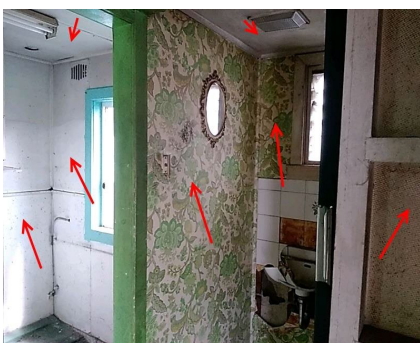
Photo No: 221107-095647  
Result: Asbestos - Presumed Positive  
Location-Level: Exterior - Ground Floor  
Room-Location: Laundry and toilet - internal walls and ceilings  
Feature-Material: FC sheeting  
Item No - Risk Rating: 13 - Low

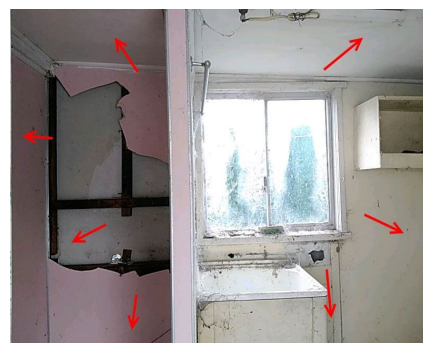
Photo No: 221107-095828  
Result: Asbestos - Positive  
Location-Level: Interior and Exterior - Ground Floor  
Room-Location: Bathroom - internal walls and ceilings  
Feature-Material: FC sheeting  
Item No - Risk Rating: 14 - Medium

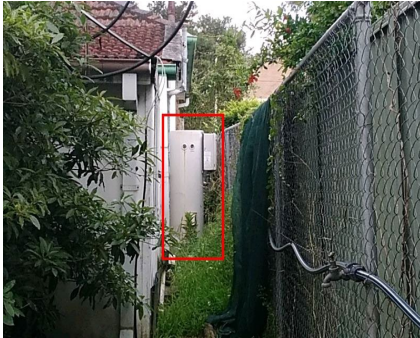
Photo No: 221107-100413  
Result: Asbestos - Presumed Positive  
Location-Level: Exterior - Ground Floor  
Room-Location: Northern elevation of building - hot water system  
Feature-Material: Internal insulation  
Item No - Risk Rating: 15 - Low

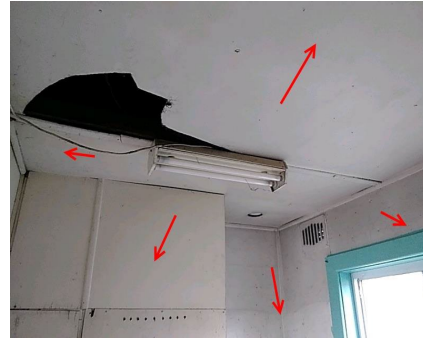
Photo No: 221107-100520  
Result: Asbestos - Presumed Positive  
Location-Level: Exterior - Ground Floor  
Room-Location: Laundry - internal walls and ceiling  
Feature-Material: FC sheeting  
Item No - Risk Rating: 16 - Medium

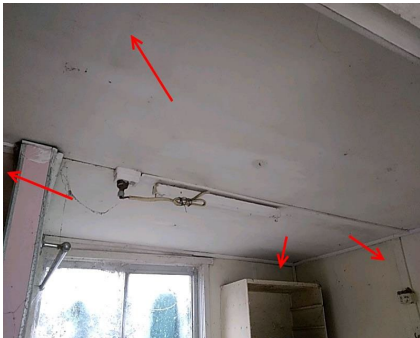
Photo No: 221107-100527  
Result: Asbestos - Presumed Positive  
Location-Level: Exterior - Ground Floor  
Room-Location: Toilet - internal walls and ceiling  
Feature-Material: FC sheeting  
Item No - Risk Rating: 17 - Medium

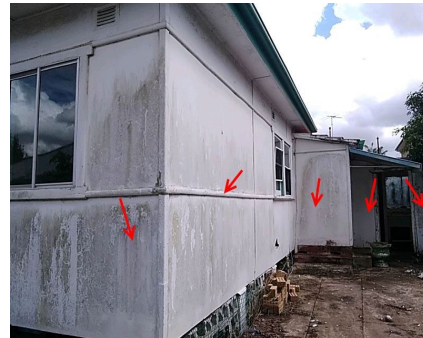
Photo No: 221107-100910  
Result: Asbestos - Positive  
Location-Level: Exterior - Ground Floor  
Room-Location: All elevation of the building - walls  
Feature-Material: FC sheeting  
Item No - Risk Rating: 18 - Medium

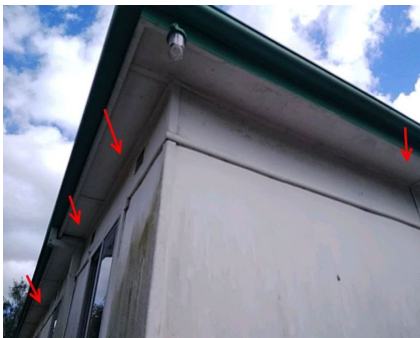
Photo No: 221107-100836  
Result: Asbestos - Presumed Positive  
Location-Level: Exterior - Ground Floor  
Room-Location: All elevation of the building - eaves  
Feature-Material: FC sheeting  
Item No - Risk Rating: 19 - Low

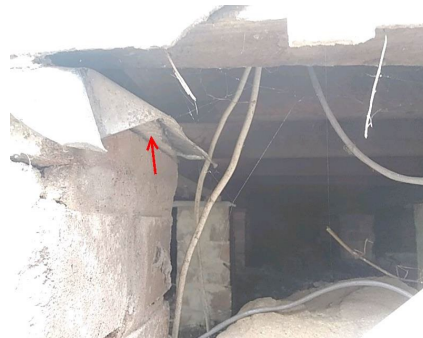
Photo No: 221107-100951  
Result: Asbestos - Positive  
Location-Level: Interior - Ground Floor  
Room-Location: All elevation of the building - packer  
Feature-Material: FC sheeting  
Item No - Risk Rating: 20 - Low

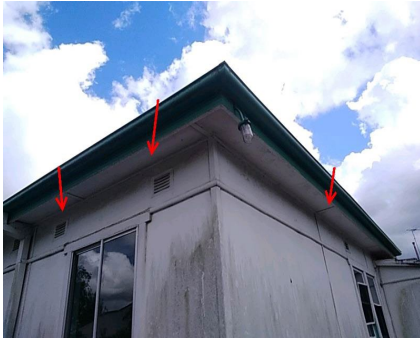
Photo No: 221107-101245  
Result: Asbestos - Presumed Positive  
Location-Level: Exterior - Ground Floor  
Room-Location: All elevation of the building - eaves  
Feature-Material: FC sheeting  
Item No - Risk Rating: 21 - Low

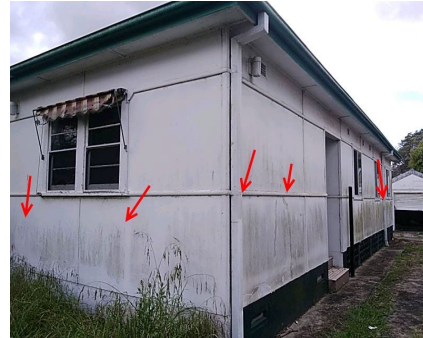
Photo No: 221107-101426  
Result: Lead in Paint - Positive  
Location-Level: Exterior - Ground Floor  
Room-Location: All elevation of the building - walls and downpipes  
Feature-Material: Lower colour paint system  
Item No - Risk Rating: 22 -

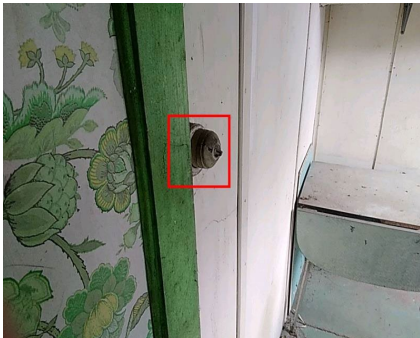
Photo No: 221107-102641  
Result: Asbestos - Presumed Positive  
Location-Level: Interior - Ground Floor  
Room-Location: Laundry - electrical power switch  
Feature-Material: Internal insulation  
Item No - Risk Rating: 26 - Low

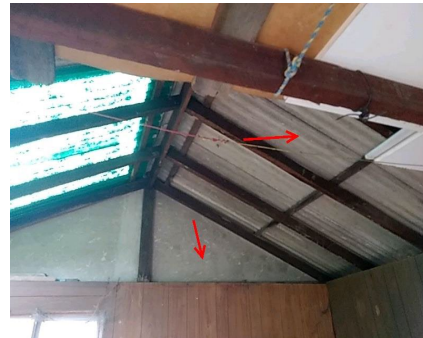
Photo No: 221107-103727  
Result: Asbestos - Presumed Positive  
Location-Level: Exterior - Ground Floor  
Room-Location: All elevation of the garage - gable  
Feature-Material: FC sheeting  
Item No - Risk Rating: 1 - Low

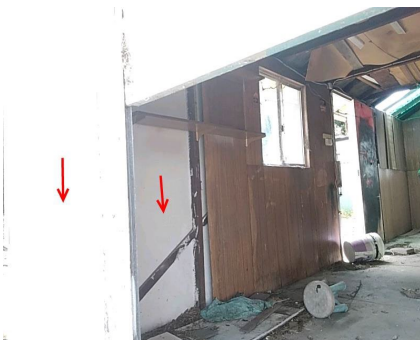
Photo No: 221107-103808  
Result: Asbestos - Presumed Positive  
Location-Level: Interior and Exterior - Ground Floor  
Room-Location: All elevation of the garage - walls  
Feature-Material: FC sheeting  
Item No - Risk Rating: 2 - Low

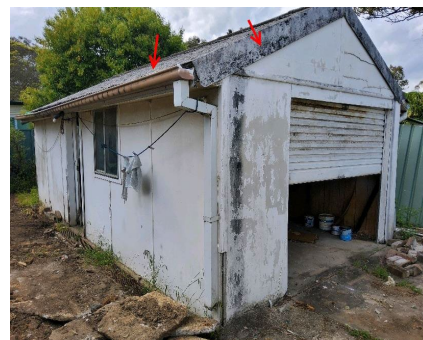
| Item | Location | Level | Room-Specific Location | Hazard Type | Item description | Sample Reference | Sample Status | Photo No | Extent | Condition | Friability | Disturbance Potential | Risk Rating | Current Label | Control Priority | Control Recommendation |
|---|---|---|---|---|---|---|---|---|---|---|---|---|---|---|---|---|
| 3 | Exterior | Ground Floor | All elevation of garage - roof and verge | Asbestos | FC sheeting | 09ASB | Presumed Positive | 221107-120202 | | Good | Non-Friable | Low | Low | No | P4 | P4 - No short term remediation works required. Review periodically and manage as part of an AMP |

Photo No: 221107-120202  
Result: Asbestos - Presumed Positive  
Location-Level: Exterior - Ground Floor  
Room-Location: All elevation of garage - roof and verge  
Feature-Material: FC sheeting  
Item No - Risk Rating: 3 - Low

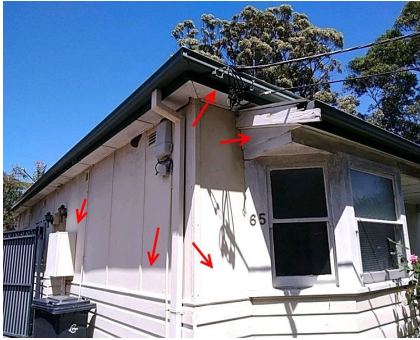
Photo No: 221107-140141  
 Result: Asbestos - Positive  
 Location-Level: Exterior - Ground Floor  
 Room-Location: All elevation of the building - walls and eaves  
 Feature-Material: FC sheeting  
 Item No - Risk Rating: 8 - Low

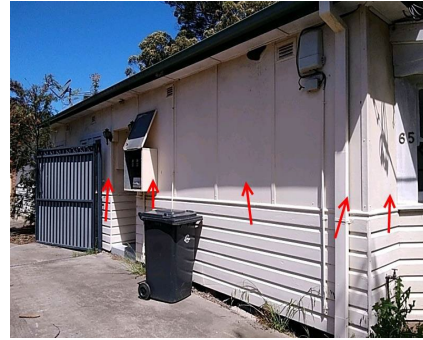
Photo No: 221107-140655  
 Result: Lead in Paint - Positive  
 Location-Level: Exterior - Ground Floor  
 Room-Location: All elevation of the building - walls  
 Feature-Material: Lower colour paint system  
 Item No - Risk Rating: 10 - Low

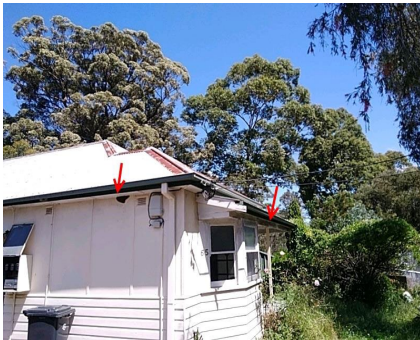
Photo No: 221107-141046  
 Result: Lead in Paint - Positive  
 Location-Level: Exterior - Ground Floor  
 Room-Location: All elevation of the building - roof  
 Feature-Material: Lower colour paint system  
 Item No - Risk Rating: 11 - Low

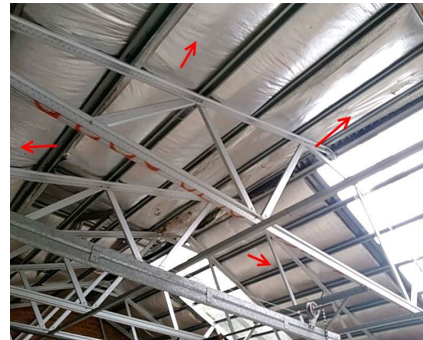
Photo No: 221107-140243  
 Result: SMF - Positive  
 Location-Level: Interior - Ground Floor  
 Room-Location: All elevation of the roof - sarking  
 Feature-Material: sarking  
 Item No - Risk Rating: 1 -

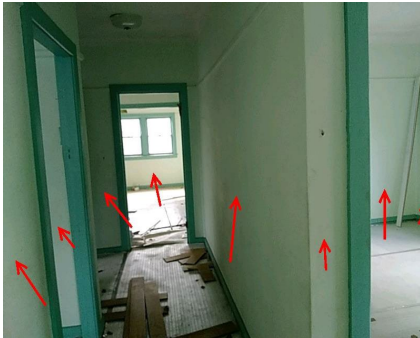
Photo No: 221107-093107  
Result: Asbestos - Negative  
Location-Level: Interior - Ground Floor  
Room-Location: Northern bedroom, living area and lobby - internal walls  
Feature-Material: Plaster-like material

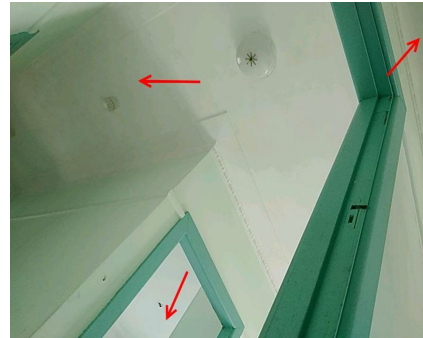
Photo No: 221107-093712  
Result: Asbestos - Presumed Negative  
Location-Level: Interior - Ground Floor  
Room-Location: Northern bedroom, living area and lobby - ceilings  
Feature-Material: Plaster-like material

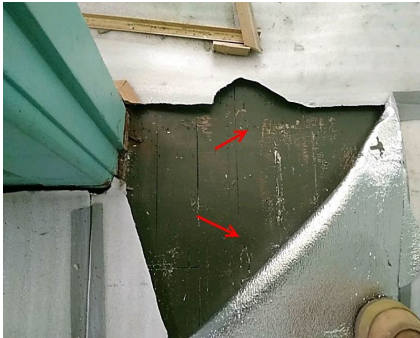
Photo No: 221107-094049  
Result: Asbestos - Negative  
Location-Level: Interior - Ground Floor  
Room-Location: All elevation of the building - flooring  
Feature-Material: Timber

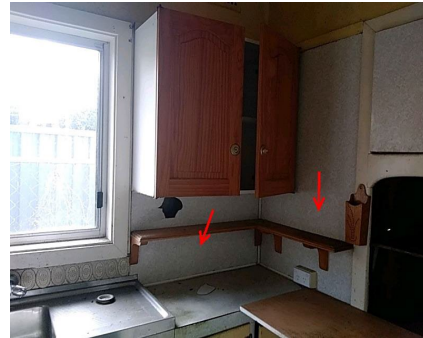
Photo No: 221107-094153  
Result: Asbestos - Negative  
Location-Level: Interior - Ground Floor  
Room-Location: Kitchen - splashback  
Feature-Material: FC sheeting

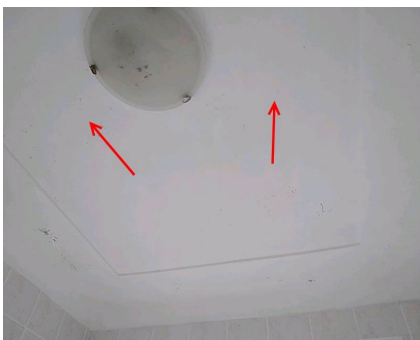
Photo No: 221107-094933  
Result: Asbestos - Presumed Negative  
Location-Level: Interior - Ground Floor  
Room-Location: Kitchen - ceiling  
Feature-Material: Plaster-like material

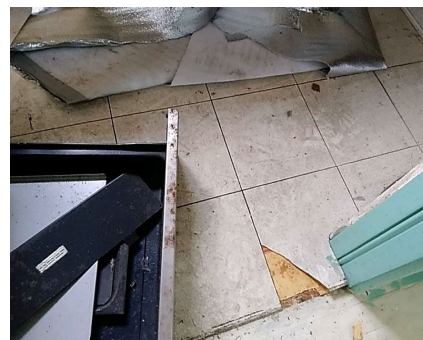
Photo No: 221107-095248  
Result: Asbestos - Negative  
Location-Level: Interior - Ground Floor  
Room-Location: Kitchen - flooring  
Feature-Material: Vinyl tiles, backing material and adhesive

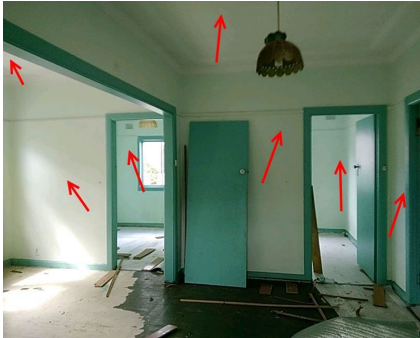
Photo No: 221107-095513  
Result: Asbestos - Presumed Negative  
Location-Level: Interior - Ground Floor  
Room-Location: Dining area and southern bedrooms - internal walls and ceilings  
Feature-Material: Plaster-like material

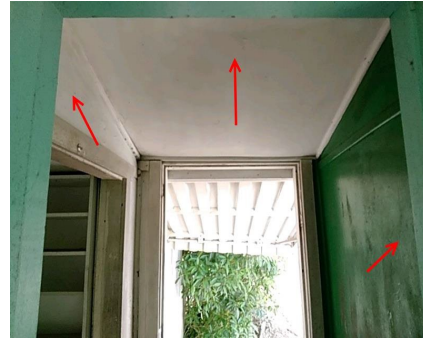
Photo No: 221107-095625  
Result: Asbestos - Presumed Negative  
Location-Level: Interior - Ground Floor  
Room-Location: Rear entrance - internal walls and ceiling  
Feature-Material: FC sheeting

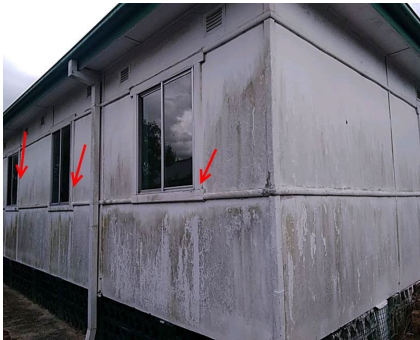
Photo No: 221107-101517  
Result: Lead in Paint - Negative  
Location-Level: Exterior - Ground Floor  
Room-Location: All elevation of the building - windows frames  
Feature-Material: Lower colour paint system

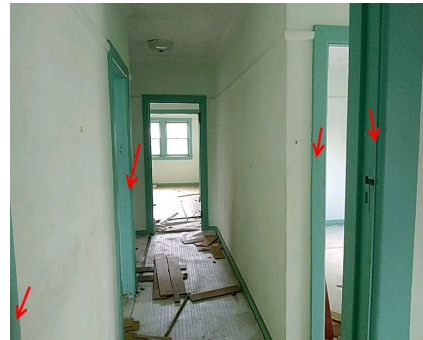
Photo No: 221107-101755  
Result: Lead in Paint - Negative  
Location-Level: Interior - Ground Floor  
Room-Location: All elevation of the floor - walls  
Feature-Material: Lower colour paint system

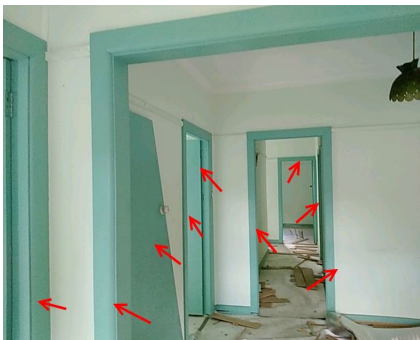
Photo No: 221107-101956  
Result: Lead in Paint - Negative  
Location-Level: Interior - Ground Floor  
Room-Location: All elevation of the building - doors and door frames  
Feature-Material: Lower colour paint system

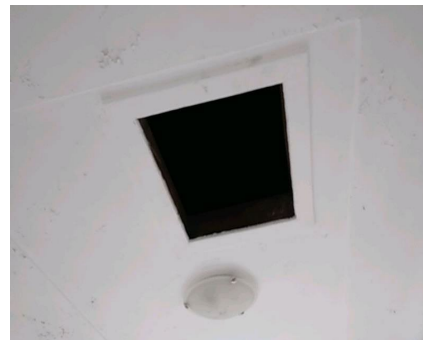
Photo No: 221107-103541  
Result: Lead in Dust - Negative  
Location-Level: Interior - Ground Floor  
Room-Location: All elevation of the building - roof cavity  
Feature-Material: Settled dust

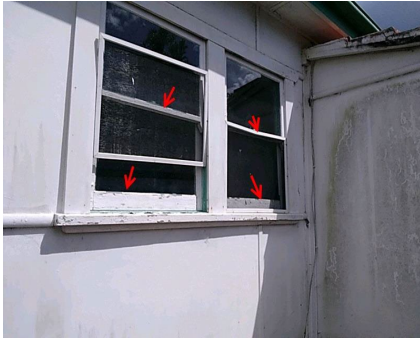
| Item | Location | Level | Room-Specific Location | Hazard Type | Item description | Sample Reference | Sample Status | Photo No | Extent | Condition | Friability | Disturbance Potential | Risk Rating | Current Label | Control Priority | Control Recommendation |
|---|---|---|---|---|---|---|---|---|---|---|---|---|---|---|---|---|
| 28 | Exterior | Ground Floor | All elevation of the building - windows frames sealant | Asbestos | Mastic-like material | 10ASB | Negative | 221107-104044 | | | | | | | | |

Photo No: 221107-104044  
Result: Asbestos - Negative  
Location-Level: Exterior - Ground Floor  
Room-Location: All elevation of the building - windows frames sealant  
Feature-Material: Mastic-like material

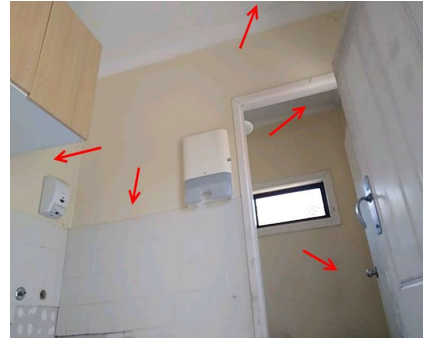
Photo No: 221107-133927  
Result: Asbestos - Negative  
Location-Level: Interior - Ground Floor  
Room-Location: Laundry and toilet - internal walls and ceilings  
Feature-Material: FC sheeting

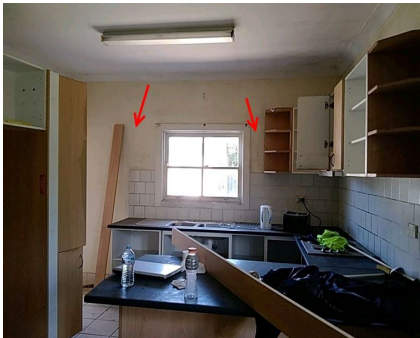
Photo No: 221107-134217  
Result: Asbestos - Negative  
Location-Level: Interior - Ground Floor  
Room-Location: Kitchen - Eastern wall  
Feature-Material: FC sheeting

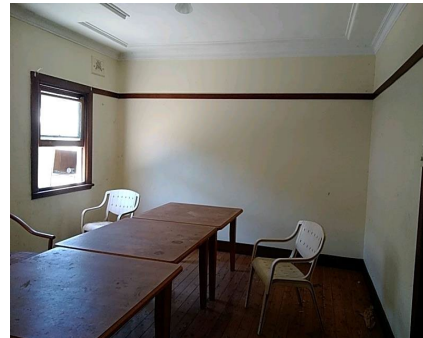
Photo No: 221107-134817  
Result: Asbestos - Presumed Negative  
Location-Level: Interior - Ground Floor  
Room-Location: Dining area and living area - internal walls and ceiling  
Feature-Material: Plaster-like material

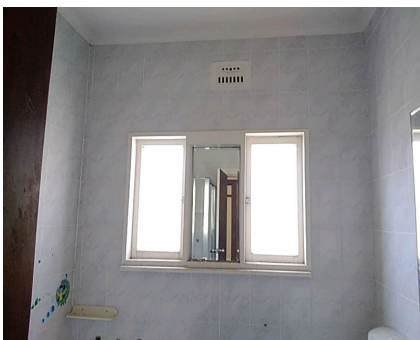
Photo No: 221107-134830  
Result: Asbestos - Negative  
Location-Level: Interior - Ground Floor  
Room-Location: Bathroom - walls (behind tiles)  
Feature-Material: FC sheeting

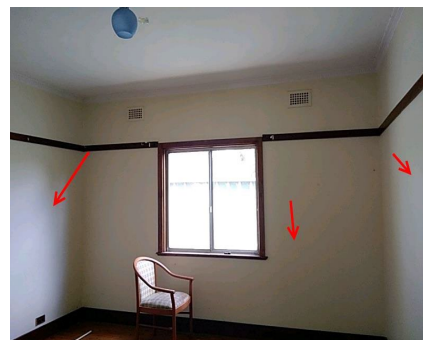
Photo No: 221107-135200  
Result: Asbestos - Presumed Negative  
Location-Level: Interior - Ground Floor  
Room-Location: Western bedroom - internal walls  
Feature-Material: Plaster-like material

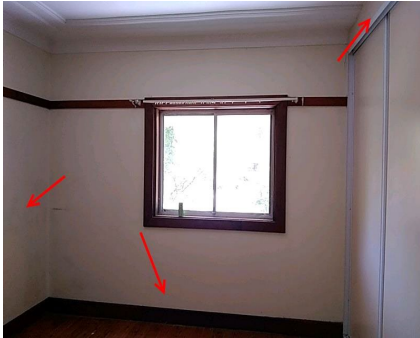
Photo No: 221107-135213  
Result: Asbestos - Presumed Negative  
Location-Level: Interior - Ground Floor  
Room-Location: Southern bedroom - internal walls  
Feature-Material: Plaster-like material

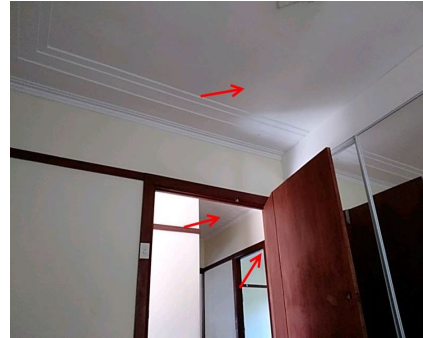
Photo No: 221107-135250  
Result: Asbestos - Presumed Negative  
Location-Level: Interior - Ground Floor  
Room-Location: Bedrooms and lobby - ceilings  
Feature-Material: Plaster-like material

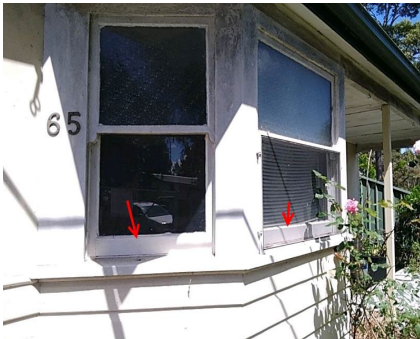
Photo No: 221107-140154  
Result: Asbestos - Negative  
Location-Level: Exterior - Ground Floor  
Room-Location: All elevation of the building - windows frames sealant  
Feature-Material: Mastic-like material

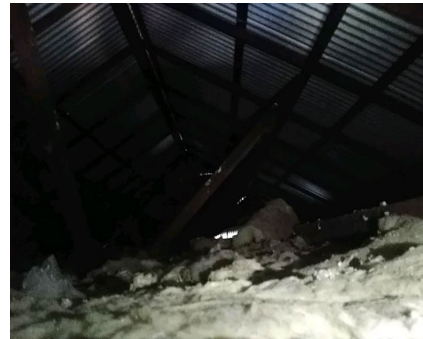
Photo No: 221107-142113  
Result: Lead in Dust - Negative  
Location-Level: Interior - Roof  
Room-Location: Roof cavity - settled dust  
Feature-Material: Settled dust

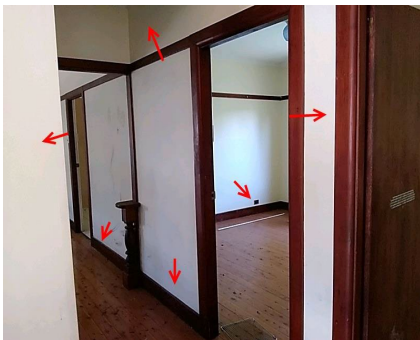
Photo No: 221107-142549  
Result: Lead in Paint - Negative  
Location-Level: Interior - Ground Floor  
Room-Location: All elevation of the floor - walls and ceilings  
Feature-Material: Lower colour paint system

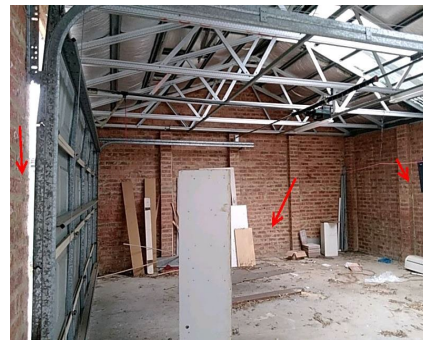
Photo No: 221107-104314  
Result: Asbestos - Negative  
Location-Level: Interior and Exterior - Ground Floor  
Room-Location: All elevation of the building - walls  
Feature-Material: Brick

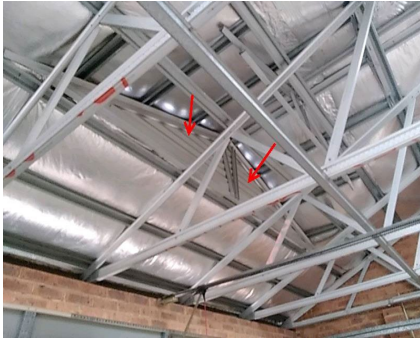
| Item | Location | Level | Room-Specific Location | Hazard Type | Item description | Sample Reference | Sample Status | Photo No | Extent | Condition | Friability | Disturbance Potential | Risk Rating | Current Label | Control Priority | Control Recommendation |
|---|---|---|---|---|---|---|---|---|---|---|---|---|---|---|---|---|
| 3 | Interior | Ground Floor | Western elevation of the building - gable | Asbestos | Metal | NA | Negative | 221107-104334 | | | | | | | | |

Photo No: 221107-104334  
 Result: Asbestos - Negative  
 Location-Level: Interior - Ground Floor  
 Room-Location: Western elevation of the building - gable  
 Feature-Material: Metal
