## PRE-CONSTRUCTION DILAPIDATION REPORT

### Bluescope Proposed Entry Crossover

### 55 Templar Rd, Erskine Park NSW

**Reference:** CO8332.11-02.rpt

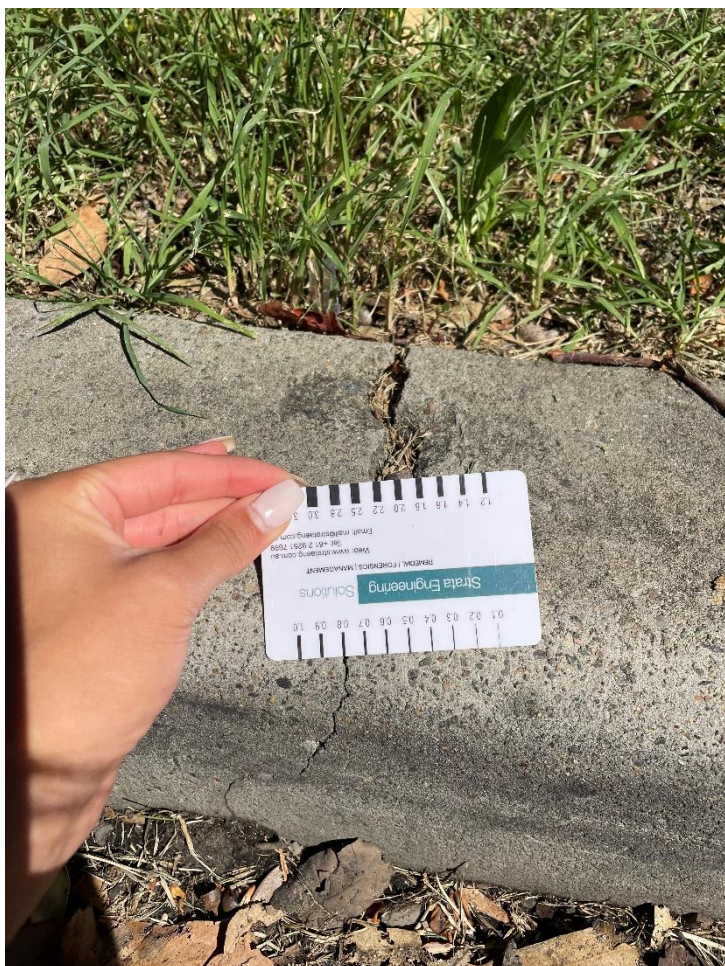
**PHOTO 3**

| ITEM | Pre-Construction Dilapidation Inspection<br>6 March 2023 | PHOTO |
|---|---|---|
| 1.1.3 | Fretting and cracking to kerb measured to be approx. 0.8mm wide. | <b>3-4</b> |

Fretting and cracking to  
kerb measured to be  
approx. 0.8mm wide.

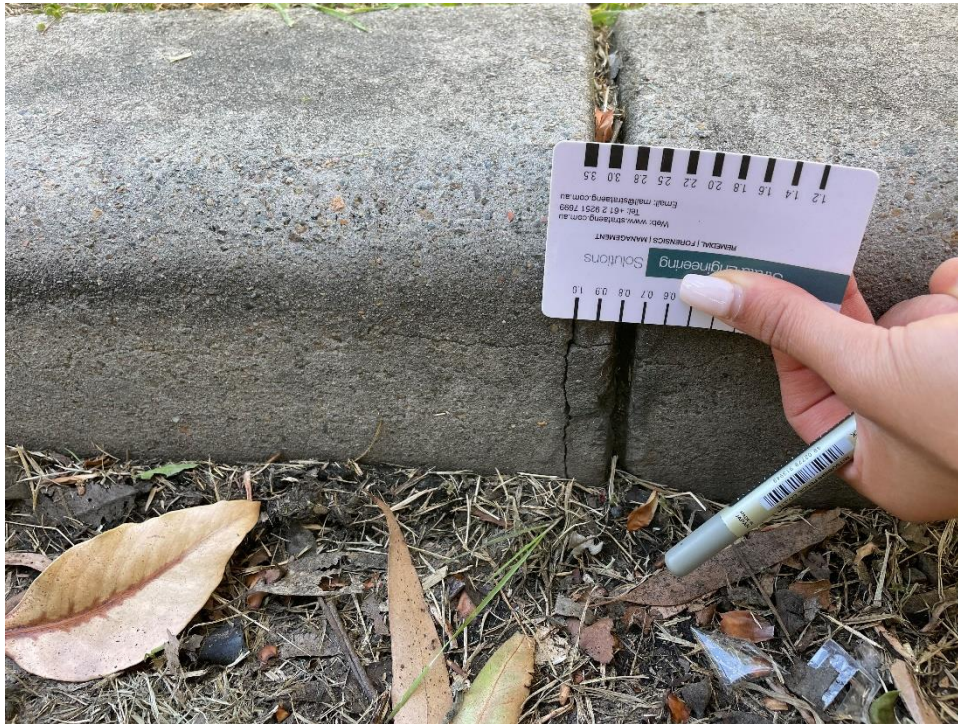
**PHOTO 4**

Fretting and cracking to  
kerb measured to be  
approx. 0.8mm wide.

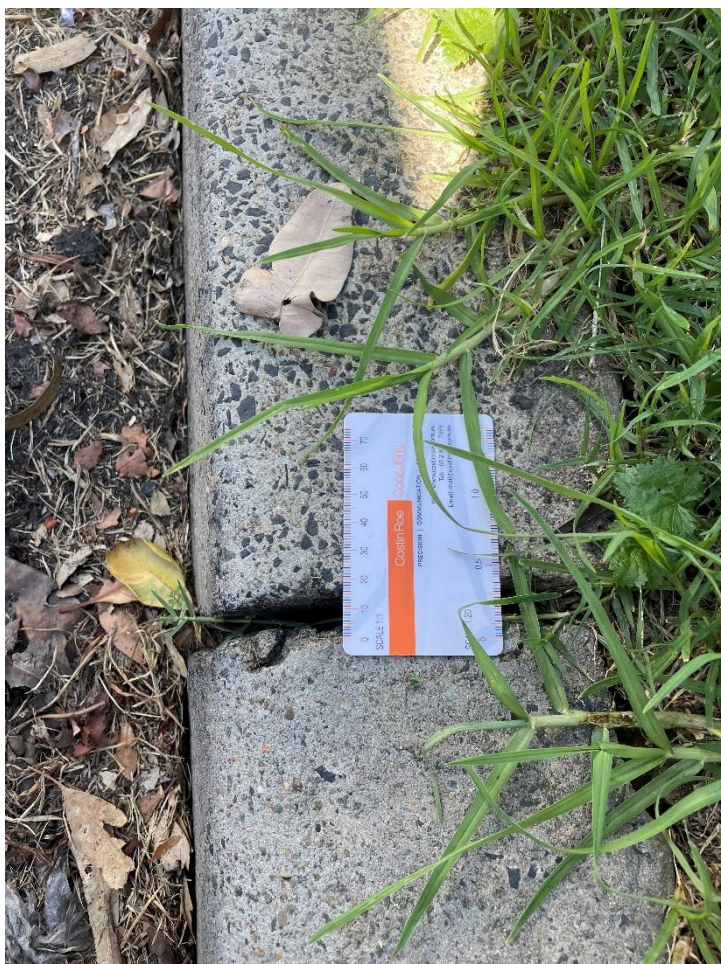
**PHOTO 7**

| ITEM | Pre-Construction Dilapidation Inspection<br>6 March 2023 | PHOTO |
|---|---|---|
| 1.1.6 | Cracking to kerb measured to be approx. 0.7mm wide. | <b>7</b> |

Cracking to kerb measured  
to be approx. 0.7mm wide.

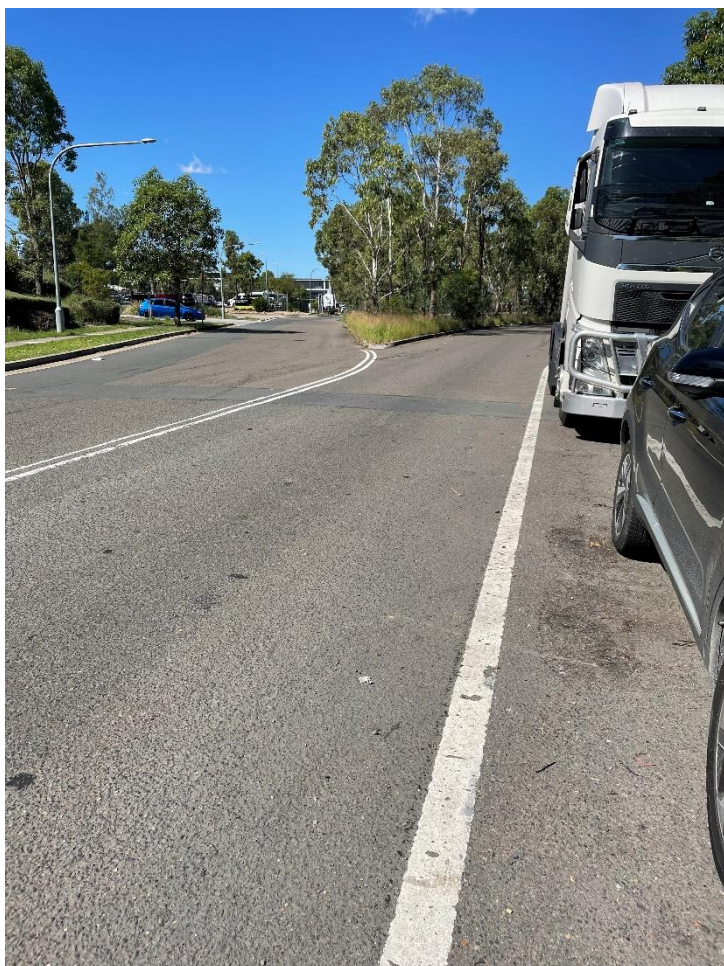
**PHOTO 9**

| ITEM | Pre-Construction Dilapidation Inspection<br>6 March 2023 | PHOTO |
|---|---|---|
| 1.1.8 | Cracking adjacent drainage opening measured to be approx. 1.0mm wide. | <b>9</b> |

Cracking adjacent drainage opening measured to be approx. 1.0mm wide.

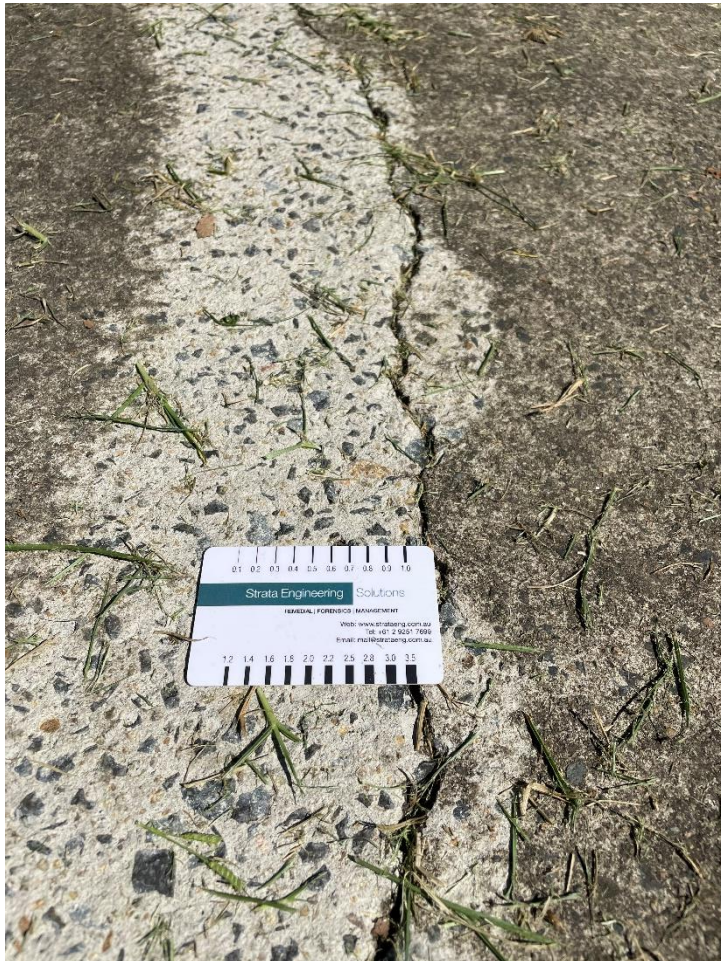
| ITEM | Pre-Construction Dilapidation Inspection<br>6 March 2023 | PHOTO |
|---|---|---|
| 1.2.2 | Cracking to path measured to be approx. 3.5mm wide. | <b>12-13</b> |

Cracking to path measured to be approx. 3.5mm wide.

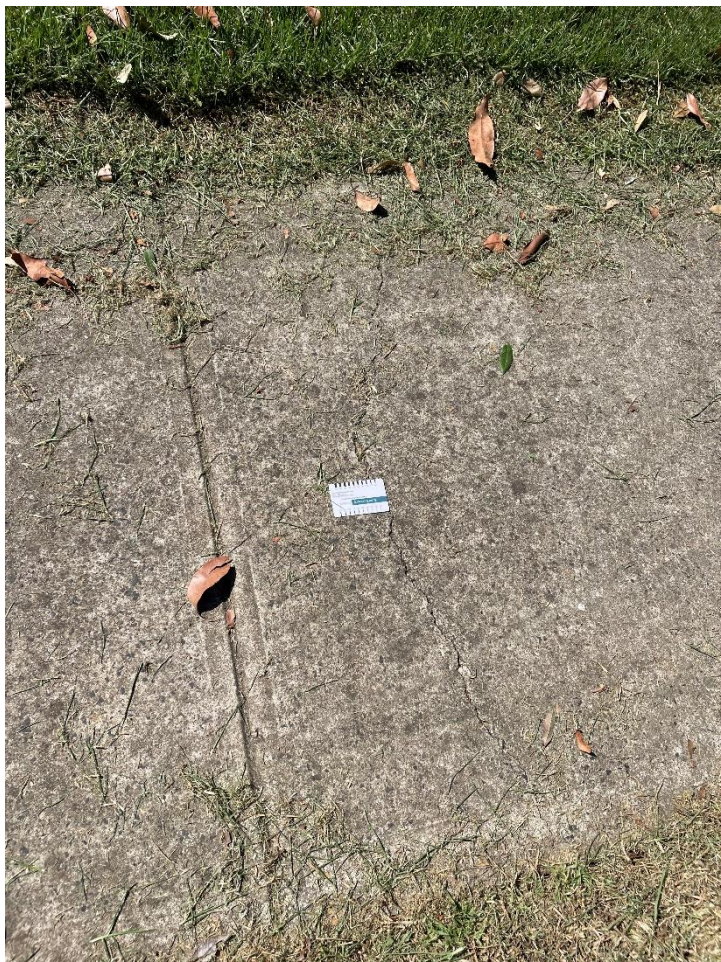
**PHOTO 13**

Cracking to path measured  
to be approx. 3.5mm wide.

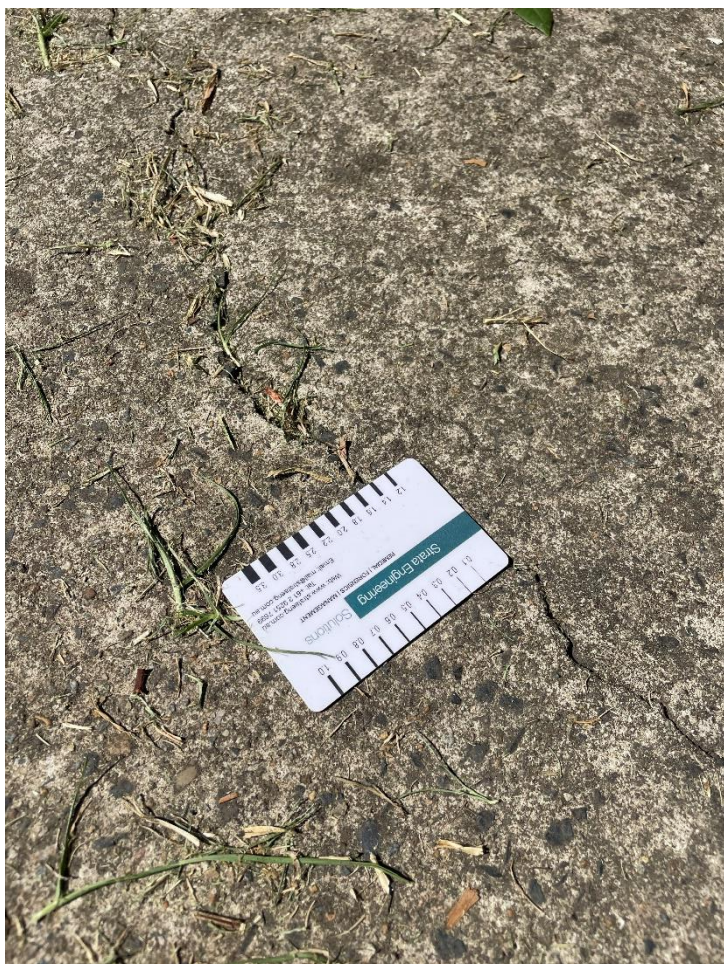
**PHOTO 14**

| ITEM | Pre-Construction Dilapidation Inspection<br>6 March 2023 | PHOTO |
|---|---|---|
| 1.2.3 | Cracking to path measured to be approx. 1.4mm wide. | <b>14-15</b> |

Cracking to path measured  
to be approx. 1.4mm wide.

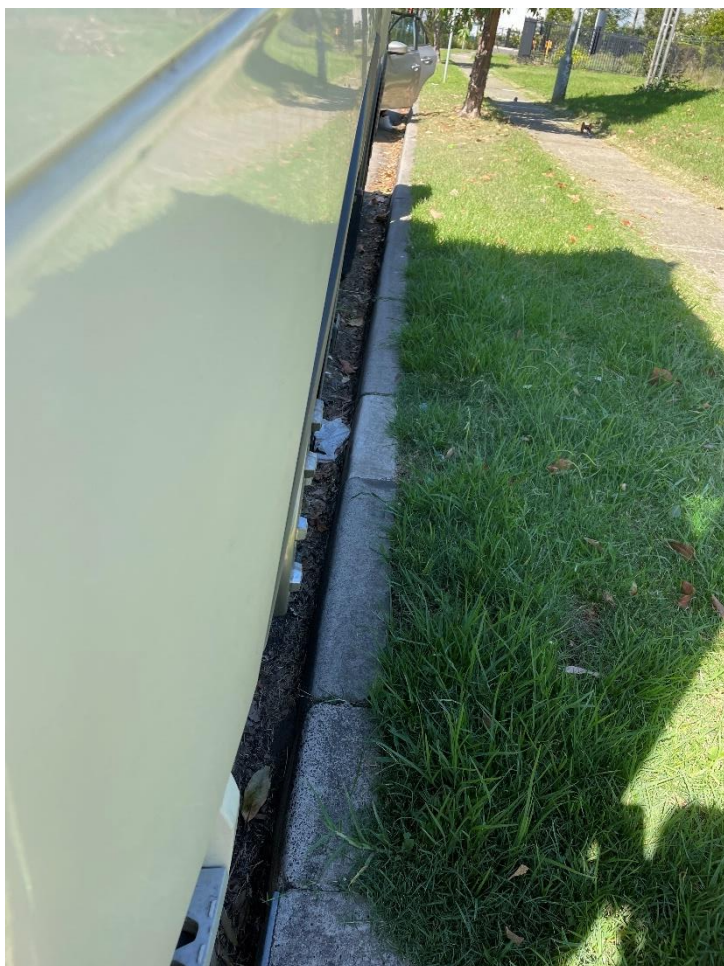
**PHOTO 15**

Cracking to path measured  
to be approx. 1.4mm wide.

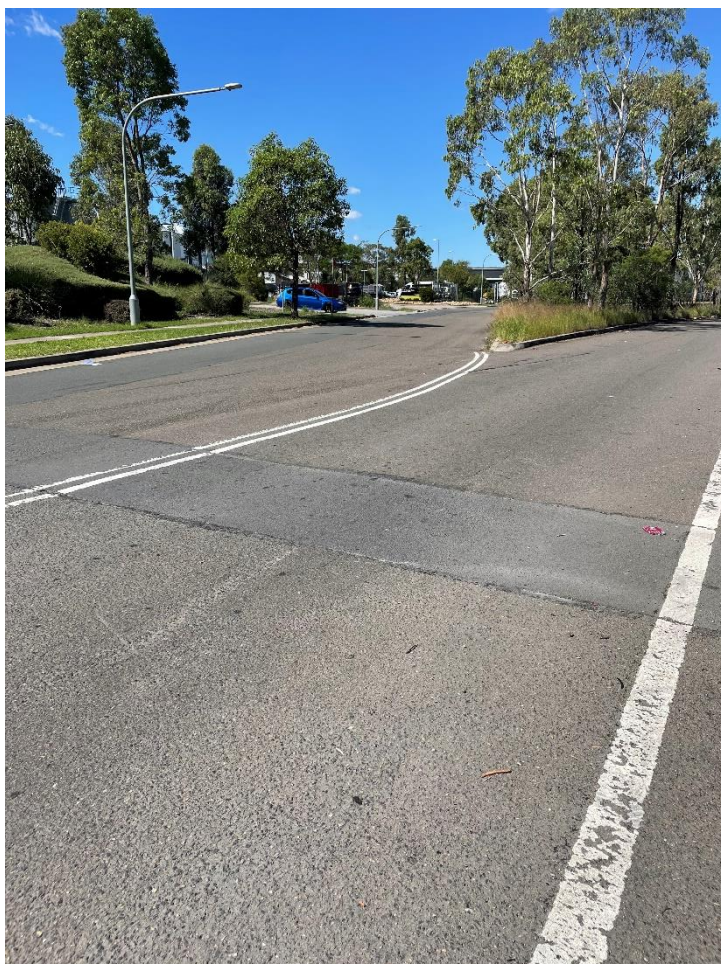
| ITEM | Pre-Construction Dilapidation Inspection<br>6 March 2023 | PHOTO |
|---|---|---|
| 1.2.7 | Cracking adjacent kerb measured to be approx. 1.2mm wide. | <b>19</b> |

Cracking adjacent kerb  
measured to be approx.  
1.2mm wide.

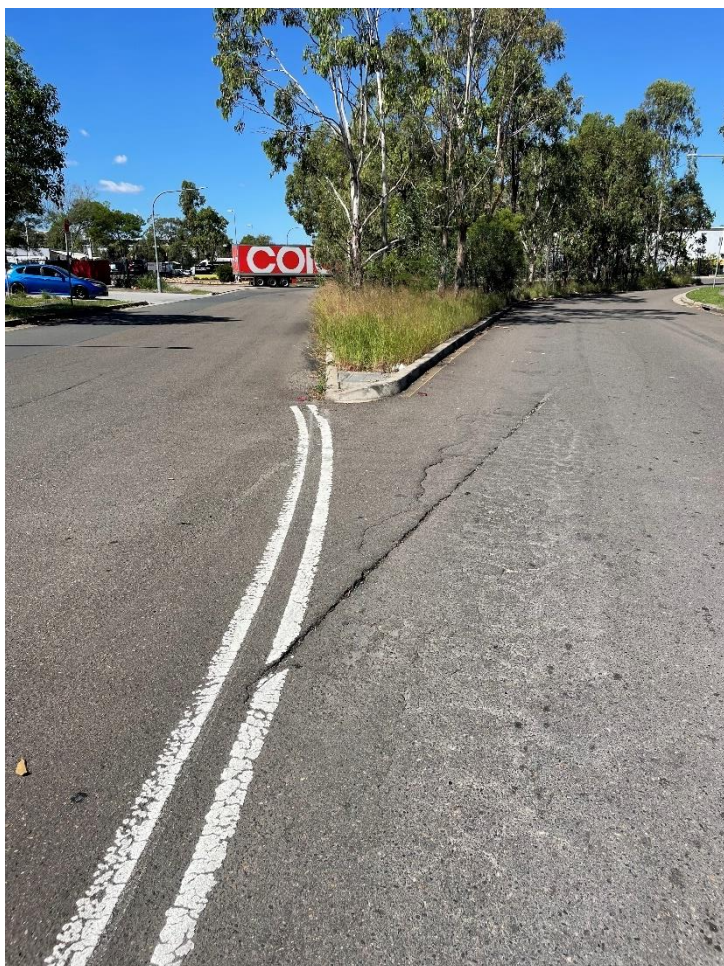
| 1.2.9 | Cracking to road measured to be approx. 8mm wide. | 21 |

Cracking to road measured  
to be approx. 8mm wide.

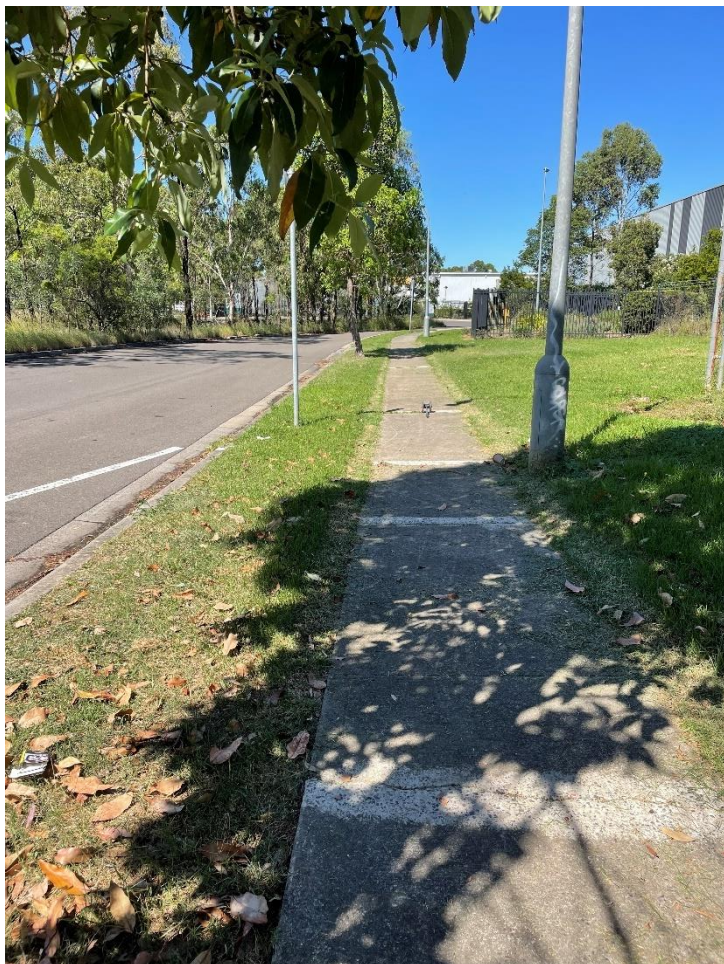
**PHOTO 22**

| 1.2.10 | Cracking to road observed. | 22 |

Cracking to road observed.

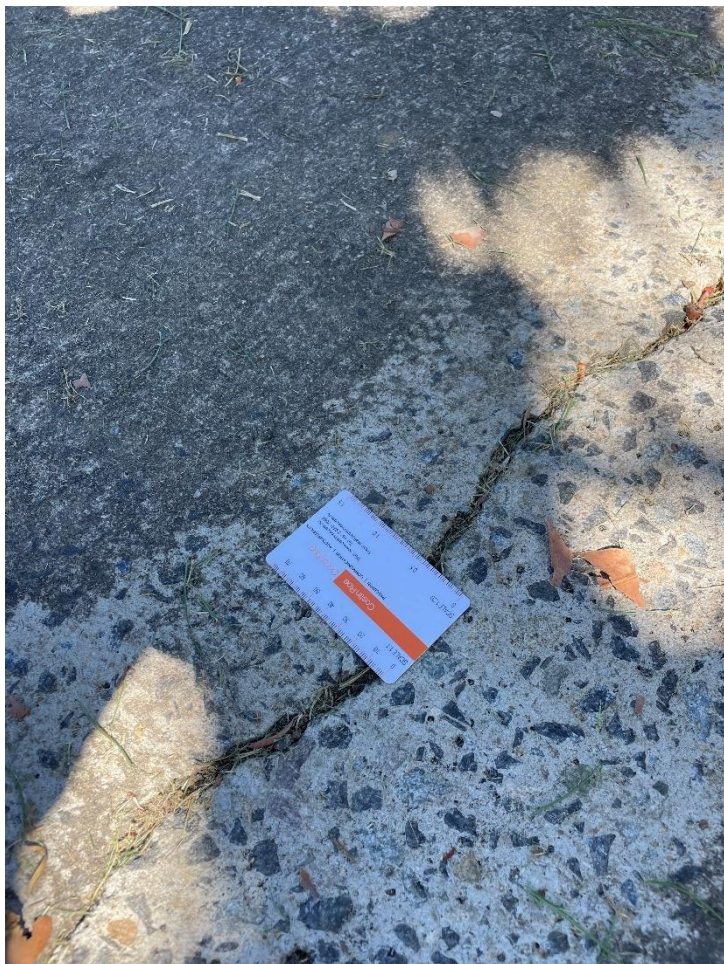
| 1.3.2 | Cracking to path measured to be approx. 10mm wide. | 24-25 |

Cracking to path measured to be approx. 10mm wide.

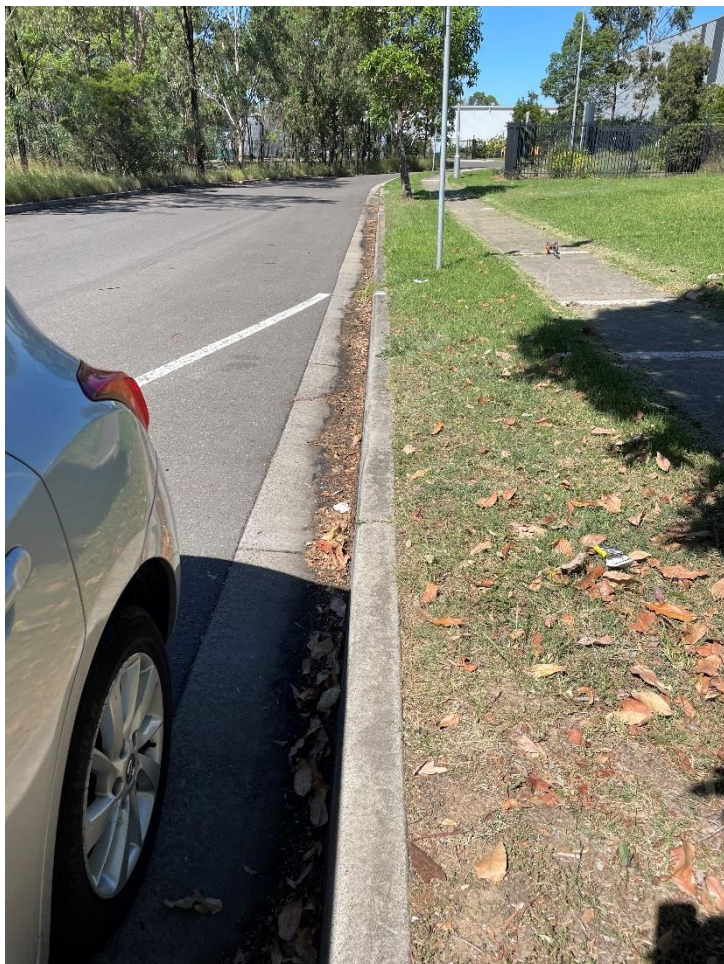
**PHOTO 25**

Cracking to path measured  
to be approx. 10mm wide.

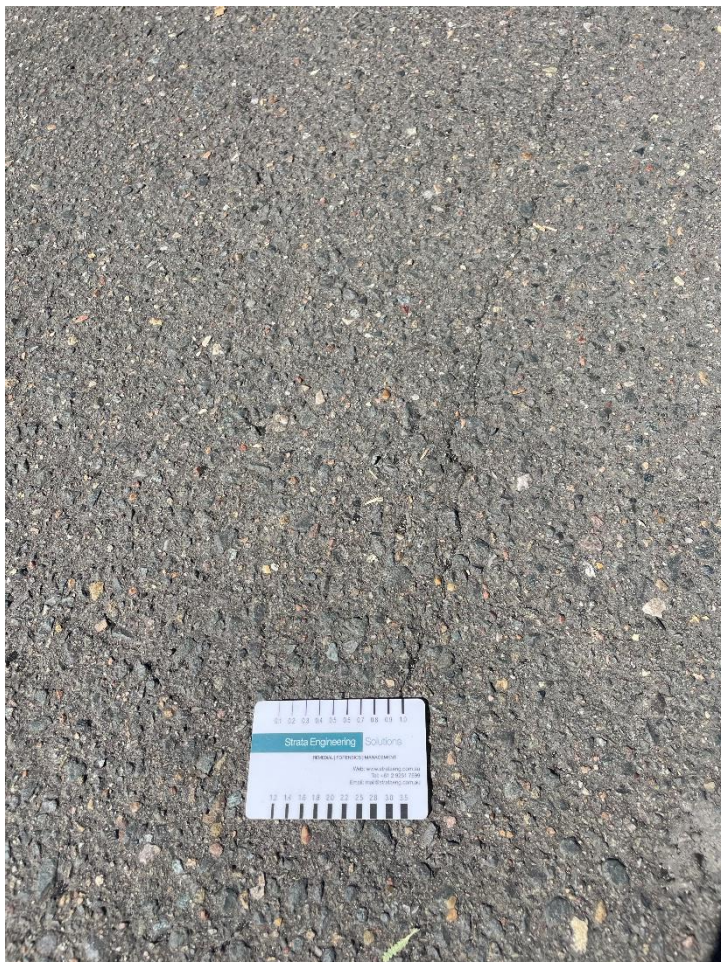
| 1.3.6 | Cracking to road measured to be approx. 1.0mm wide. | 29-30 |

Cracking to road measured  
to be approx. 1.0mm wide.

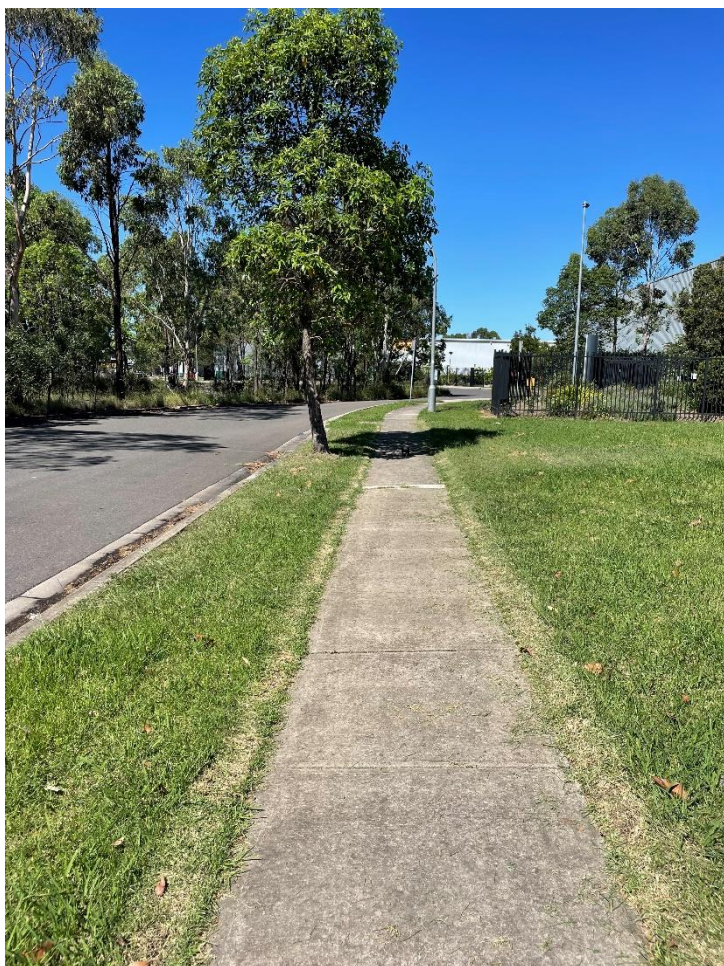
**PHOTO 30**

Cracking to road measured  
to be approx. 1.0mm wide.

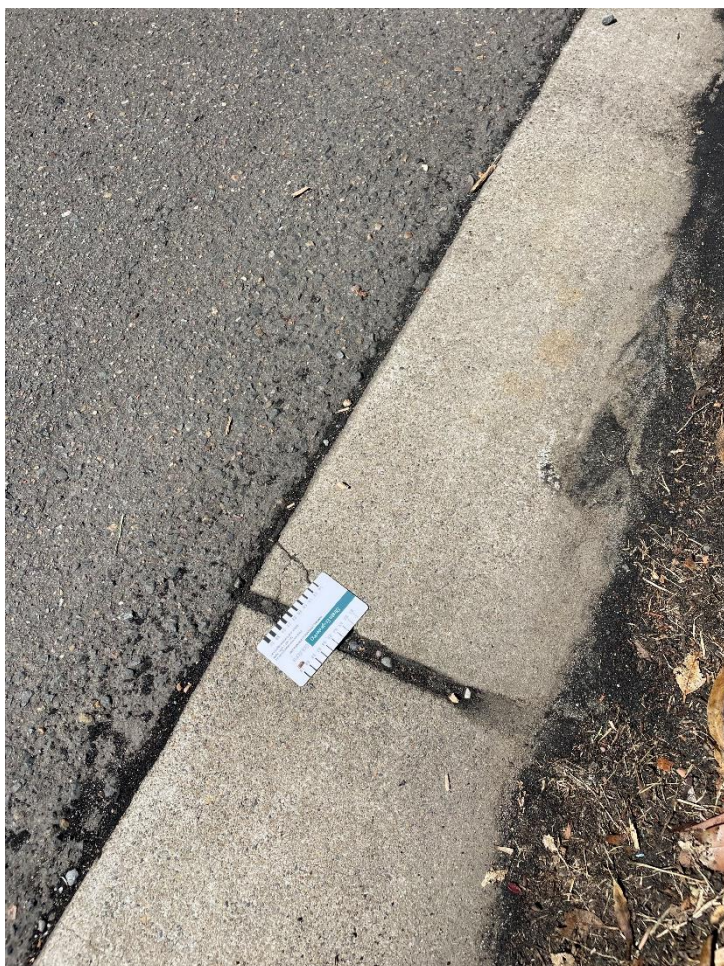
| 1.4.3 | Fretting and cracking adjacent kerb measured to be approx. 1.2mm | 33-34 |

Fretting and cracking  
adjacent kerb measured to  
be approx. 1.2mm

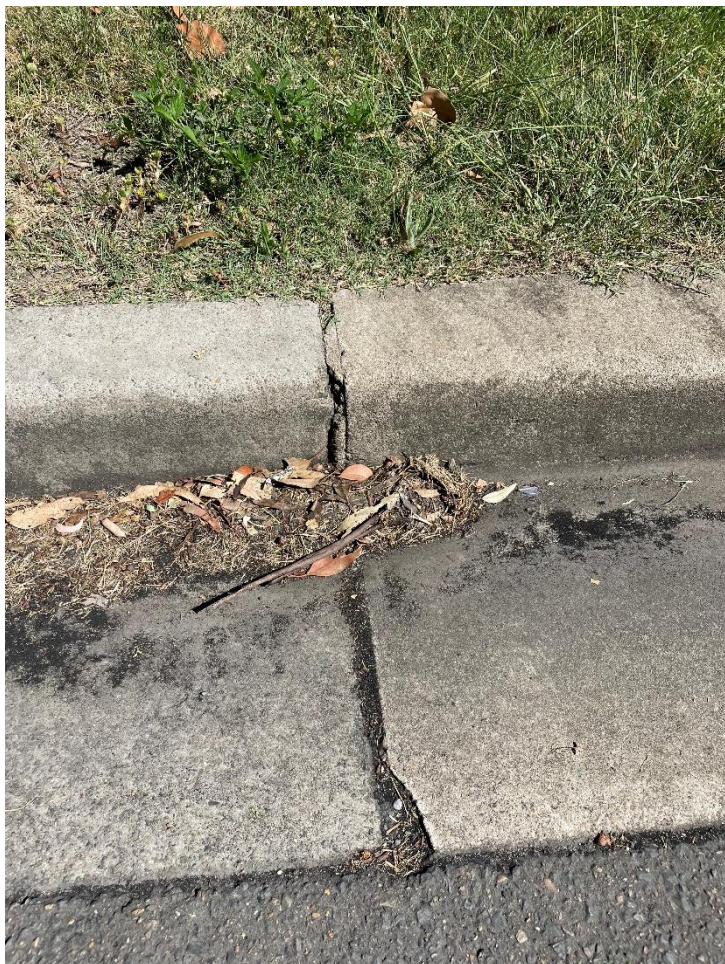
**PHOTO 34**

Fretting and cracking  
adjacent kerb measured to  
be approx. 1.2mm

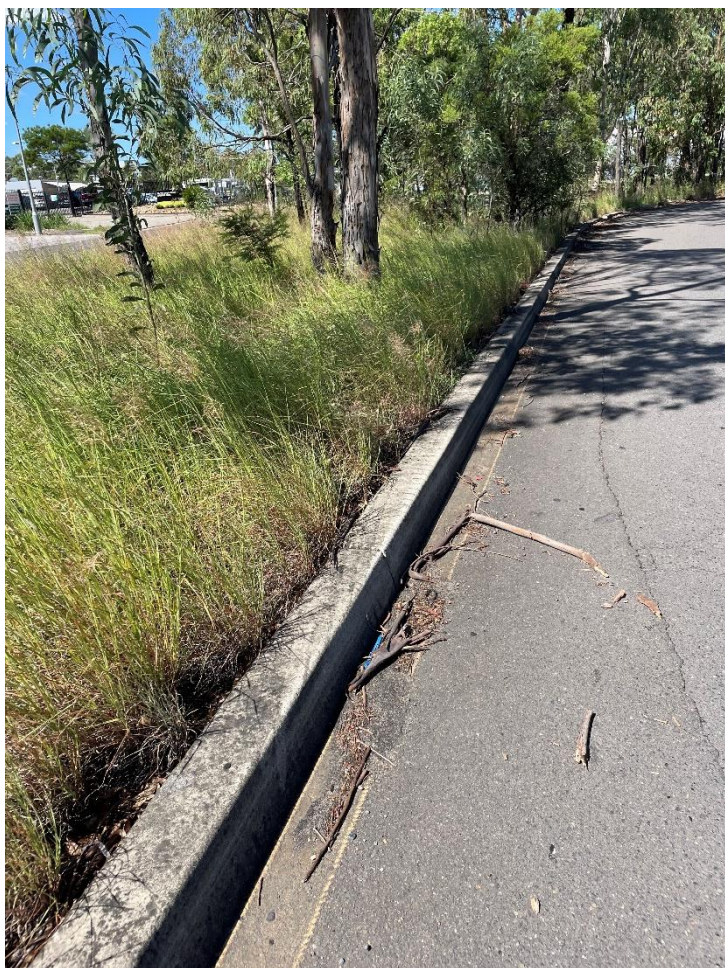
**PHOTO 35**

| 1.4.4 | Fretting to kerb observed. | 35 |

Fretting to kerb observed.

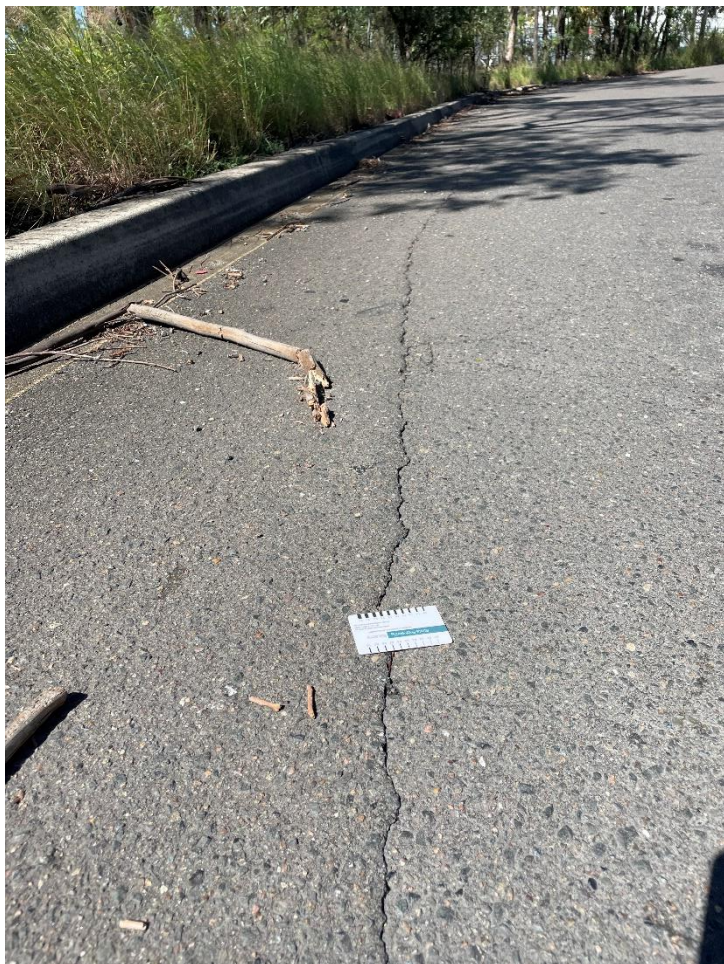
| 1.4.7 | Alligator cracking to road observed. | 38 |

Alligator cracking to road observed.

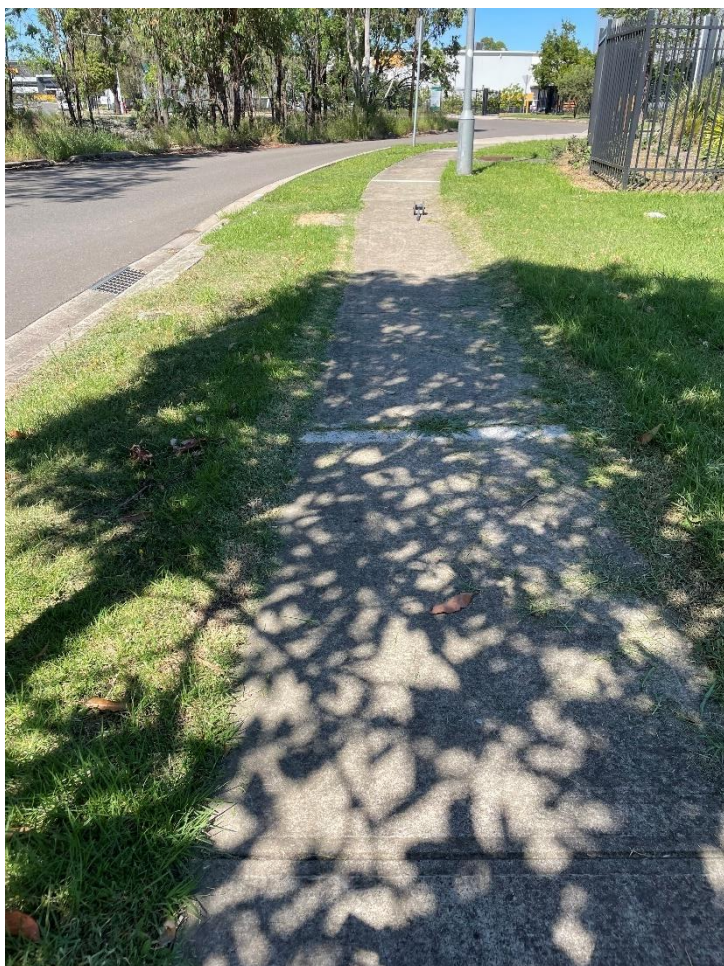
**PHOTO 39**

| 1.4.8 | Cracking to road measured to be approx. 2.5mm wide. | 39 |

Cracking to road measured to be approx. 2.5mm wide.

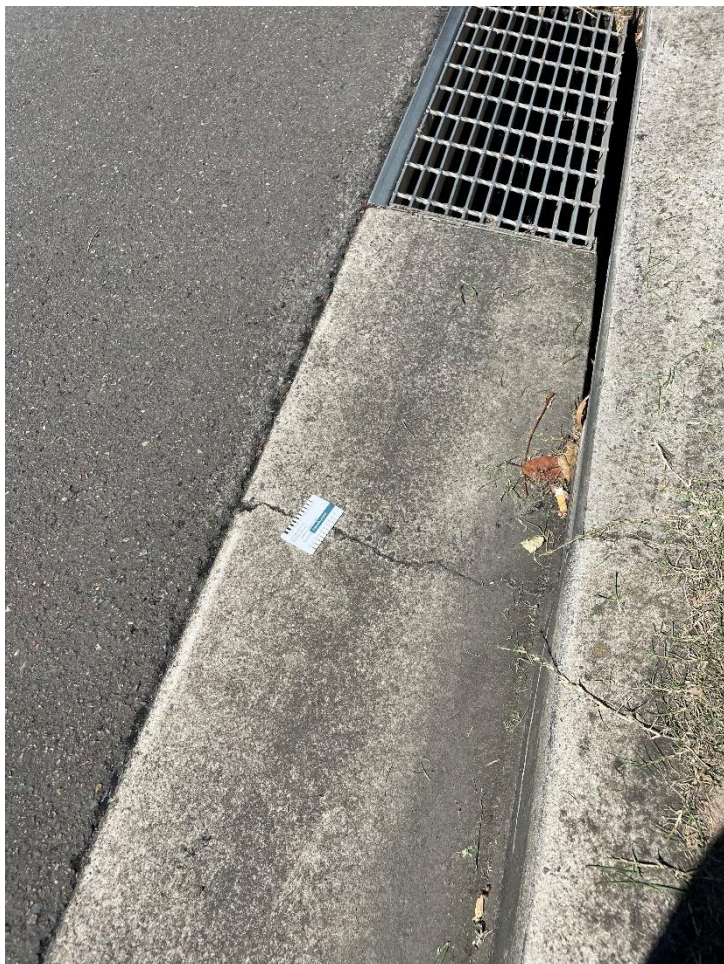
| 1.5.3 | Fretting to kerb observed. | 42 |

Fretting to kerb observed.

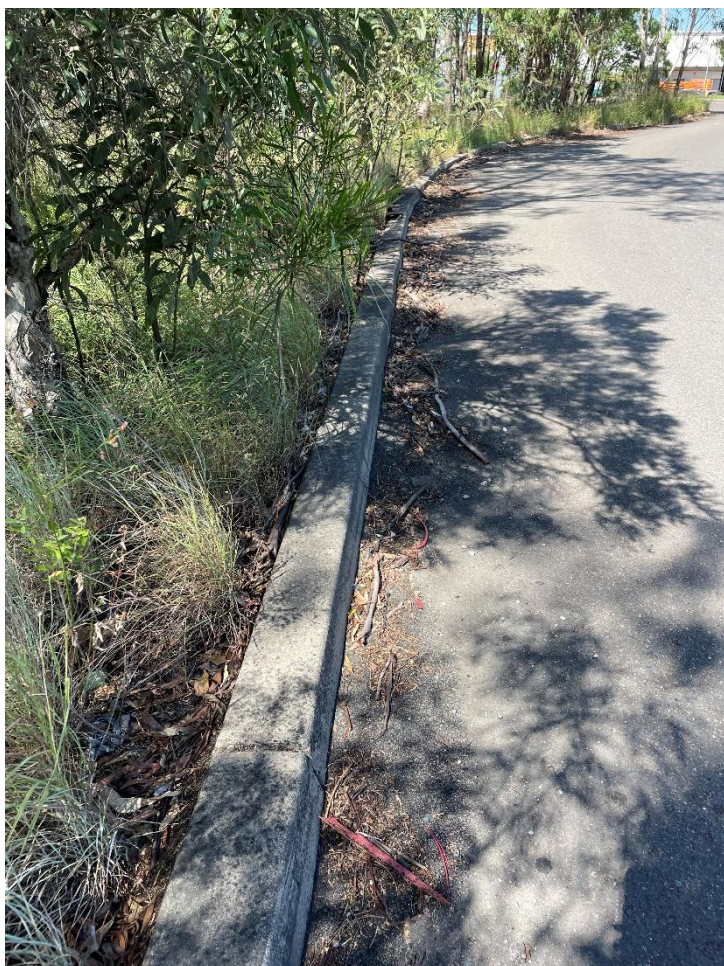
**PHOTO 43**

| 1.5.4 | Cracking adjacent kerb measured to be approx. 2.2mm wide. | 43 |

Cracking adjacent kerb  
measured to be approx.  
2.2mm wide.

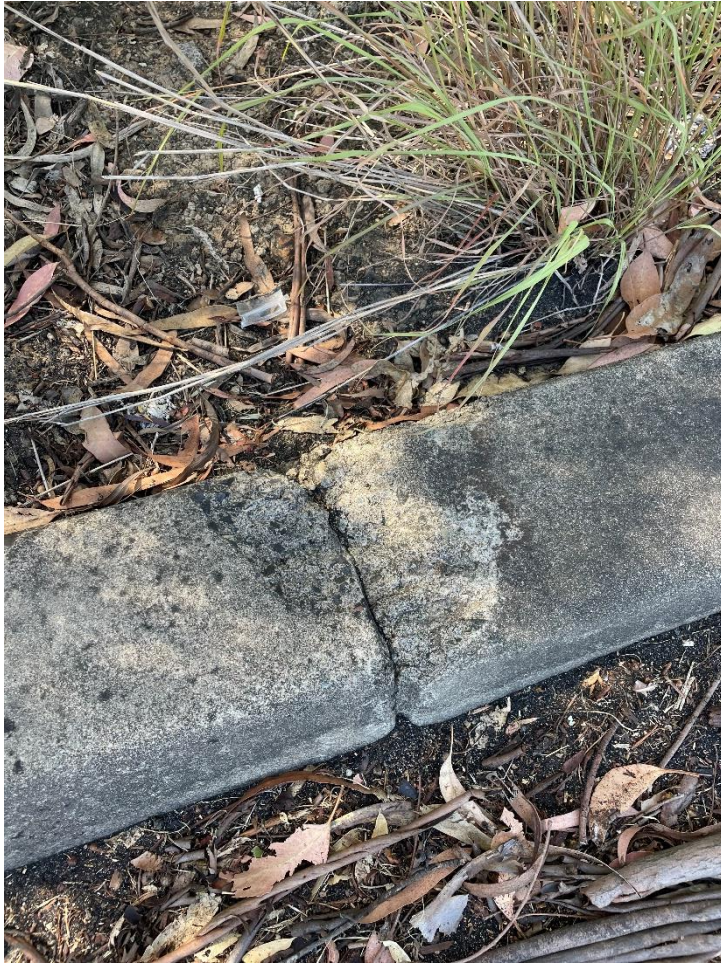
| 1.5.7 | Cracking to kerb measured to be approx. 1.6mm wide. | 46 |

Cracking to kerb measured  
to be approx. 1.6mm wide.

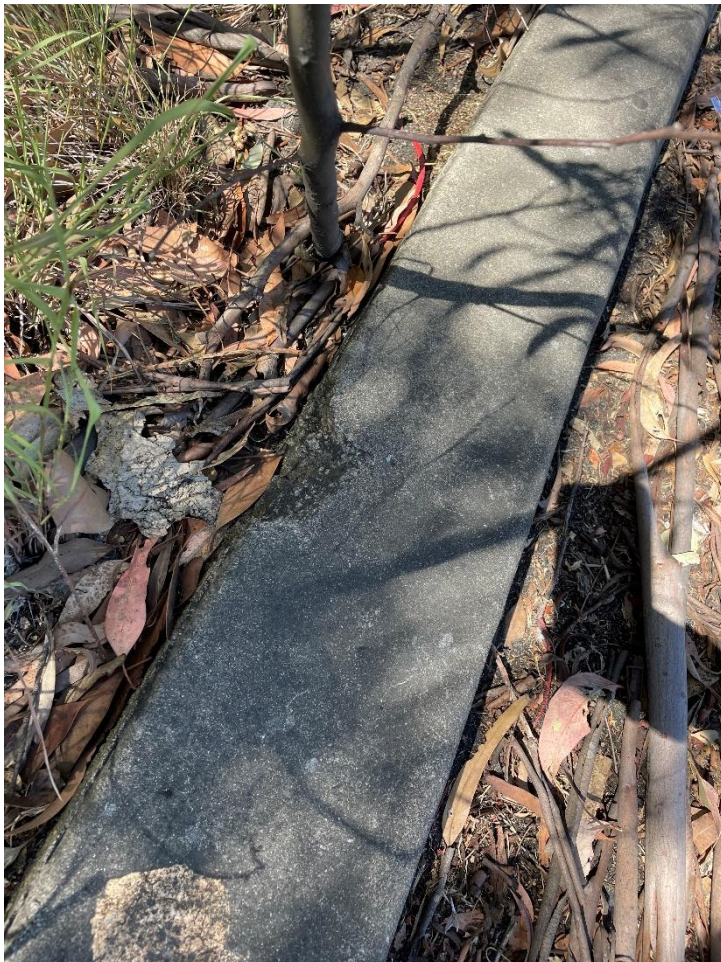
**PHOTO 47**

| 1.5.8 | Fretting to kerb observed. | 47 |

Fretting to kerb observed.

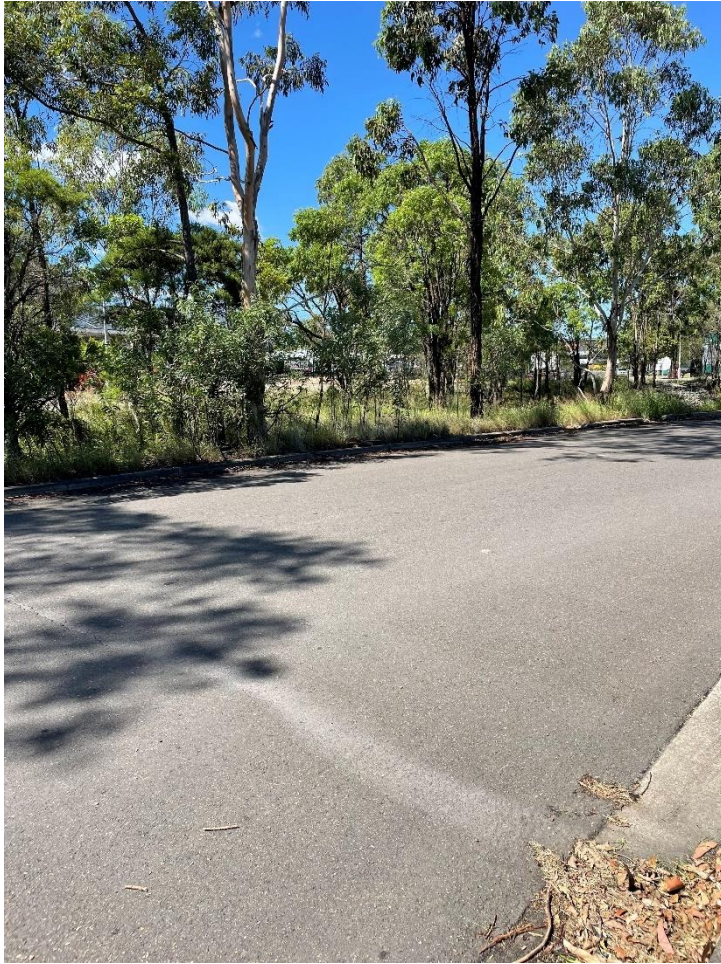
**PHOTO 48**

| 1.5.9 | Damage to kerb observed. | 48 |

Damage to kerb observed.

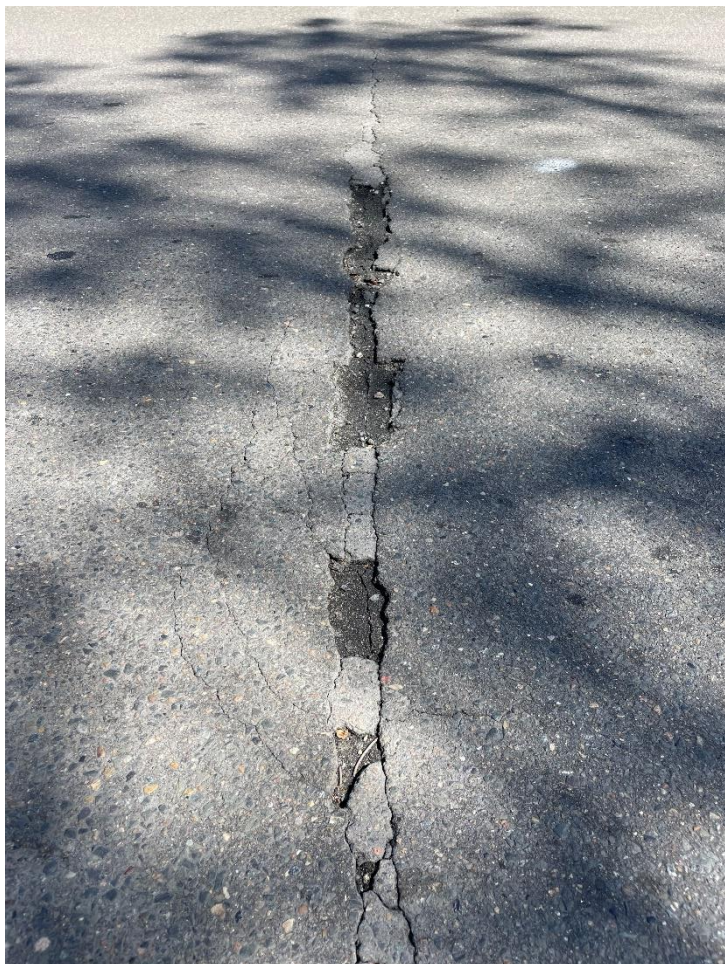
| 1.5.11 | Cracking and fretting to road observed. | 50-51 |

Cracking and fretting to road observed.

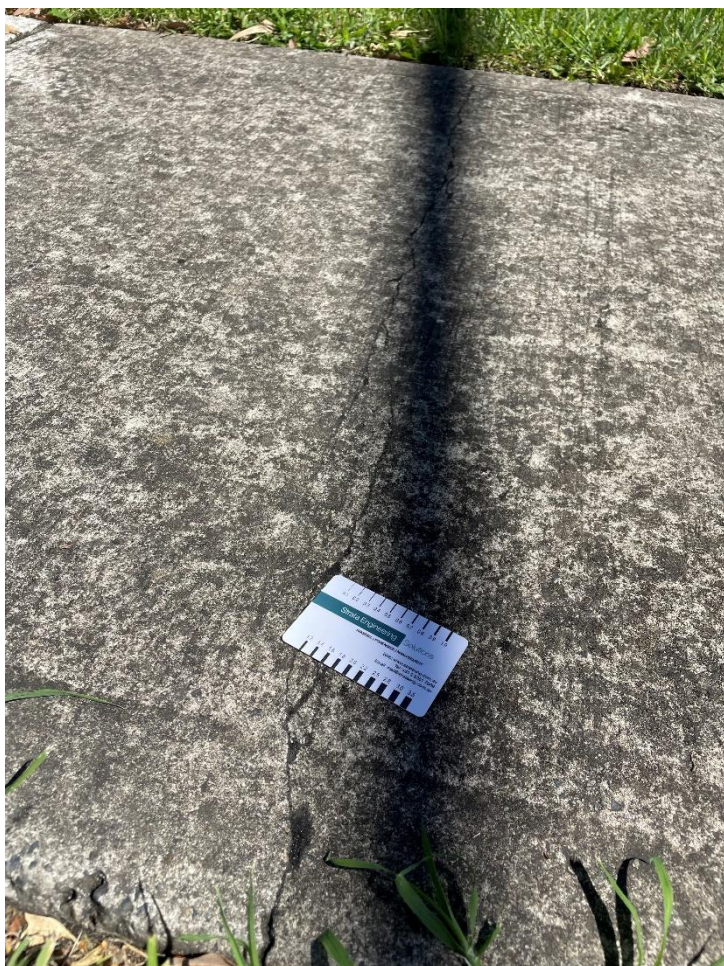
| 1.6.2 | Cracking to path measured to be approx. 1.8mm wide. | 53-54 |

Cracking to path measured  
to be approx. 1.8mm wide.

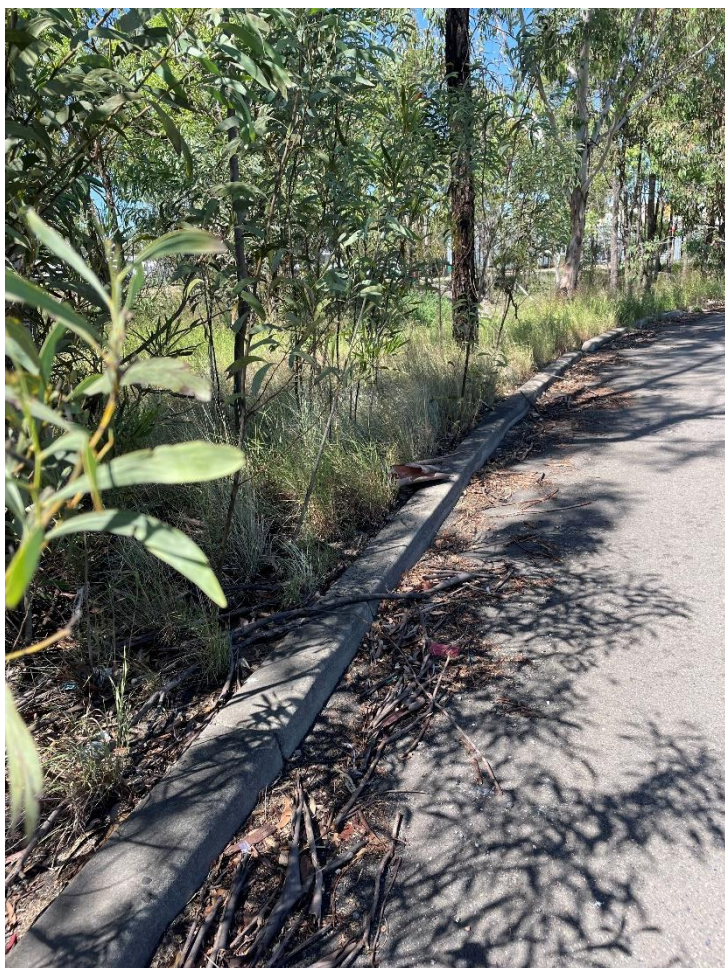
| 1.6.4 | Fretting to kerb observed. | 57 |

Fretting to kerb observed.

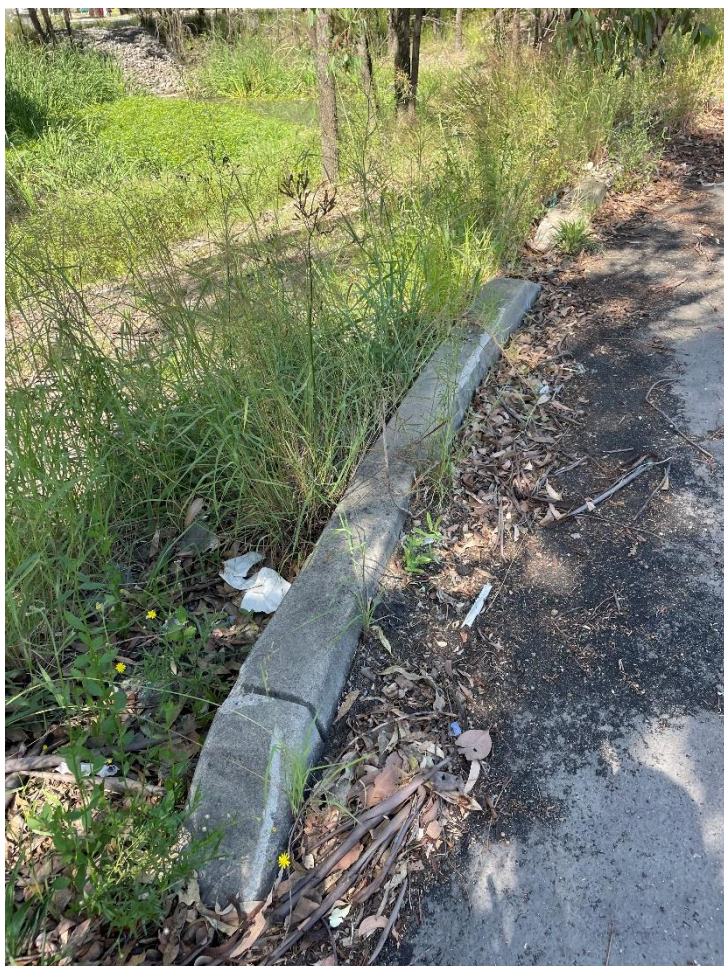
| 1.6.6 | Cracking to kerb measured to be approx. 1.8mm wide. | 61 |

Cracking to kerb measured  
to be approx. 1.8mm wide.

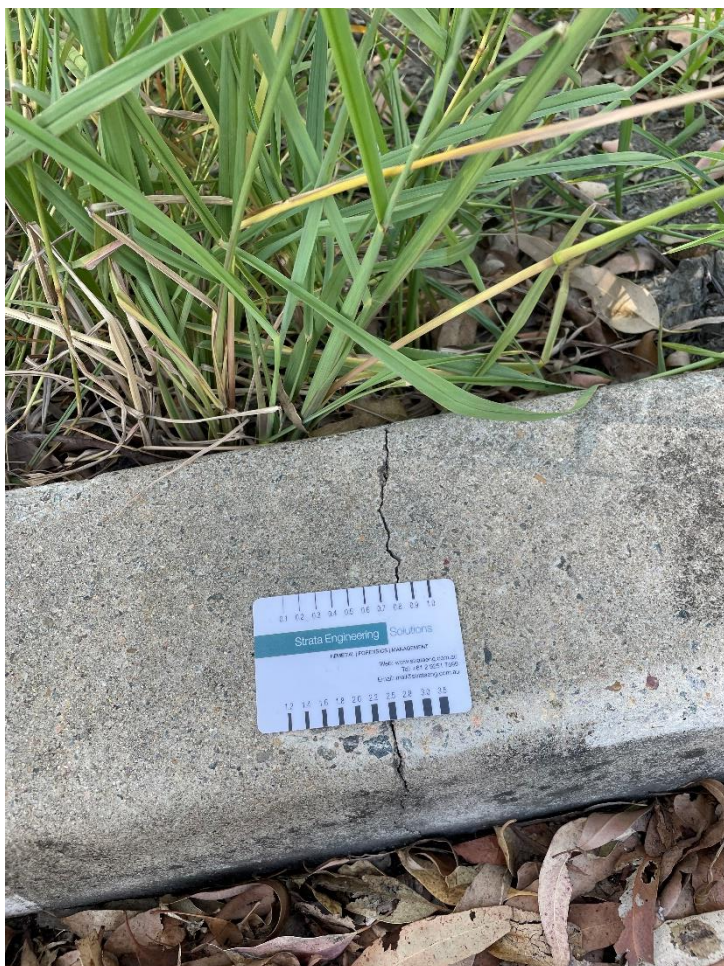
| 1.6.8 | Fretting to kerb observed. | 63 |

Fretting to kerb observed.

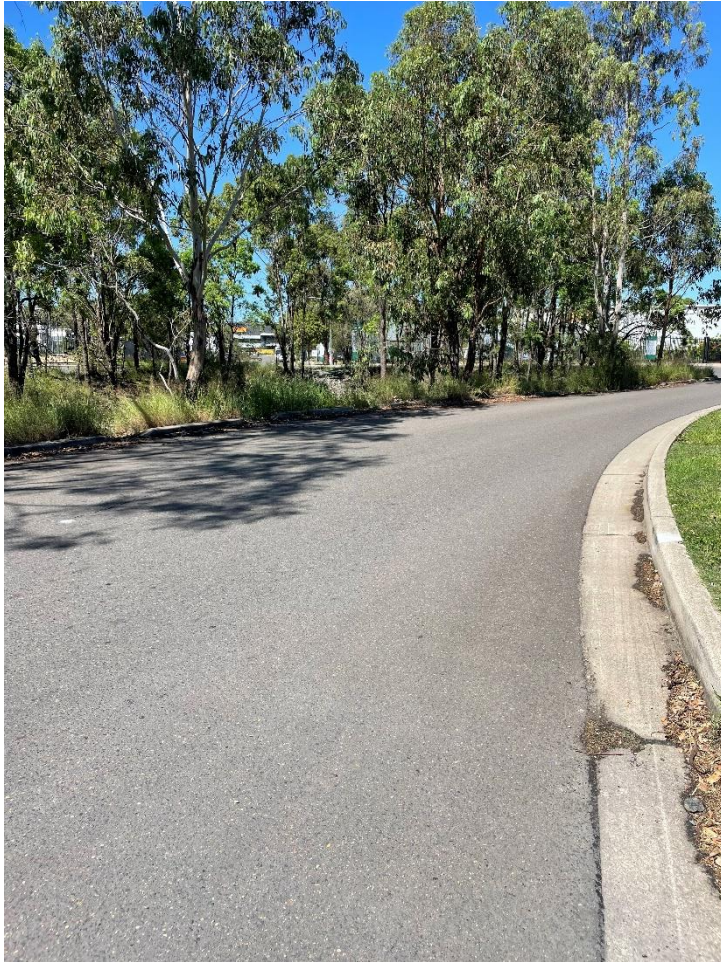
**PHOTO 64**

| 1.6.9 | Cracking to kerb measured to be approx. 0.8mm wide. | 64 |

Cracking to kerb measured  
to be approx. 0.8mm wide.
