## PRE-CONSTRUCTION DILAPIDATION REPORT

### Bluescope Proposed Entry Crossover

### 55 Templar Rd, Erskine Park NSW

**Reference:** CO8332.11-02.rpt

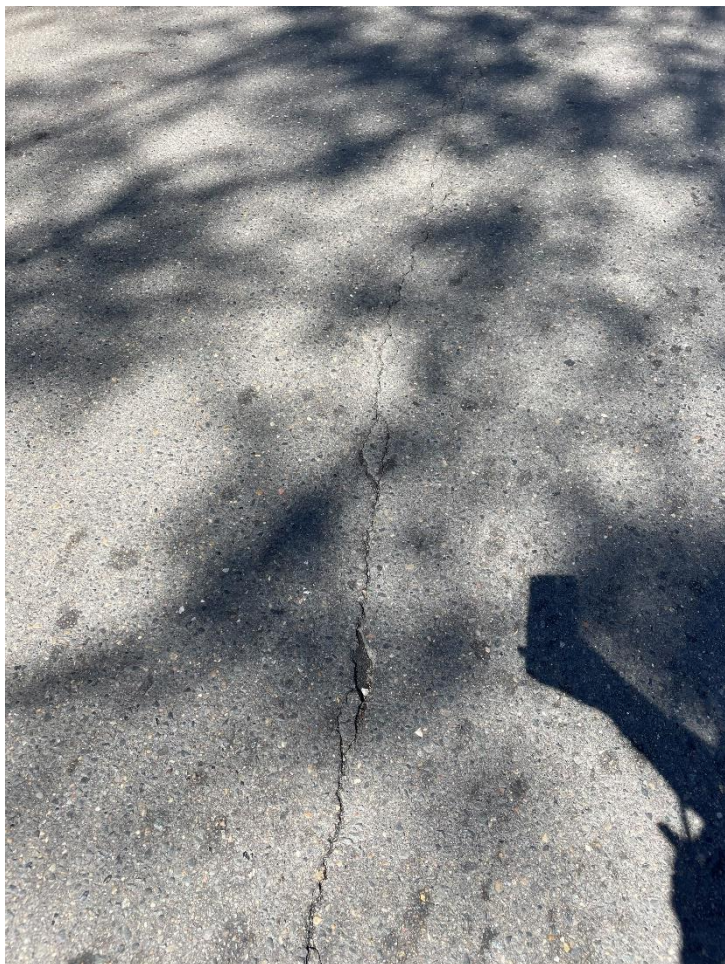
| 1.6.11 | Cracking to road measured to be approx. 3.5mm wide. | 66-68 |

Cracking to road measured to be approx. 3.5mm wide.

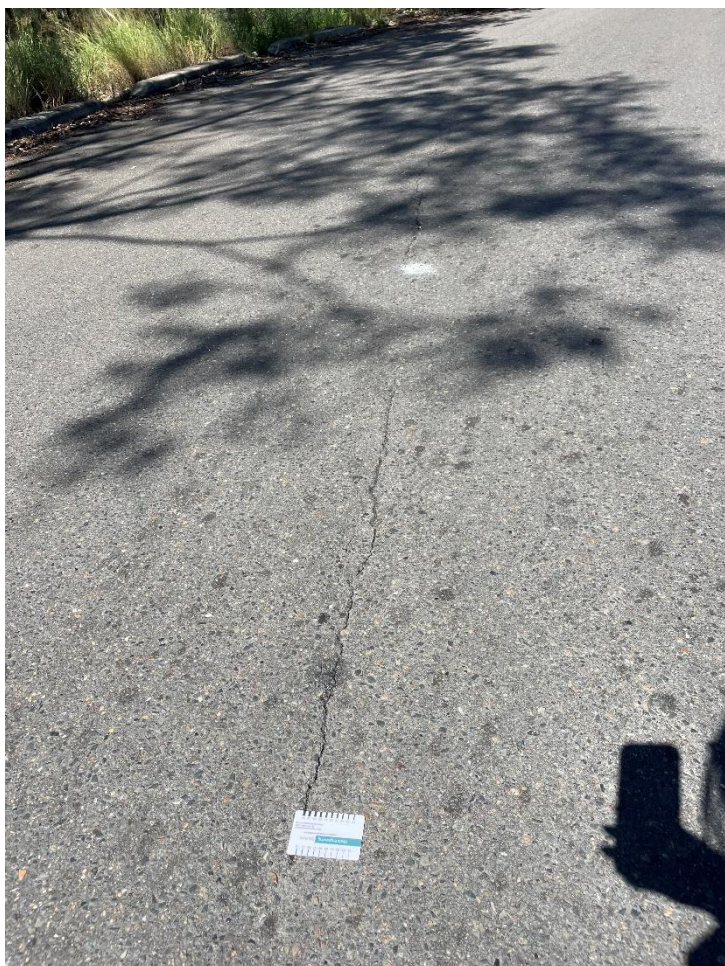
**PHOTO 67**

Cracking to road measured  
to be approx. 3.5mm wide.

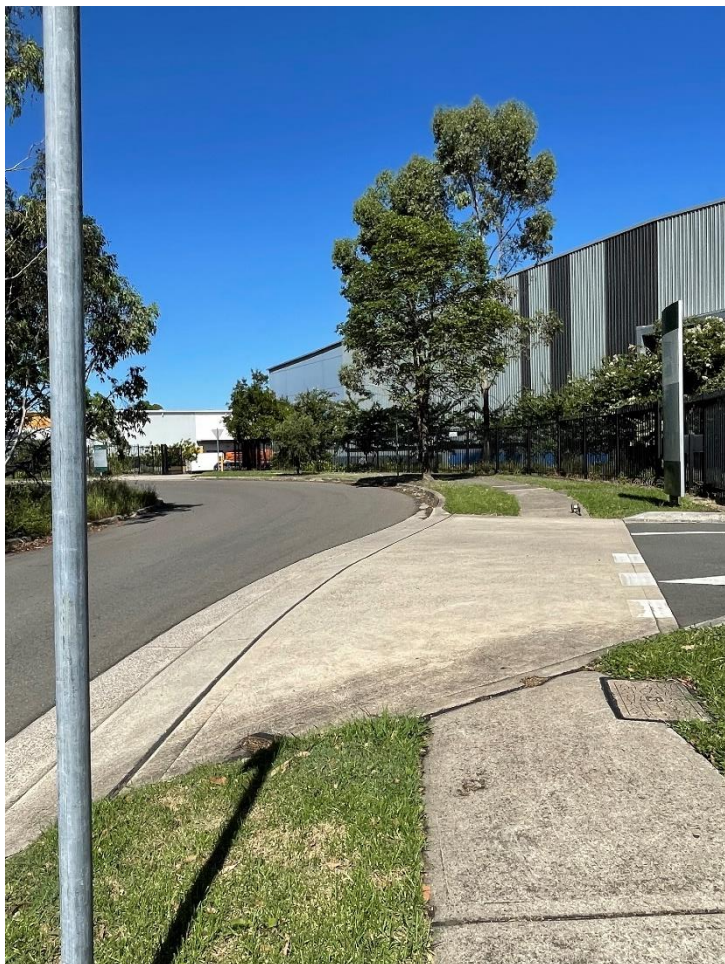
**PHOTO 68**

Cracking to road measured  
to be approx. 3.5mm wide.

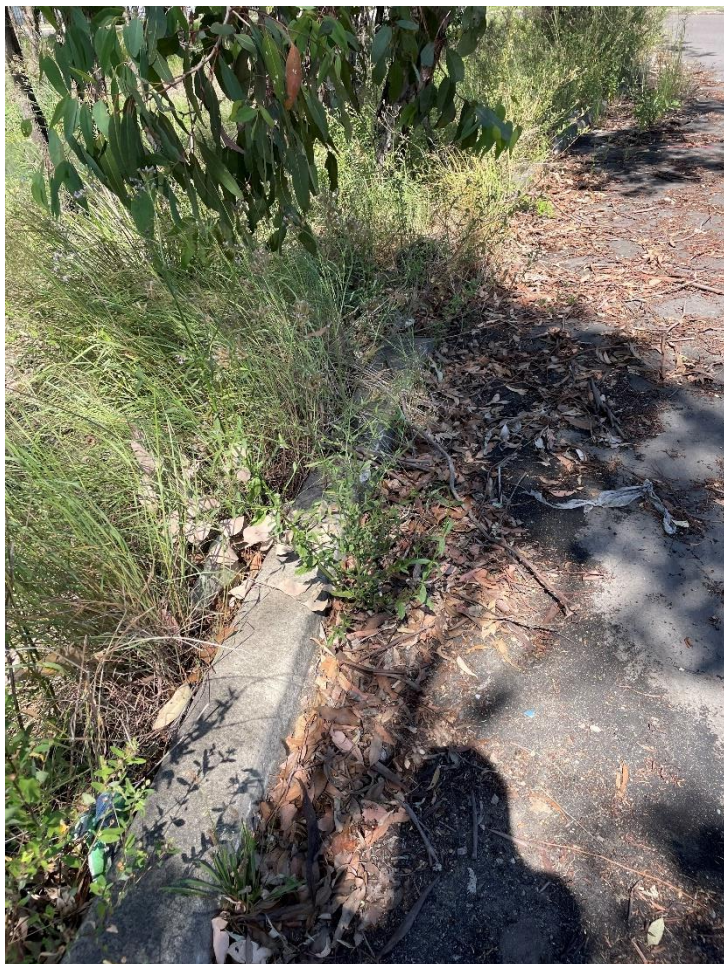
| 1.7.2 | Fretting to kerb observed. | 70 |

Fretting to kerb observed.

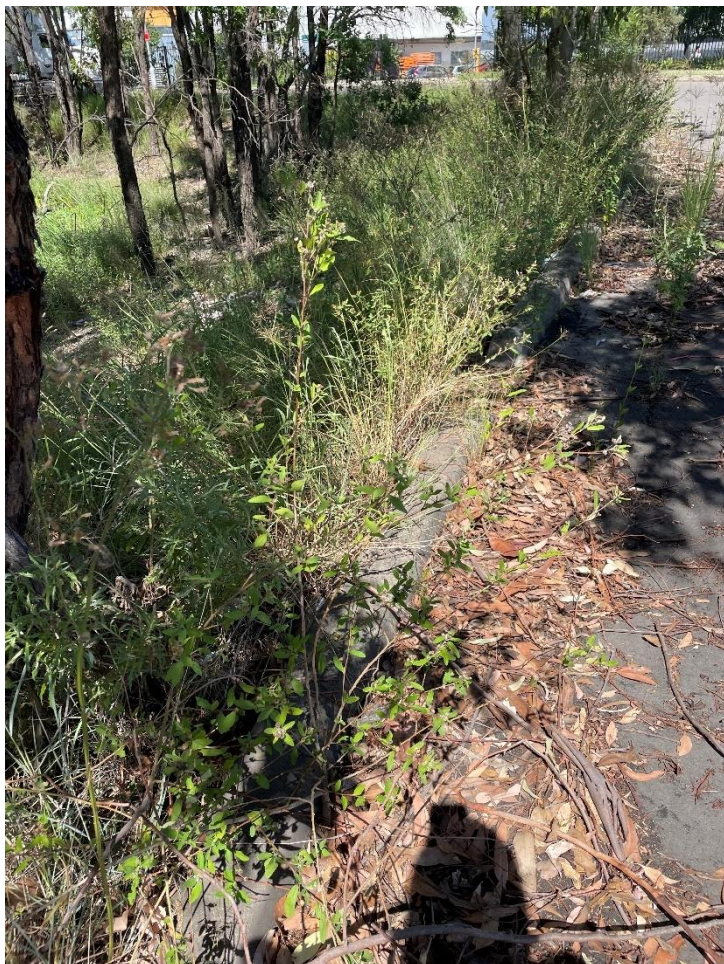
| 1.7.4 | Cracking to kerb measured to be approx. 0.4mm wide. | 72 |

Cracking to kerb measured to be approx. 0.4mm wide.

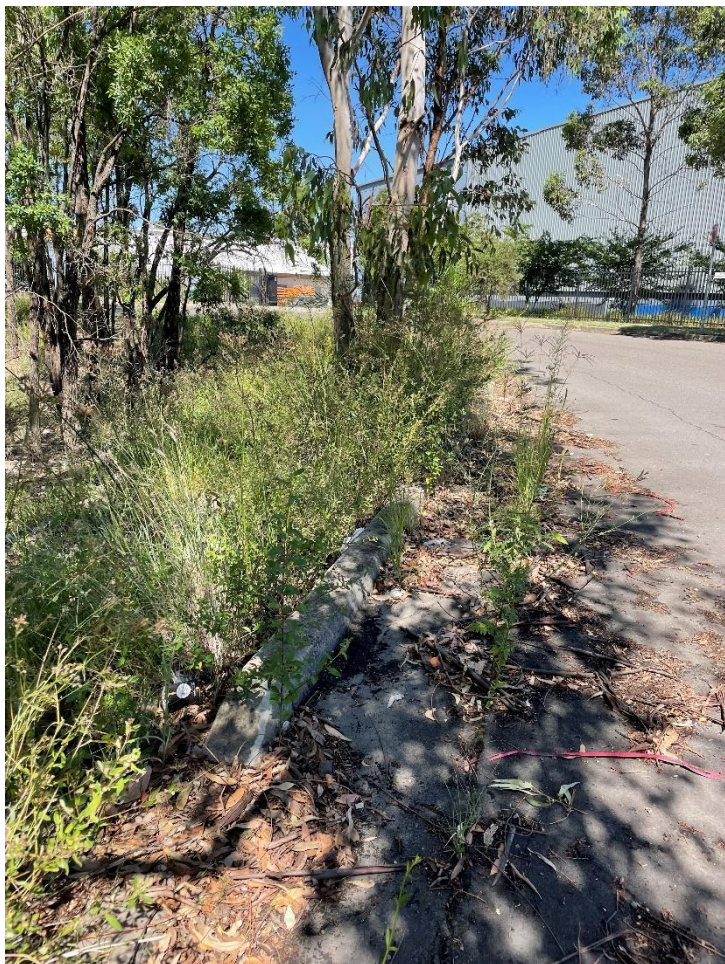
| 1.7.6 | Cracking to kerb measured to be approx. 2.8mm wide. | 74 |

Cracking to kerb measured to be approx. 2.8mm wide.

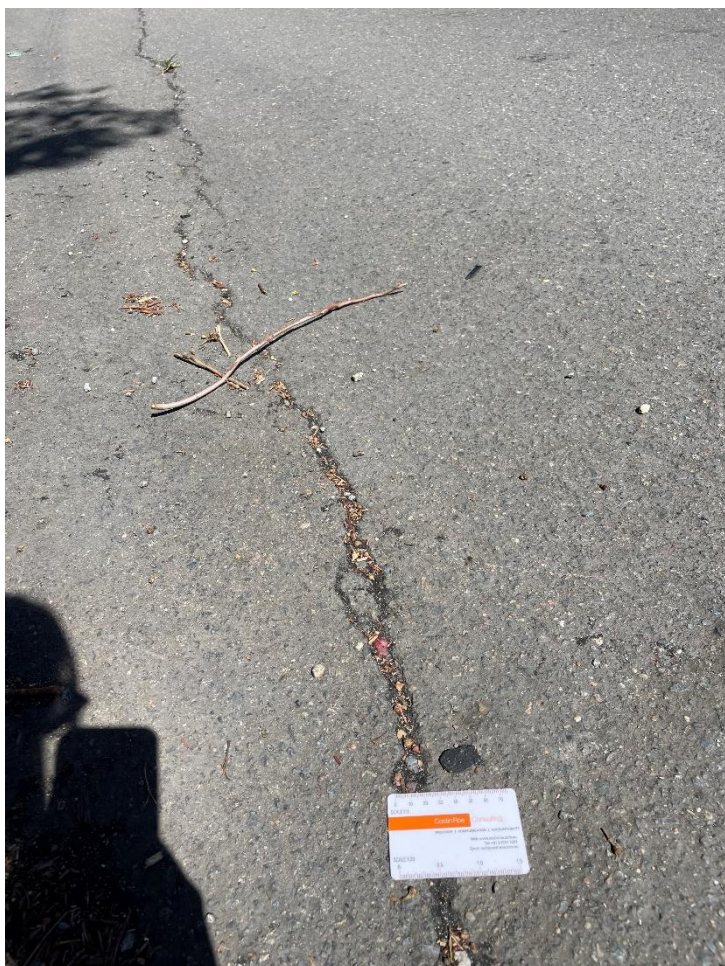
| 1.7.8 | Cracking to road measured to be approx. 20mm wide. | <b>76-78</b> |

Cracking to road measured  
to be approx. 20mm wide.

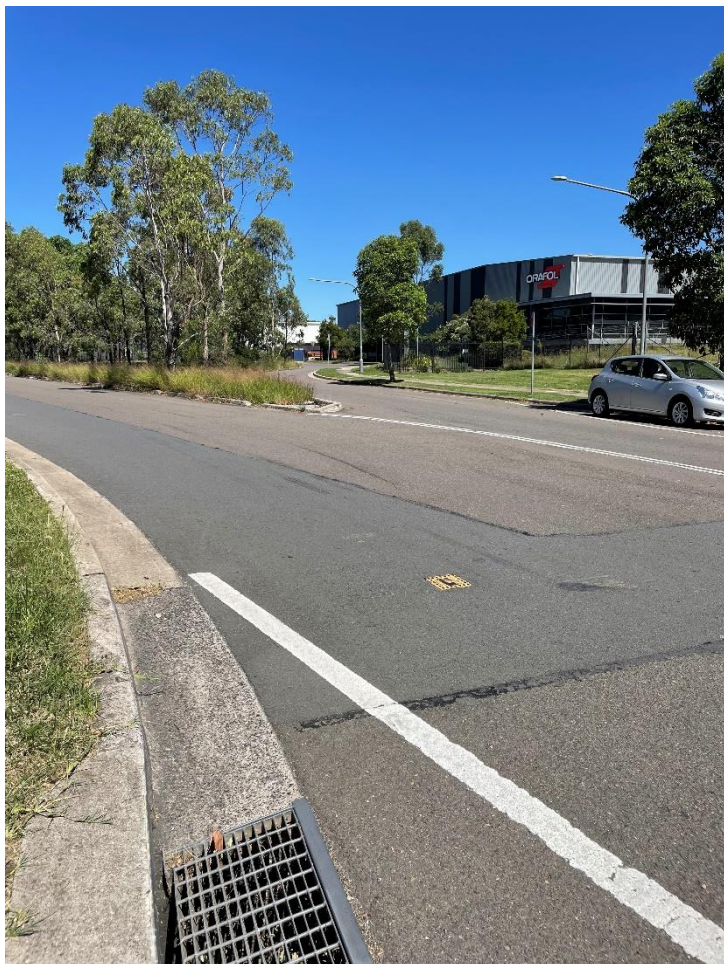
| 2.1.3 | Fretting to kerb observed. | <b>3-4</b> |

Fretting to kerb observed.

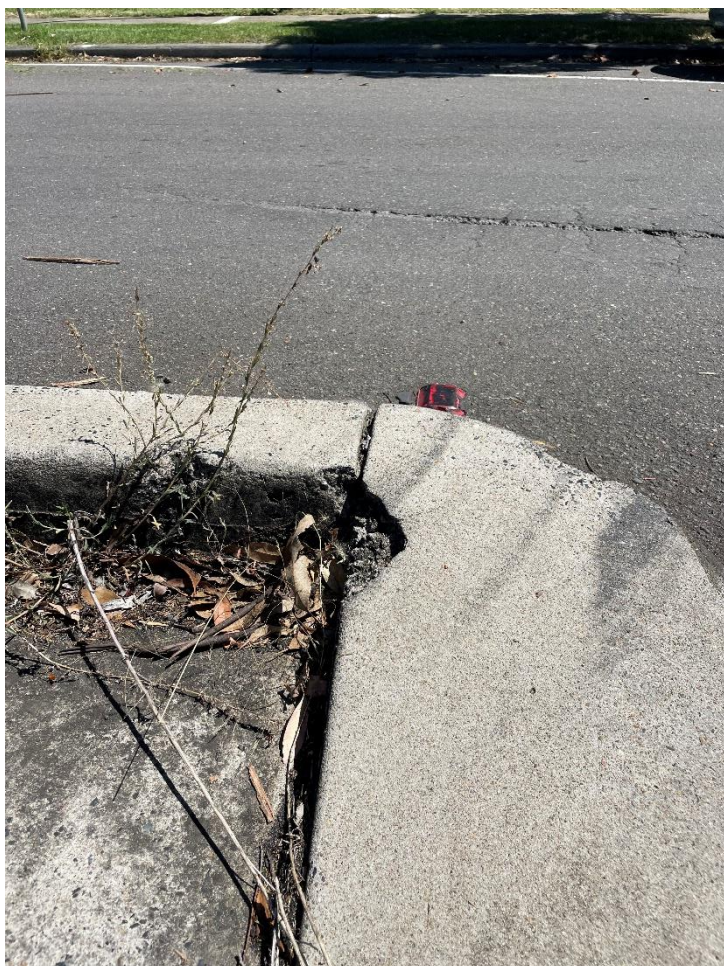
| 2.2.4 | Fretting to kerb observed. | <b>11-12</b> |

Fretting to kerb observed.

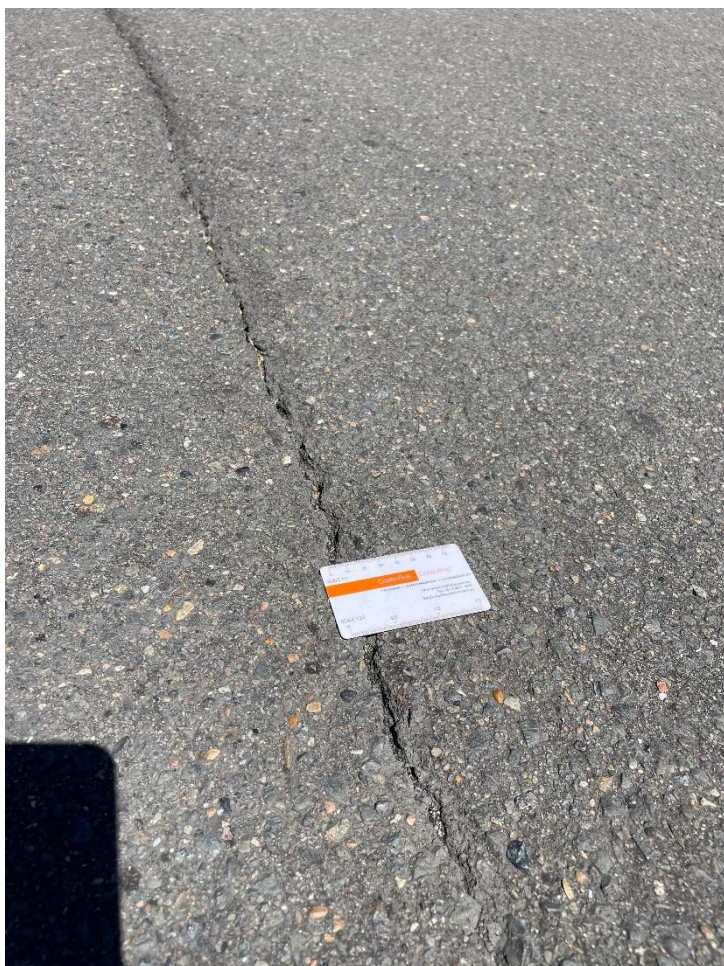
| 2.2.7 | Cracking to road measured to be approx. 15mm wide. | <b>15-16</b> |

Cracking to road measured  
to be approx. 15mm wide.

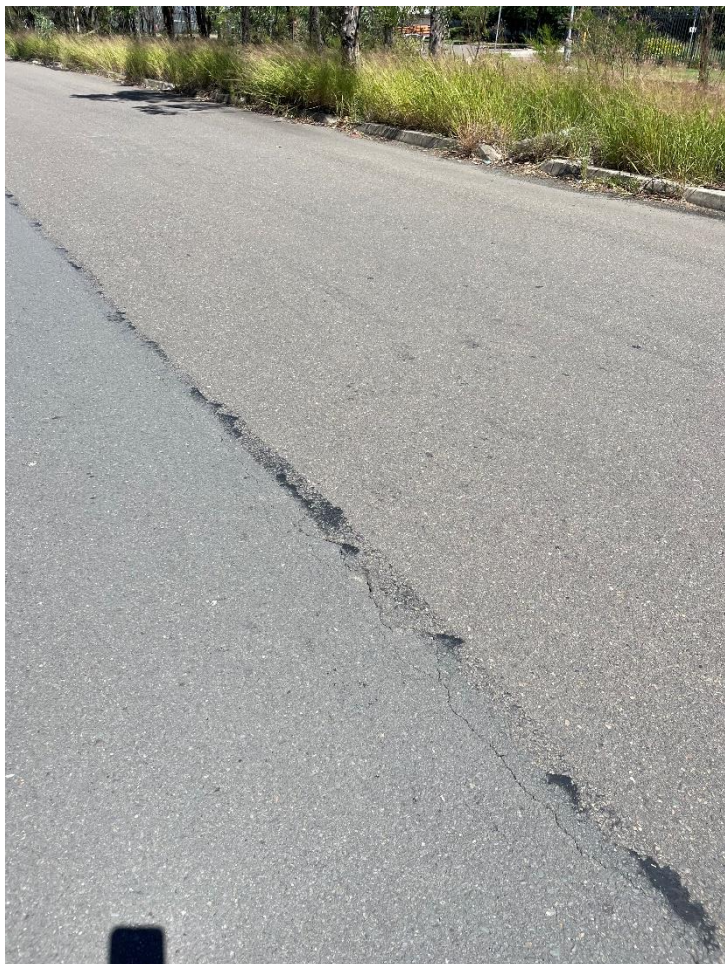
**PHOTO 16**

Cracking to road measured  
to be approx. 15mm wide.

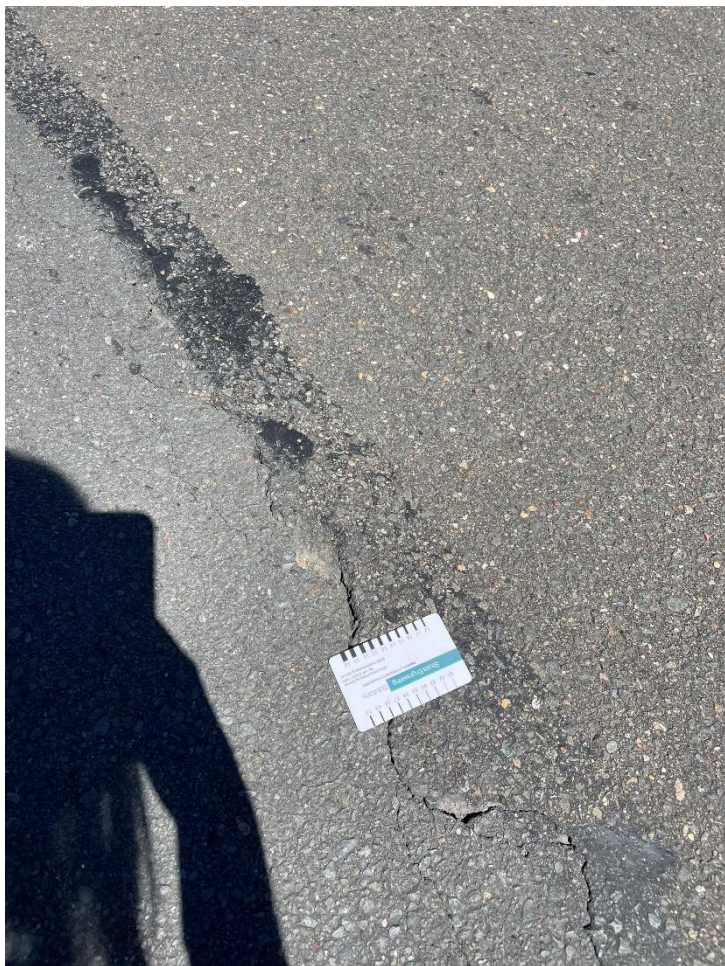
**PHOTO 17**

| 2.2.8 | Cracking to road measured to be approx. 3.0mm wide. | <b>17-18</b> |

Cracking to road measured  
to be approx. 3.0mm wide.

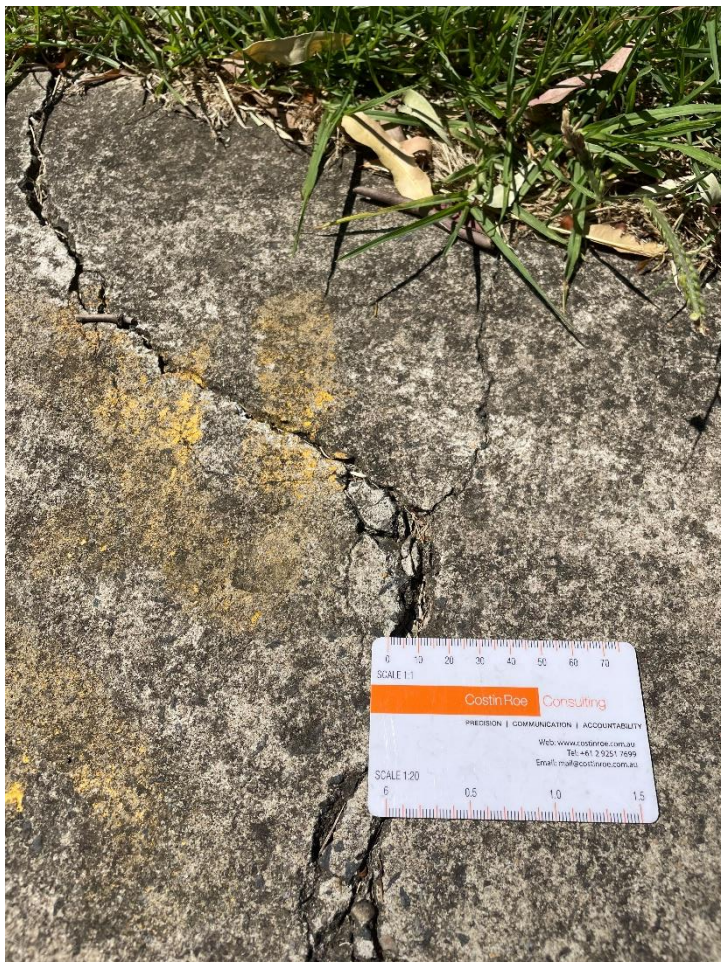
| 2.4.2 | Cracking to path measured to be approx. 8mm wide. | <b>25-26</b> |

Cracking to path measured  
to be approx. 8mm wide.

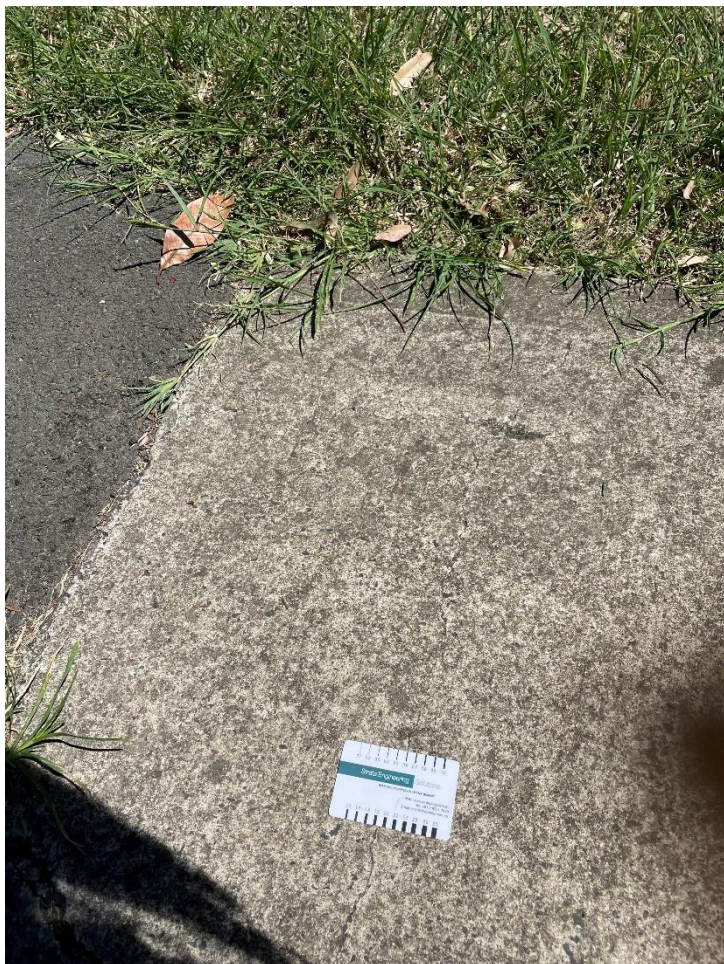
**PHOTO 26**

Cracking to path measured  
to be approx. 8mm wide.

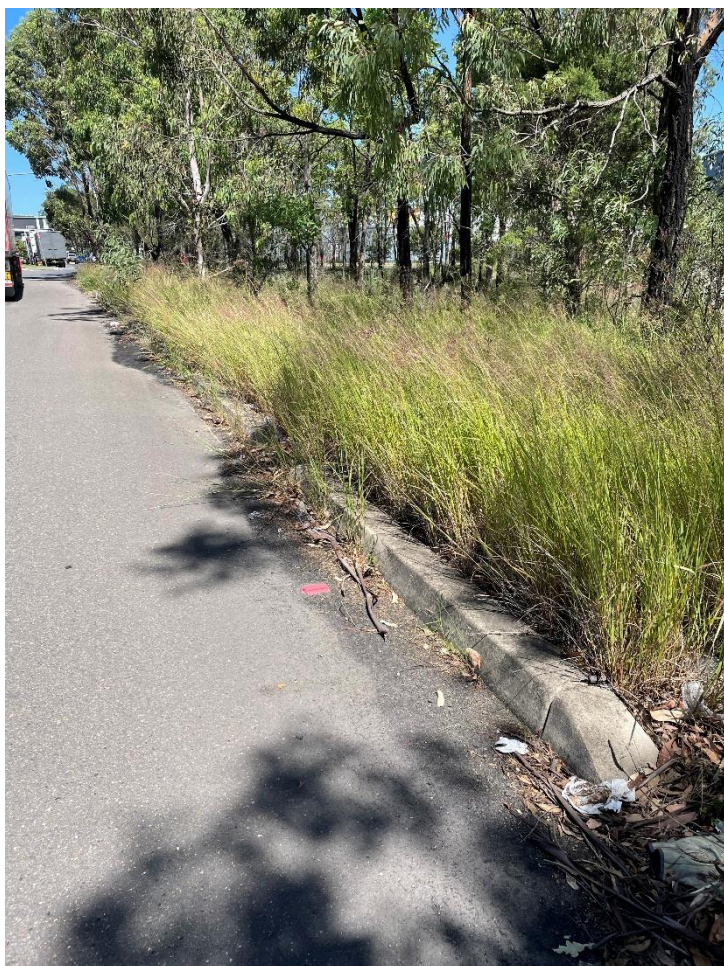
**PHOTO 27**

| 2.4.3 | Cracking to path measured to be approx. 1.6mm wide. | <b>27</b> |

Cracking to path measured  
to be approx. 1.6mm wide.

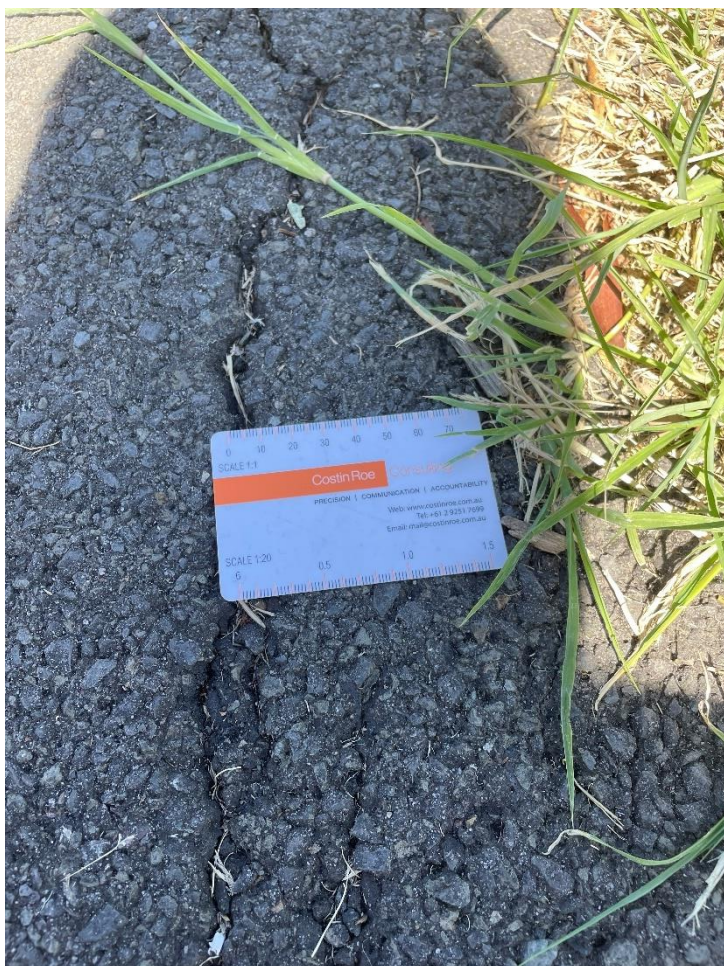
| 2.5.2 | Cracking to path measured to be approx. 7mm wide. | <b>33-34</b> |

Cracking to path measured  
to be approx. 7mm wide.

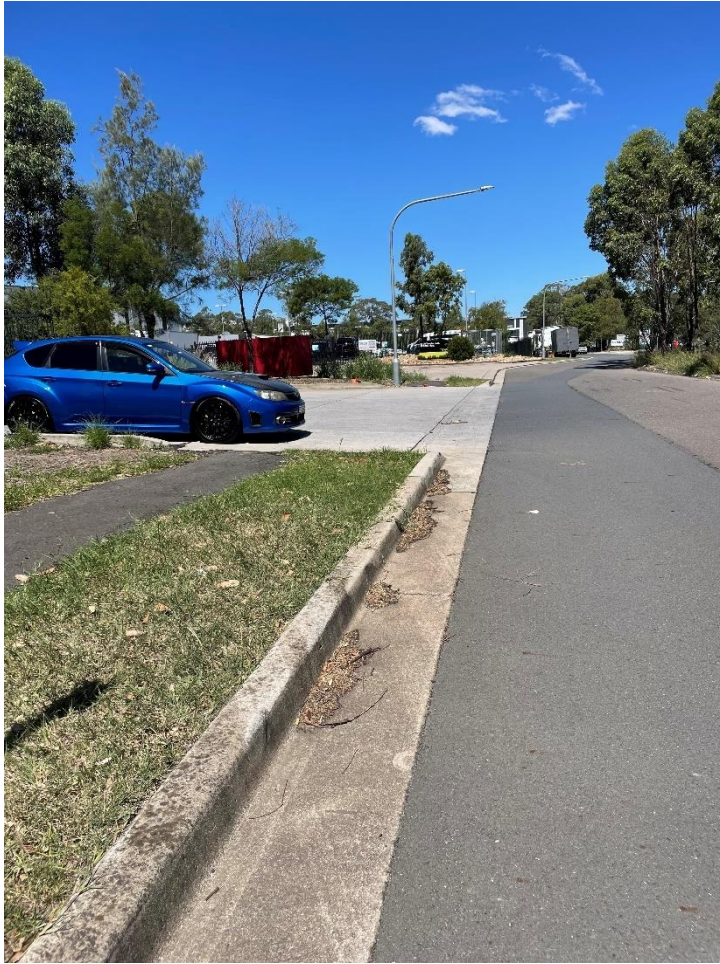
**PHOTO 34**

Cracking to path measured  
to be approx. 7mm wide.

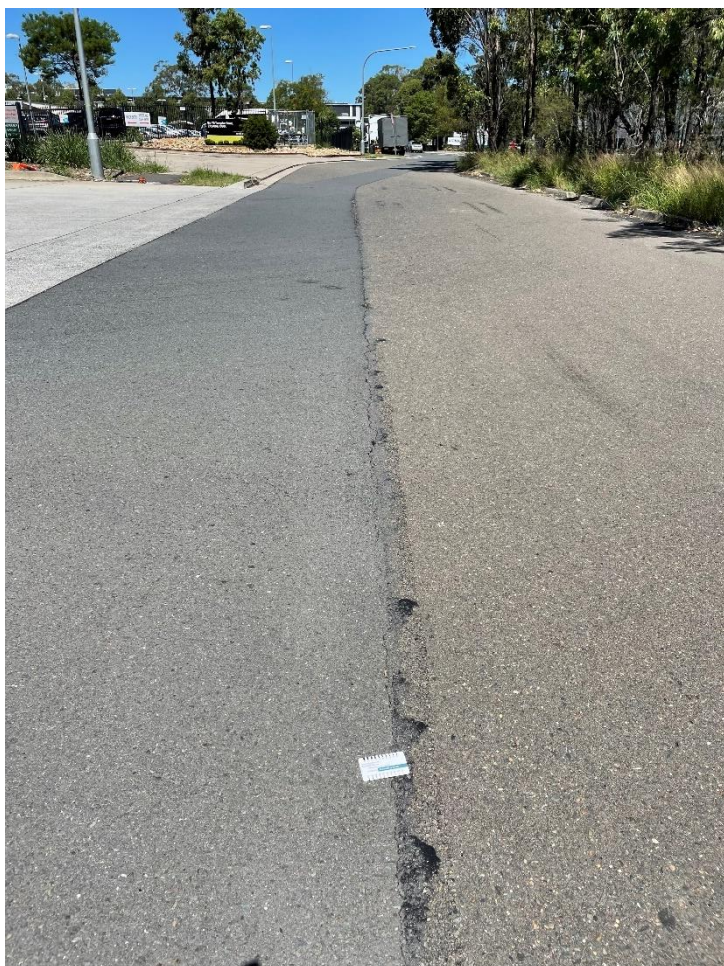
| 2.5.7 | Alligator cracking to road observed. | <b>39</b> |

Alligator cracking to road observed.

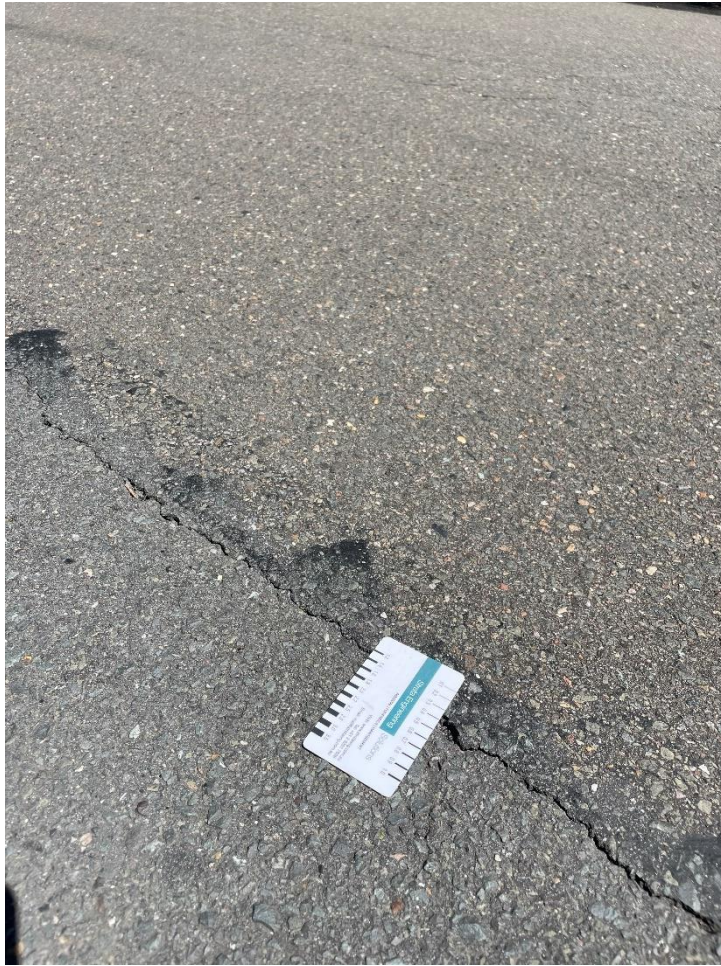
**PHOTO 40**

| 2.5.8 | Cracking to road measured to be approx. 1.2mm wide. | <b>40-41</b> |

Cracking to road measured to be approx. 1.2mm wide.

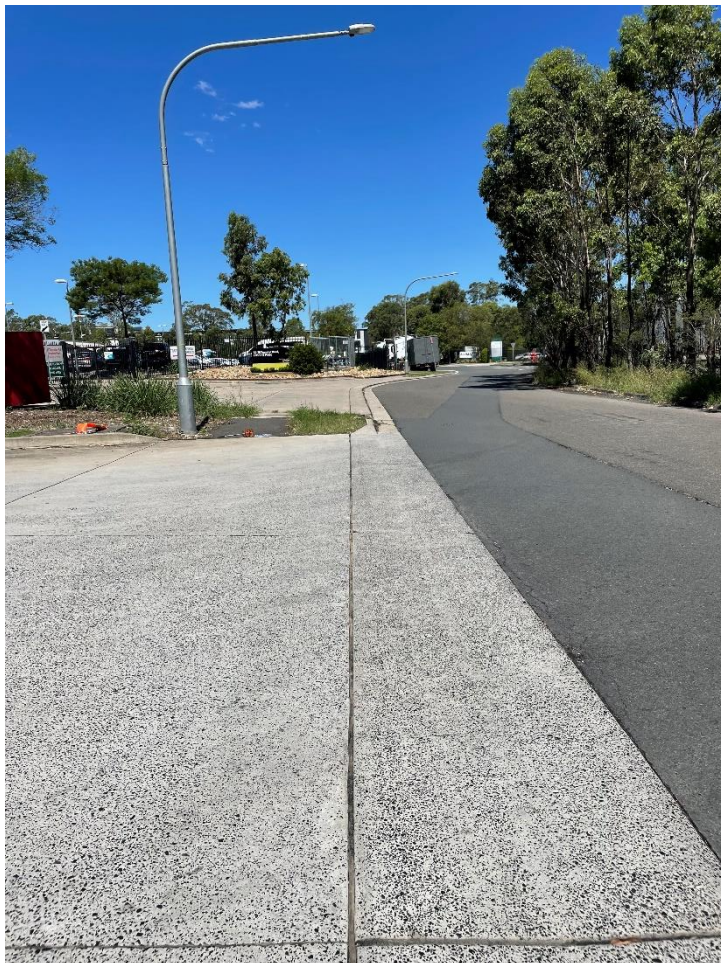
**PHOTO 41**

Cracking to road measured  
to be approx. 1.2mm wide.

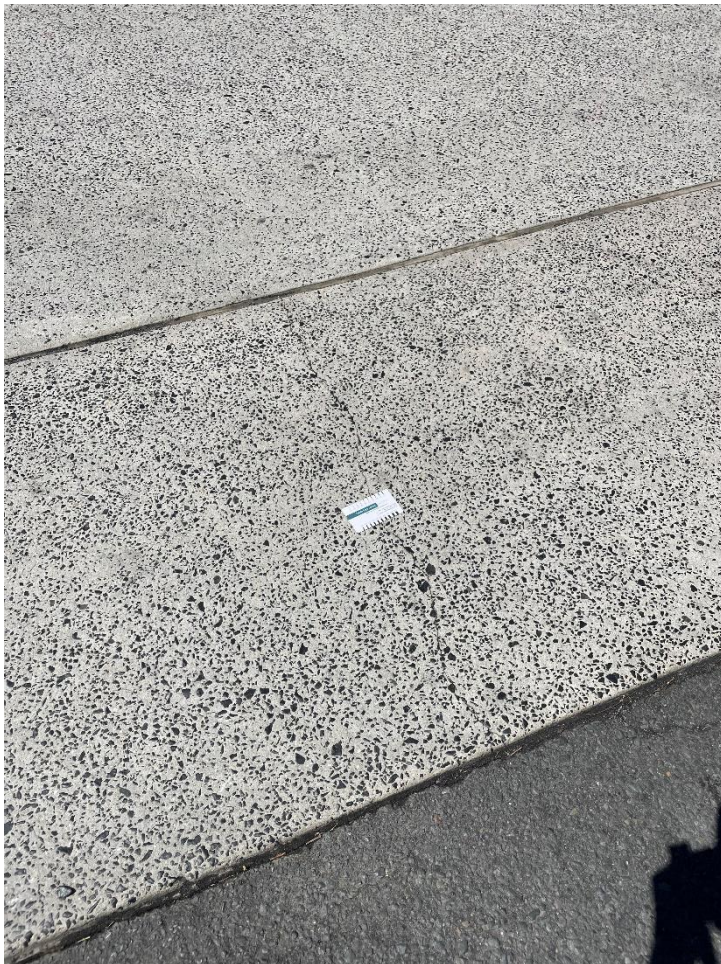
| 2.6.2 | Fretting to driveway observed. | <b>43</b> |

Fretting to driveway  
observed.

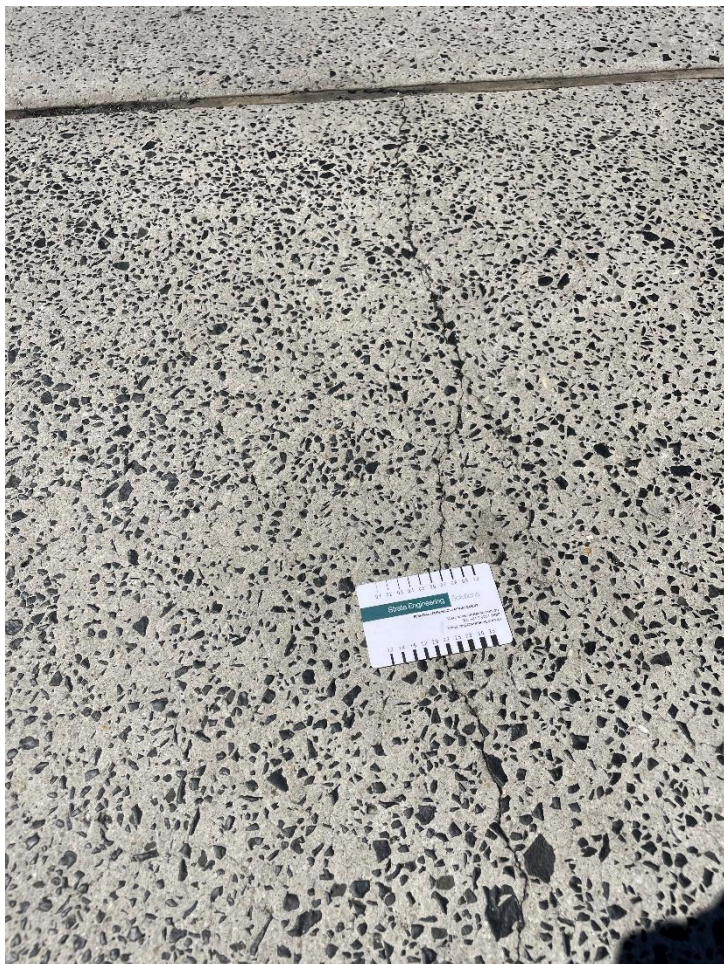
**PHOTO 44**

| 2.6.3 | Cracking to driveway measured to be approx. 0.7mm wide. | <b>44-45</b> |

Cracking to driveway  
measured to be approx.  
0.7mm wide.

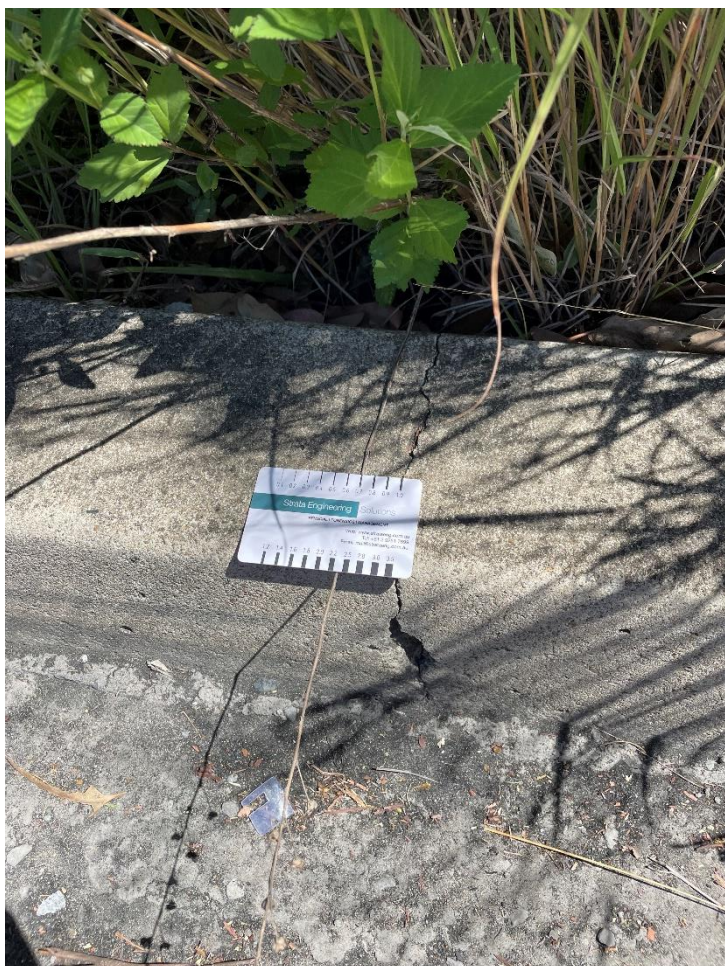
| 2.6.5 | Cracking to kerb measured to be approx. 1.0mm wide. | <b>47-58</b> |

Cracking to kerb measured  
to be approx. 1.0mm wide.

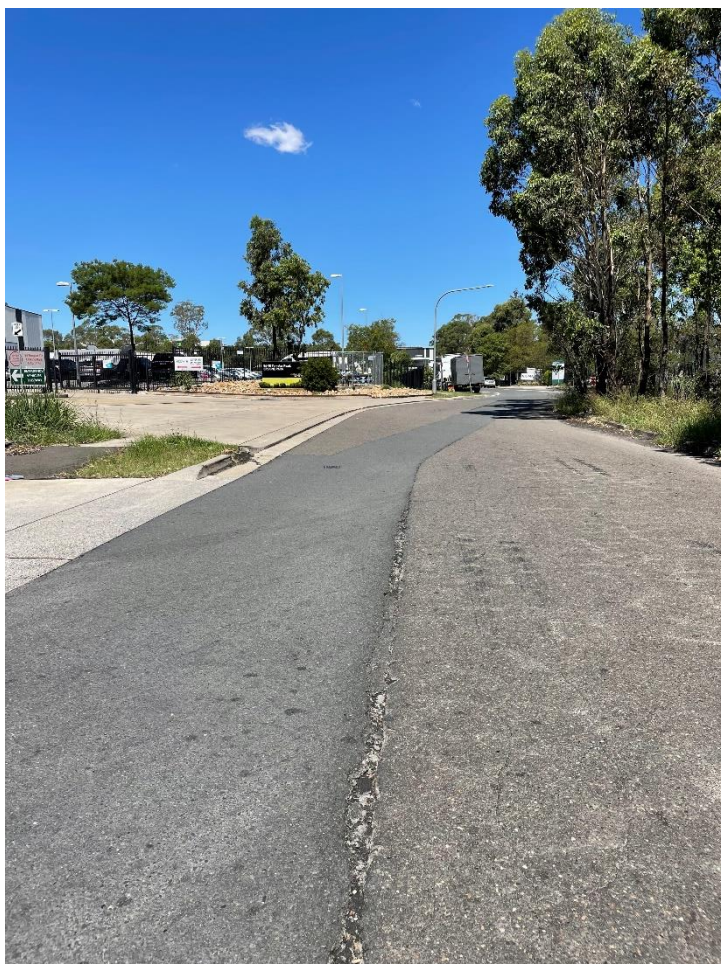
| 2.6.7 | Cracking to road measured to be approx. 1.8mm wide. | <b>50-51</b> |

Cracking to road measured  
to be approx. 1.8mm wide.

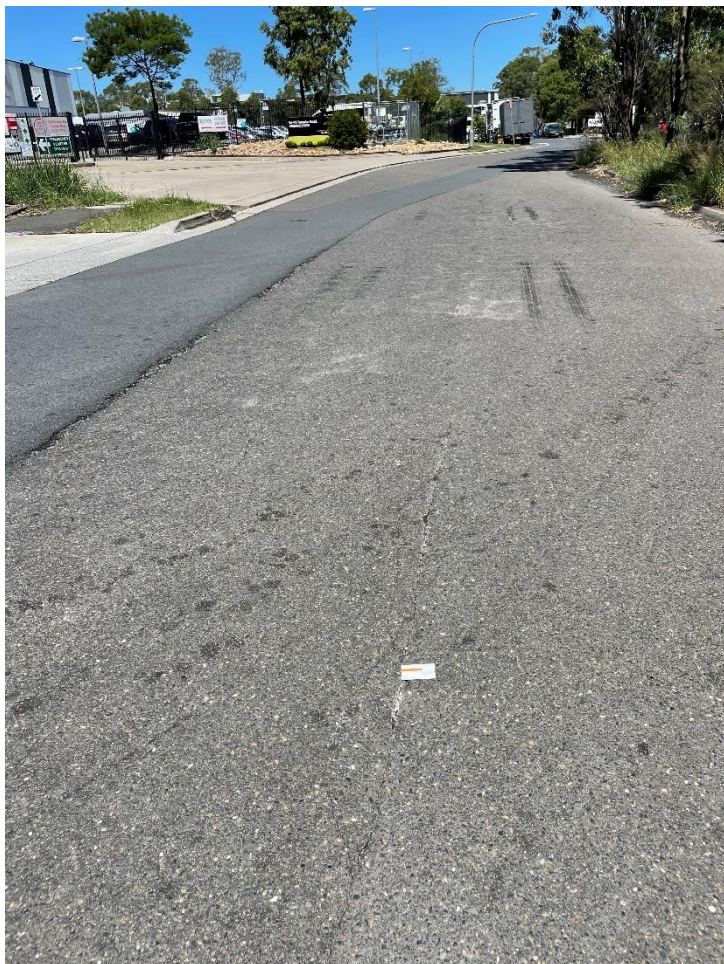
**PHOTO 52**

| 2.6.8 | Damage to road observed. | <b>52</b> |

Damage to road observed.

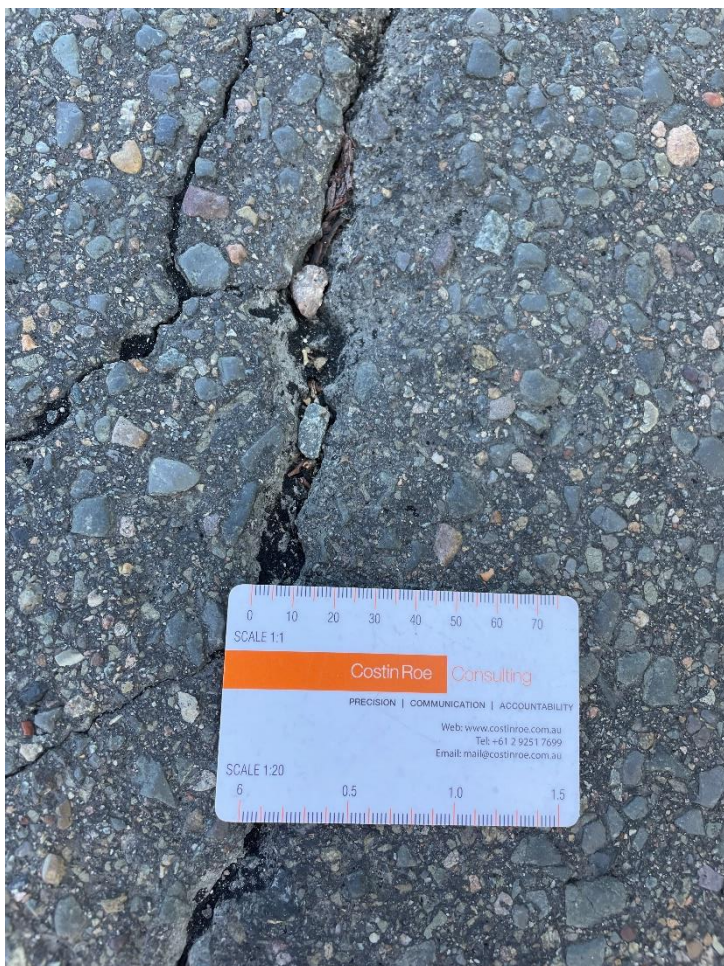
**PHOTO 53**

| 2.6.9 | Cracking to road measured to be approx. 11mm wide. | <b>53-54</b> |

Cracking to road measured  
to be approx. 11mm wide.

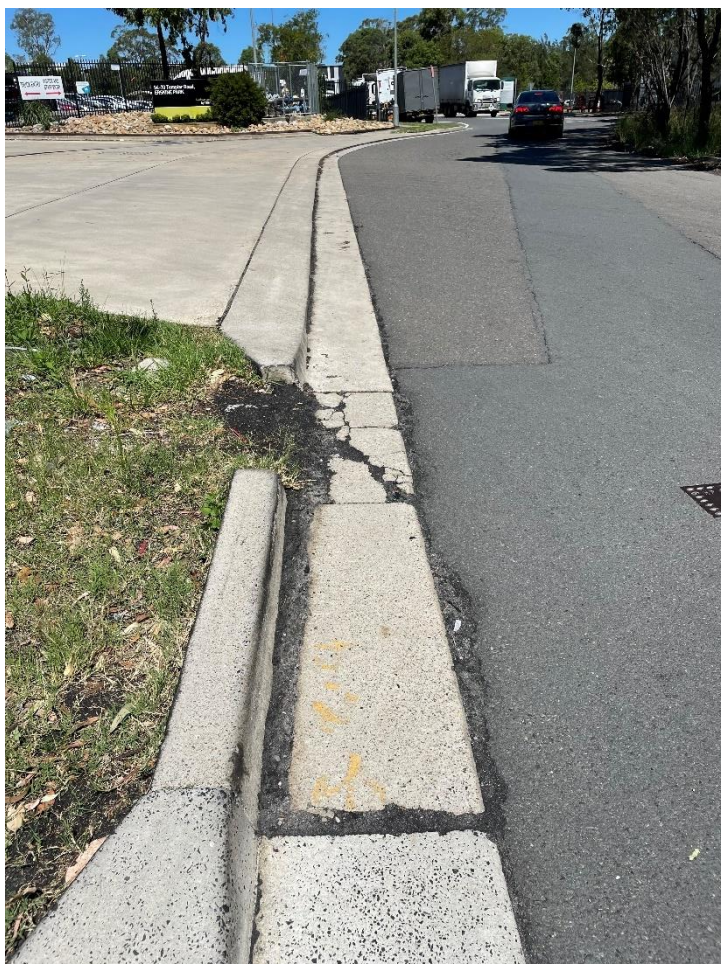
| 2.7.2 | Cracking to path measured to be approx. 8mm wide. | <b>56-57</b> |

Cracking to path measured  
to be approx. 8mm wide.

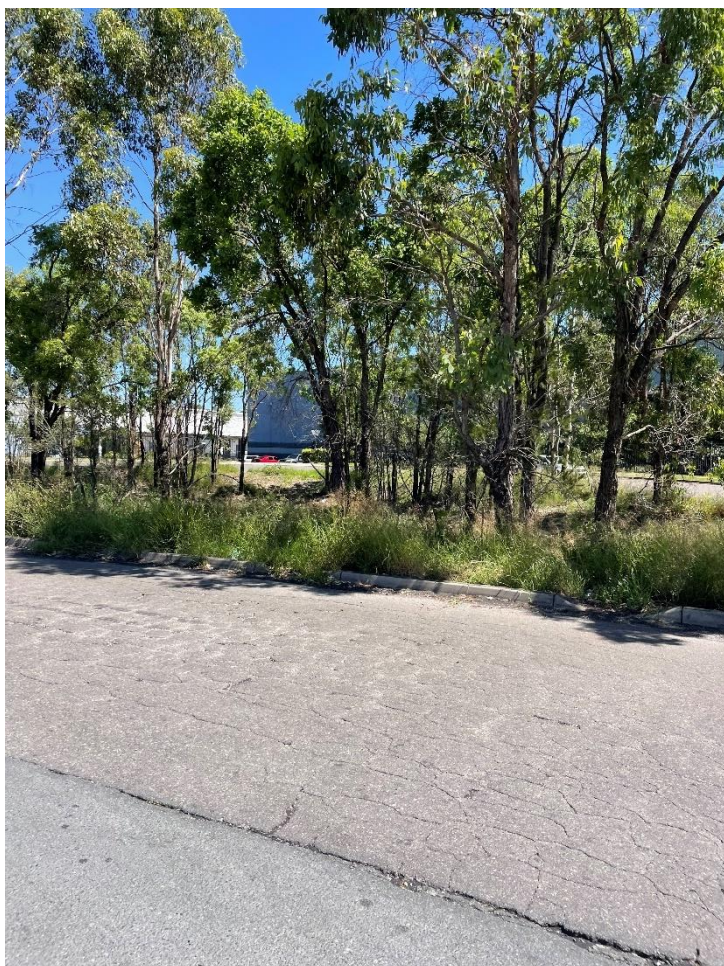
| 2.7.4 | Cracking and fretting to kerb observed. | <b>59</b> |

Cracking and fretting to  
kerb observed.

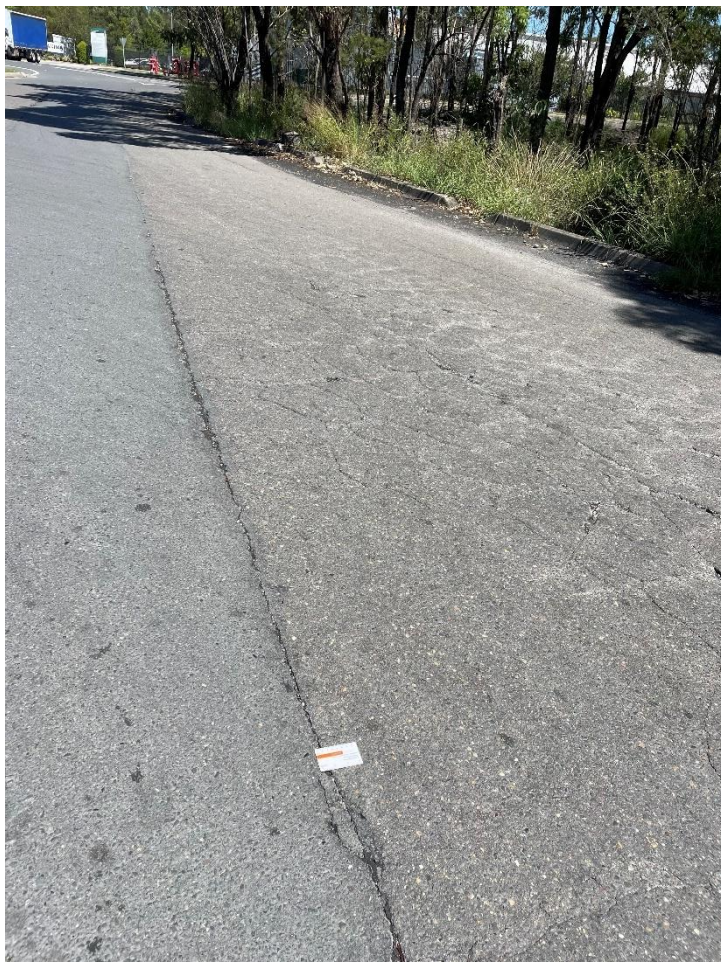
| 2.7.7 | Cracking to road measured to be approx. 17mm wide. | <b>62-63</b> |

Cracking to road measured  
to be approx. 17mm wide.

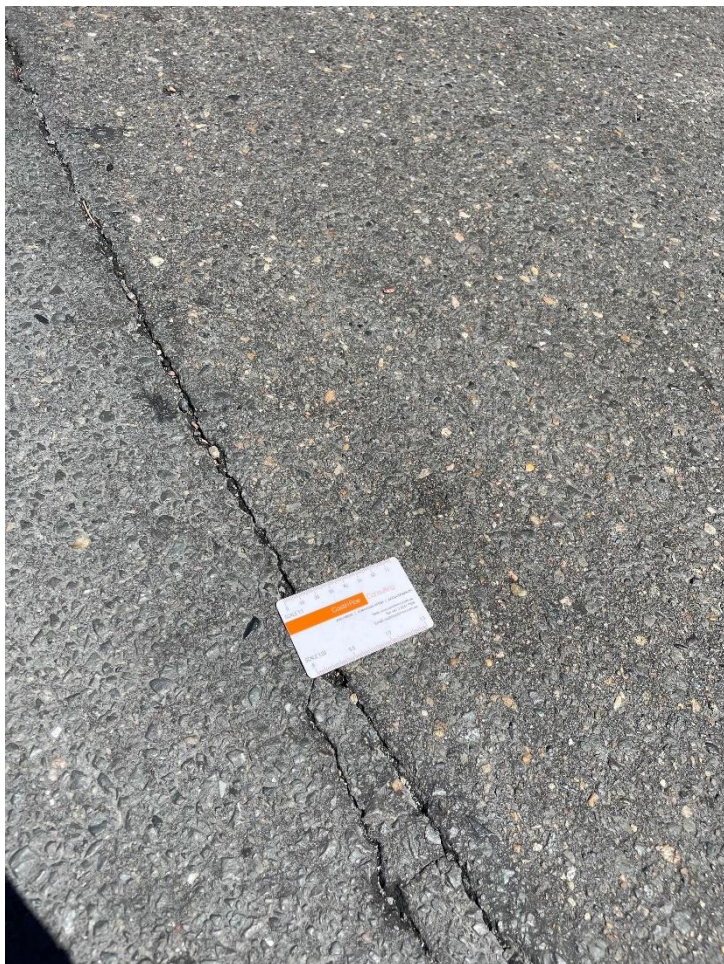
**PHOTO 64**

| 2.7.8 | Cracking to road measured to be approx. 10mm wide. | <b>64-65</b> |

Cracking to road measured  
to be approx. 10mm wide.

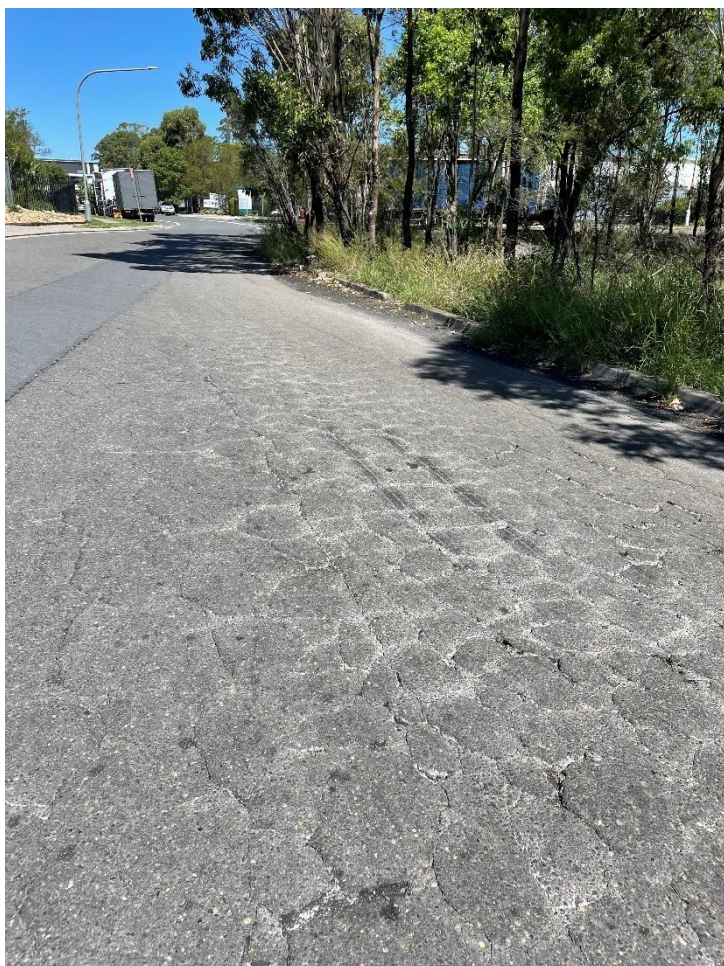
**PHOTO 65**

Cracking to road measured  
to be approx. 10mm wide.
