Children's Medical Research Institute
Pre-Demolition Hazardous Building Materials Survey

Children's Medical Research Institute Gene
Technologies Building,
214 Hawkesbury Road,
Westmead, NSW

26 October 2022
63529/148,264 (Rev 0)
JBS&G Australia Pty Ltd

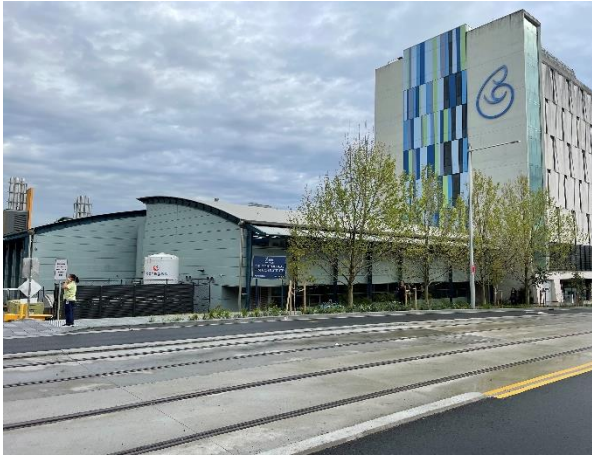
Photo 1: Overview of Research building.

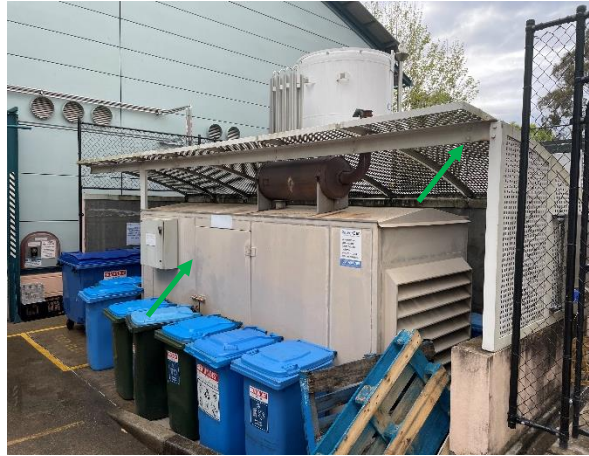
Photo 2: External – Non-asbestos containing grey mastic seals to generator and non-lead based cream paint to generator shed.

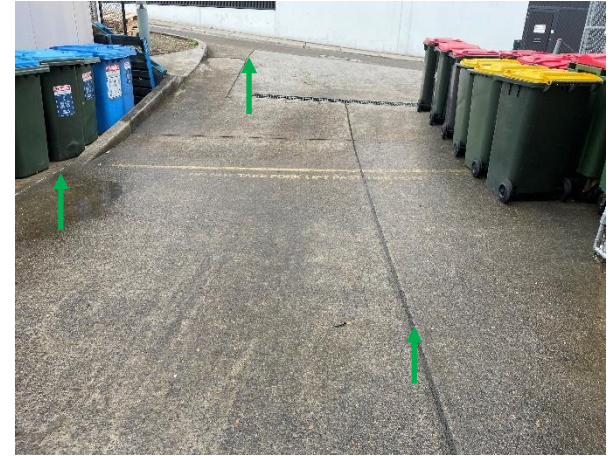
Photo 3: External – Non-asbestos containing bituminous mastic and grey mastic to loading dock and footpath expansion joint.

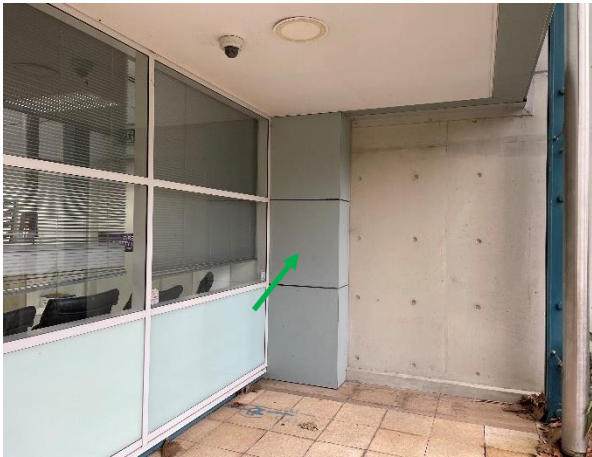
Photo 4: External – Non-asbestos containing fibre cement grey sheet cladding panel to the southeast interface of Research building and Ainsworth building

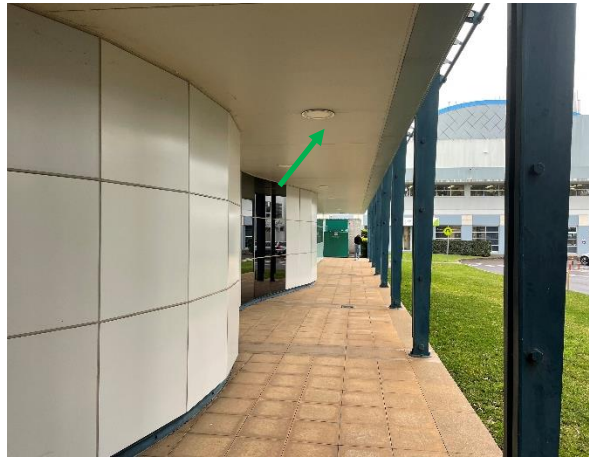
Photo 5: External – Non-asbestos containing fibre cement sheeting to the soffit lining and eaves

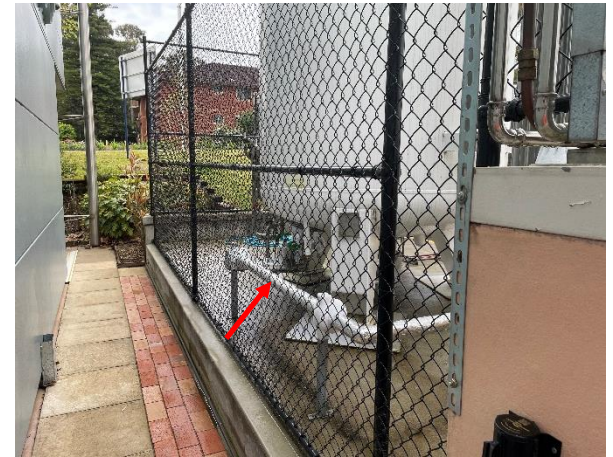
Photo 6: External – Assumed SMF insulation to nitrogen tank pipework

The synthetic mineral fibres encountered during this inspection were generally contained and deemed to be low risk. These SMF materials can be removed with the building and demolition waste with care taken not to generate fibres. Appropriate PPE is recommended including the use of P2 respirator as minimum and appropriate removal methodology as outlined in [NOHSC: 1004(1990)] and [NOHSC: 2006(1990)].

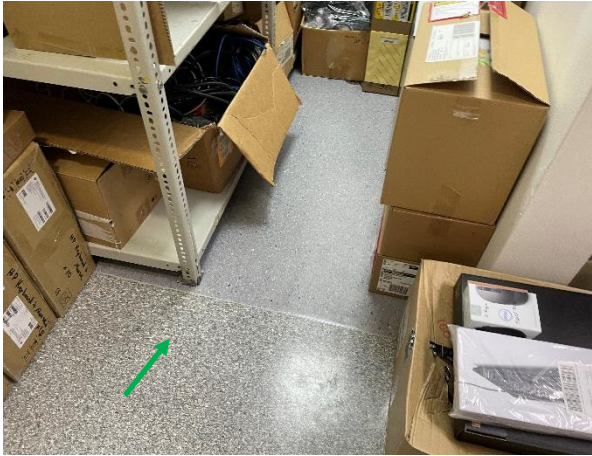
Photo 7: Ground – Non-asbestos containing grey speckled vinyl floor

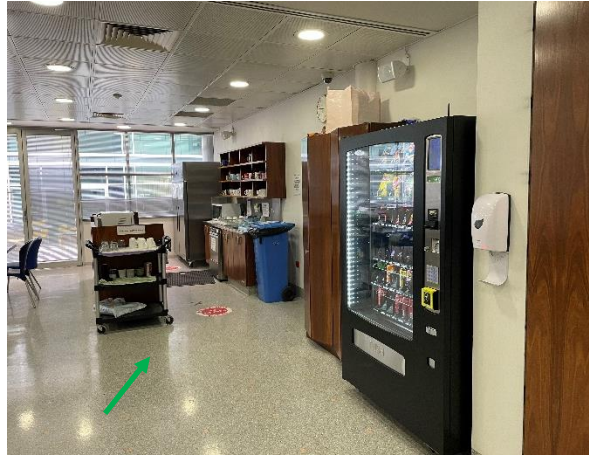
Photo 8: Non-asbestos containing light grey speckled vinyl floor

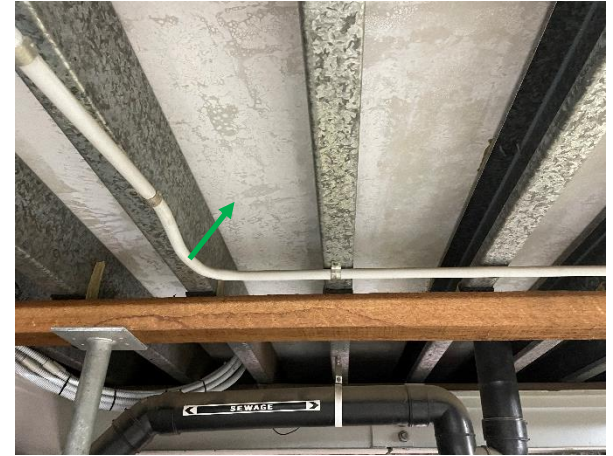
Photo 9: Basement – Non-asbestos containing compressed fibre cement to the ceiling

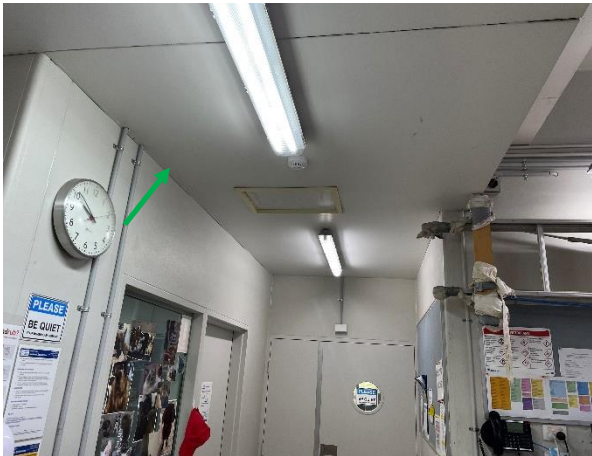
Photo 10: Ground – Non-asbestos containing fibre cement sheeting to ceiling cable runner within the loading dock

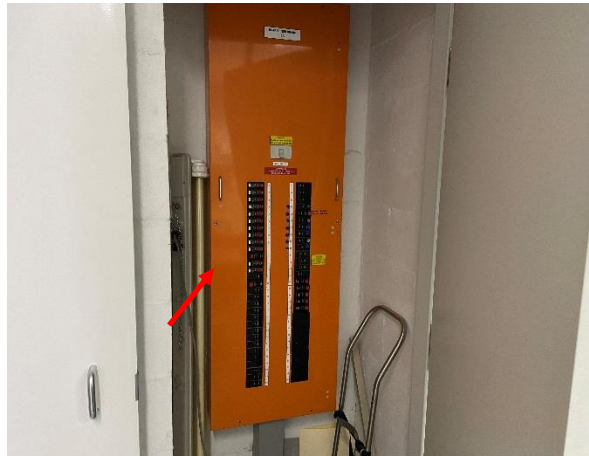
Photo 11: Ground – Lead based orange paint to electrical distribution box

The lead based paints, as identified in Hazardous Materials Register (**Appendix A**), were observed in a good condition and should be managed in accordance with the AS4361.2-2017. Where peeling or deteriorated they should be removed under controlled conditions by an experienced contractor prior to demolition. Stable lead based paints adhered to building fabric can be disposed as general solid waste in accordance with NSW EPA 2014 provided care is taken to minimise any potential for paint flakes to be dispersed onto ground surfaces and building and demolition waste is not proposed to be recycled.

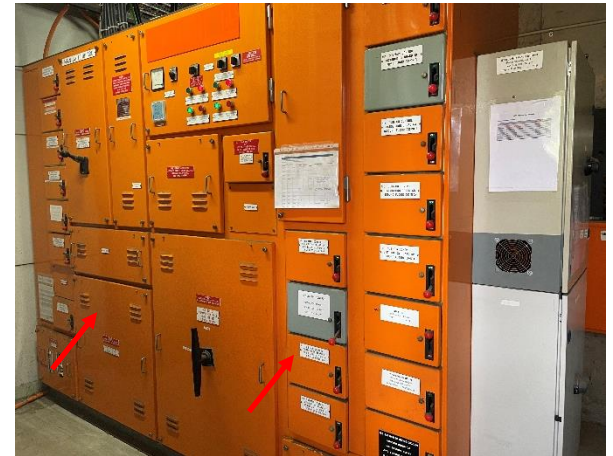
Photo 12: Ground – Assumed lead based orange paint to electrical distribution box

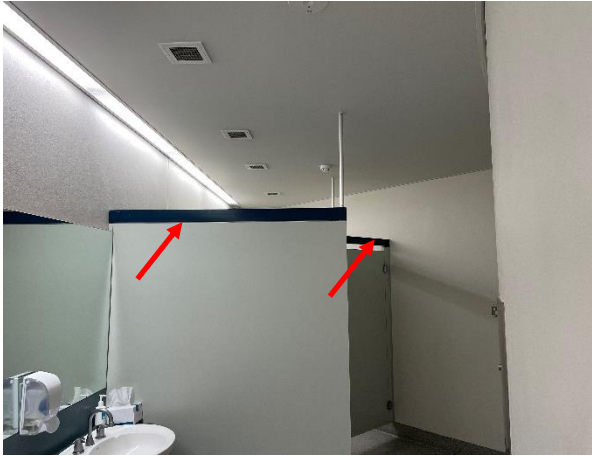
Photo 13: Ground – Lead based blue paint to metal rail over toilet cubical within the male bathroom

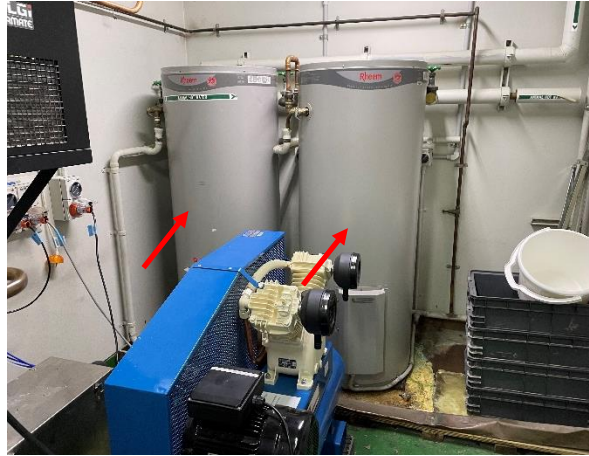
Photo 14: Ground – Assumed SMF internal insulation to hot water units within room G53

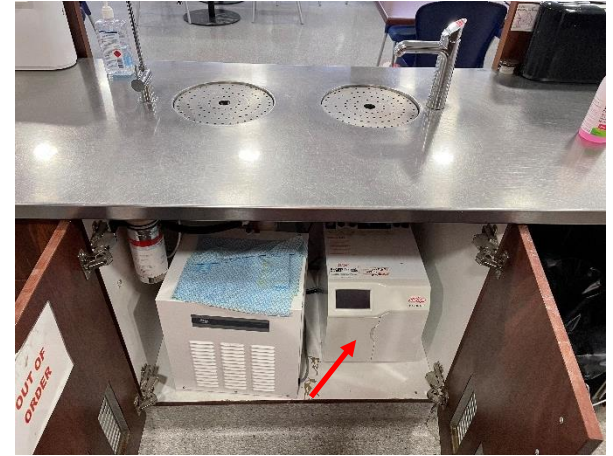
Photo 15: Ground – Assumed SMF internal insulation to Zipp instant unit within kitchen

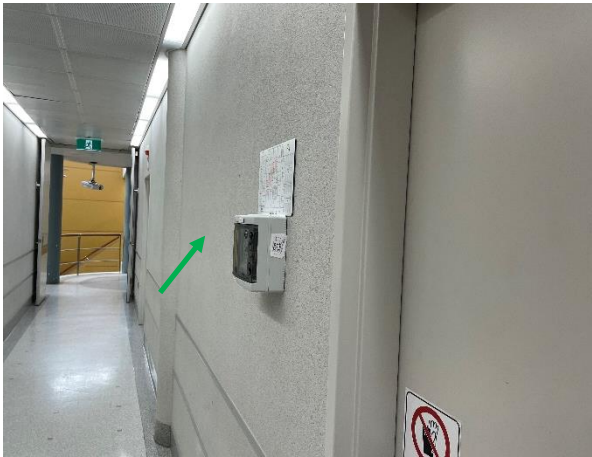
Photo 16: Level 1 – Non-asbestos containing or Lead based textured paint to the walls

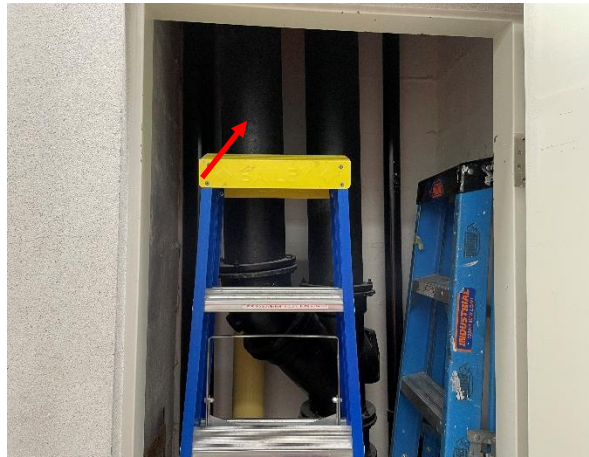
Photo 17: Level 1 – Lead based black paint to metal sewer pipework

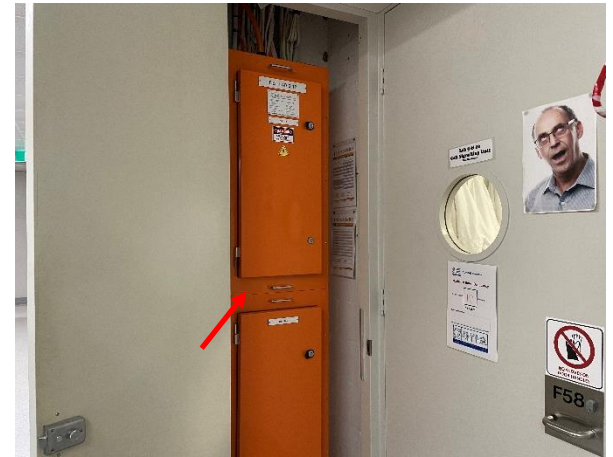
Photo 18: Level 1 – Assumed lead based orange paint to electrical distribution box

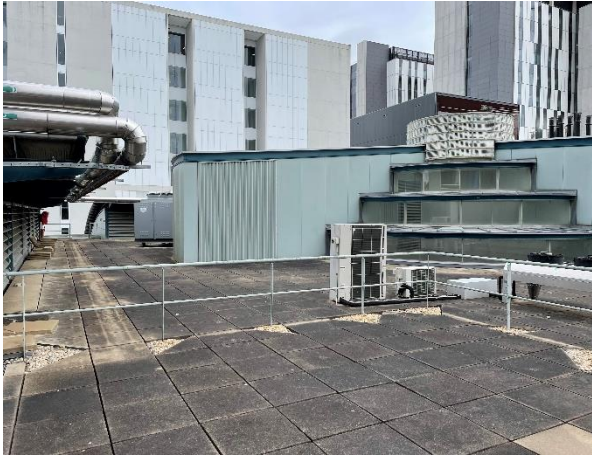
Photo 19: Overview of the roof and associated plant rooms

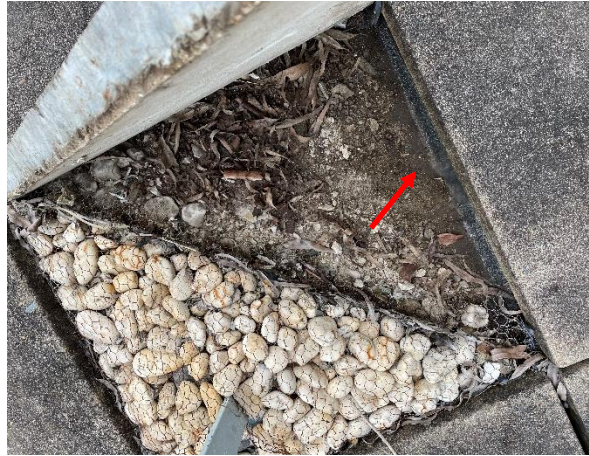
The waterproofing membrane to the roof level is suspected to contain asbestos. Prior to the demolition of the structures, it is recommended that the following work is undertaken:

Photo 20: Roof – Assumed asbestos containing waterproofing membrane

- A suitably qualified occupational hygienist or licensed asbestos assessor is engaged to undertake an assessment of the waterproofing membrane, determine the presence or absence of asbestos within the membrane material and provide appropriate recommendations for management and/or removal (if required).

- Assume the waterproofing membrane does contain asbestos and engage a Class A or B licensed asbestos removalist to remove the assumed asbestos hazard. Removal and disposal of asbestos materials shall be undertaken in accordance with the *Work Health and Safety Act (2011)*, *Work Health and Safety Regulation (2017)* and SWNSW 2019a including air monitoring and clearance certification requirements.

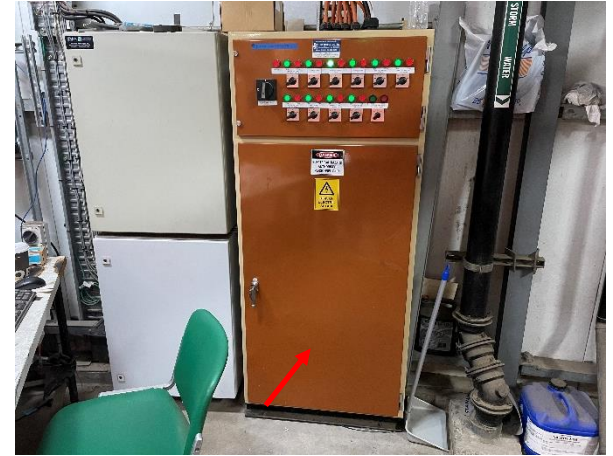
Photo 21: Roof – Lead based brown paint to electrical distribution box within the central plant room

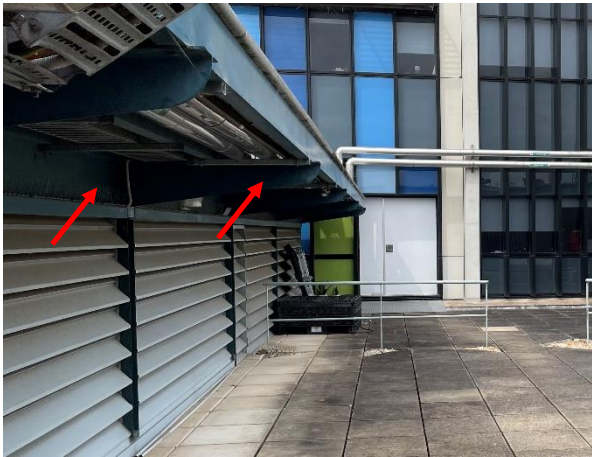
Photo 22: Roof – Lead based blue paint to metal framework of building

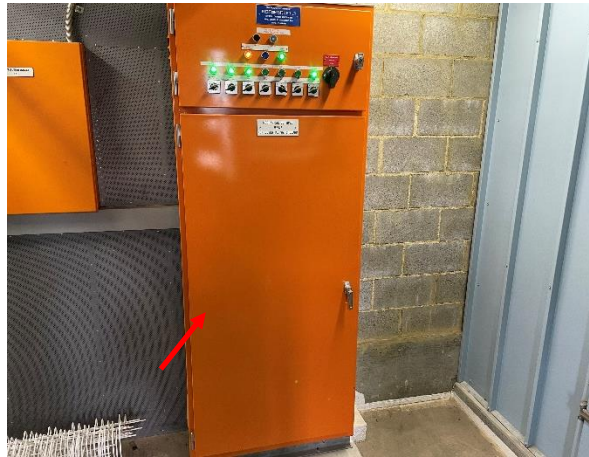
Photo 23: Roof – Assumed lead based orange paint to electrical distribution box

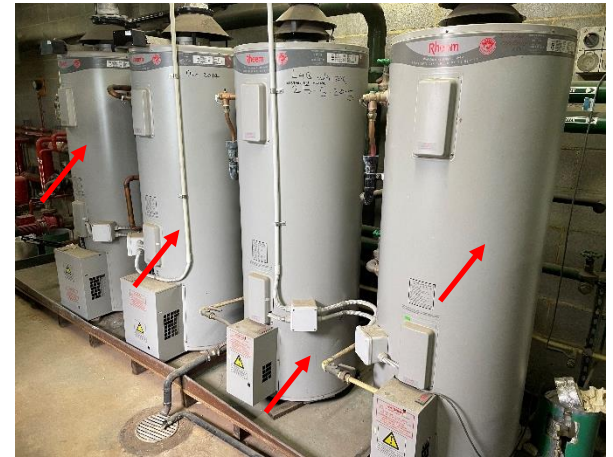
Photo 24: Roof – Assumed SMF insulation core to hot water heater
