# Arboricultural Impact Assessment Report

**AIA-01**

Revision C  
5 March, 2025

## **BaptistCare Macquarie Park - Concept Master Plan State Significant Development Application (SSDA)**

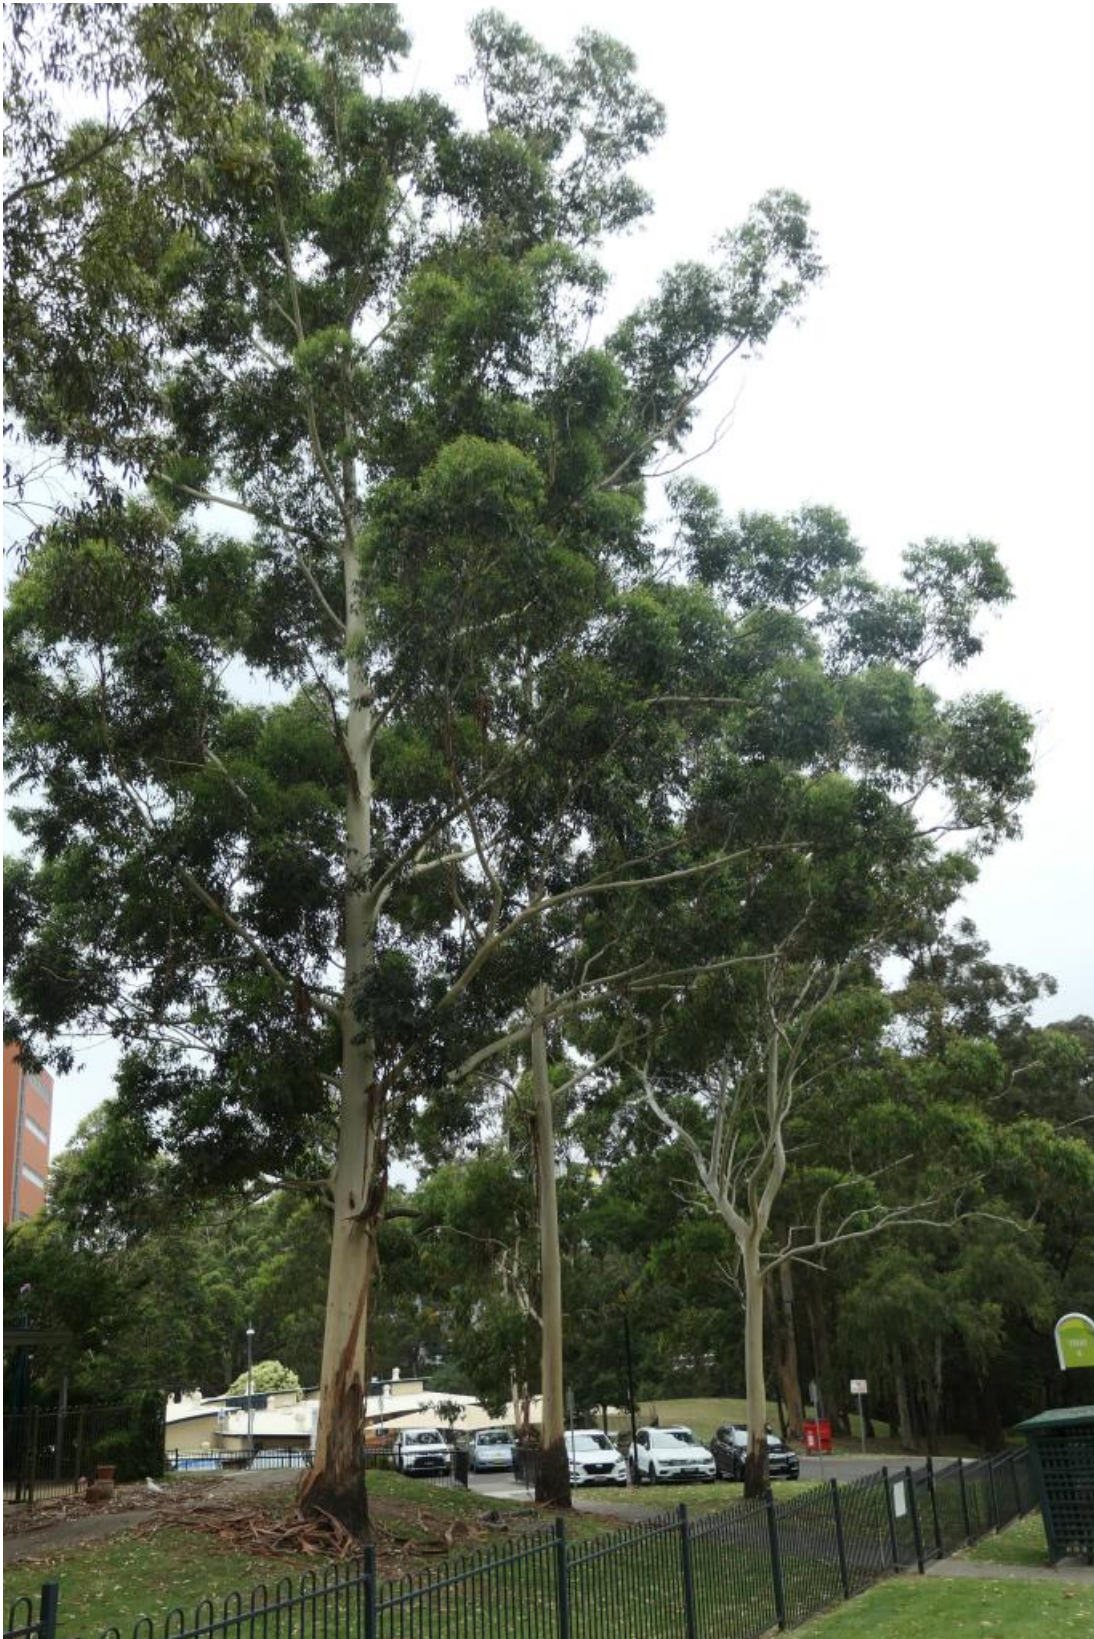
Figure 1.6 – View south-east from the site, illustrating the large neighbouring trees (*Eucalyptus grandis*) on the adjoining University site. (T01-T03). Although these are not 'endemic' native trees they are large and prominent trees that will require protection from any development impacts due to being on the neighbouring property. (Photo: Arterra 21/12/21)

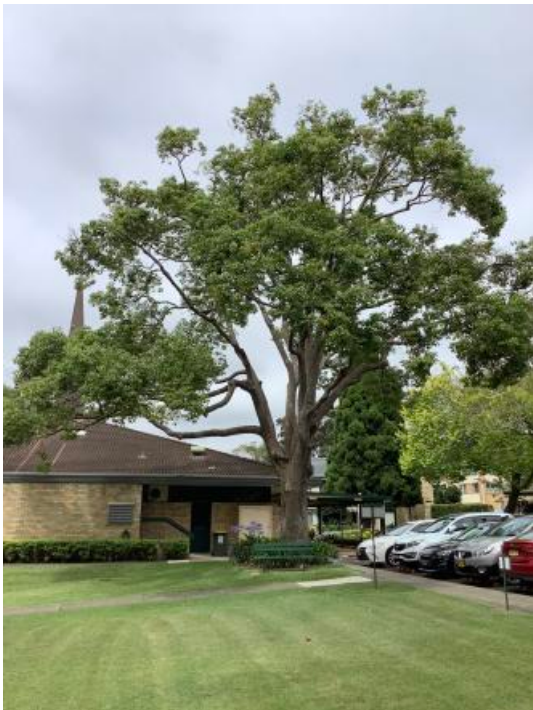
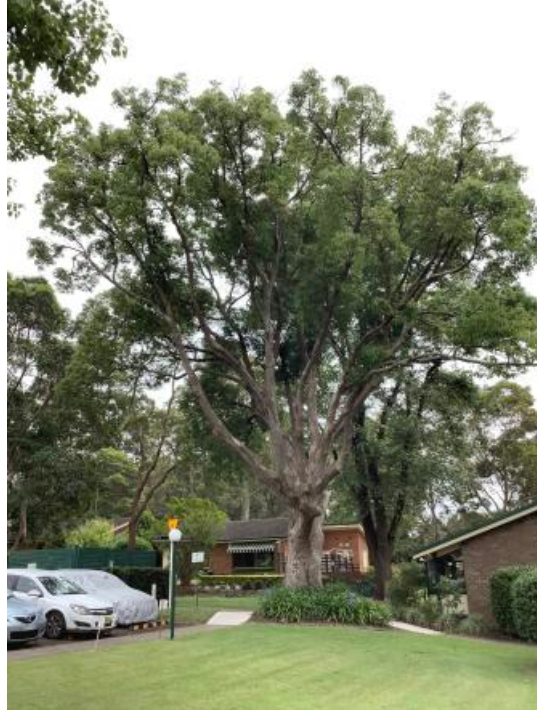
Figure 1.8 – T37(L) and T38(R) are the two Camphor Laurels that remain in the centre of the site and likely date from the early 1940s, being the last remaining remnants of a previous and more extensive driveway row planting. These trees are large, and relatively historic, but are now in only fair condition and have been extensively canopy lifted and pruned and have very sparse canopies for the species. Camphor Laurels are now also a relatively undesirable species, as they are frequently invasive within gardens and surrounding bushland. Given this, their declining conditions and their sizes, these trees have not been a focus for retention. (Photo: Arterra 22/12/21).

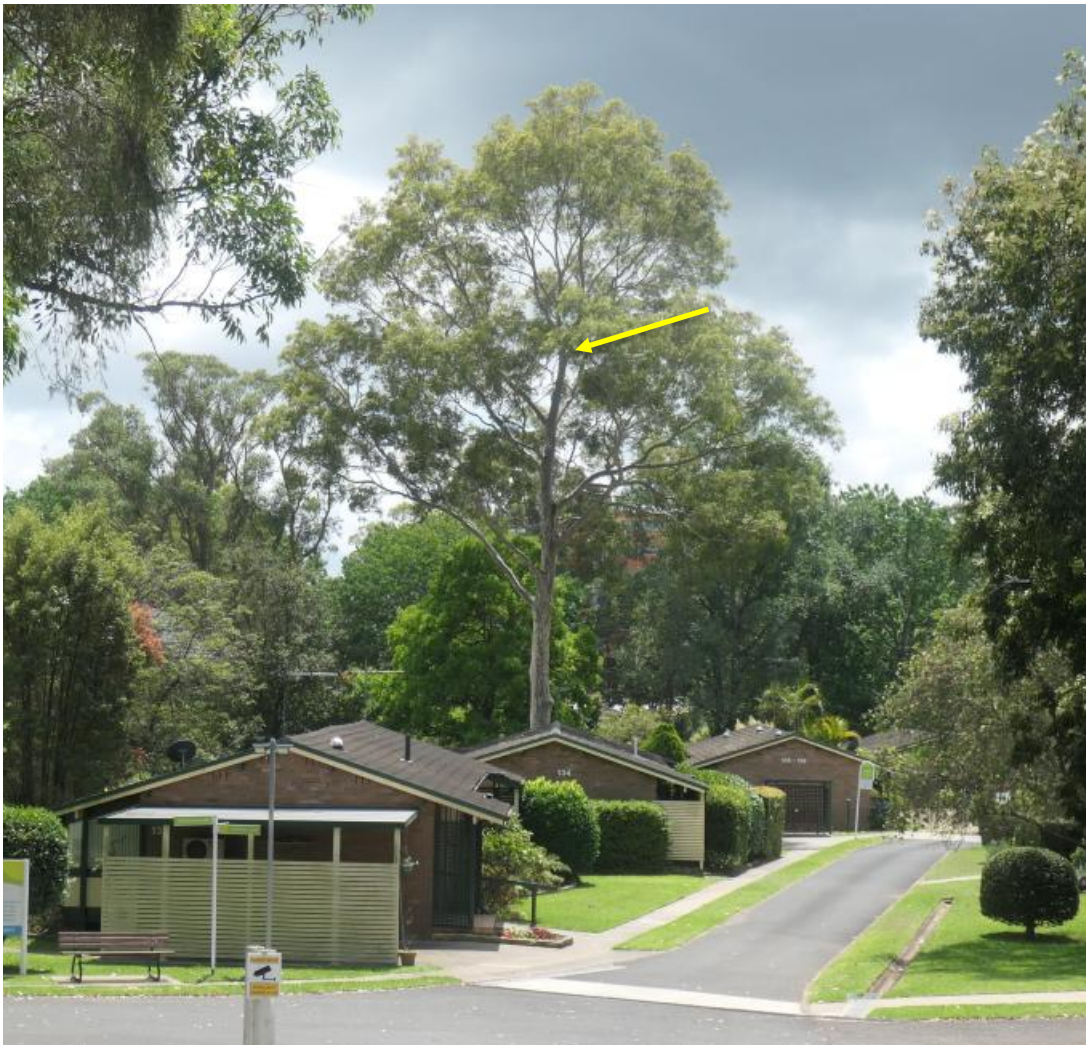
Figure 1.10 – Prominent individual Spotted Gums such as **T87 (in centre and arrowed)** are located around the site. This specimen is considered one of the best trees on the site and has been a major focus for retention and protection within the Kikkiya Park creek precinct. It provides very useful softening of adjacent future towers. Site planning and grading has very seriously considered the location of this tree and maintained it within a designed and centralised park system. (Photo: Arterra 15/8/23).

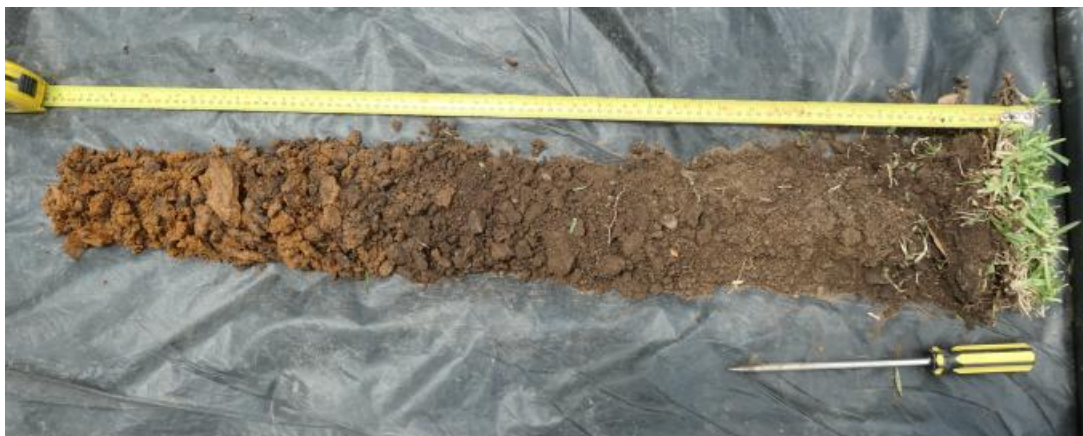
Figure 2.5 – Soil sample with clay loam soil to 400mm then very heavy clay below this. (Photo: Arterra 22/12/21)

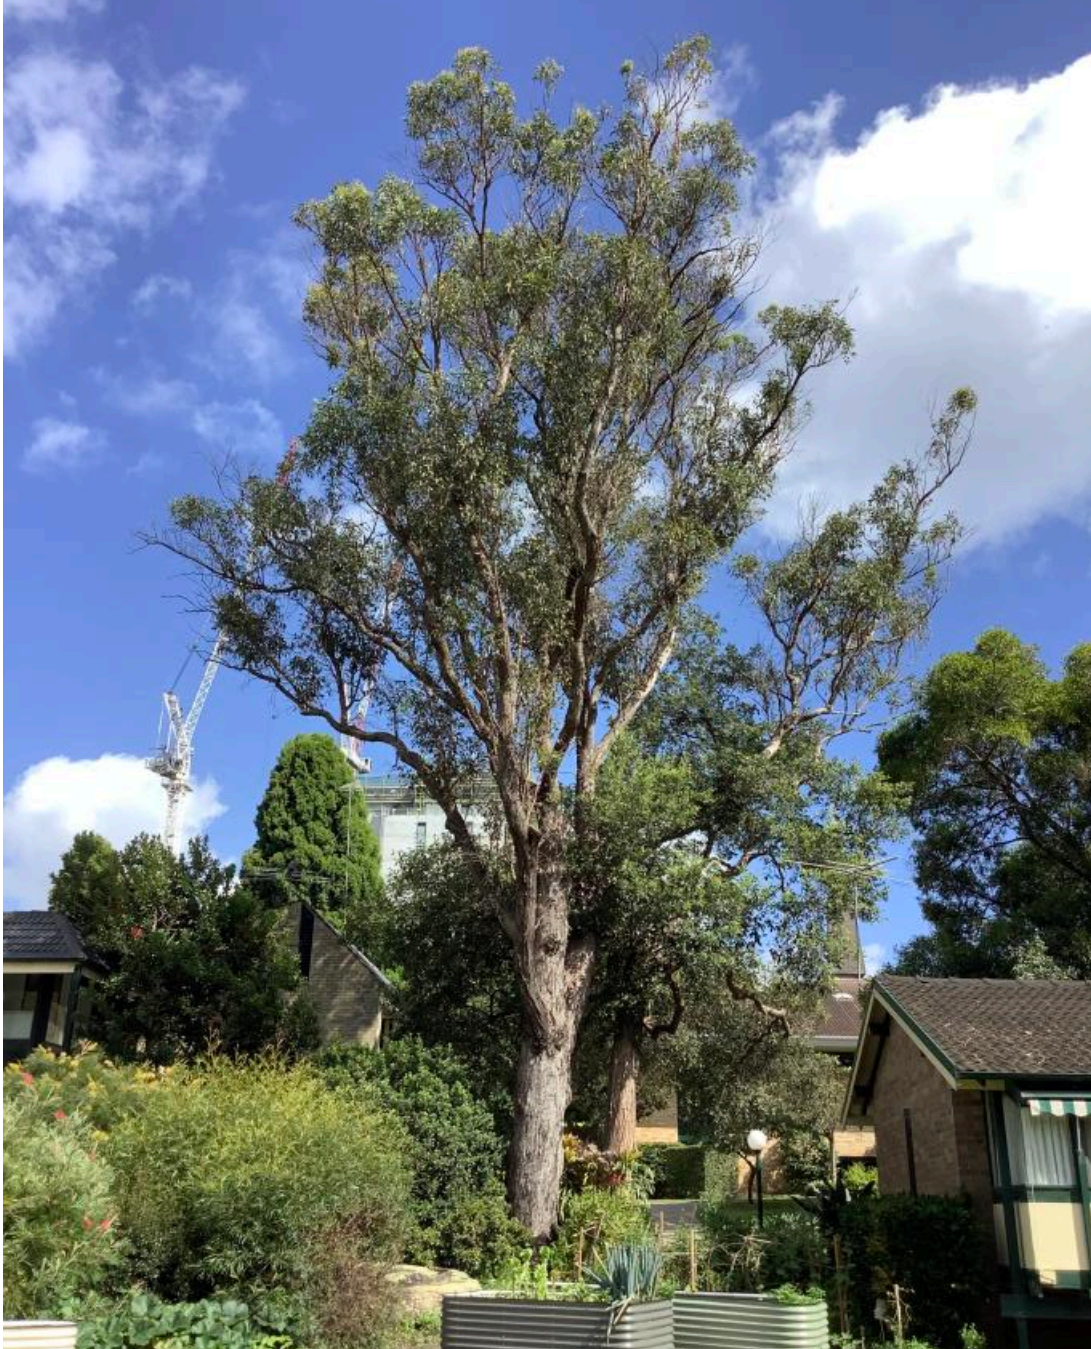
*Figure 2.8 – Two existing endemic trees within the site that have been a focus of retention. Great care has been taken to retain and protect these trees. T71 Eucalyptus resinifera shown above. (Photo: Arterra 11/3/22).*

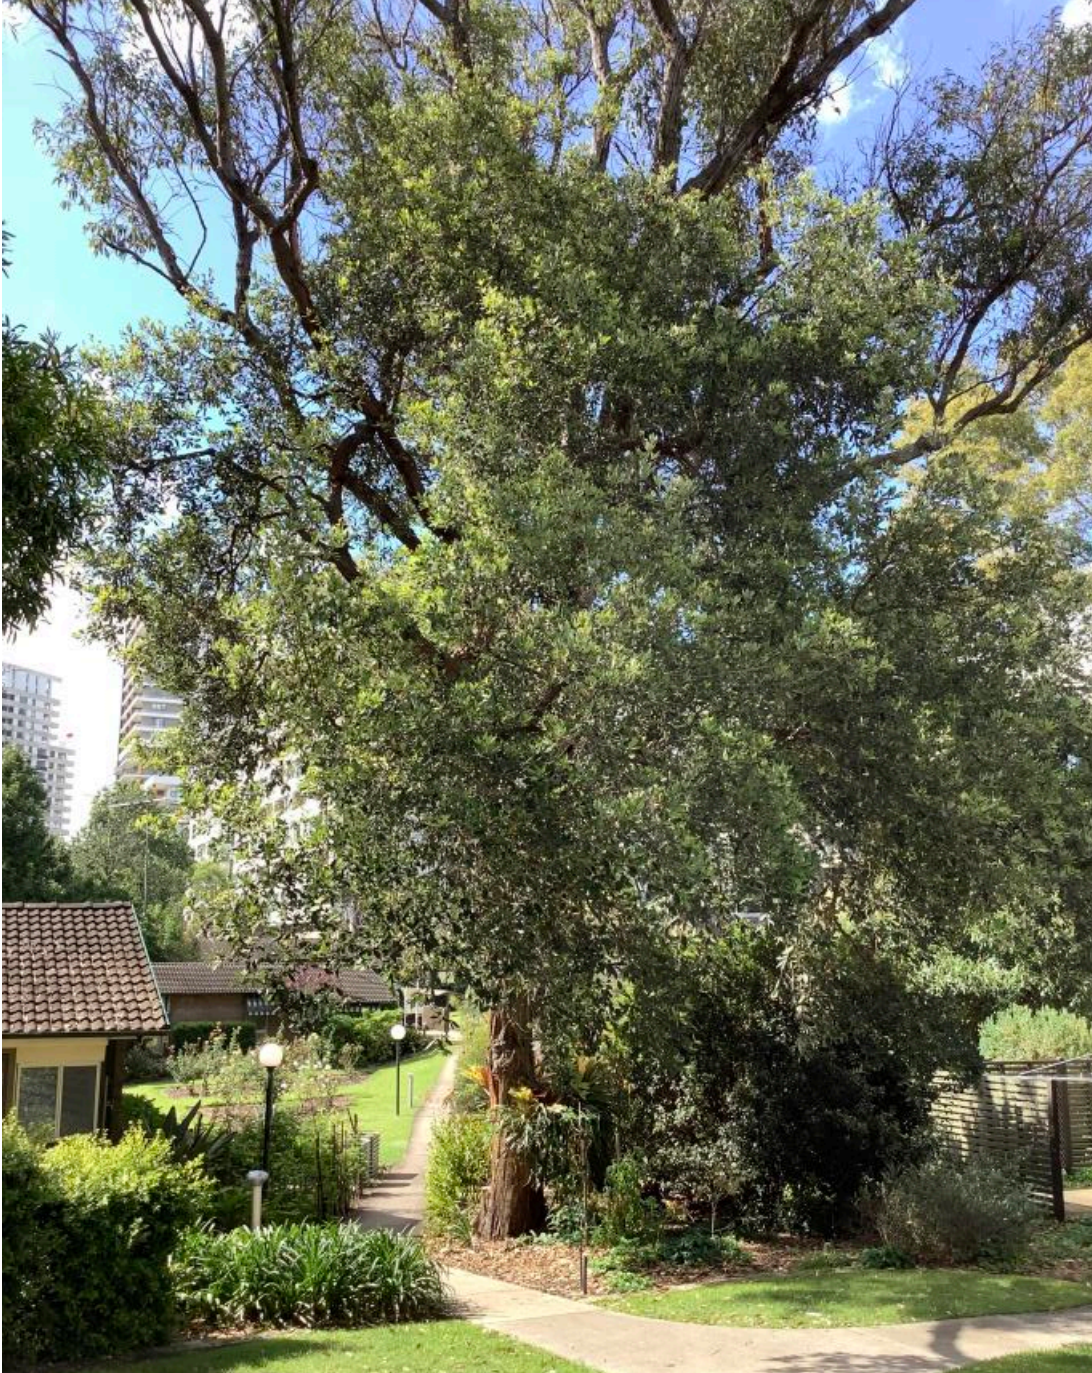
*Figure 2.9 – Two existing endemic trees within the site that have been a focus of retention. Great care has been taken to retain and protect these trees. T70 Syncarpia glomulifera shown above. (Photo: Arterra 11/3/22).*

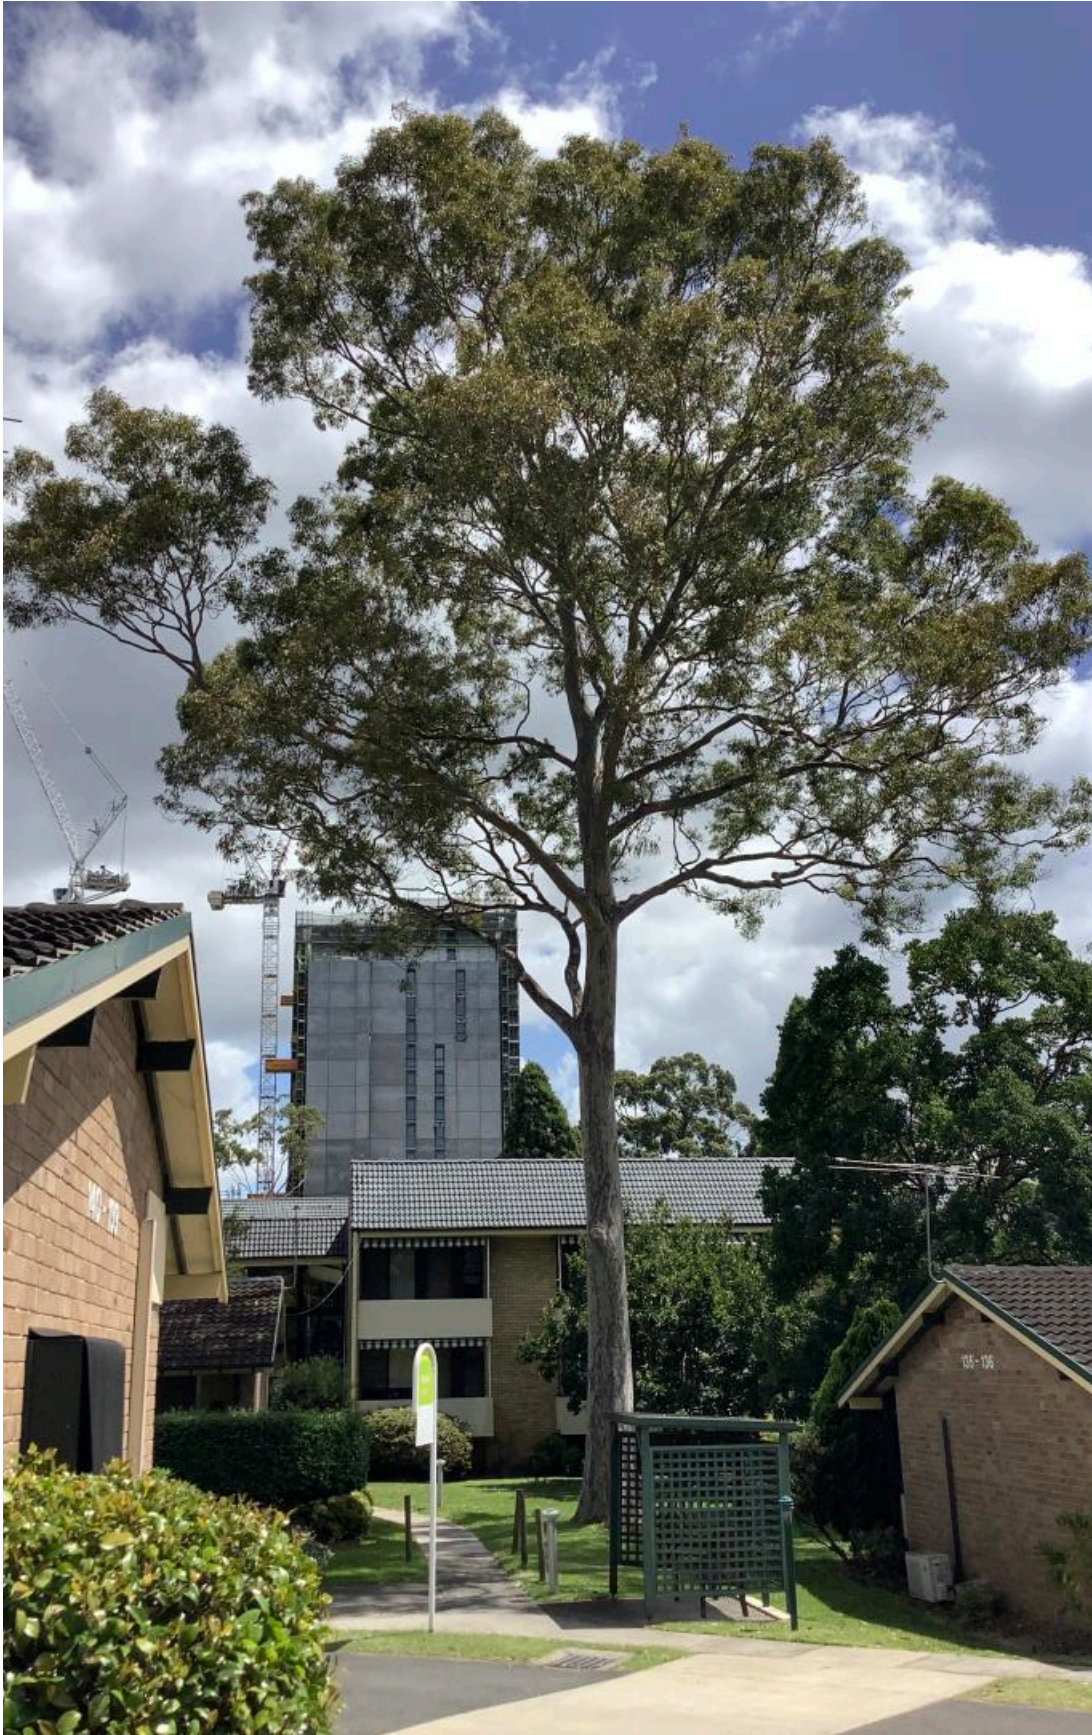
*Figure 2.10 – Tree T87 is a very prominent tall and native Corymbia maculata (Spotted Gum) in the central - eastern portion of the site and visible from Epping Rd. Great emphasis and focus have been placed on maintaining this tree, and the adjoining but much smaller exotic tree. This tree has been used as a focal element in the centre primary open space area along the re-established watercourse and gives the future landscape an immediate focal point, maturity, shade and canopy cover.(Photo: Arterra 11/3/22).*

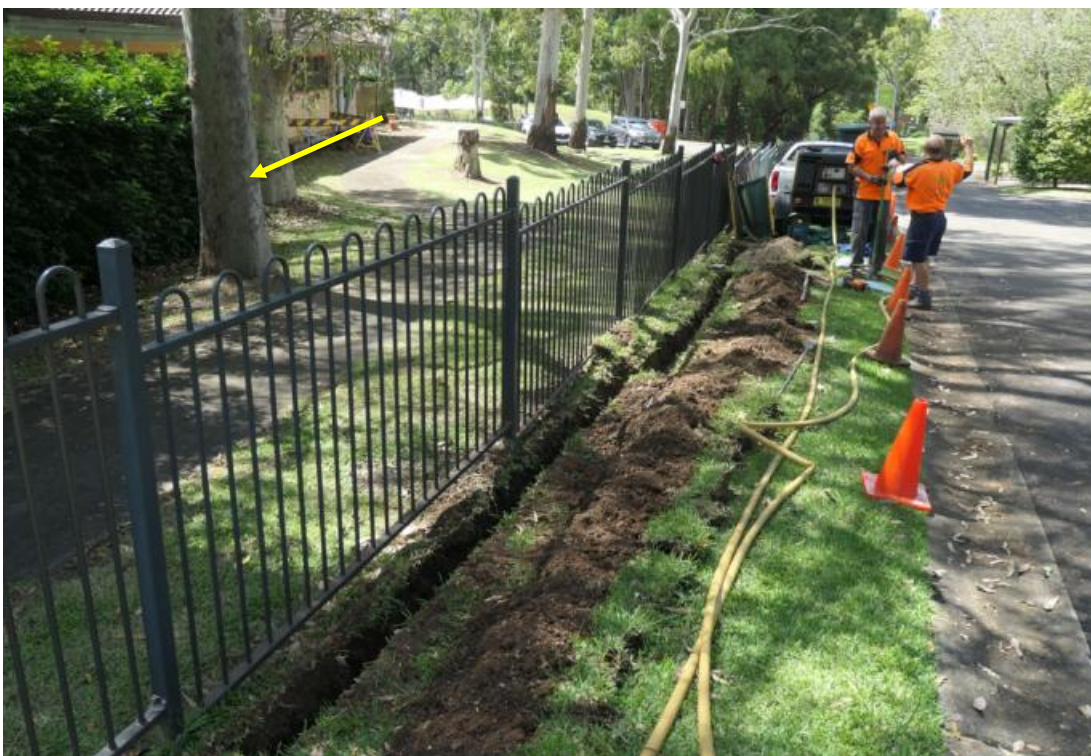
Figure 2.11 – Photo of subsurface root investigations, with trench completed. T05 arrowed at left. (Photo: Arterra 16/2/22)

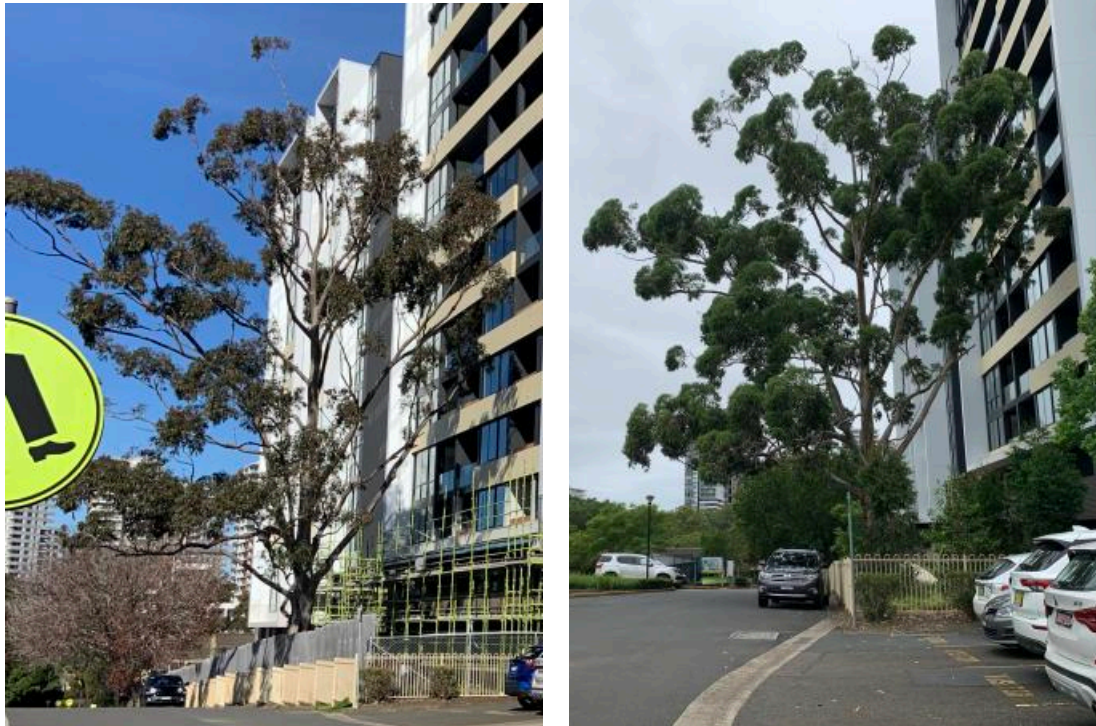
Figure 2.12 – Photo of adjoining Parkside site tree T76 *Eucalyptus saligna*. Left image captured on the 27/07/22 and right image captured on the 01/03/24. The health and vigour of the tree appears to have improved following the completion of the Parkside construction, with the tree canopy appearing fuller. It is the authors opinion that the additional topsoil and potential additional watering within the TPZ has likely aided the improvement in the trees overall health and condition (Photo: Arterra 27/07/22 and 01/03/24)

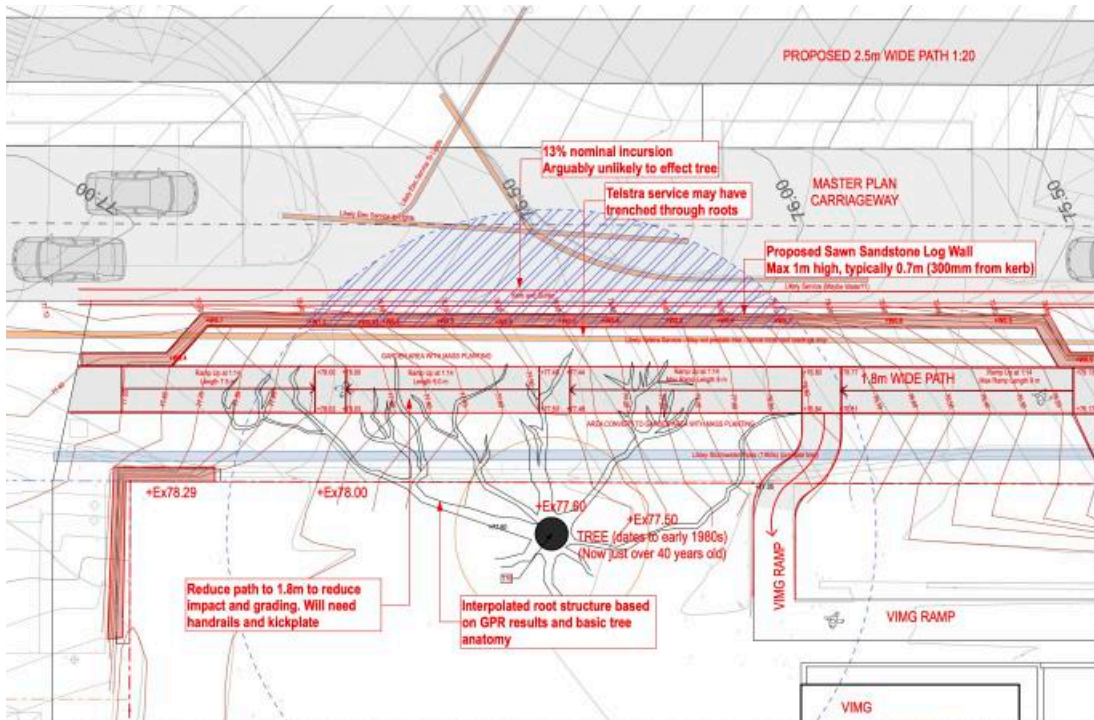
Figure 2.14 –Proposed design adjoining the Parkside site tree T76 *Eucalyptus saligna*. All efforts are being made and implemented to retain this tree. A series of 1:14 ramps are proposed to maintain the existing levels immediately north of the tree with the utilisation of a sandstone log retaining wall adjacent the proposed carriageway. The proposed roadway, though at a lower level, is not expected to adversely impact the health of the tree as no roots were found during the ground penetrating radar works in this location (Plan: Arterra 18/03/24)

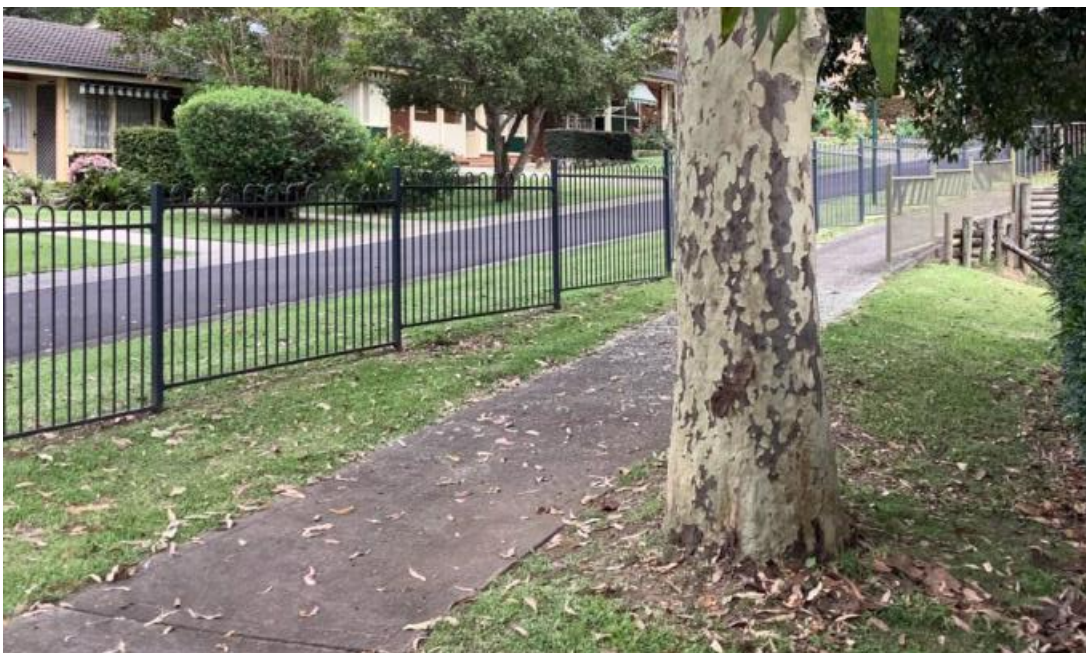
Figure 1 – Photo of the base of Tree T05 *Corymbia maculata* with existing concrete footpath shown close to the base of the tree. (Photo: Arterra 11/12/21)

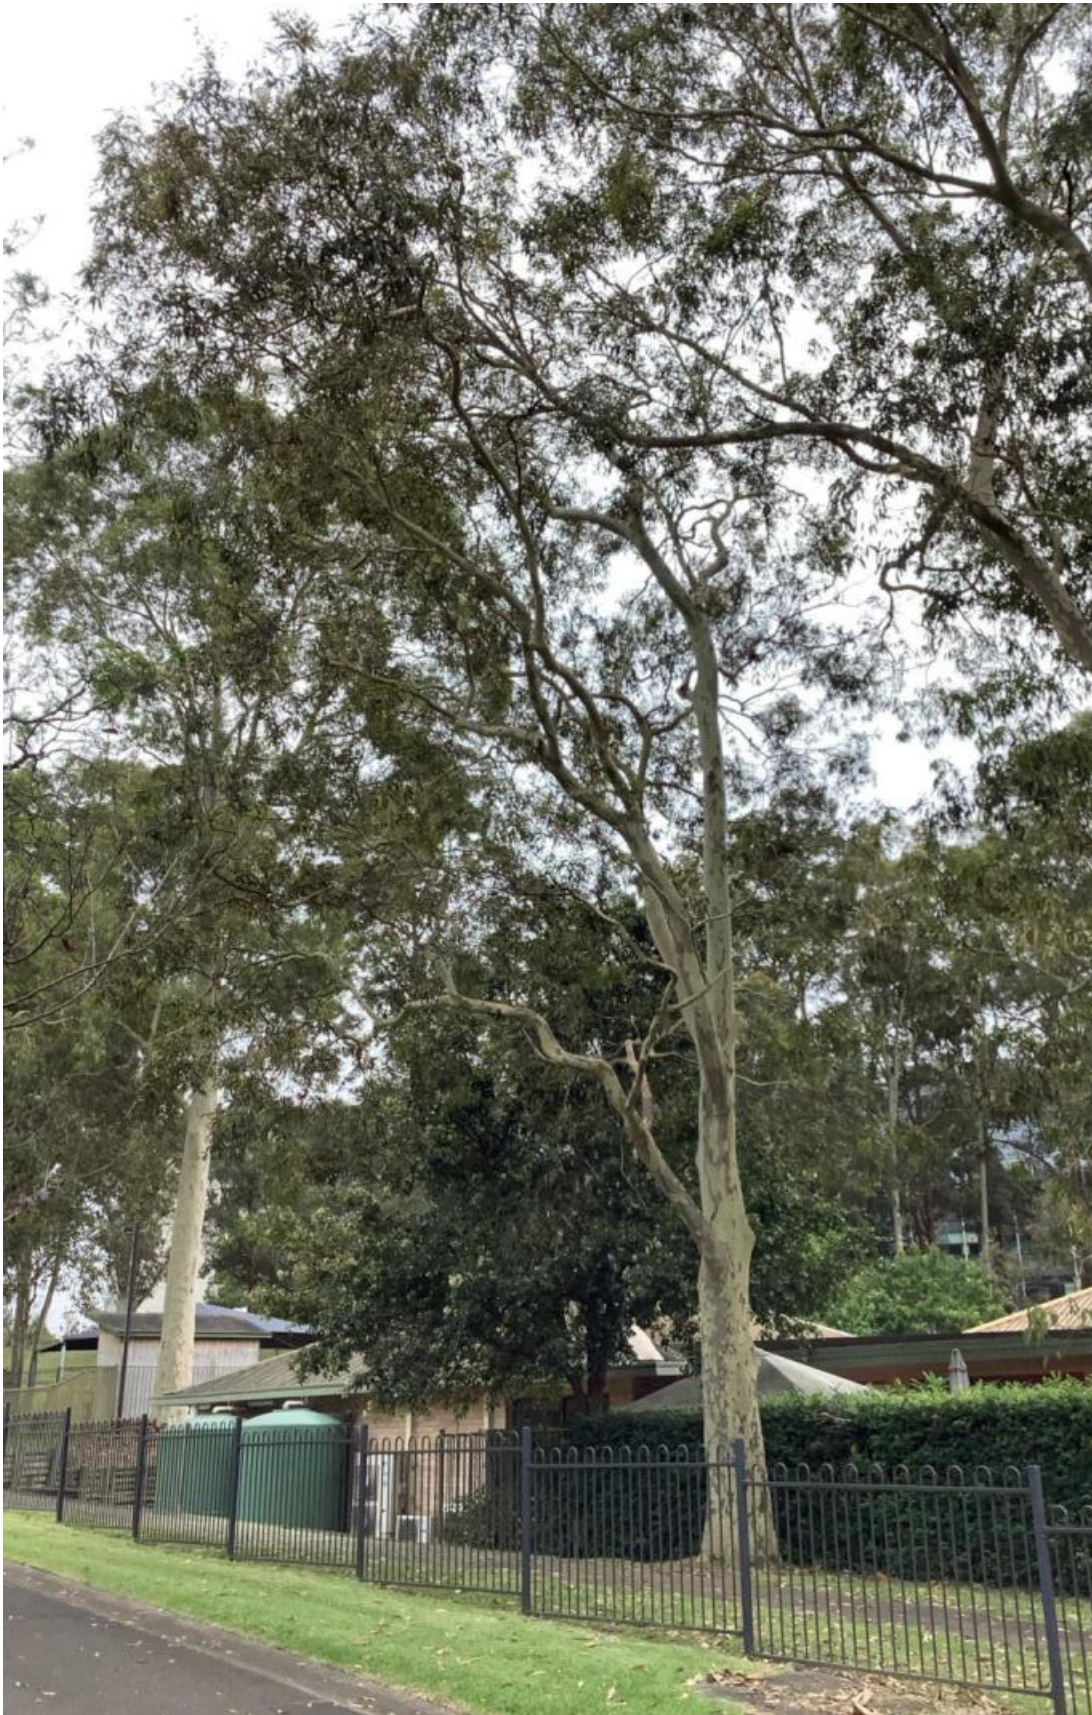
*Figure 2 – Photo of Tree T05 *Corymbia maculata* shown within the Macquarie University site just north of the BaptistCare boundary, with the existing childcare building (Gumnut Cottage) shown in the background. The canopy of the tree is somewhat asymmetrical with much of its canopy is to the south of the tree. (Photo: Arterra 11/12/21)*

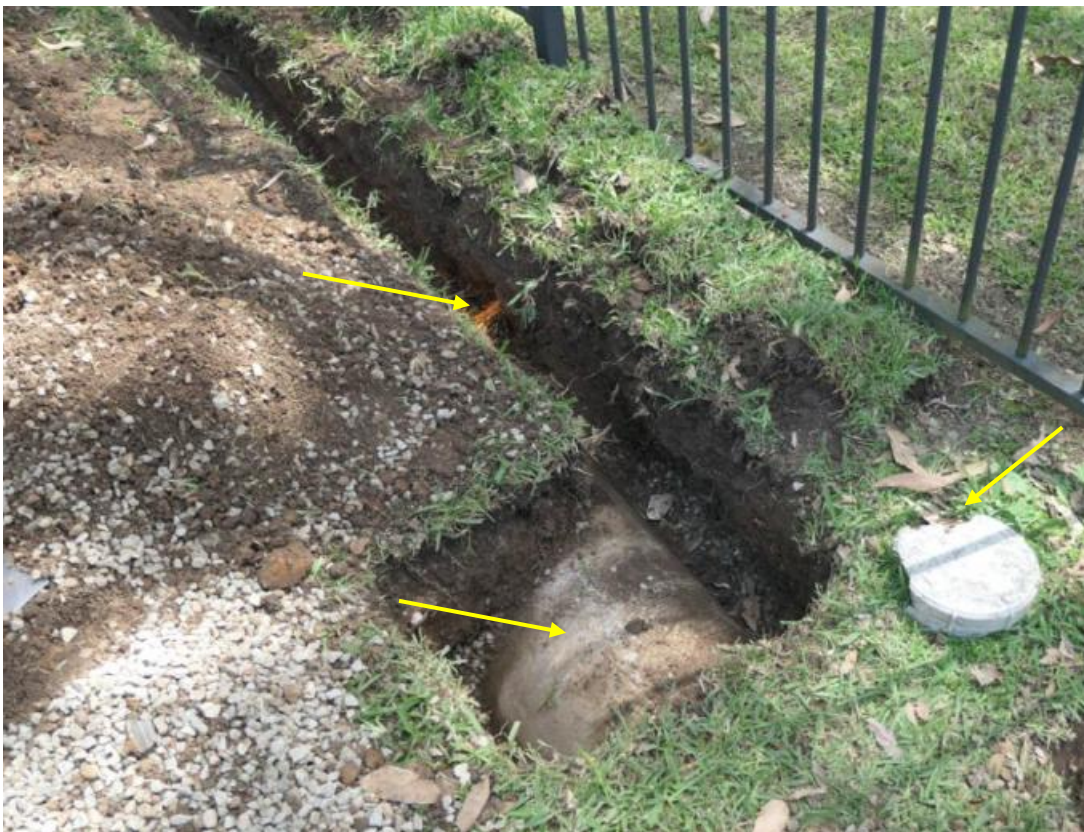
*Figure 5 – Photo of the area where root investigations were carried out. Line of trench and depth in some areas of the investigation were dictated by the presence of a large concrete stormwater pipe. The northern side of pipe was exposed where possible to check for any roots tracking along pipe run. Only one very small root was observed in any of the trenching. Note the riser cap from the lower sewer line which was running alongside and lower than the stormwater line. The small root, stormwater pipe and sewer shown arrowed. (Photo: Arterra 16/2/22)*

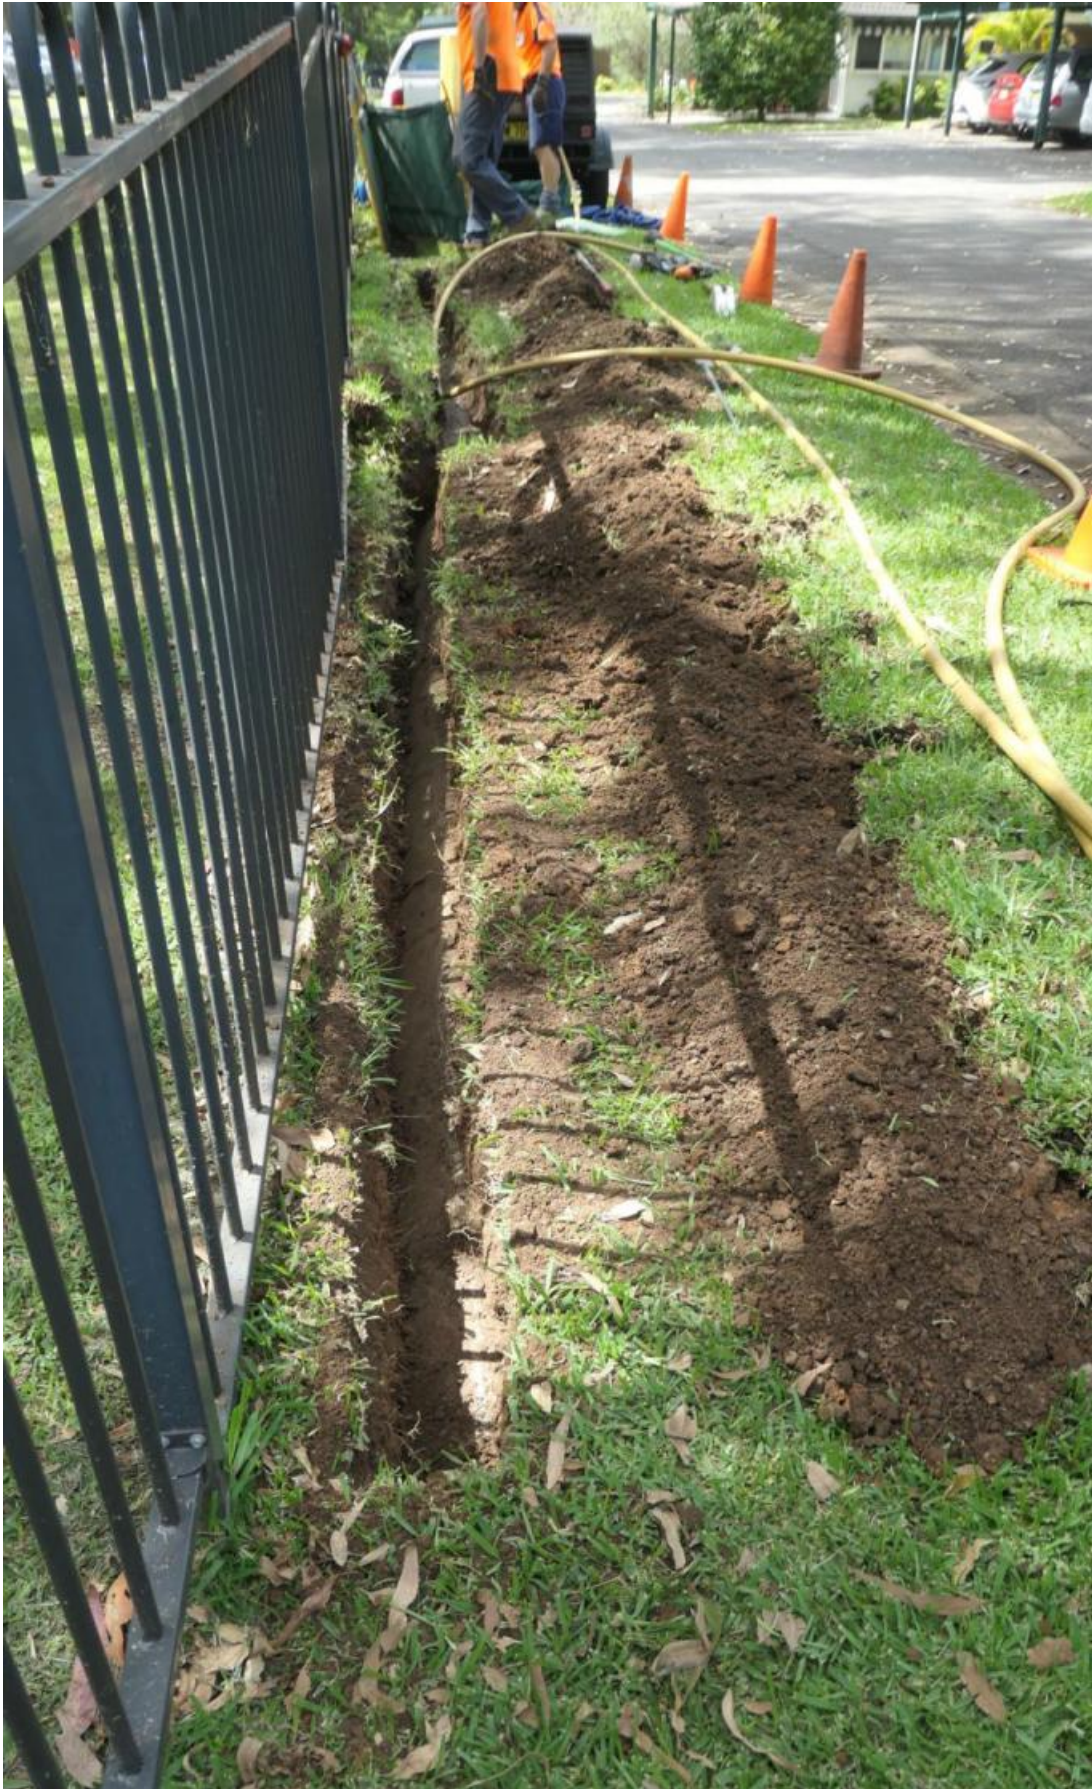
*Figure 6 – Photo of the area where root investigations were carried out. Trench depth and depth of investigation was dictated by presence of large concrete stormwater pipe. The northern side of pipe was exposed and investigated where possible to check for any roots tracking along the pipe run. None were observed. (Photo: Arterra 16/2/22)*

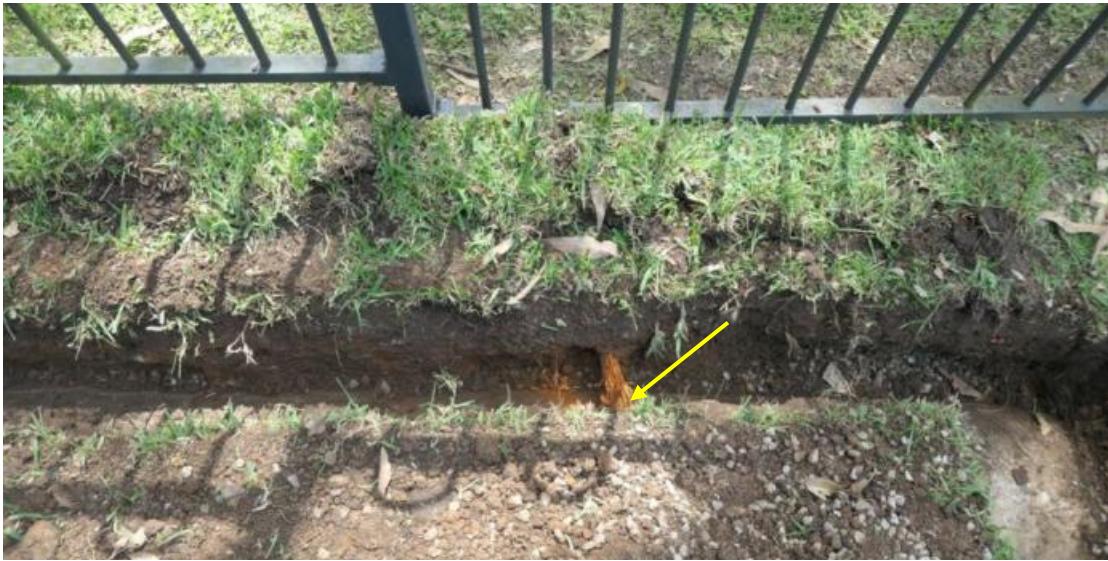
Figure 7 – Only one very small root (20mm  $\phi$ ) was discovered along the entire length of the trench. The root was spray painted orange for visibility and shown arrowed. (Photo: Arterra 16/2/22)

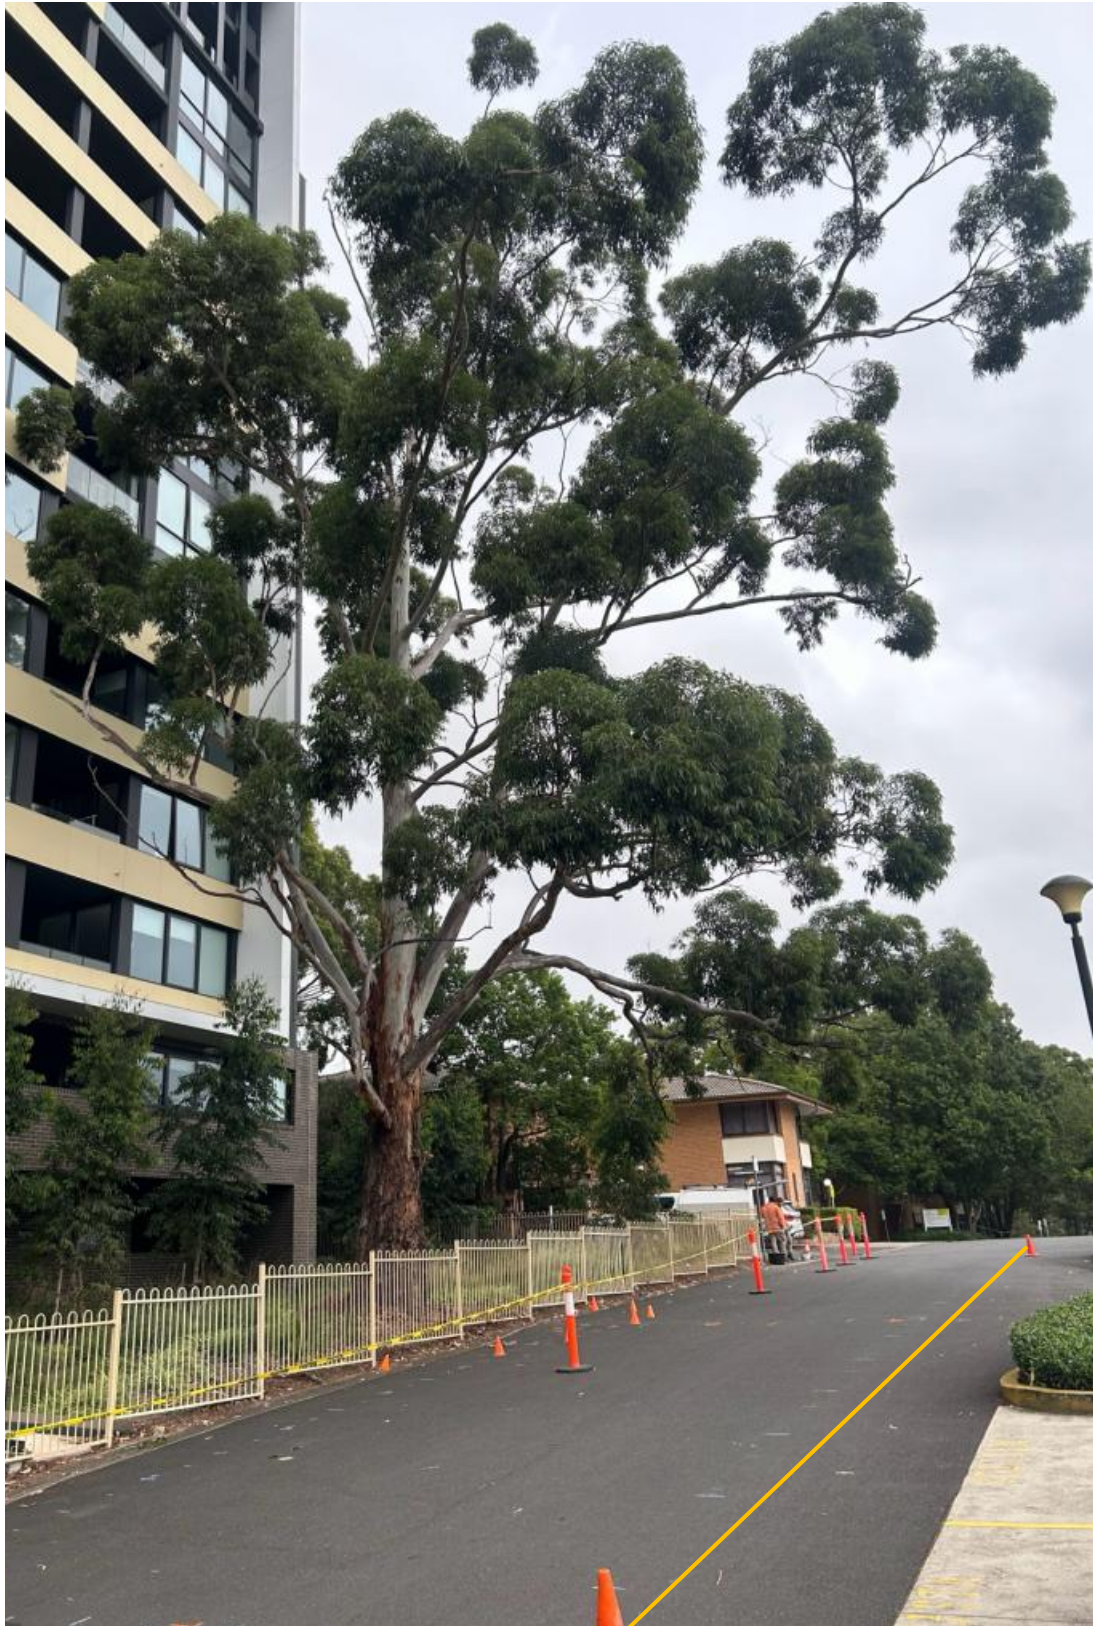
*Figure 1 – Image of Tree T76 Eucalyptus saligna (Sydney Blue Gum) on the northern boundary of the adjoining Parkside site showing the existing asphalt driveway within the BaptistCare site to the north of the tree and the recently constructed Parkside building to the south of the tree. The area defined by witch's hats outlines where the proposed master plan road edge is located approximately 9m from the base of the tree. (shown with line). (Photo: Arterra 1 March 2024)*

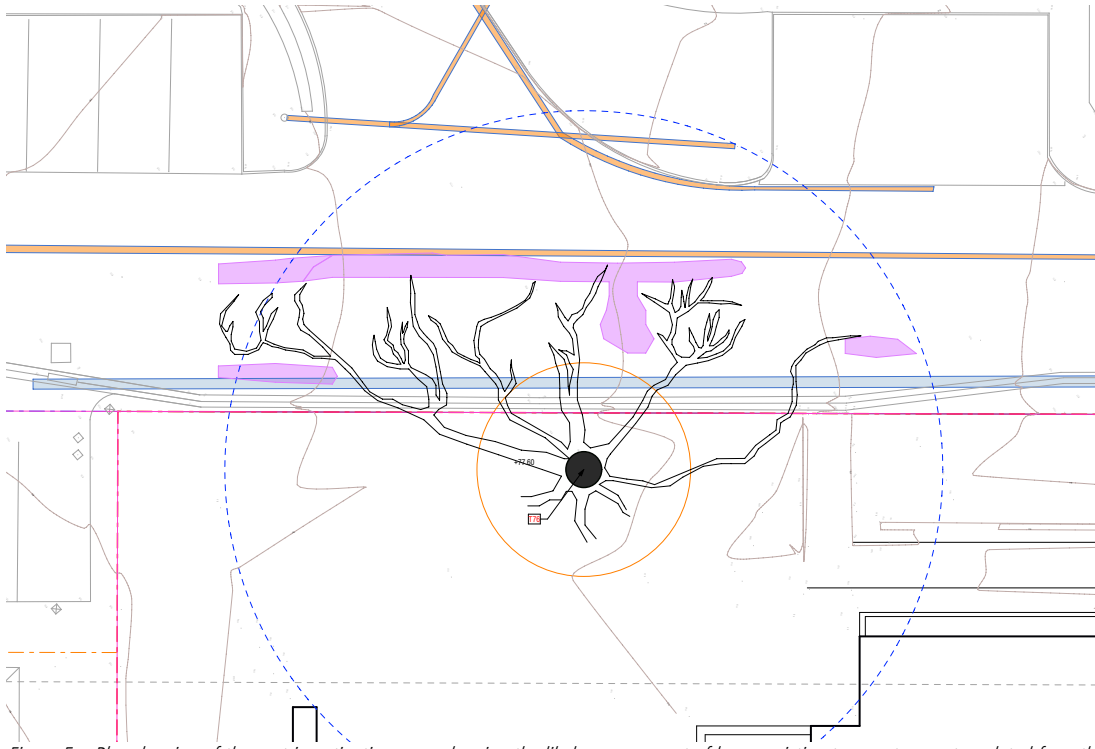
Figure 5 – Plan drawing of the root investigation area, showing the likely arrangement of larger existing tree roots as extrapolated from the RAW data results received from the GPR shown within the TPZ of T76. It is clear that the existing tree roots are probably radially emanating from the centre of the tree. The boundary to Parkside is shown as a red dashed line with the BaptistCare site to the north of this line. The pink fill highlights an area that was likely trenched and backfilled and/or disturbed with material clearly different to other subgrade treatments, likely resulting in disturbance to any existing root growth. The blue fill running east to west is the likely existing stormwater service and the orange fills are other services under the road (likely electrical and/or water) (Drawing: By Arterra - utilising GBG Group supplied Data 17/05/24)

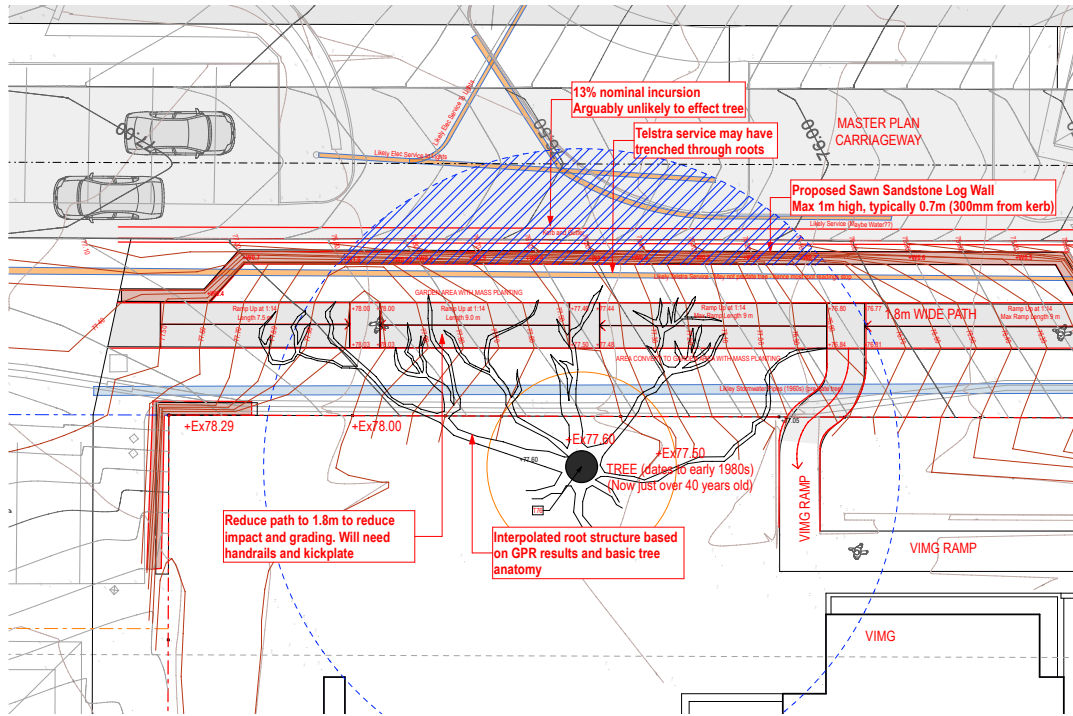
Figure 6 – The existing tree root arrangement (as extrapolated from the GPR results) were overlaid on the proposed road. The verge design has now been amended to cater for the protection of the existing tree roots close to the tree. To limit significant incursion into the TPZ, there has been significant modifications made to the masterplan designs to ensure that the proposed ‘verge’ is sensitively implemented and graded to minimise disturbance. The verge footpath has been designed with a series of 1:14 ramps to ensure that the footpath is maintained at or above the existing levels when passing through the TPZ of T76. A low impact sandstone log retaining wall (ie. no footings) has been utilised, to the north of the tree adjacent to the proposed road kerb. This is to retain the existing levels around the tree and prevent unnecessary incursions. Additionally, with the alignment of the proposed new internal road is much further north than the existing road alignment. This also allows for the removal of the existing asphalt that is close to the tree and the installation of new topsoil and better horticultural conditions within the TPZ which would likely help to further improve the health of the tree rather than impacting it. (Drawing: By Arterra - utilising G&B Group supplied Data 17/05/24)
