# Arboricultural Impact Assessment Report

**AIA-01**

Revision C  
5 March, 2025

## **BaptistCare Macquarie Park - Concept Master Plan State Significant Development Application (SSDA)**

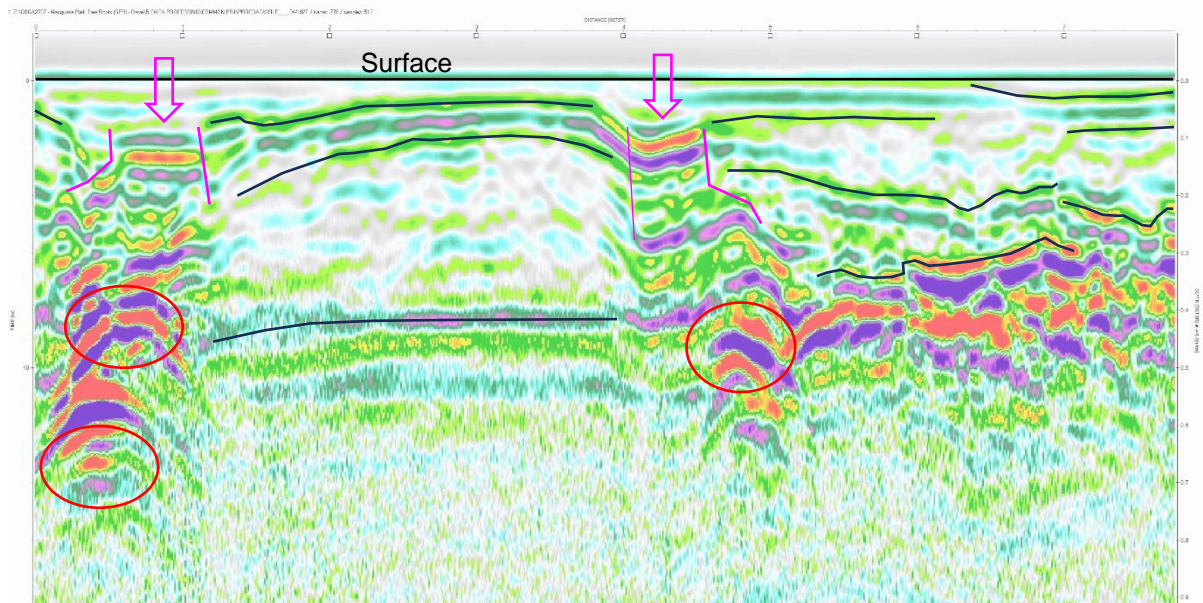
**Figure 2:** File 44 – 900 MHz radargram highlighting the variation in road construction. The black lines denote the different layer interfaces, the magenta arrows and lines are disturbed ground / possible service trenches, and the red circles are services.

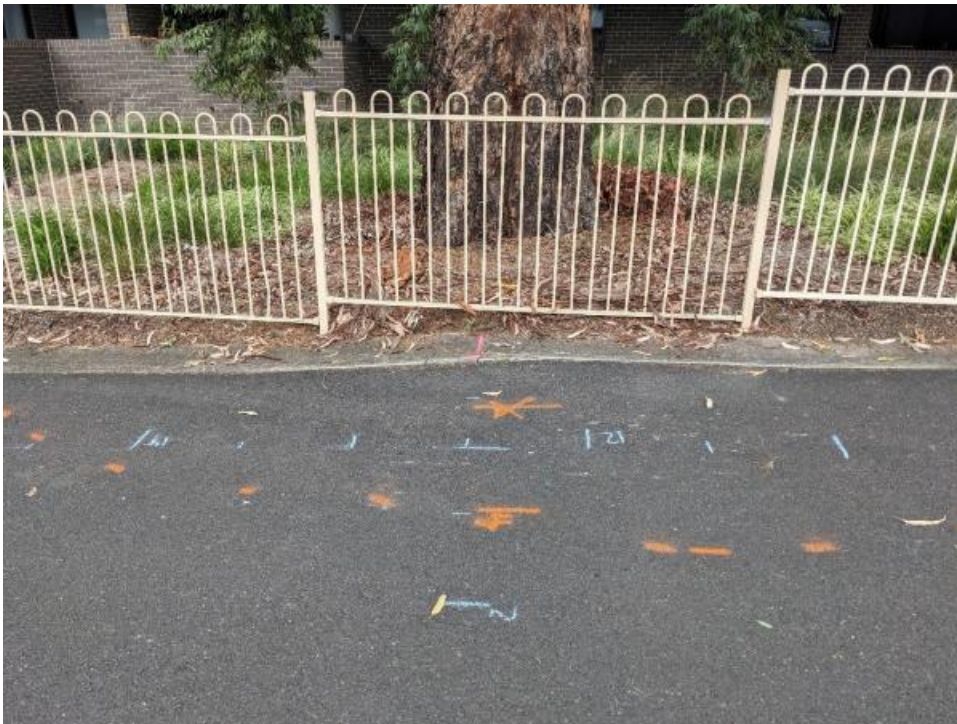
**Figure 3. Site image looking towards tree T76 and the area of ground deformation. The dashed orange lines outline the extent of the deformation.**

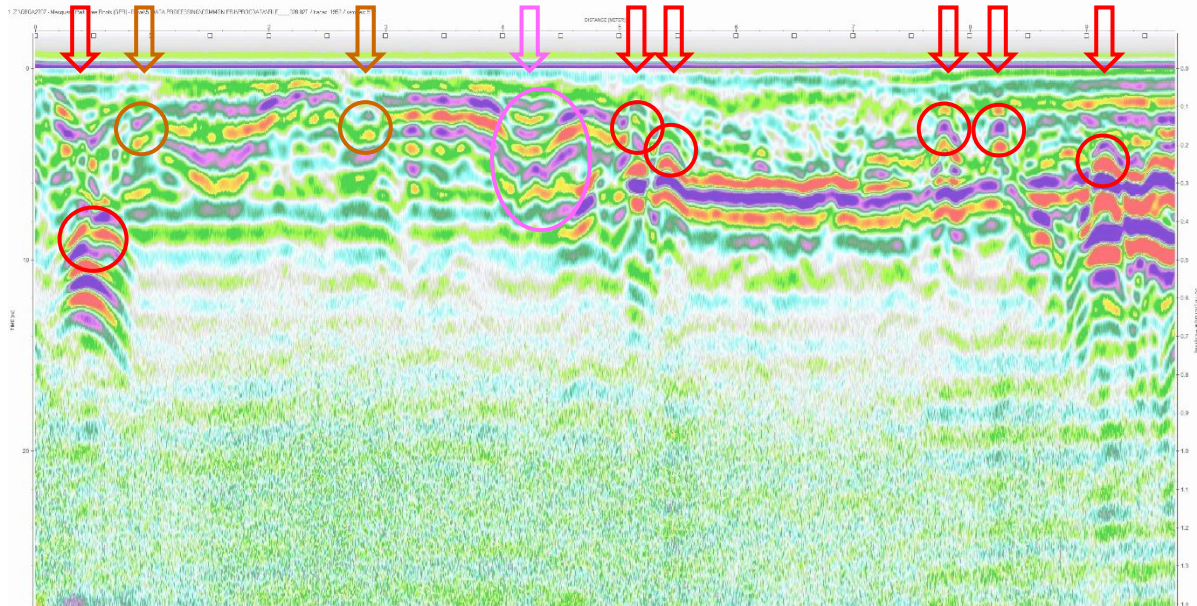
**Figure 4.** File 28 600 MHz radargram highlighting identification of tree roots in brown (x2), services in red (x6) and an area of disturbed ground / a possible service trench in magenta (x1).
