## DILAPIDATION REPORT

10 EASTERN CREEK DRIVE EASTERN CREEK, NSW, 2766

THURSDAY, 22 FEBRUARY 2024

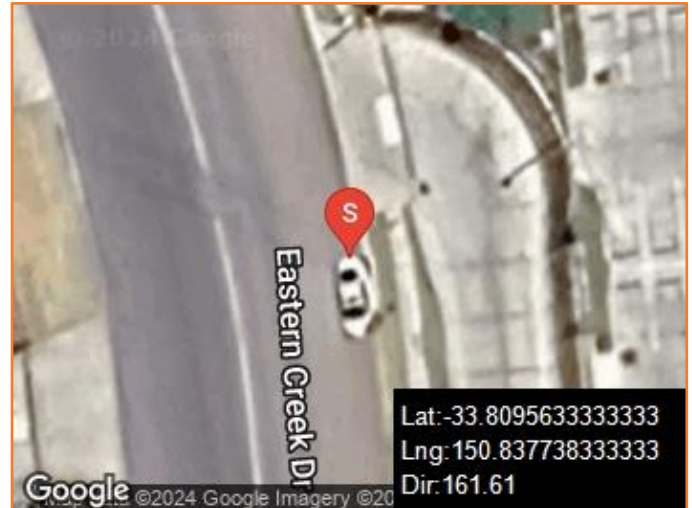
Figure 34: Good - General condition of footpath and service pits.

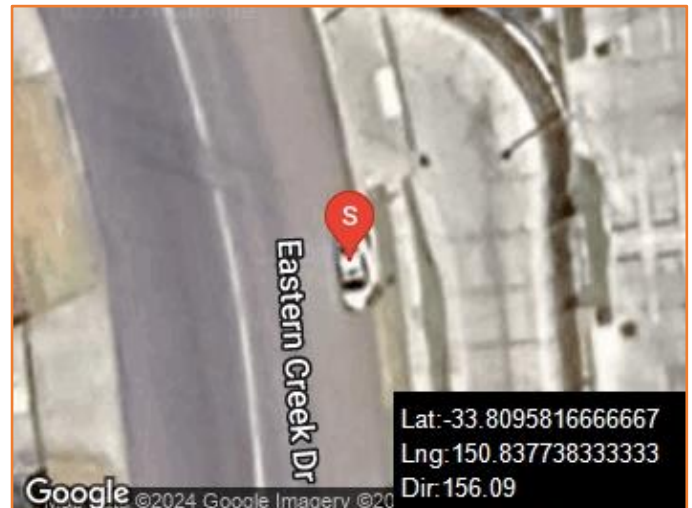
Figure 35: Good - General condition of footpath.

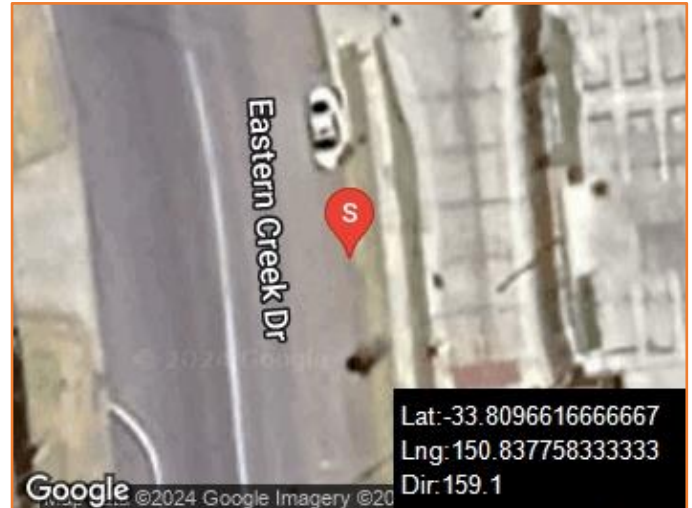
Figure 37: Good - General condition of service pits.

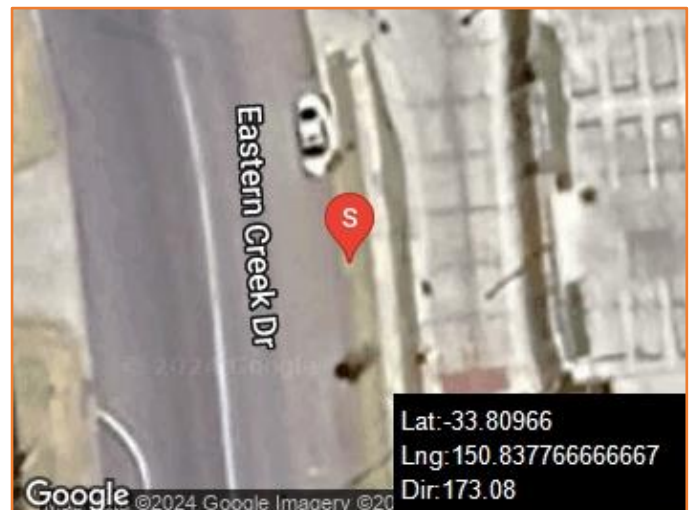
Figure 38: Good - General condition of footpath.

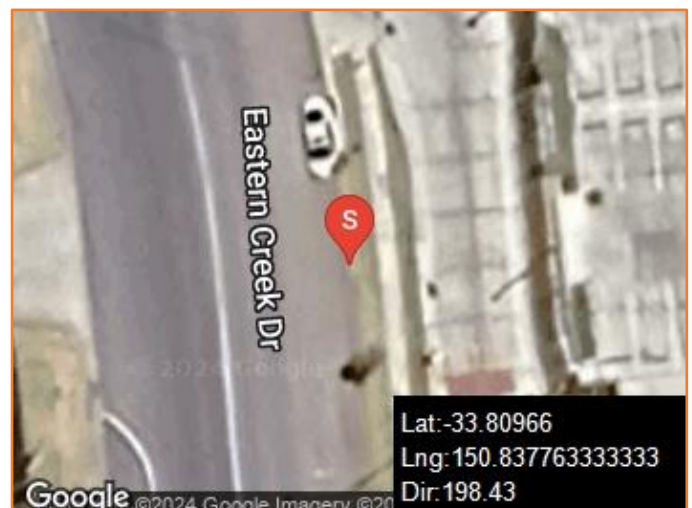
Figure 39: Good - General condition of street planting.

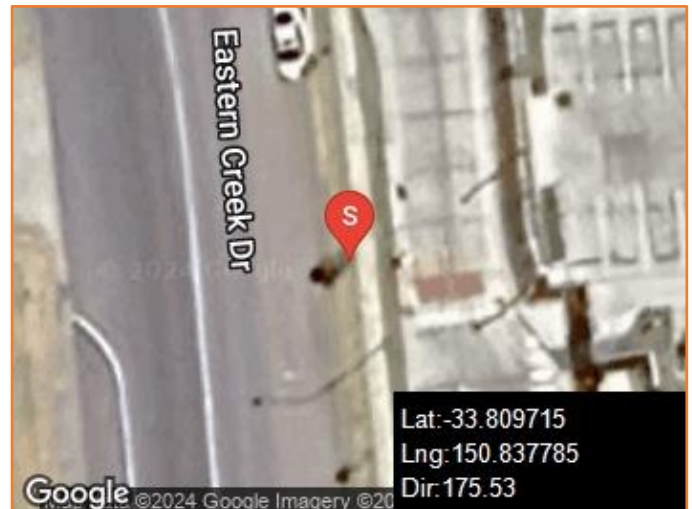
Figure 43: Good - General condition of footpath.

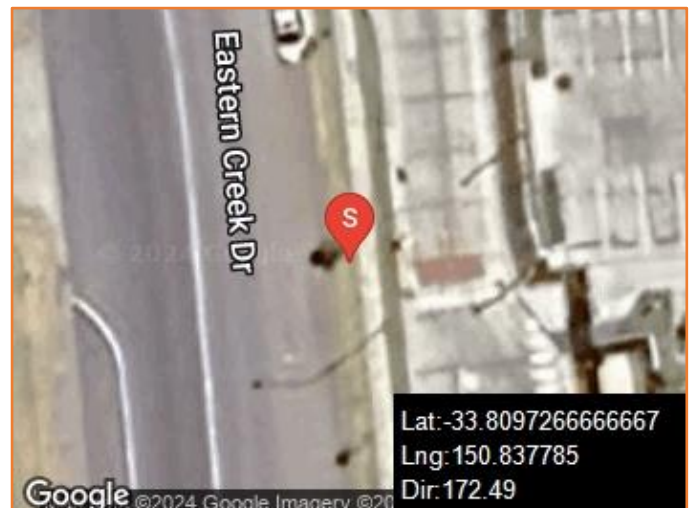
Figure 44: Good - General condition of street planting.

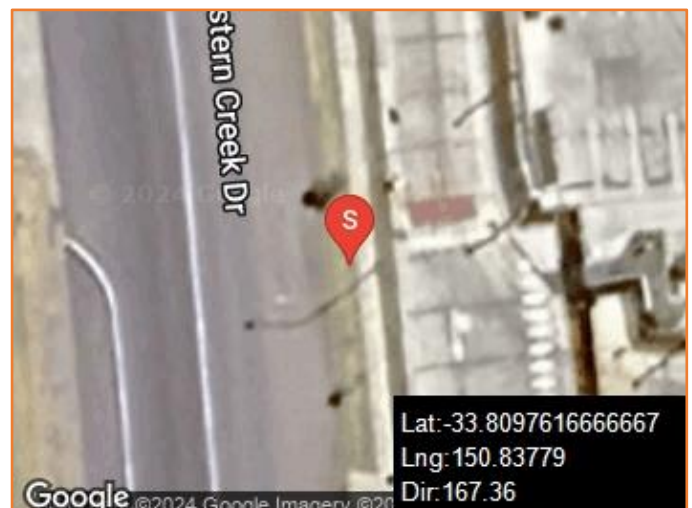
Figure 45: Good - General condition of footpath.

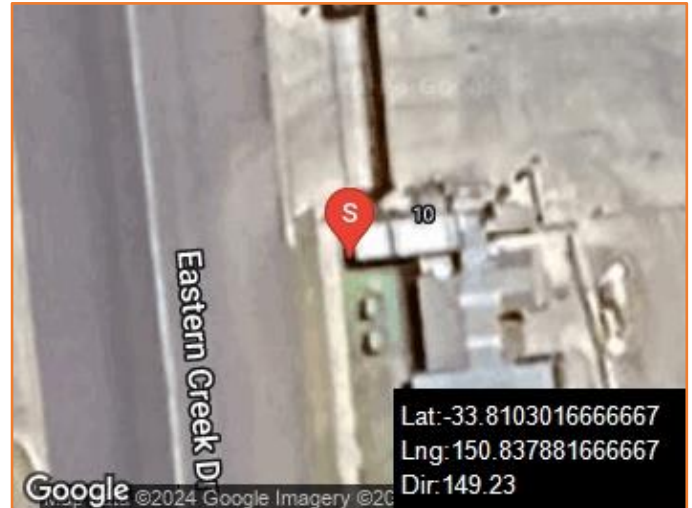
Figure 70: Good - General condition of substations.

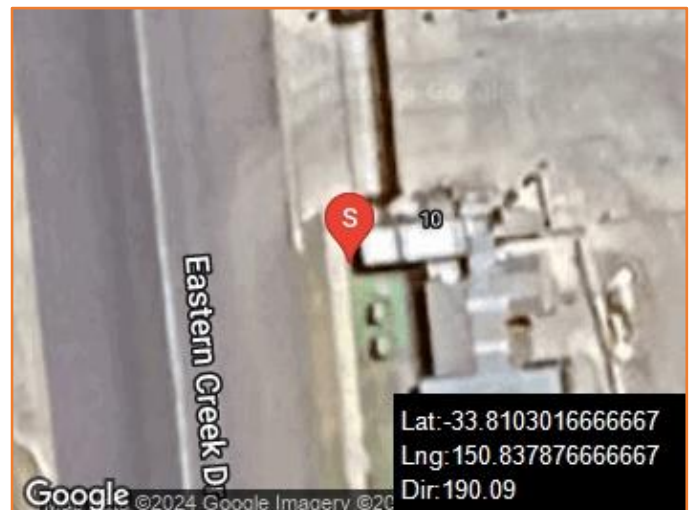
Figure 71: Good - General condition of footpath.

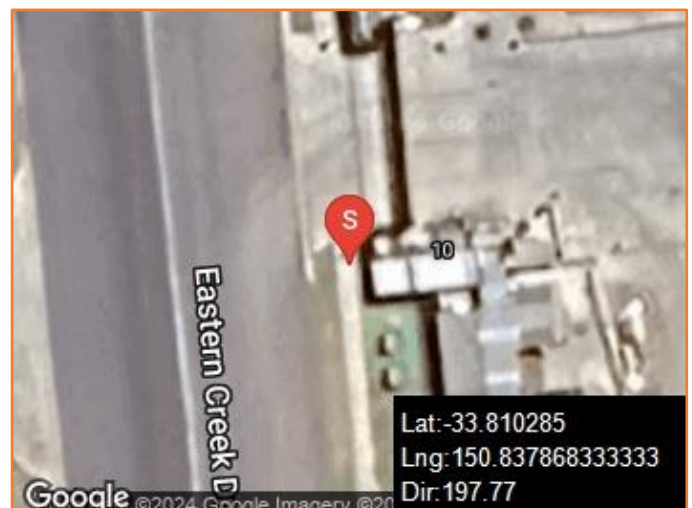
Figure 72: Good - General condition of footpath.

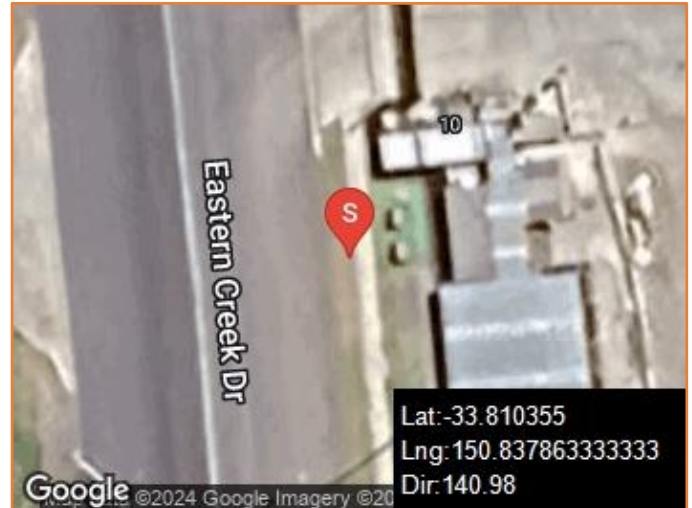
Figure 76: Good - General condition of monopole assembly.

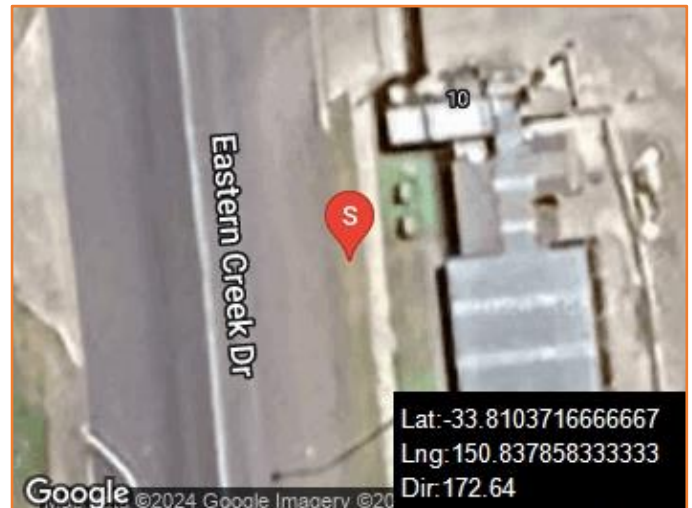
Figure 77: Good - General condition of footpath.

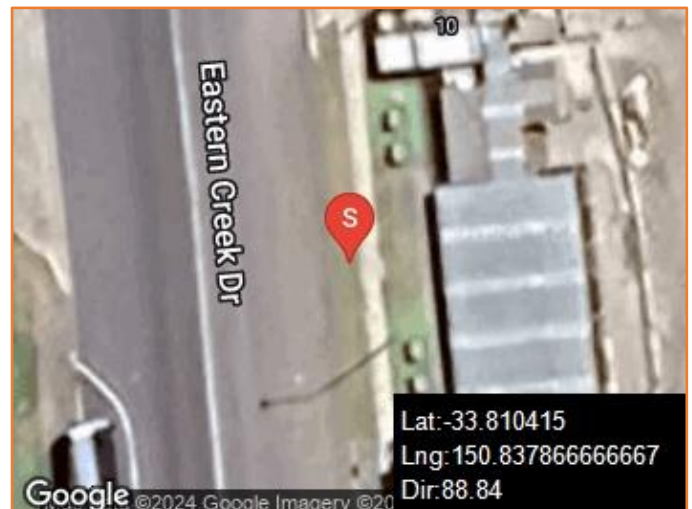
Figure 78: Good - General condition of substations.

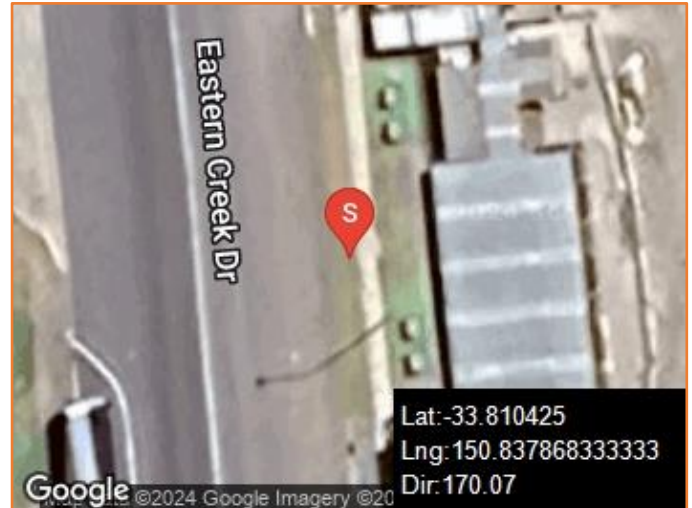
Figure 79: Good - General condition of footpath.

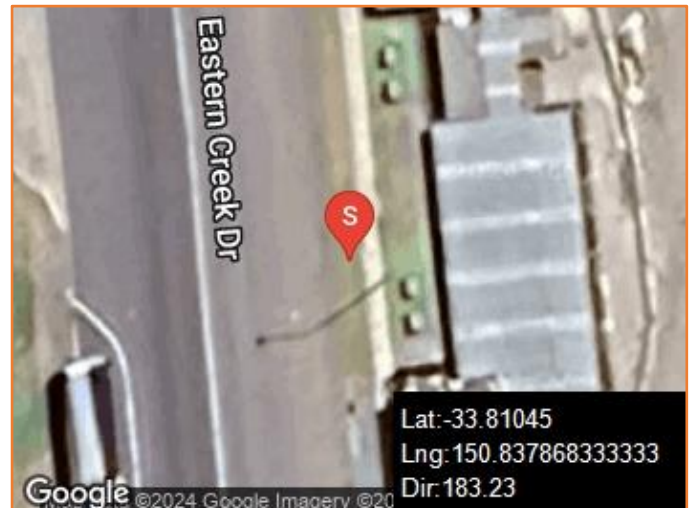
Figure 80: Good - General condition of footpath.

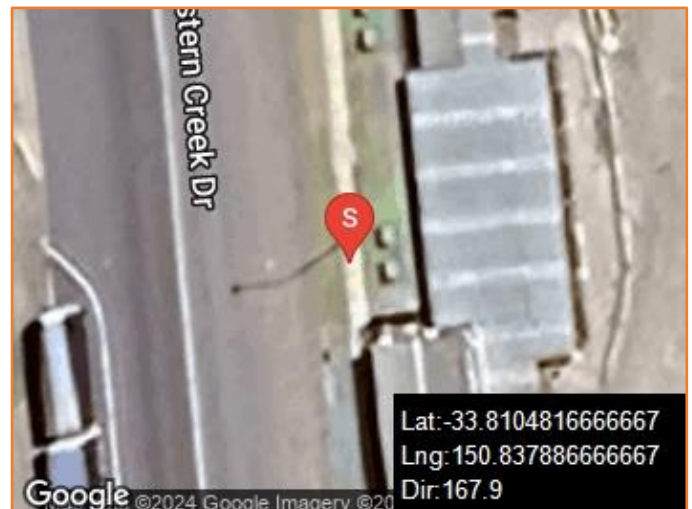
Figure 81: Good - General condition of footpath.

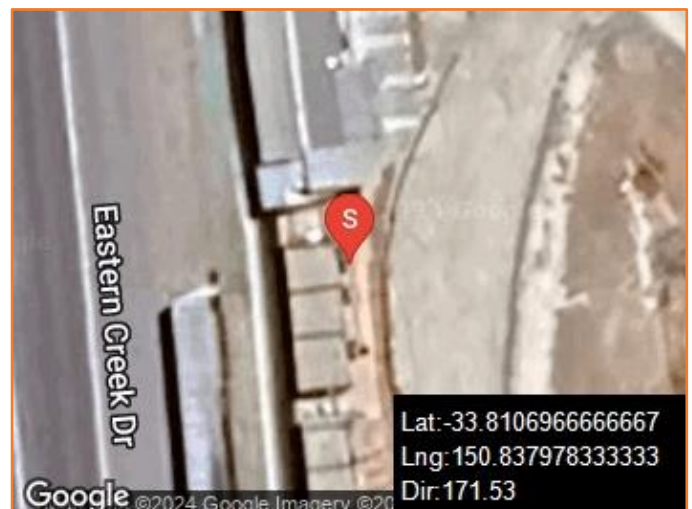
Figure 87: Reasonable - General condition of footpath. Moderate cracking observed.

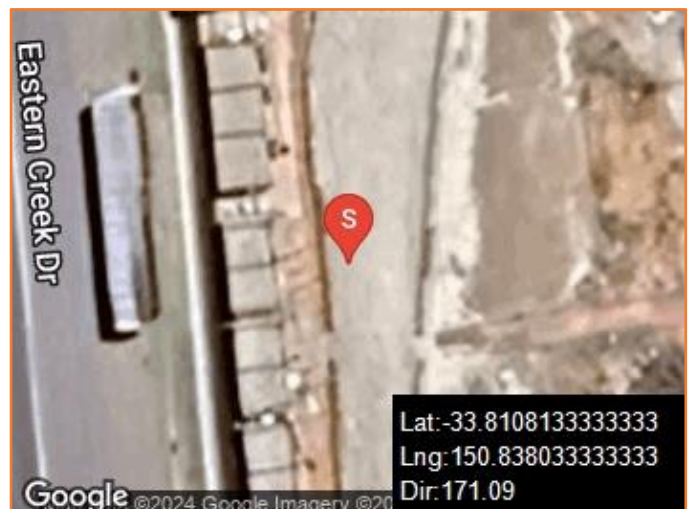
Figure 93: Good - General condition of footpath.

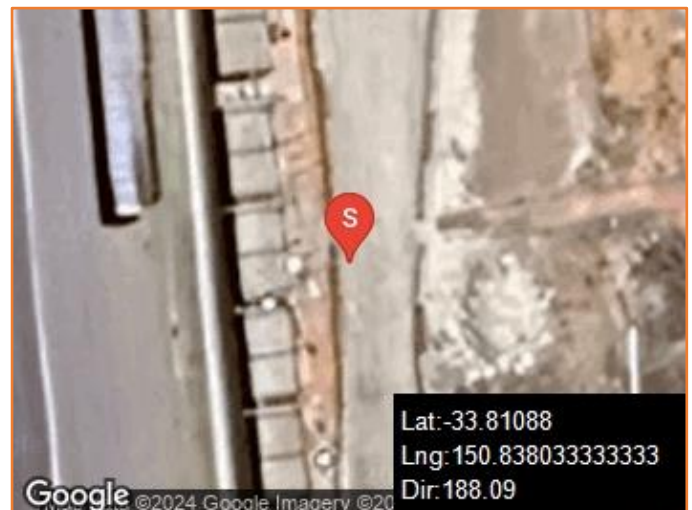
Figure 95: Reasonable - General condition of footpath. Moderate hairline cracking observed.

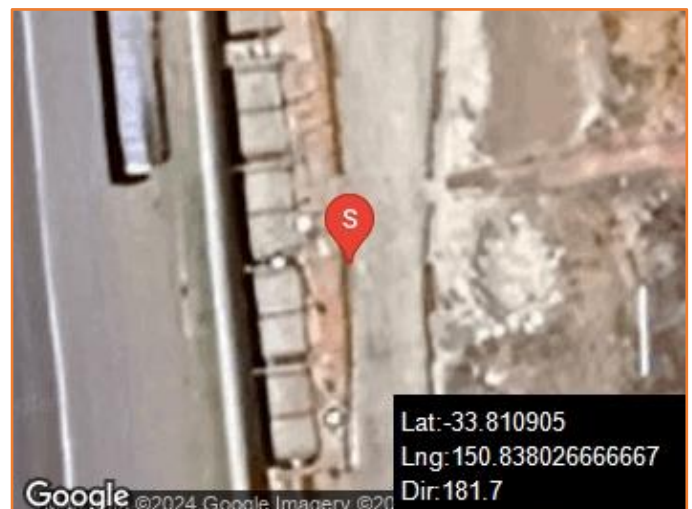
Figure 96: Good - General condition of footpath.

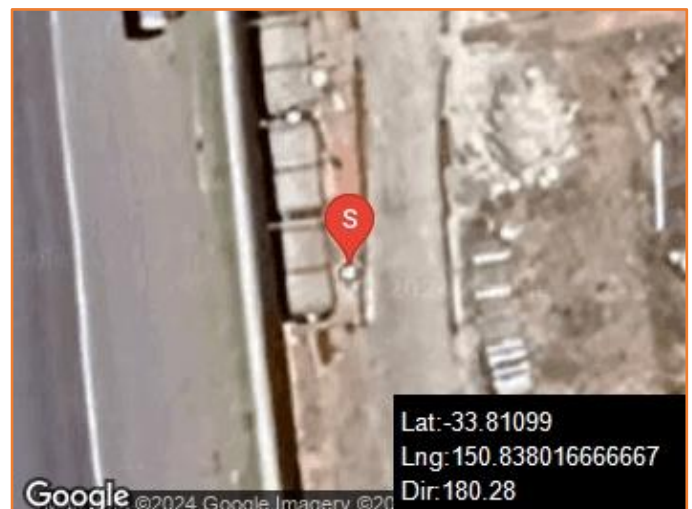
Figure 99: Good - General condition of footpath.

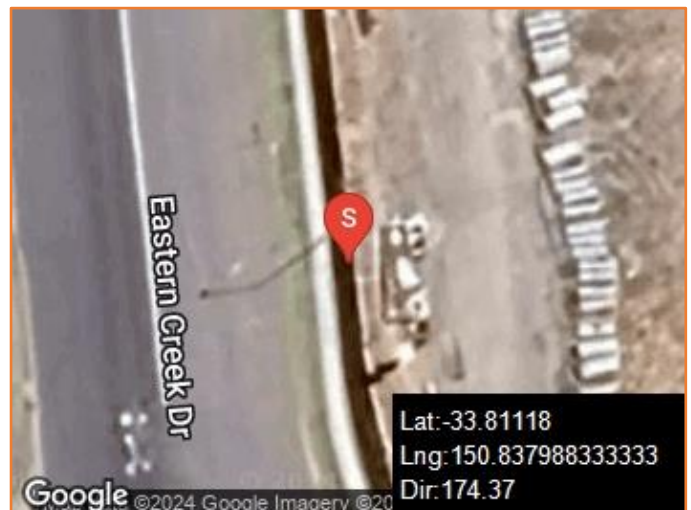
Figure 107: Reasonable - General condition of service pits.

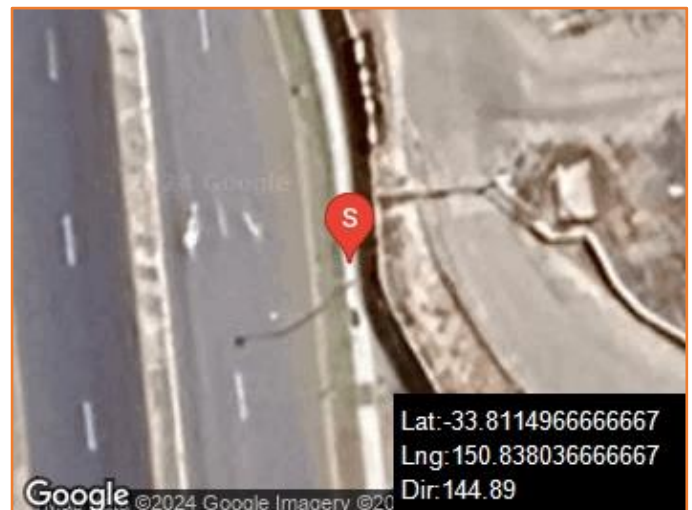
Figure 116: monopole assembly.

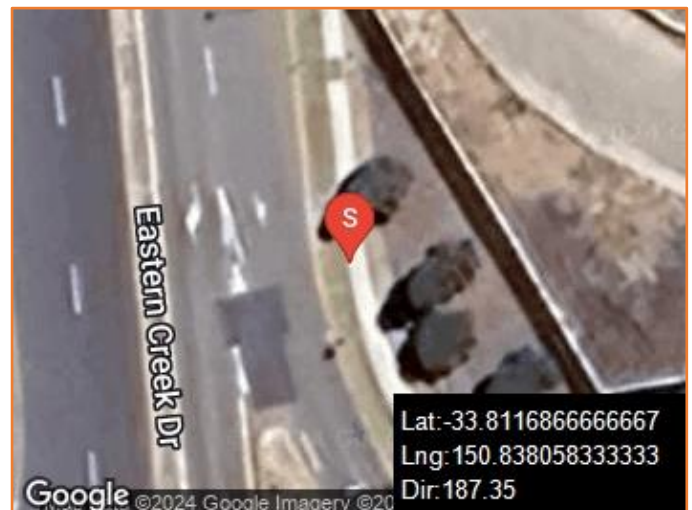
Figure 125: Good - General condition of service pit.

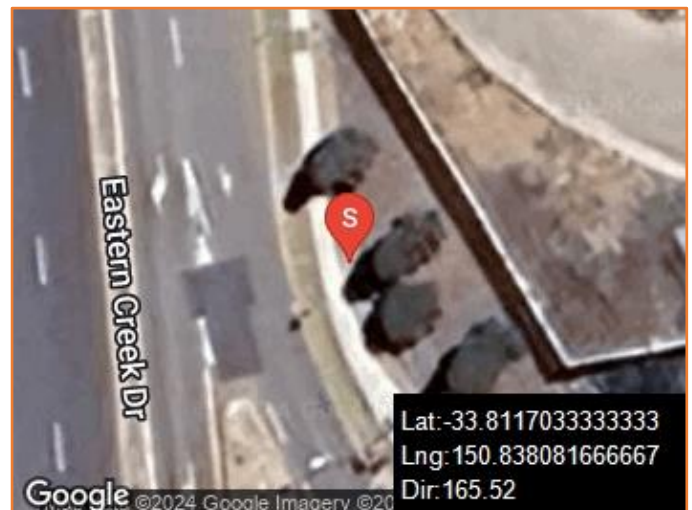
Figure 128: Good - General condition of footpath.

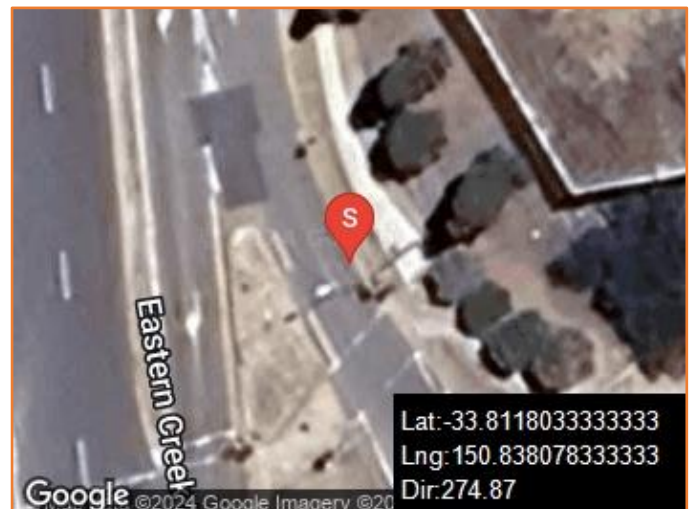
Figure 138: Reasonable - General condition of flexible pavement. Previous repair observed.

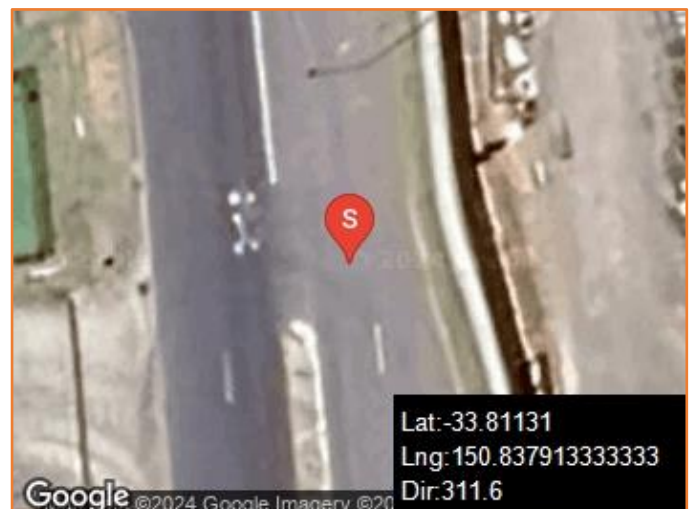
Figure 153: Reasonable - General condition of flexible pavement.  
 Moderate alligator cracking observed.

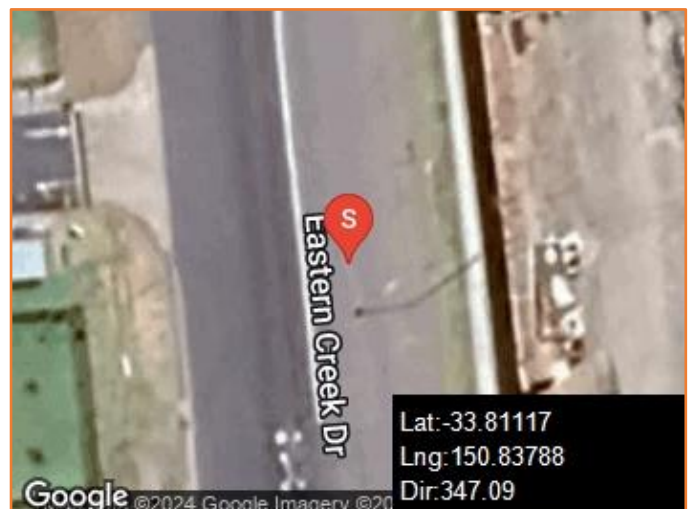
Figure 156: Reasonable - General condition of flexible pavement.

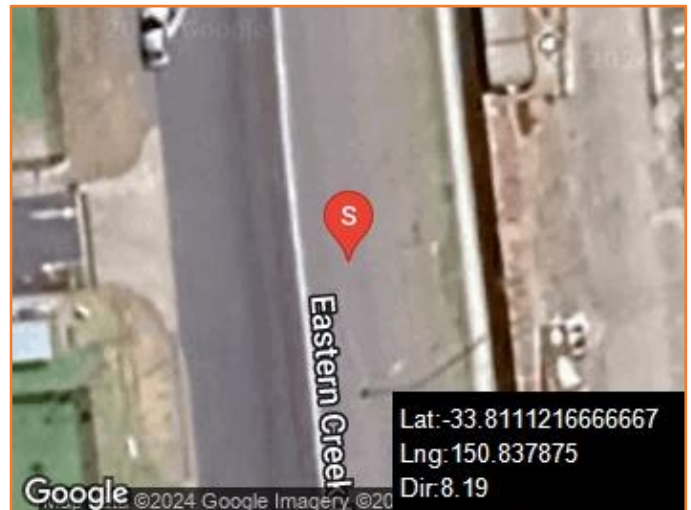
Figure 158: Reasonable - General condition of flexible pavement.

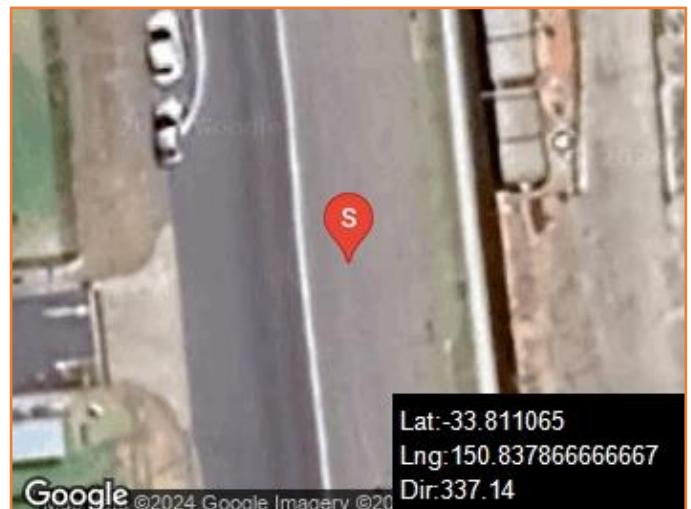
Figure 159: Reasonable - General condition of flexible pavement.

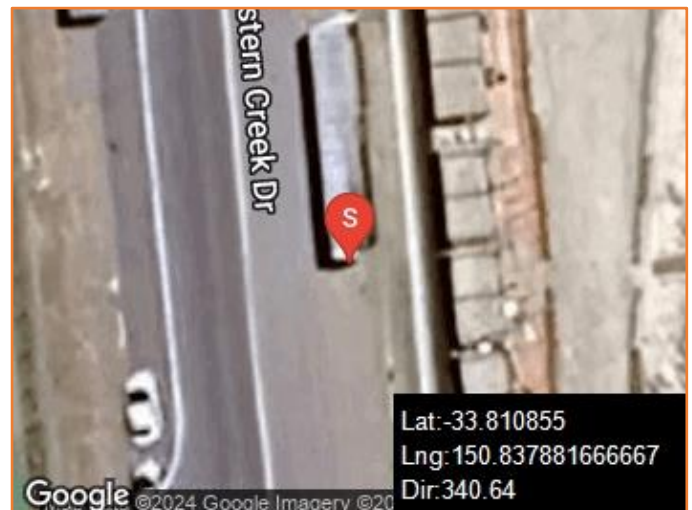
Figure 164: Reasonable - General condition of flexible pavement.

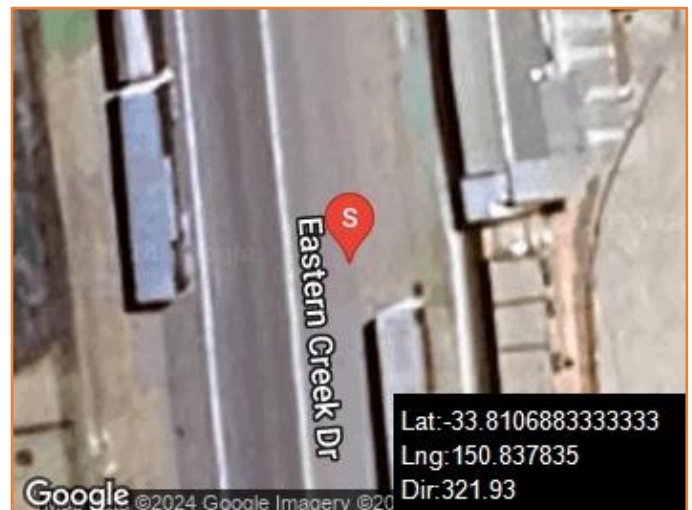
Figure 167: Reasonable - General condition of flexible pavement.

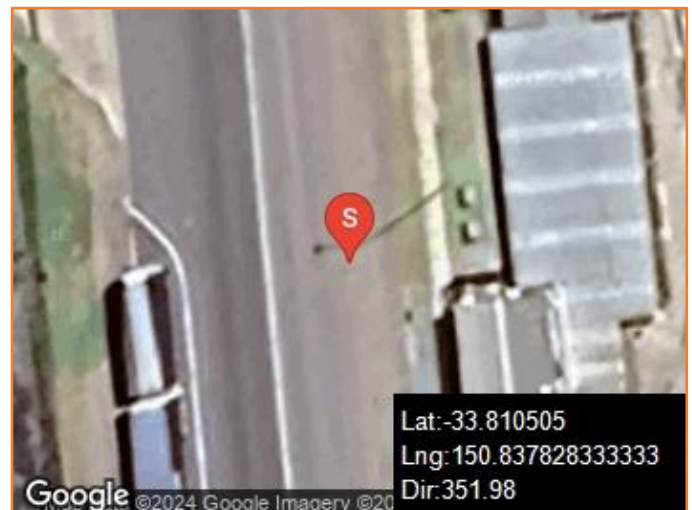
Figure 170: Reasonable - General condition of flexible pavement.  
Moderate alligator cracking observed.

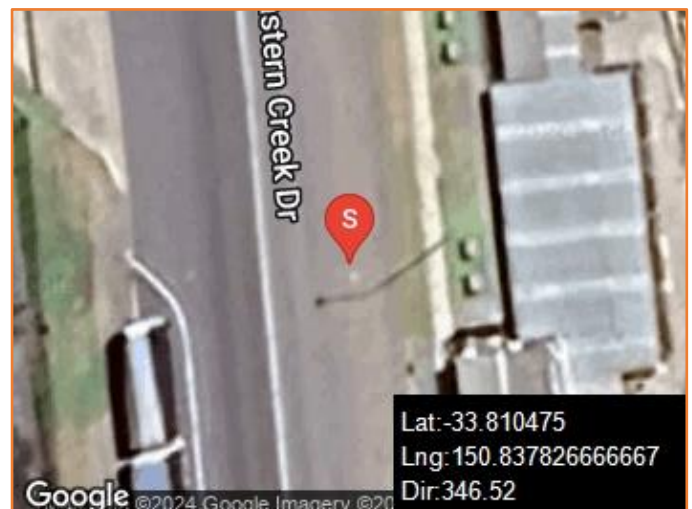
Figure 171: Reasonable - General condition of flexible pavement.

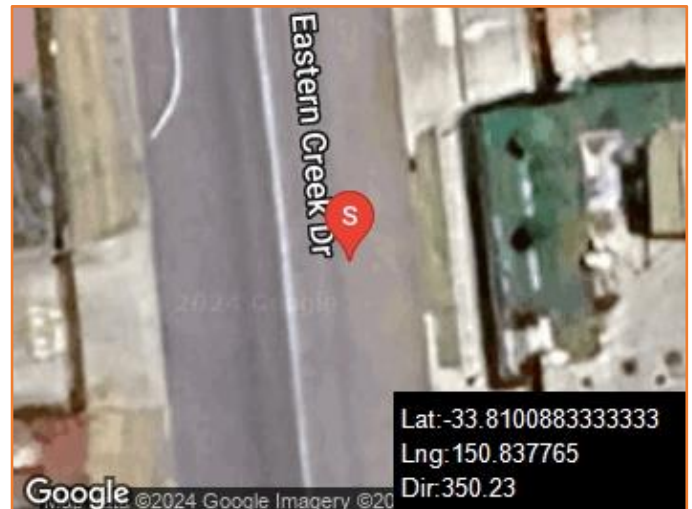
Figure 184: Reasonable - General condition of flexible pavement.  
Moderate alligator cracking and rutting observed.

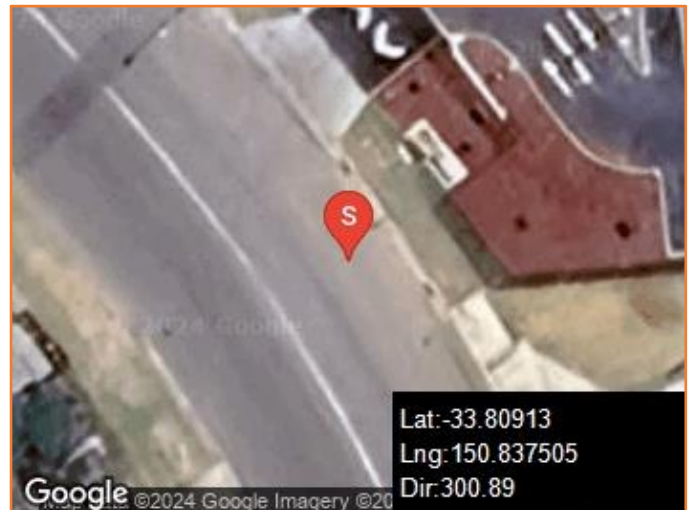
Figure 212: Reasonable - General condition of flexible pavement.

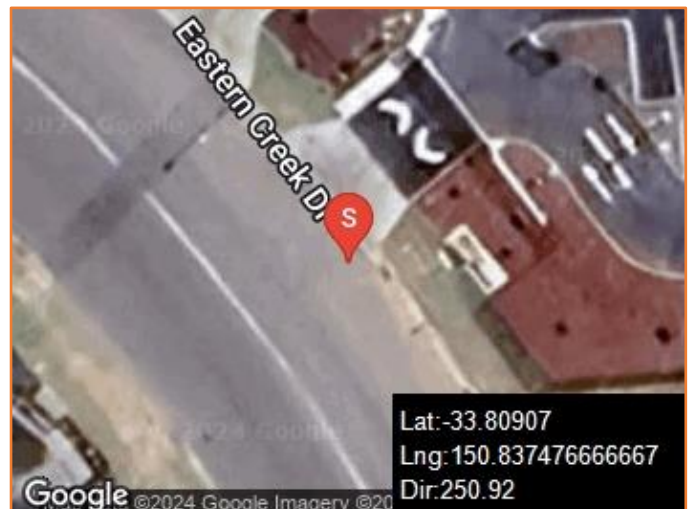
Figure 213: Reasonable - General condition of flexible pavement.

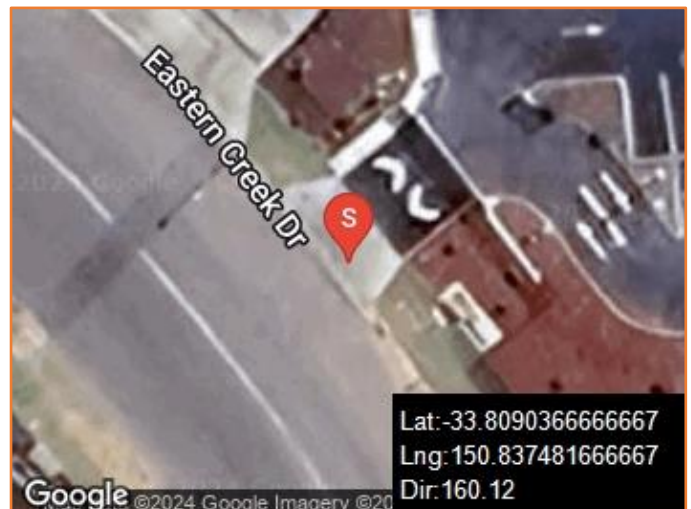
Figure 219: Reasonable - General condition of kerb inlet pit.

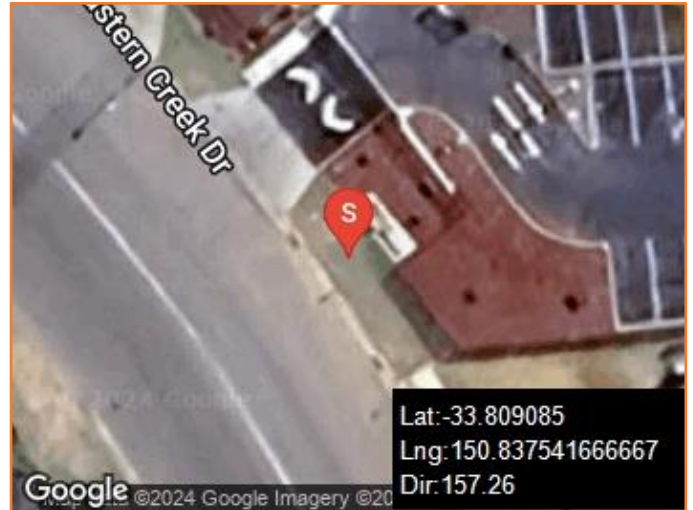
Figure 223: Reasonable - General condition of kerb inlet pit.

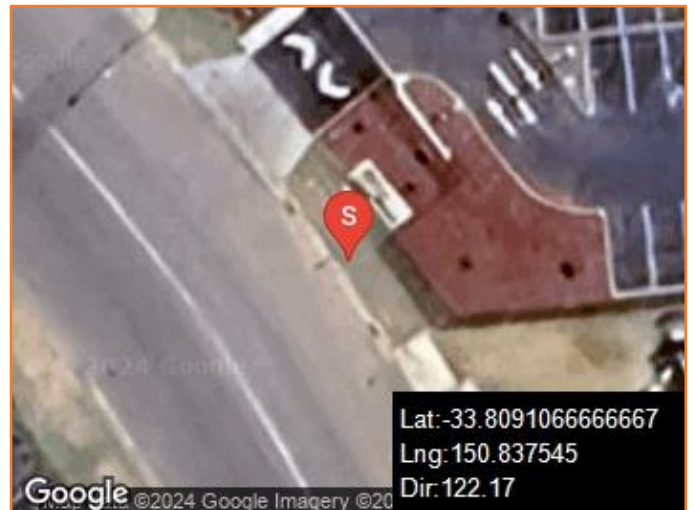
Figure 224: Reasonable - General condition of kerb inlet pit.

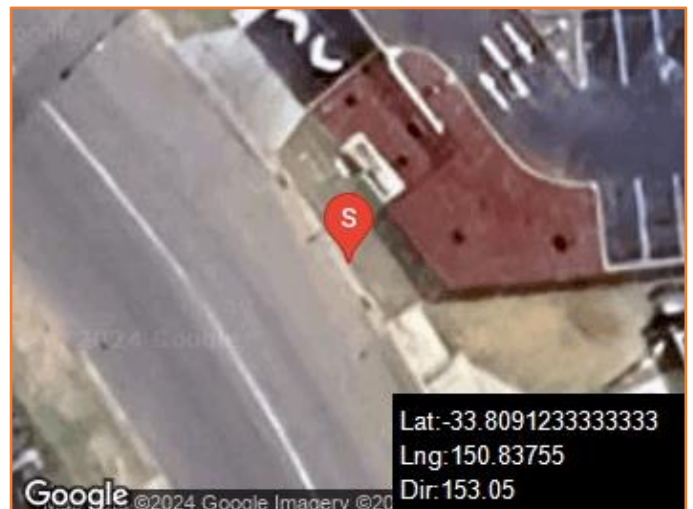
Figure 225: Reasonable - General condition of kerb and gutter.

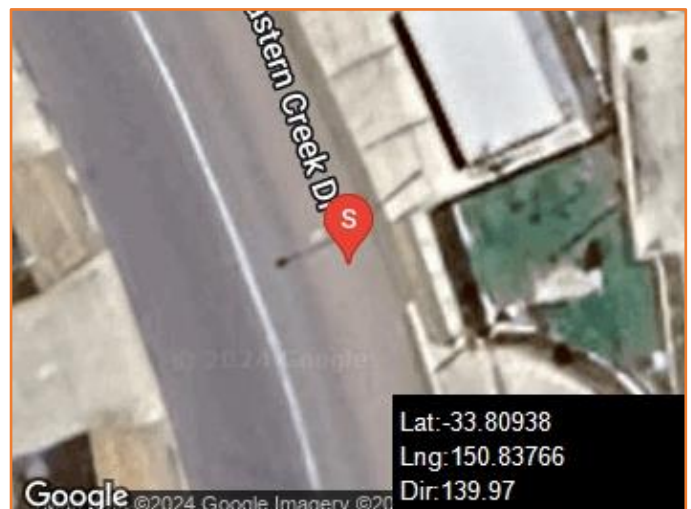
Figure 237: Reasonable - General condition of driveway layback. Minor spalling observed.

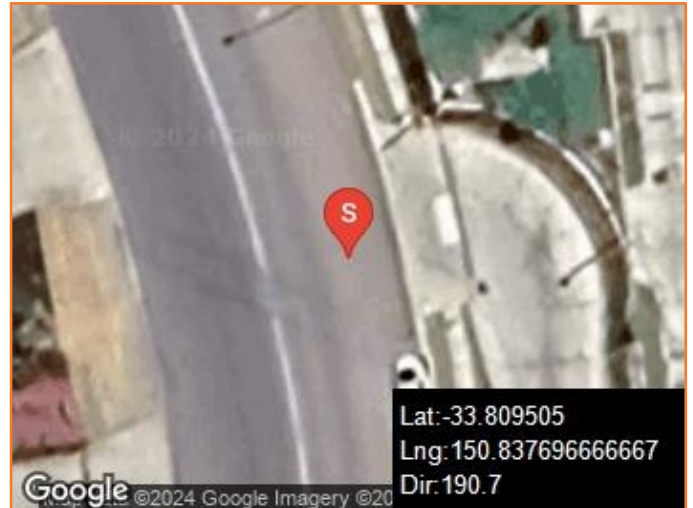
Figure 241: Reasonable - General condition of kerb inlet pit.

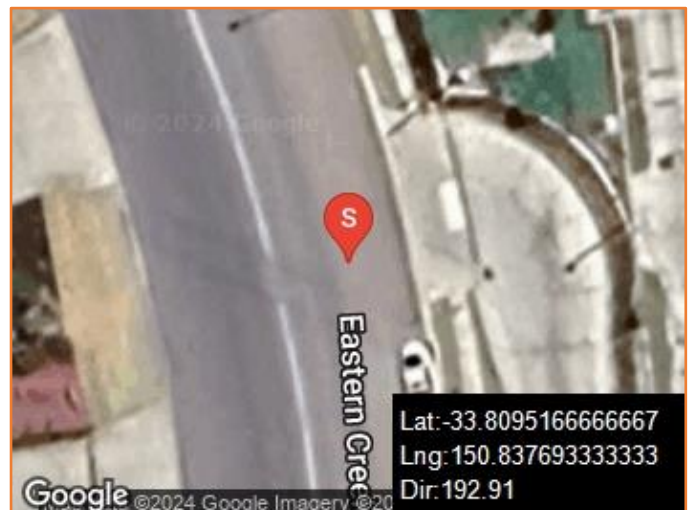
Figure 242: Reasonable - General condition of kerb and gutter.

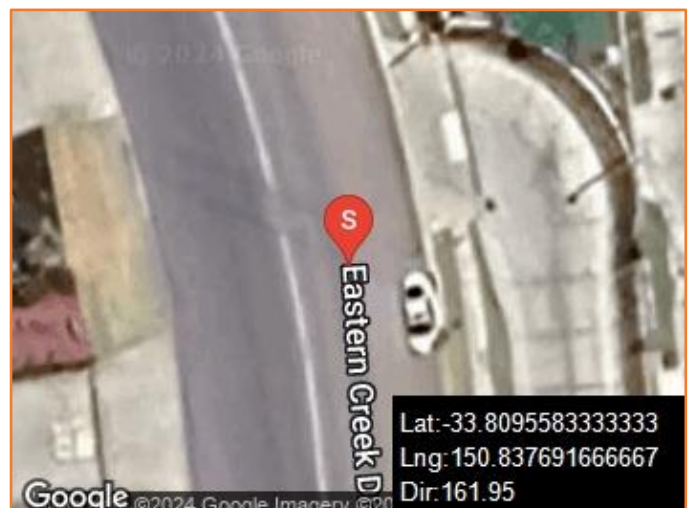
Figure 243: Reasonable - General condition of kerb and gutter.

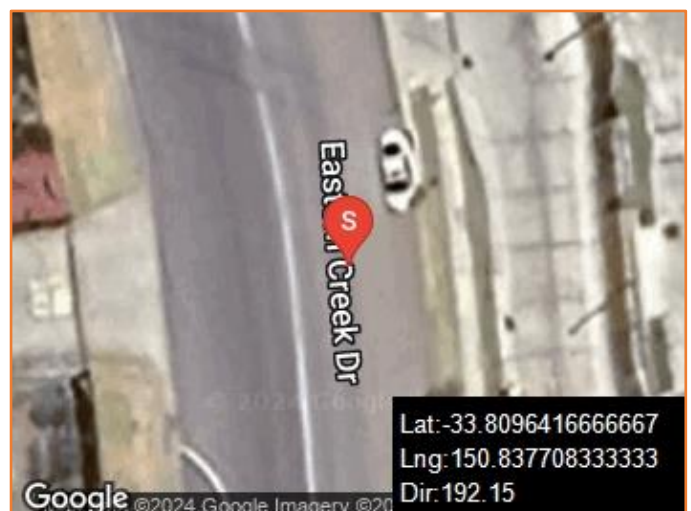
Figure 246: Reasonable - General condition of kerb and gutter.

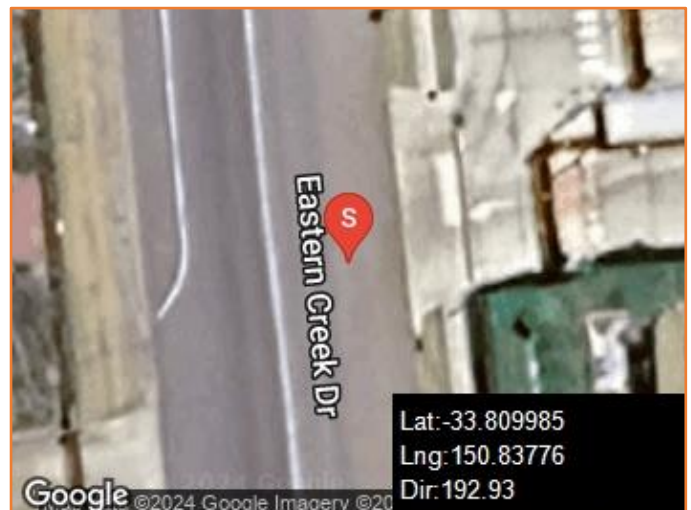
Figure 257: Reasonable - General condition of kerb inlet pit. Moderate cracking observed.

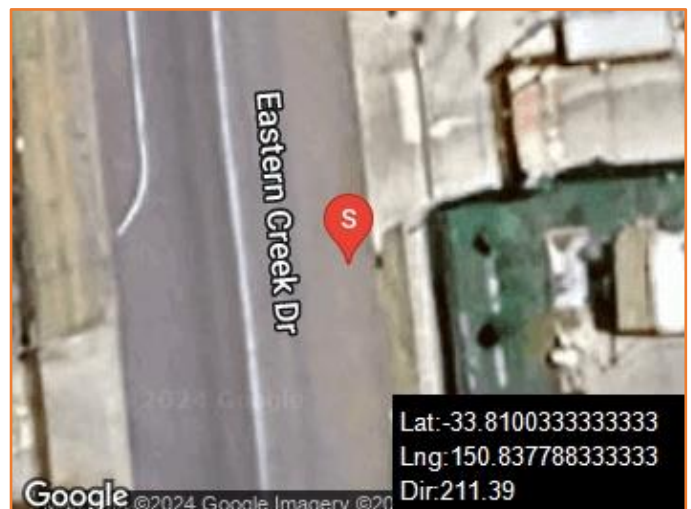
Figure 258: Reasonable - General condition of kerb and gutter.

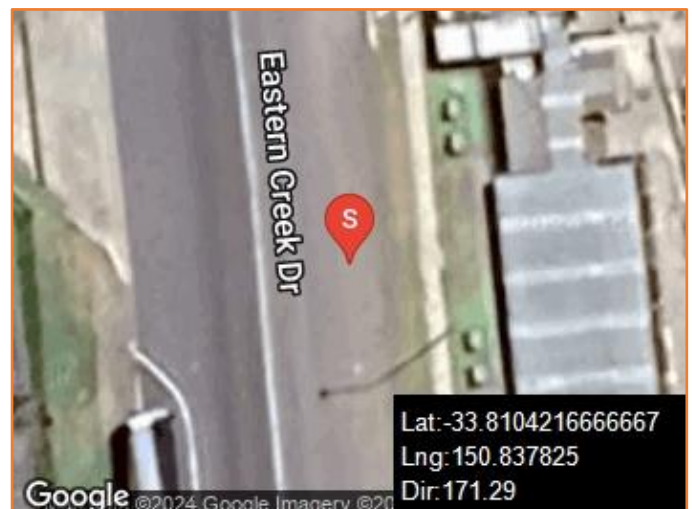
Figure 273: Reasonable - General condition of kerb and gutter.

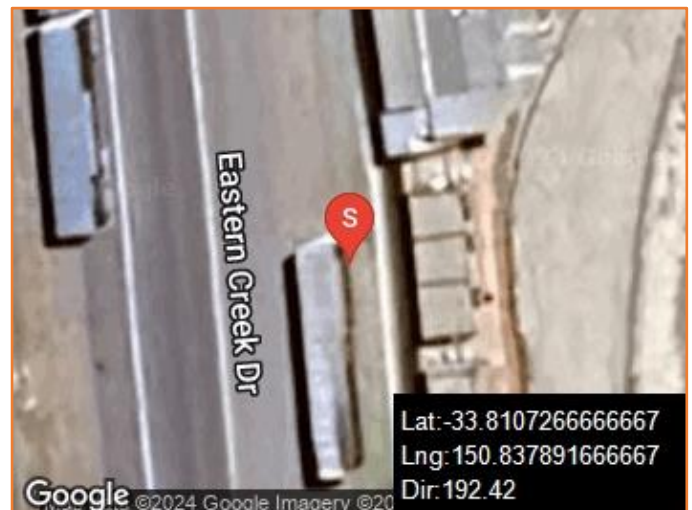
Figure 284: Reasonable - General condition of kerb and gutter. Minor spalling observed.

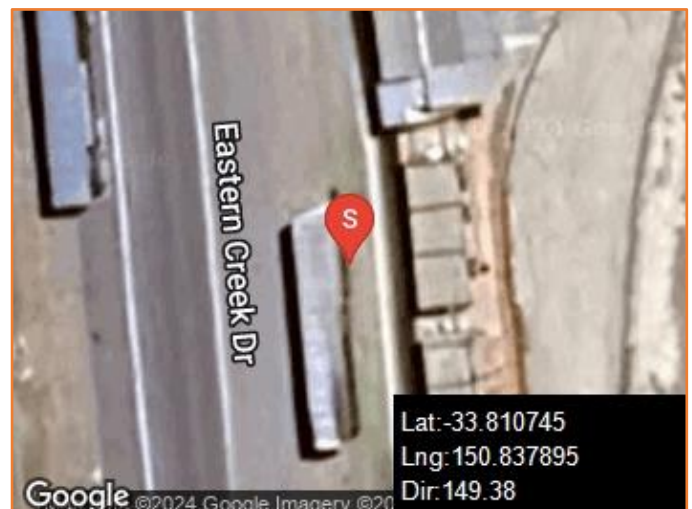
Figure 285: Reasonable - General condition of kerb and gutter.

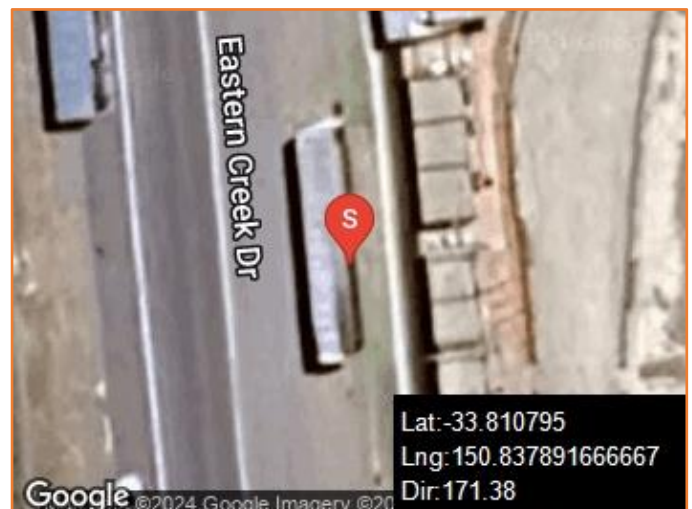
Figure 288: Reasonable - General condition of kerb and gutter.

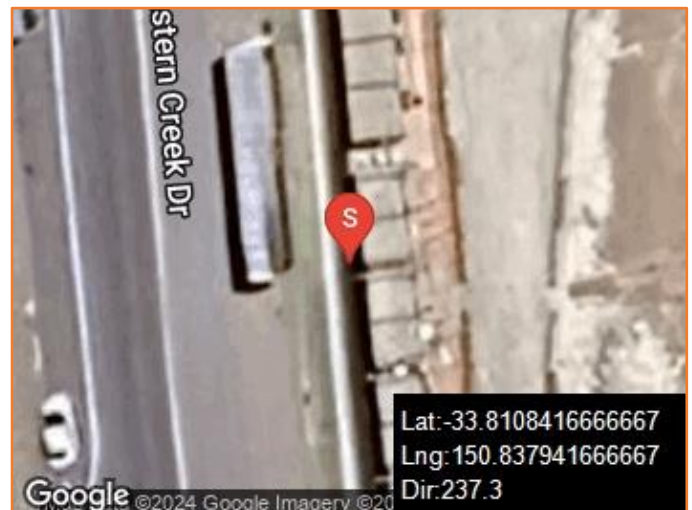
Figure 290: Reasonable - General condition of kerb and gutter. Minor spalling observed.

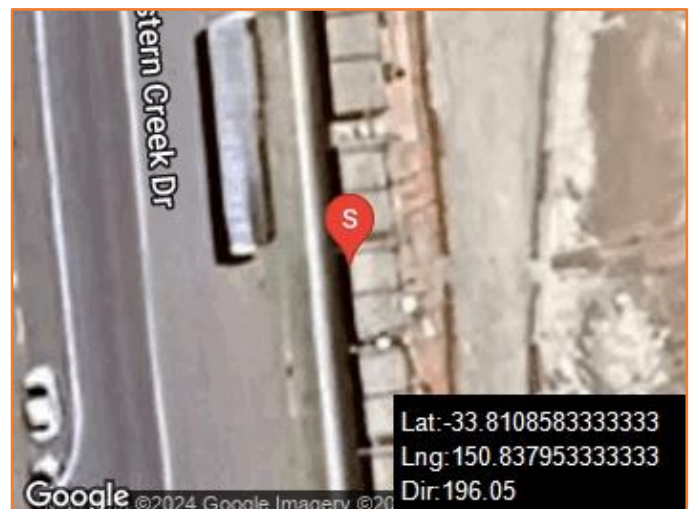
Figure 291: Reasonable - General condition of kerb and gutter.

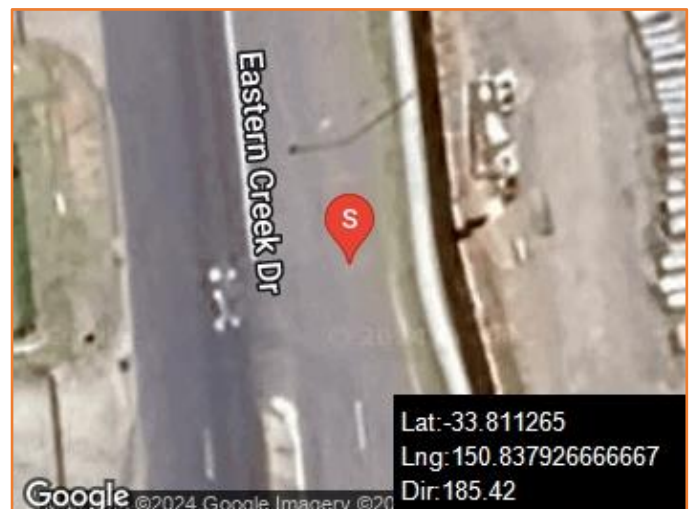
Figure 306: Reasonable - General condition of kerb and gutter.

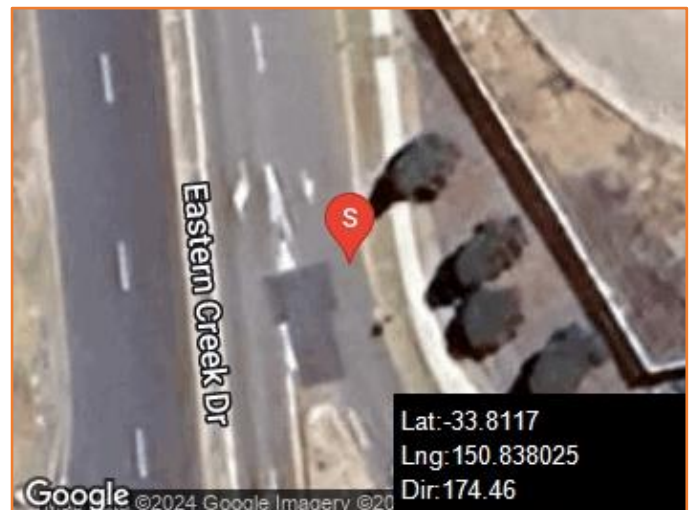
Figure 317: Reasonable - General condition of kerb and gutter.

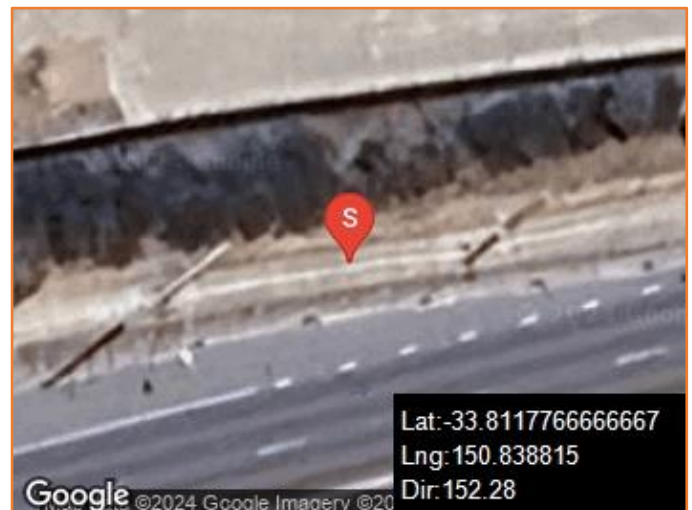
Figure 345: Reasonable - General condition of footpath.

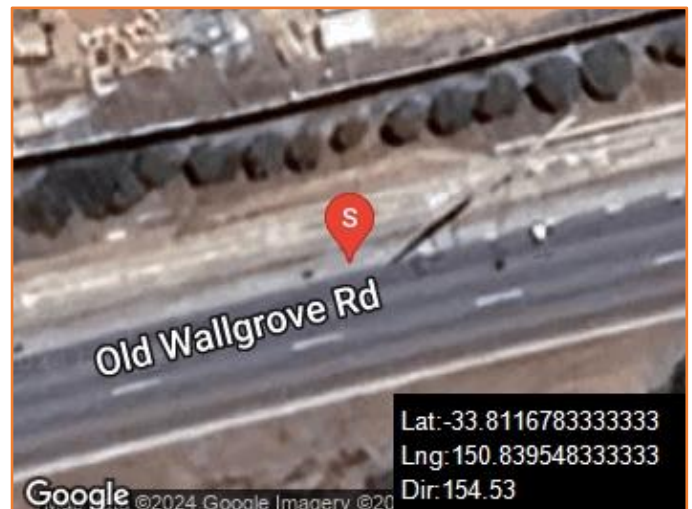
Figure 361: Reasonable - General condition of footpath.

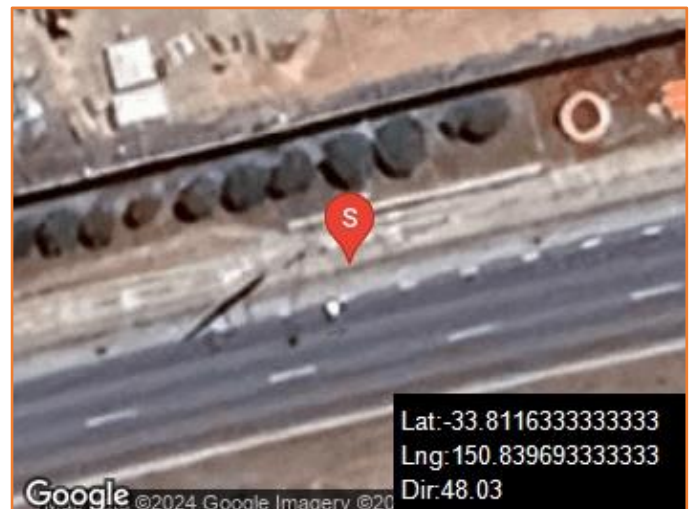
Figure 364: Reasonable - General condition of service pit.

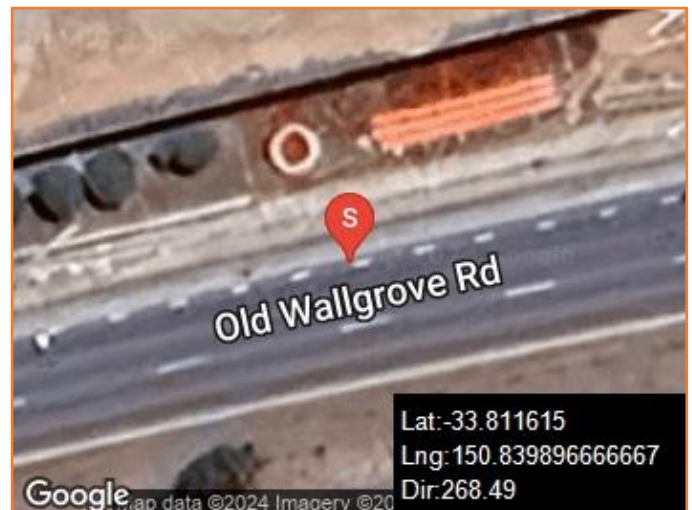
Figure 378: Reasonable - General condition of kerb and gutter.

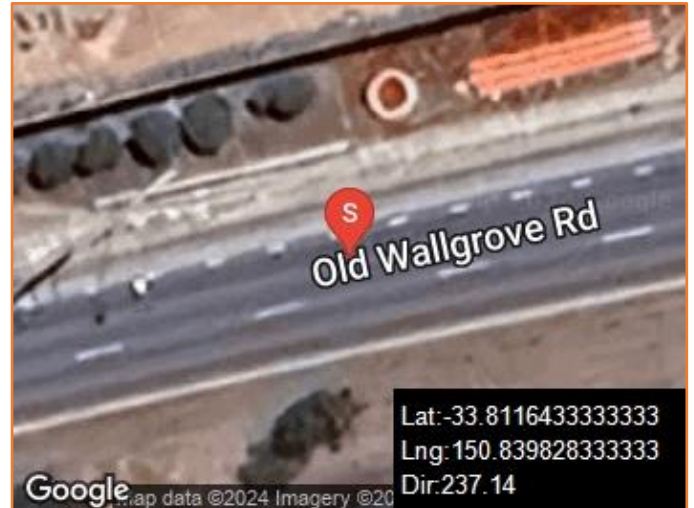
Figure 380: Reasonable - General condition of kerb and gutter.

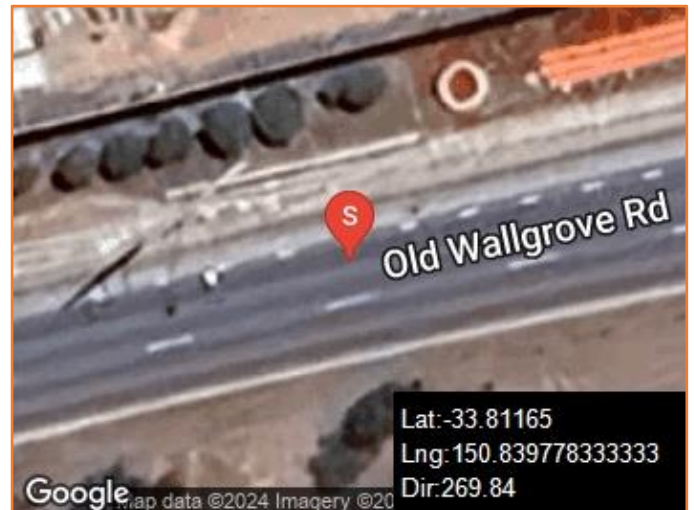
Figure 381: Reasonable - General condition of kerb and gutter.
