## DILAPIDATION REPORT

10 EASTERN CREEK DRIVE EASTERN CREEK, NSW, 2766

THURSDAY, 22 FEBRUARY 2024

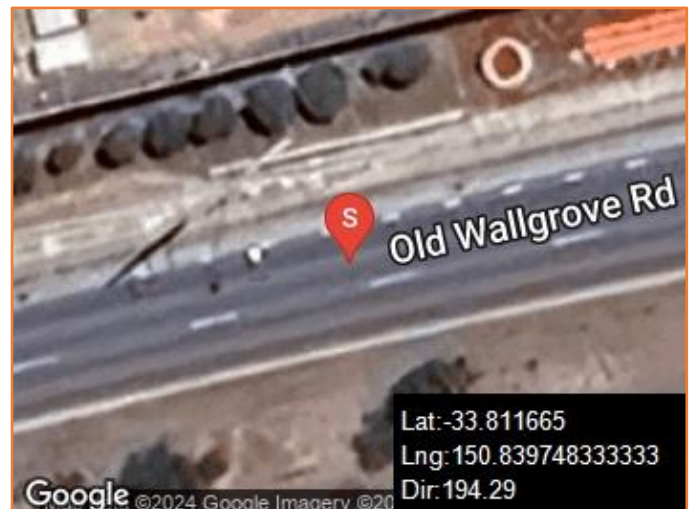
Figure 382: Reasonable - General condition of kerb and gutter.

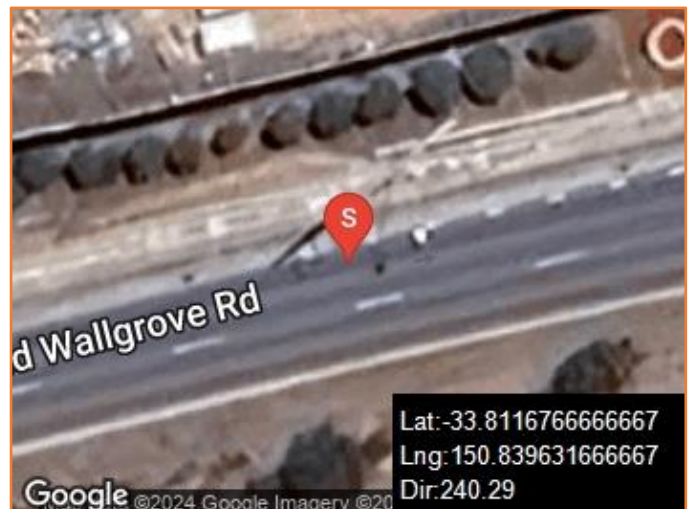
Figure 385: Reasonable - General condition of kerb and gutter.

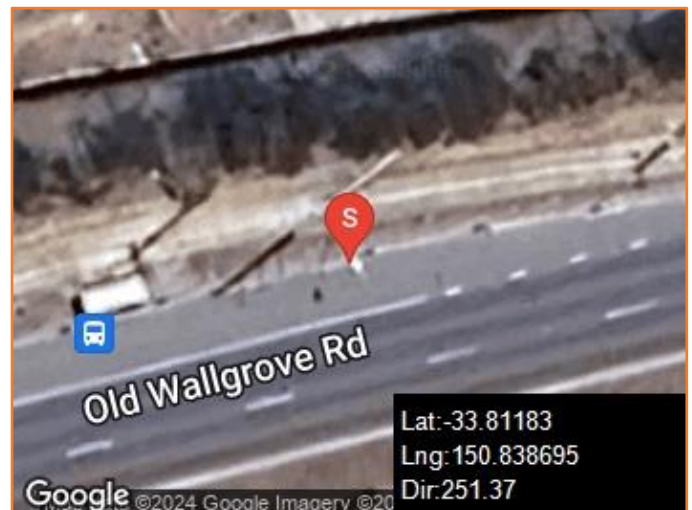
Figure 408: Reasonable - General condition of kerb and gutter.

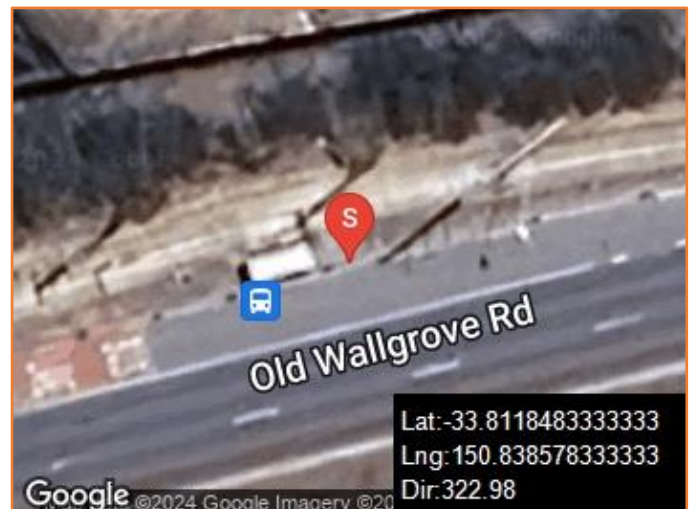
Figure 412: Reasonable - General condition of bus shelter.

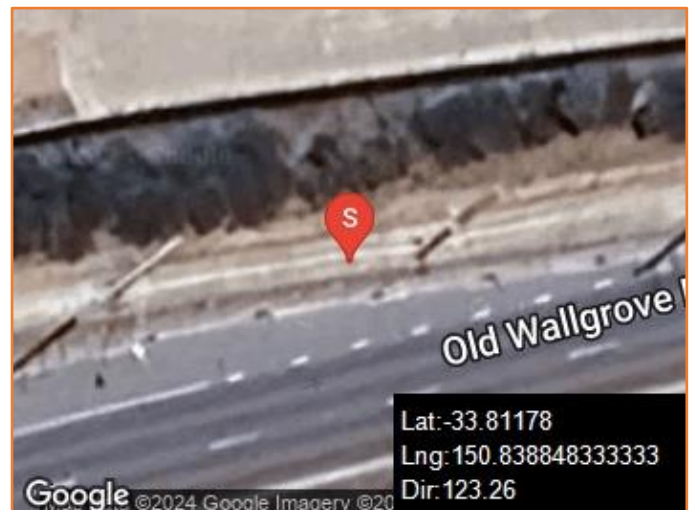
Figure 438: Reasonable - General condition of flexible pavement.

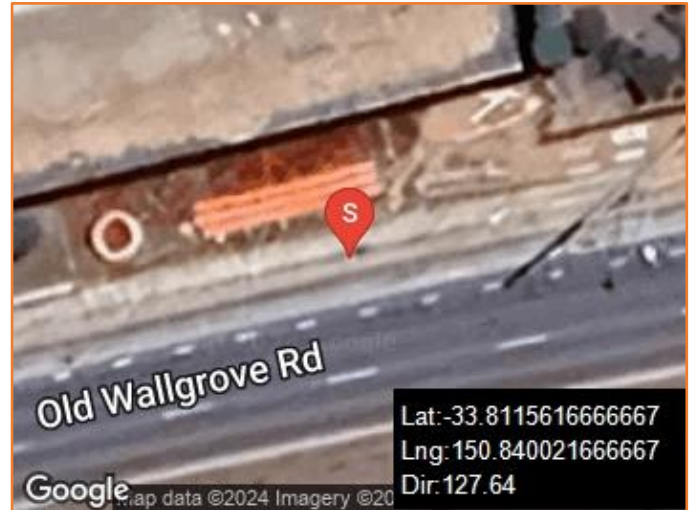
Figure 458: Reasonable - General condition of flexible pavement.
