Asbestos Clearance Inspection Report

Zoric Group

1 Merriman Street, Barangaroo NSW

Report Details	
Report type	Asbestos Clearance Report / CLR1
Report version	Version 1 final
Job Number	9449
Client	Zoric Group
Asbestos Removalist	Zoric Group Pty Ltd – AD213757
Date of Inspection	26.06.2024
Date of Report	27.06.2024
Address	1 Merriman Street, Barangaroo NSW
Subject areas	<ol style="list-style-type: none"> 1. Site interior, northern extent, adjacent rock wall, excavated section of concrete, top of surfaces only to former asbestos containing soil; 2. Site interior, northern extent, adjacent rock wall, excavator Kubota U35-4, top of bucket to former asbestos containing soil; and 3. Transit route. <p>(refer to Appendix B – Photographs)</p>

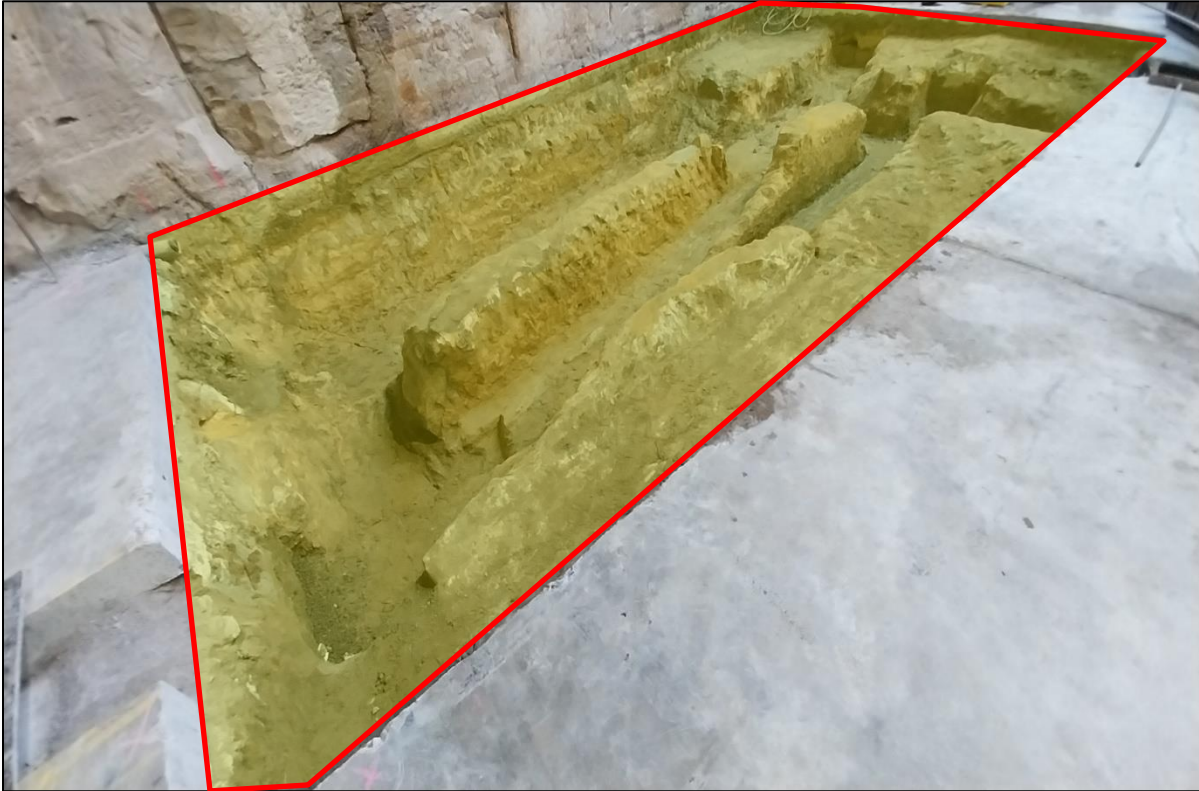
Photograph 1. Subject area 1) - Site interior, northern extent, adjacent rock wall, excavated section of concrete, top of surfaces only to former asbestos containing soil.

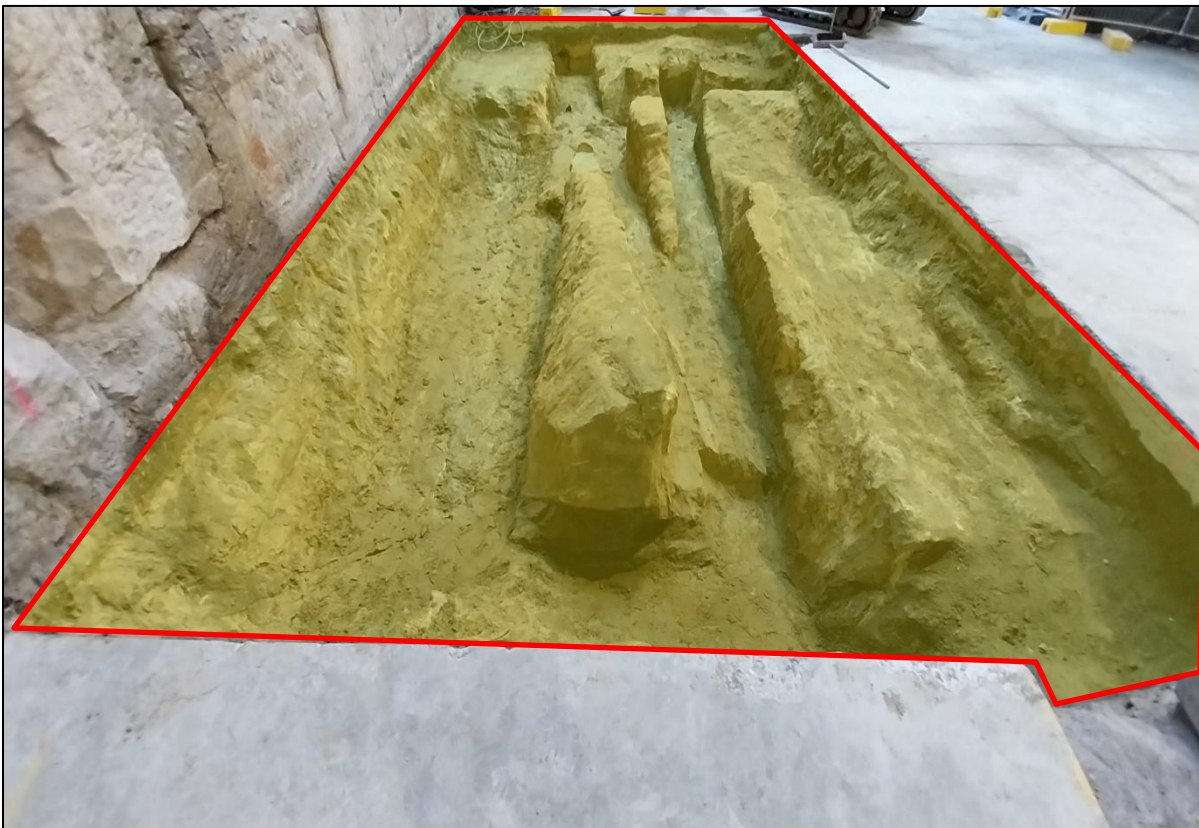
Photograph 2. Subject area 1) - Site interior, northern extent, adjacent rock wall, excavated section of concrete, top of surfaces only to former asbestos containing soil.

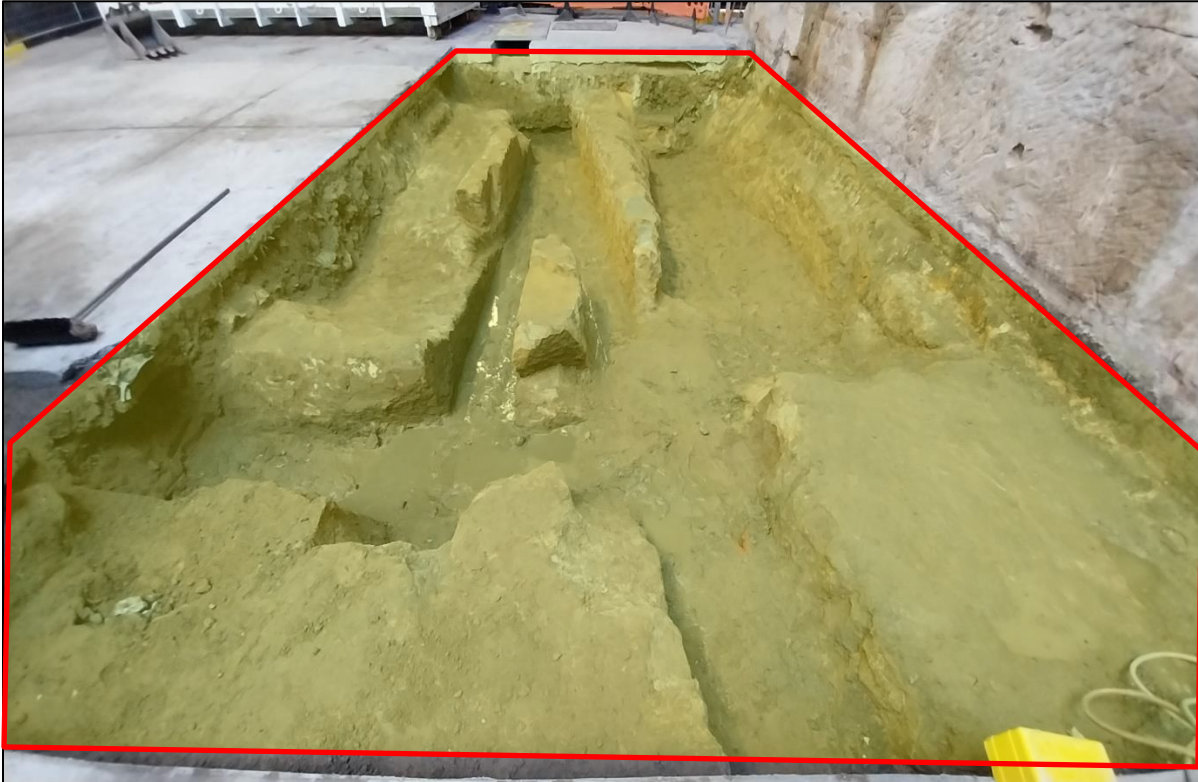
Photograph 3. Subject area 1) - Site interior, northern extent, adjacent rock wall, excavated section of concrete, top of surfaces only to former asbestos containing soil.

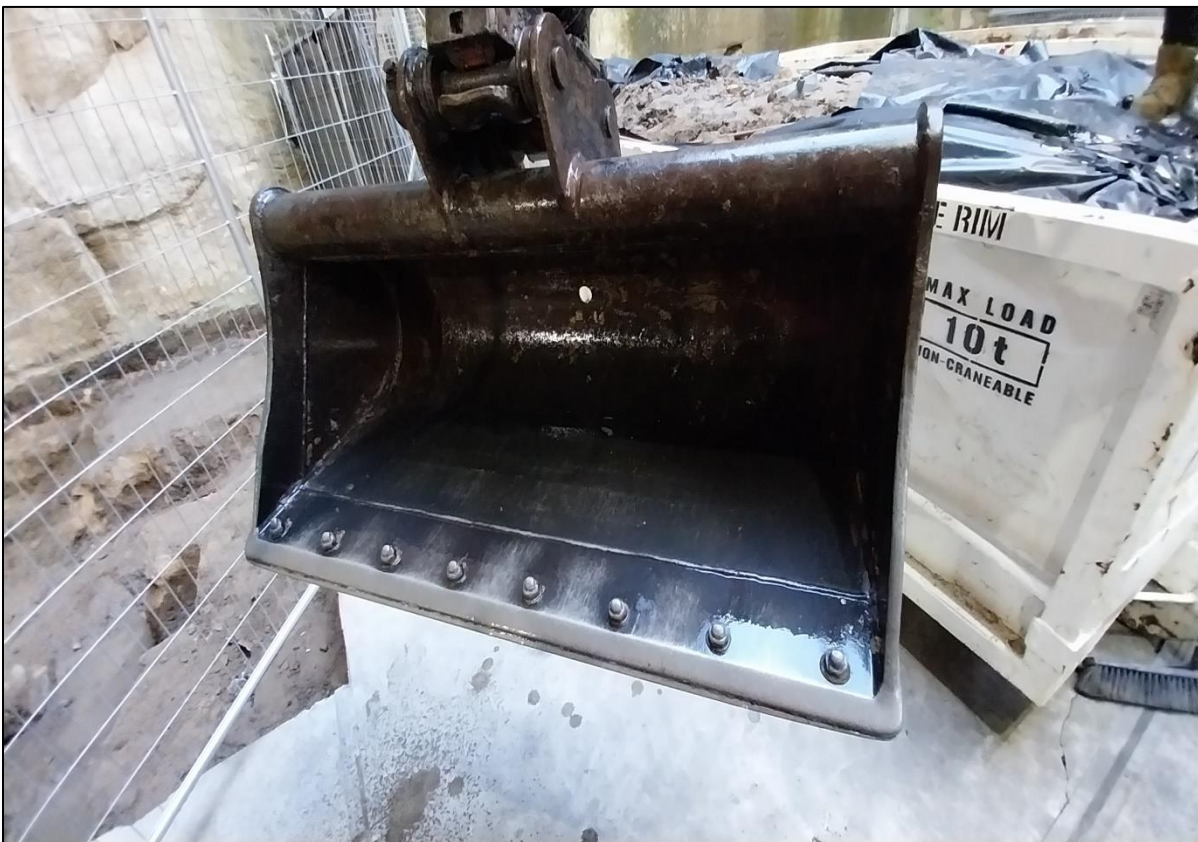
Photograph 4. Subject area 2) - Site interior, northern extent, adjacent rock wall, excavator Kubota U35-4, top of bucket to former asbestos containing soil.
