# Hazardous Building Materials Survey Report

Building 64, Administration Building  
RPA Hospital, Camperdown NSW

**Sydney Local Health District (c/- Cardno)**

**Report No:** 1284-HBMS-07-260722.v1f

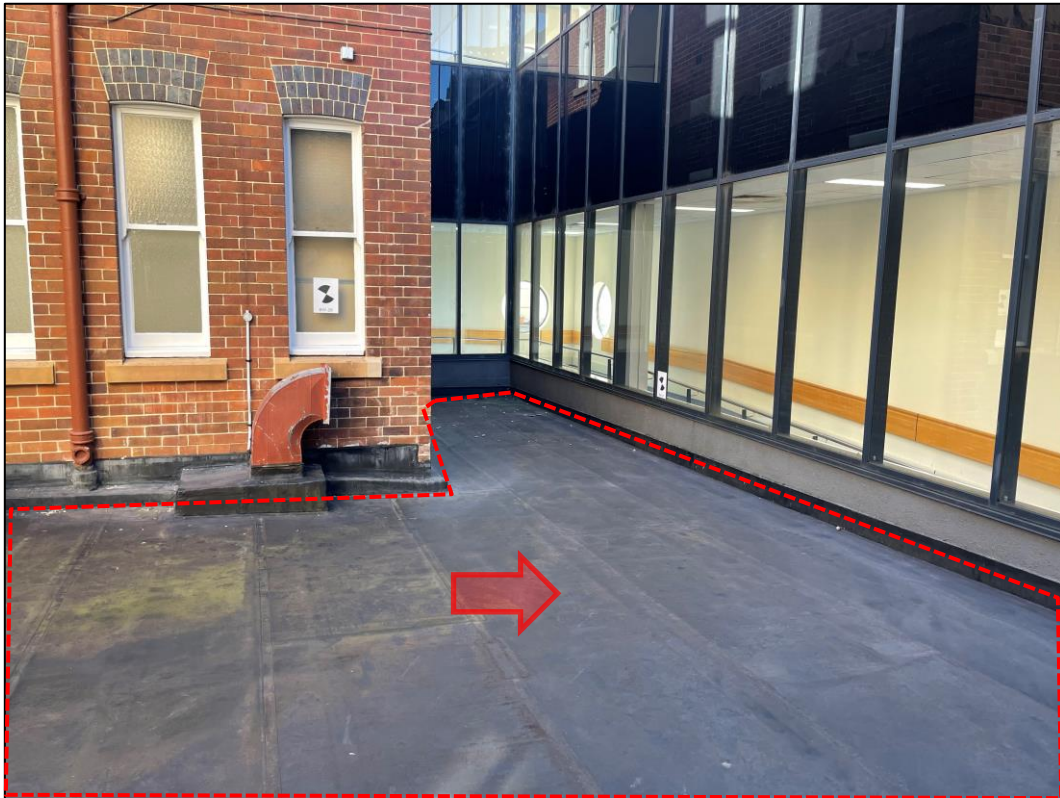
**Photograph 1** Asbestos bituminous layer (underlying observable black vinyl covering), observed on L6 flat roof. **Chrysotile Asbestos detected.**

- Asbestos containing materials identified within B64 in the bituminous membrane underlying the flat roof ceiling lining accessible from L6. All identified materials were in good condition and must be removed by a licensed asbestos removalist prior to refurbishment or demolition works;

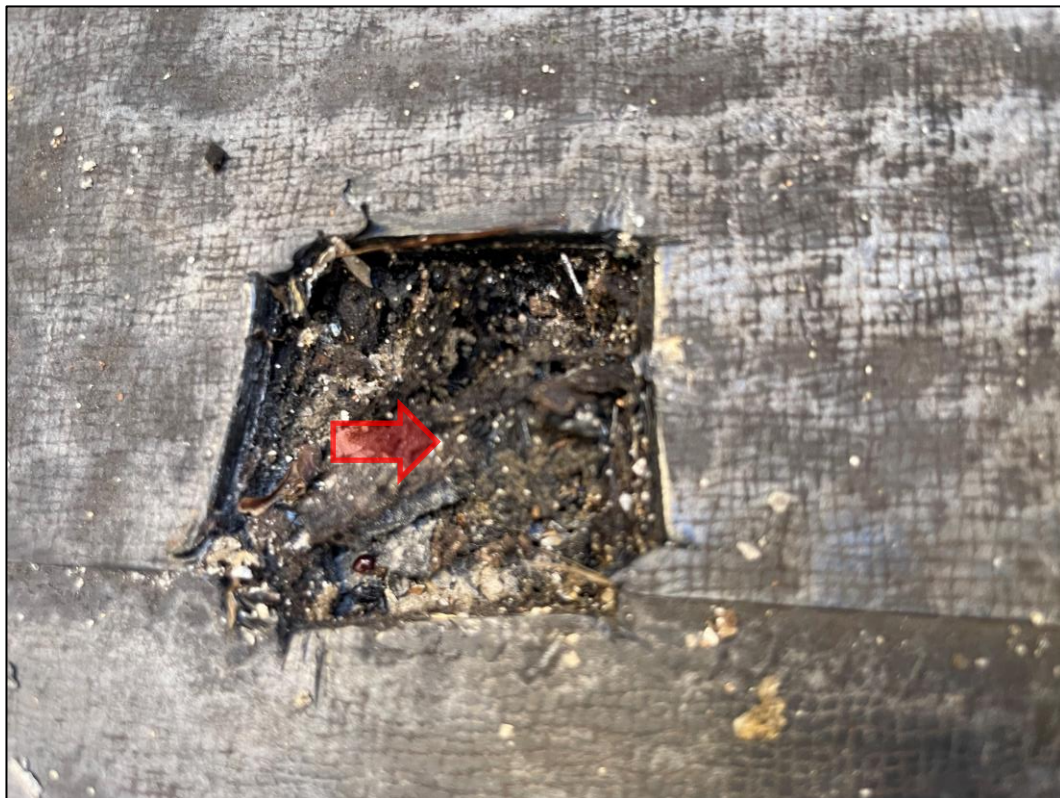
**Photograph 2** Example of asbestos containing bituminous layer, underlying black vinyl covering on the L6 flat roof. Location of sample 'B64-L6-ROOF-ASB01'. **Chrysotile asbestos detected.**

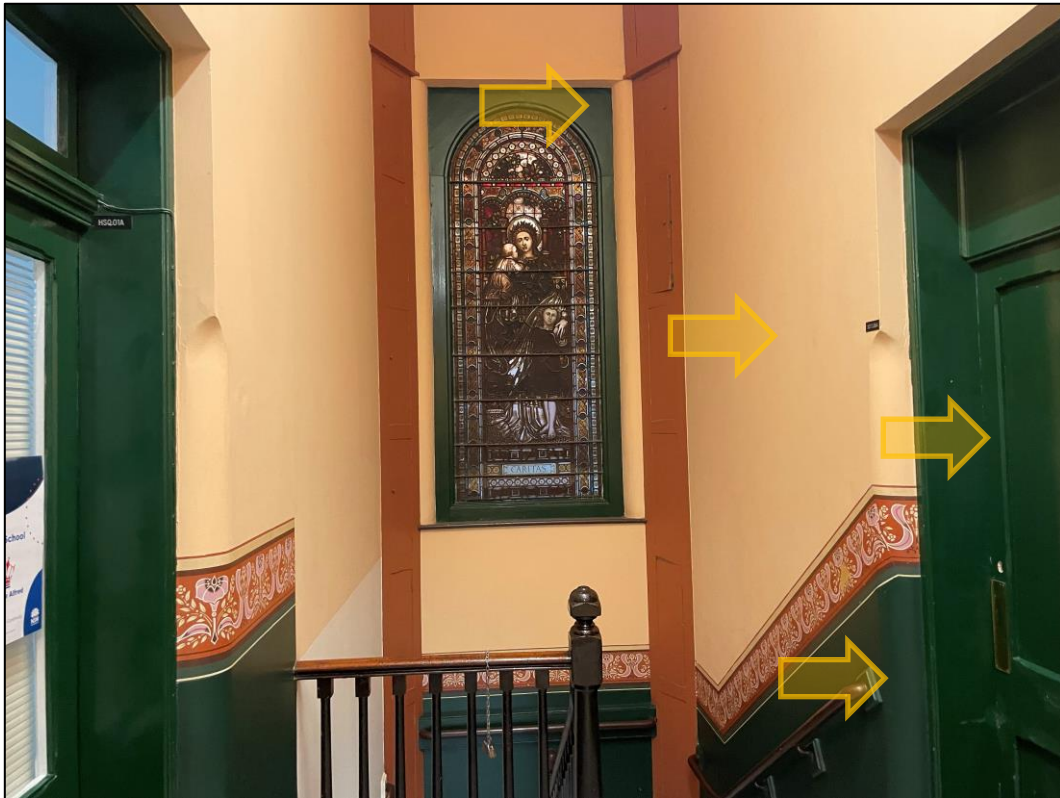
- Lead Containing Paint (LCP) was identified in the green and cream paint systems observed within the L5 entrance hall and adjacent rooms. No further LCP was identified during the survey;

**Photograph 3** Example of green and cream lead paint systems identified on the L5 entrance hallway walls.

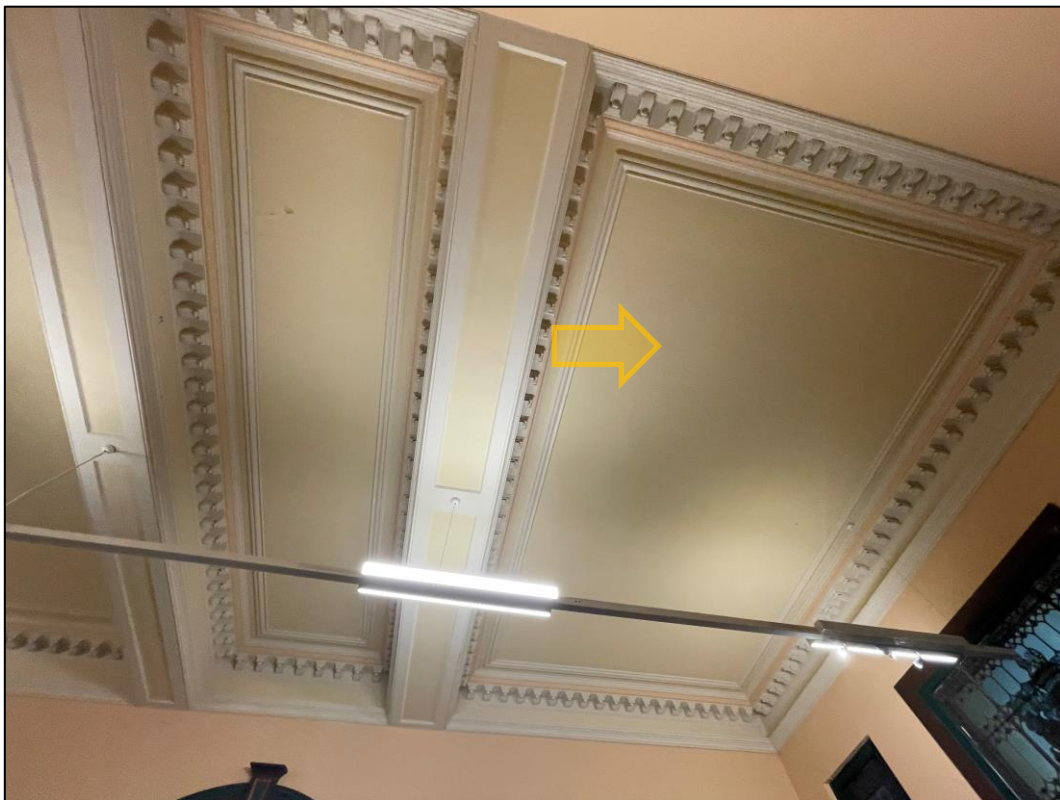
**Photograph 4** Example of cream presumed lead paint systems identified on the L5 entrance hallway ceiling.

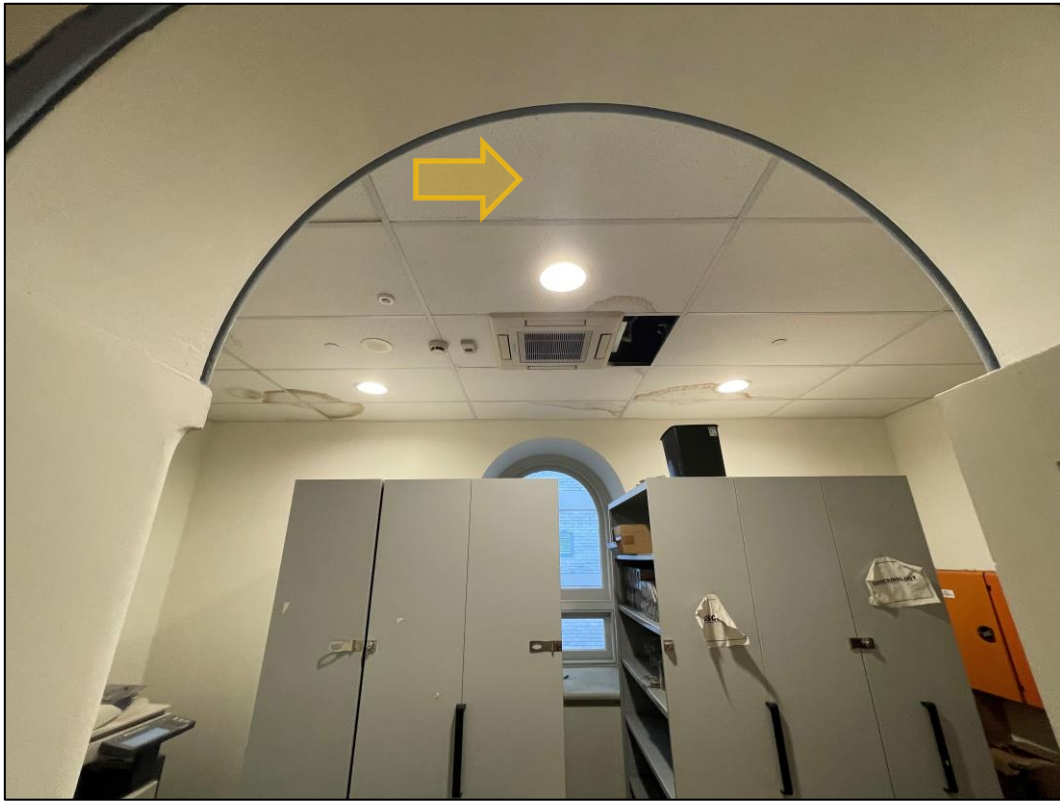
**Photograph 5** Example of compressed synthetic mineral fibre ceiling tiles identified within some sections of B65. Presumed to contain SMF.

- All air conditioning, ducting, and insulation material is presumed to contain SMF. Caution is required when handling SMF products in order to minimise airborne SMF fibre levels. It is recommended that the code of practice "Code of Practice for the Safe Use of Synthetic Mineral Fibres NOHSC:2006 (1990)]" be closely adhered to when handling such materials;

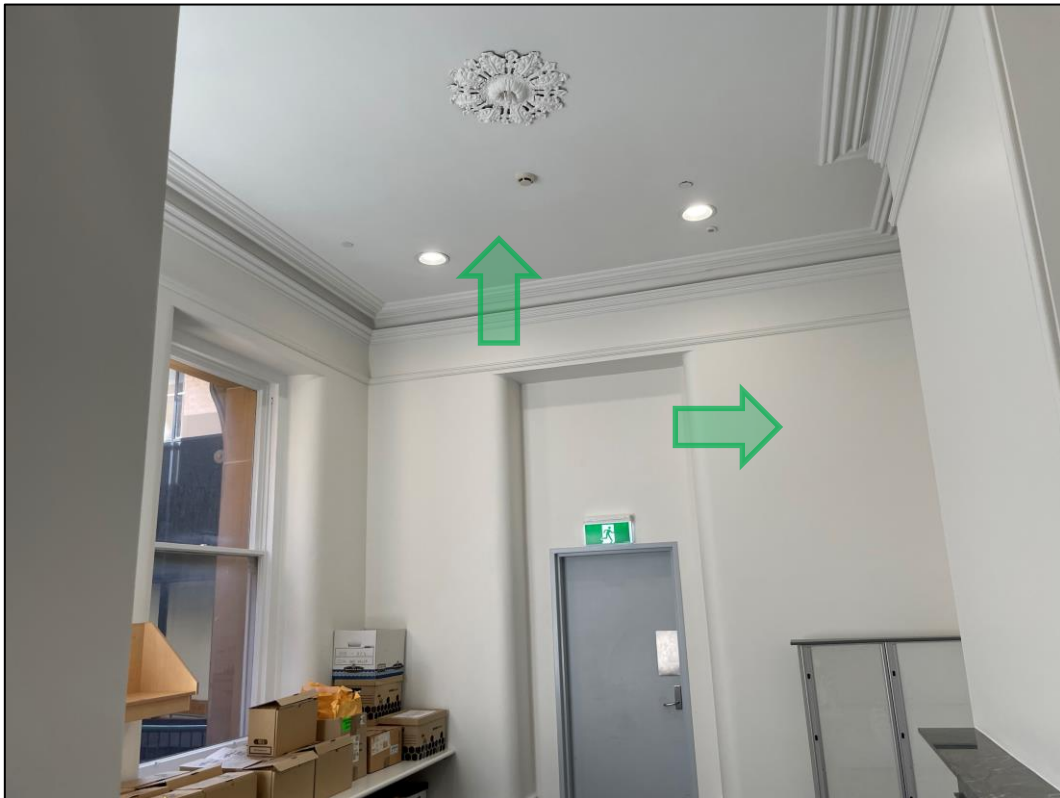
**Photograph 6** Example of most rooms encountered throughout L6 and L7 of B64. Rendered brick wall, non-lead containing paint, and plasterboard ceiling lining.
