Hazardous Building Materials Survey Report

Portion Building 75 and 89 Main Hospital and
Clinical Services, RPA Hospital, Camperdown NSW

Report No: 1284-HBMS-11-130922.v1f

Report Date: 13 September 2022

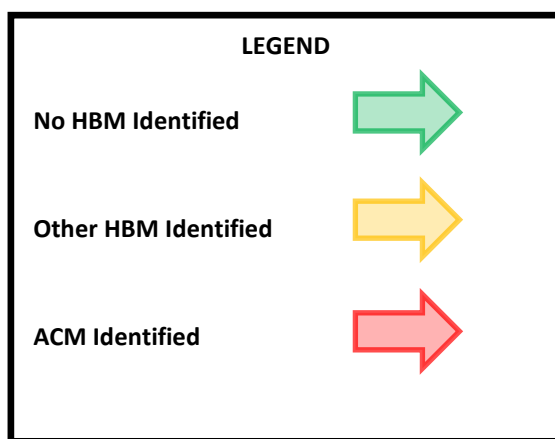
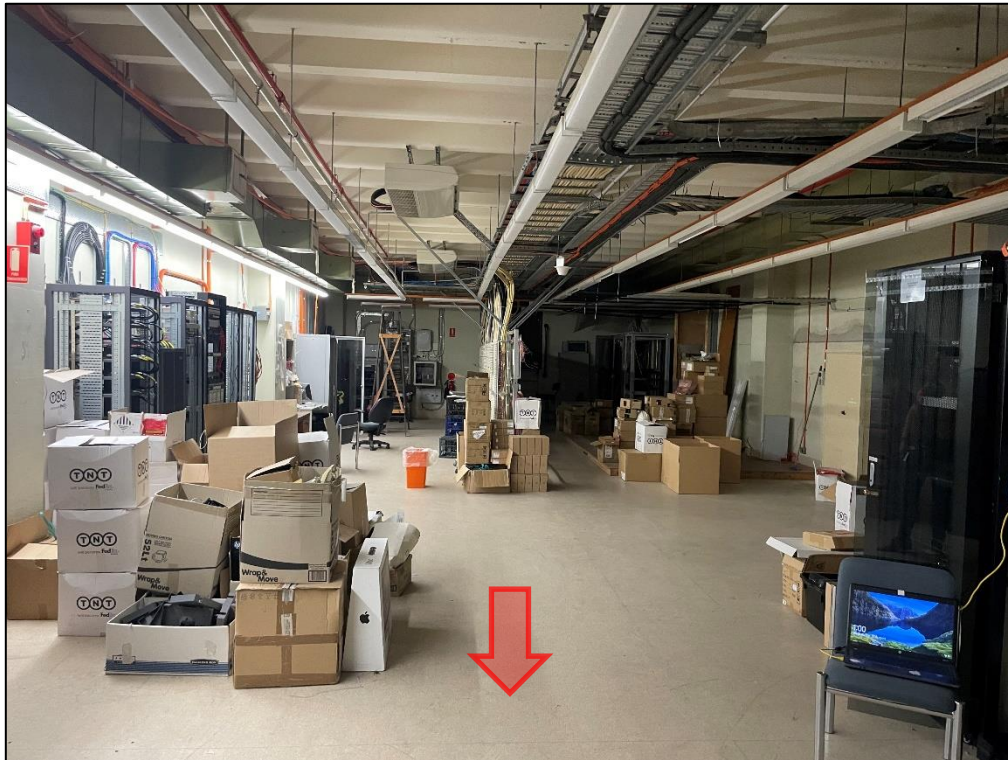
Photograph 1 Location of level 1 IT plant room where representative fibre cement floor sample was taken (B75-L1-IT-VINYL-ASB03). Asbestos detected. Note that asbestos fibre cement is underlying the existing non-asbestos vinyl tile.

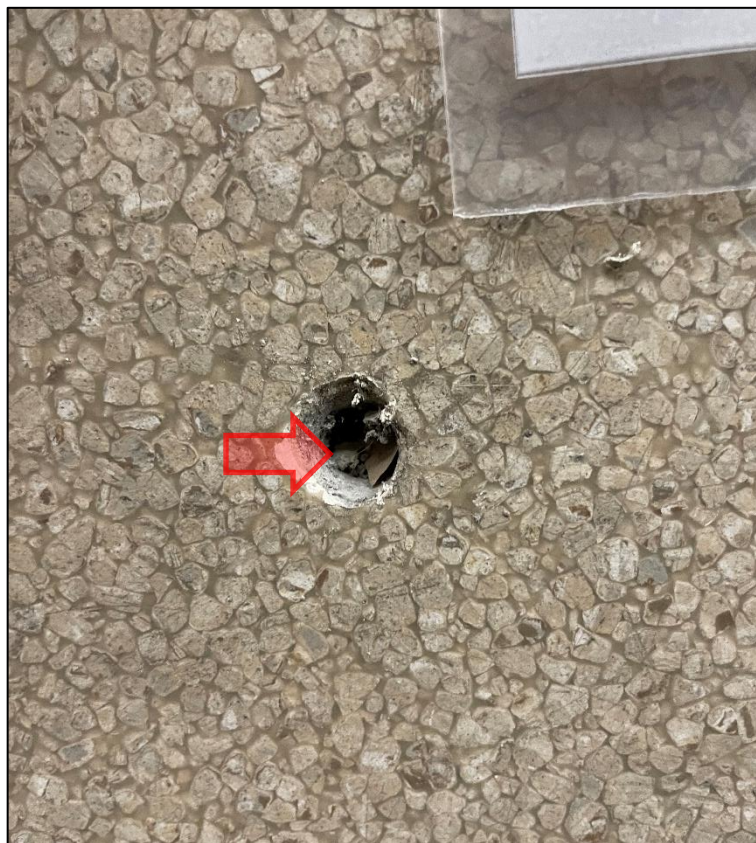
Photograph 2 Close up photograph of utility room floor lining where asbestos fibre cement was identified.

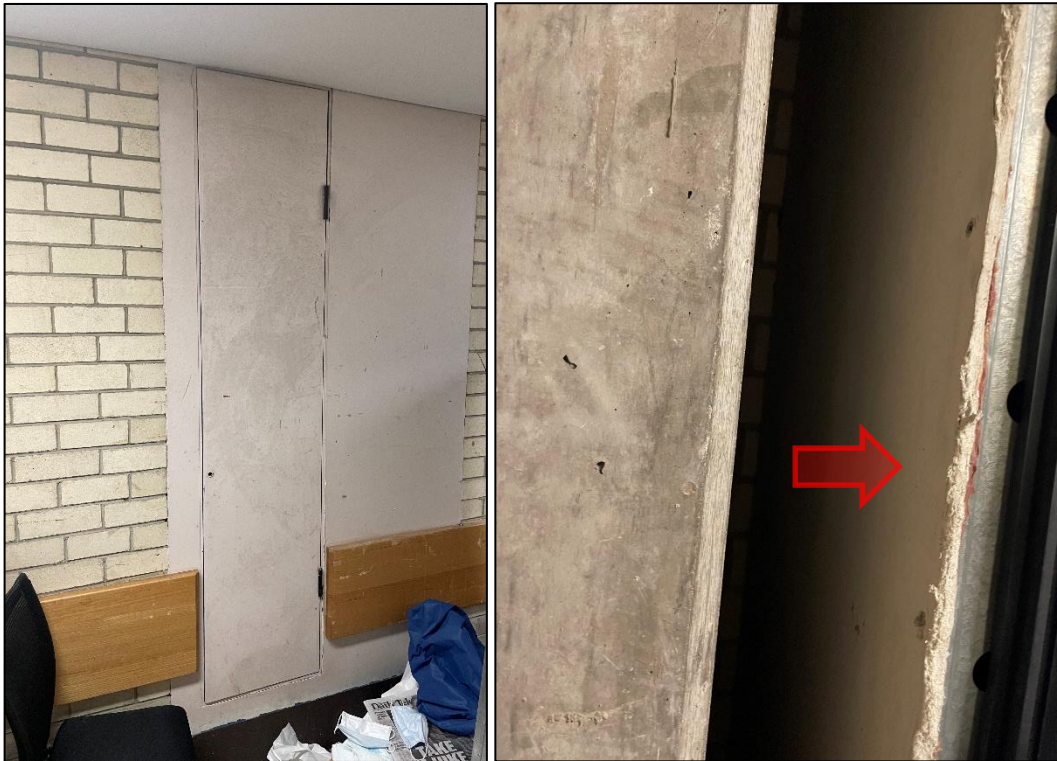
Photograph 3 Services cupboard located on various levels (left), containing internal asbestos fibre cement wall lining (right). Location of sample 'B89-23-HALL-CUPBOARD-ASB01'. Asbestos detected.

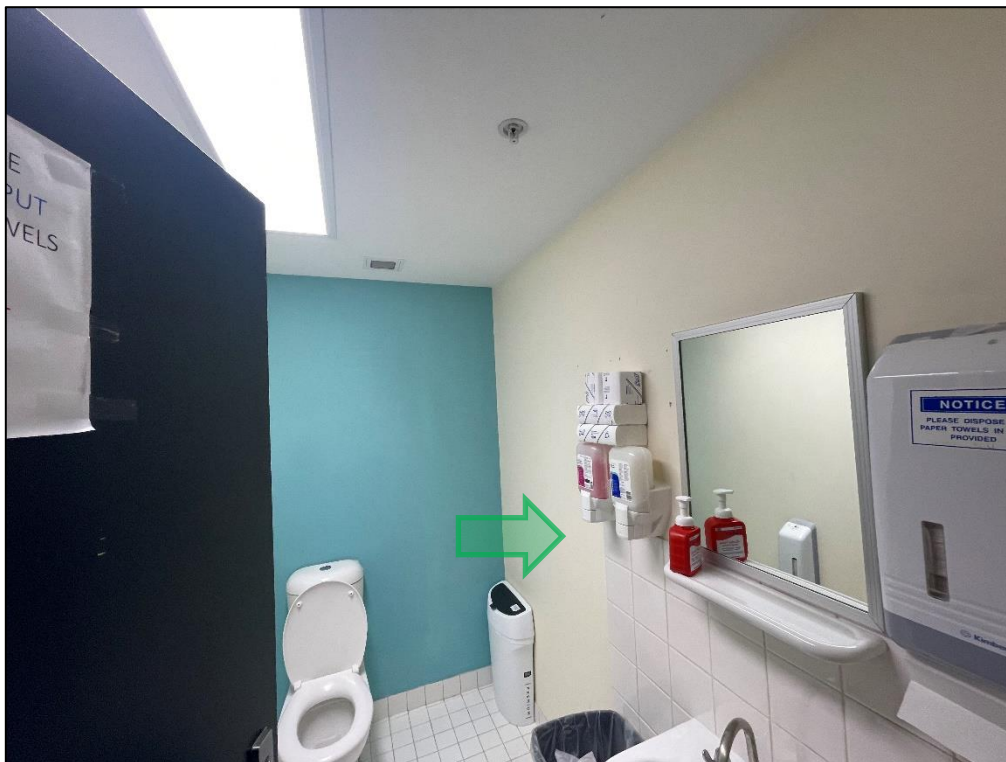
Photograph 4 Example of bathroom walls. Location of sample 'B75-L2-BATH-WALL-ASB02'. No asbestos detected.

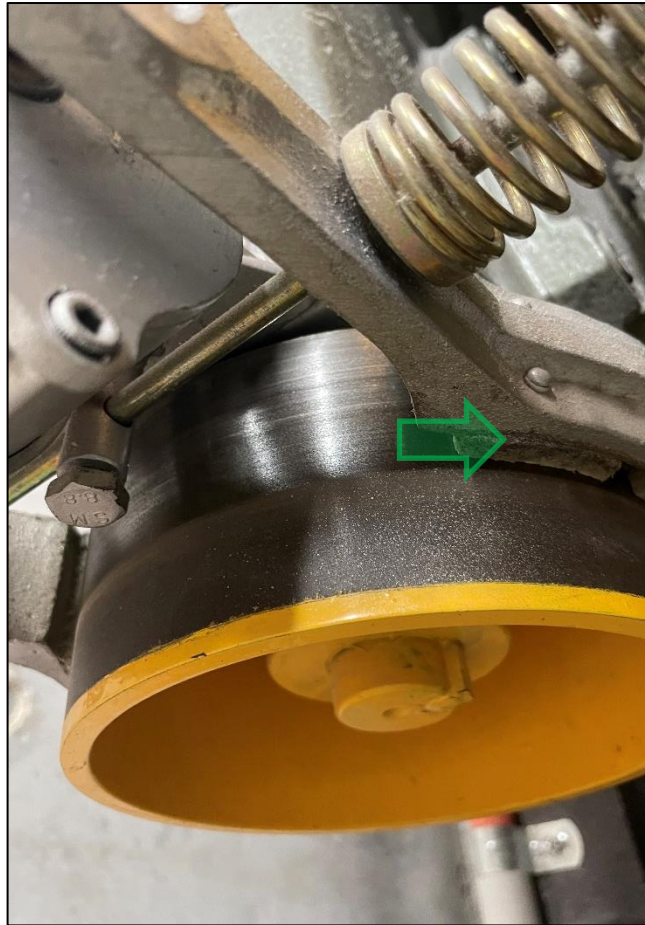
Photograph 5 Example of brake pad identified in lift motor room 9. Location of sample 'B75-L4-PLANT-LMR-BRAKE-ASB05' No asbestos detected.

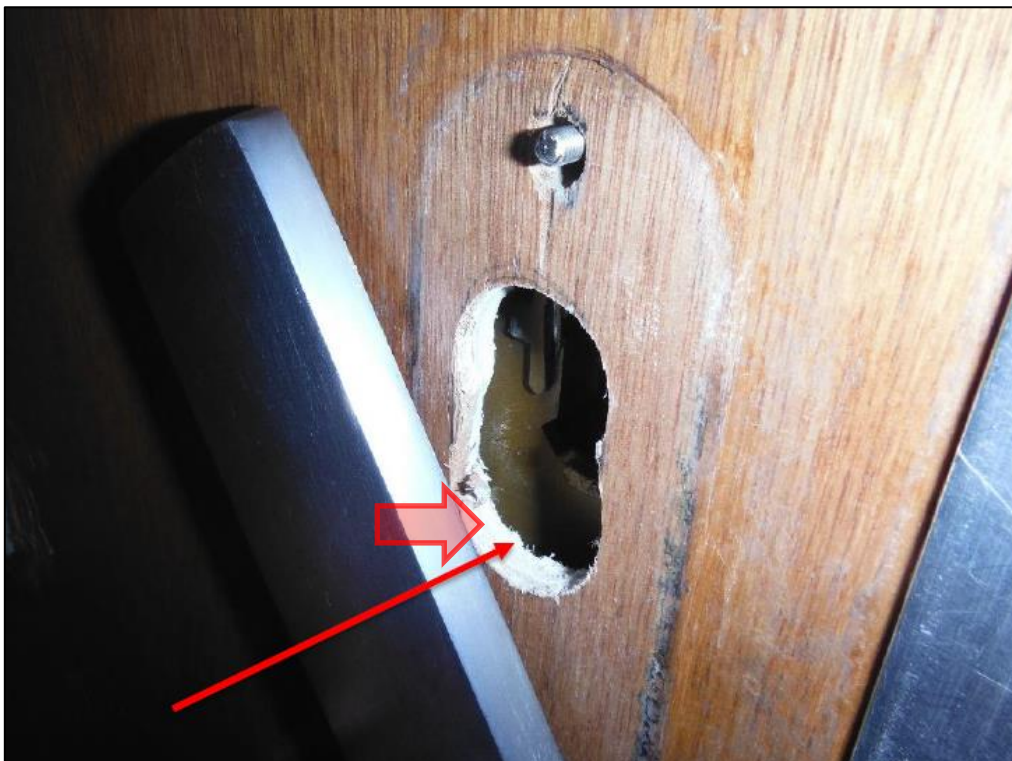
Photograph 6 Example of timber veneered door with internal asbestos insulation. Photograph courtesy of Environmental Monitoring Services 'Building 75 – E Block, RPA Hospital, Camperdown NSW' Asbestos Register. Asbestos detected during sampling.

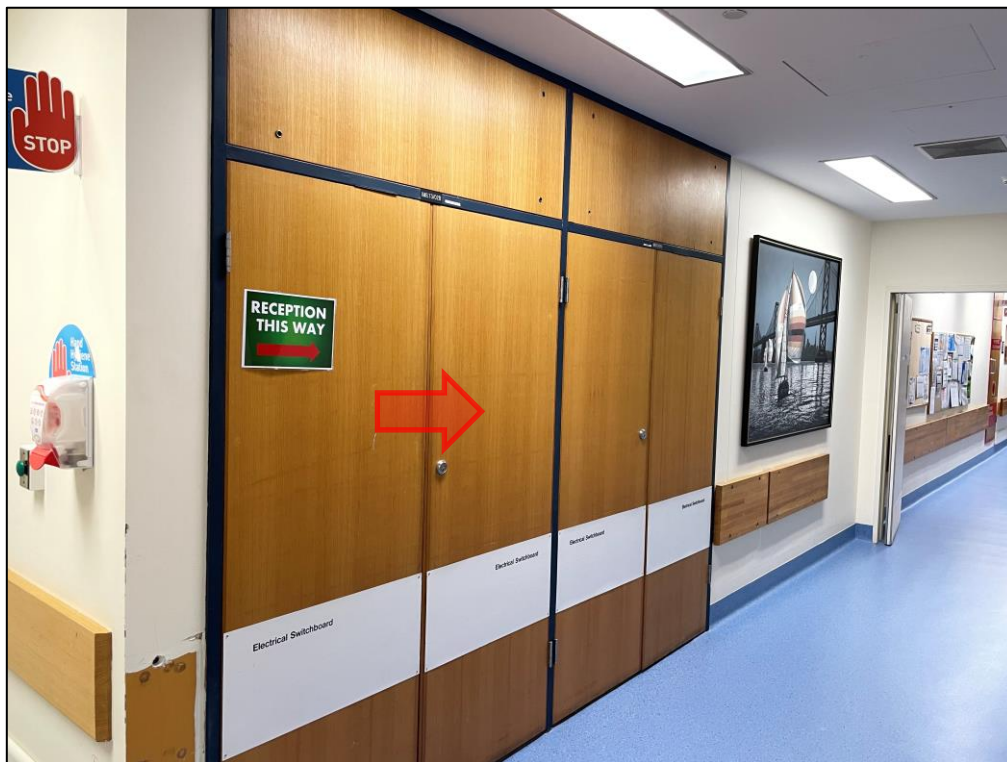
Photograph 7 Example of timber veneered doors within Level 5 corridors that may contain asbestos (Doors were locked at time of inspection).

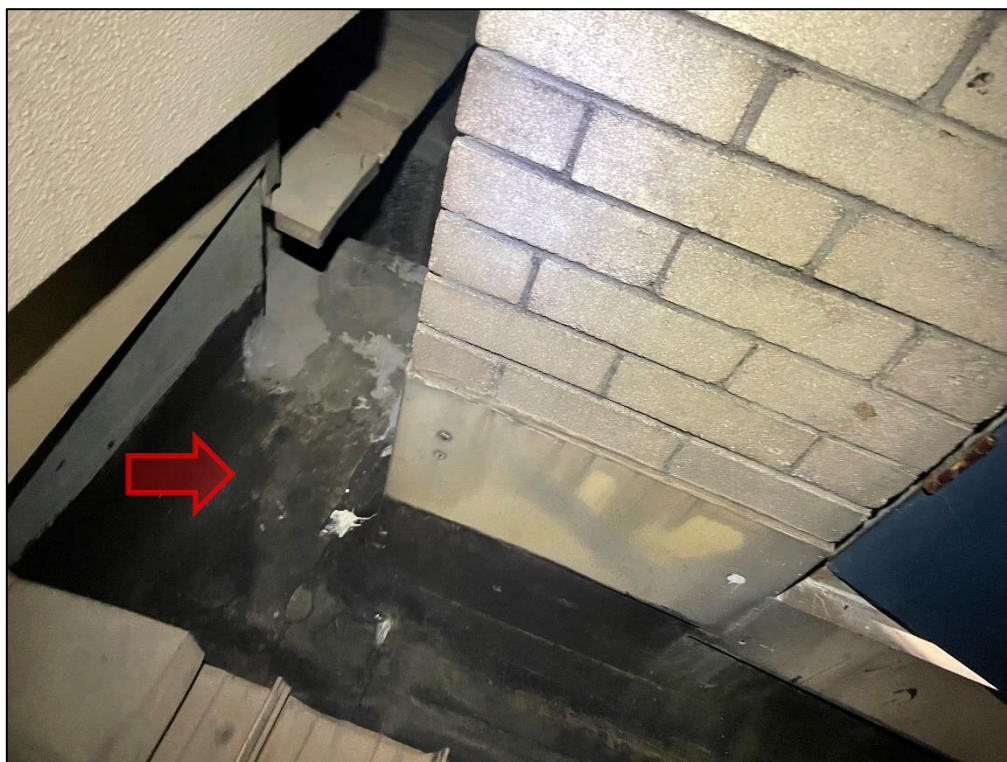
Photograph 8 Example of asbestos bituminous membrane identified on the roof of building 75 and 89. Location of sample 'B89-L12-ROOF-MASTIC-ASB04'. Asbestos detected.

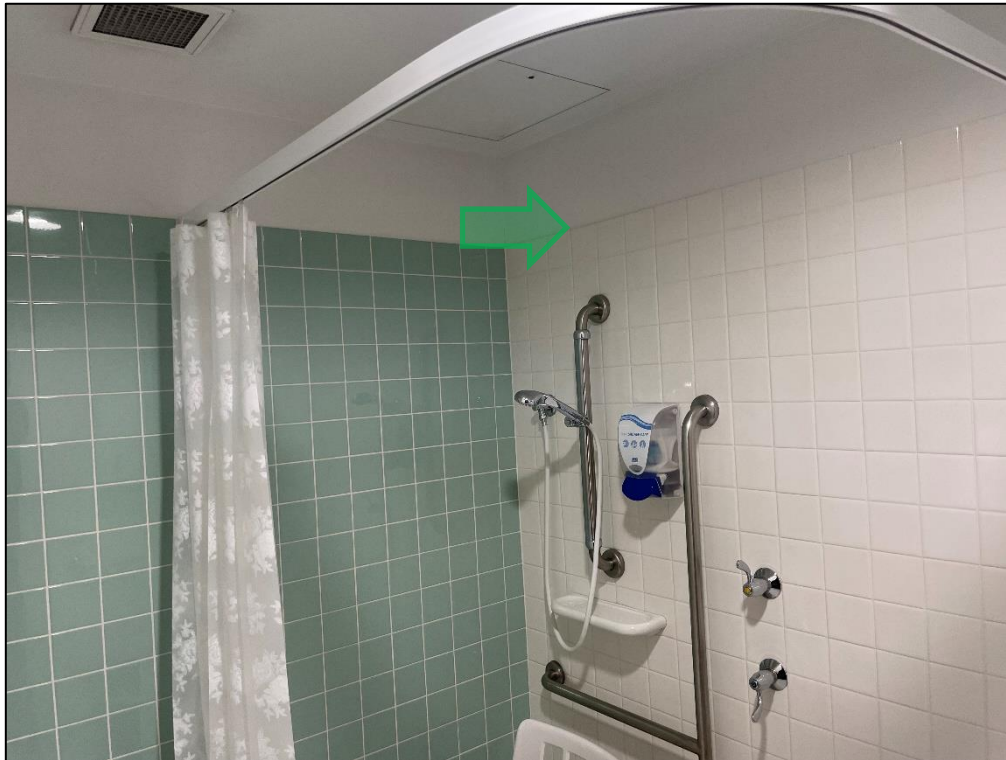
Photograph 9 Location of non-asbestos bathroom walls. Location of sample 'B89-L5-NATAL-BATH-WALL-ASB06'. No asbestos detected.

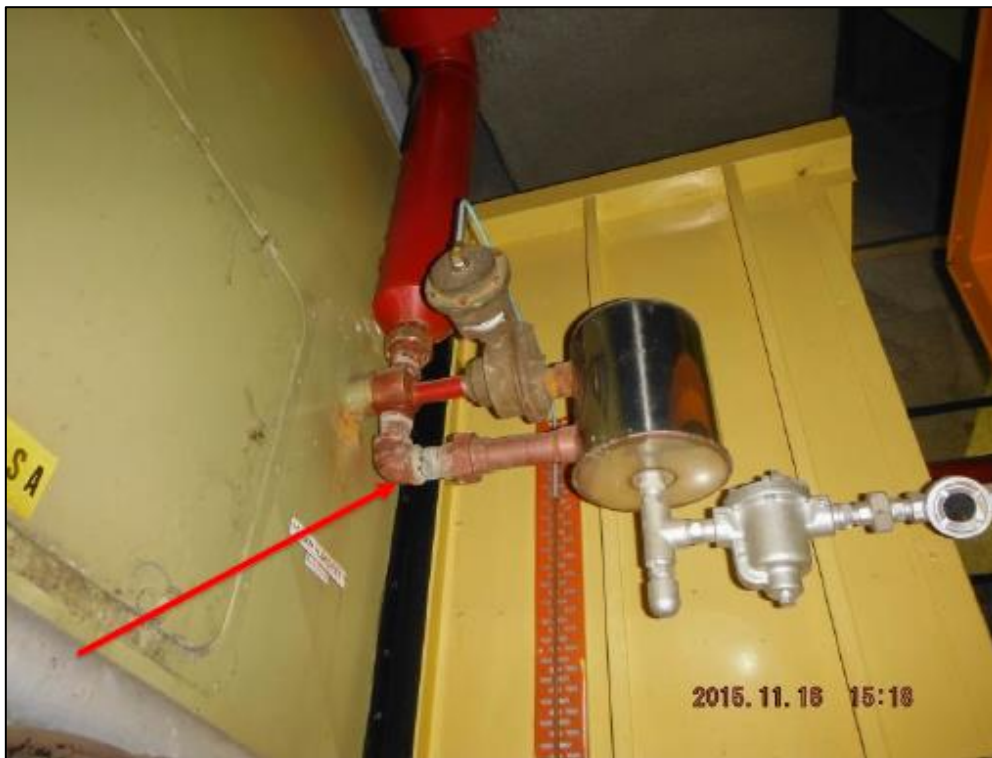
Photograph 10 Example of red asbestos gasket identified in old pipework. Photograph courtesy of Environmental Monitoring Services 'Building 75 – E Block, RPA Hospital, Camperdown NSW' Asbestos Register. Asbestos detected during sampling.

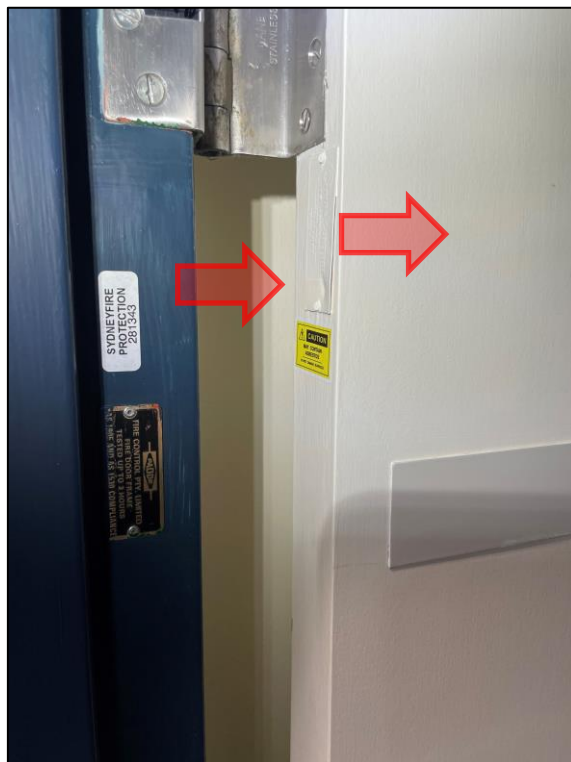
Photograph 11 Compliance plate without date (note black 'PADDE Fire Control Pty Ltd' compliance plates are taken to be indicative of asbestos containing fire doors). Additionally, a "presumed to contain" asbestos sticker had been previously applied to the door to indicate that it may contain asbestos.

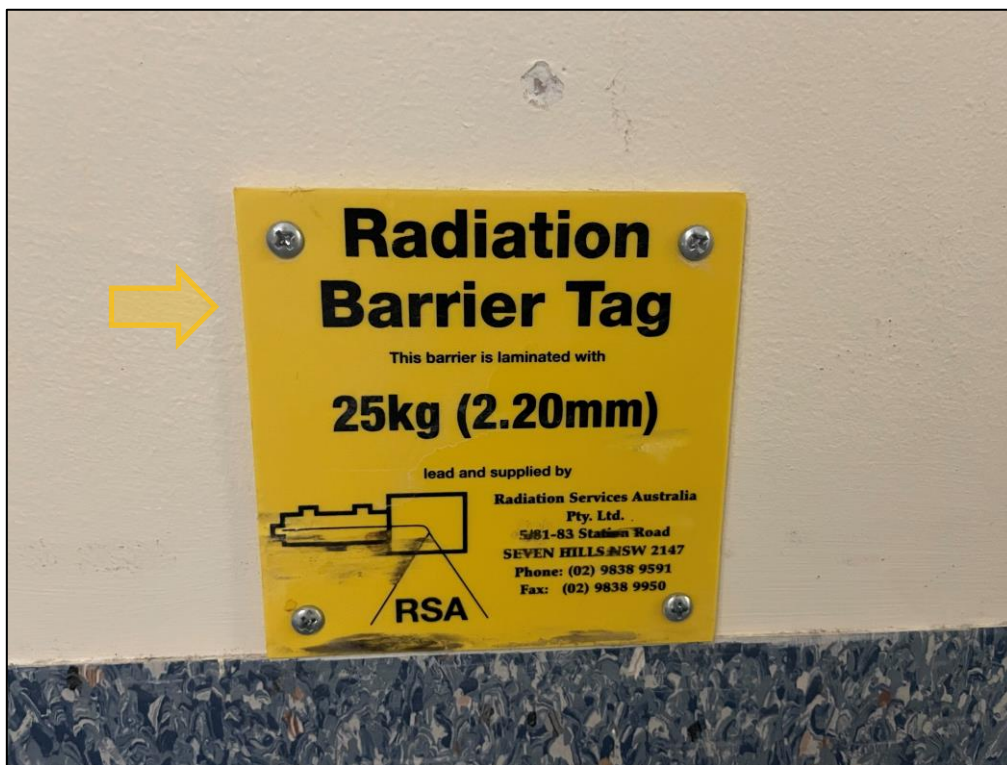
Photograph 12 Example of tag applied to walls / doors / windows with lead lining.

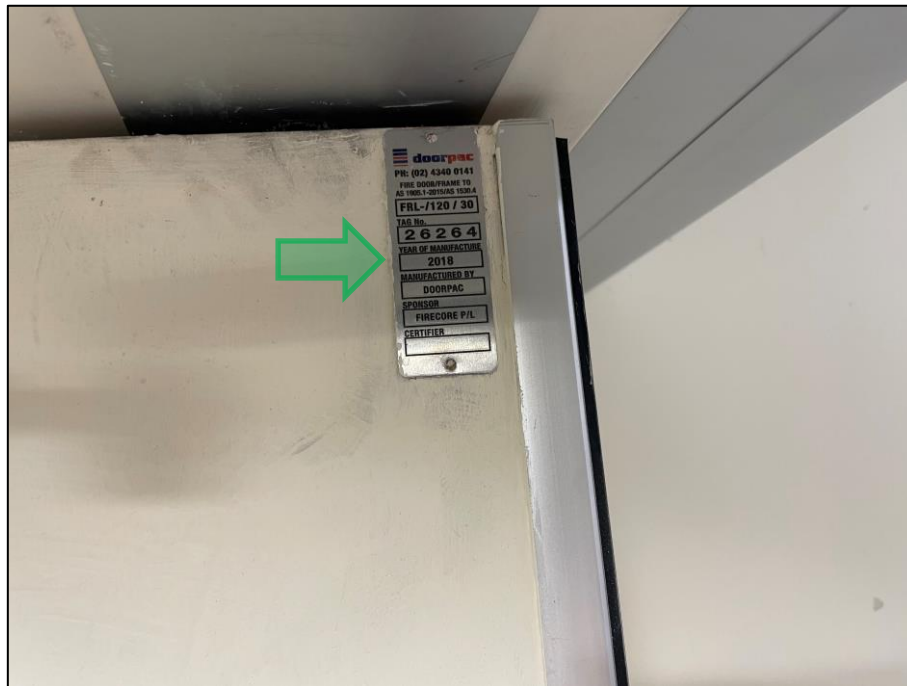
Photograph 13 Example of fire door compliance plate observed on level 6. Year of manufacture 2018 indicates that there is no asbestos within the door.

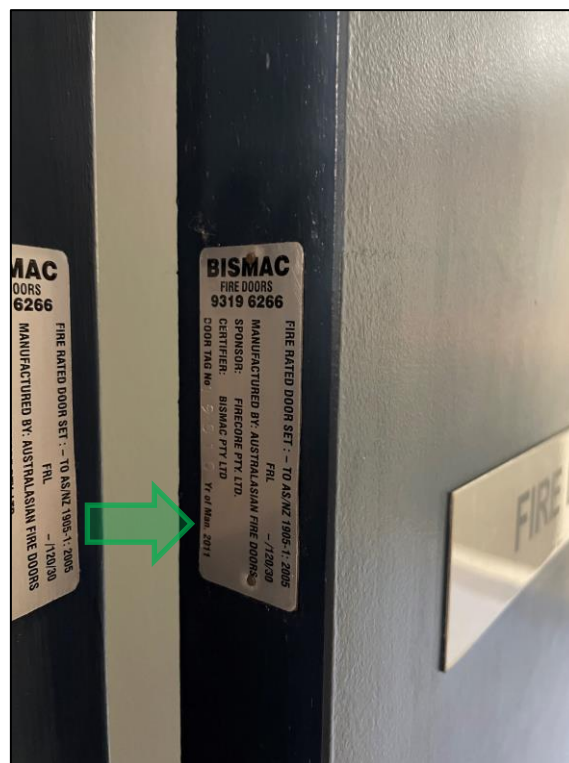
Photograph 14 Example of fire door compliance plate observed on level 5. Year of manufacture 2011 indicates that there is no asbestos within the door.

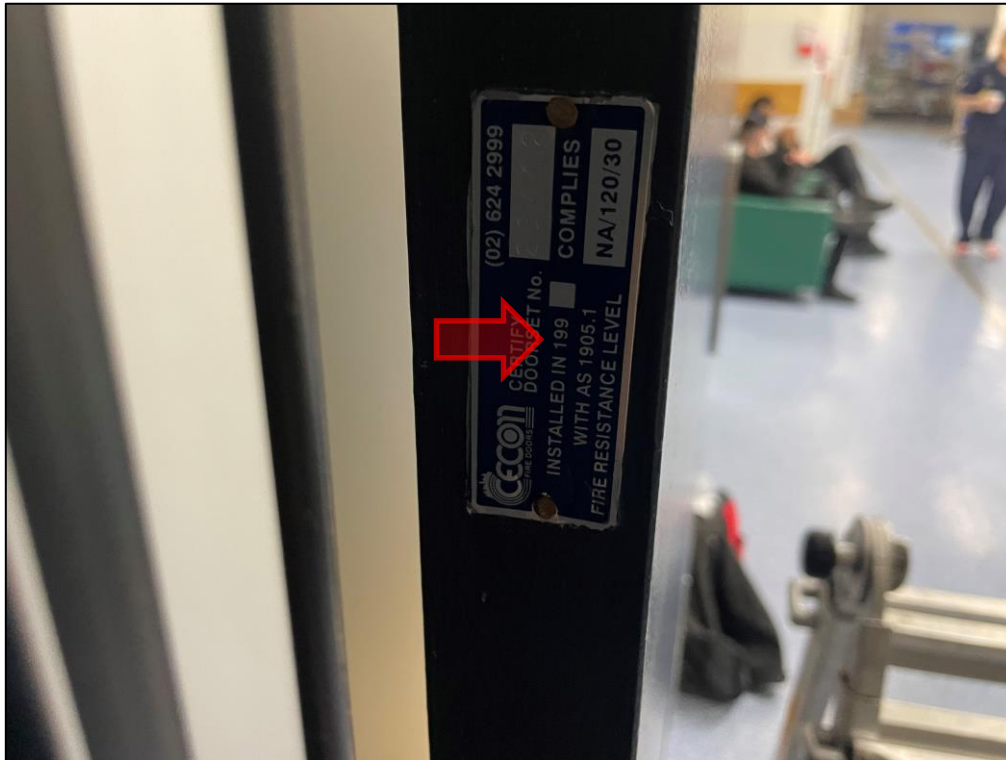
Photograph 15 Example of fire door compliance plate observed on level 4. Year of manufacture 199? indicates that there may be asbestos within the door.

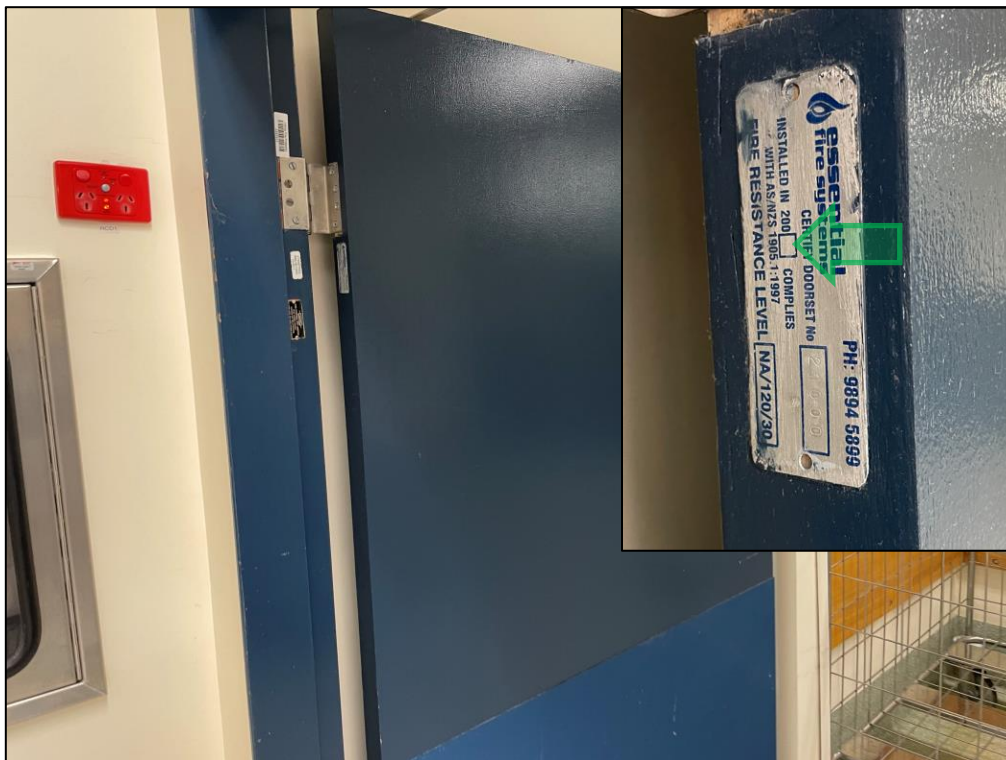
Photograph 16 Example of fire door located on level 3 with black 'PADDE' compliance plate on door frame, but with new door with 2000 + compliance plate. Not suspected of containing asbestos.

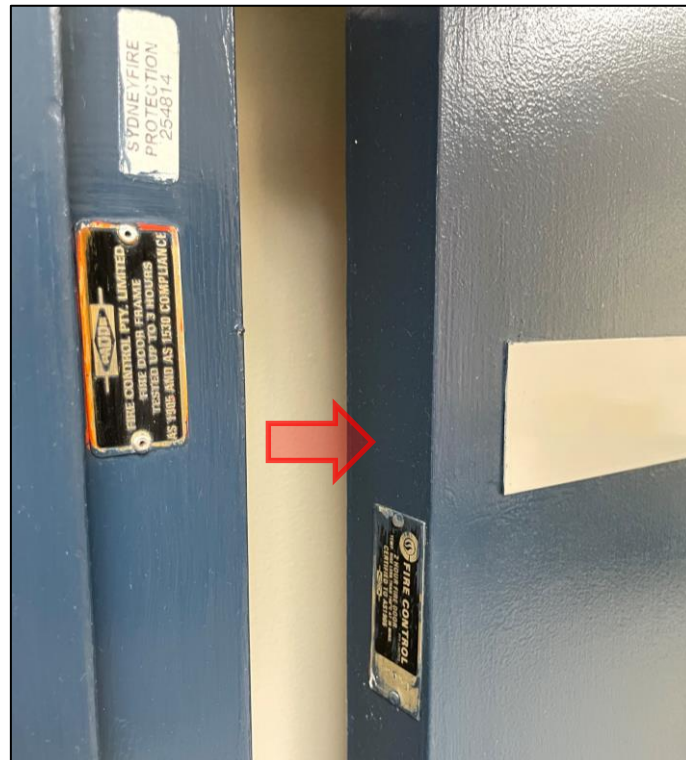
Photograph 17 Example of fire door located on level 3 with black 'PADDE' compliance plate on both door and door frame. Presumed to contain asbestos.
