Hazardous Building Materials Survey Report

Building 94, Tissue Pathology and Diagnostic
Oncology RPA Hospital, Camperdown NSW

Sydney Local Health District (c/- Cardno)

Report No: 1284-HBMS-09-110822.v1f

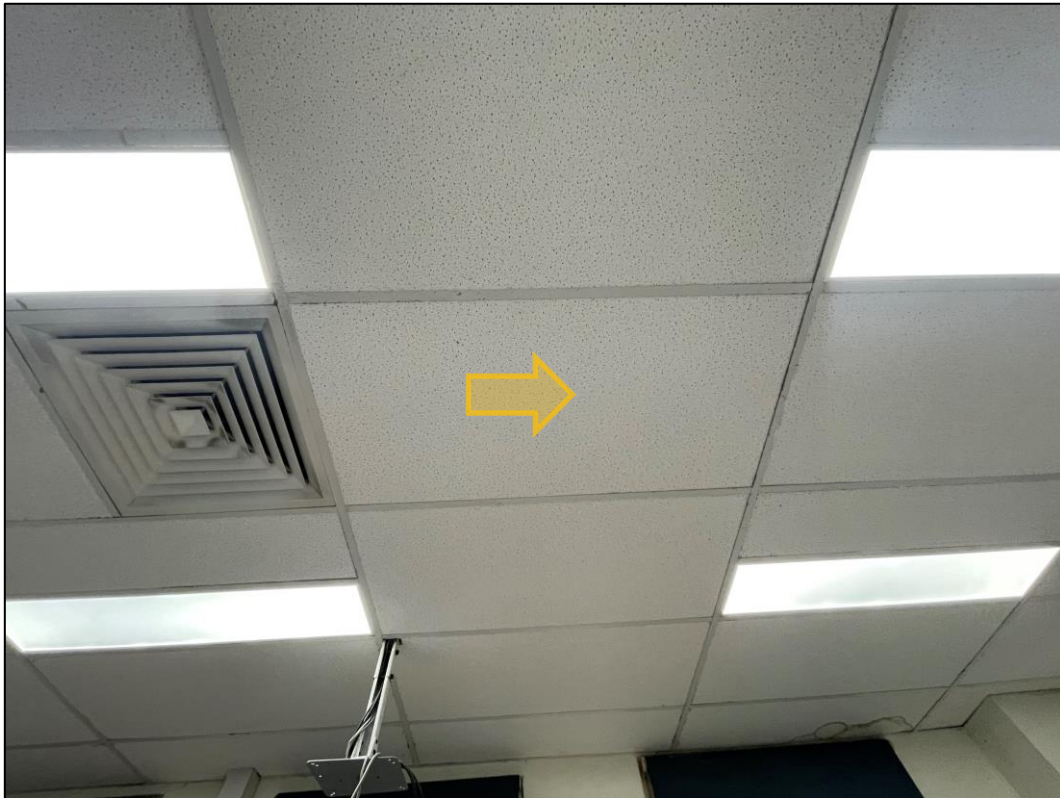
Photograph 1 Example of compressed SMF ceiling tiles. Presumed to contain SMF.

- All air conditioning, ducting, and insulation material is presumed to contain SMF. Caution is required when handling SMF products in order to minimise airborne SMF fibre levels. It is recommended that the code of practice "Code of Practice for the Safe Use of Synthetic Mineral Fibres NOHSC:2006 (1990)]" be closely adhered to when handling such materials;

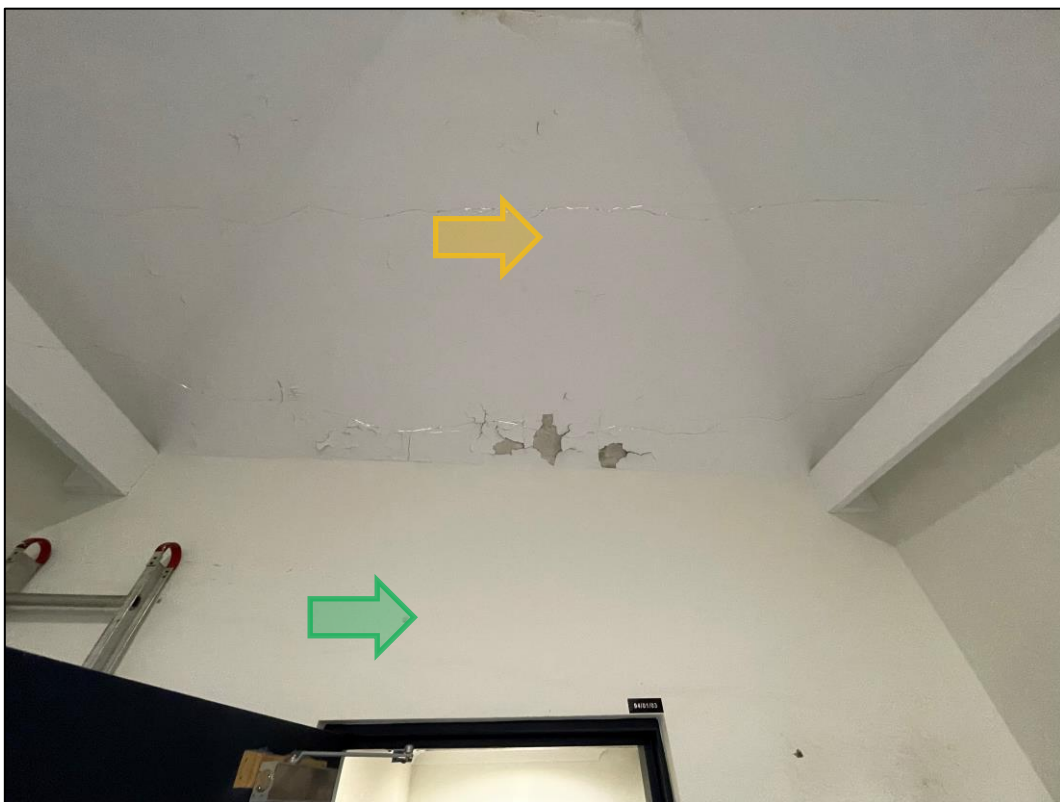
Photograph 2 White lead paint system (3.1 % w/w lead, 'B94-LG-WHITE-PB02') and cream, non-lead paint system (< 0.01 %w/w lead, 'B94-LG-CREAM-PB01'). Lead paint detected.

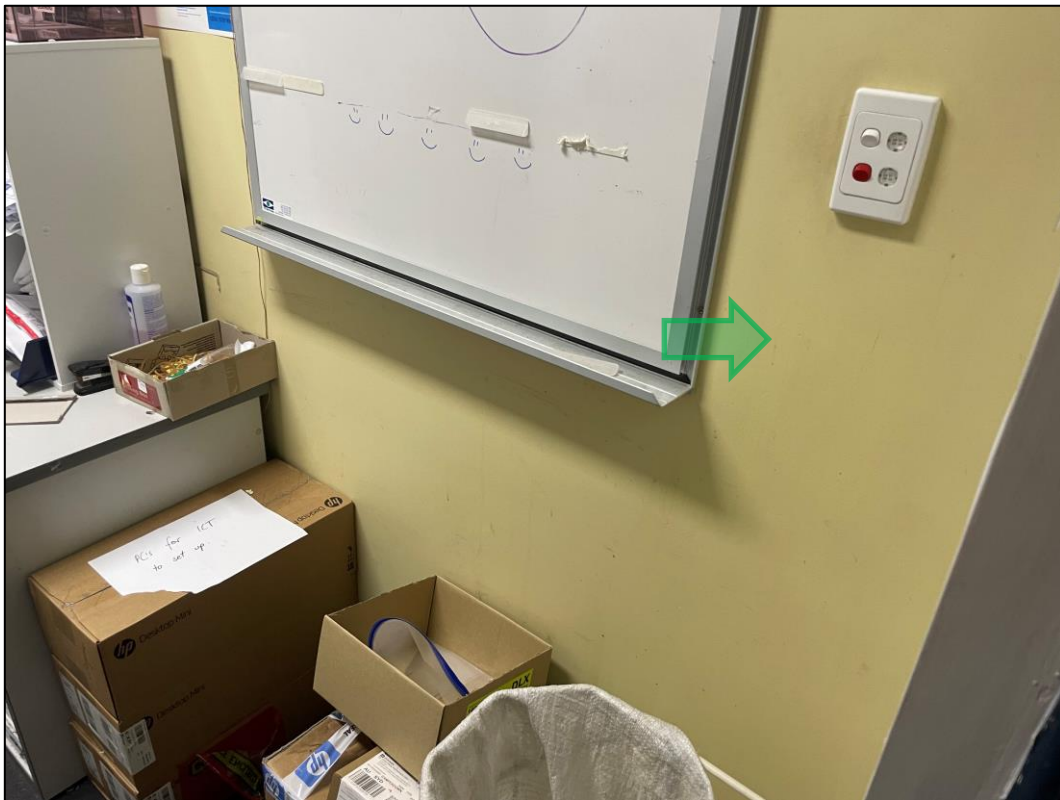
Photograph 3 Yellow, non-lead paint system (<0.01 %w/w lead, 'B94-LG-YELLOW-PB03'). No lead paint detected.

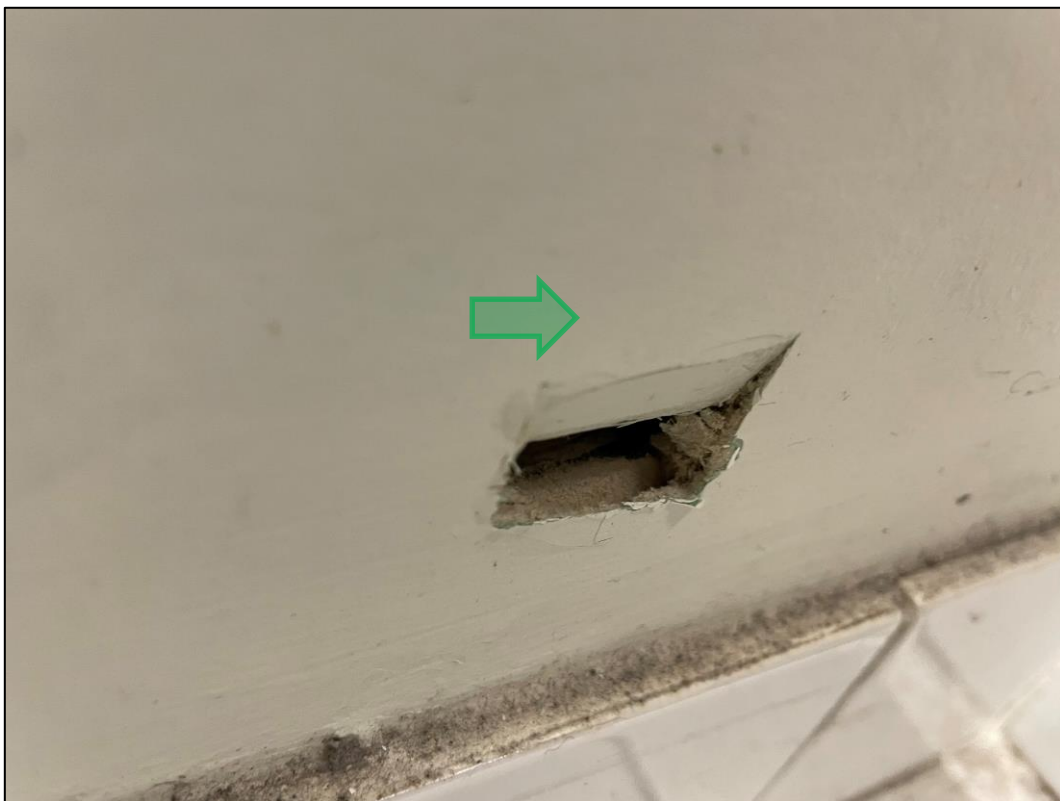
Photograph 4 Non-asbestos fibre cement observed within the bathrooms. Location of sample 'B94-LG_BATH-A01'.

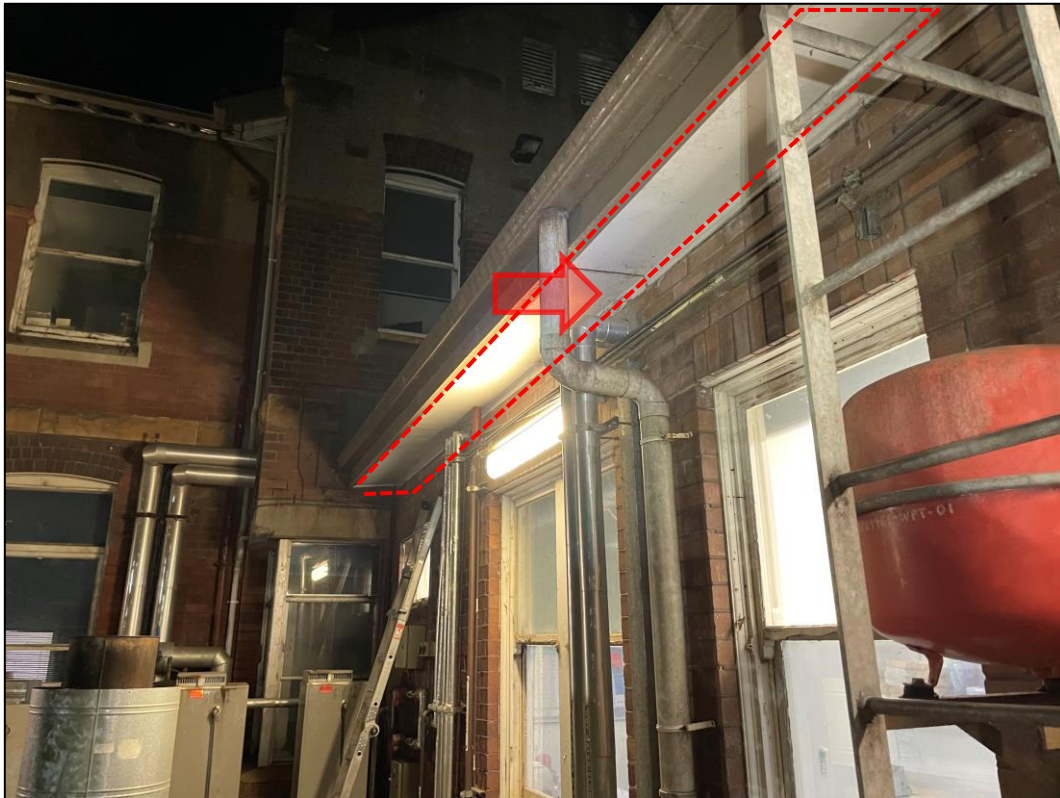
Photograph 5 Asbestos fibre cement eaves identified on the exterior of the building. Location of sample 'B94-LG-EAVES-A02'.

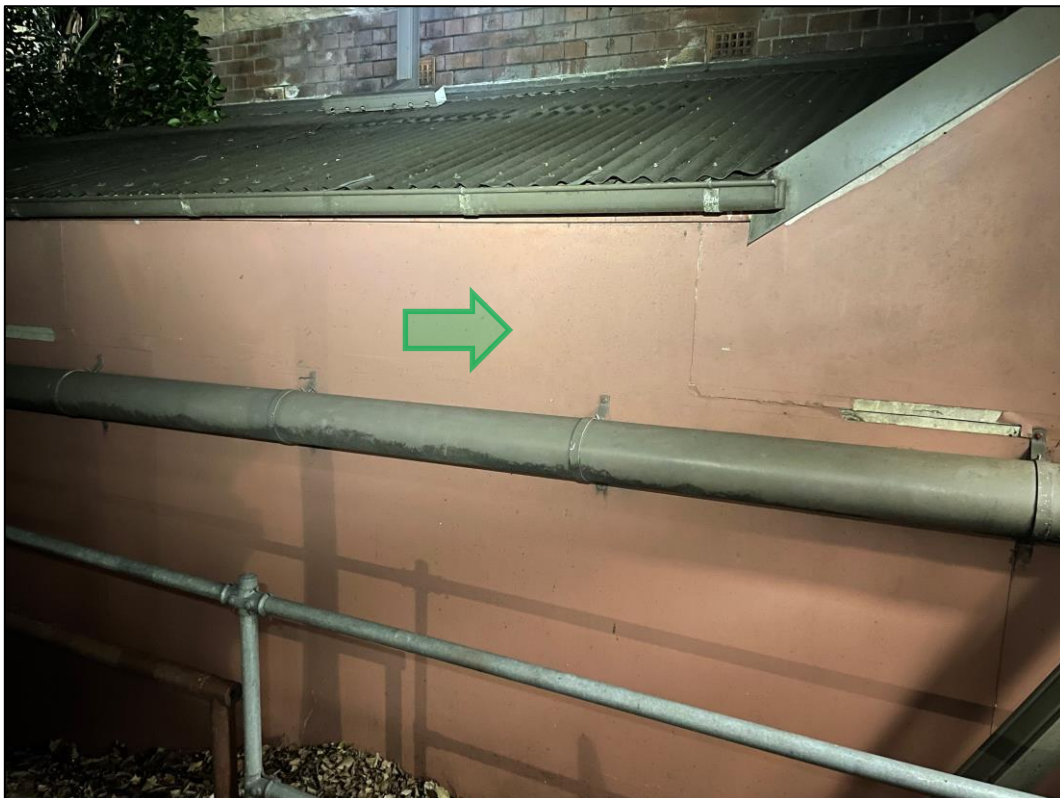
Photograph 6 Exterior non-asbestos fibre cement wall lining. Location of sample 'B94-EXT-WALL-A05'. No asbestos detected.

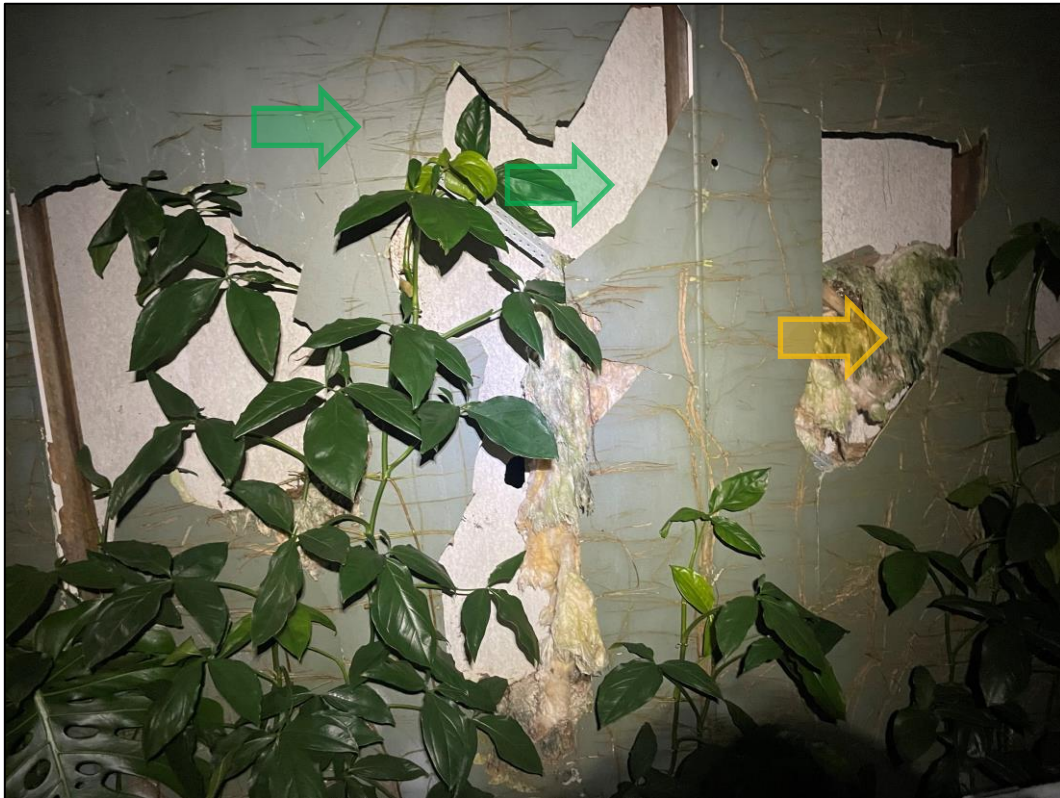
Photograph 7 External and internal non-asbestos fibre cement wall linings identified on the external shed.
Location of samples 'B94-SHED-EXT-WALL-A03' and 'B94-SHED-EXT-WALL-A04'. No asbestos detected.
Presumed SMF insulation observed.
