Hazardous Building Materials Survey Report

Building 95 Chapel, RPA Hospital,
Camperdown NSW

Report No: 1284-HBMS-04-250522.v1f

Report Date: 25 May 2022

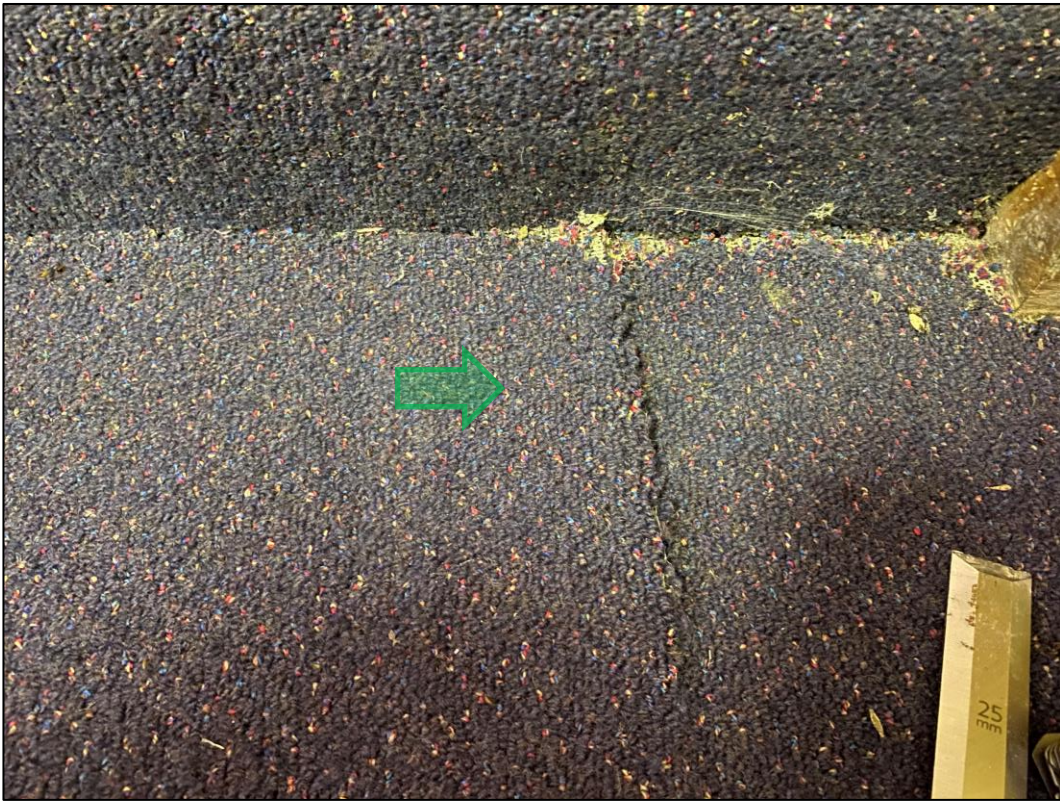
Photograph 1 Building 95: Interior carpet flooring within chapel, as observed on 07/05/22. Location of sample 'B95-CARPET-01'. No asbestos detected.

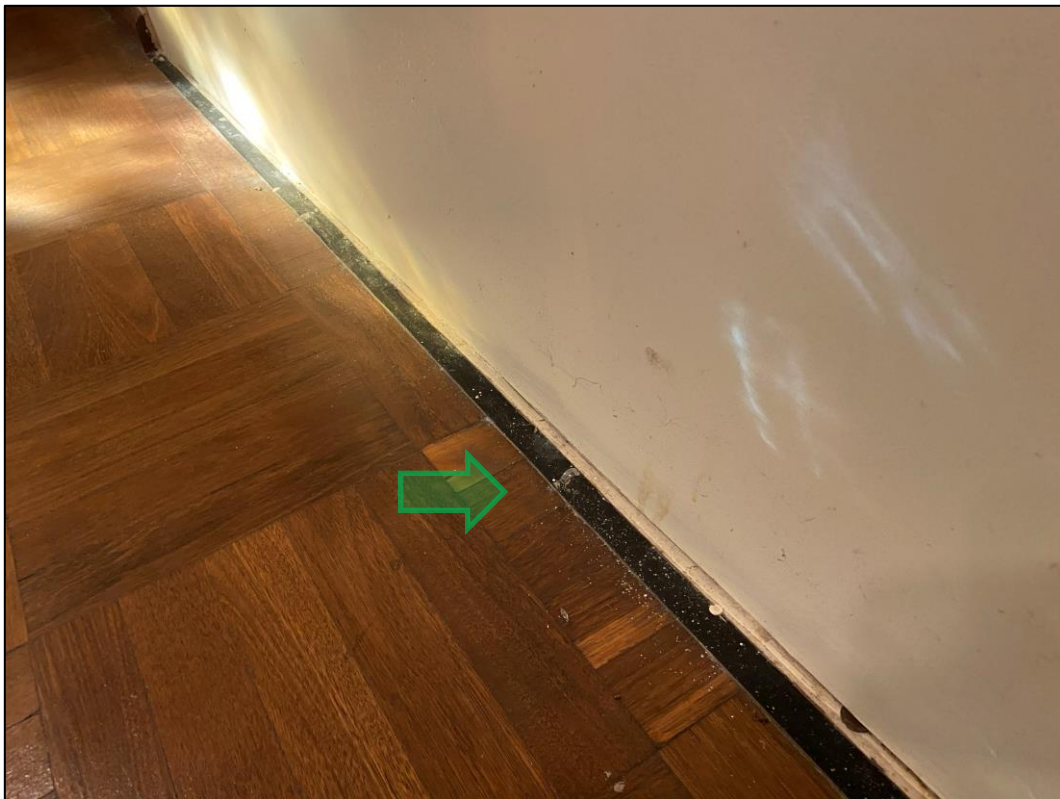
Photograph 2 Building 95: Interior timber flooring within the chapel foyer, as observed 07/05/22. Location of sample 'B95-MST-01'. No asbestos detected.

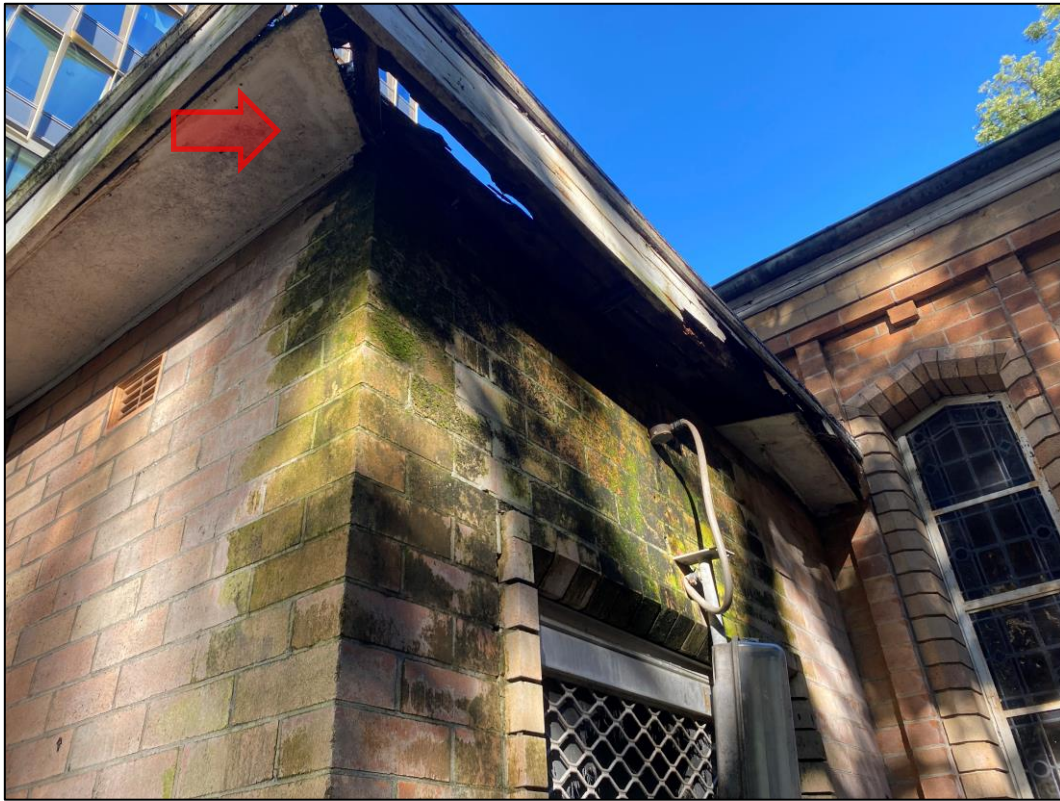
Photograph 3 Building 95: Exterior asbestos fibre cement eaves, as observed 07/05/22. Location of sample 'B95-EAVE-01'. **Asbestos detected.**

- Asbestos containing materials were identified in the eaves and in vinyl tiles beneath the carpeted flooring of the chapel. All identified materials were in good condition and must be removed by a licensed asbestos removalist prior to refurbishment or demolition works;
