**From:** Cheralee Heynes <cheralee@jdg.com.au>  
**Date:** Sunday, 19 April 2020 at 6:31 pm  
**To:** Jenny Watt <jenny@mandlinvestments.com.sg>  
**Cc:** Michael Babbage <Michael.Babbage@ttw.com.au>, "Stephen. Brain" <Stephen.Brain@ttw.com.au>  
**Subject:** RE: lighting level assessment for pedestrian crossing - quote

Further to our site visit with Stephen Brain and discussions with you, we have measured lighting illumination levels vertically at the pedestrian crossing to assess compliance. The road is single lane and one way from the South and compliance is achieved with minimum 32 Lux vertical illumination measurement in the plain facing south at 18 points across the pedestrian crossing to AS1158.4. The measurements were taken at 7pm.

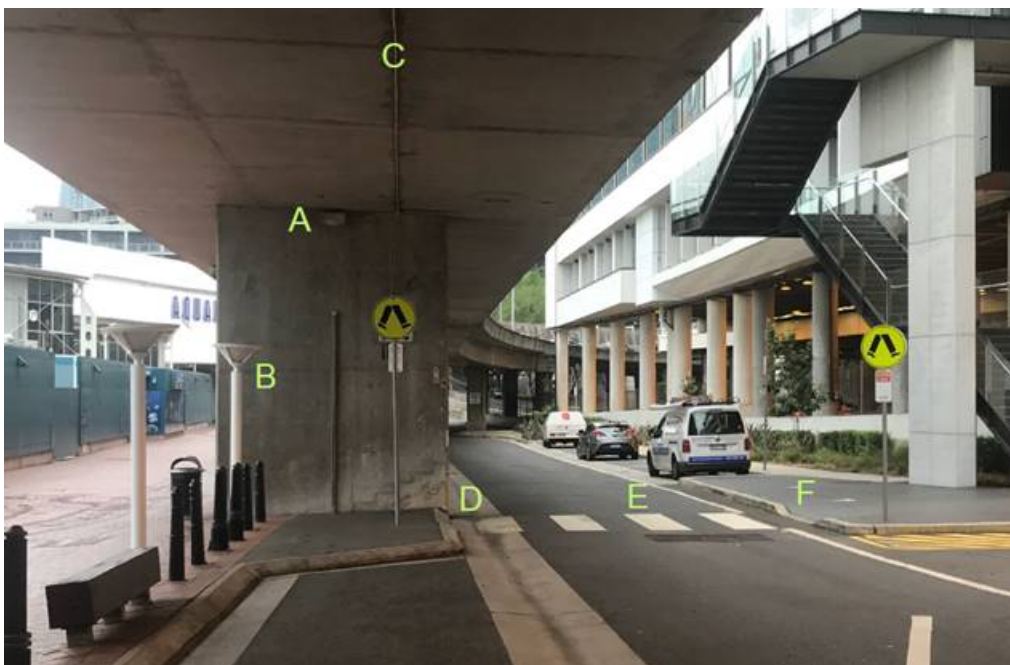
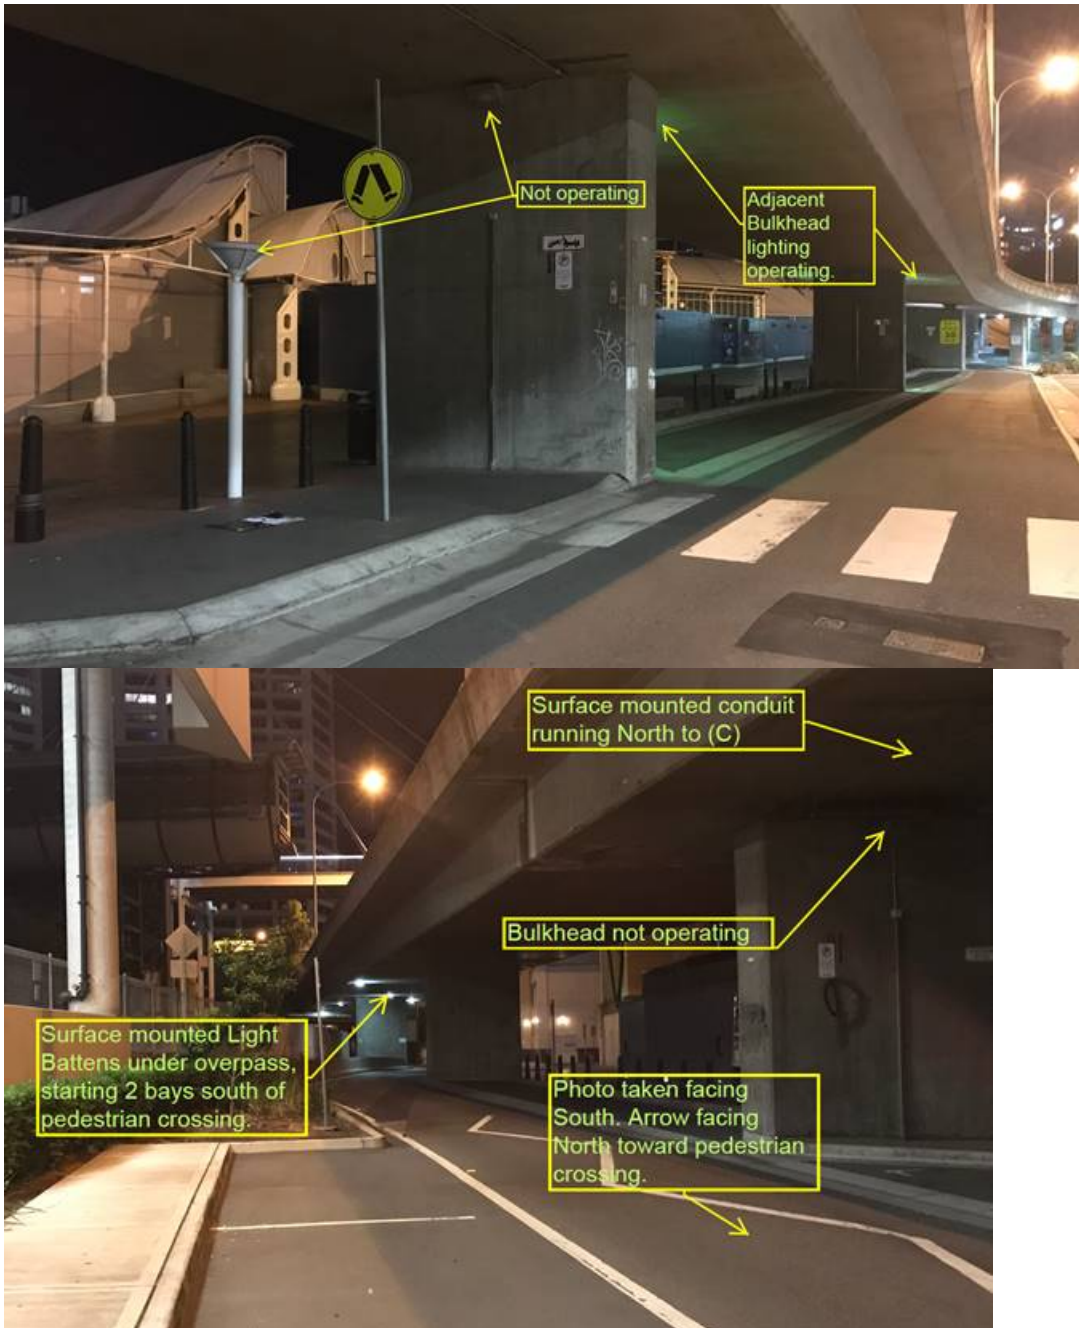
The below are three photos taken. The first at day, second at night facing north toward the crossing and the third at night facing south away from the crossing.

- The vertical illumination levels measured at all compliance points on the crossing ranged between 5.9 Lux (D) and 15.1 Lux (F). These values are lower than the minimum pedestrian crossing lighting levels of 32 Lux required.

- Adjacent Bulkhead (A) and Post Top (B) lighting are currently not operating. All lighting to the pedestrian crossing is currently from light spill.
- Bulkhead lighting in the adjacent northern bays are operating. In the locations shown above, vertical illumination levels measured at the adjacent bay were approximately 6 Lux and a maximum of 29 Lux was measured in the next northern bay. These measurements were taken at locations on the Western side of the road in line with (D). Illumination levels dropped away toward the opposing kerb in line with (F). These two bulkheads have different lamp sources and there is potential for an alternative lamp source to provide illumination above 32 Lux however this minimum level is unlikely to be achievable across all 18 compliance points of the crossing using the existing fitting type.

- An operating Post Top such as (B) luminaire was not found and could not be measured. The Post Top style is also not an appropriate light fitting to provide sufficient vertical illumination to a pedestrian crossing.

- The location of the existing bulkhead (A) is not positioned to provide incident light on the crossing from the direction of the oncoming traffic (the plain used to measure the vertical illumination for compliance)
- It is concluded the existing luminaires, if operational, or upgrade of these luminaires, will not provide the required illumination levels to achieve compliance.

- Install a directional flood light at (C), directed to the centre of the pedestrian crossing (E) and connect into an existing local lighting circuit.
- This arrangement needs the following confirmation:
  - Capacity to connect an additional 1 Amp into a local circuit. NB: This is unlikely to be an issue.
  - The local circuit is controlled by Photo electric (PE) Cell. This ensures the lighting will operate at all times in the absence of daylight such as the expected arrangement for the light battens under the overpass to the south.
  - Ownership of the lighting circuits. NB: It is expected the existing lighting circuits will be owned and operated by Transport NSW (RMS) due to the location and intended function.

- Confirm ownership of existing local lighting circuits;
- Obtain any existing information including as installed drawings or maintenance manuals if available.
- Obtain approvals to carry out the proposed work.
- Engage an electrical contractor to determine operation and connectivity of the local circuit proposed for connection.
- Suggest fixing existing lighting circuits to make existing post top and bulkhead lighting operational;
