Report on
Hazardous Building Materials (HBM) Survey

Police Citizens Youth Club (PCYC)
600-660 Elizabeth Street, Redfern NSW

Project 99510.01
December 2019

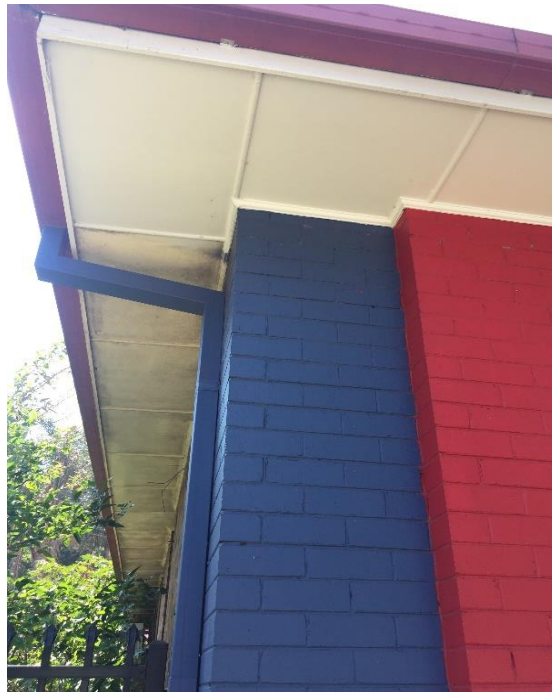
Photograph 1: PCYC, exterior, western façade, northern end, eave lining, fibre cement sheeting, asbestos detected by analysis

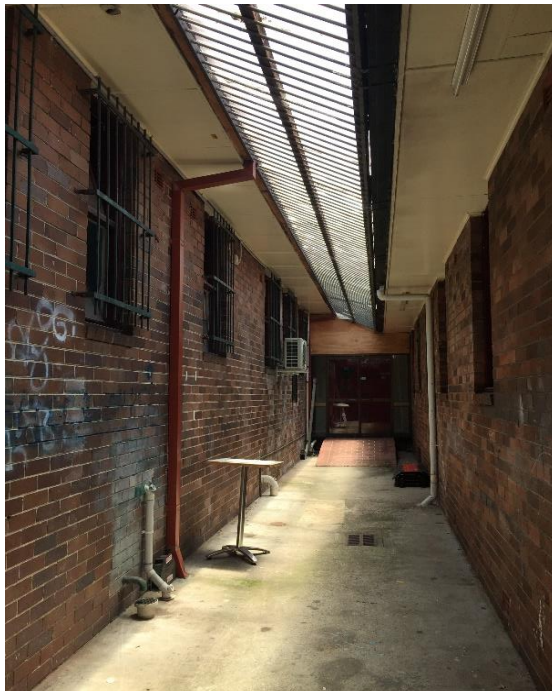
Photograph 2: PCYC, exterior, central passageway, dance studio, western eave lining, fibre cement sheeting, asbestos detected by analysis

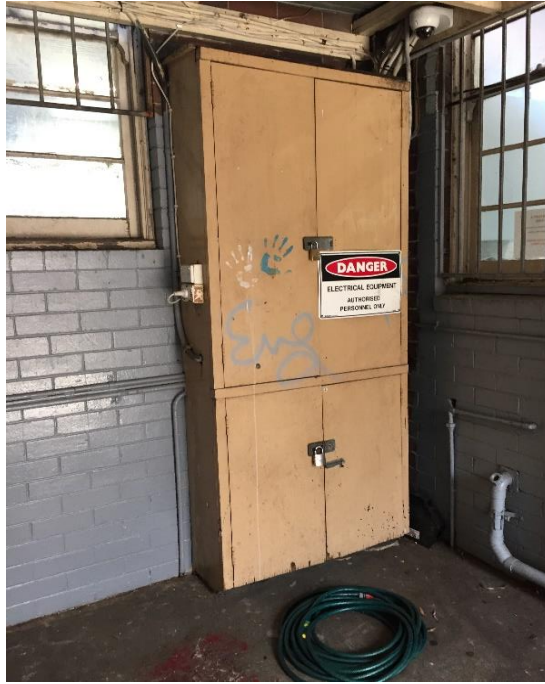
Photograph 3: PCYC, exterior, covered courtyard at centre of building, electrical cabinet, internal components, electrical backing board, fuse insulation and/or other materials, asbestos (assumed)

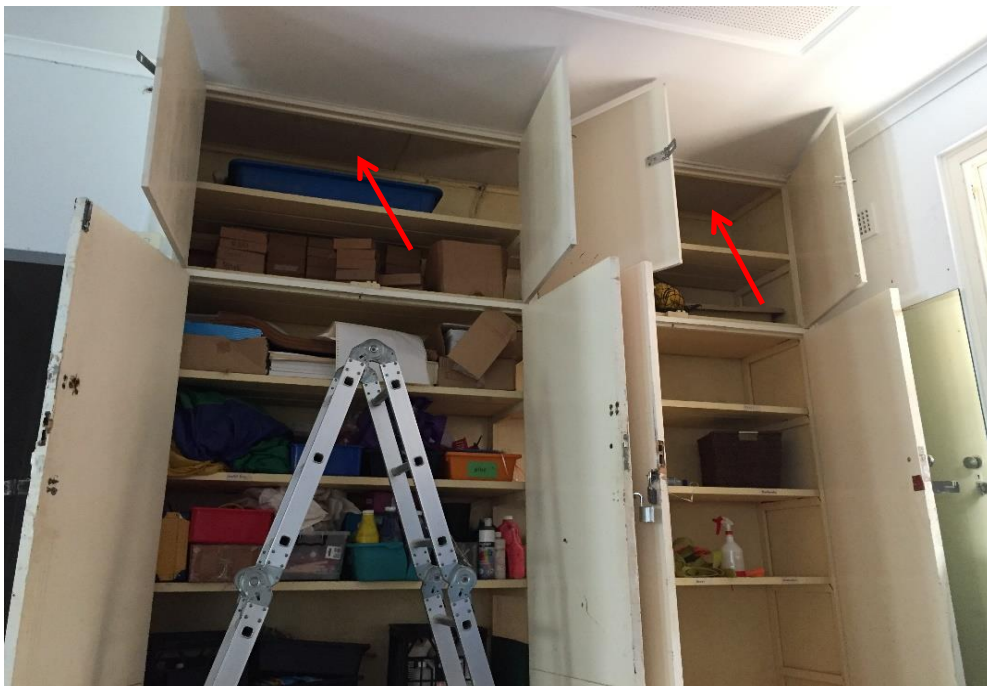
Photograph 4: PCYC, interior, dance studio, southwestern corner, cupboards, ceiling lining, fibre cement sheeting, asbestos (assumed)

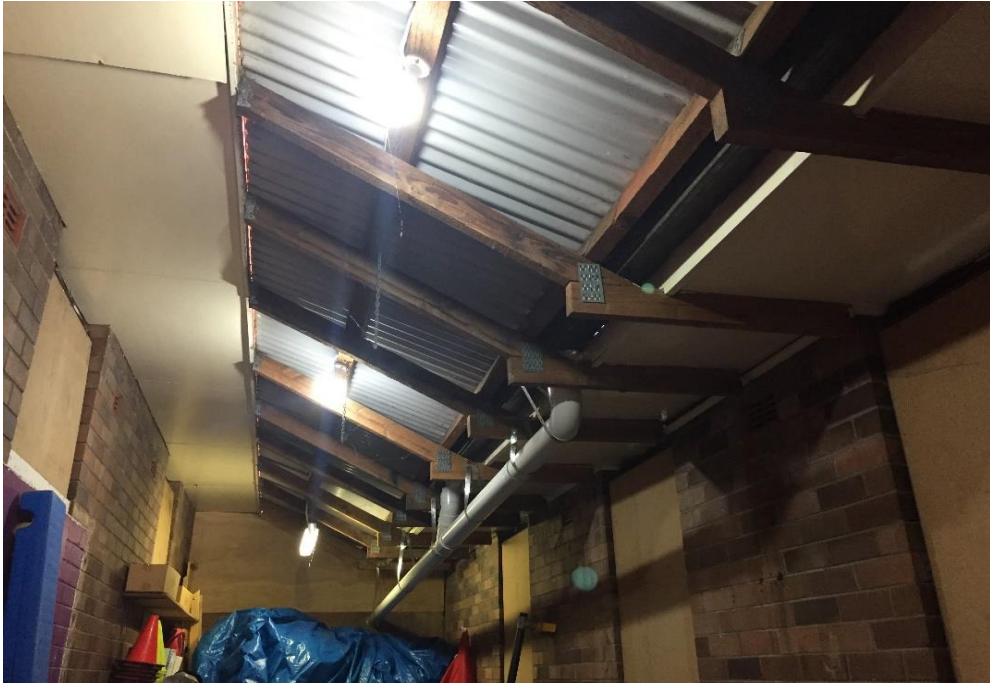
Photograph 5: PCYC, interior, photo room, continuation of eave linings throughout, fibre cement sheeting, asbestos (assumed)

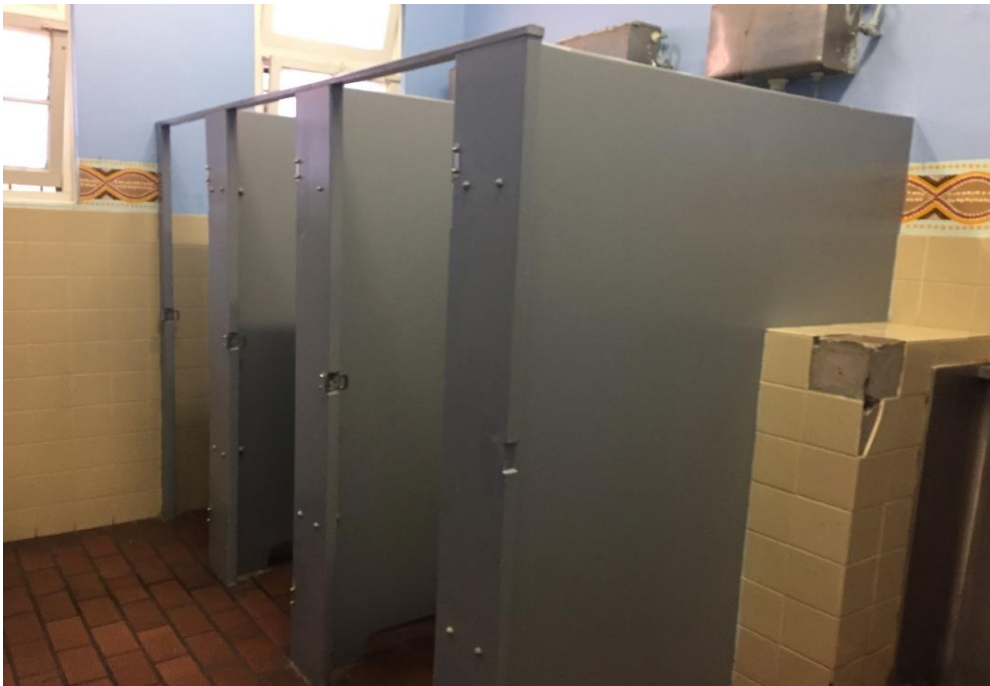
Photograph 6: PCYC, interior, male toilets (adjacent north of police change room), partitions, possible fibre cement product, asbestos (assumed)

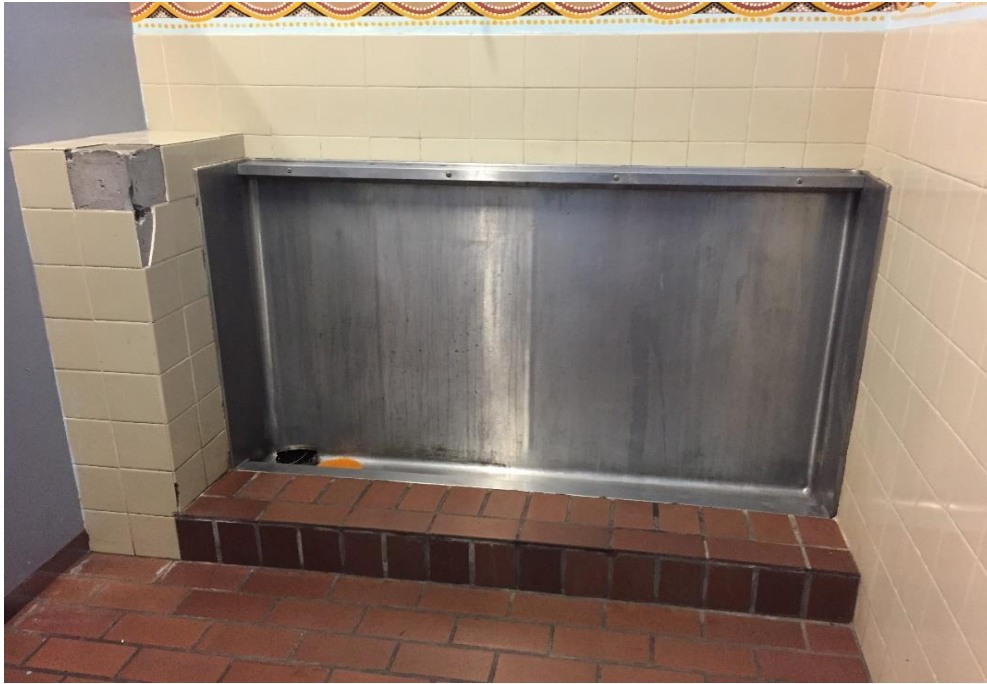
Photograph 7: PCYC, interior, male toilets (adjacent north of police change room), rear side of urinal, possible bituminous lining/coating, asbestos (assumed)

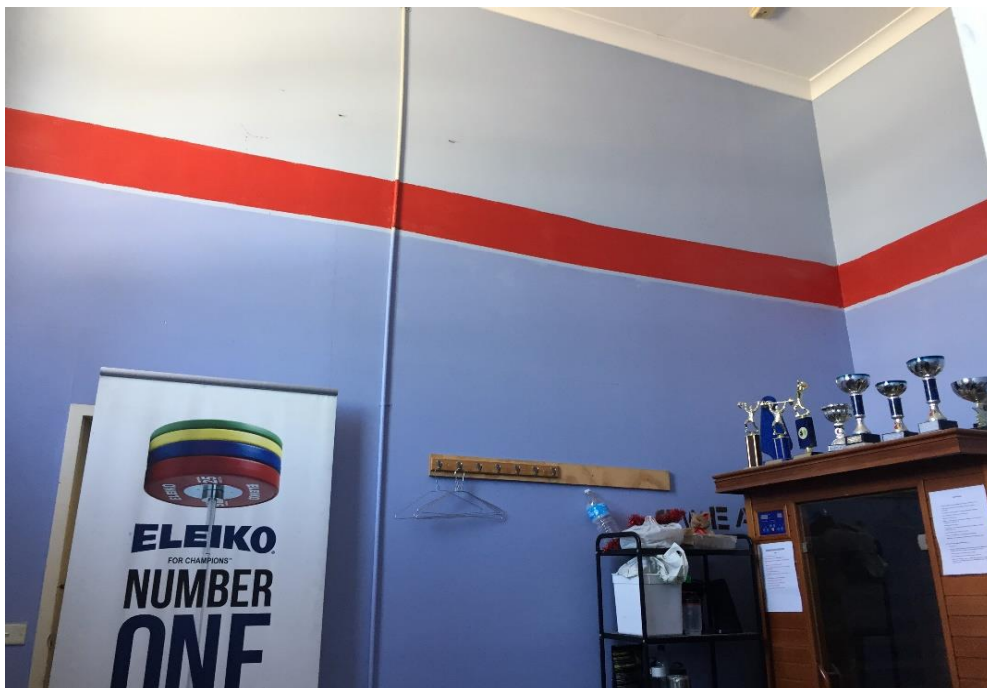
Photograph 8: PCYC, interior, storage 7, portion wall linings, fibre cement sheeting, asbestos detected by analysis

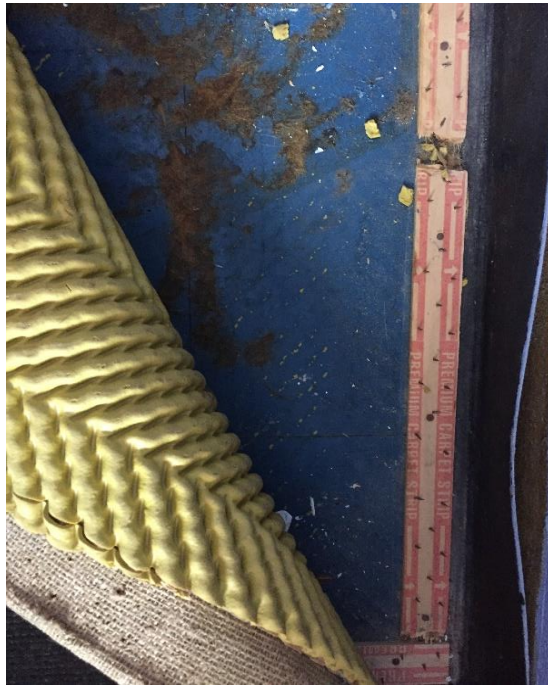
Photograph 9: PCYC, interior, storage 7, floor, below carpet, blue vinyl tiles, asbestos detected by analysis

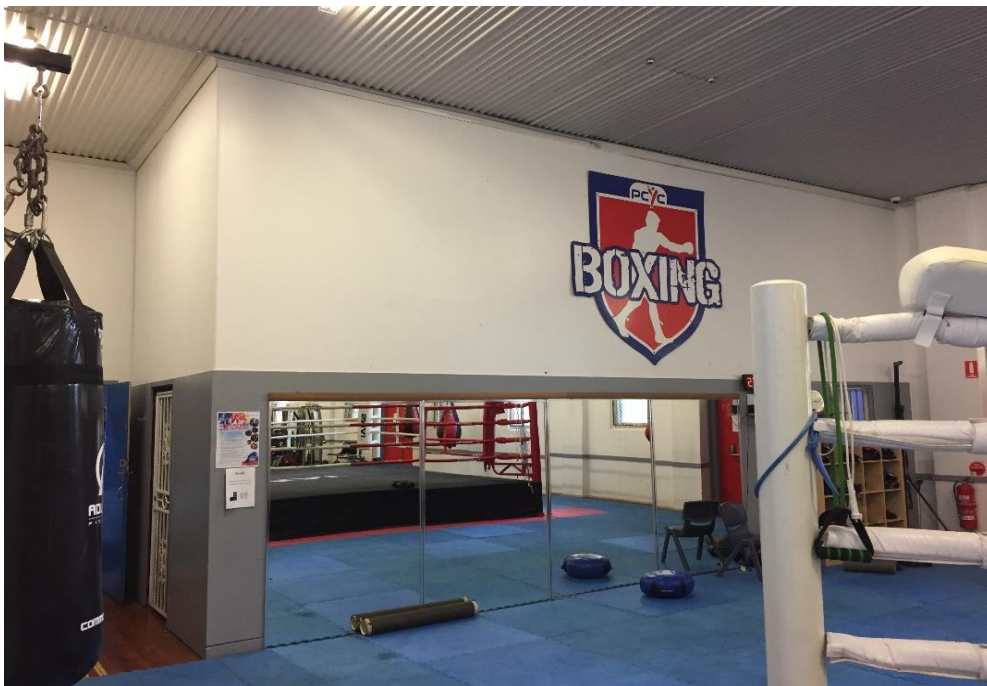
Photograph 10: PCYC, interior, gym/boxing, eastern wall (adjacent storage 7 and stationary store), fibre cement sheeting, asbestos detected by analysis

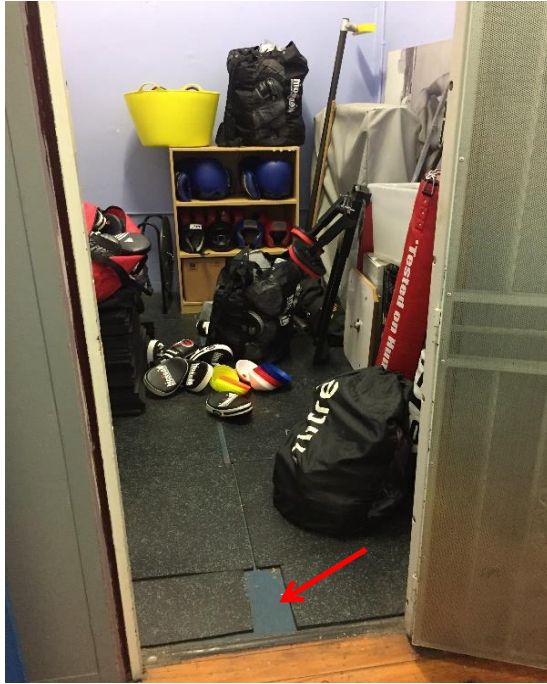
Photograph 11: PCYC, interior, stationary store, floor, blue vinyl tiles, asbestos detected by analysis

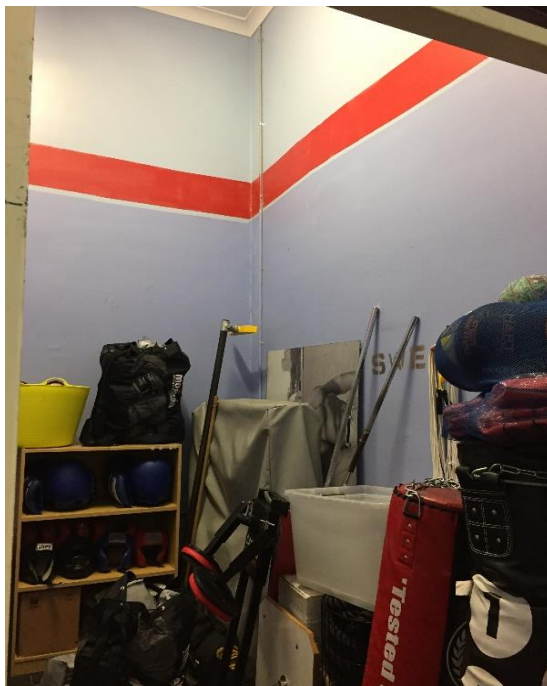
Photograph 12: PCYC, interior, stationary store, portion of wall linings, fibre cement sheeting, asbestos detected by analysis

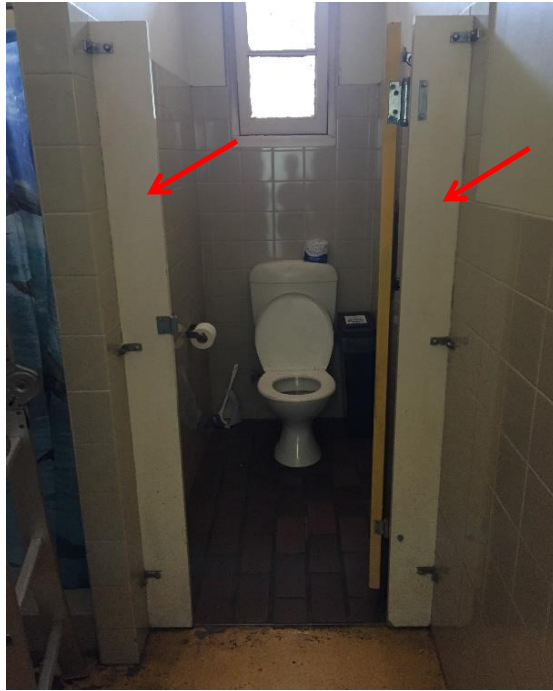
Photograph 13: PCYC, interior, police changing room, partitions, possible fibre cement product, asbestos (assumed)

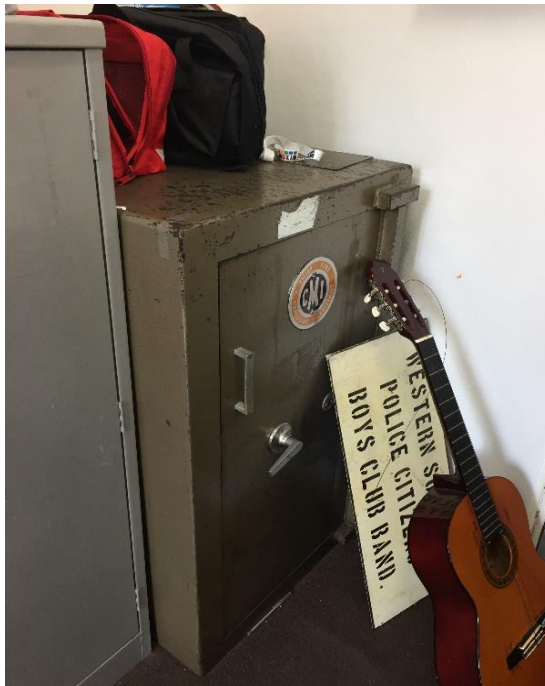
Photograph 14: PCYC, interior, office 1a/1b, safe, internal insulation, asbestos (assumed)

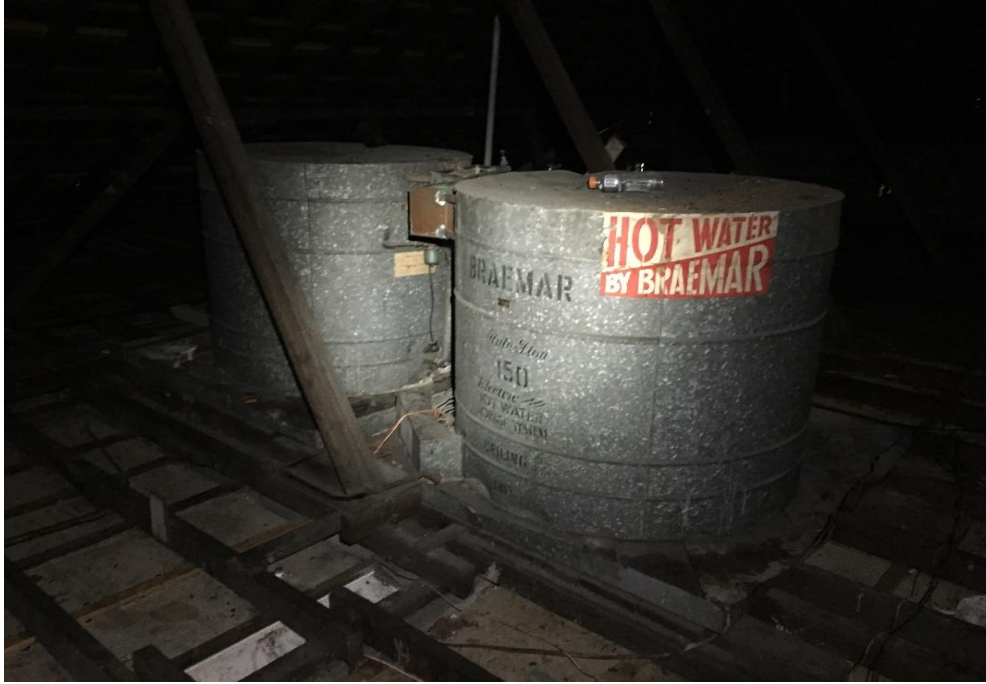
Photograph 15: PCYC, interior, ceiling cavity , hot water tanks (x2) in vicinity of main entrance foyer, internal insulation, asbestos (assumed)

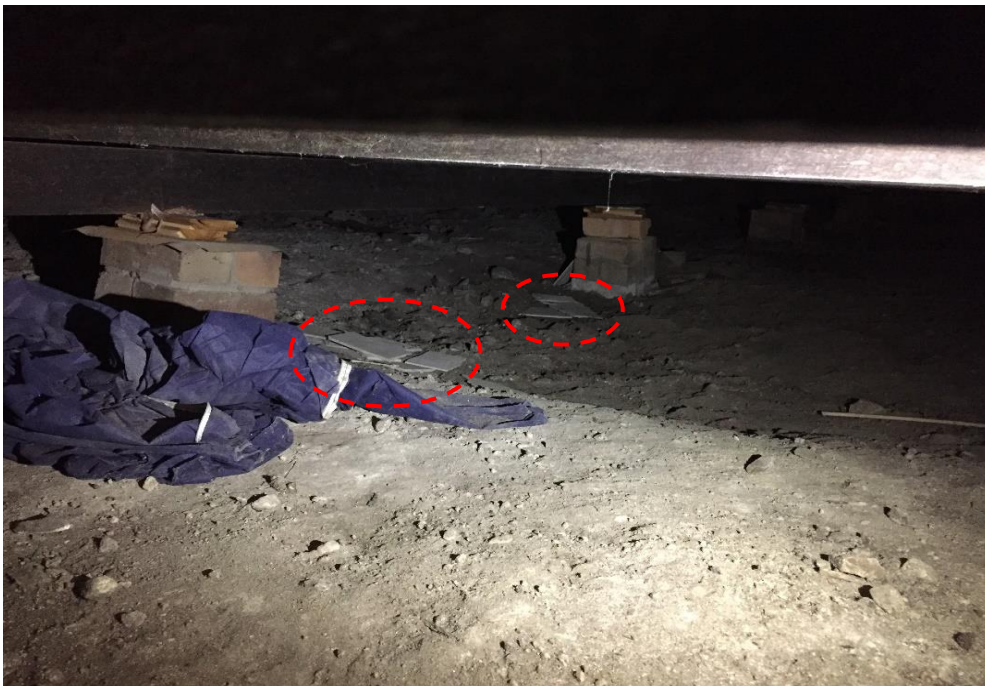
Photograph 16: PCYC, exterior, below dance studio, subfloor area, ground surfaces, fibre cement sheeting debris, asbestos (assumed)

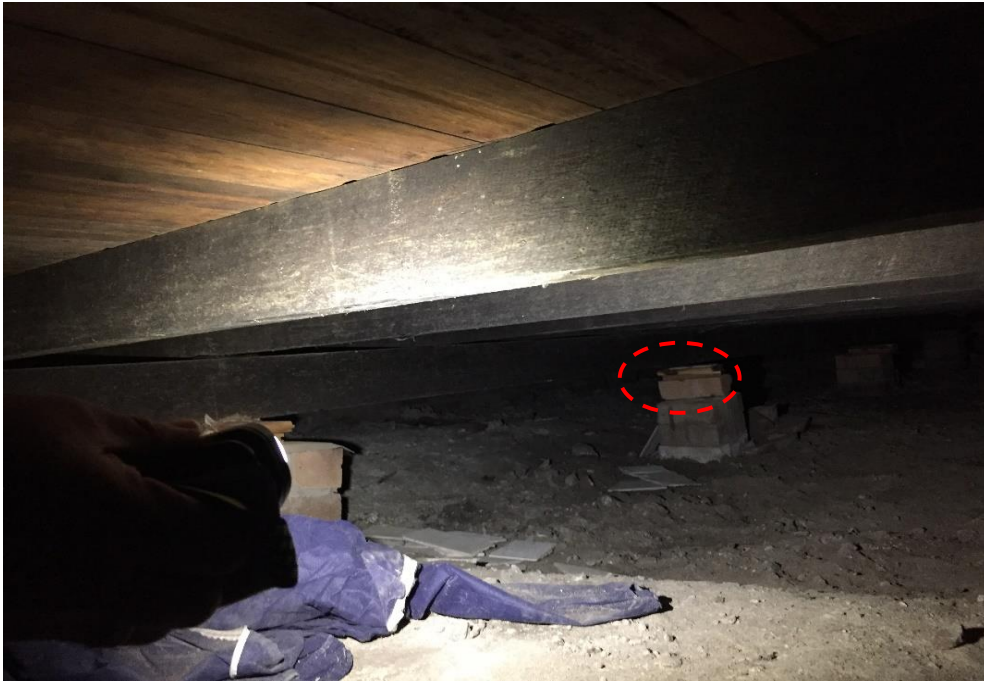
Photograph 17: PCYC, exterior, below dance studio, subfloor area, packing materials to brick piers, fibre cement sheeting, asbestos (assumed)

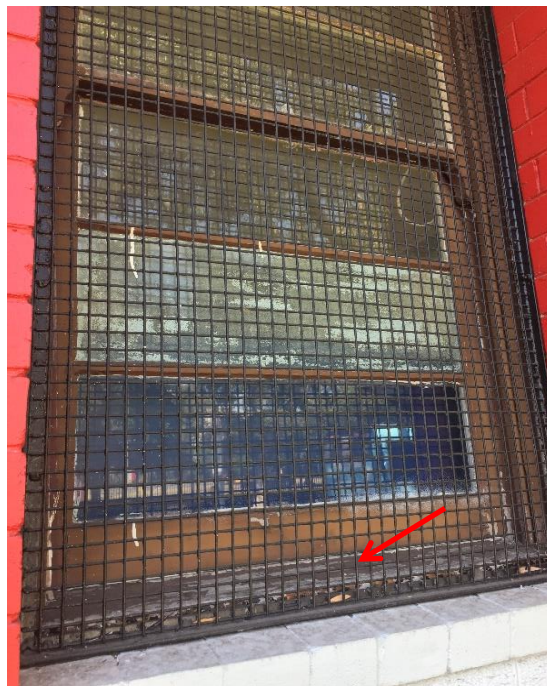
Photograph 18: PCYC, exterior, western façade, north end building, typical window frame, brown paint, lead paint (>0.1% lead w/w)

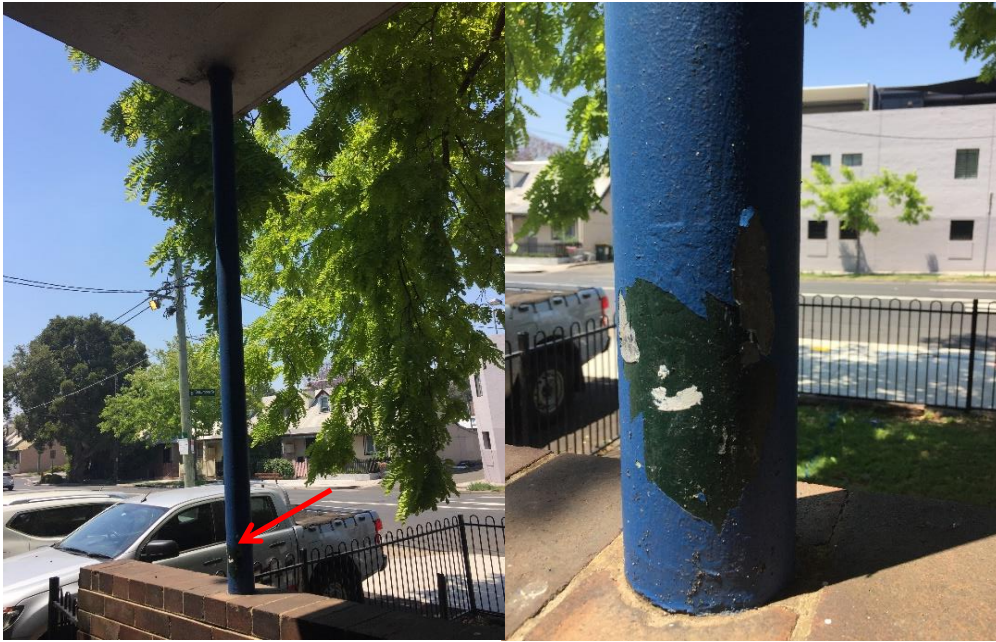
Photograph 19: PCYC, exterior, southern façade, western awning, metal supports posts, typical blue and underlying green paint, lead paint (>0.1% lead w/w)

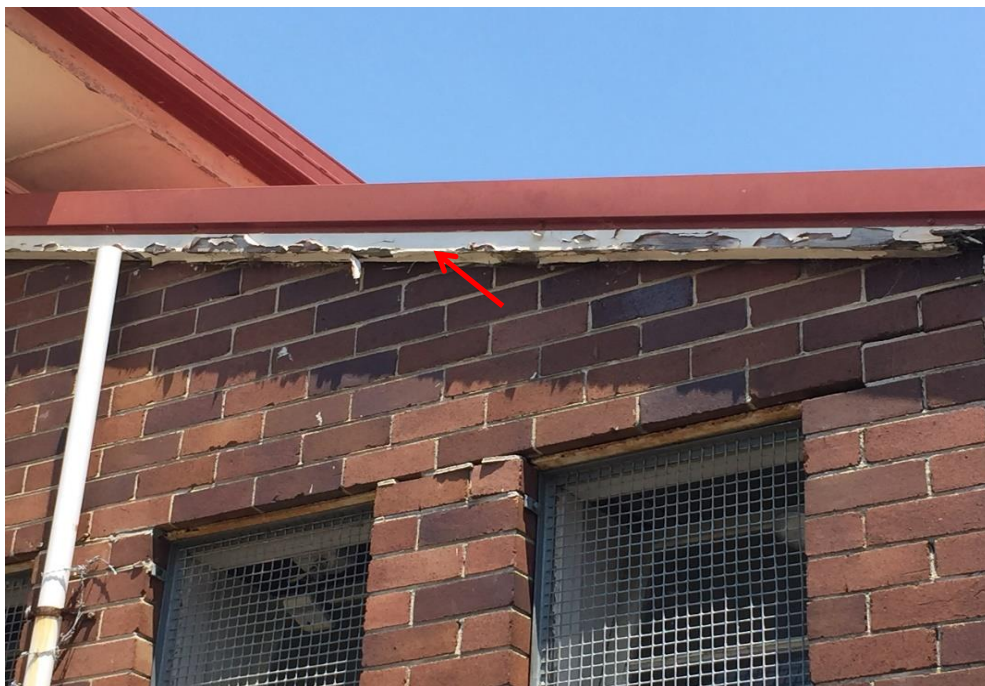
Photograph 20: PCYC, exterior, eastern façade, southern end of building, fascia, typical cream paint, lead paint (>0.1% lead w/w)

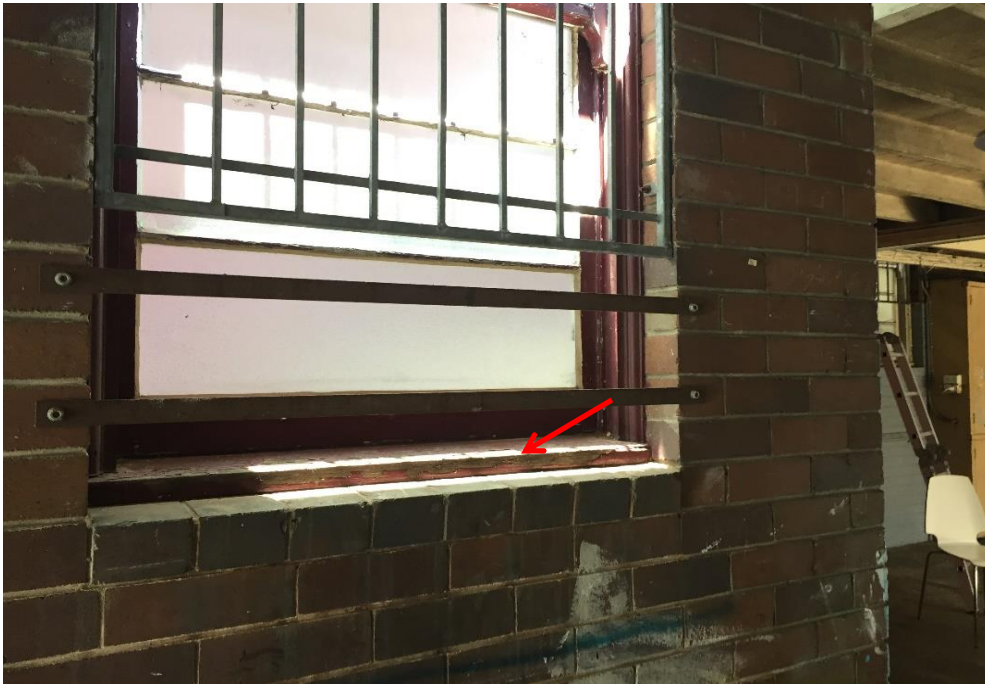
Photograph 21: PCYC, exterior, covered courtyard at centre of building, southern side, timber window frame, typical burgundy paint, lead paint (>0.1% lead w/w)

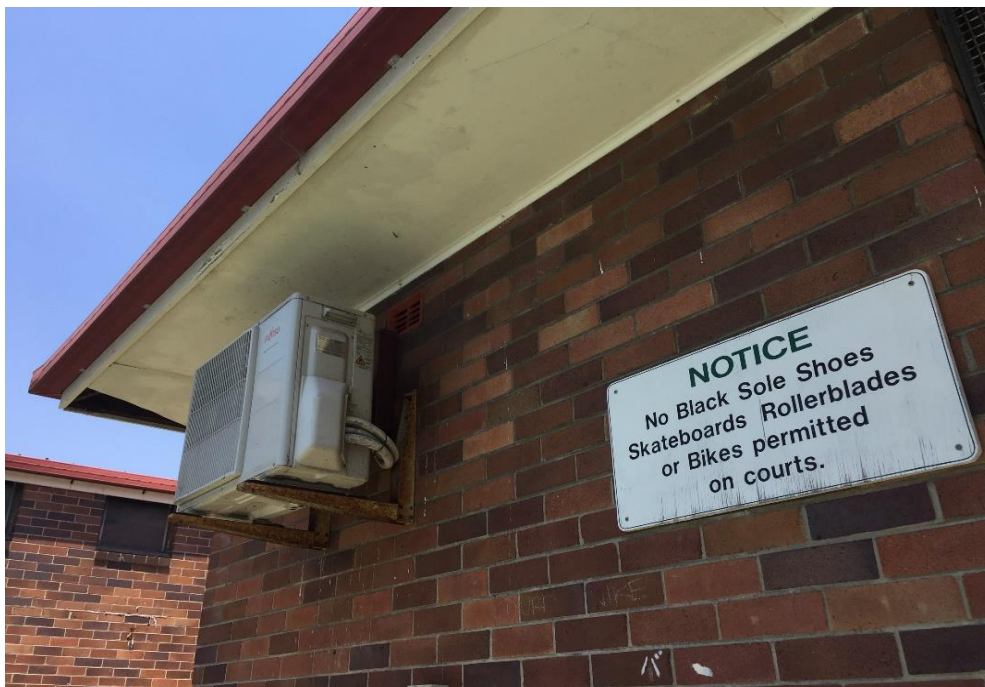
Photograph 22: PCYC, exterior, eastern façade, eastern side of dance studio, Fujitsu AC unit, refrigerant, refrigerant R32

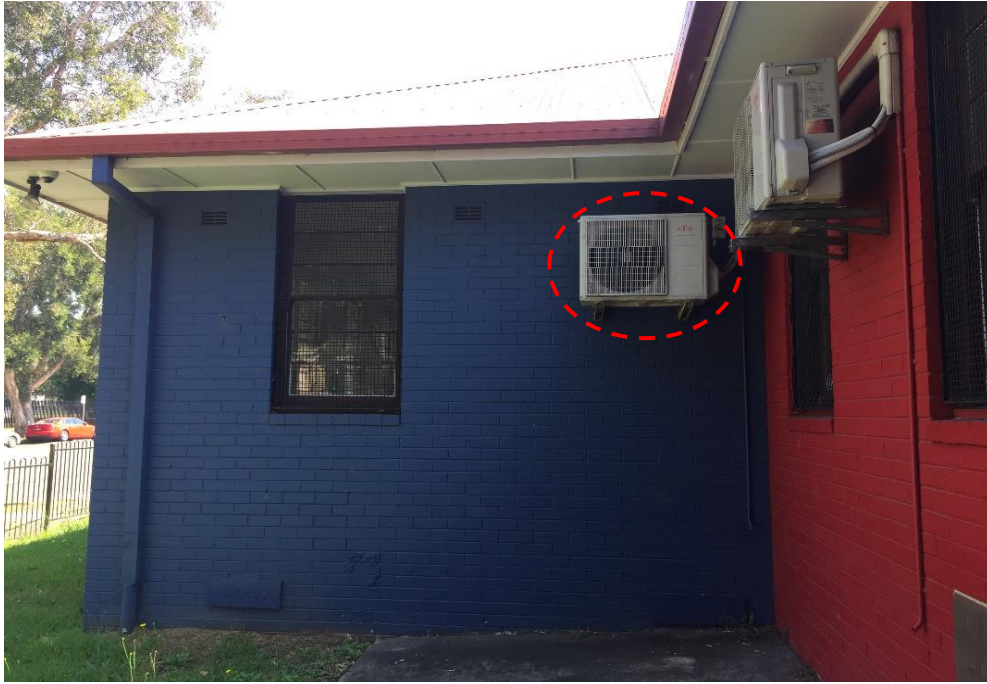
Photograph 23: PCYC, exterior, western façade, adjacent north of main entrance, Fujitsu AC unit, refrigerant, refrigerant R32

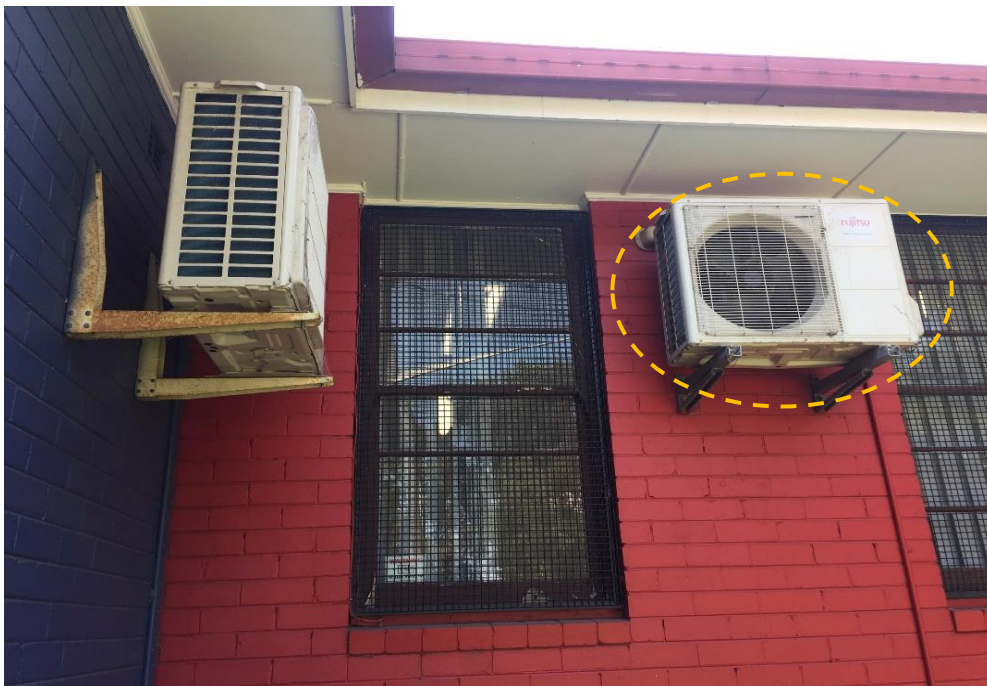
Photograph 24: PCYC, exterior, western façade, adjacent north of main entrance, Fujitsu AC unit, refrigerant, refrigerant 410A

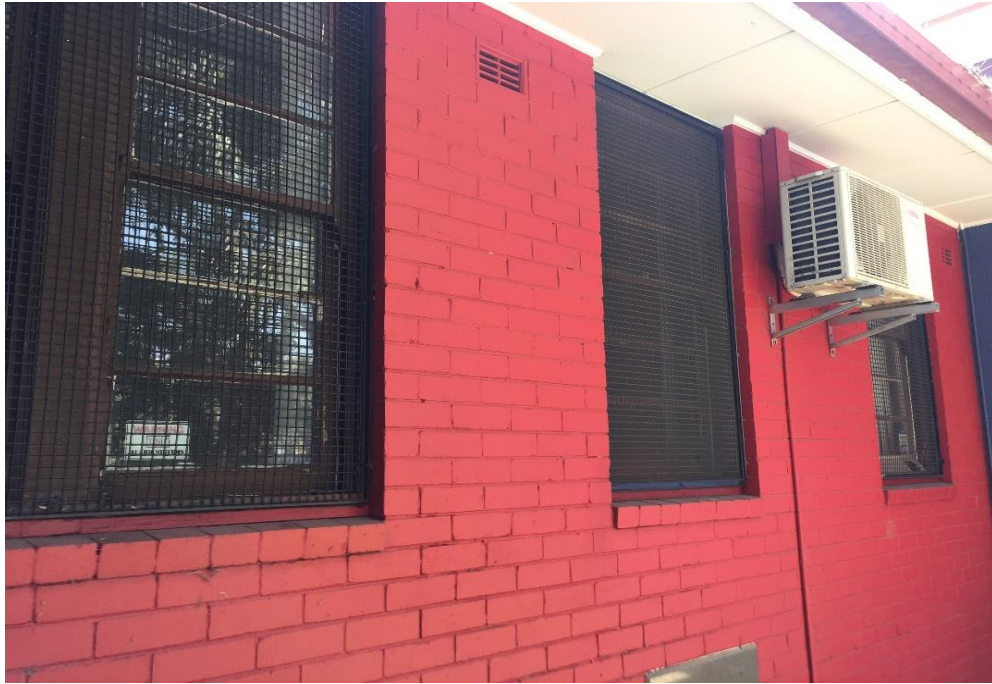
Photograph 25: PCYC, exterior, western façade, adjacent south of main entrance, AC unit, refrigerant, refrigerant R32

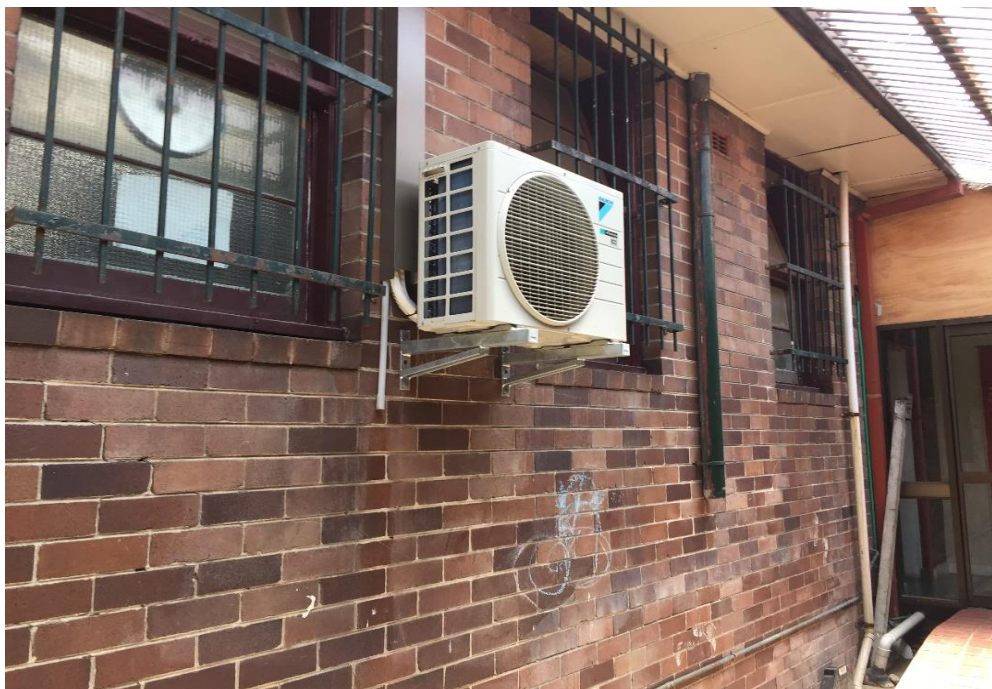
Photograph 26: PCYC, exterior, central passageway / courtyard, Daikin AC unit, refrigerant, refrigerant R32

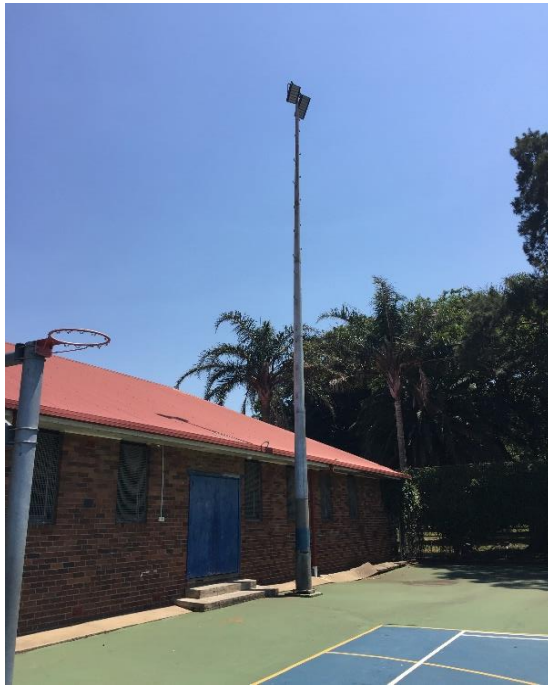
Photograph 27: PCYC, exterior, sports court, light poles, internal components, capacitors (if present), PCB (assumed)

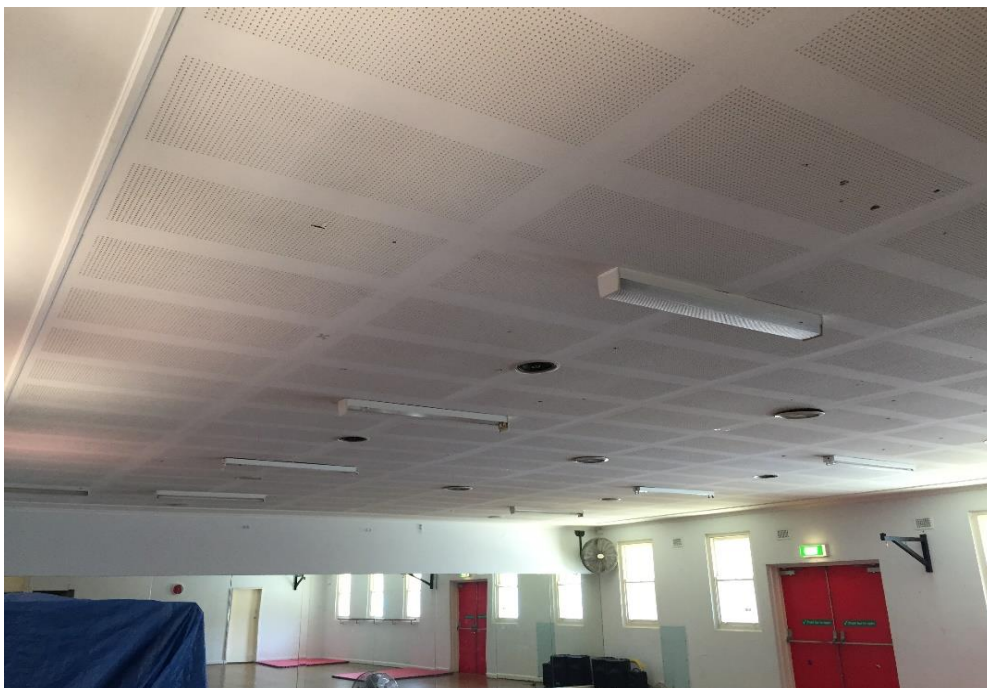
Photograph 28: PCYC, interior, dance studio, ceiling, fluorescent light fittings x 10, capacitors, insulating oil, PCB (assumed)

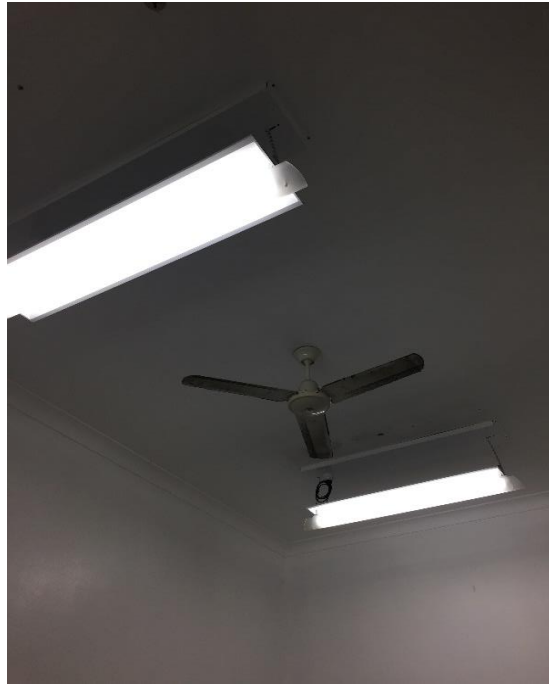
Photograph 29: PCYC, interior, storage 6, ceiling, fan x 1, capacitors, insulating oil, PCB (assumed)

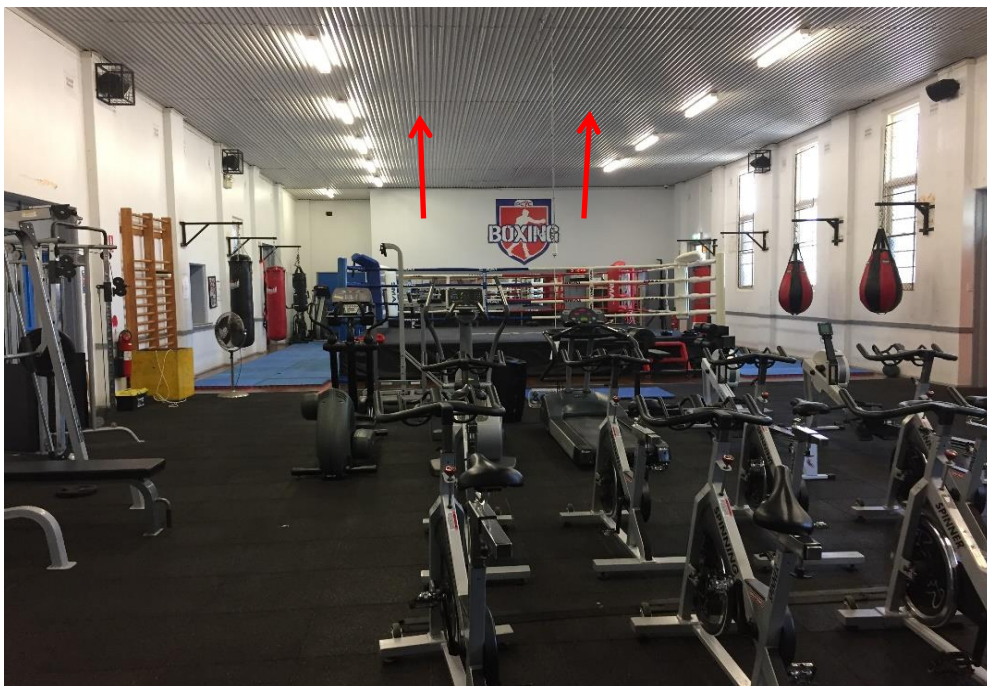
Photograph 30: PCYC, interior, gym/boxing, above perforated metal sheeting to ceiling, insulation, SMF (assumed)

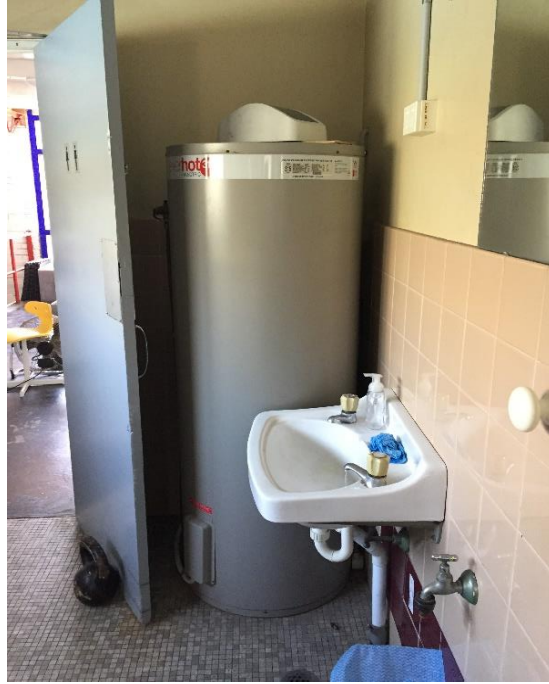
Photograph 31: PCYC, interior, mezzanine off weight gym 2, amenities area, hot water unit, insulation, SMF (assumed)

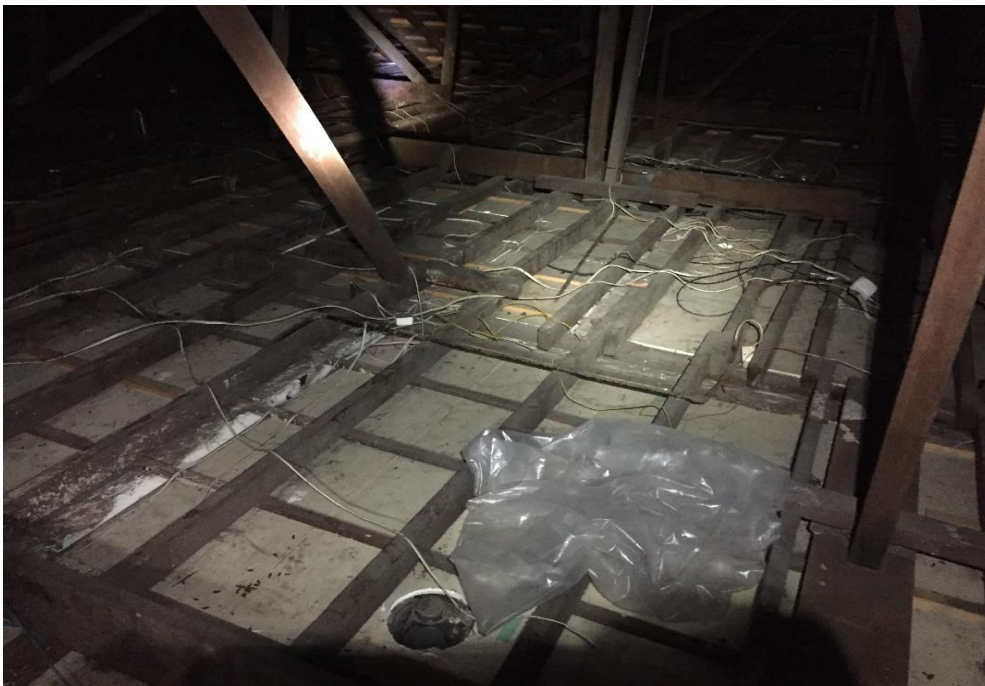
Photograph 32: PCYC, interior, ceiling cavity, northern end of building (near storage 4), settled dust/debris, 280 mg/m2 lead

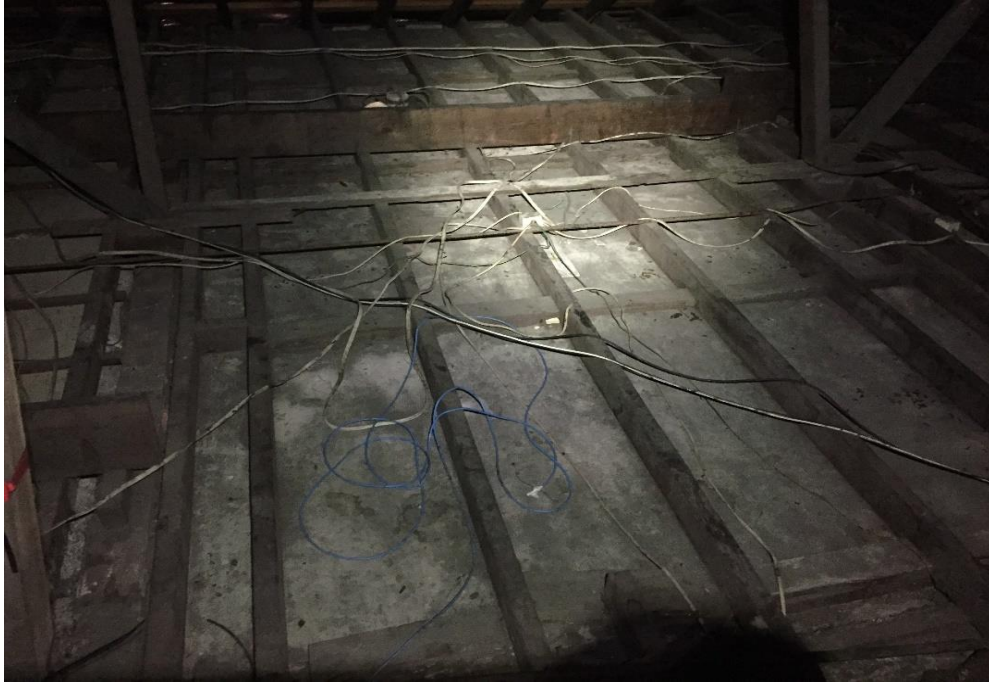
Photograph 33: PCYC, interior, ceiling cavity, toward southern end of building (near office 2), settled dust/debris, 380 mg/m2 lead

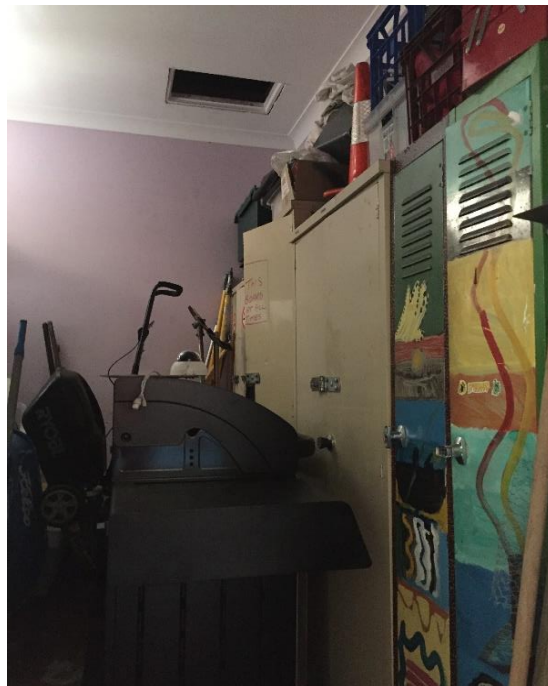
Photograph 34: PCYC, interior, garden storage room, materials in general, generally inaccessible (due storage)

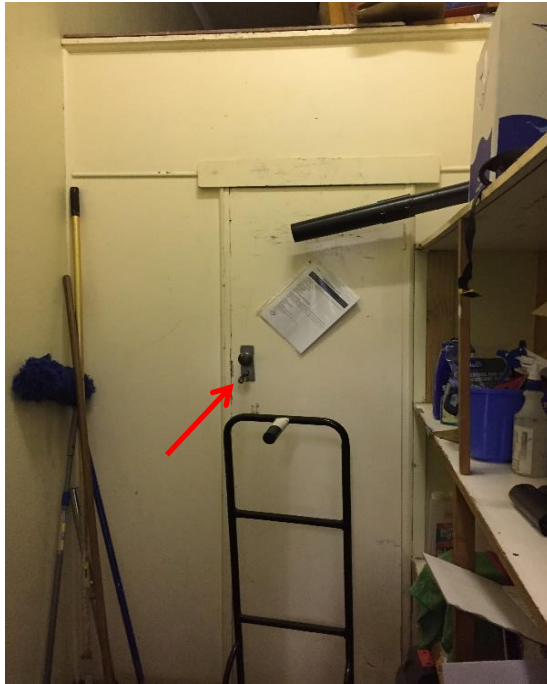
Photograph 35: PCYC, interior, storage 4, materials in general, generally inaccessible (door locked and handle removed/broken)
