# **Extraction Plan**

## **Longwalls 25-31**

### **Six-Monthly Report**

#### **Mandalong Mine**

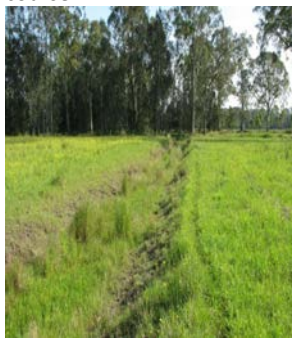
| Remnant Ponding Remediation | | | | | | | |
|---|---|---|---|---|---|---|---|
| Longwall 2 (P2) | Open grassland | Drained | Constructed open drain and connected to nearby water course.<br> | Yes | Yes | Completed | Ref. 7, 8<br>1/557230<br>3/557230 |

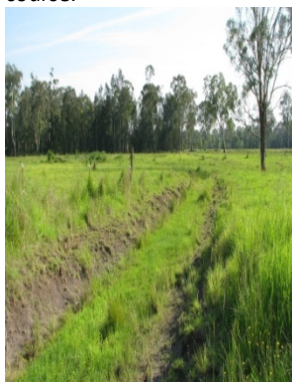
| Remnant Ponding Remediation | | | | | | | |
|---|---|---|---|---|---|---|---|
| Longwall 3 (P3) | Open grassland | Drained | Constructed open drain and connected to nearby water course.<br> | Yes | Yes | Completed | Ref. 7<br>1/557230 |

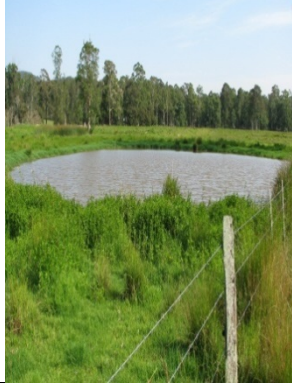
| Remnant Ponding Remediation | | | | | | | |
|---|---|---|---|---|---|---|---|
| Longwall 4 (P4) | Open grassland | Allowed to remain as a source of water for stock. | | Yes | Yes | Completed | Ref. 7, 59<br>1//557230<br>580/73322<br>7 |

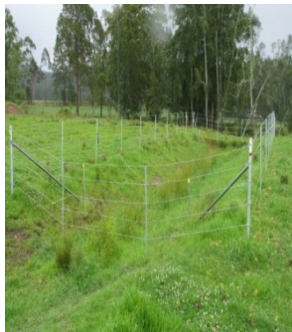
| Remnant Ponding Remediation | | | | | | | |
|---|---|---|---|---|---|---|---|
| Longwall 5 (P5) | Open grassland | Drained | Constructed open drain and connected to nearby water course. Fenced to restrict stock access causing erosion.<br> | No | Yes | Completed | Ref. 59 580/73322 7 |

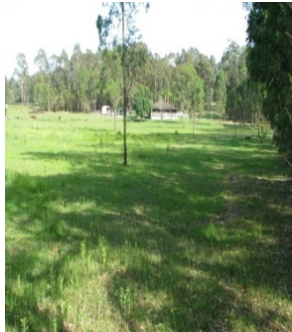
| Remnant Ponding Remediation | | | | | | | |
|---|---|---|---|---|---|---|---|
| Longwall 6 (P6) | Open grassland | Drained | Installed sub-surface drainage and drainage to Stockton Creek.<br> | Yes | Yes | Completed | Ref. 56 12/582283 |

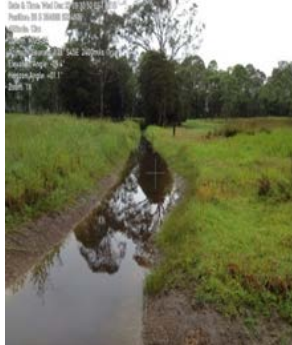
| Remnant Ponding Remediation | | | | | | | |
|---|---|---|---|---|---|---|---|
| Longwall 7 (P7) | Open grassland fringed with Cabbage Gums and <i>Melaleuca biconvexa</i> . | Drained | Open drain constructed and connected to nearby water course. Drainage designed to allow access across by farm machinery and stock.<br> | Yes | Yes | Completed | Ref. 56 12//58228 3 |

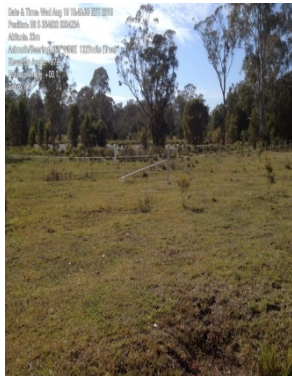
| Remnant Ponding Remediation | | | | | | | |
|---|---|---|---|---|---|---|---|
| Longwall 8 (P8) | Expansion of an already wet area having scattered Swamp Mahogany and <i>Melaleuca biconvexa</i> . | Remain as expansion of existing freshwater wetland and fenced.<br><br>Included in Wetland Monitoring Program as Wetland 9. | Following a period of monitoring and limited options for drainage, a decision was made to fence the wetland to protect from stock and allow to develop as a freshwater wetland.<br> | Yes | Yes | Completed | Ref. 55 11/582283 |

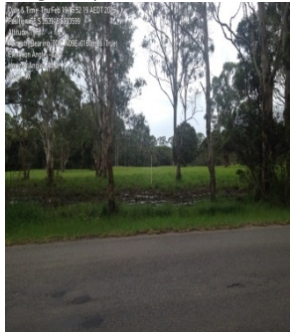
| Remnant Ponding Remediation | | | | | | | |
|---|---|---|---|---|---|---|---|
| Longwall 13 (P13) | Open grassland and Redgum Rough-barked Apple Forest | Minor increase in low lying area. No permanent ponding. | Existing ponding has been moved towards centre of longwall panel.<br> | No | Yes | Completed | Ref. 44 , 50 9/800491 10/800491 |

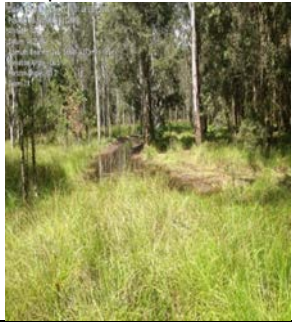
| Remnant Ponding Remediation | | | | | | | |
|---|---|---|---|---|---|---|---|
| Longwall 16 (P16) | Redgum Rough-barked Apple Forest and Coastal Foothill Spotted Gum-Ironbark Forest. | Increase in existing ponded area remediated to pre-mining condition.<br><br>Minimal impact on flora | Constructed open drain and connected to nearby water course to return existing ponding to pre-mining levels.<br>Quarterly ecology monitoring program completed.<br> | Yes | Yes | Completed | Ref. 69 61/755238 |

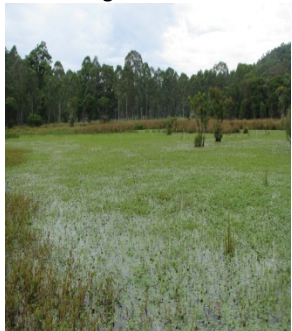
| Remnant Ponding Remediation | | | | | | | |
|---|---|---|---|---|---|---|---|
| Longwall 17 (P17) | Freshwater Wetland Complex EEC and Redgum Rough-barked Apple Forest EEC | No remediation required. | Marginal increase in extent and depth of wetland as predicted. No predicted long-term impact on wetland.<br>Wetland 4 & 5 in Wetland Management Plan – property sole and monitoring finished<br> | Yes | Yes | Completed | Ref. 68 22/812406 |

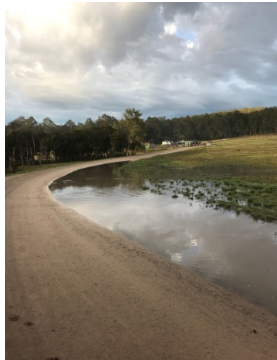
| Remnant Ponding Remediation | | | | | | | |
|---|---|---|---|---|---|---|---|
| Longwall 24 (P24) | Observation Point 'K'<br><br>Trotting track | Constructed new drainage system around track and resurface affected sections. Upgrade dams and catchment. | Affected existing drainage around entire trotting track. Affected dams and catchment<br> | Yes | Yes | Completed | Ref. 213 2/755238 |
