# BENGALLA MINE ANNUAL REVIEW 2024

**BENGALLA MINING COMPANY PTY LIMITED**  
LOCKED BAG 5  
MUSWELLBROOK NSW 2333

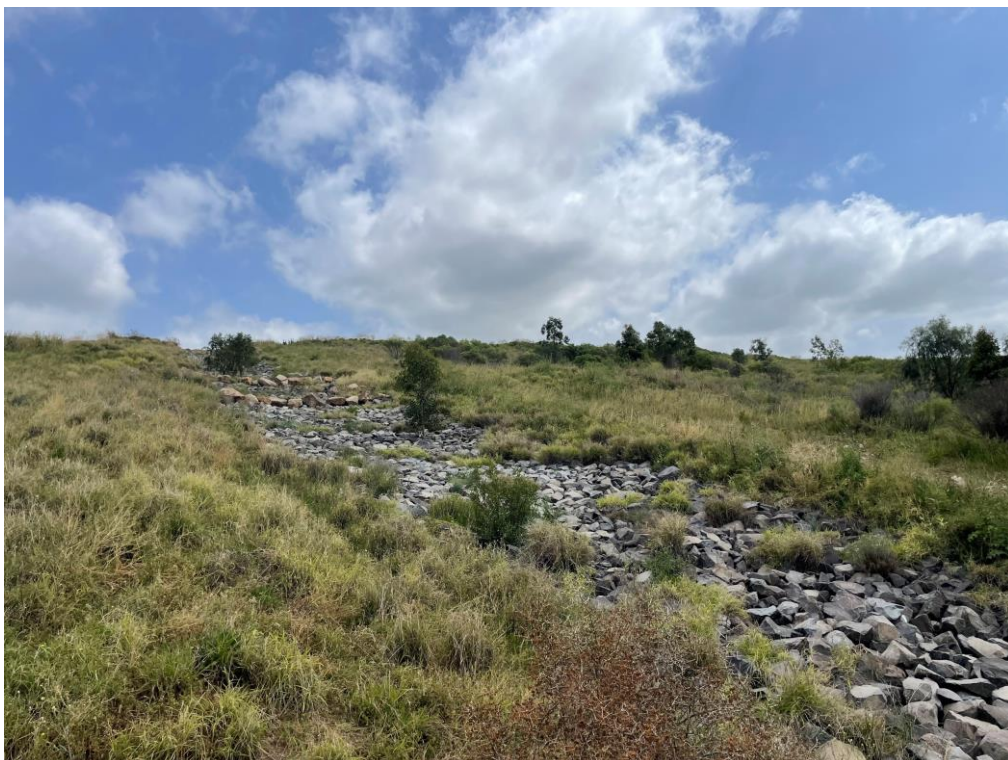
**Photo 10 – Repaired contour bank in Zone 5**

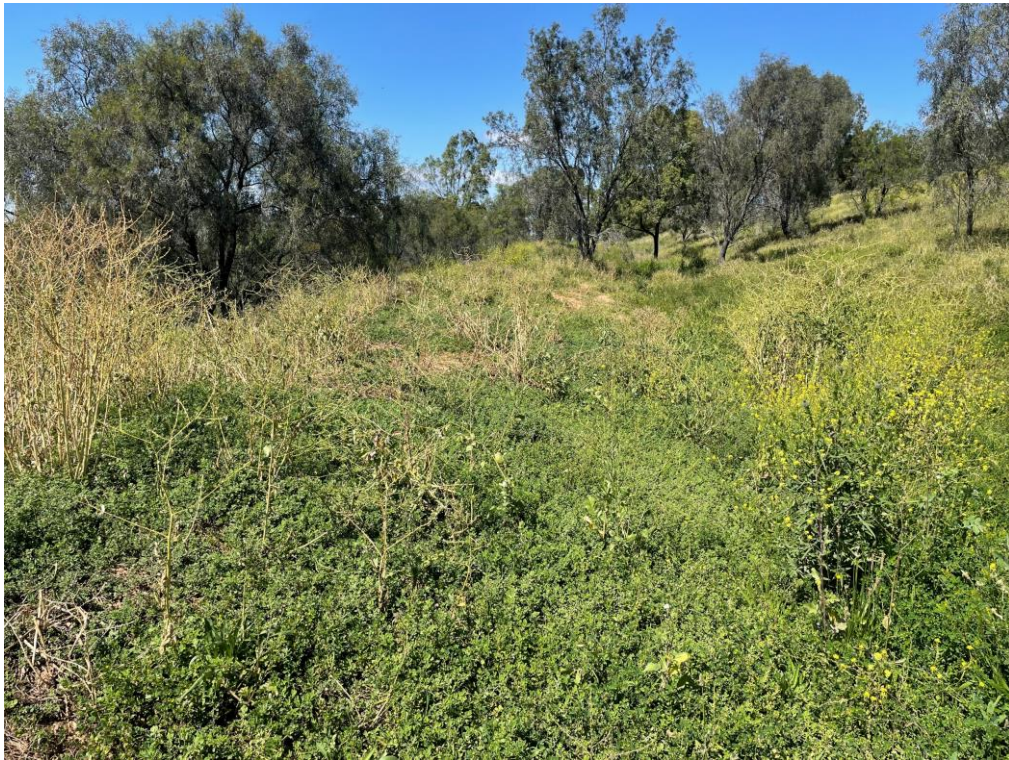
**Photo 11 – Excessive topsoil application rates in Zone 6**

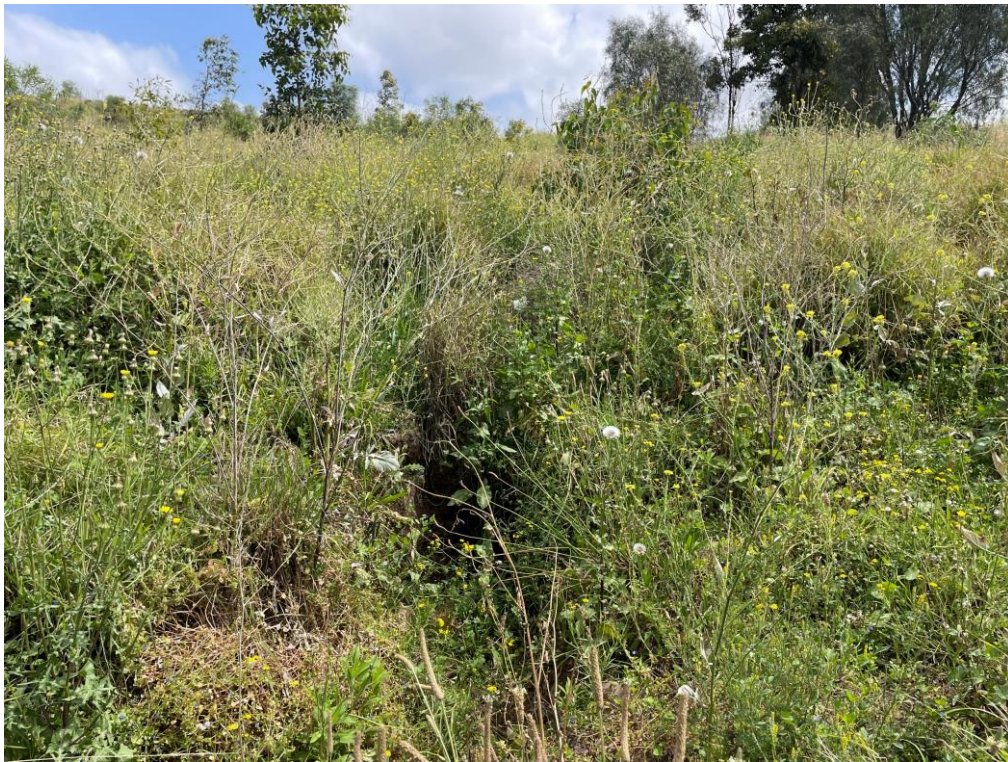
**Photo 15 – Typical ground cover condition dominated by invasive grasses**

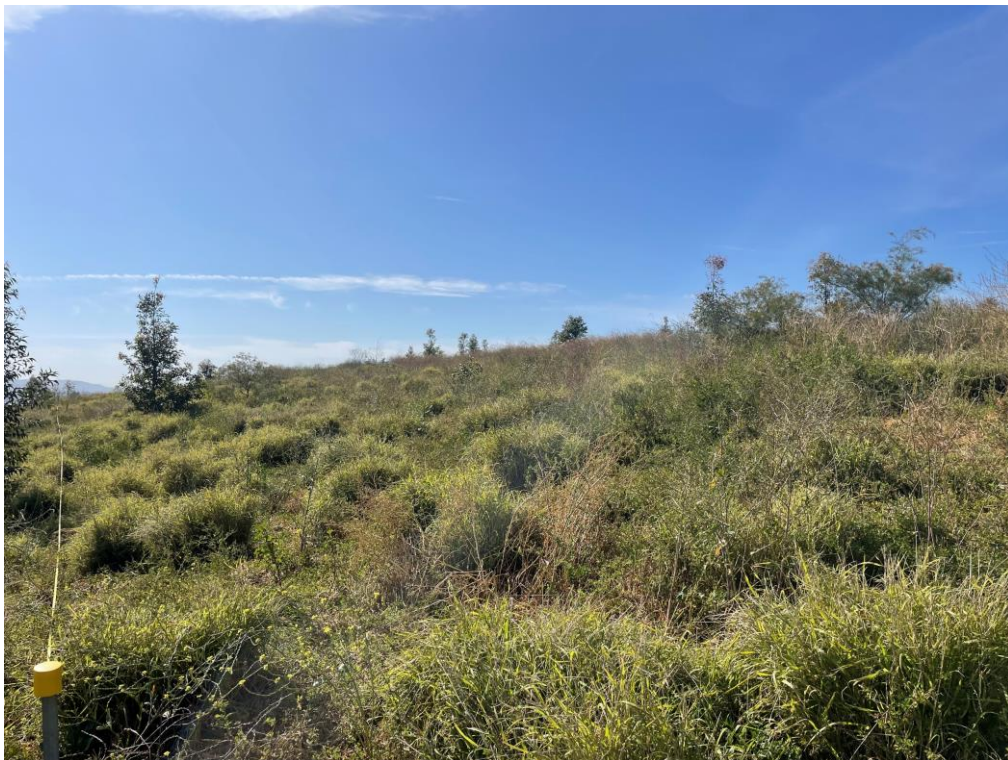
**Photo 16 – Severe Golden Wreath Wattle infestation in Zone 3**

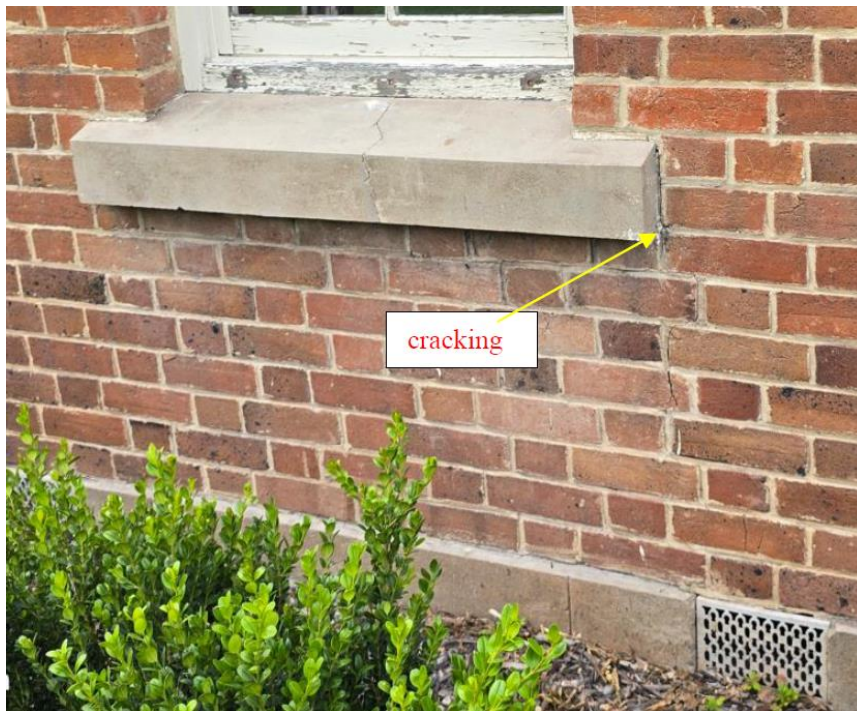
Example of brick and mortar repairs needed
