Report on
Phase 1 Contamination Assessment

Proposed Tamworth Hospital Redevelopment

Project 75393.00
April 2012

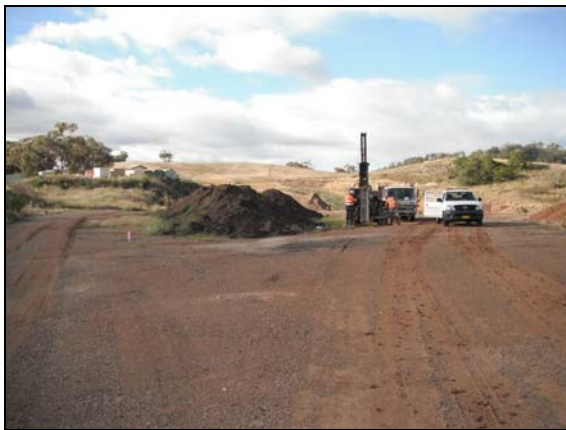
Based on the location of survey pegs placed by the project surveyor, it appears that the landfill site encroaches upon the hospital site. The survey pegs were placed within the stockpiles present within the western section of the former landfill (refer Figure 2 and Drawing 3).

Figure 2: Drilling rig at Bore 109 with stockpiles on hospital boundary

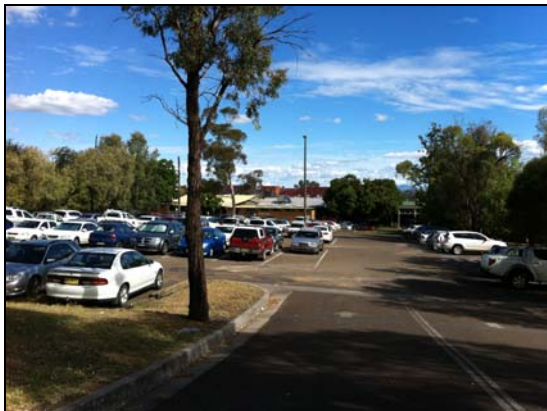
Figure 4: Central car park, looking south

It has a spray seal wearing course and inspection of the area identified a number of defects in the pavement including crocodile cracking, rutting and stone loss. The car park will be extended to the east and west of its present extents into generally grass covered areas with scattered trees.

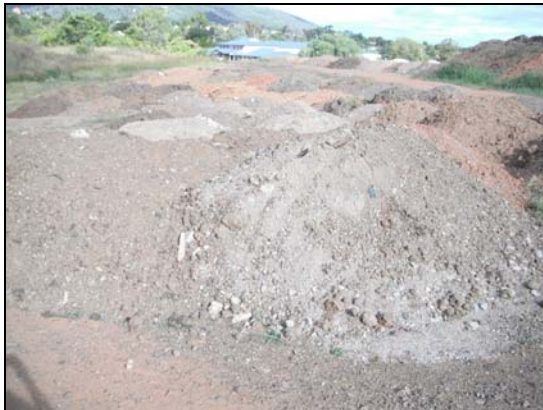
- The landfill encroaches upon the hospital site as discussed in Section 3.2;
- A number of stockpiles of various sizes were present within the area of the proposed ring road (refer Figure 6);

Figure 6: Landfill site (looking south). The boundary of hospital passes through large stockpile on right

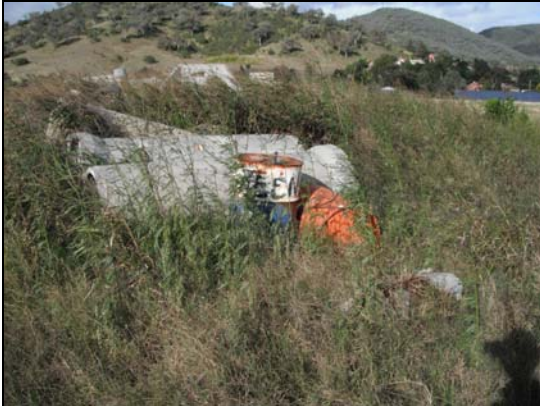
- A number of drums were noted within the former landfill, close to the proposed ring road alignment (refer Figure 7).

Figure 7: Drums and concrete pipes in landfill area

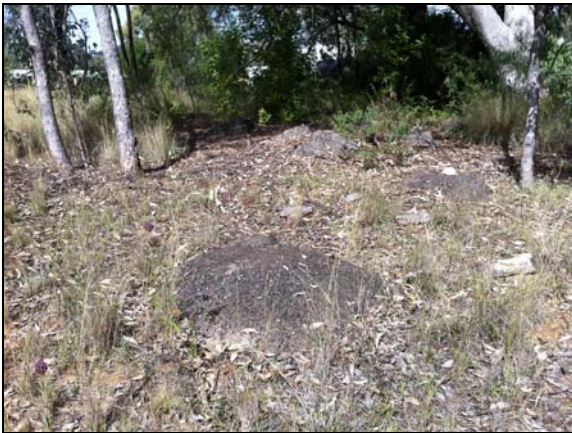
- The area of the proposed western car park is a grass covered with scattered trees;
- Some lumps of asphalt and concrete were observed scattered on the surface (refer Figure 8). Similarly, the ground surface appeared to have been previously modified. It should be noted that since the field work has been undertaken the proposed western car park has been moved to the south and Bore 113 was located approximately 10 m to the north of the car park footprint;

Figure 8: Asphalt on ground surface near Bore 113
