Report on  
Geotechnical Investigation

Proposed Tamworth Hospital Redevelopment

Prepared for  
Aurecon Group

Project 75393.00  
April 2012

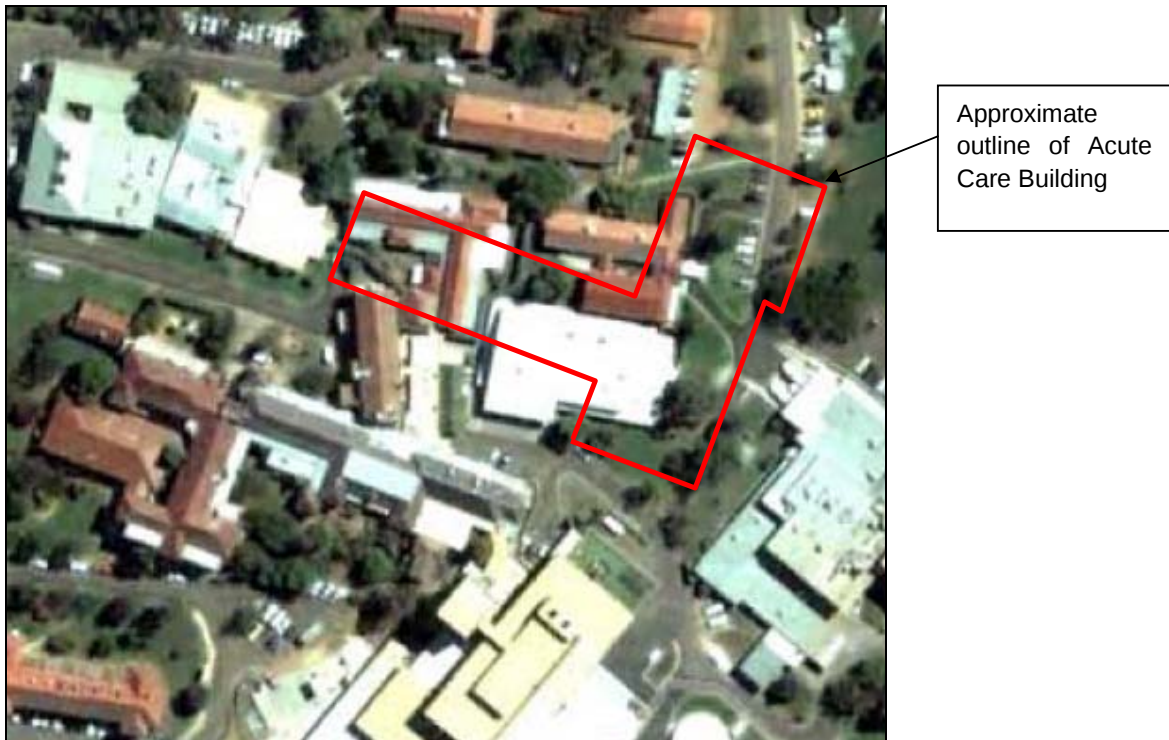
**Figure 1: Approximate outlined of proposed Acute Care Building**

A number of existing buildings are present within the proposed footprint of the Acute Care Building. These are a combination of single and two storey buildings, generally of masonry construction. Cut and fill earthworks appears to have been undertaken during the development of this area of the site, with a number of terraced areas and intermediate batters of up to 2 m in height.

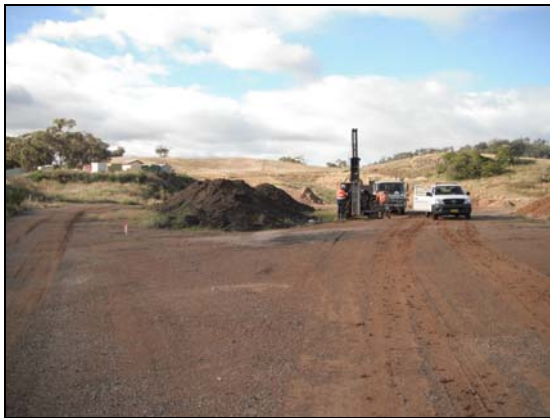
Based on the location of survey pegs placed by the project surveyor, it appears that the landfill site encroaches upon the hospital site. The survey pegs were placed within the stockpiles present within the western section of the former landfill (refer Figure 2 and Drawing 3).

**Figure 2: Drilling rig at Bore 109 with stockpiles on hospital boundary**

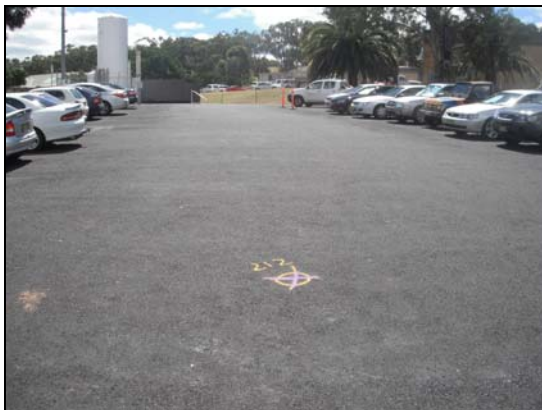
Beyond approximately CH 300 m the alignment passes through a recently constructed car park (refer Figure 3) with a spray seal wearing course and a batter slope to the north of the car park, which exposes a combination of gravelly clay and meta-siltstone bedrock.

**Figure 3: Existing staff car park in north-eastern area of site**

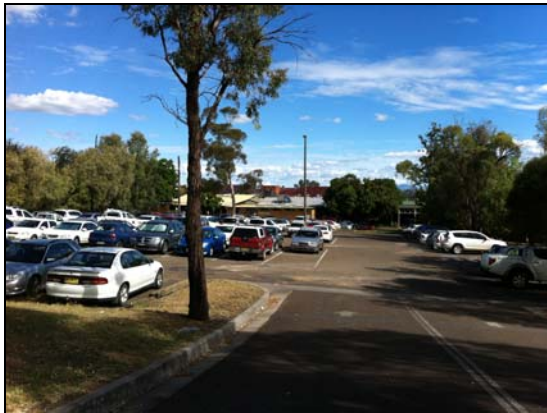
**Figure 4: Central car park, looking south**

It has a spray seal wearing course and inspection of the area identified a number of defects in the pavement including crocodile cracking, rutting and aggregate loss. The car park will be extended to the east and west of its present extents into generally grass covered areas with scattered trees.

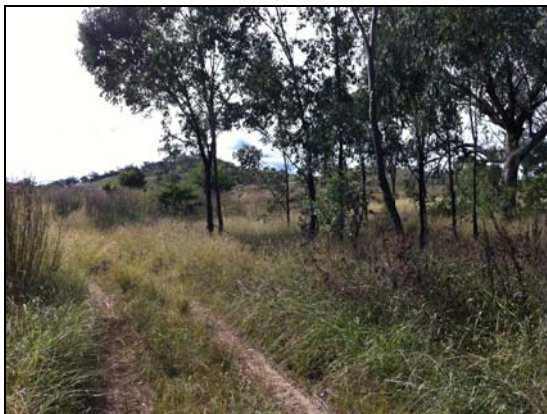
**Figure 5: Access track to Bore 113 (western car park)**

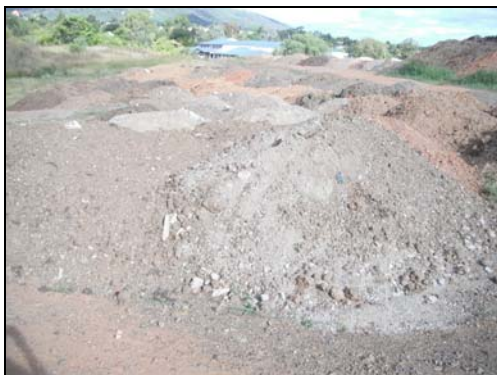
- The landfill site encroaches upon the hospital site as discussed in Section 2.1;
- A number of stockpiles of various sizes were present within the area of the proposed ring road (refer Figure 6).

**Figure 6: Landfill site (looking south). The boundary of hospital passes through large stockpile on right**

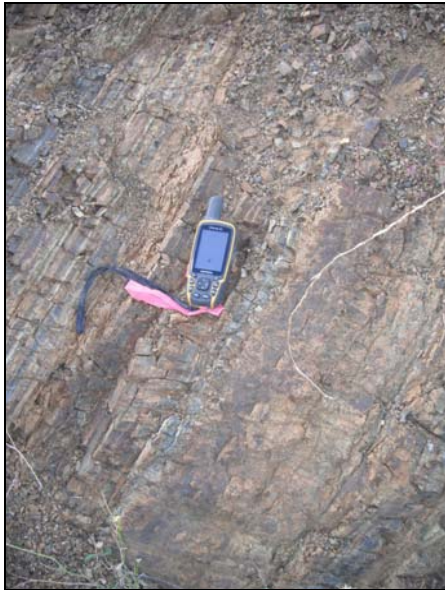
It is noted that the bedrock present at the site is highly fractured and the predominant jointing present within the core samples ranged from 60° to 80° below the horizontal. Inspection of two cuttings within the bedrock, located within the former quarry (designated at TC1 and TC2 on Drawing 2) and under the existing Brudelin Wing of the hospital was undertaken by a senior geotechnical engineer from DP (refer Figures 7 and 8).

**Figure 7: Steeply bedded, fractured rock in base of quarry (TC1 on Drawing 2)**

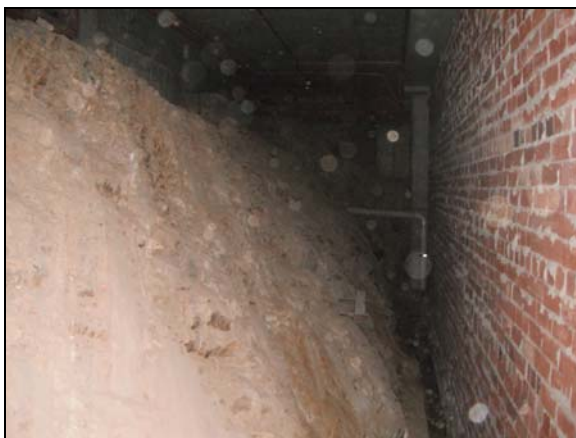
**Figure 8: Existing cutting under Brudelin Wing at 0.6H:1V**
