Report on  
Hazardous Building Materials Assessment –  
Main Works

Dubbo Base Hospital  
Myall Street, Dubbo

Prepared for  
Health Infrastructure

Project 72811.01  
June 2012

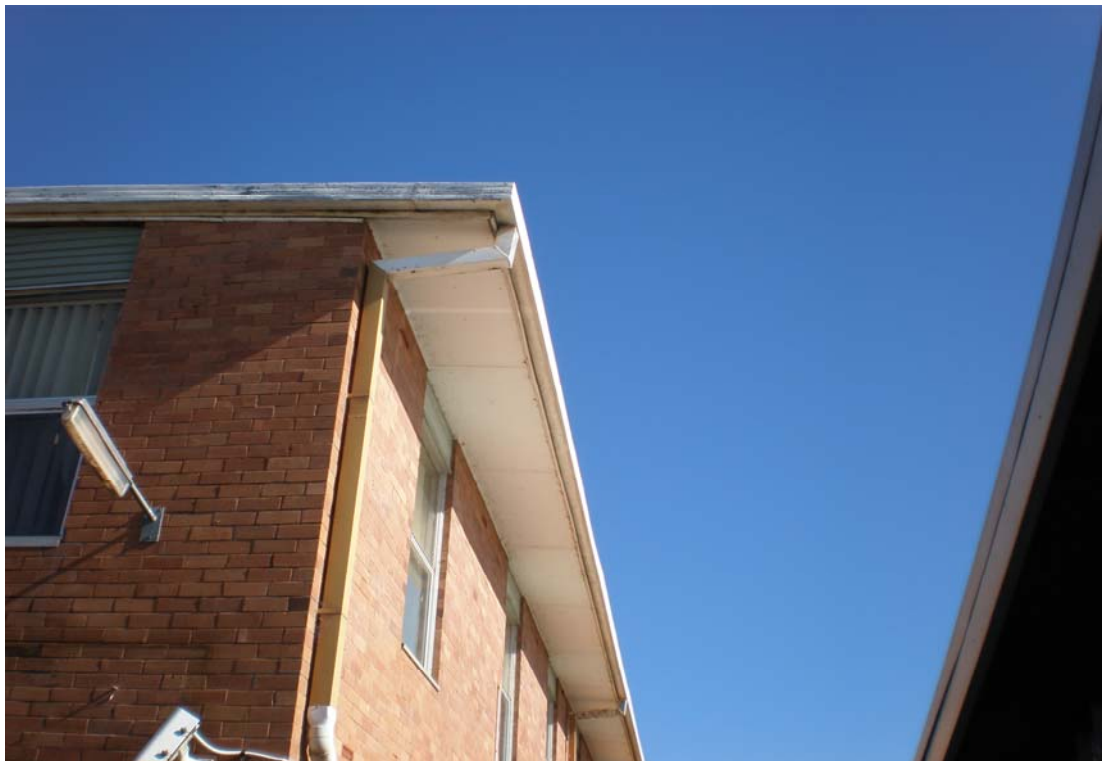
| Location of ACM | Description | Bonded or Friable |
|---|---|---|
| External eve lining | Flat asbestos-cement sheeting | Bonded |

Photo 16/2 - Bonded asbestos eve lining

The removal of ACM from the Maternity building should be carried out prior to the commencement of large-scale demolition activities and in accordance with the requirements of WorkCover NSW and the National Occupational Health and Safety Commission (NOHSC) *Code of Practice for the Safe Removal of Asbestos 2<sup>nd</sup> Edition* [NOHSC:2002(2005)]. This work will need to be undertaken by a contractor with an appropriate asbestos-removal licence.

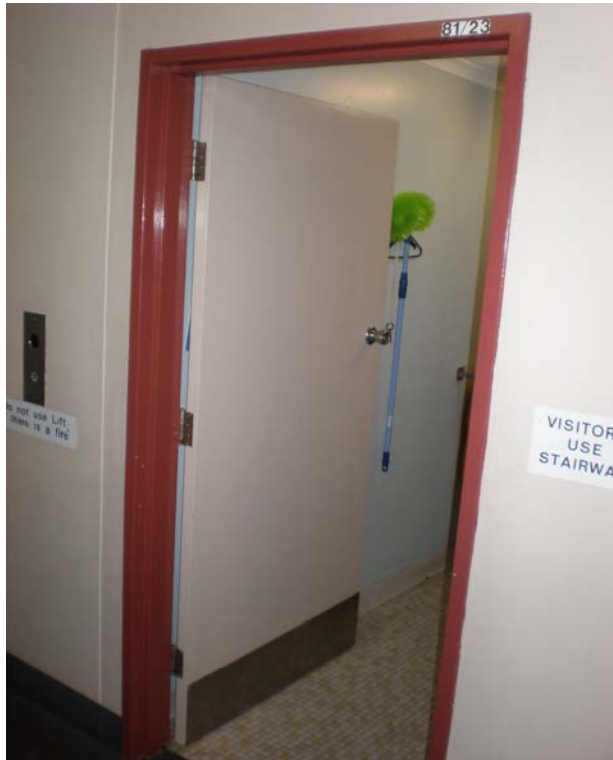
| Location of ACM | Description | Bonded or Friable |
|---|---|---|
| Room 23 Fire Door | Loose asbestos core | Friable |

Photo 16/3 - Fire door (Room 23) with friable asbestos core

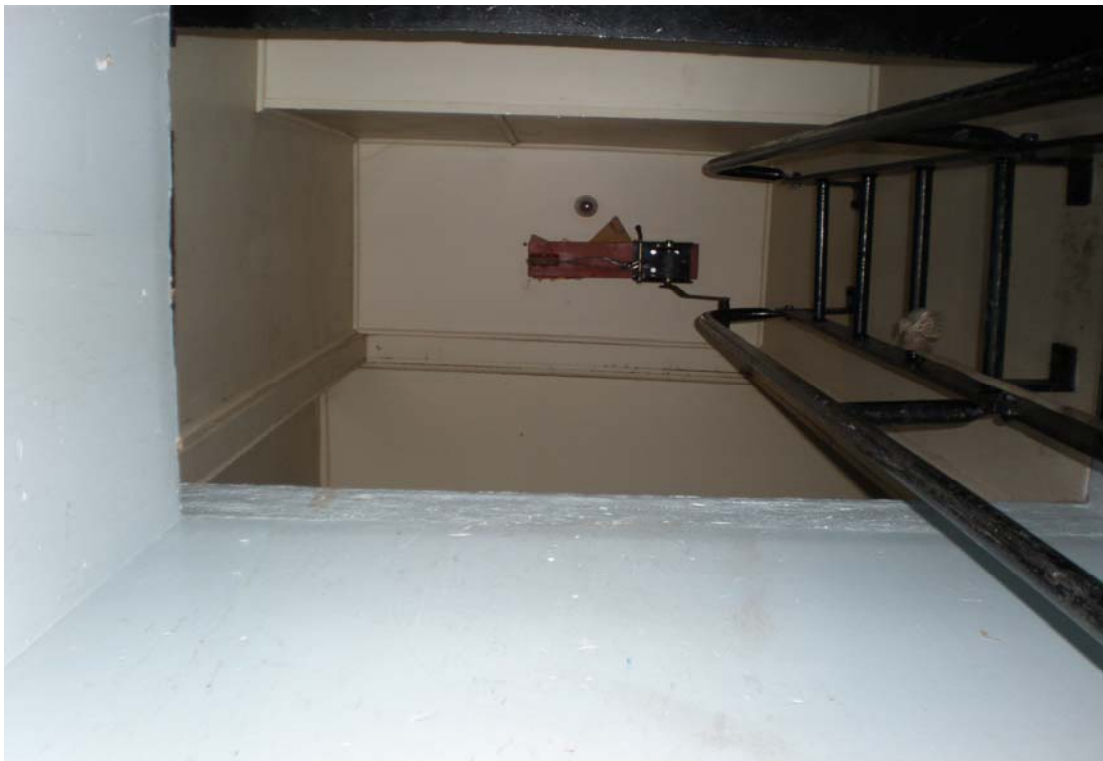
| Location of ACM | Description | Bonded or Friable |
|---|---|---|
| Plant Room (above Room 23) | Flat asbestos-cement sheeting | Bonded |

Photo 16/4 - Bonded asbestos lining in plant room (above Room 23)

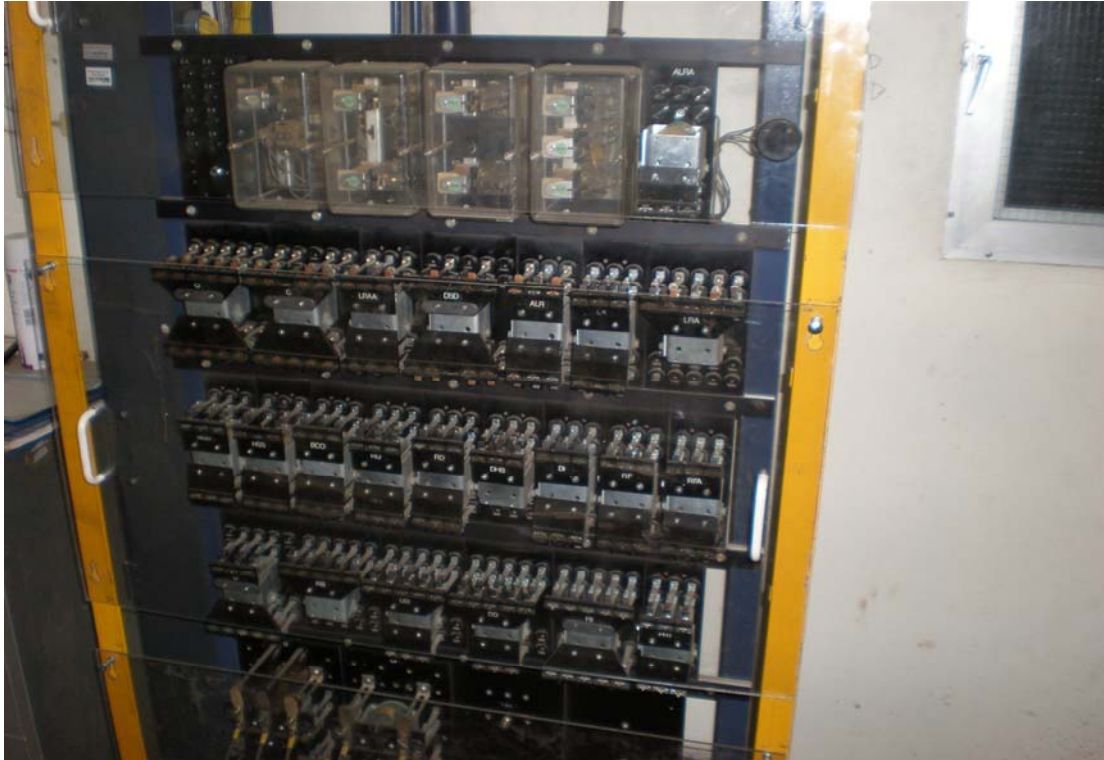
| Location of ACM | Description | Bonded or Friable |
|---|---|---|
| Lift Motor Room | Lebah switchboard backing | Bonded |

Photo 16/5 - Bonded asbestos backing-board on lift control panel

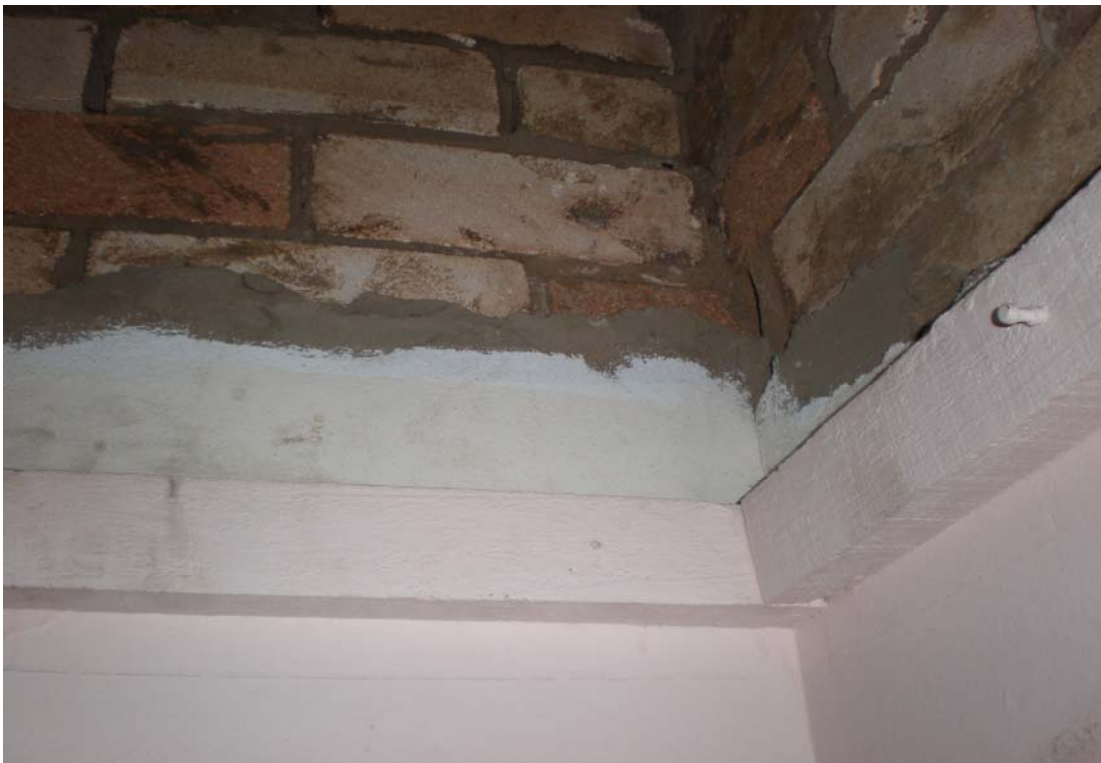
The inspections undertaken as part of the current assessment generally confirmed that the ACM listed in the register remain on site. One exception is one of the fire hose reel cupboards in which the ceiling lining has been removed, although potential asbestos cement wall-lining has been exposed. The presence of ACM within the products listed in the register was assumed to be correct; additional laboratory analysis was considered unwarranted.

Photo 16/6 - Potential asbestos lining above former asbestos ceiling in fire hose cupboard #1

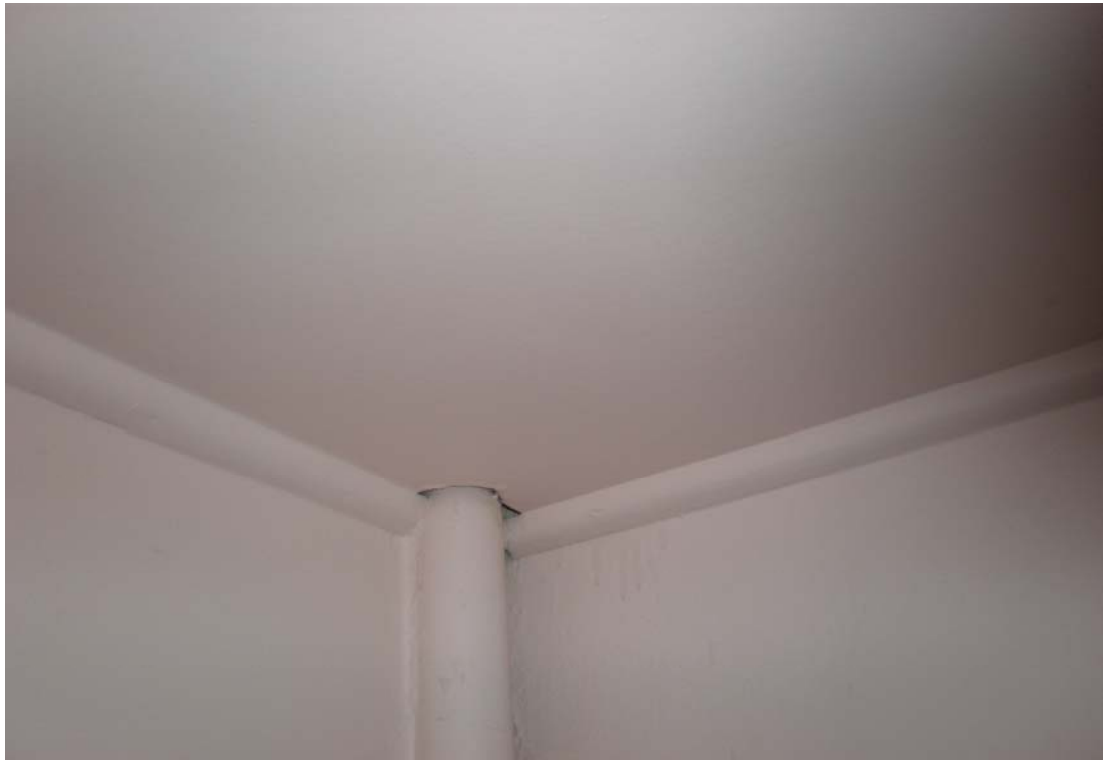
| Location of ACM | Description | Bonded or Friable |
|---|---|---|
| Fire hose reel cupboards | Flat asbestos-cement sheeting | Bonded |

Photo 16/7 - Bonded asbestos ceiling in fire hose cupboard #2

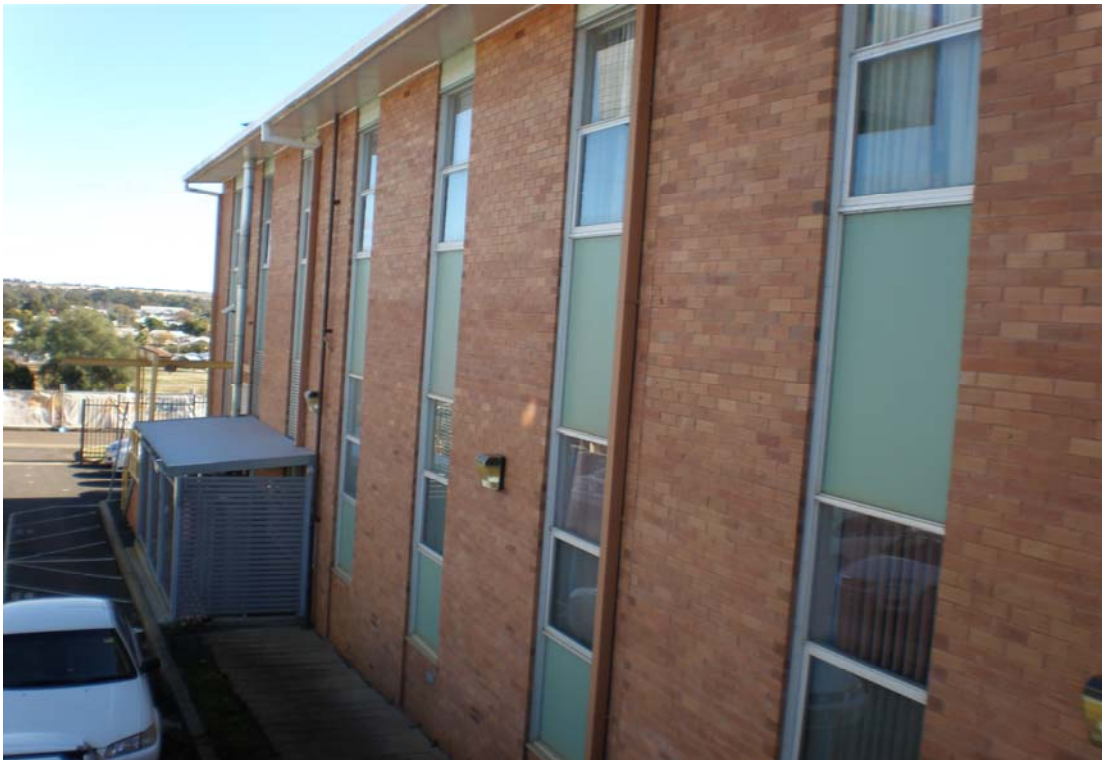
| Location of ACM | Description | Bonded or Friable |
|---|---|---|
| External window spandrels | Flat asbestos-cement sheeting | Bonded |

Photo 16/8 - Bonded asbestos window spandrels

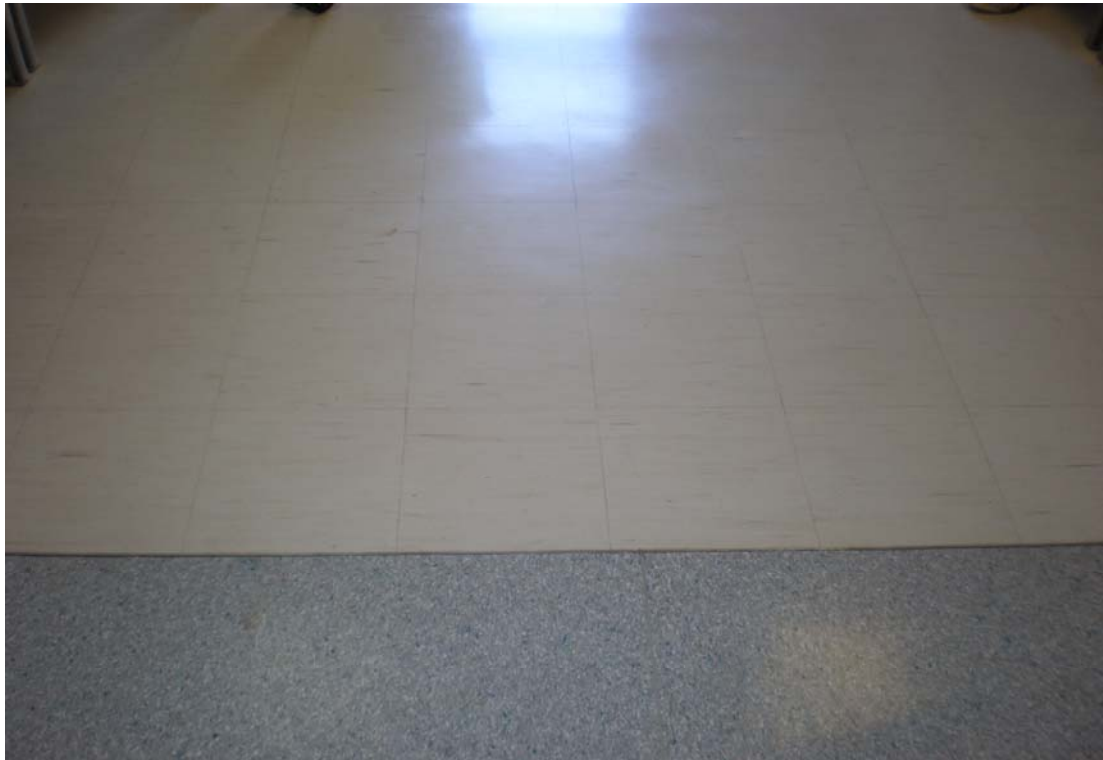
| Location of ACM | Description | Bonded or Friable |
|---|---|---|
| Ground floor & stairs | Asbestos vinyl tiles | Bonded |

Photo 16/9 - Asbestos vinyl floor tiles

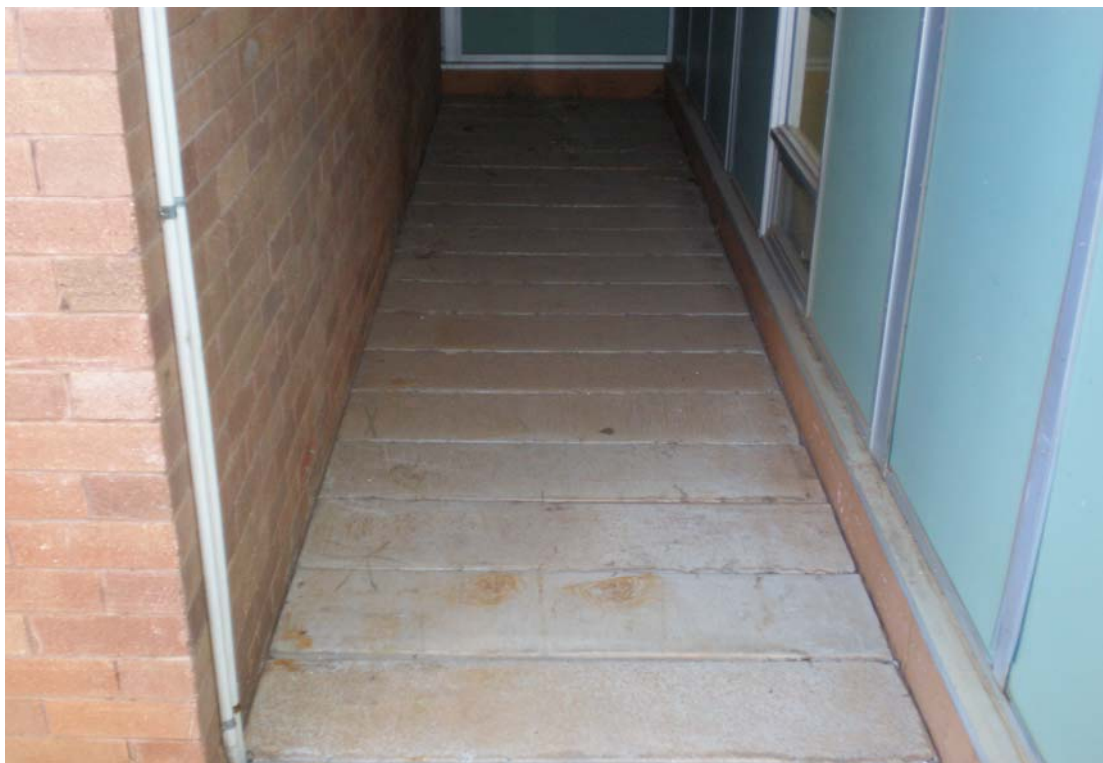
| Location of ACM | Description | Bonded or Friable |
|---|---|---|
| Service trench (external) | Pipe insulation | Friable |

Photo 16/10 - Friable asbestos lagging within service trench
