Bank Street Park
Blackwattle Bay / Tjerruing

Arboricultural Impact Assessment Report (TreeiQ)

ARBORICULTURAL IMPACT ASSESSMENT REPORT

Bank Street Park Blackwattle Bay

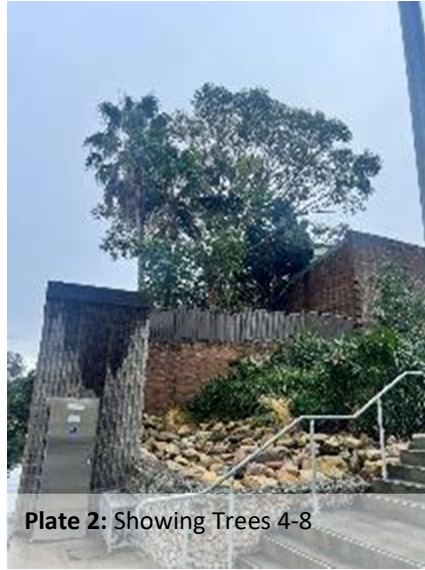
Plate 2: Showing Trees 4-8

Tree 4 was identified as *Cupressus sempervirens* (Italian Cypress) and is located near the southern boundary of 1 Bank Street. The tree is a partially suppressed specimen in fair health and fair structural condition. Its crown is in contact with the adjacent building. Tree 4 is of low Landscape Significance and has been allocated a Retention Value of *Priority for Removal*.

Tree 5 was identified as *Eucalyptus saligna* (Sydney Blue Gum) and is located near the southern boundary of 1 Bank Street. The tree is in fair health and fair structural condition with a reduced crown density. Tree 5 is of moderate Landscape Significance and has been allocated a Retention Value of *Consider for Retention*.

3.2.2 The supplied plans show Tree 4 is proposed for removal to accommodate the proposed community facilities. Replacement tree planting using a healthy, advanced-size specimen could replace the loss of amenity from tree removal within a short timeframe.

3.2.8 The supplied plans show Trees 7 and 8 are proposed for removal to accommodate the proposed community facilities. Replacement tree planting using healthy, advanced-size specimens could replace the loss of amenity from tree removal within a short timeframe.

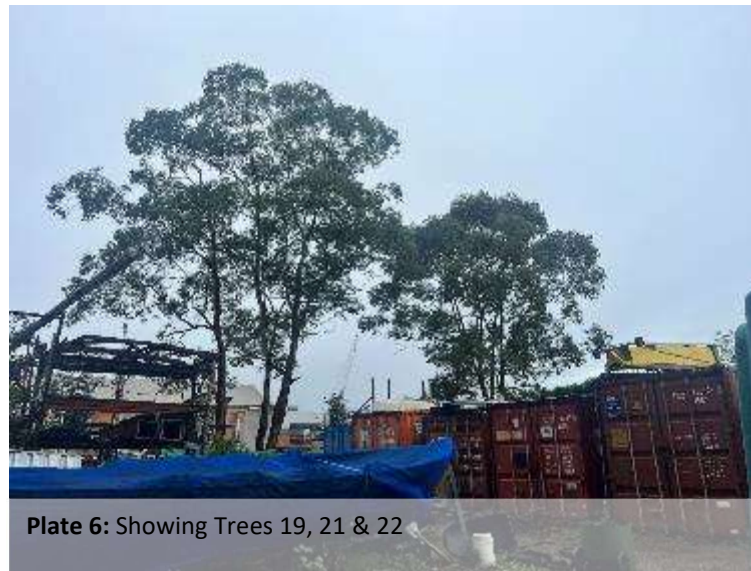
Plate 6: Showing Trees 19, 21 & 22

3.3.9 It should be noted Trees 19, 21 and 22 have been subject to storm damage resulting in wounds with various stages of decay. The removal of deadwood, storm damaged branch stubs and aerial inspection of the trees' crowns should be undertaken as part of the development works. Any potentially significant structural defects identified by the aerial inspection should be reported to the Project Arborist to determine appropriate management recommendations.

21	<i>Eucalyptus saligna</i> (Sydney Blue Gum)	16	10	550	Good	Good	Crown density 75-95%. Partially suppressed. Storm damage. Wound(s), various stages of decay. Limited site access.	Mature	15-40	Moderate	Consider for Retention	6.6	2.6	Retain.
22	<i>Eucalyptus saligna</i> (Sydney Blue Gum)	17	10	650	Good	Good	Crown density 75-95%. Partially suppressed. Storm damage. Wound(s), various stages of decay. Limited site access.	Mature	15-40	Moderate	Consider for Retention	7.8	2.8	Retain.
77	<i>Eucalyptus saligna</i> (Sydney Blue Gum)	12	6	250	Fair	Fair	Storm damage. Small (<25mm \emptyset) & medium (25-75mm \emptyset) deadwood in moderate volumes. Wound/s, various stages of decay. Limited site access.	Mature	5-15	Moderate	Consider for Retention	3	1.9	Retain.
78	<i>Cotoneaster</i> sp.	5	5	300@ base	Fair	Fair	Small (<25mm \emptyset) & medium (25-75mm \emptyset) deadwood in moderate volumes. Wound/s, various stages of decay. Limited site access.	Mature	<5	Low	Priority for Removal	3.6	2	Remove.

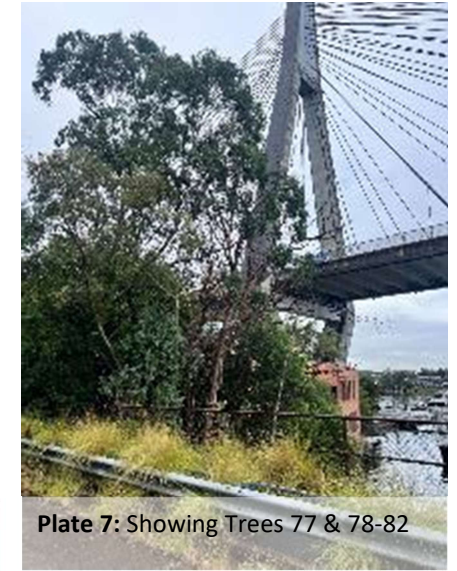
Plate 7: Showing Trees 77 & 78-82

79	<i>Eucalyptus saligna</i> (Sydney Blue Gum)	12	6	650	Good	Good	Storm damage. Small (<25mm \emptyset) & medium (25-75mm \emptyset) deadwood in moderate volumes. Wound/s, various stages of decay. Limited site access.	Mature	15-40	Moderate	Consider for Retention	7.8	2.8	Retain.

3.2.16 The supplied plans show Trees 78, 80, 81 and 82 are proposed for removal to allow for the planting of more suitable species. Replacement tree planting using healthy, advanced-size specimens could replace the loss of amenity from tree removal within a short timeframe.
