Bank Street Park
Blackwattle Bay / Tjerruing

Hazardous Building Materials Survey Report (Presna)

Hazardous Building Materials Re-assessment V2

1-3 Bank Street, Pyrmont NSW 2009

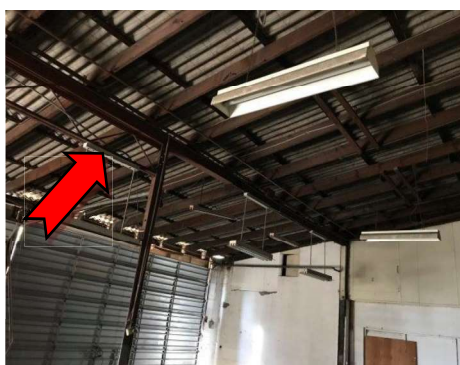
1. Building A warehouse — asbestos-containing corrugated fibre cement sheeting.

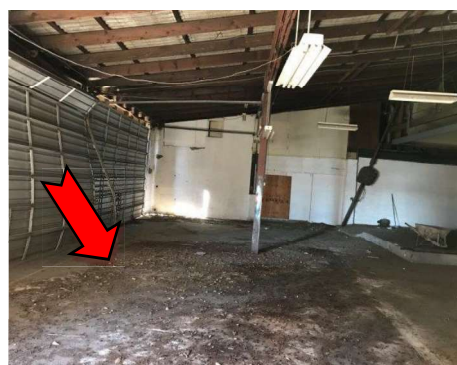
- High risk, friable asbestos in the form of dust and debris was identified within Building A (including warehouse) and Building C, likely associated with historic deterioration and weathering of the asbestos-containing corrugated sheet roof;

2. Building A warehouse — assumed asbestos-containing dust throughout.

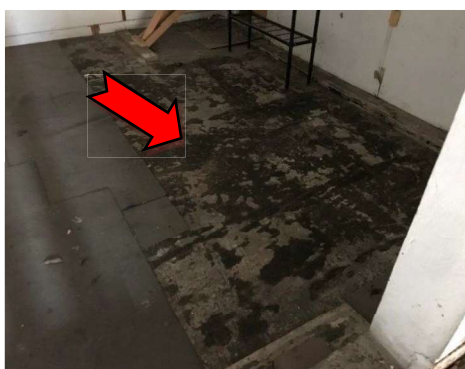
- Medium risk, non-friable asbestos in the form of bituminous adhesive or “blackjack” was identified within the Building A warehouse in various locations, to both floor surfaces and to the lower portion of the walls; and

3. Building A warehouse — asbestos-containing bituminous adhesive residues.

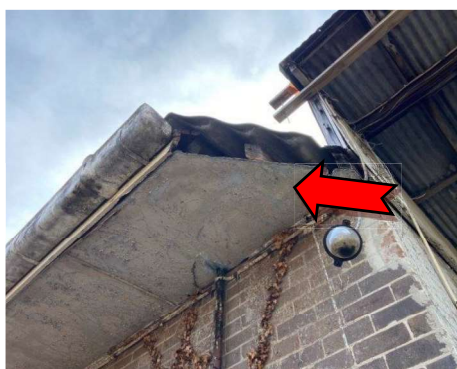
4. Building D, south-west elevation, eaves — damaged asbestos-containing fibre cement sheeting.

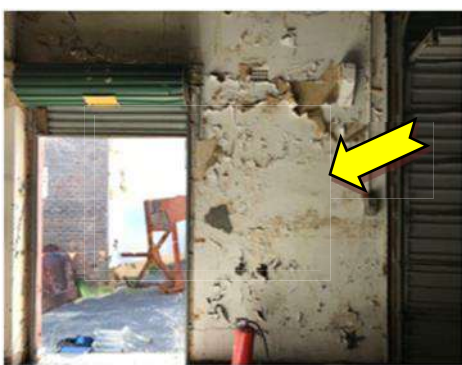
5. Building A, walls — lead-containing white upper paint system.

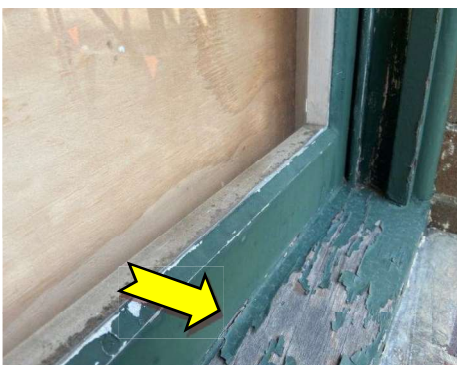
6. Building D, window frames — lead-containing green upper paint system.
