## Independent Environmental Audit 2021

### Centennial Airly Mine

May 2021

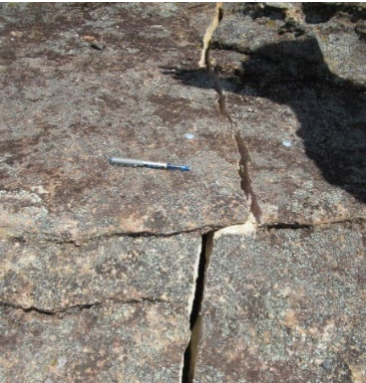
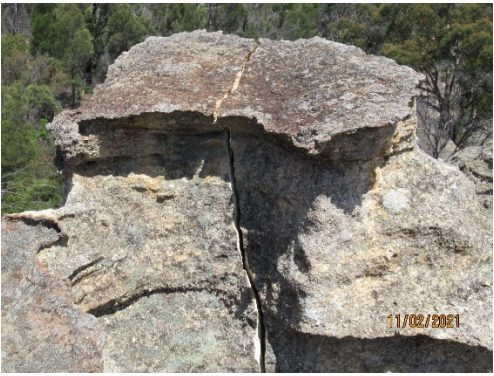
Surface cracking (Fracture 01 and Fracture 02) that occurred on Mt Airly in 2020 is associated with mining in the Panel and Pillar Mining Zone in the area described in Table 1 as ‘*All other land not covered by a performance measure above*’. The subsidence impact performance measure for ‘*All other land not covered by a performance measure above*’ is ‘*No greater subsidence impacts or environmental consequences than predicted in the EIS.*’

Subsidence impacts predicted in the EIS include ‘*no surface fracturing*’.

| Surface Cracking (IEA Site Inspection, 11 February 2021) | |
|---|---|
| <p>Photo 1: Surface crack (Fracture 01).</p> | <p>Photo 2: Surface crack (Fracture 01).</p> |

Following triggering of TARP Level Red actions for Surface Crack (Fracture 01) and Surface Crack (Fracture 02), the following adaptive management processes have been implemented by Centennial Airly to transition Airly Mine to subsidence less than EIS predictions and minimise further impacts:

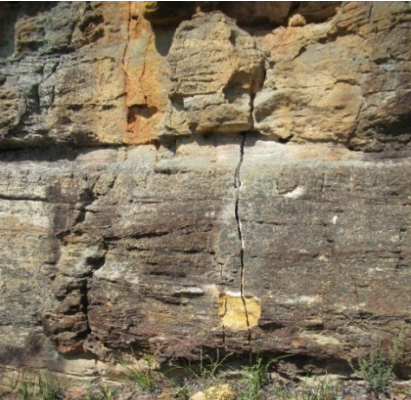
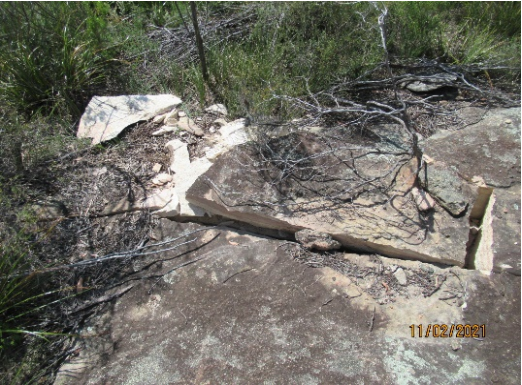
| Surface Cracking (IEA Site Inspection, 11 February 2021) | |
|---|---|
| <p>Photo 3: Surface crack (Fracture 02).</p> | <p>Photo 4: Surface crack (Fracture 02).</p> |

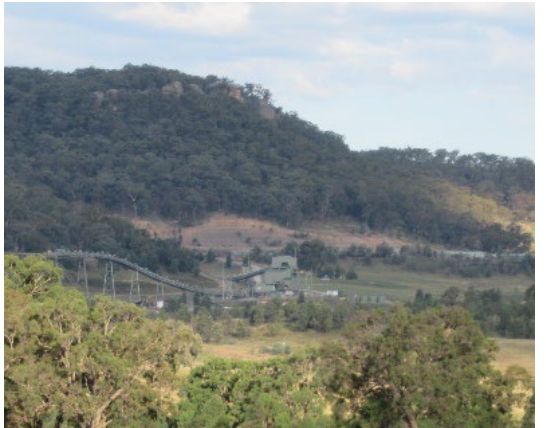
| Photo # | Comment | Photo |
|---|---|---|
| Photo 5 | Visual appearance of buildings and structures, blend with the surrounding landscape. (SSD_5581 Schedule 4 Condition 23). | |

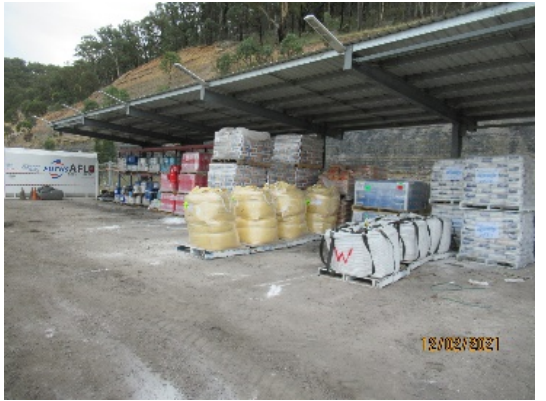
| Photo # | Comment | Photo |
|---|---|---|
| Photo 6 | New roof for chemical storage area at pit top. (SSD_5581 Schedule 4 Condition 12 and EPL12374 Condition O1.1). | |

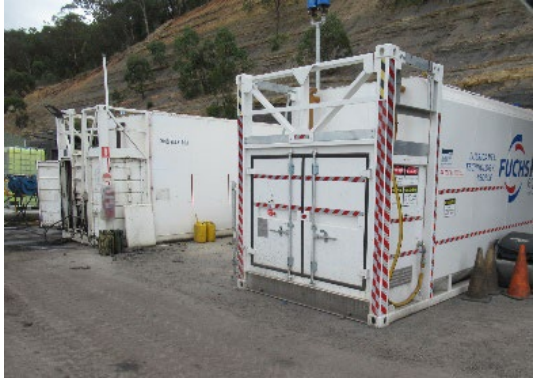
| Photo # | Comment | Photo |
|---|---|---|
| Photo 7 | Bunded diesel and lubricant tanks at pit top. (SSD_5581 Schedule 4 Condition 12 and EPL12374 Condition O1.1). | |

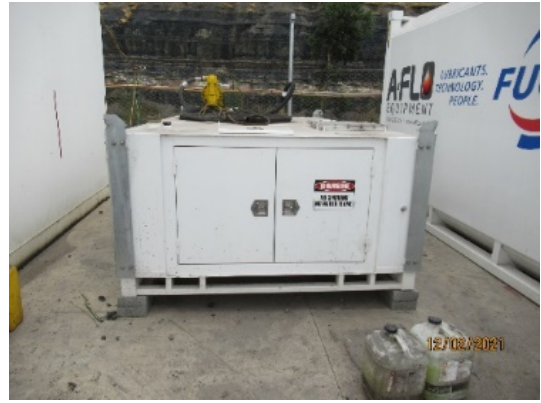
Photo 8 New waste oil bunded tank at pit top.  
(SSD\_5581 Schedule 4 Condition 12 and  
EPL12374 Condition O1.1).

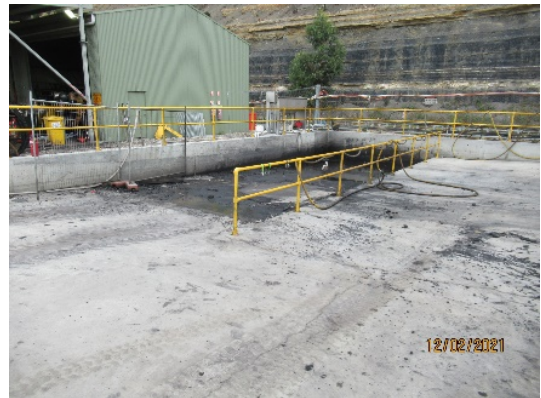
Photo 9 Improved hard stand area and oil/water separator for vehicle wash bay at pit top.  
(SSD\_5581 Schedule 4 Condition 12 and  
EPL12374 Condition O1.1).

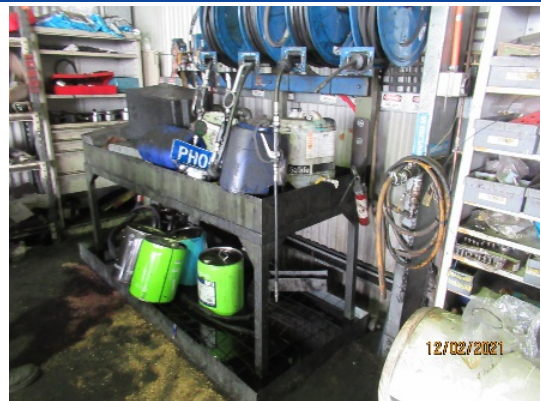
Photo 10 Waste oil storage in workshop (SSD\_5581  
Schedule 4 Condition 12 and EPL12374  
Condition O1.1)

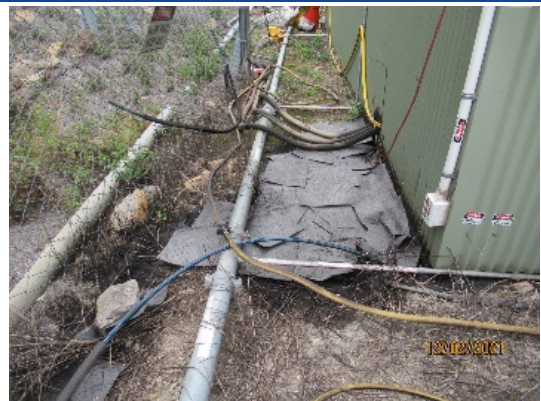
Photo 11 Loss of containment of waste oils staining soil  
at back of workshop.  
(SSD\_5581 Schedule 4 Conditions 10 and 12  
and EPL12374 Conditions L1.1 and O1.1).

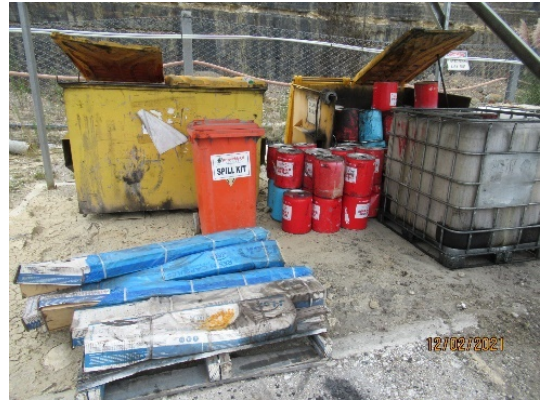
Photo 12      Reduced bund capacity from sediment load.  
(SSD\_5581 Schedule 4 Condition 12 and  
EPL12374 Condition O1.1).

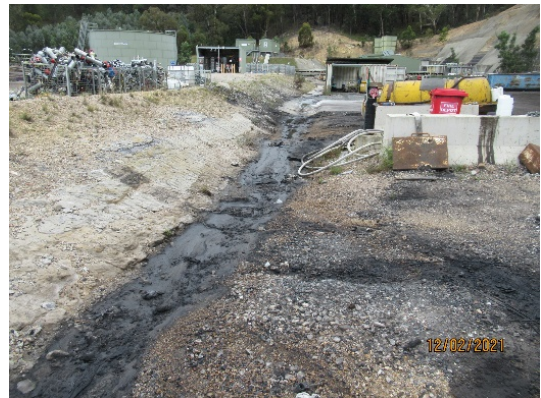
Photo 13      Sediment / coal fines in surface water drains at  
pit top.  
(SSD\_5581 Schedule 4 Condition 10 and  
EPL12374 Condition O1.1).

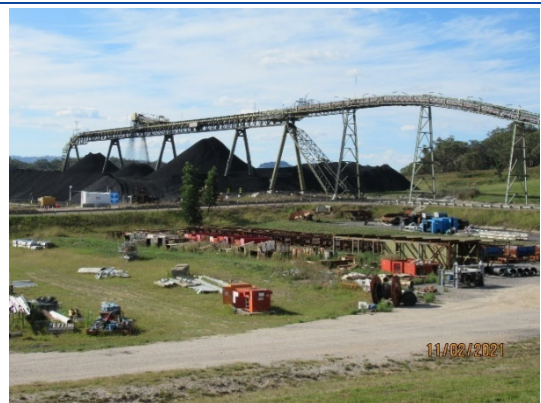
Photo 14      Product coal stockpile

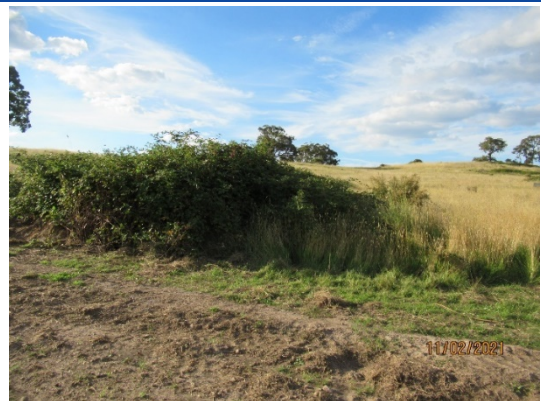
Photo 15      Blackberries on grazing land on the track to  
weather station (east of train loading area)  
(SSD\_5581 Schedule 4 Condition 15).

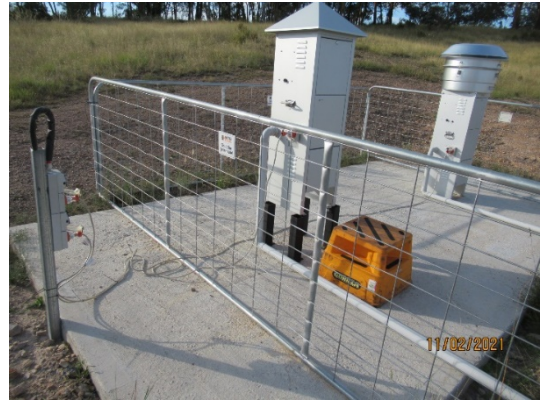
Photo 16 Weather station and HVAS  
(SSD\_5581 Schedule 4 Condition 8)

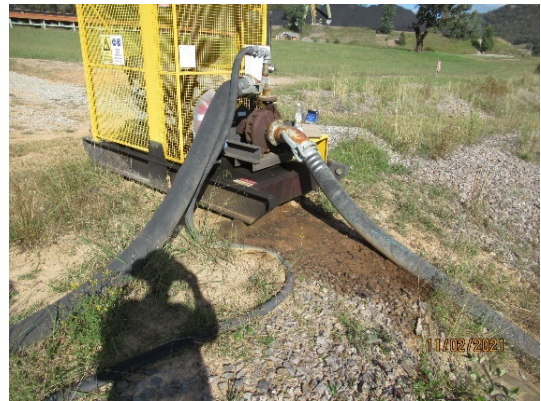
Photo 17 Pump at the Train Loader Dam and discharge point LDP2. Water is pumped from this dam to the Production Dam for re-use.  
(SSD\_5581 Schedule 4 Condition 12 and EPL12374 Condition O1.1).

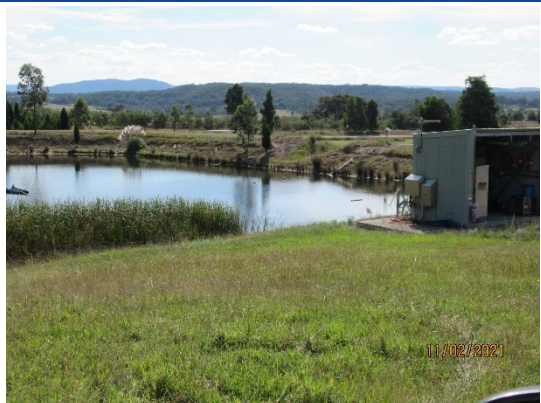
Photo 18 Discharge Dam/Production Dam with adequate freeboard and presence of reeds in dam. Water is re-used back into the mining operation from this dam and pump house.  
(SSD\_5581 Schedule 4 Condition 10 and EPL12374 Condition O4.1).

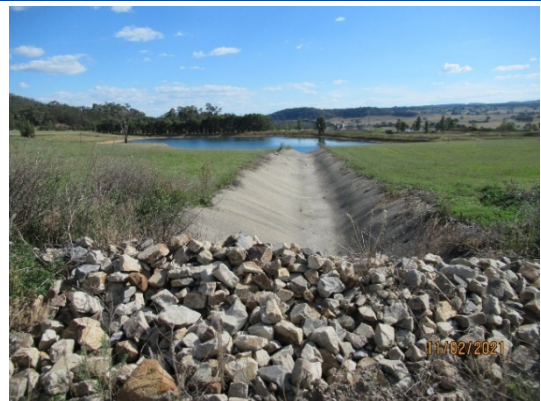
Photo 19 V notch weir discharge point LDP1 at the Discharge Dam.  
(SSD\_5581 Schedule 4 Condition 10 and EPL12374 Conditions M1.1 and O4.1).

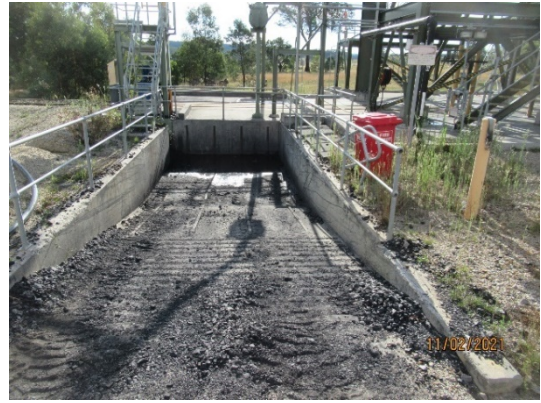
Photo 20 Coal collection traps at the Train Loader bin.

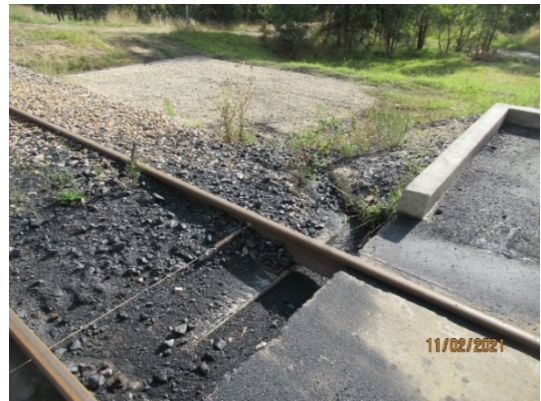
Photo 21 Loss of containment of minor volumes of coal and coal fines adjacent to Train Loader bin.  
(SSD\_5581 Schedule 4 Condition 10 and EPL12374 Condition O1.1).

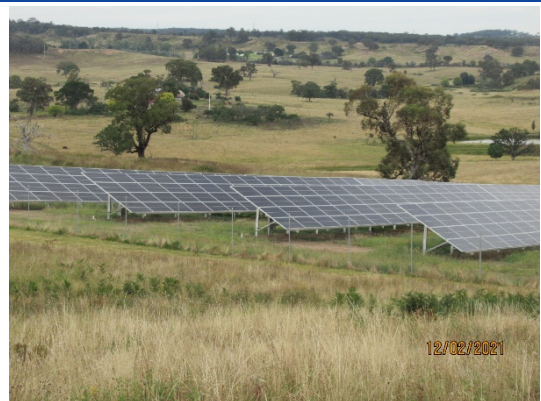
Photo 22 2MW solar plant commissioned in 2020.  
(SSD\_5581 Schedule 4 Condition 6).

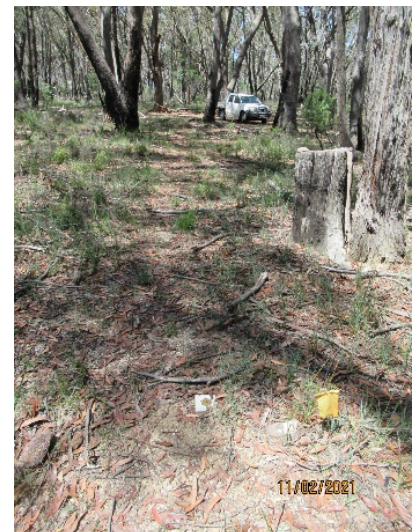
Photo 23 B-Line survey markers on Mt Airly

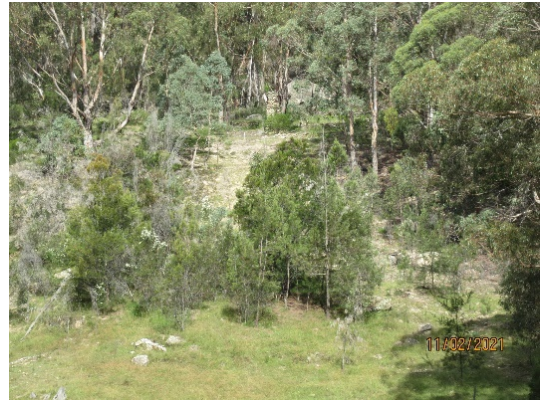
Photo 24 Stone cottage near Gap Creek.  
(SSD\_5581 Schedule 3 Condition 3)

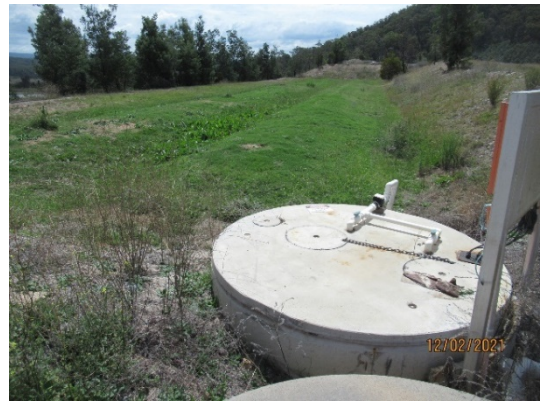
Photo 25 Ecomax® effluent treatment system including  
irrigation area.

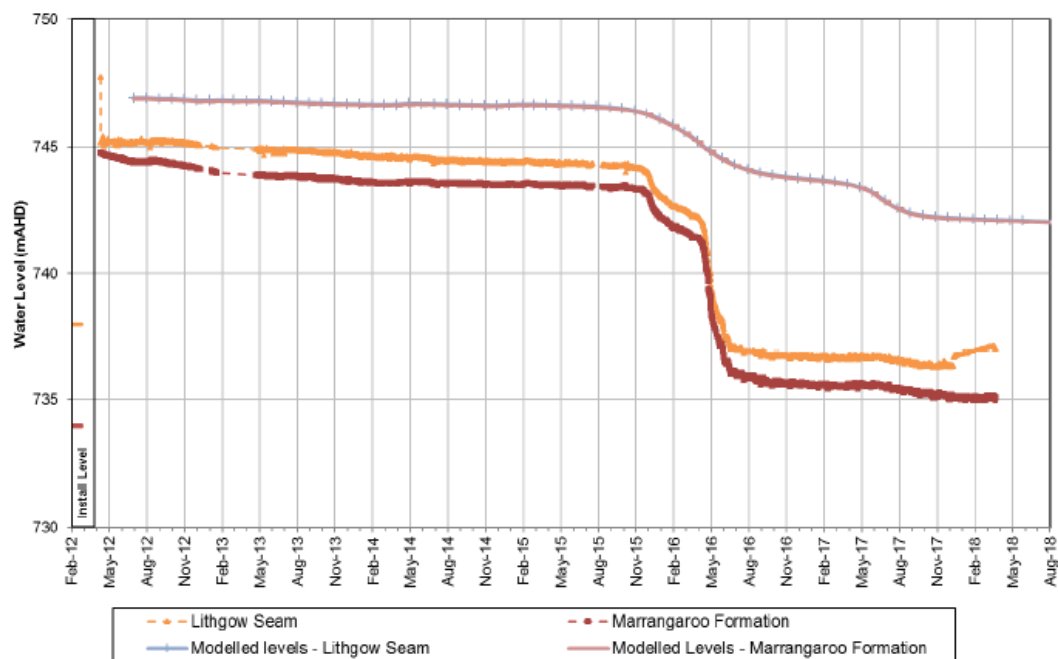
**Figure 1 ARP04 Calibration Hydrograph – Modelled vs Observed Groundwater Levels (GHD, 2019)**

The groundwater model recalibration did not include ARP05. Therefore, the comparison between observed and simulated groundwater levels was not possible. The 2020 annual water monitoring report (GHD 2021) noted that groundwater levels at the standpipe ARP08 were significantly higher in 2020. Electrical conductivity also displayed an increasing trend during 2020. The standpipe ARP08 is installed in the Lithgow Seam. Like ARP05, ARP08 was not included in the model recalibration. Therefore, it is unknown how the model is simulating the groundwater levels at ARP08. No reason was given in GHD (2019) report as why some of the VVPs and standpipes were excluded from the recalibration.

It is recommended that the simulated groundwater levels at the VVPs and standpipes excluded from the recalibration should be extracted from the model and be used to compare against the groundwater measurements.
