# Desktop study of Hazardous Materials Surveys to WHS Regulations 2011

### Lismore Base Hospital (Targeted Buildings), Lismore NSW

July 2012

Our Ref: C107305: J111111

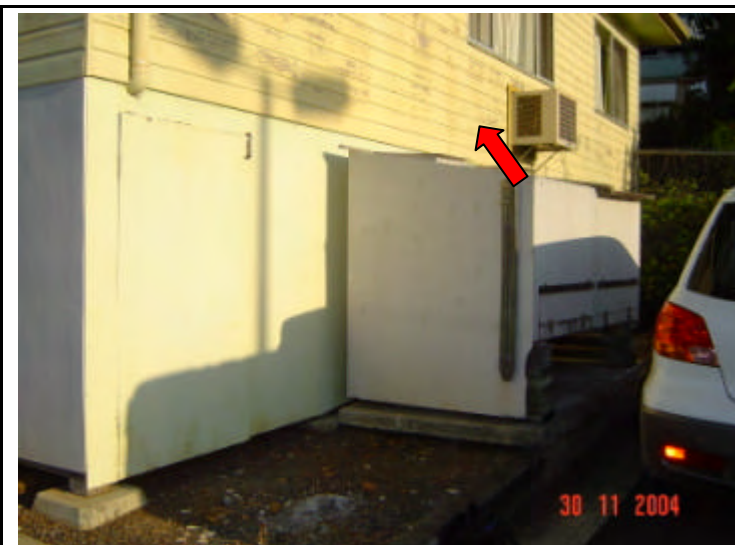
| Location<br>Description, Colour | Photo No. | Lead Swab Results | Condition | Control Recommendations |
|---|---|---|---|---|
| Walls<br>Horizontal timber panelling, Beige | 1 | Top layer positive | Fair | See Section 6.4 for further details |

**Photograph 1:** E Block exterior, showing lead-containing horizontal wall panelling paint

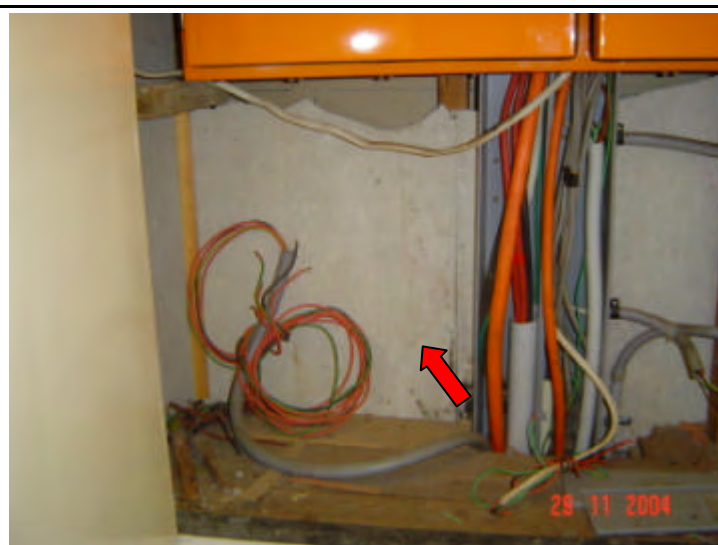
**Photograph 2:** E Block Level 1, Staff lounge – distribution board ward 9 cupboard – showing asbestos-containing wall panels

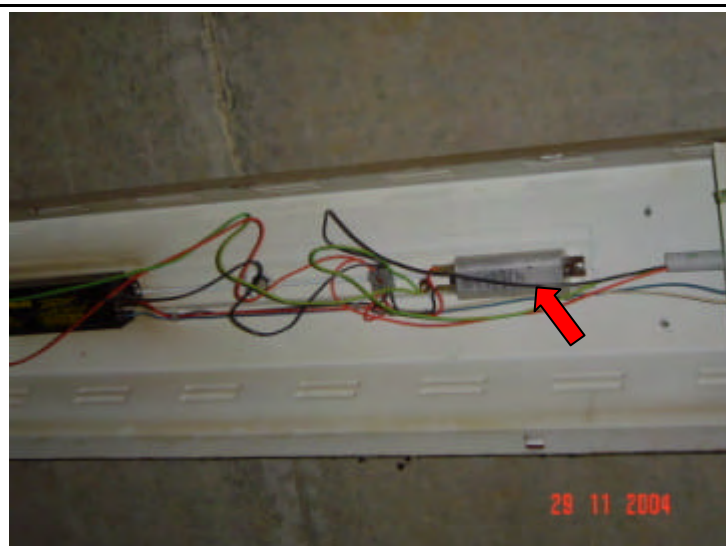
**Photograph 1:** G Block, Workshop level maintenance steel rack corridor - showing PCBs-containing fluorescent light fittings

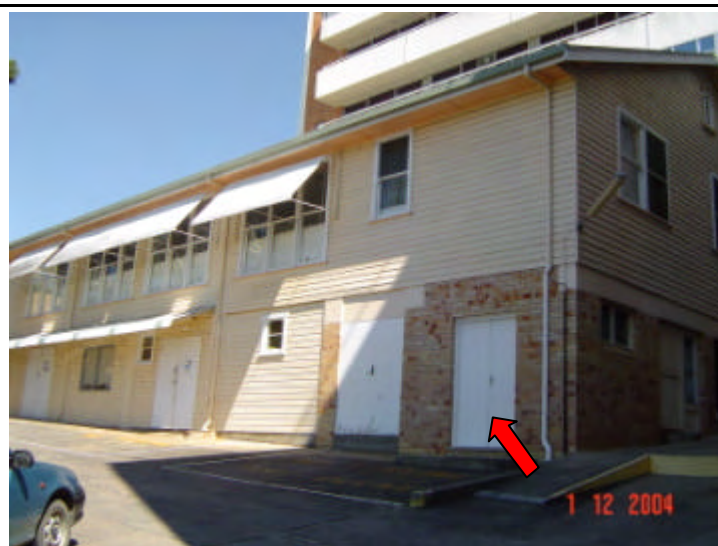
**Photograph 2:** G Block exterior – showing lead-containing paint on workshop entry doors

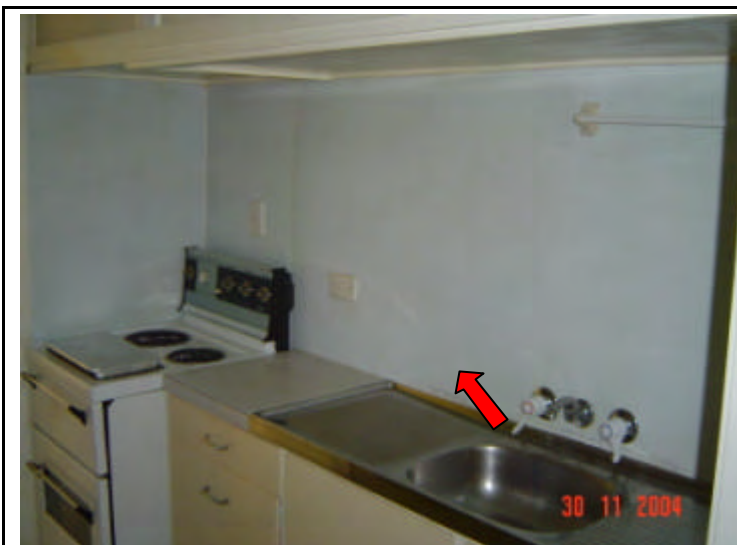
**Photograph 1 :** Kitchen, lower wall panelling behind stove and sink – showing asbestos-containing fibre-cement sheet panels

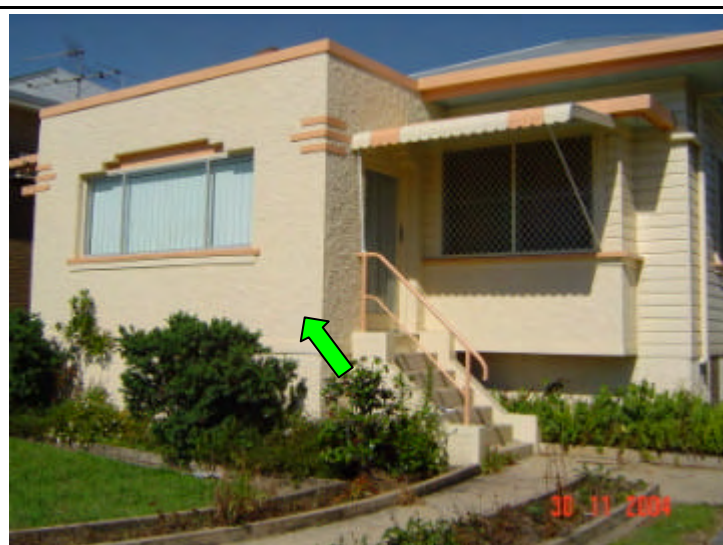
**Photograph 2 :** Exterior, front of house – showing non asbestos-containing 'stucco' wall finish

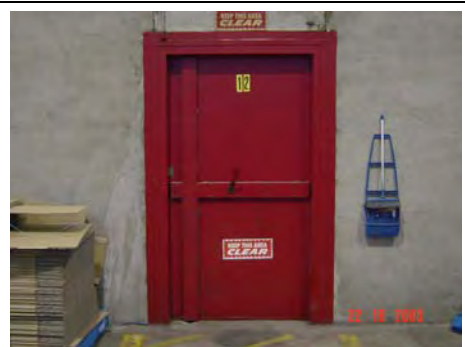
A number of fire doors were found on-site that were installed prior to 1980 and are known to contain asbestos cores. All doors assessed appear in reasonable, un-damaged condition. It is unlikely that fire doors would present a significant hazard unless damaged or during demolition. It is important that the doors, as with other asbestos-containing materials, are inspected regularly, to ensure they are not damaged inadvertently.

Photograph No.3: An example of an asbestos containing fire door
