## **HAZARDOUS MATERIALS SURVEY**

**One Carrington  
Development**

**Project No.  
21582**

**Date:  
10-01-14**

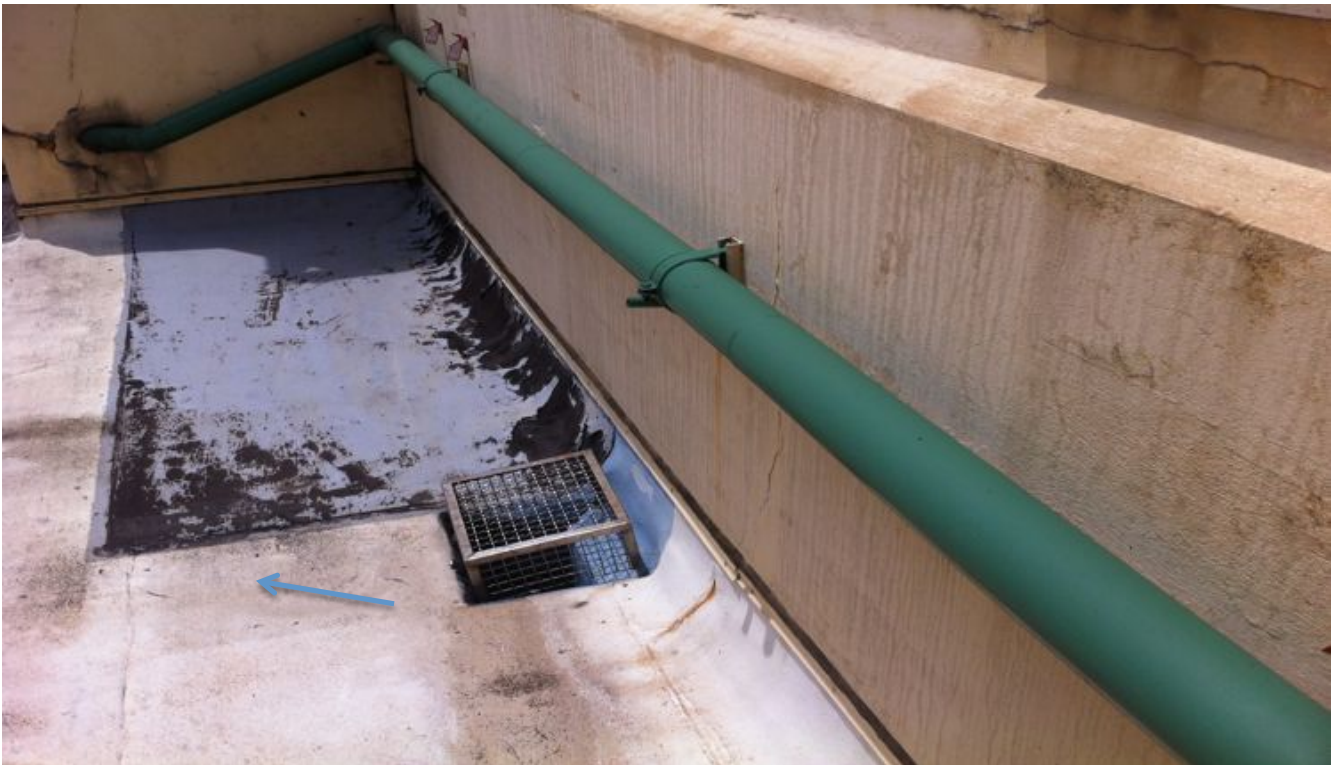
**Photo 1:** Bituminous waterproofing membrane containing asbestos and pipe work containing internal SMF insulation on the North Wing Rooftop Level – Menzies Hotel.

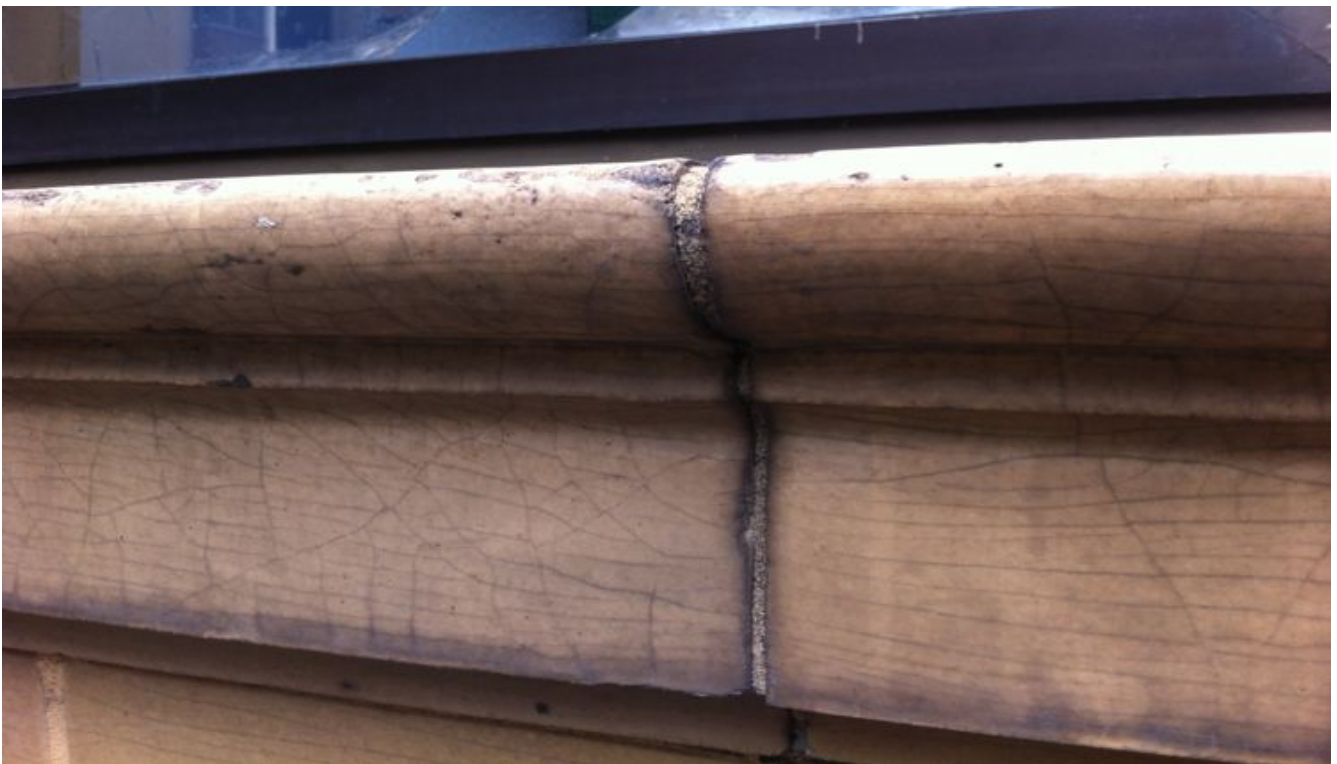
**Photo 2:** Caulking containing asbestos on the external façade to the North Wing – Menzies Hotel.

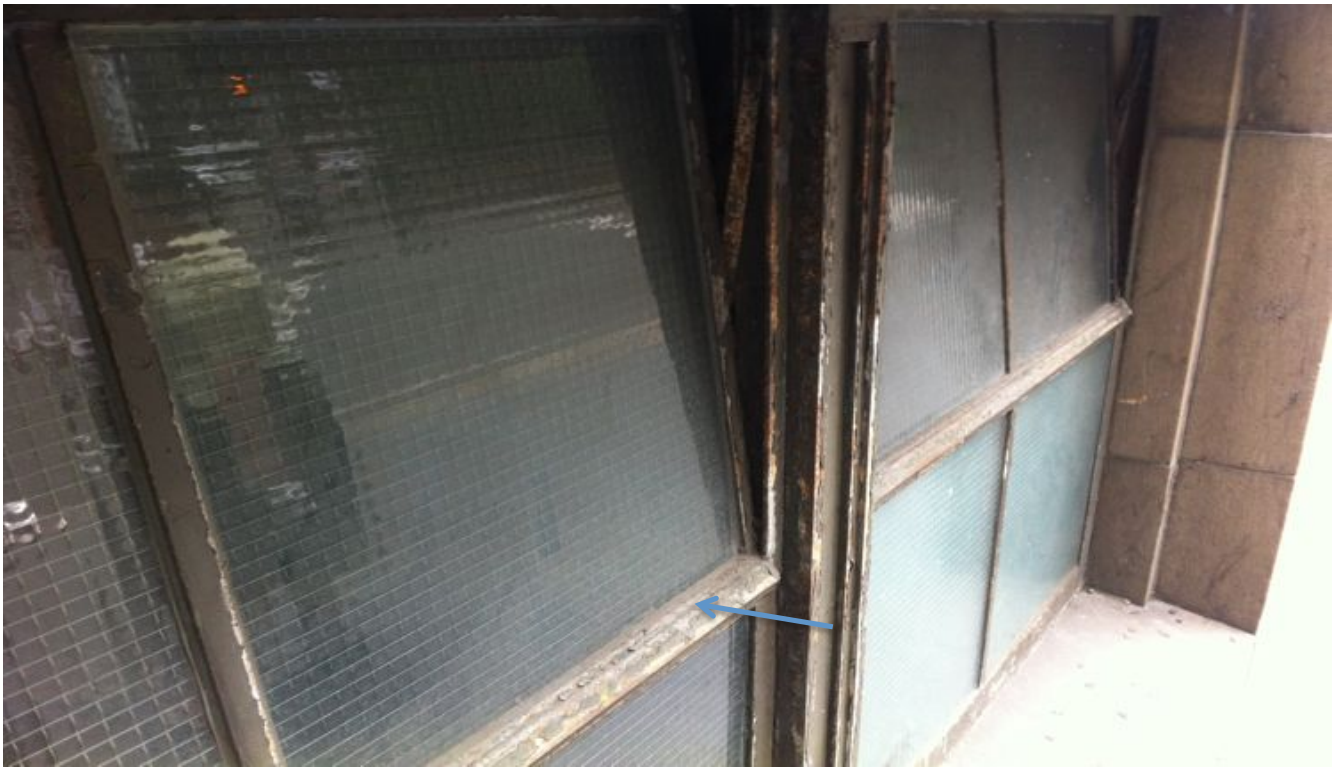
**Photo 3:** Window mastic containing asbestos on the external window frames of the North Wing – Menzies Hotel.

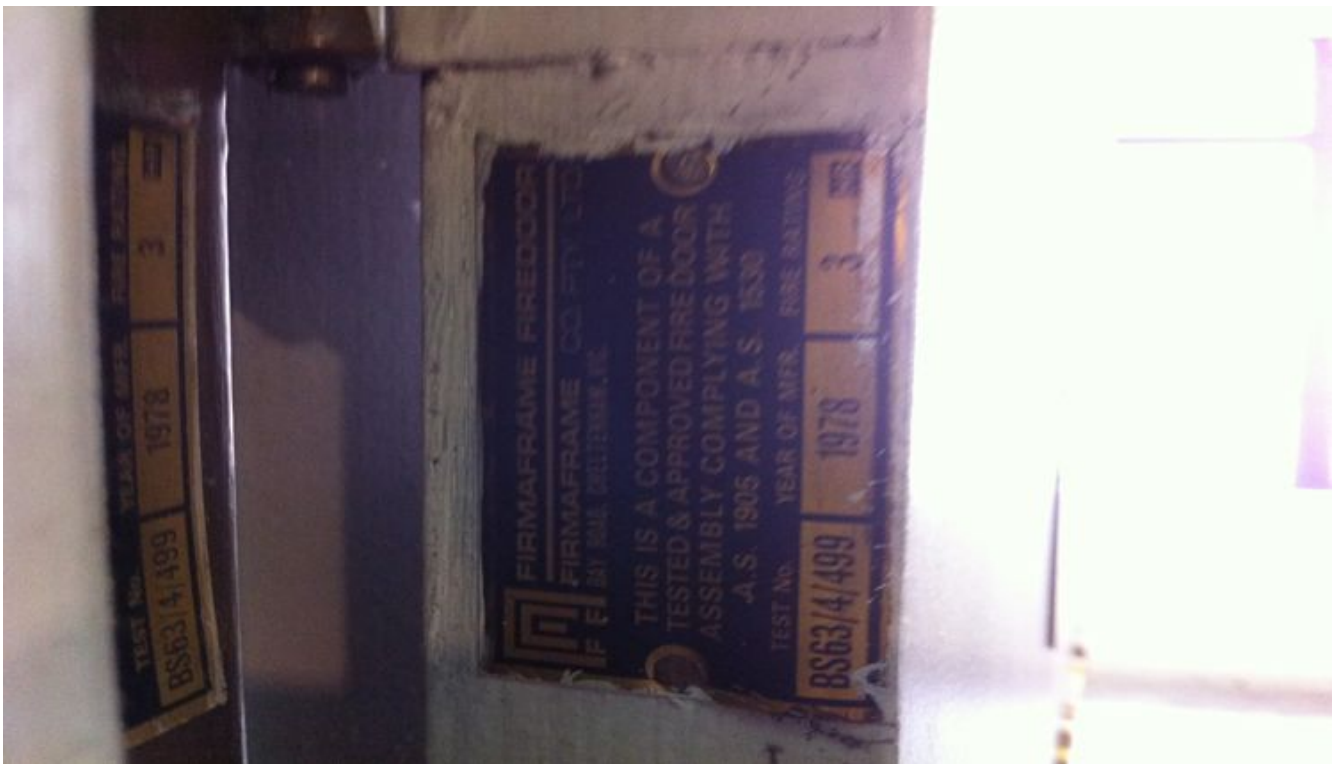
**Photo 4:** A sample of a Fire Door assumed to contain asbestos core throughout the North Wing – Menzies Hotel.

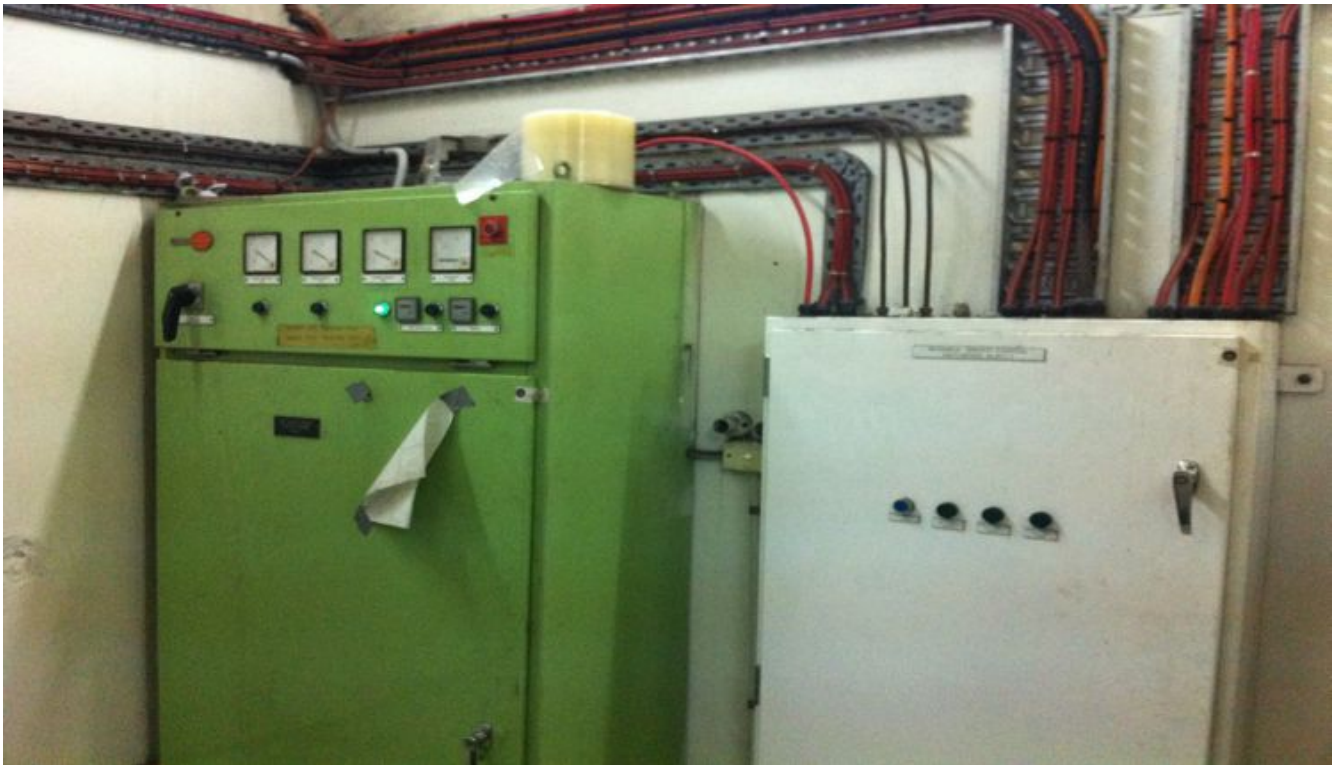
**Photo 5:** Two (2) electrical switchboards located within the Air Supply/Exhaust Plant Room on the Rooftop Level of the North Wing – Menzies Hotel.

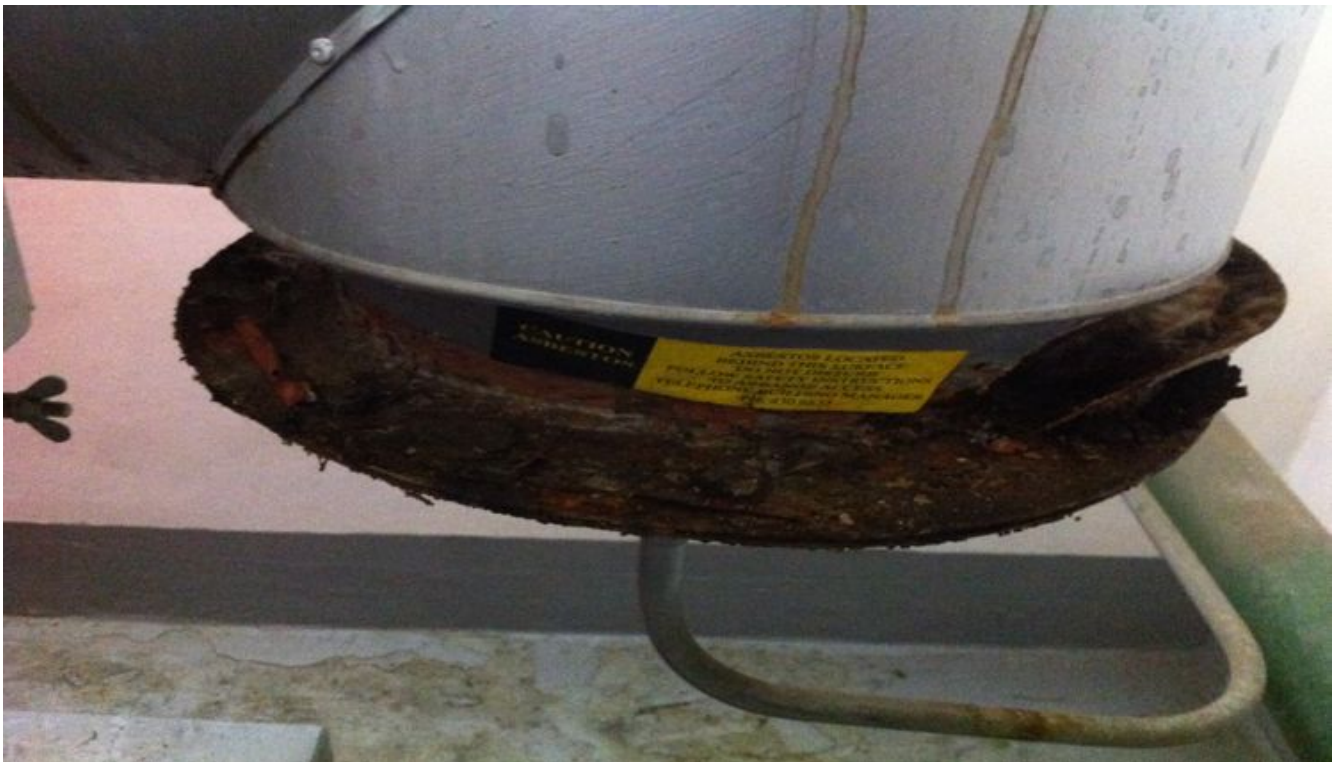
**Photo 6:** One (1) gasket containing asbestos located at the back of the boiler within the Boiler Room on the Rooftop Level of the North Wing – Menzies Hotel.

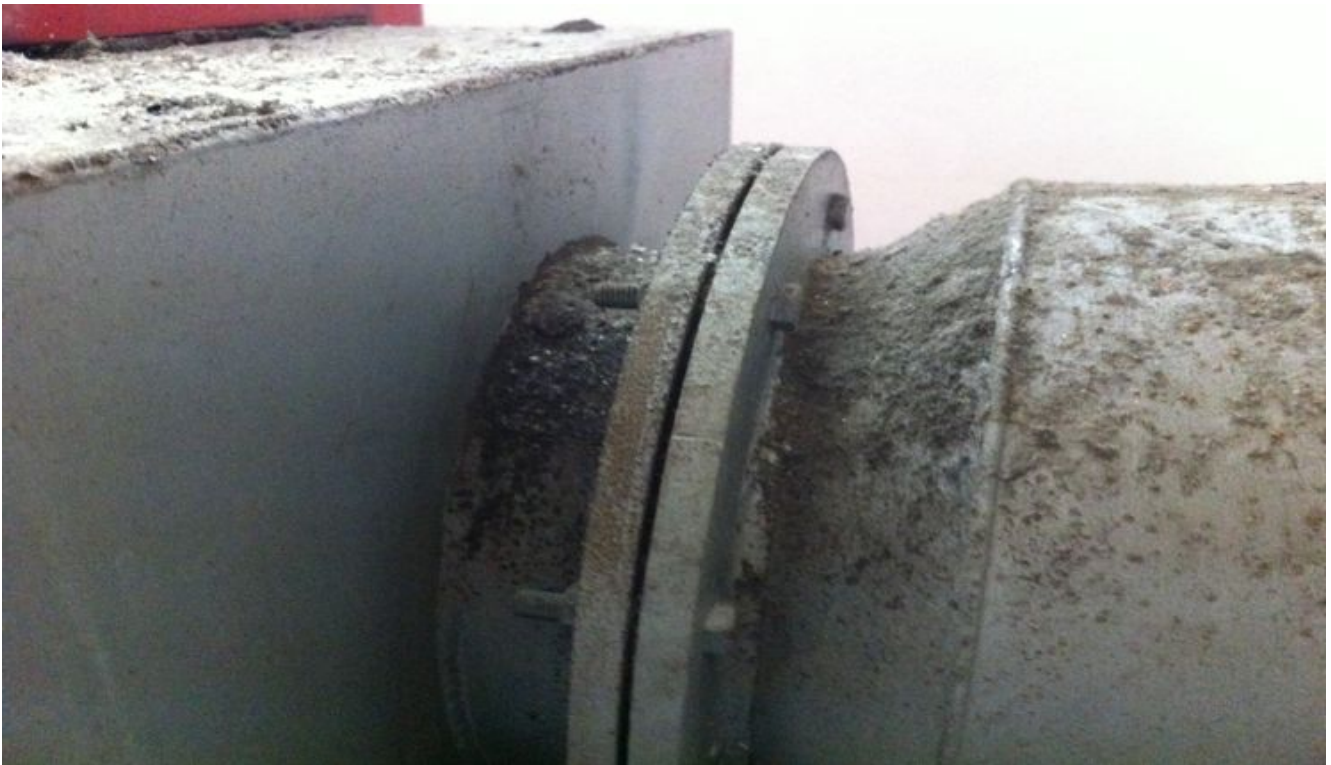
**Photo 7:** One (1) rope flange containing asbestos on the boiler within the Boiler Room on the Rooftop Level of the North Wing – Menzies Hotel.

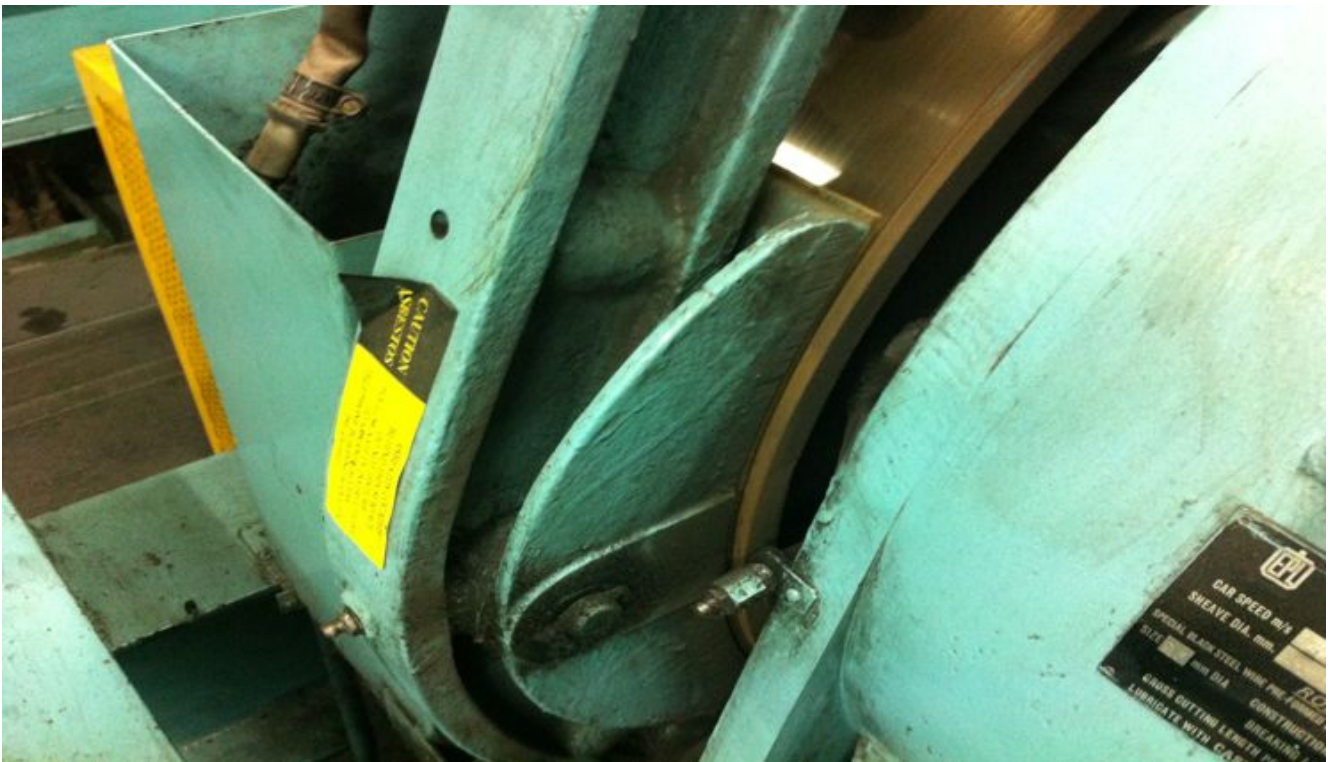
**Photo 8:** Bituminous brake pads assumed to contain asbestos within the Lift Motor Room of the North Wing – Menzies Hotel.

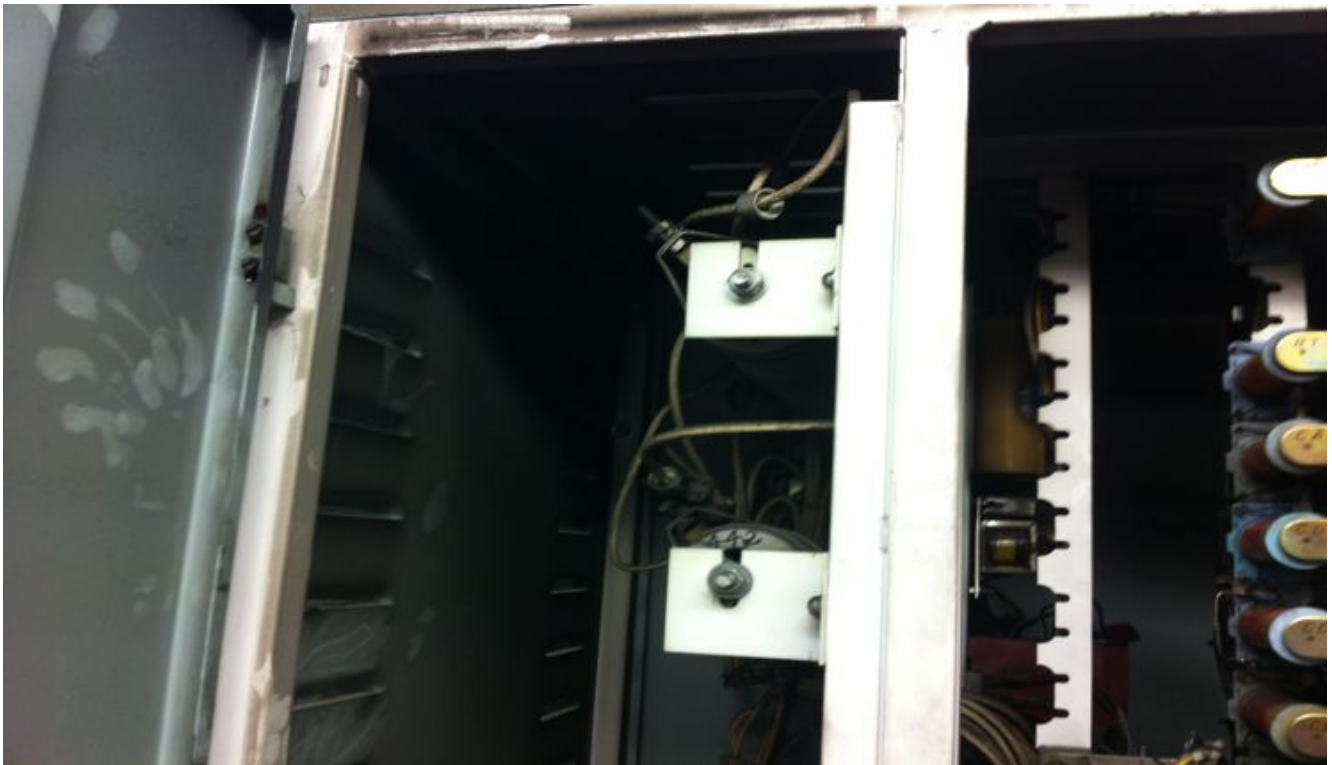
**Photo 9:** Cable insulation containing asbestos within the Control Cabinets of the Lift Motor Room of the North Wing – Menzies Hotel.

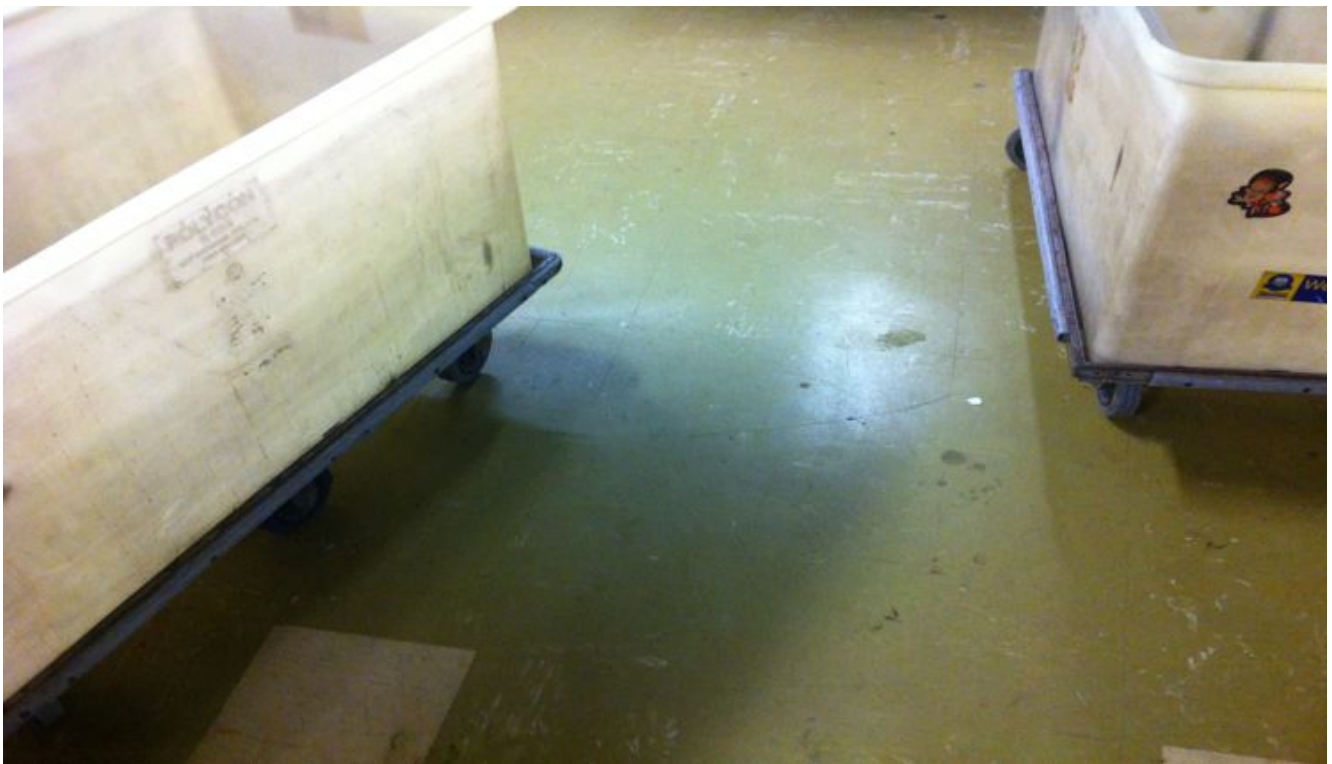
**Photo 10:** Vinyl floor tiles containing asbestos within the Laundry Room on Level 7 of the North Wing – Menzies Hotel.

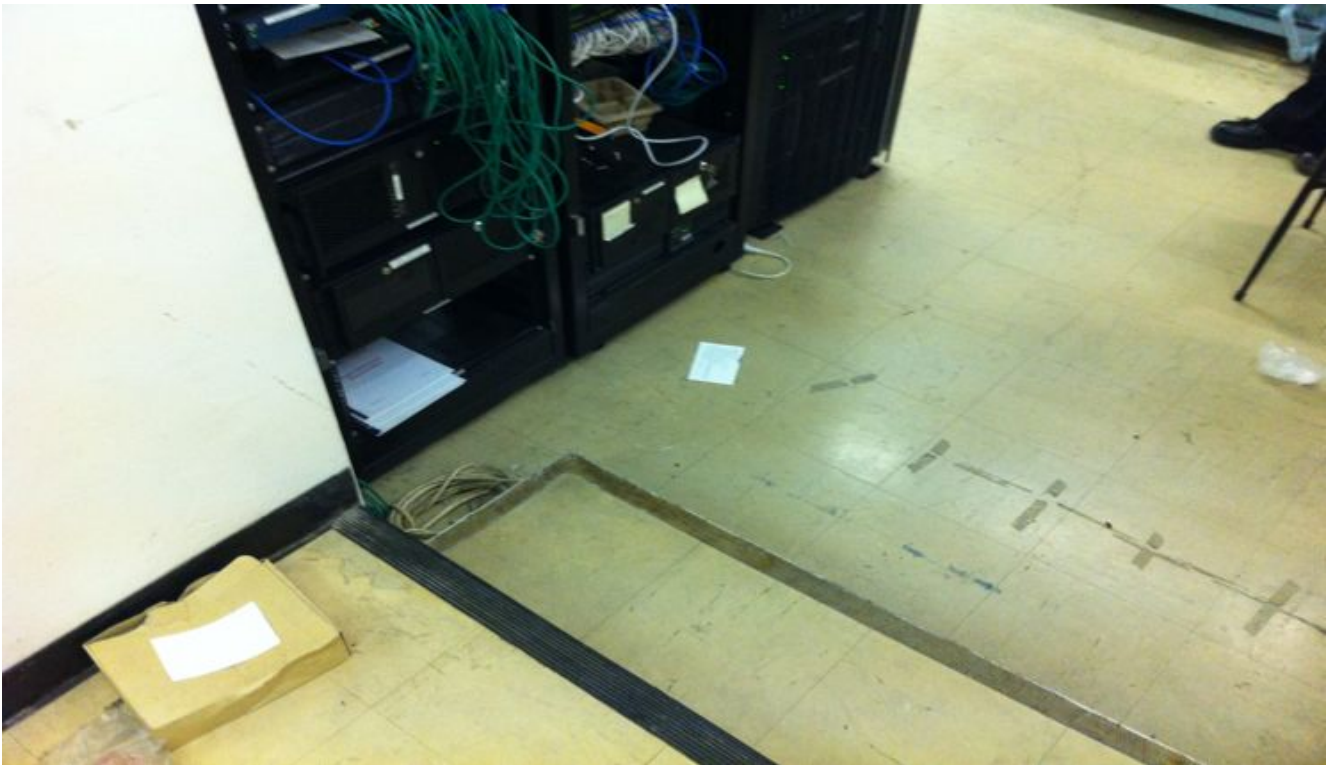
**Photo 11:** Vinyl floor tiles containing asbestos within the Movie Link/Commas Room on the Lower Ground Level of the North Wing – Menzies Hotel..

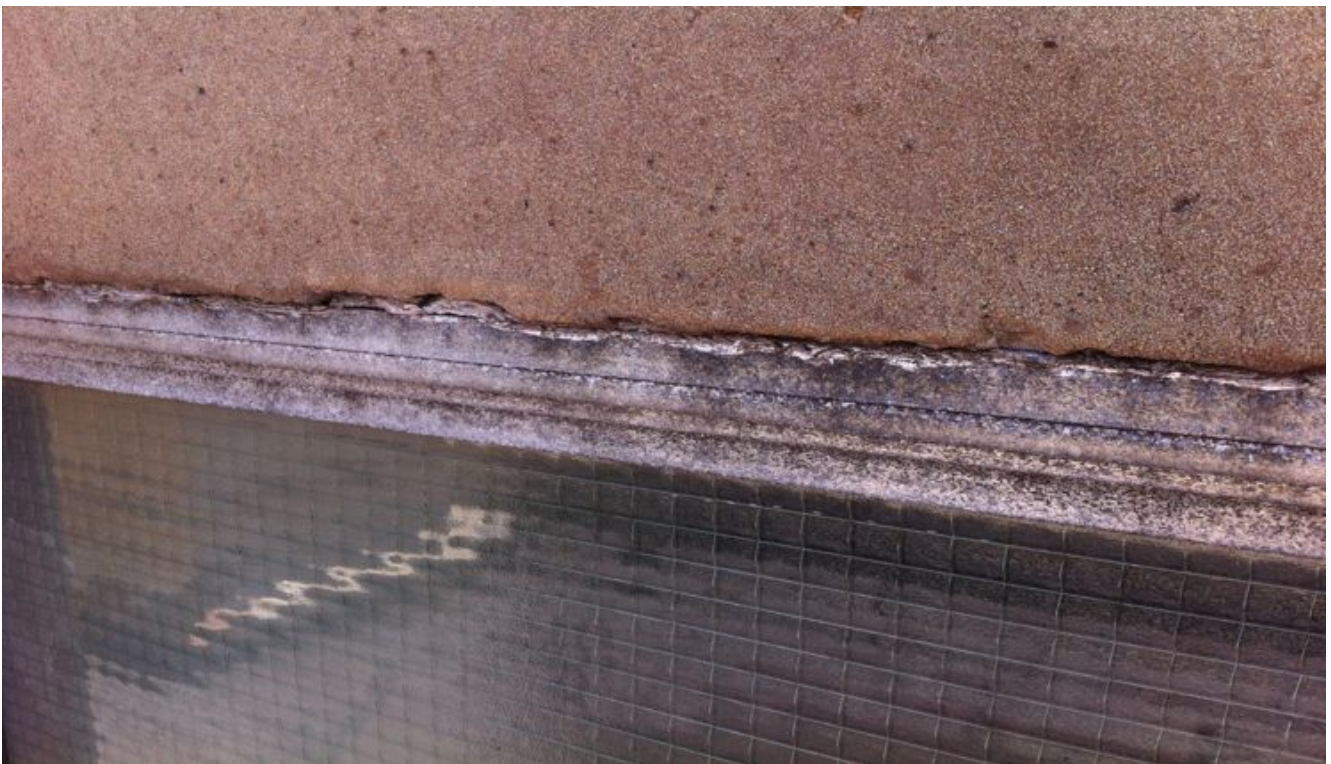
**Photo 12:** Mastic containing asbestos on the external window frames on Level 16 of South Wing – Menzies Hotel.

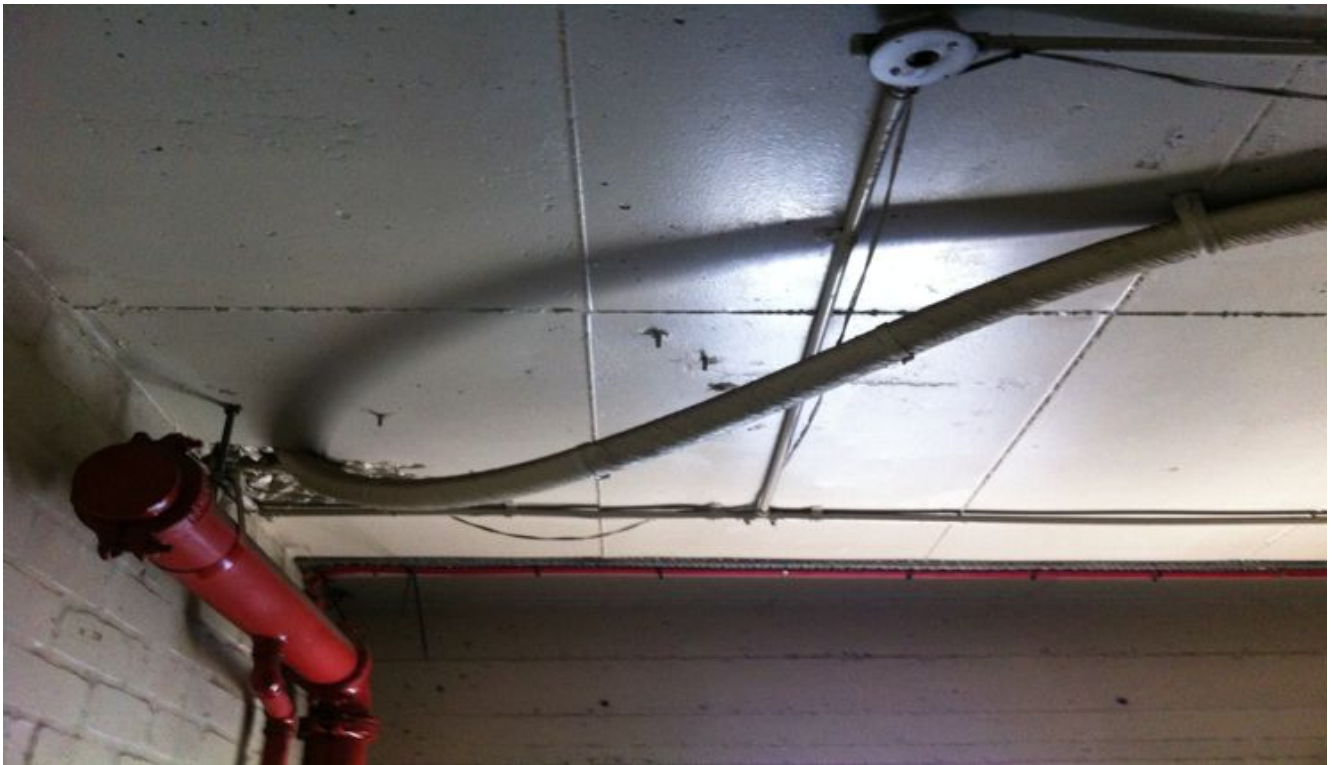
**Photo 13:** Bituminous rope insulation containing asbestos on the main electrical cable on Level 16 of the South Wing – Menzies Hotel.

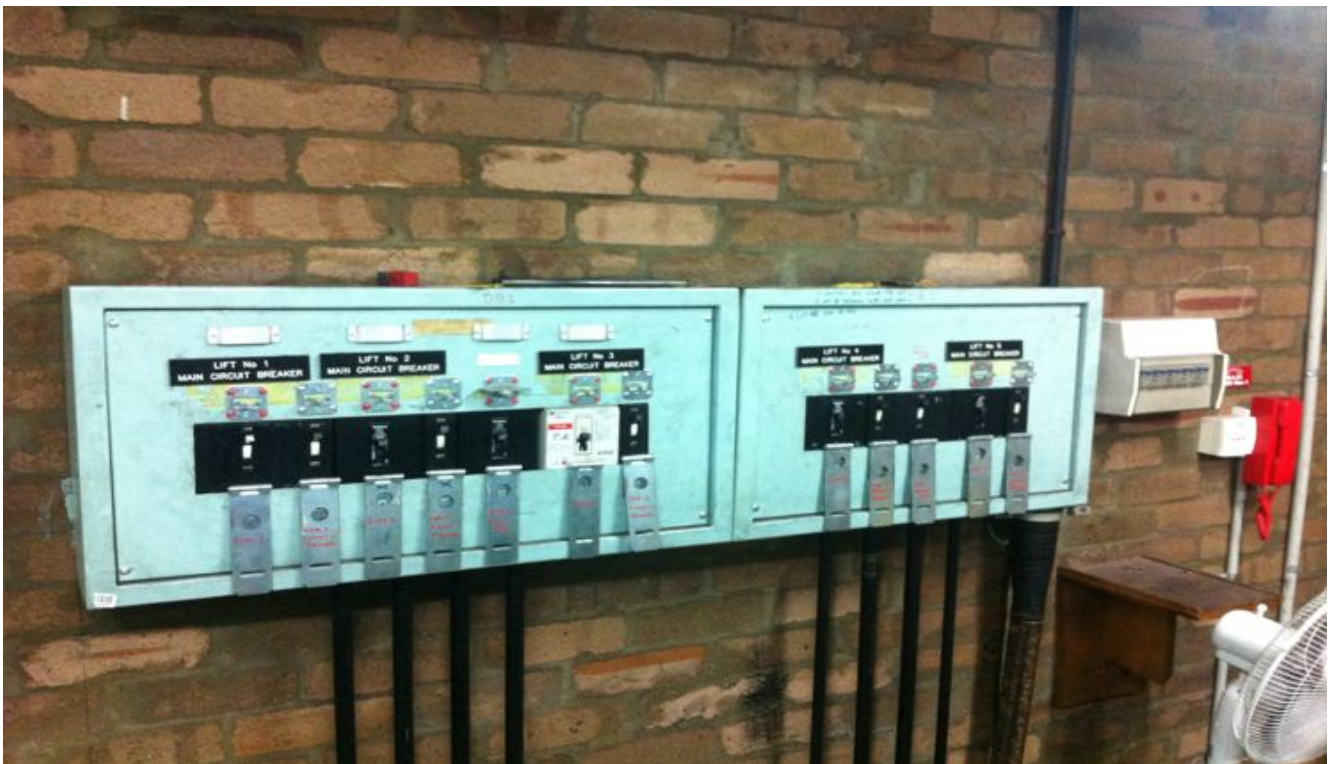
**Photo 14:** Two (2) electrical switchboards containing asbestos located within the Plant Room on the Lift Motor Room Level of the South Wing – Menzies Hotel.

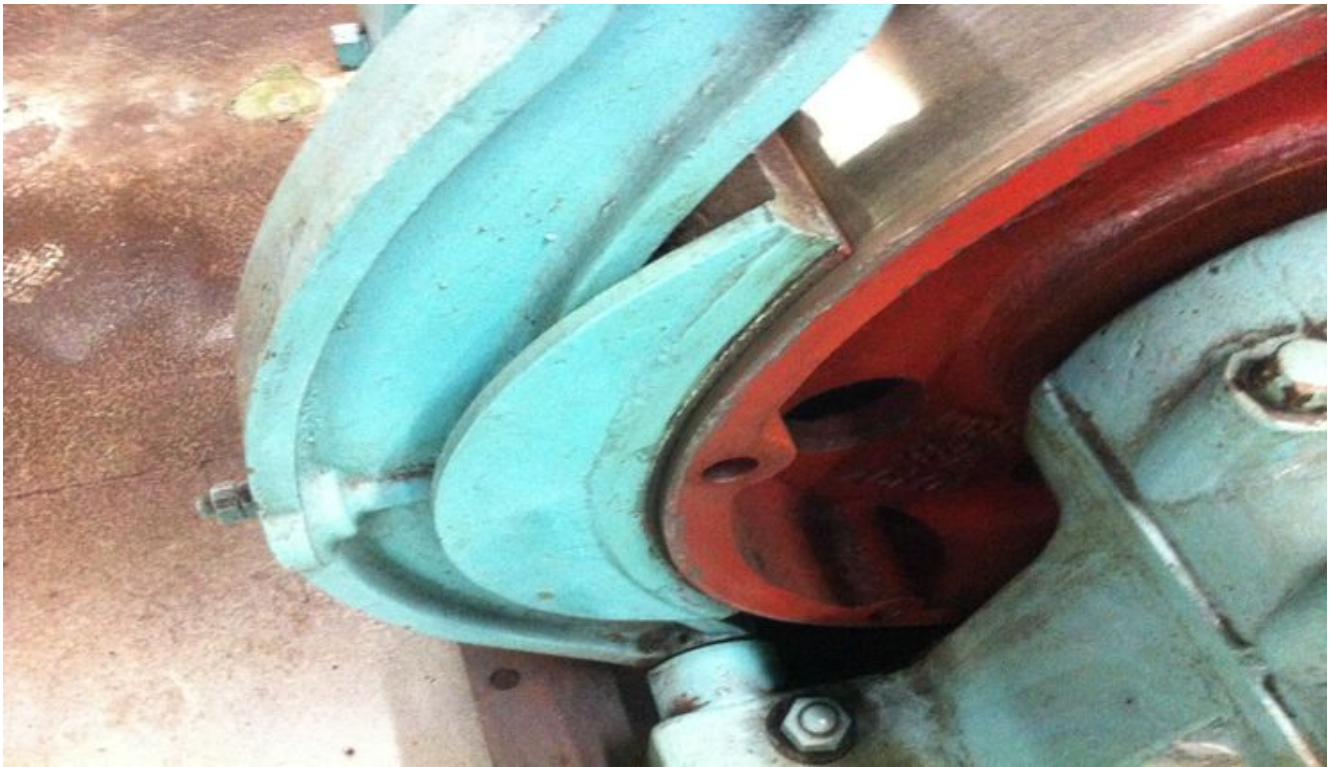
**Photo 15:** Bituminous brake pads assumed to contain asbestos within the Lift Motor Room of the South Wing – Menzies Hotel.

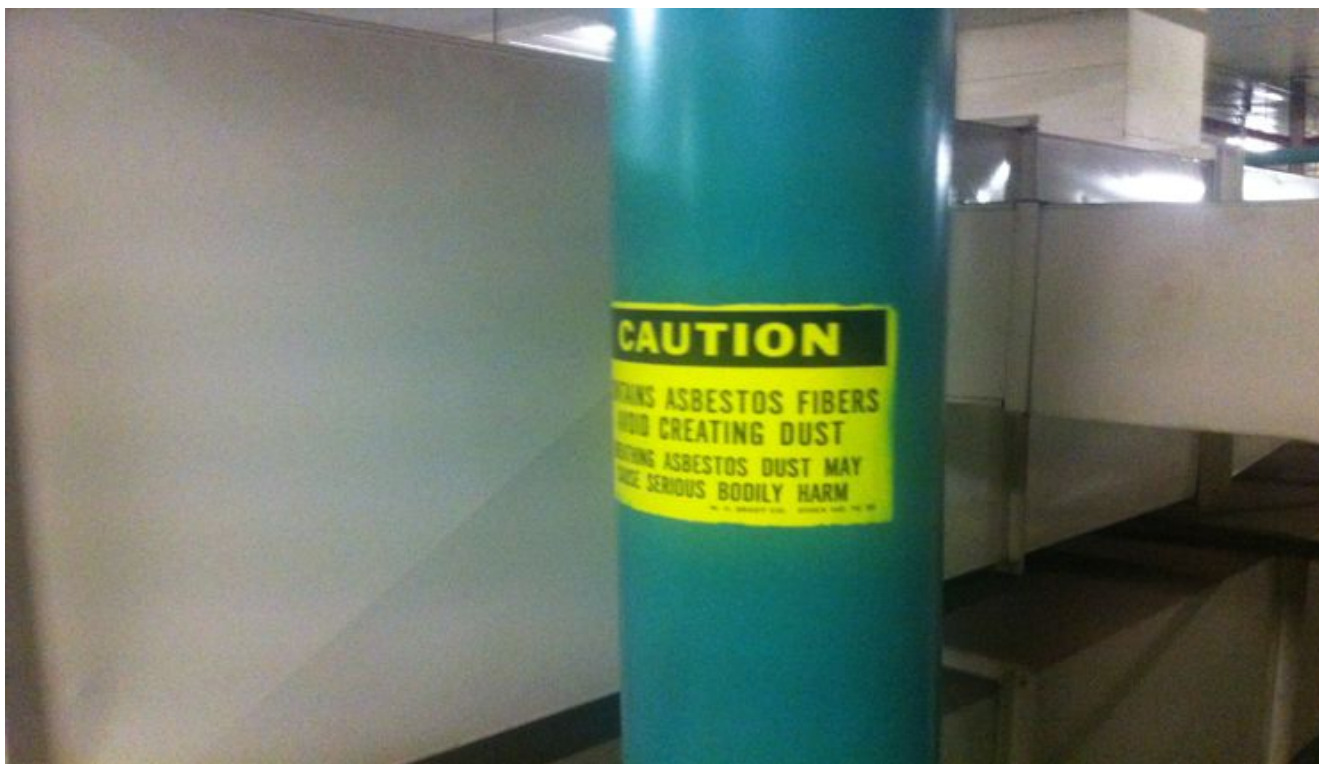
**Photo 17:** Pipe work containing asbestos insulation located throughout the Plant Room on Level 15 of the South Wing – Menzies Hotel.

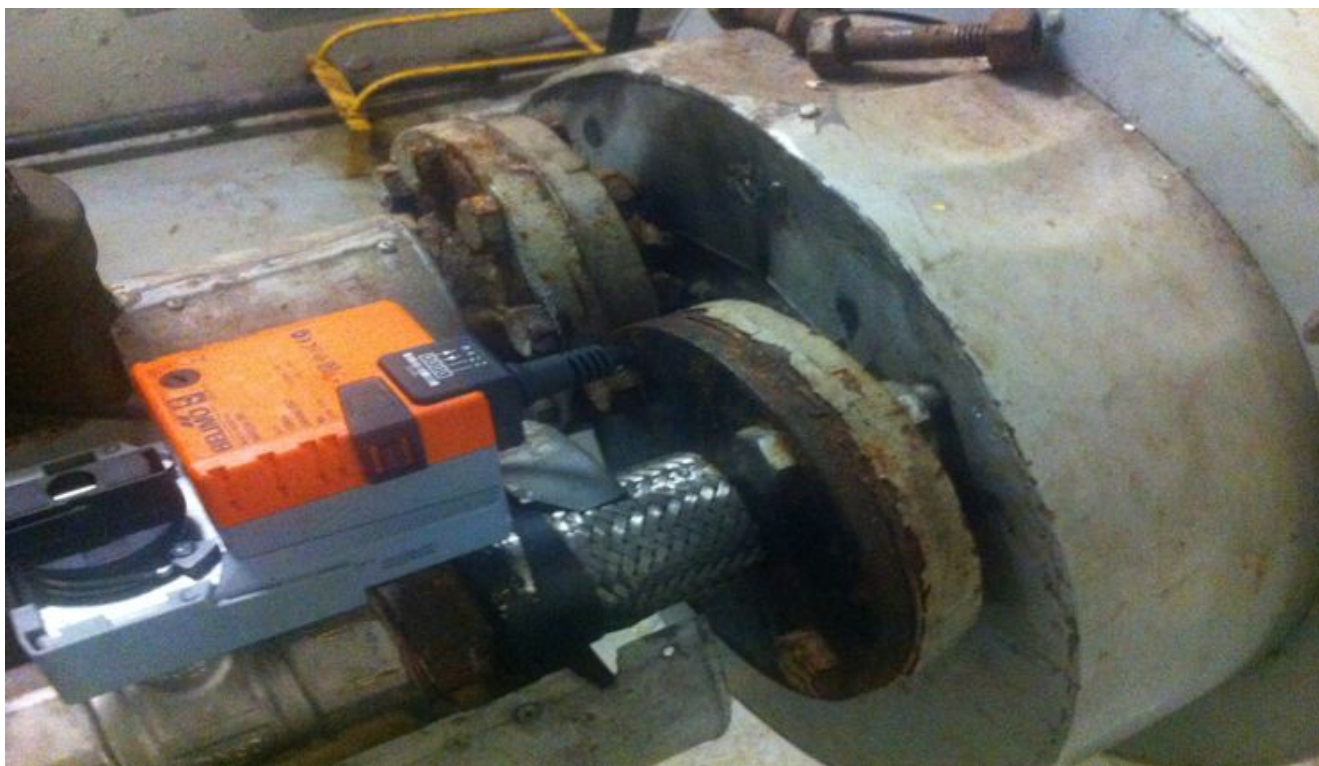
**Photo 18:** Asbestos gaskets located in the Plant Room on Level 15 of the South Wing – Menzies Hotel.

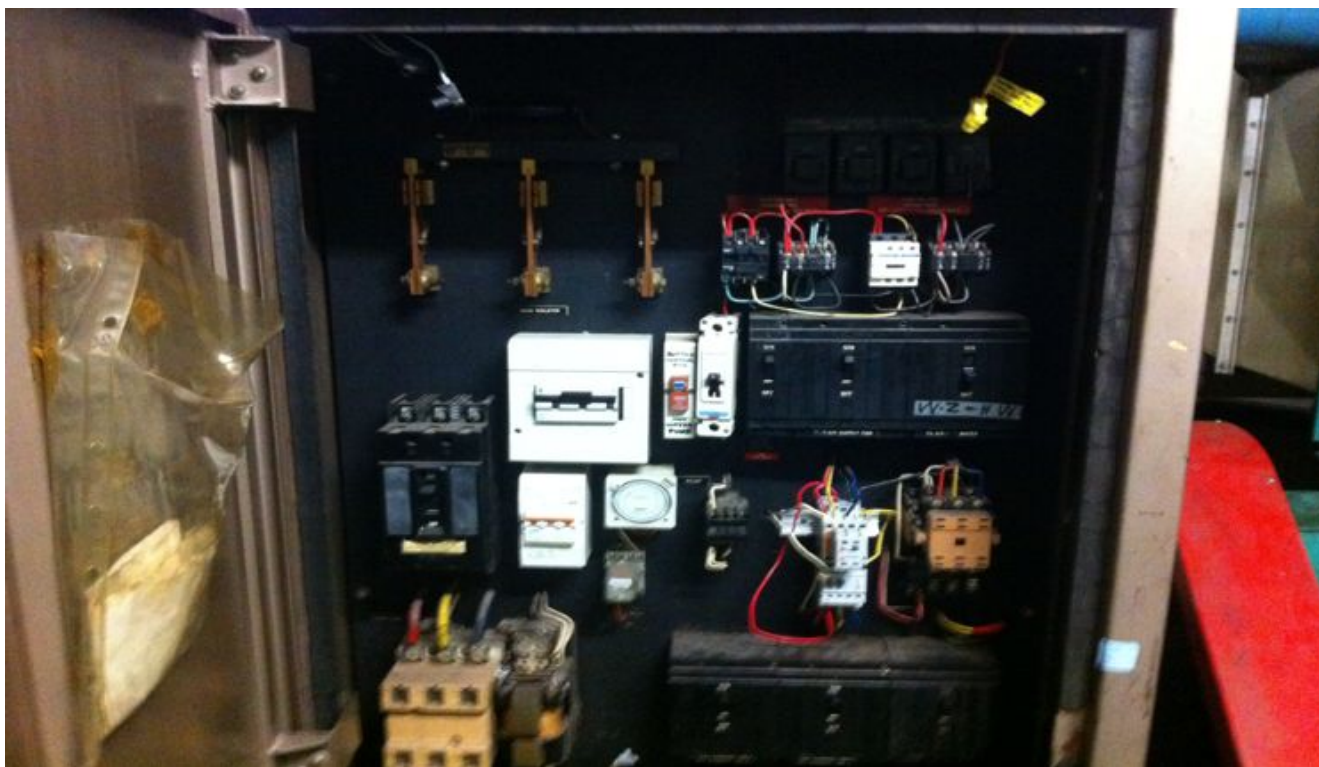
**Photo 19:** One (1) of two (2) bituminous backing boards containing asbestos adjacent the entrance door to the Plant Room on Level 15 of the South Wing – Menzies Hotel.

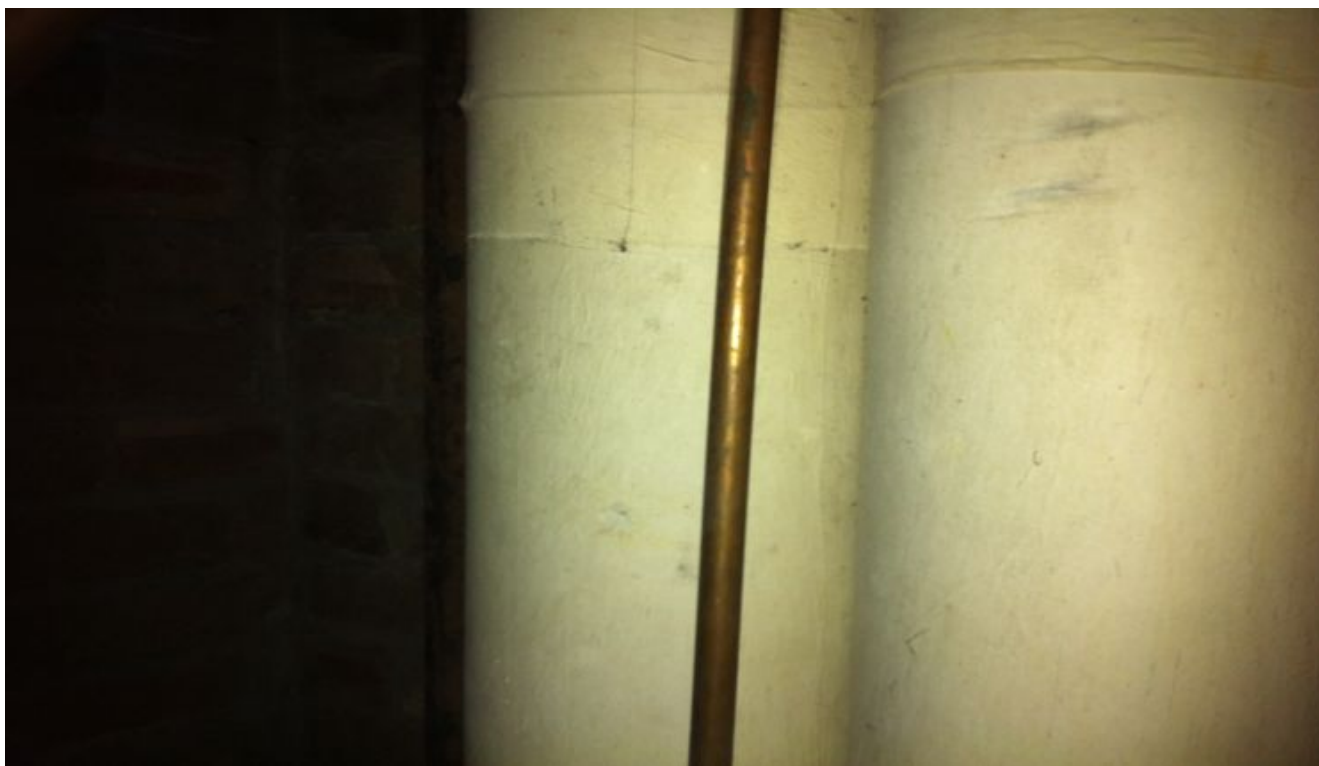
**Photo 20:** Two (2) large asbestos wrapped pipes within the Lifties Room on Level 15 of the South Wing – Menzies Hotel.

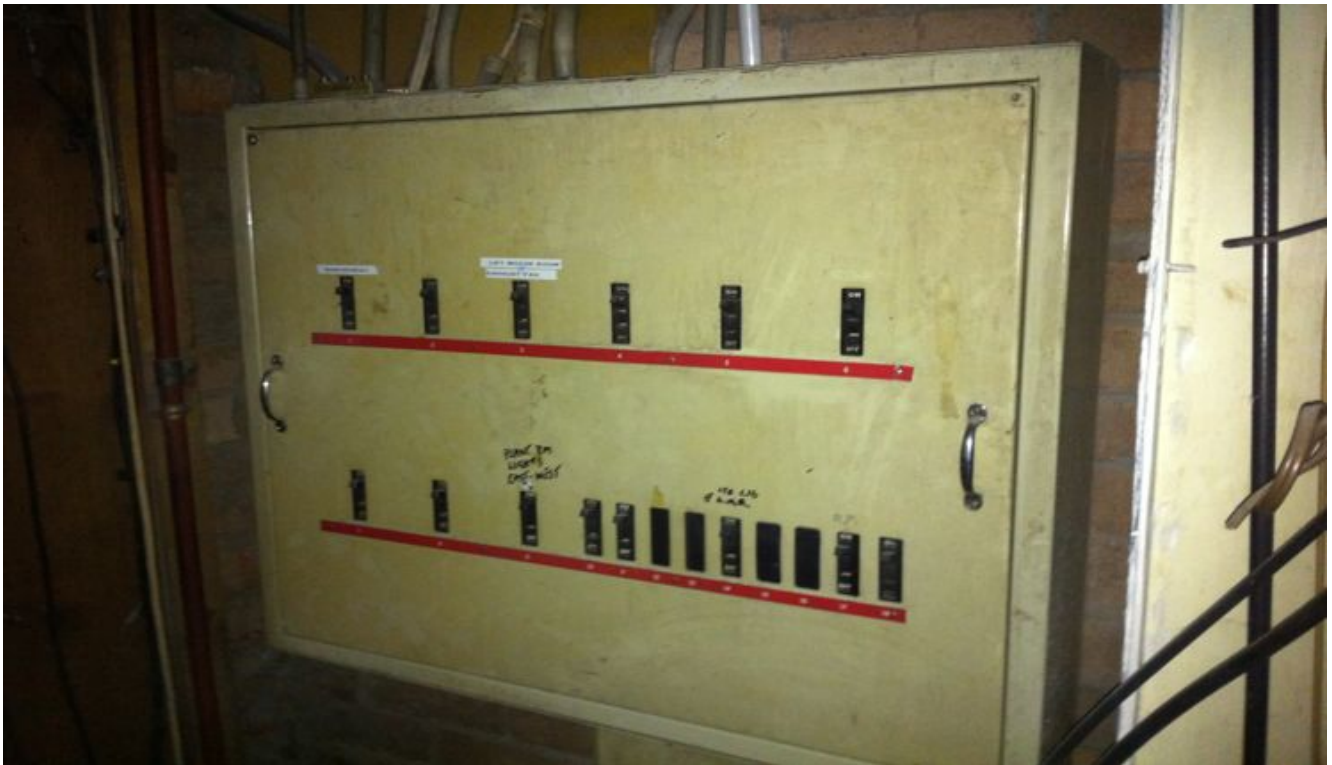
**Photo 21:** One (1) electrical distribution cupboard within the Lifties Room on Level 15 of the South Wing – Menzies Hotel.

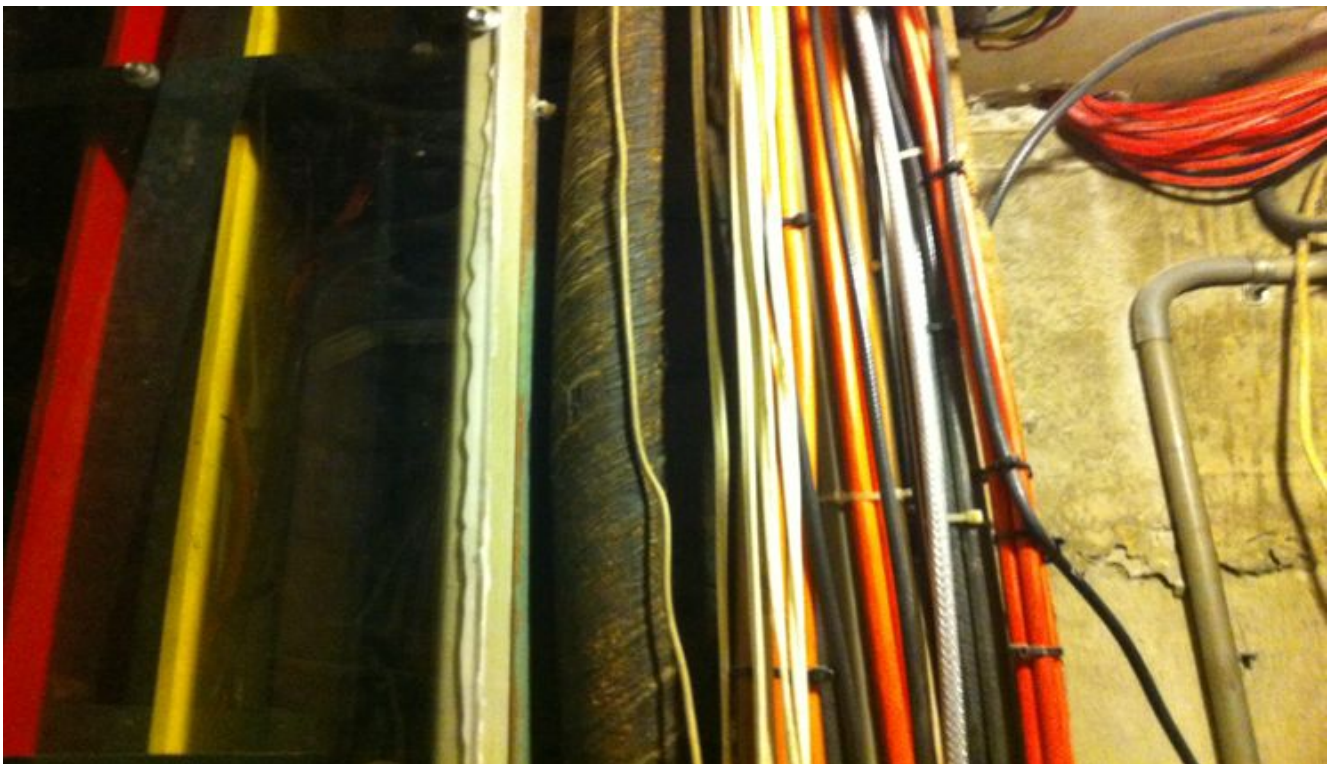
**Photo 22:** Bituminous rope insulation on the main electrical cable located within the riser cupboard of Level 15 of the South Wing – Menzies Hotel.

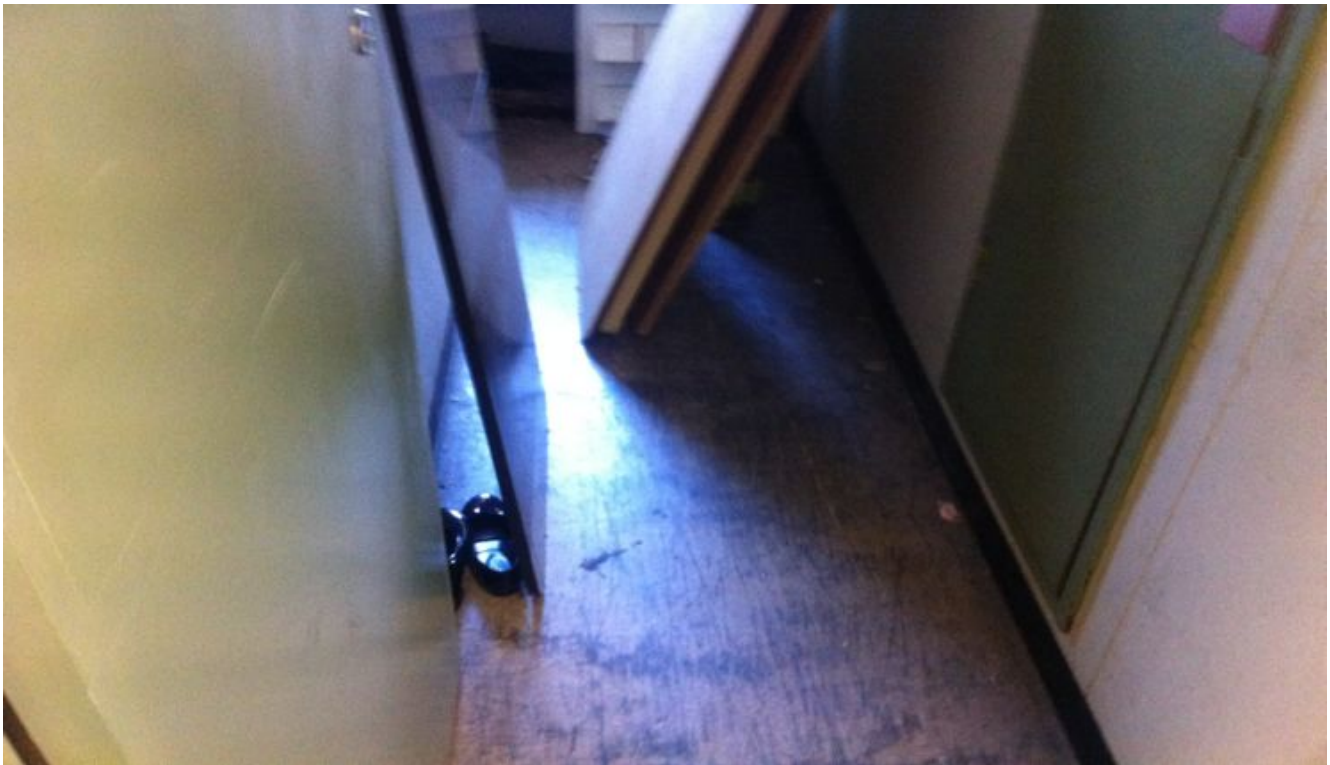
**Photo 23:** Vinyl floor tiles containing asbestos within the Laundry Store on Level 14 of the South Wing – Menzies Hotel.
