## **HAZARDOUS MATERIALS SURVEY**

**One Carrington  
Development**

**Project No.  
21582**

**Date:  
10-01-14**

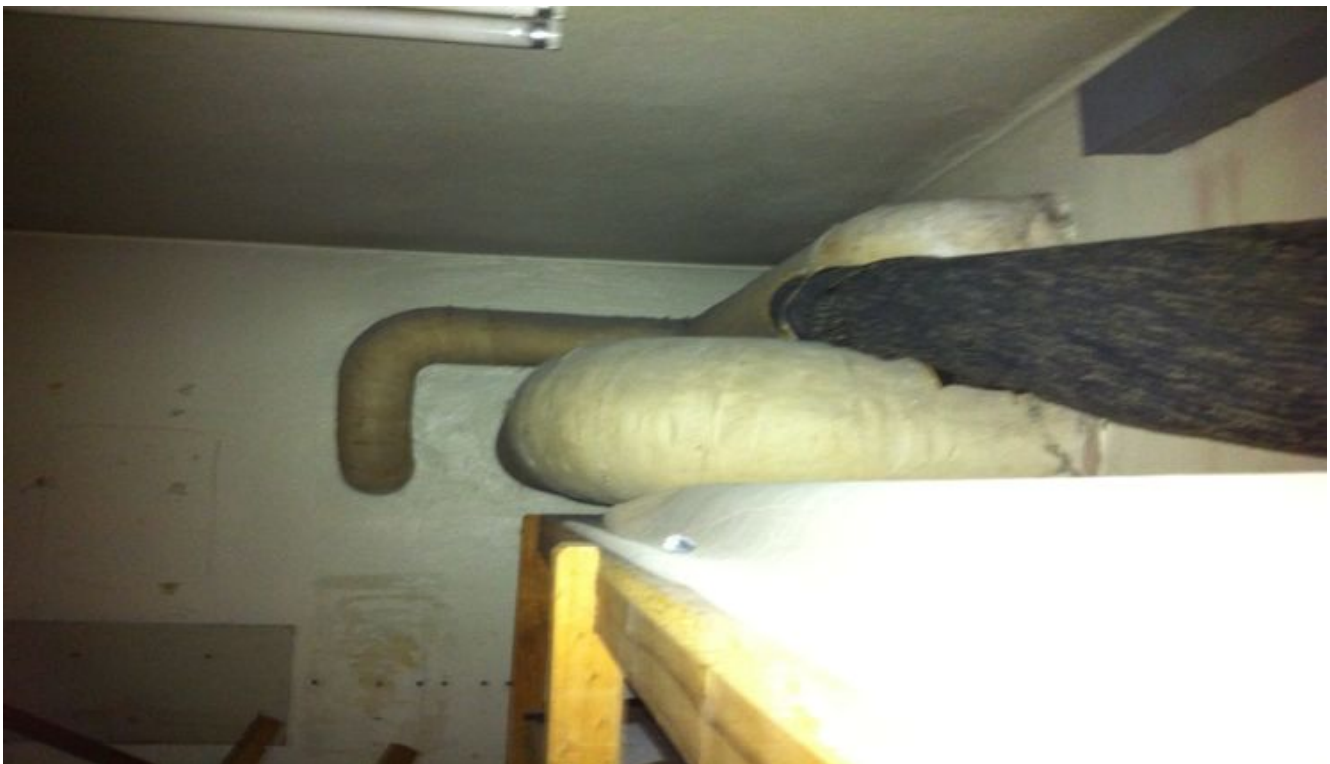
**Photo 24:** Asbestos insulated pipe work in the Store Room on Level 4 of the South Wing – Menzies Hotel.

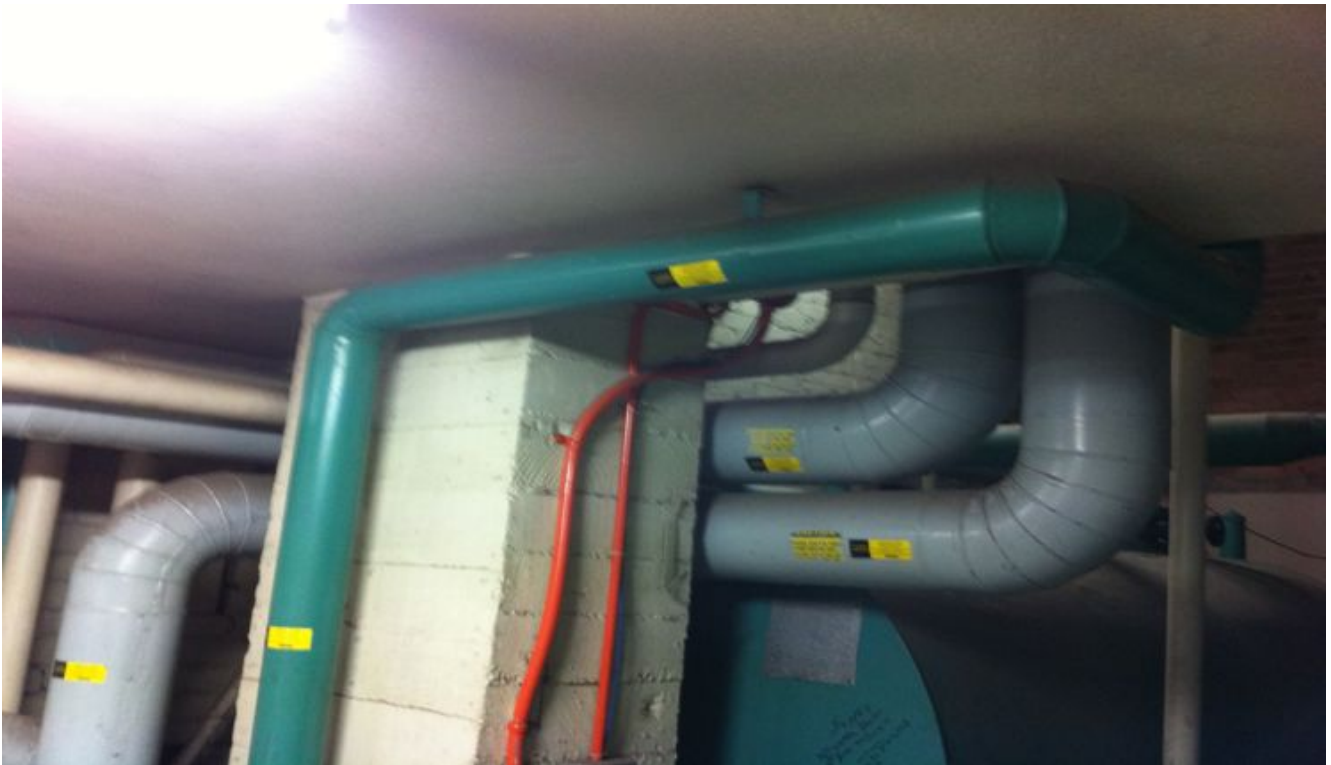
**Photo 25:** Asbestos insulated pipe work in the Plant Room on Level 3 ½ of the South Wing – Menzies Hotel.

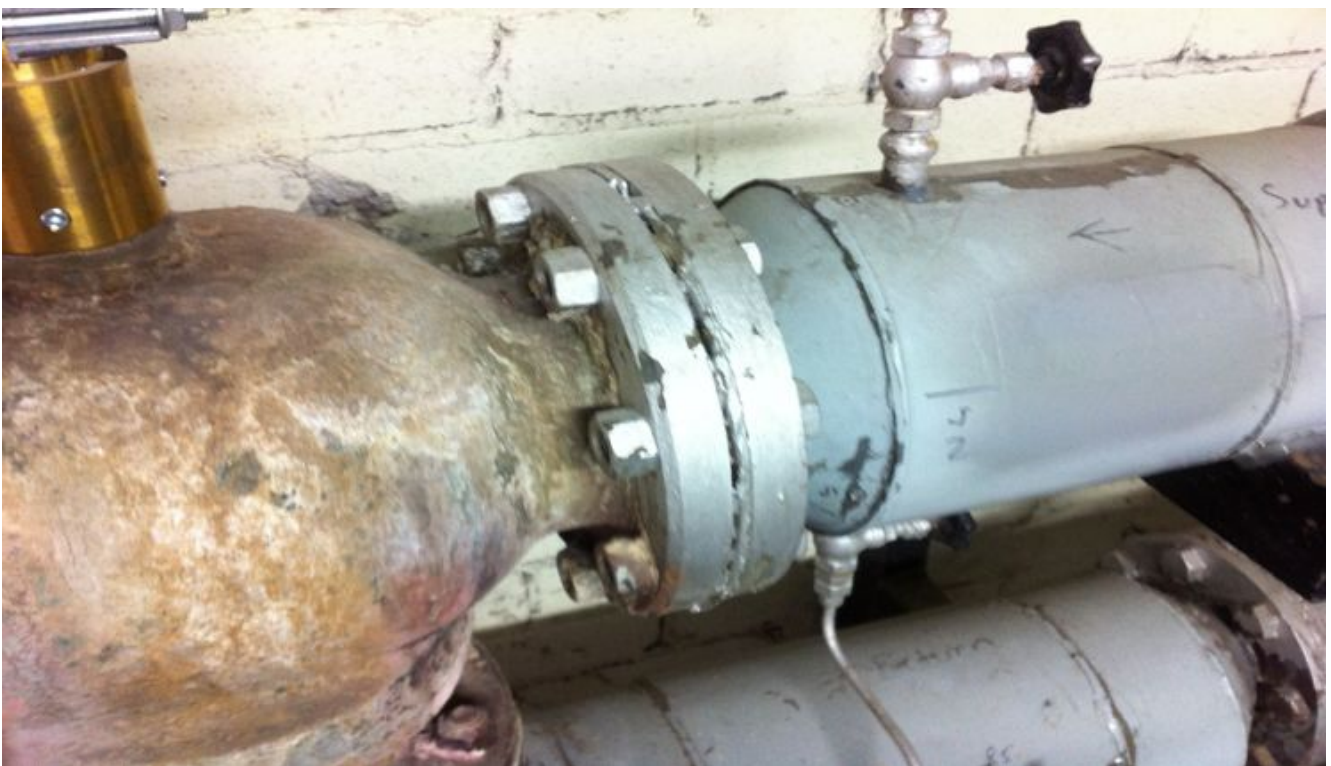
**Photo 26:** Asbestos gaskets in the Plant Room on Level 3 ½ of the South Wing – Menzies Hotel.

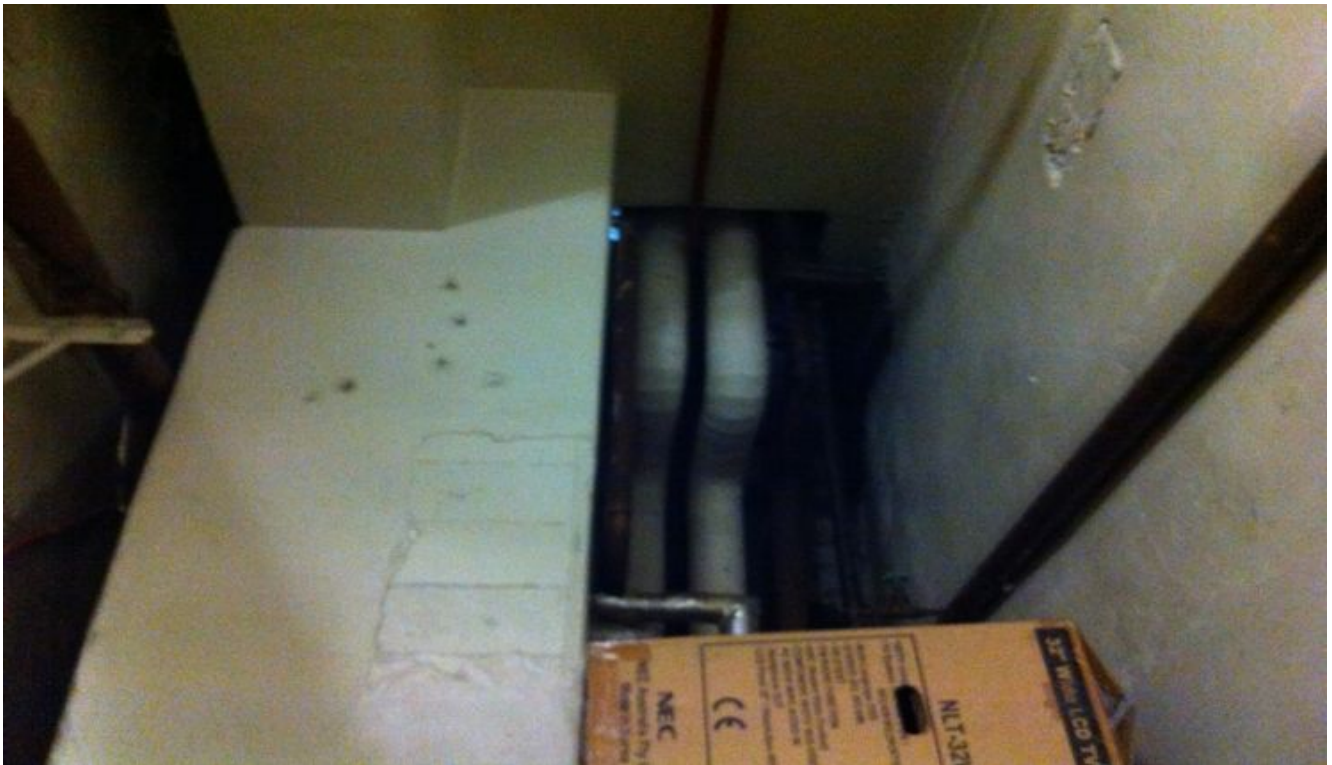
**Photo 27:** Two (2) large asbestos wrapped pipes within the AV Room of the Banquet Kitchen on Level 2 of the South Wing – Menzies Hotel.

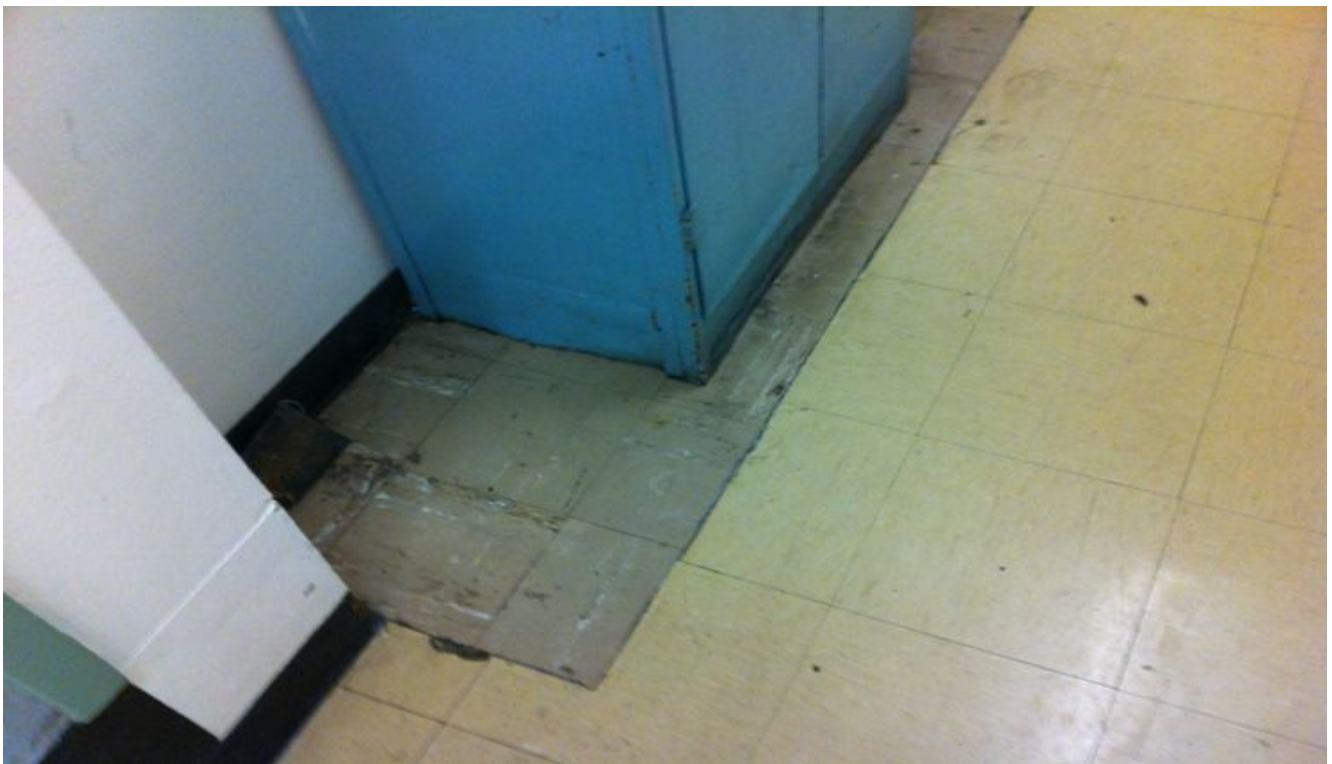
**Photo 28:** Dark brown vinyl floor tiles containing asbestos throughout the Service Corridor on the Ground Level of the South Wing – Menzies Hotel.

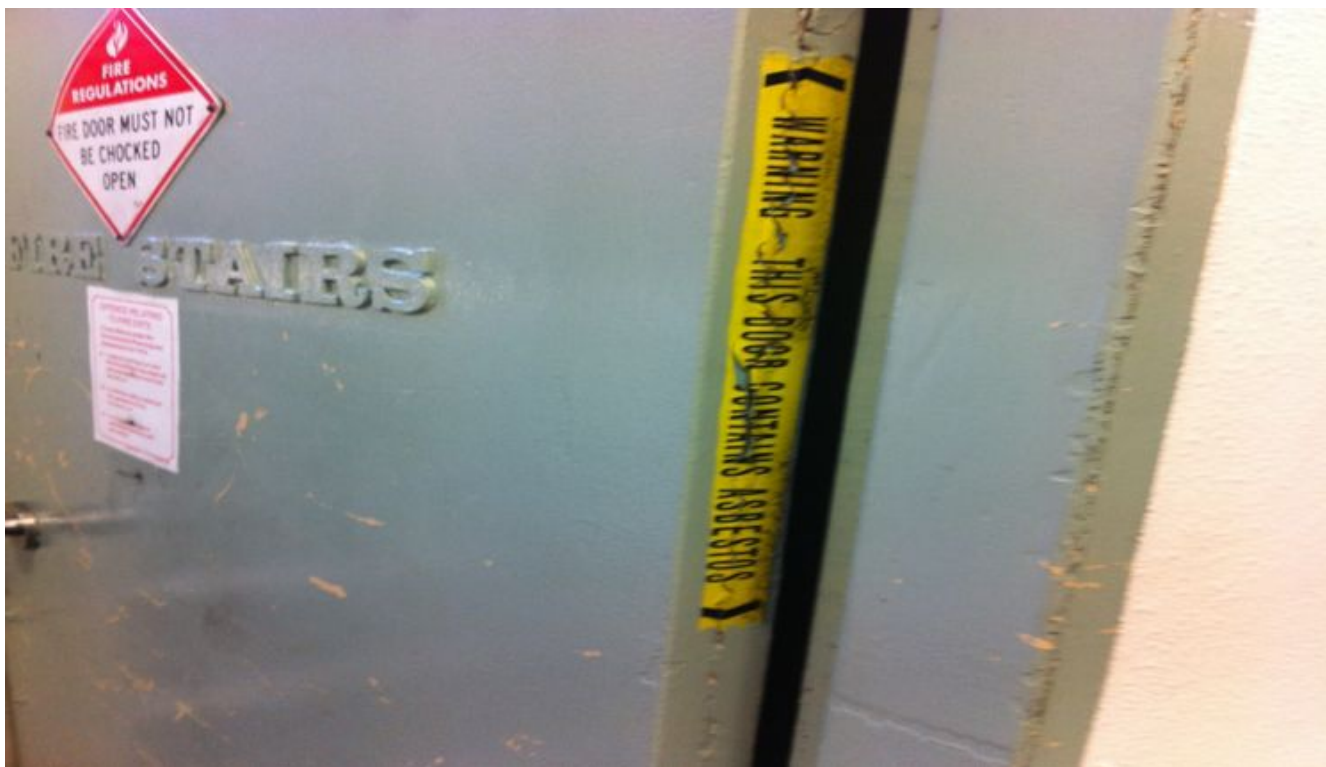
**Photo 29:** One (1) fire door containing asbestos from the Fire Stairs of the South Wing – Menzies Hotel.

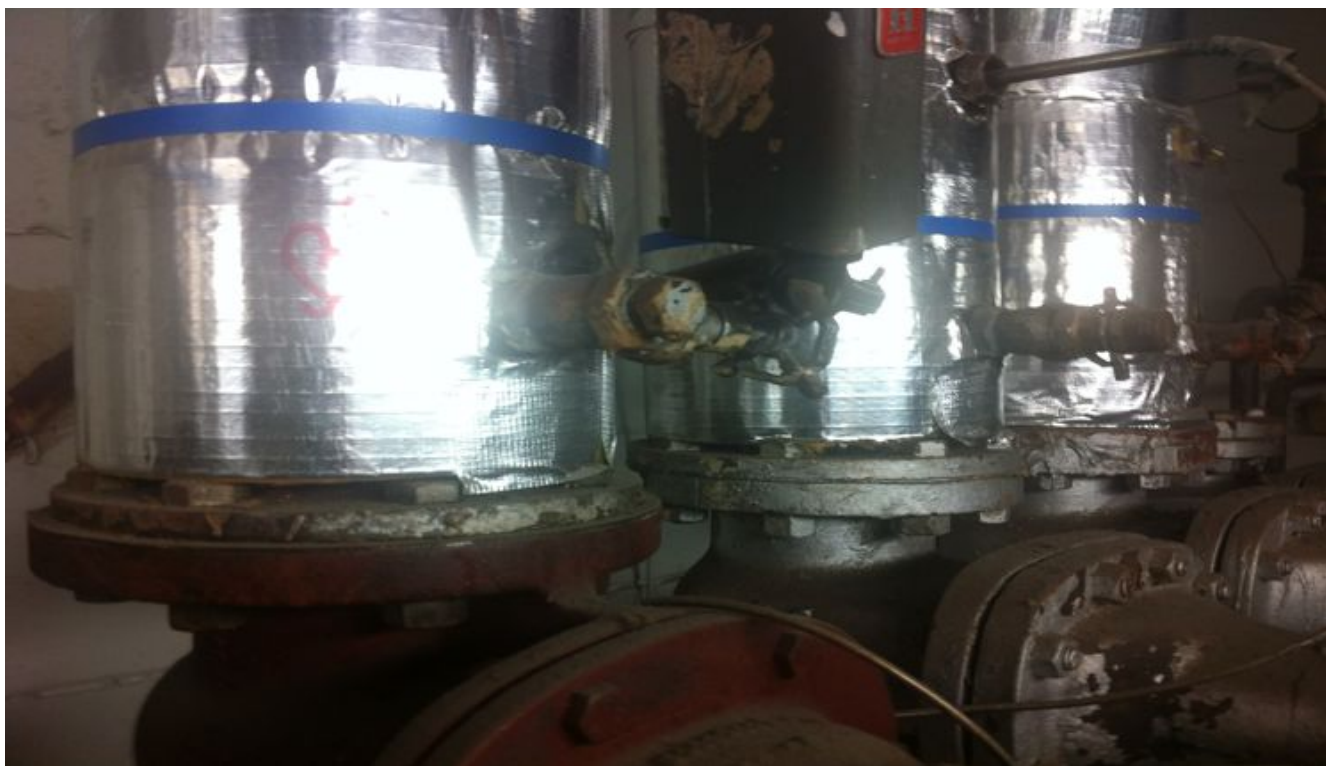
**Photo 30:** Hot water pipe work gaskets located within the Boiler Room on the Basement Level of the South Wing – Menzies Hotel.

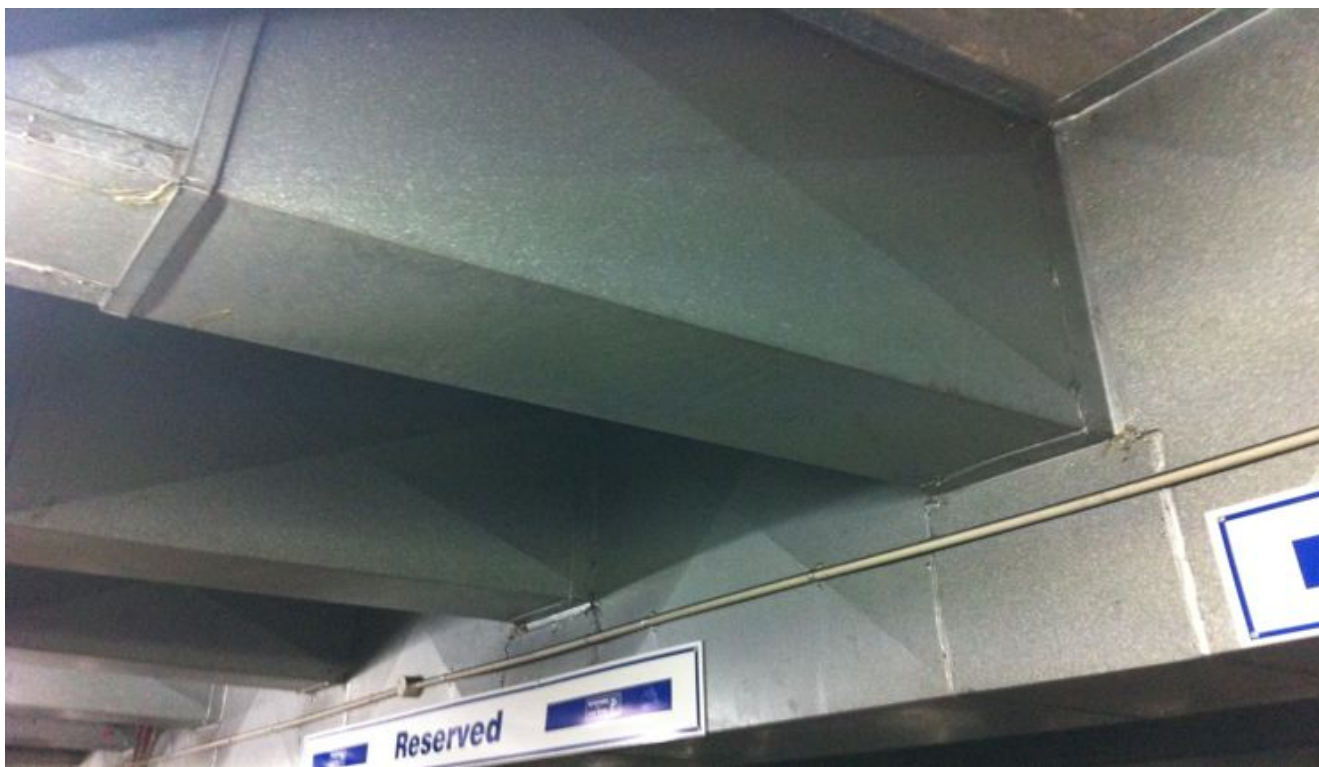
**Photo 31:** Encapsulated ceilings containing asbestos lagging insulation located throughout the Upper Tunnel of the Wynyard Lane Car Park.

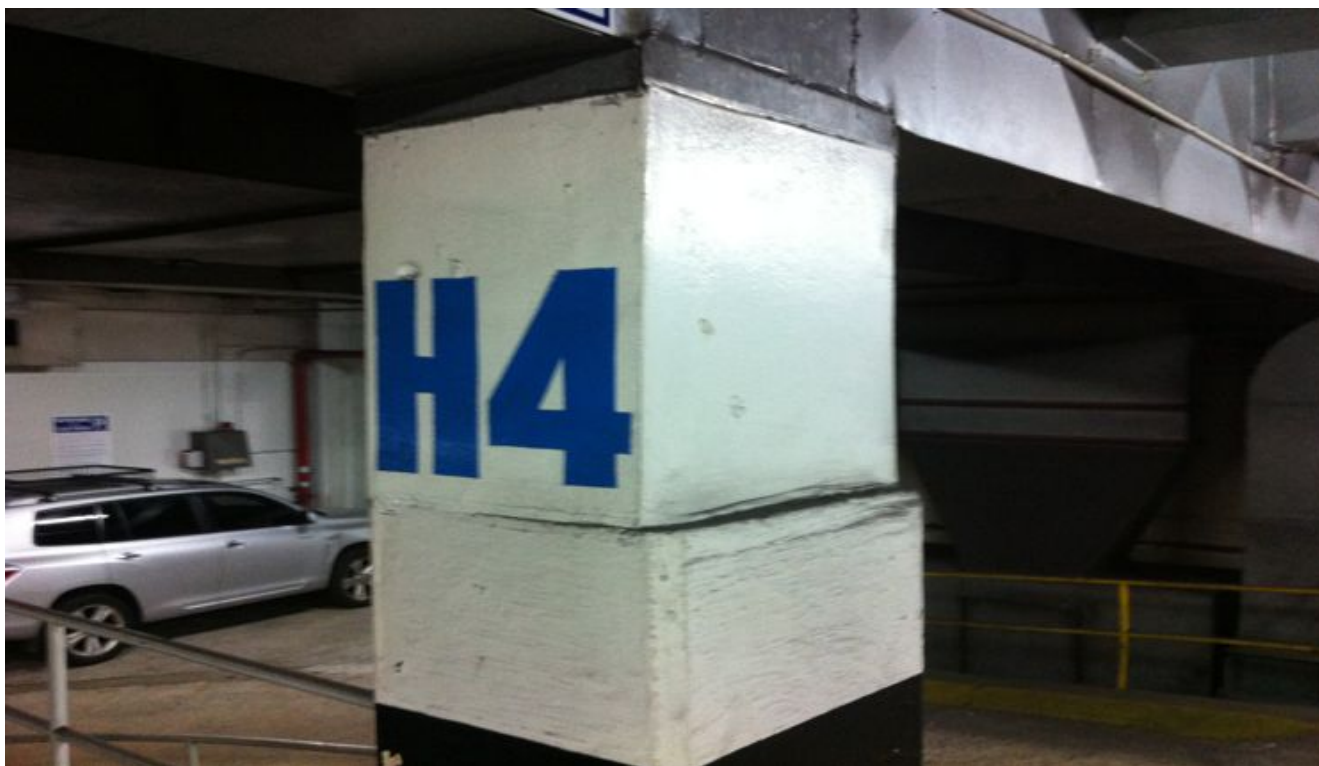
**Photo 32:** Encapsulated columns containing asbestos lagging insulation located throughout the Upper and Lower Tunnels of the Wynyard Lane Car Park.

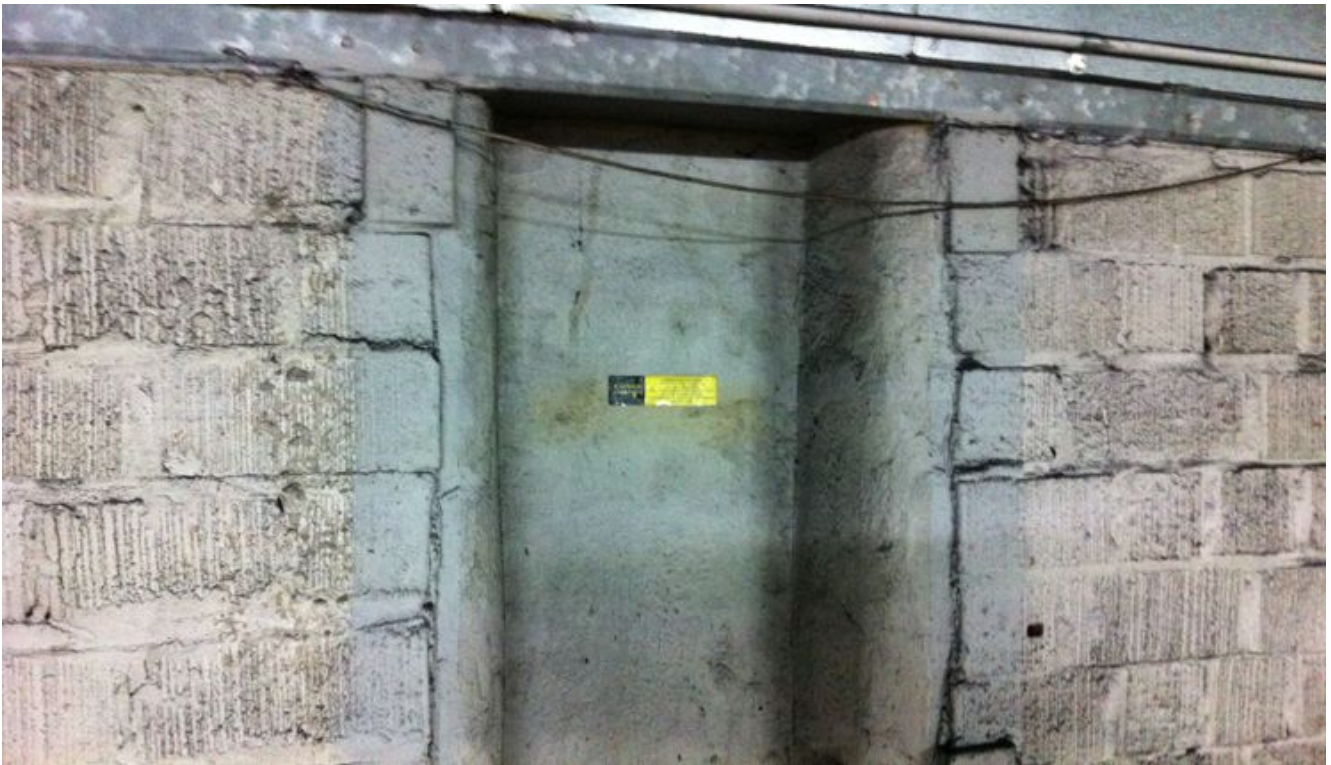
**Photo 33:** Encapsulated columns containing asbestos lagging insulation located throughout the Upper and Lower Tunnels of the Wynyard Lane Car Park.

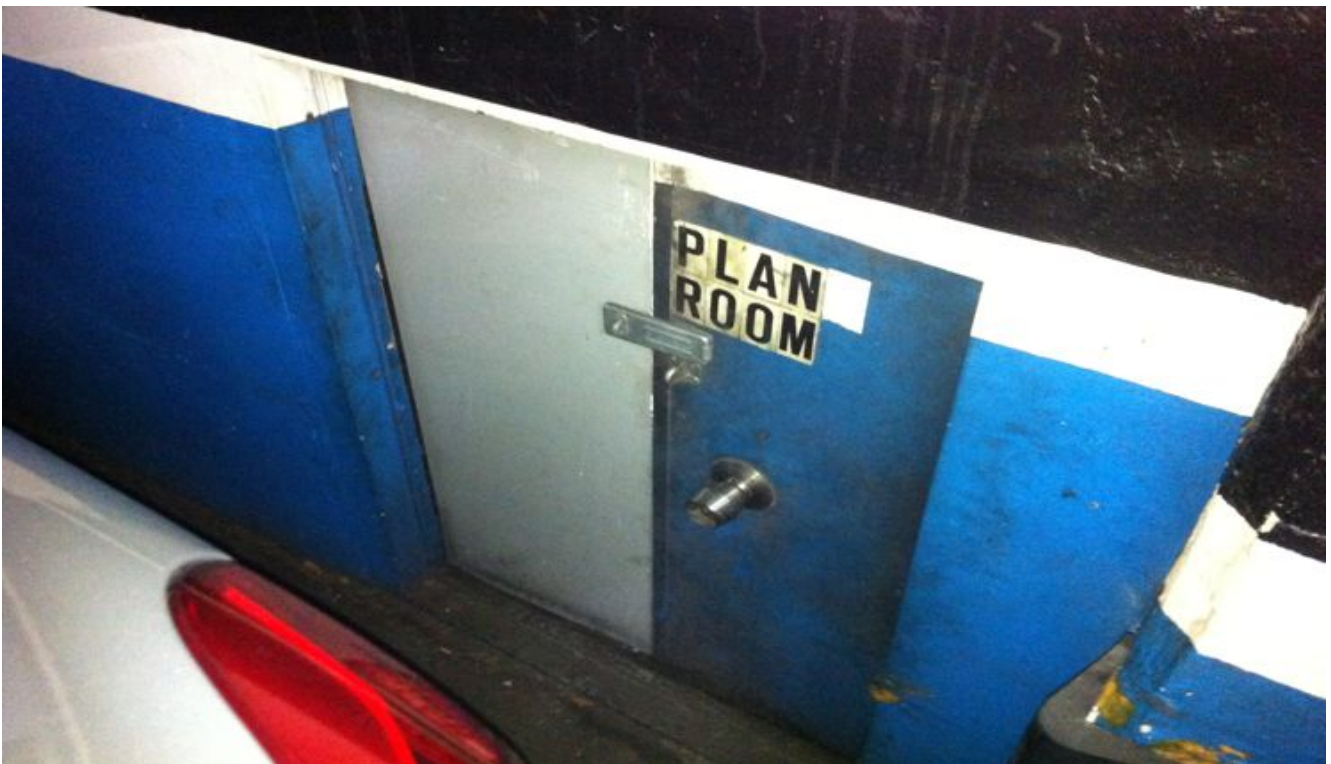
**Photo 34:** Fire doors containing asbestos on the Upper Level Plant Rooms of the Wynyard Lane Car Park.

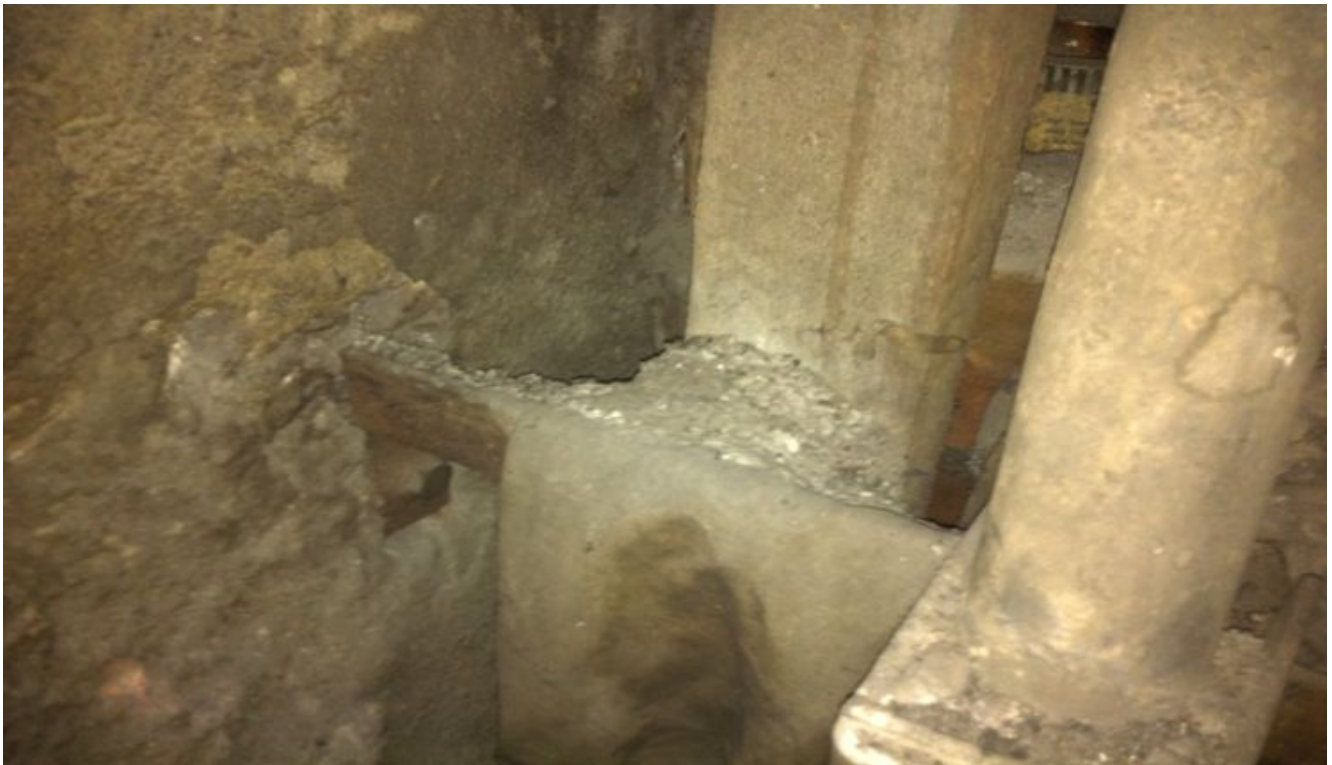
**Photo 35:** Asbestos lagging debris located within the Plumbers Riser Cupboard adjacent to the Entrance of the Wynyard Lane Car Park.

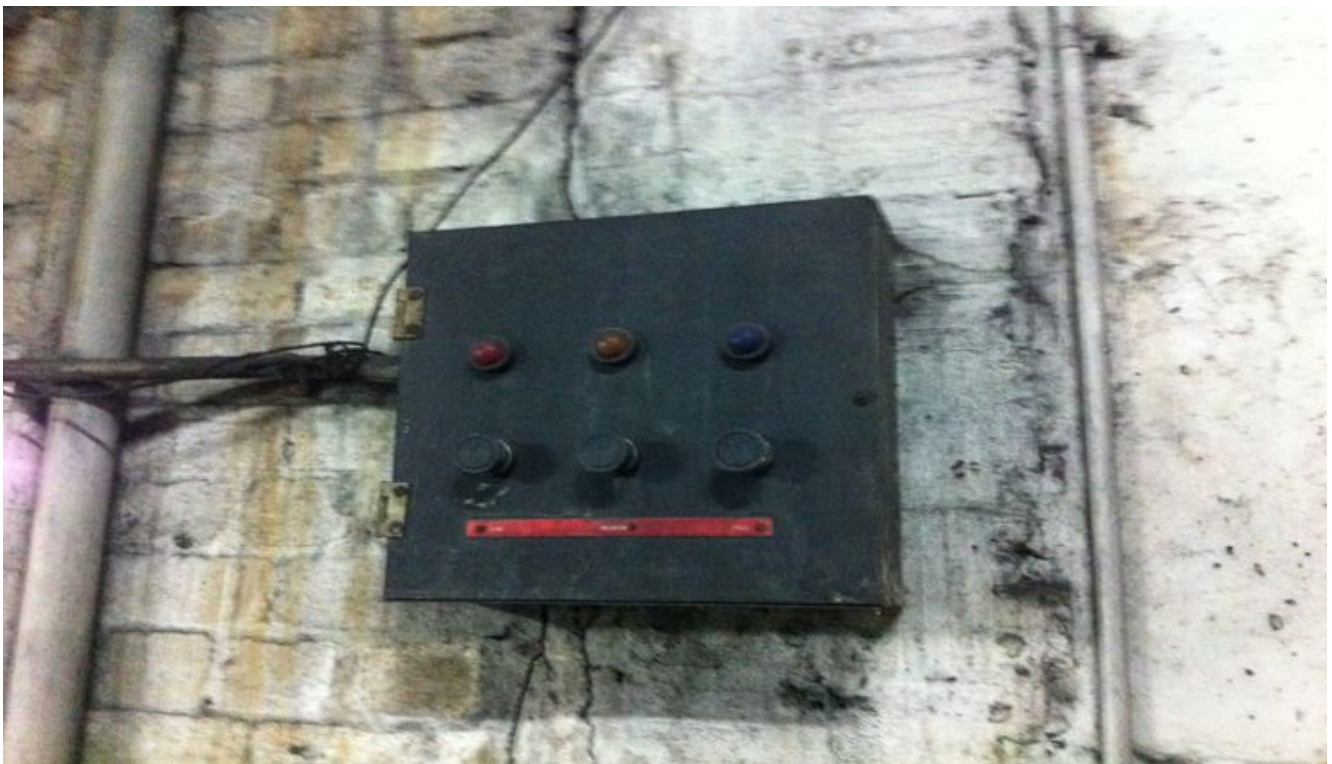
**Photo 36:** Bituminous backing board containing asbestos on the south-western wall of the Northern Section of the Lower Tunnel of Wynyard Lane Car Park.

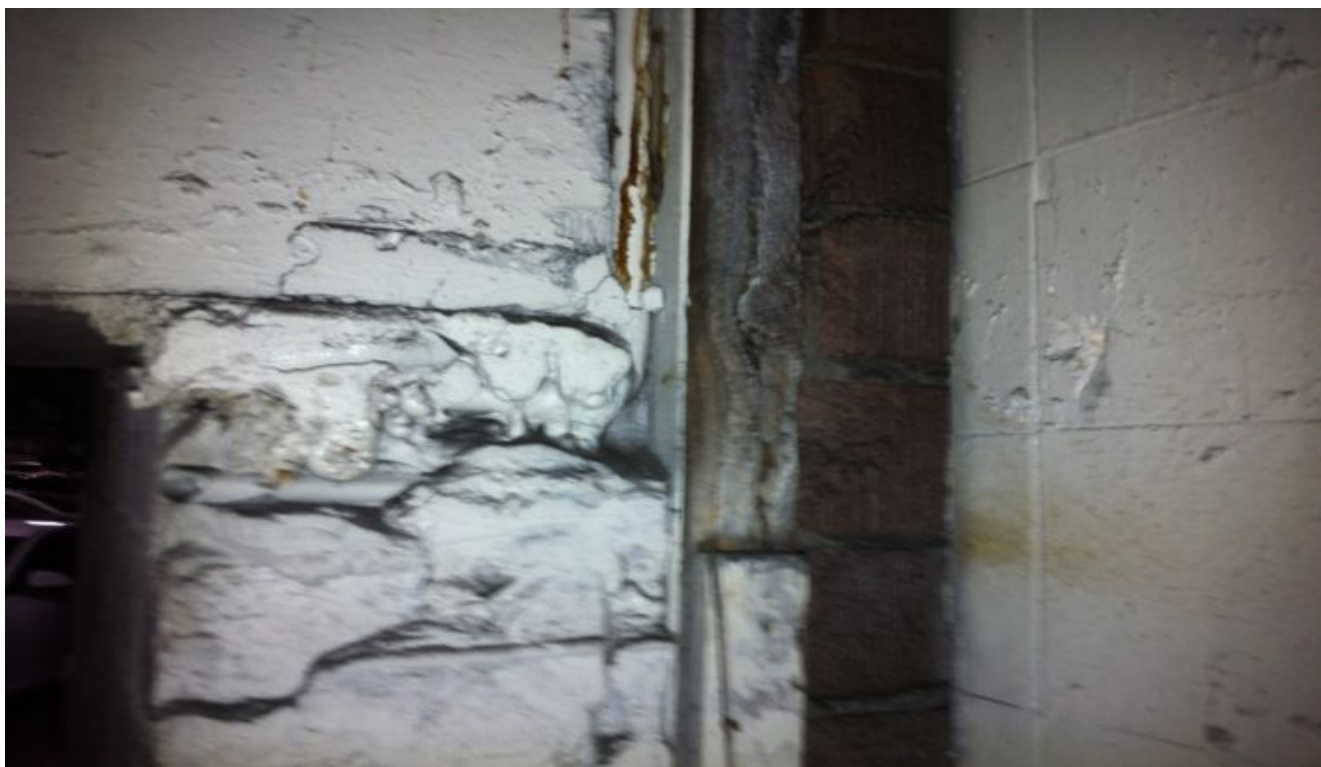
**Photo 37:** Asbestos cement sheeting on the old wall cladding to the Basement Level Tunnel 1 within Wynyard Lane Car Park.

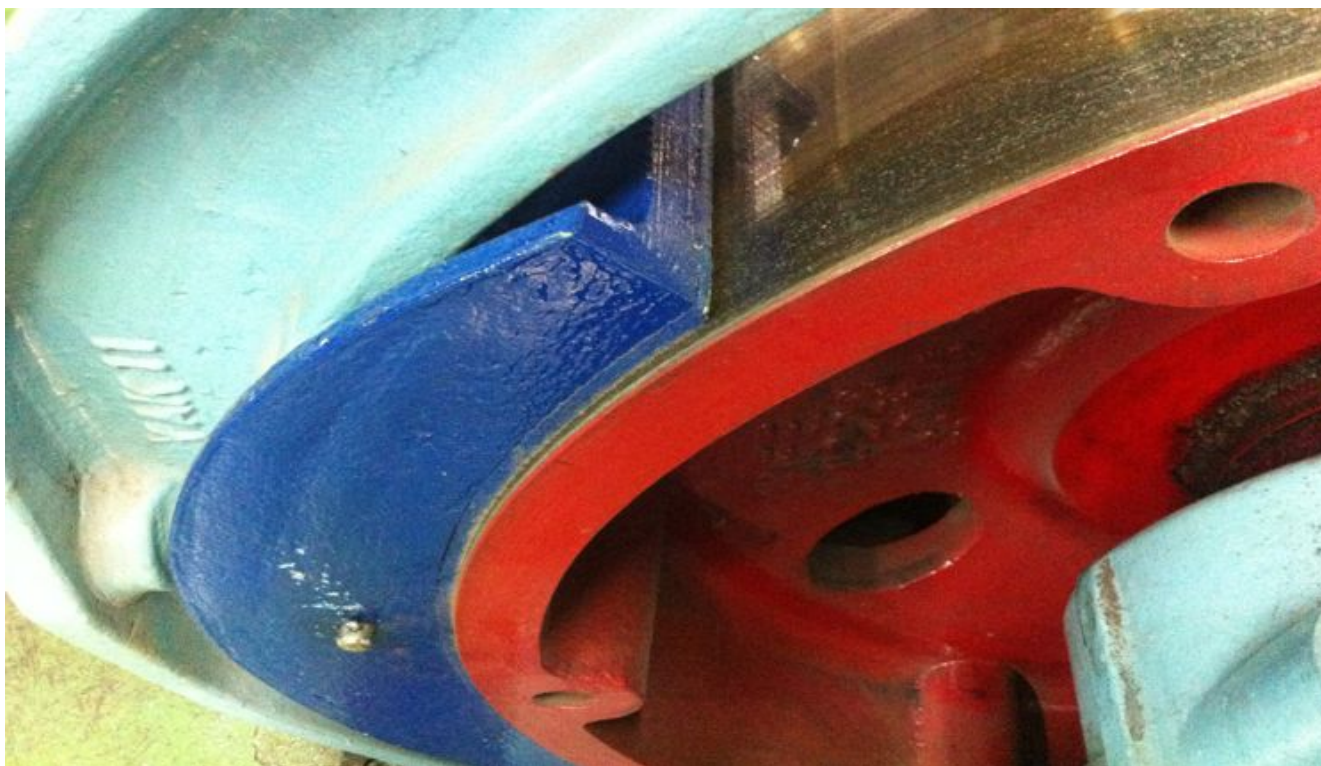
**Photo 38:** Bituminous brake pads containing asbestos on the Lift Motors located within the Lift Motor Room on Level 15 – 301 George Street, Sydney.

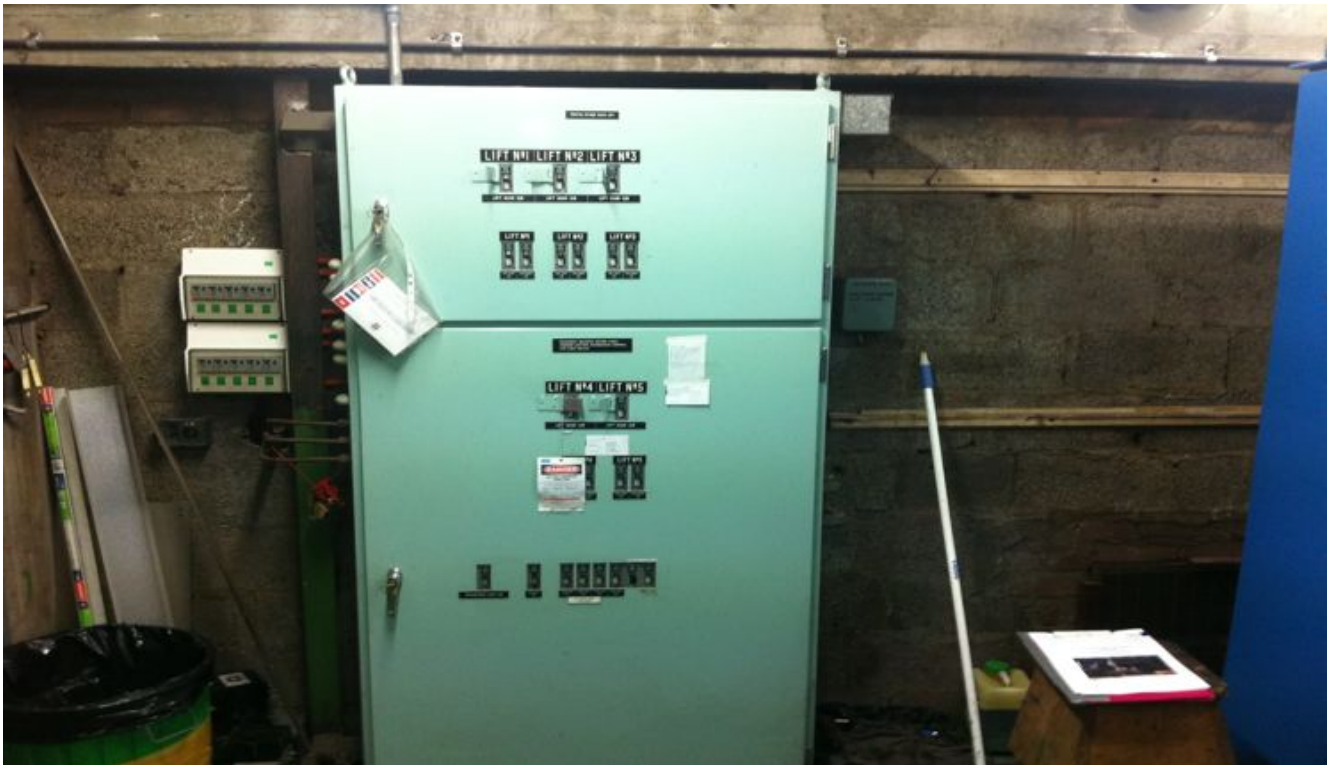
**Photo 39:** One (1) electrical switchboard containing asbestos arc shields within the Lift Motor Room on Level 15 – 301 George Street, Sydney.

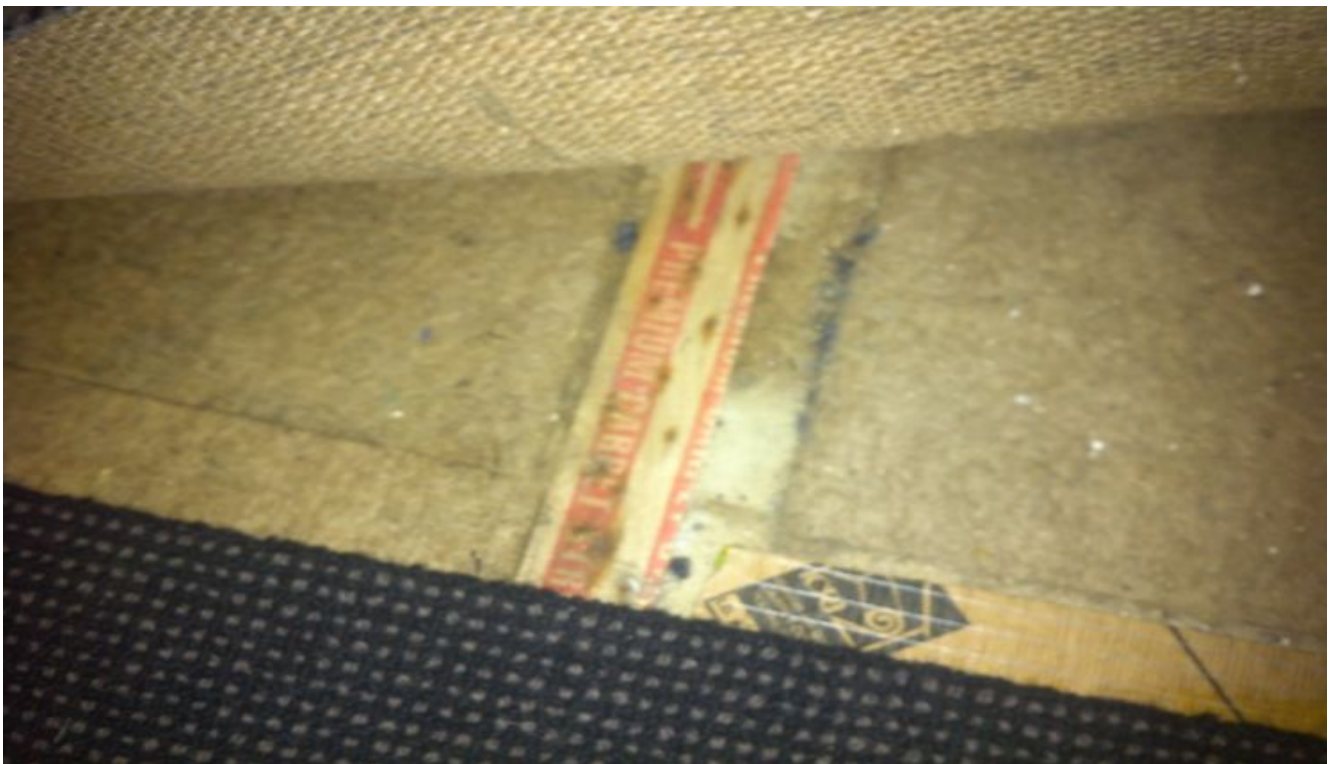
**Photo 40:** Vinyl floor tiles containing asbestos beneath the carpet on all Tenanted Levels of 301 George Street, Sydney.

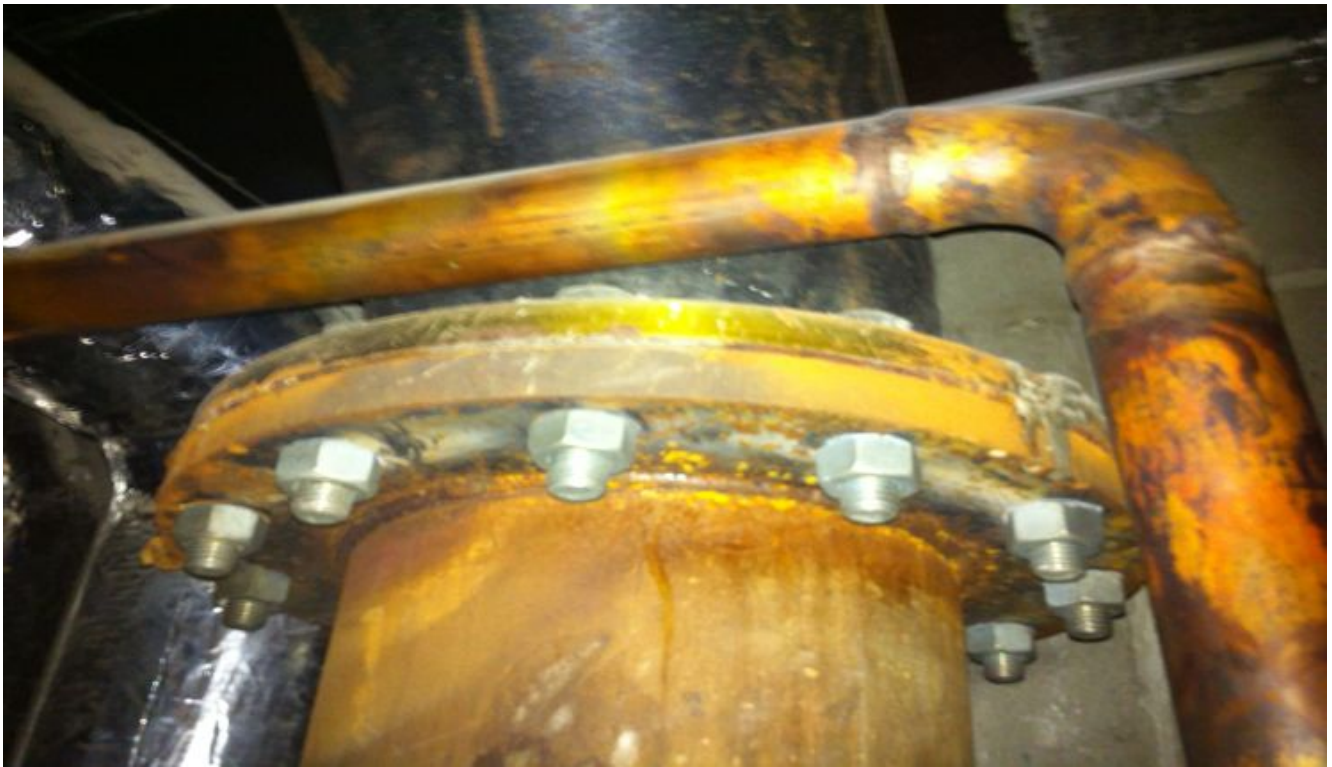
**Photo 41:** One (1) asbestos gasket on the large copper pipe work within the Main Western Riser on Level 3 of 301 George Street, Sydney.

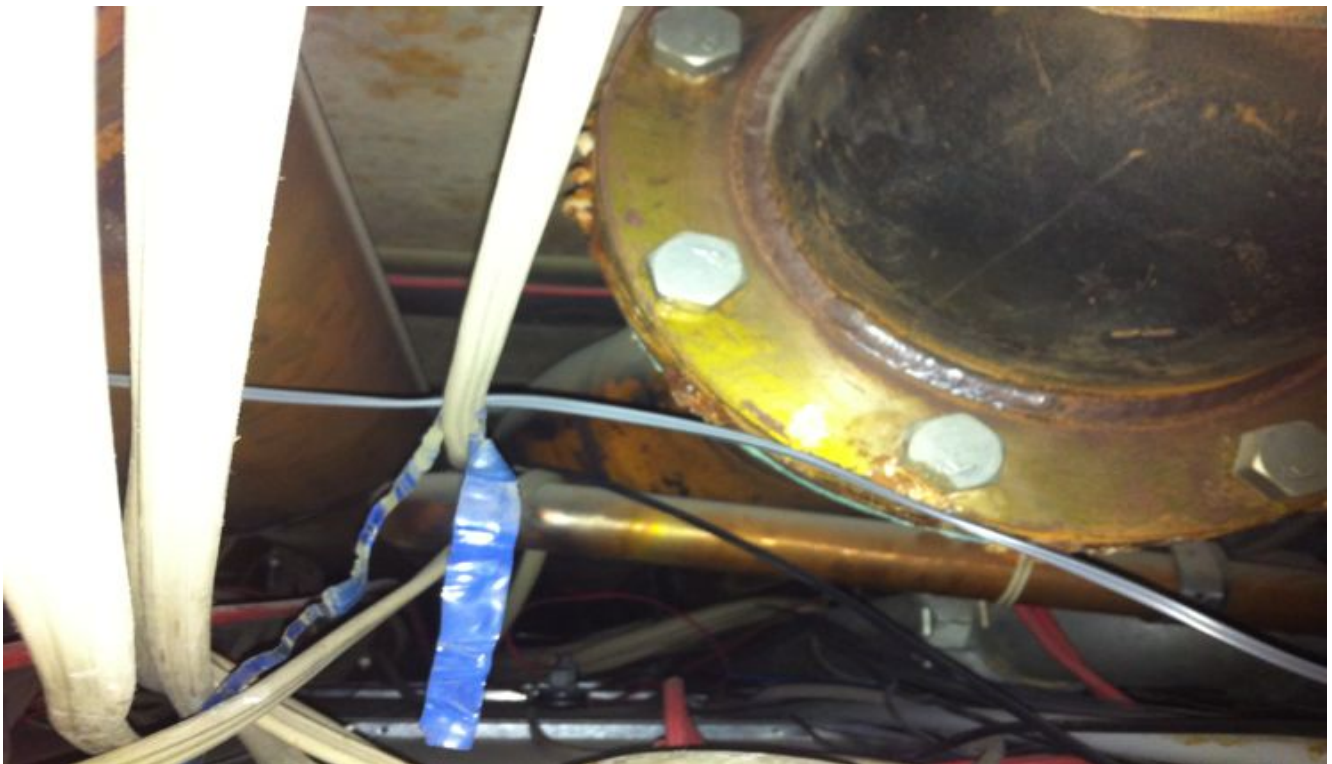
**Photo 42:** One (1) asbestos gasket on the large copper pipe work within the ceiling space of the Main Hallway on Level 2 of 301 George Street, Sydney

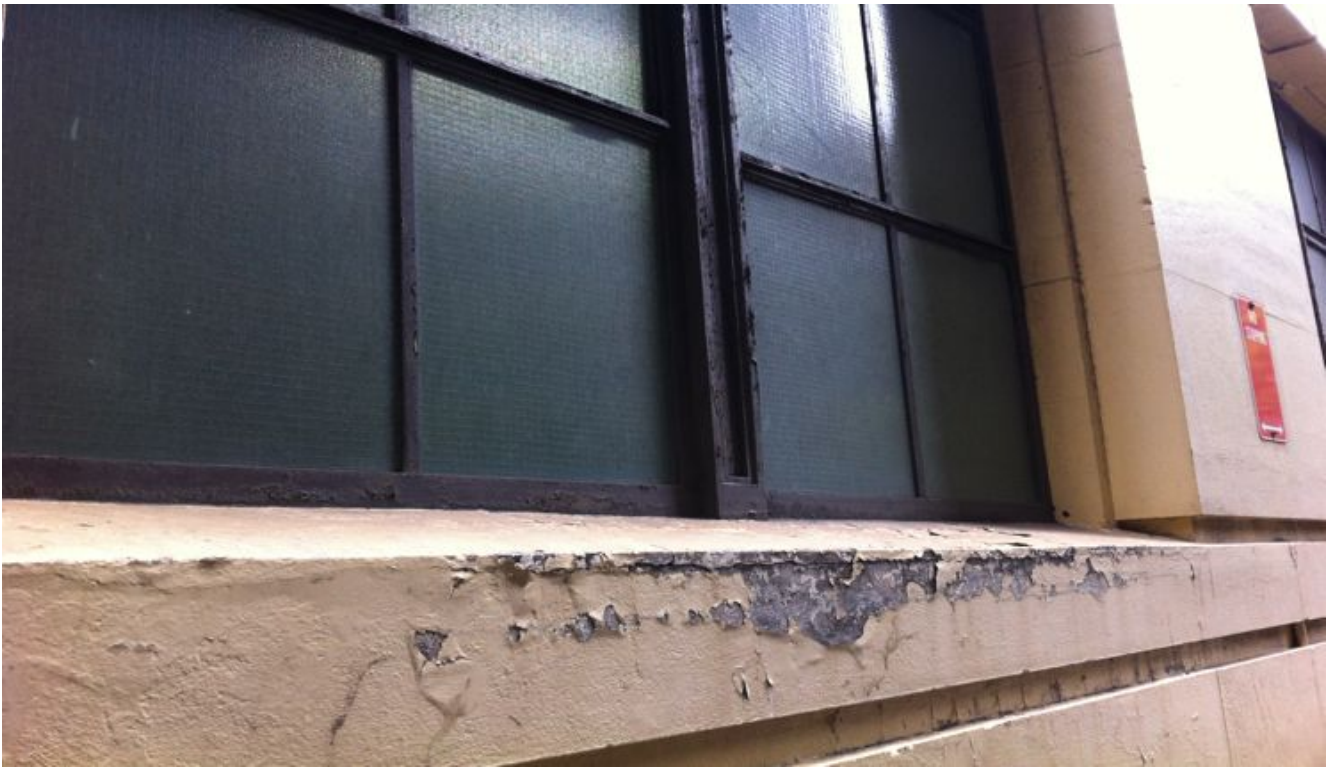
| Location | Sample ID | Sample Status | Photo No. | Condition | Action Required | Action Taken |
|---|---|---|---|---|---|---|
| External – Ground Level – walls – yellow paint | 21582-2/3 | >1% lead by weight | 43 | Poor<br>[Flaking, Peeling, chalking] | Presents a hazard in it's current state.<br>Remove of encapsulate paint | |
| External – Ground Level to Rooftop Level – window frames – brown paint | 21582-2/4 | >1% lead by weight | 43 | Poor<br>[Flaking, Peeling, chalking] | Presents a hazard in it's current state.<br>Remove of encapsulate paint | |

**Photo 43:** Brown and yellow paint containing elevated levels of lead on the external area of the North Wing – Menzies Hotel.

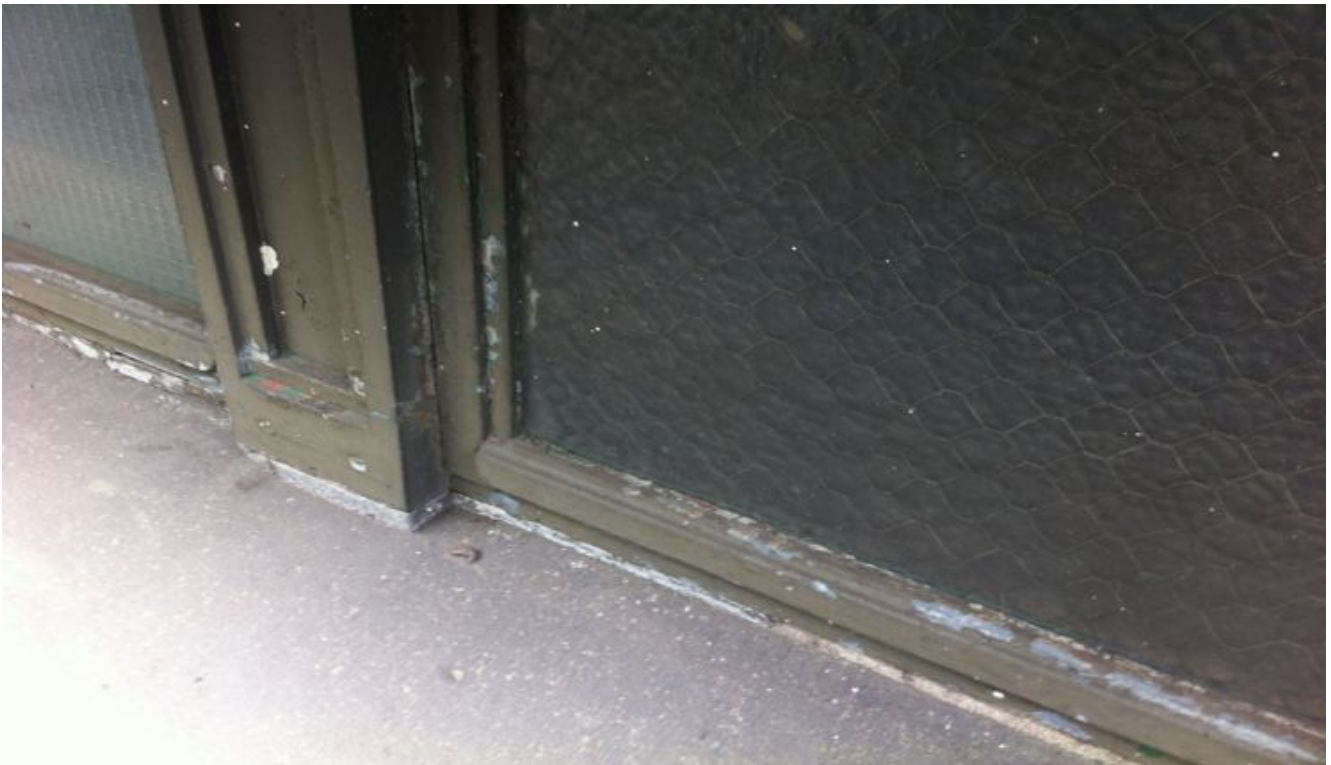
| Location | Sample ID | Sample Status | Photo No. | Condition | Action Required | Action Taken |
|---|---|---|---|---|---|---|
| External – Ground Level - Rooftop Level – window frames – green paint | 21582-2/5 | >1% lead by weight | 44 | Poor<br>[Flaking, Peeling, chalking] | Presents a hazard in it's current state.<br>Remove of encapsulate paint | |

**Photo 44:** Green paint containing elevated levels of lead on the external window frames of the North Wing – Menzies Hotel.
