## **HAZARDOUS MATERIALS SURVEY**

**One Carrington  
Development**

**Project No.  
21582**

**Date:  
10-01-14**

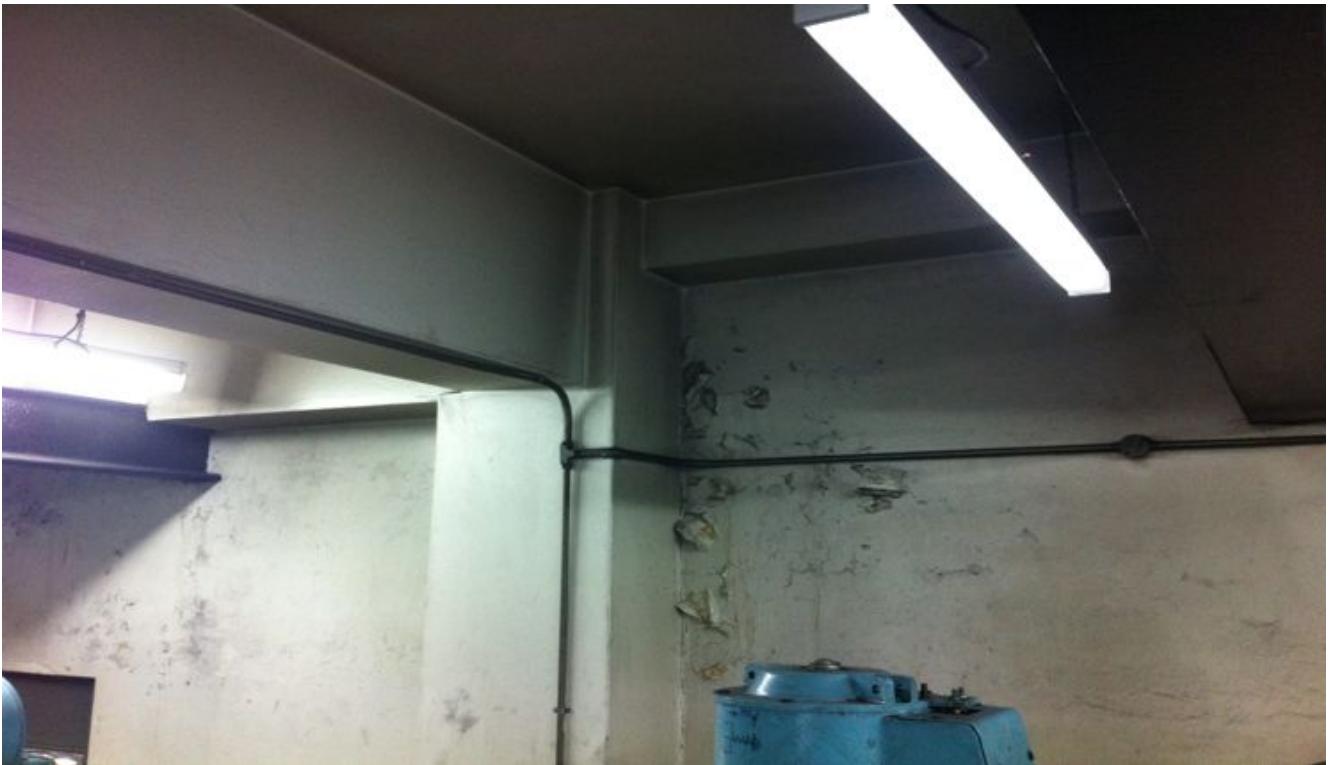
| Location | Sample ID | Sample Status | Photo No. | Condition | Action Required | Action Taken |
|---|---|---|---|---|---|---|
| Internal – Level Lift Motor Room – ceiling & walls – beige paint | 21582-2/6 | >1% lead by weight | 45 | Poor<br>[Flaking, Peeling, chalking] | Presents a hazard in it's current state.<br>Remove of encapsulate paint | |

**Photo 45:** Beige paint containing elevated levels of lead on the ceiling and walls within the Lift Motor Room on the North Wing – Menzies Hotel.

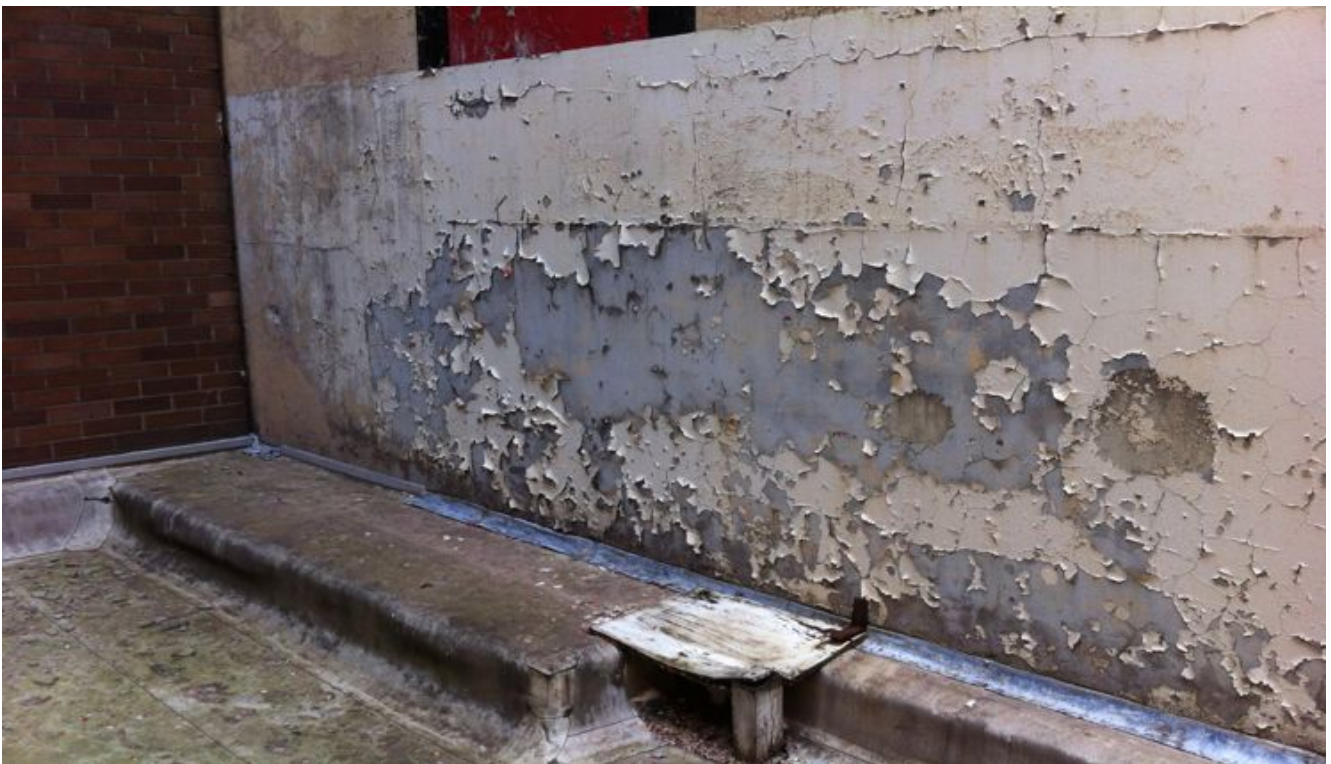
| Location | Sample ID | Sample Status | Photo No. | Condition | Action Required | Action Taken |
|---|---|---|---|---|---|---|
| External – Level 3 ½ - northern wall – beige paint | 21582-2/2 | >1% lead by weight | 46 | Poor<br>[Flaking, Peeling, chalking] | Presents a hazard in it's current state.<br>Remove of encapsulate paint | - |

**Photo 46:** Beige paint containing elevated levels of lead on the external walls of Level 3 ½ on the South Wing – Menzies Hotel.

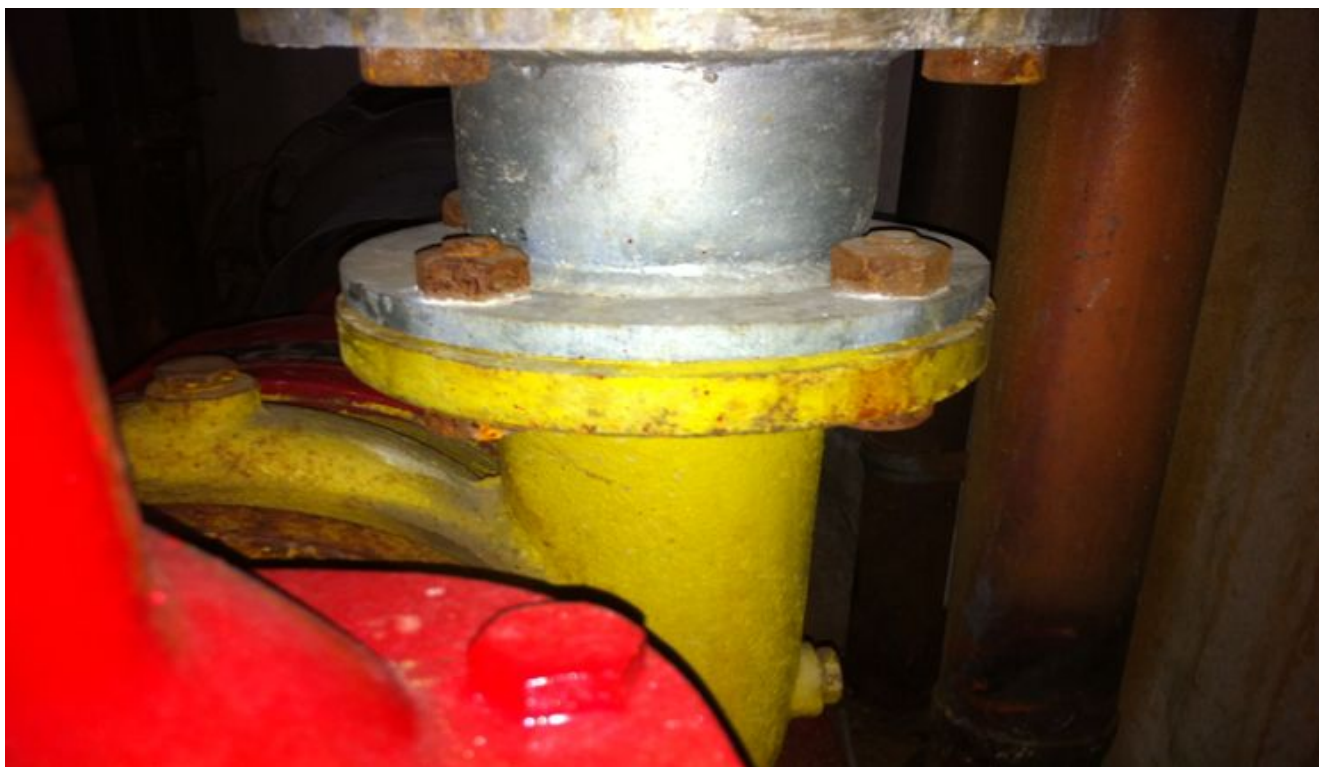
| Location | Sample ID | Sample Status | Photo No. | Condition | Action Required | Action Taken |
|---|---|---|---|---|---|---|
| Internal – Level 3 – Hydrant Booster Pump Room – pipe work – yellow paint | 21582-2/22 | >1% lead by weight | 47 | Poor<br>[Flaking, Peeling, chalking] | Presents a hazard in it's current state.<br>Remove of encapsulate paint | - |

**Photo 47:** Yellow paint containing elevated levels of lead on pipe work within the Hydrant Booster Pump Room on Level 3 of 301 George Street, Sydney.

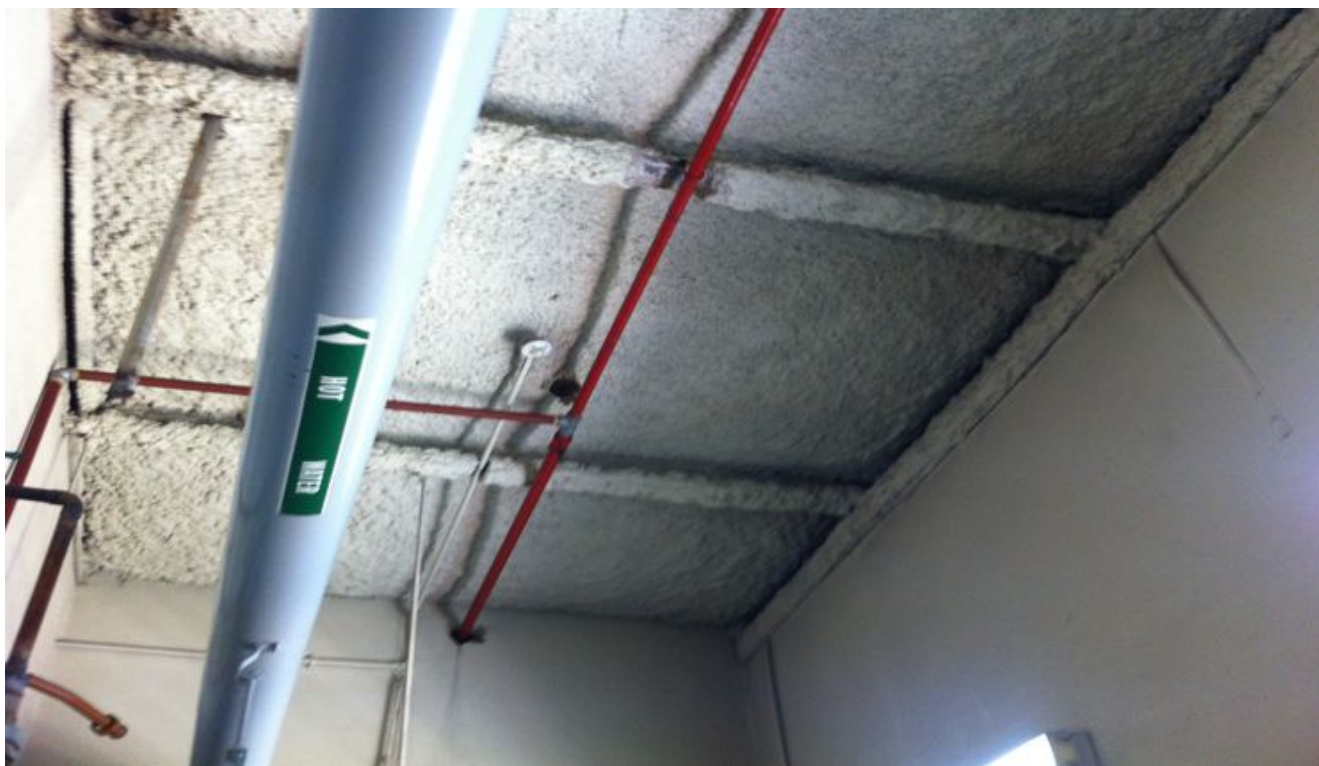
**Photo 48:** Sprayed SMF insulation on the ceiling of the Boiler Room on the Rooftop Level of the North Wing – Menzies Hotel.

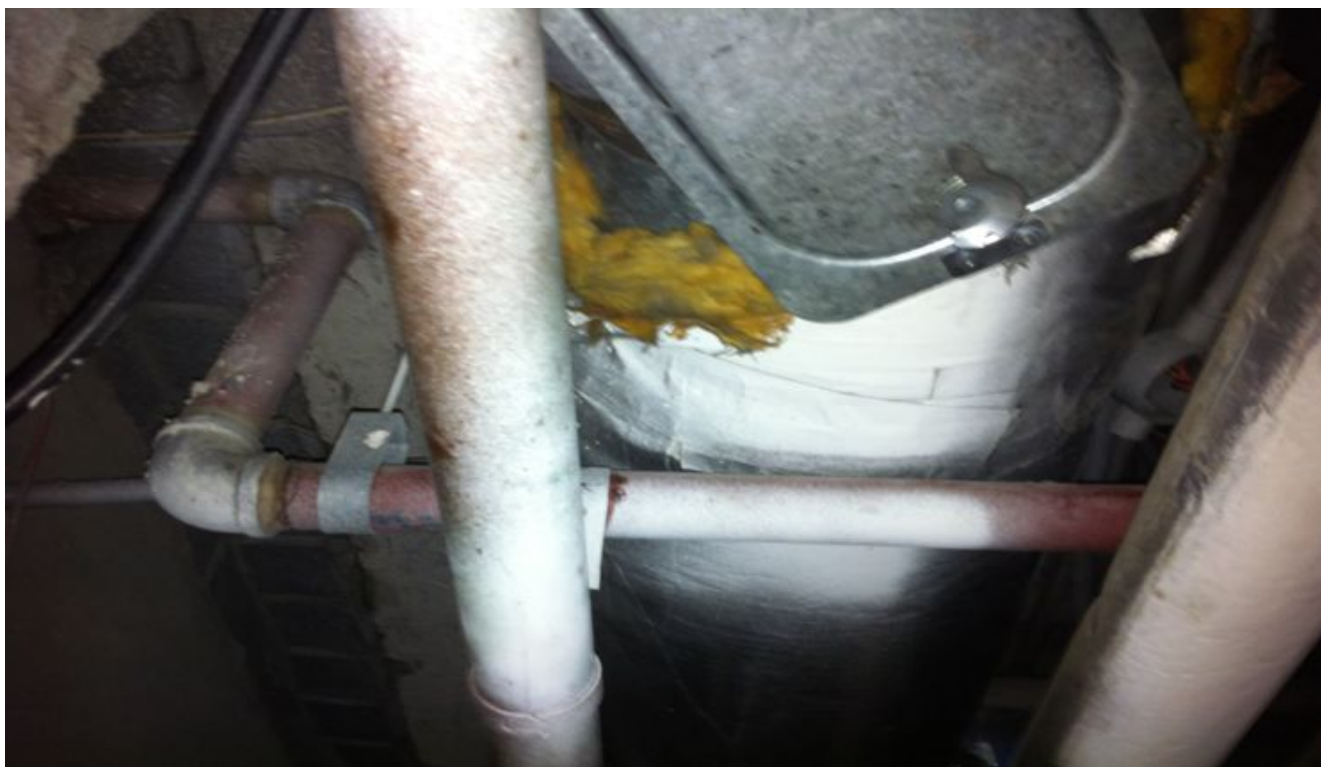
| Location | Material | Photo No. | Form | Condition | Action Required | Action Taken |
|---|---|---|---|---|---|---|
| Throughout – air conditioning duct work – internal insulation | Performed insulation | 49 | Bonded | Stable. Inaccessible. | Procedures and precautions detailed in the National code of Practice for the Safe Use of Synthetic mineral Fibres [NOHSC: 2006 (1990)] should be followed in the management and removal/treatment of all SMF materials. | |

**Photo 49:** SMF insulation surrounding ductwork and oversprayed SMF insulation throughout ceiling spaces of the North Wing – Menzies Hotel.

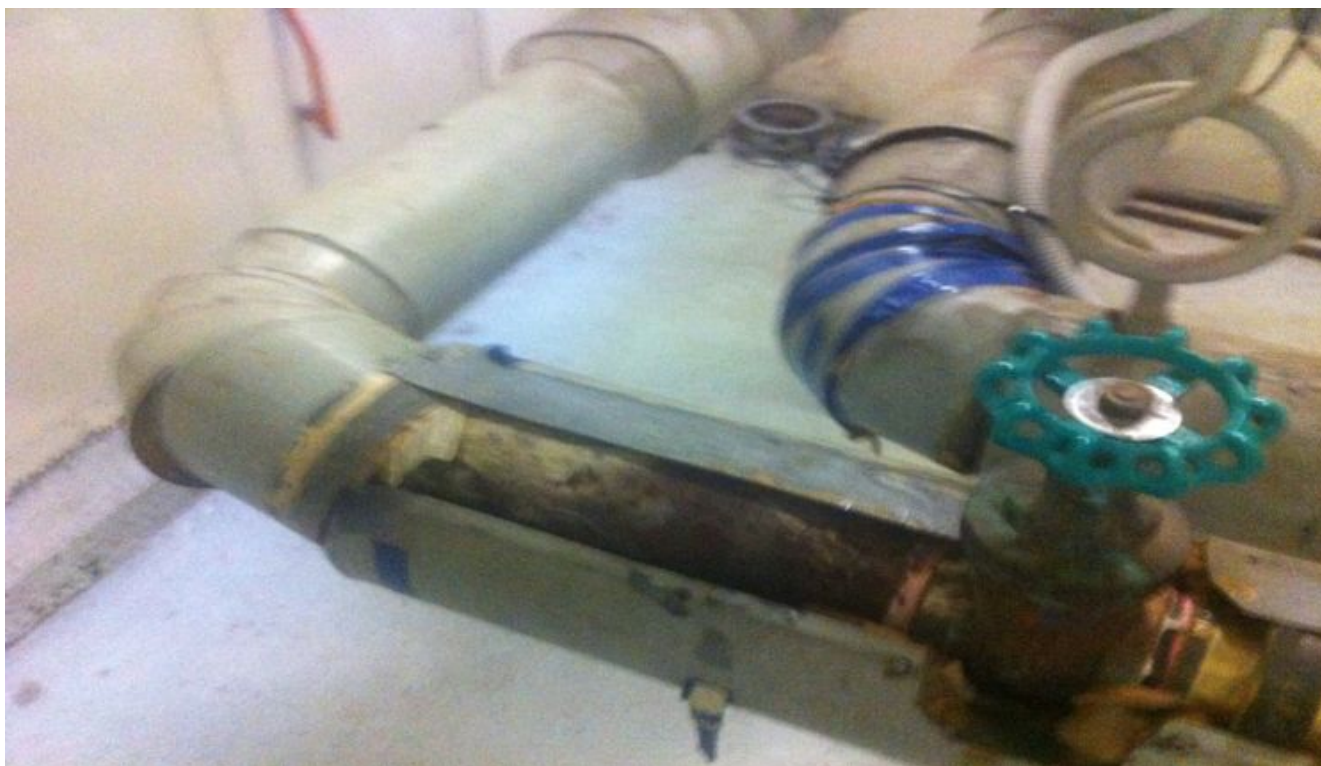
**Photo 50:** Pipe work containing SMF insulation throughout the Plant Rooms within the South Wing – Menzies Hotel.

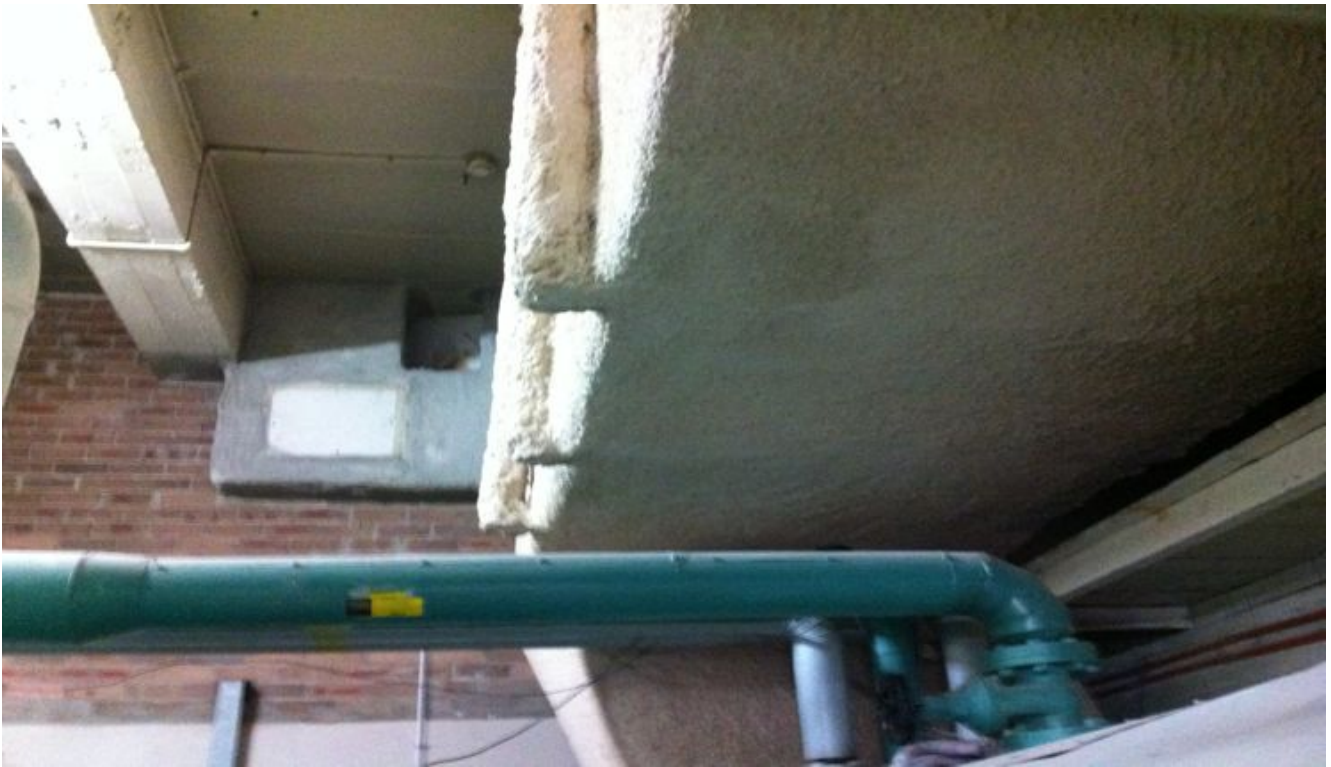
**Photo 51:** Sprayed SMF insulation located within Plant Rooms throughout the South Wing – Menzies Hotel.

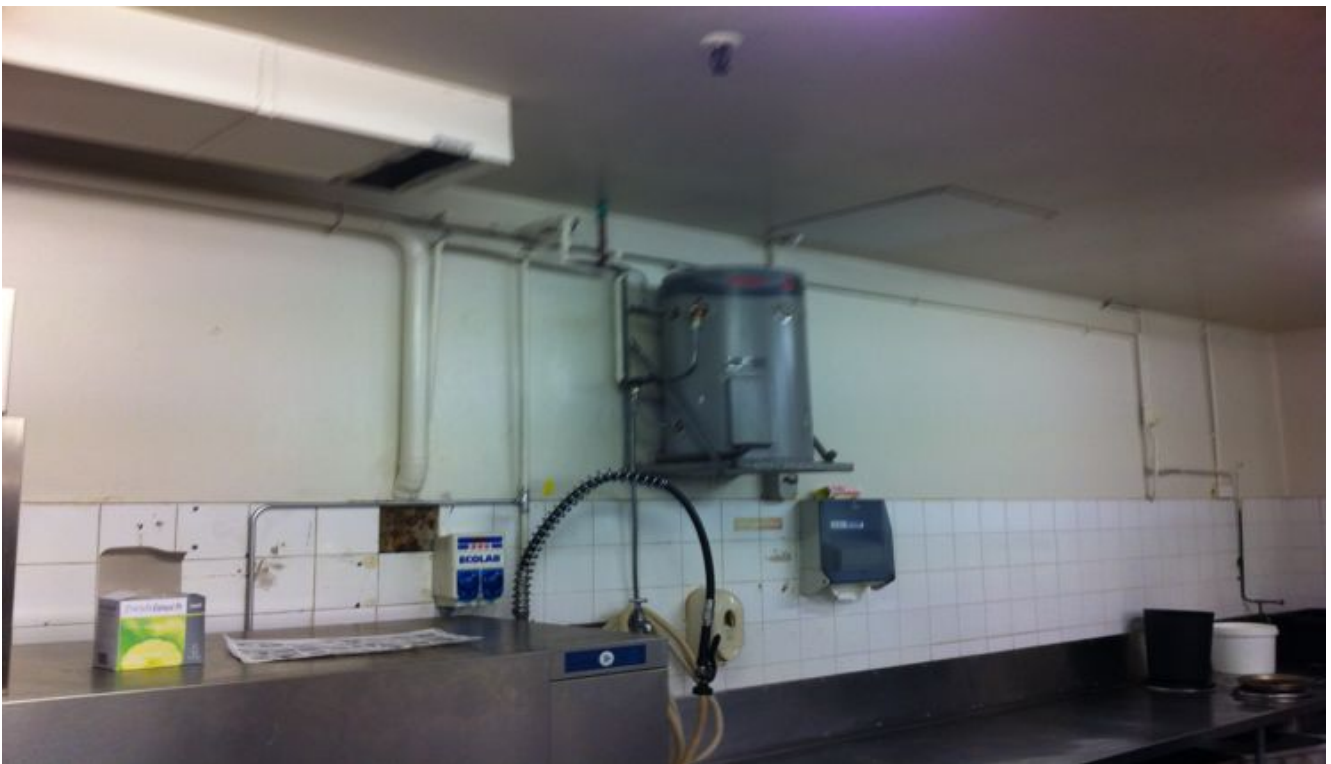
**Photo 52:** Various hot water systems containing internal SMF insulation located throughout the South Wing – Menzies Hotel.

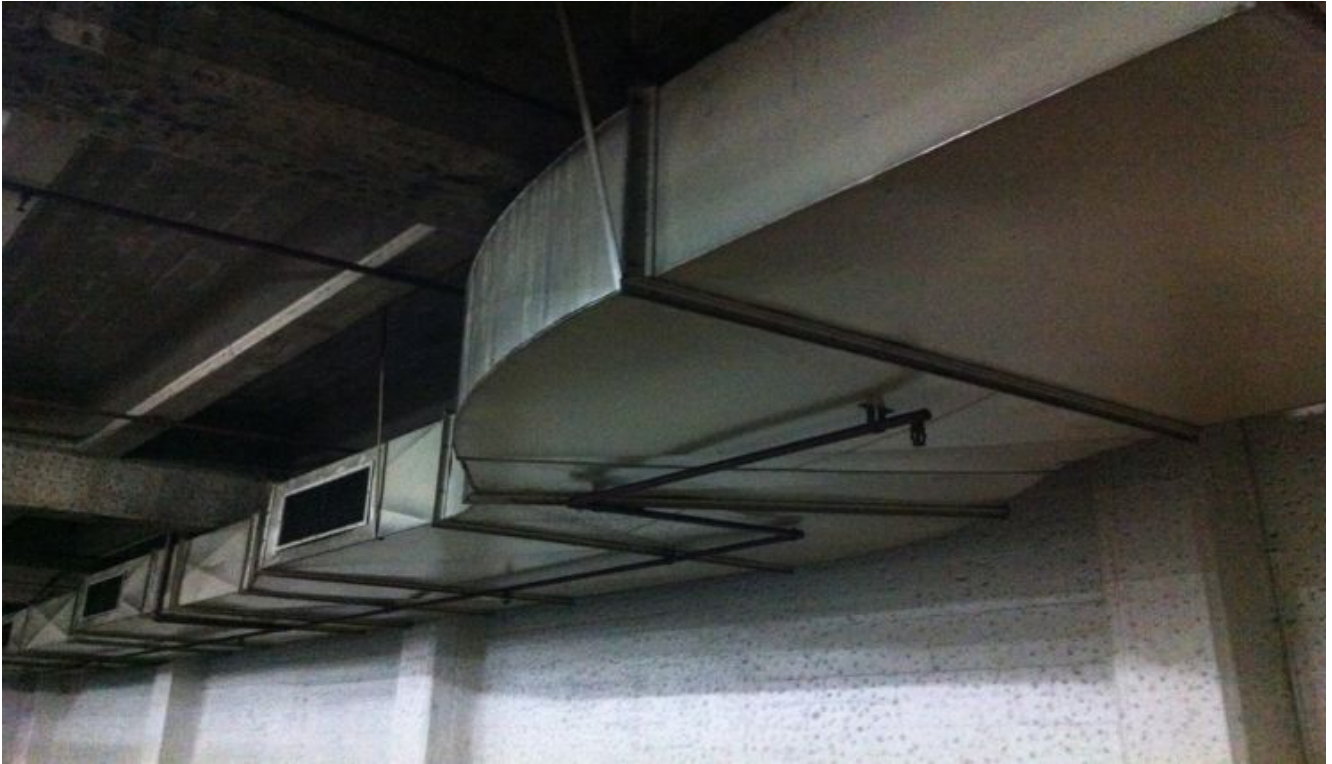
**Photo 53:** Ductwork containing internal SMF insulation located throughout the Wynyard Lane Car Park.

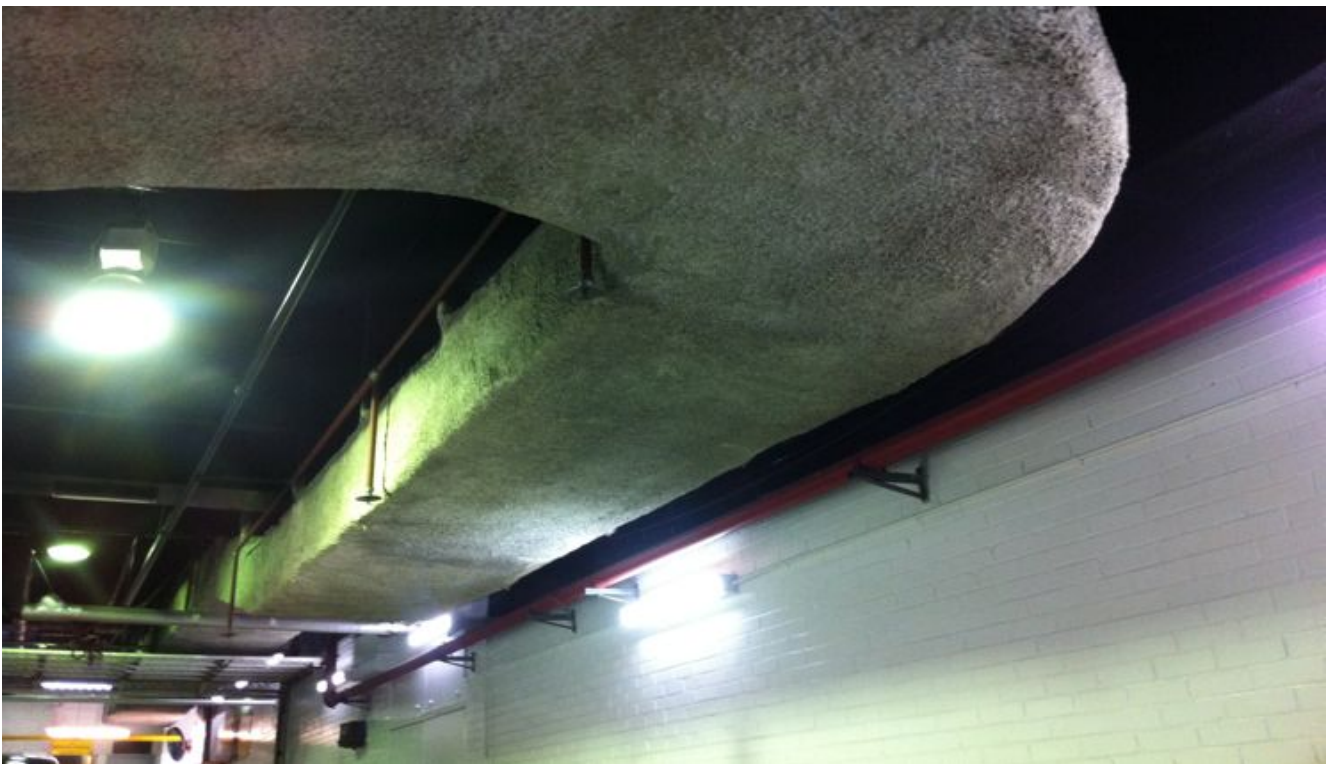
**Photo 54:** Sprayed SMF insulation located adjacent to the entrance to the Wynyard Lane Car Park.

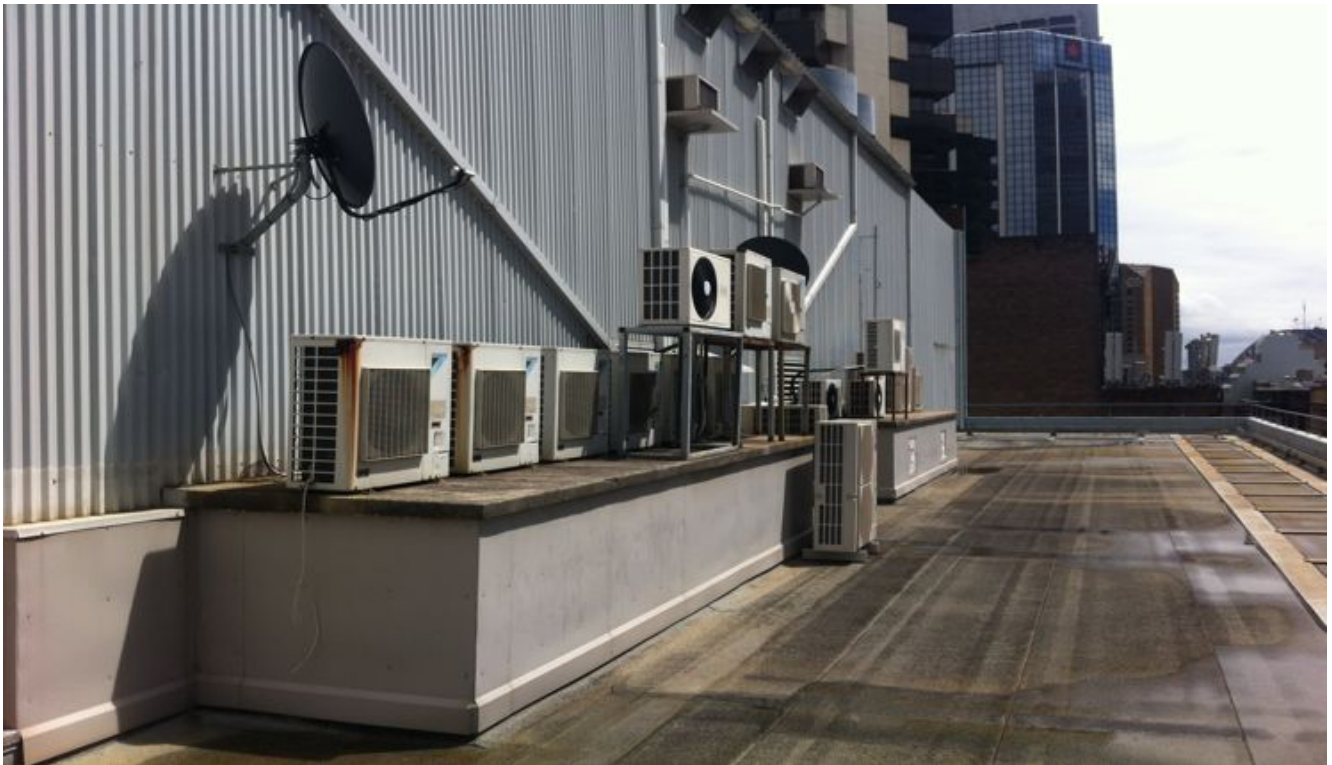
| Location | Material | Photo No. | Form | Condition | Action Required | Action Taken |
|---|---|---|---|---|---|---|
| External – Air Conditioning Units – internal insulation | Performed insulation | 55 | Bonded | Stable.<br>Inaccessible. | Procedures and precautions detailed in the National code of Practice for the Safe Use of Synthetic mineral Fibres [NOHSC: 2006 (1990)] should be followed in the management and removal/treatment of all SMF materials. | |

**Photo 55:** SMF waterproofing and air conditioning units containing SMF insulation on the Rooftop Level of 301 George Street, Sydney.

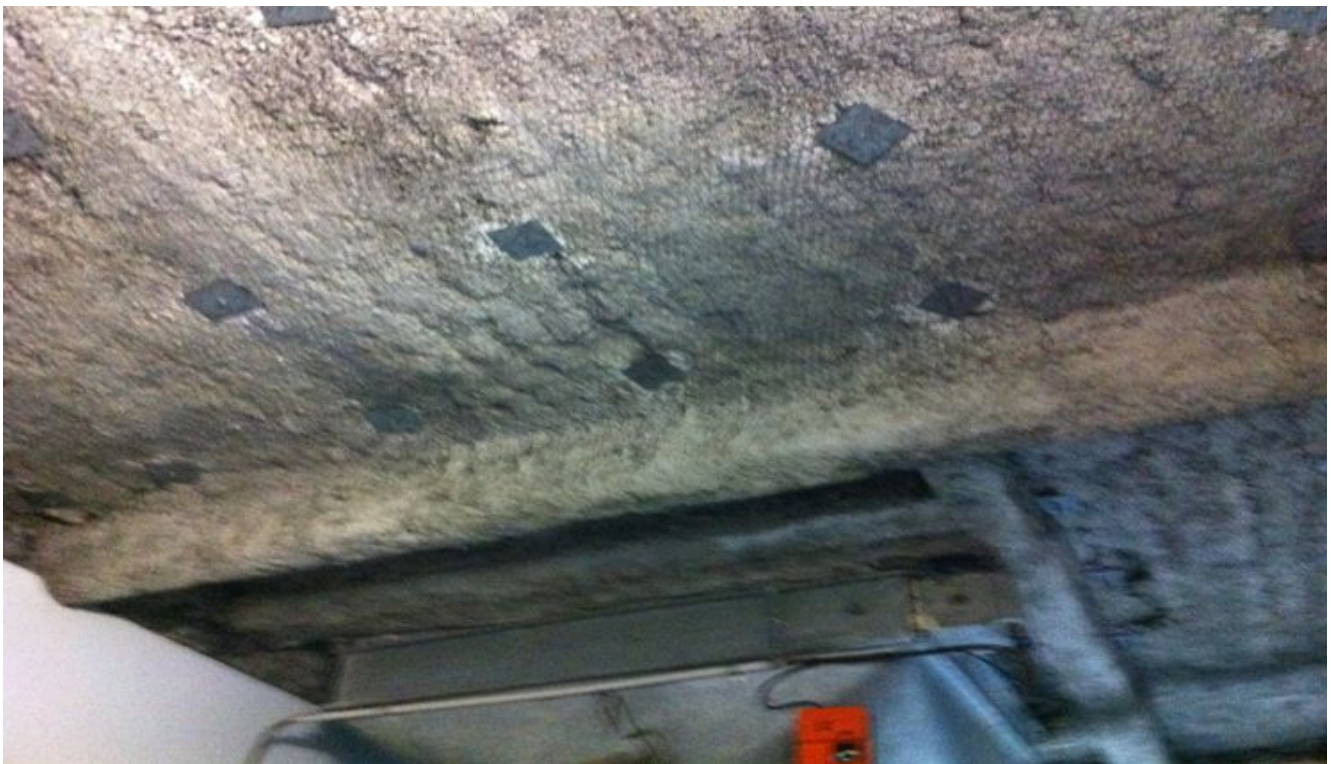
**Photo 56:** SMF insulation on the ceiling of the Fire Stairwell of 301 George Street, Sydney.

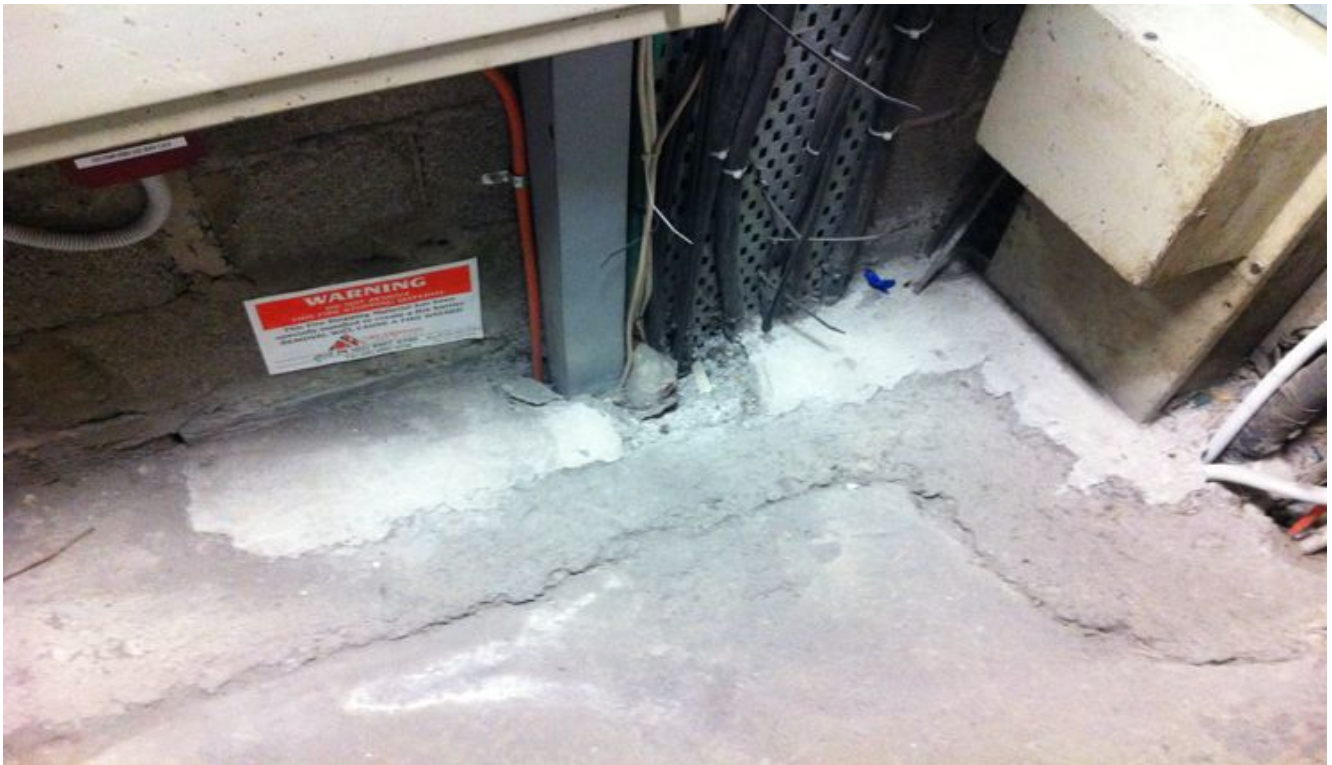
**Photo 57:** SMF fire rating in the penetrations within the riser cupboards of 301 George Street, Sydney.

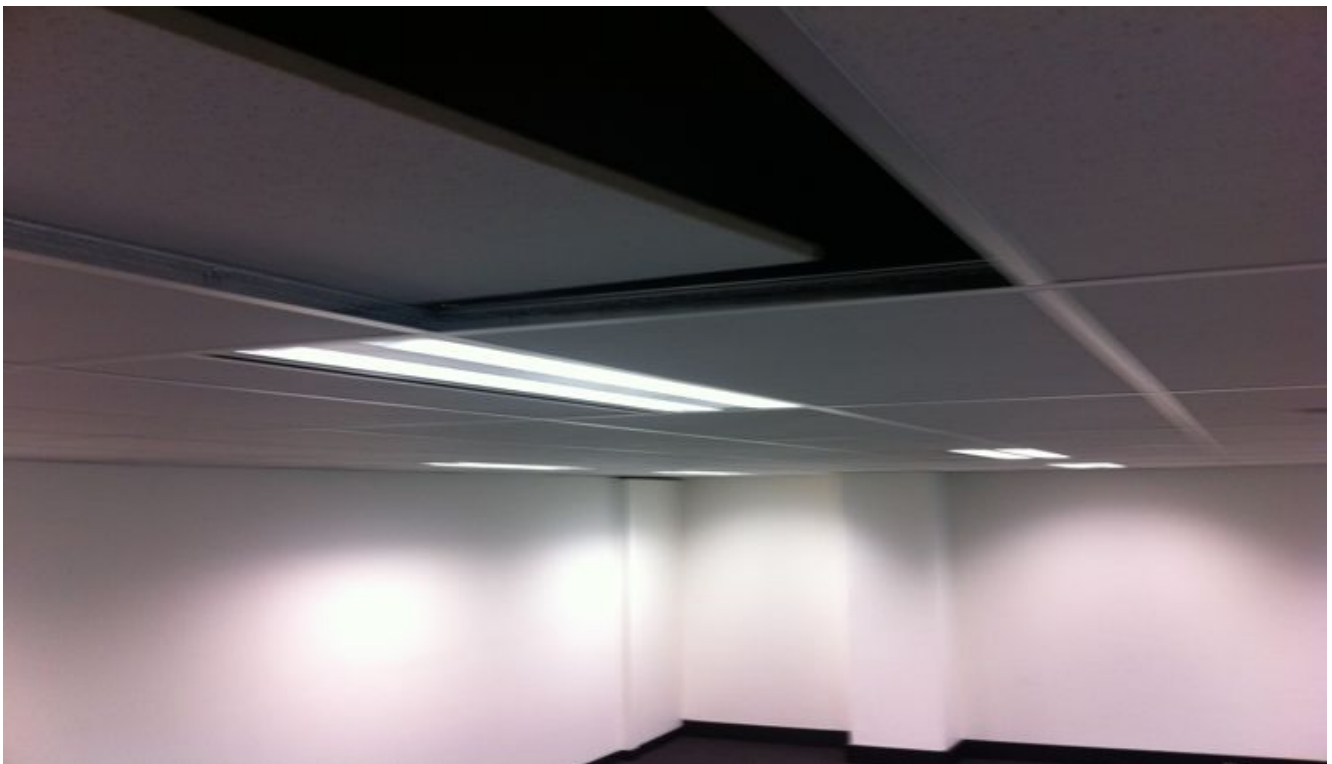
**Photo 58:** Cellulose ceiling tiles containing SMF within the Tenancies of 301 George Street, Sydney.

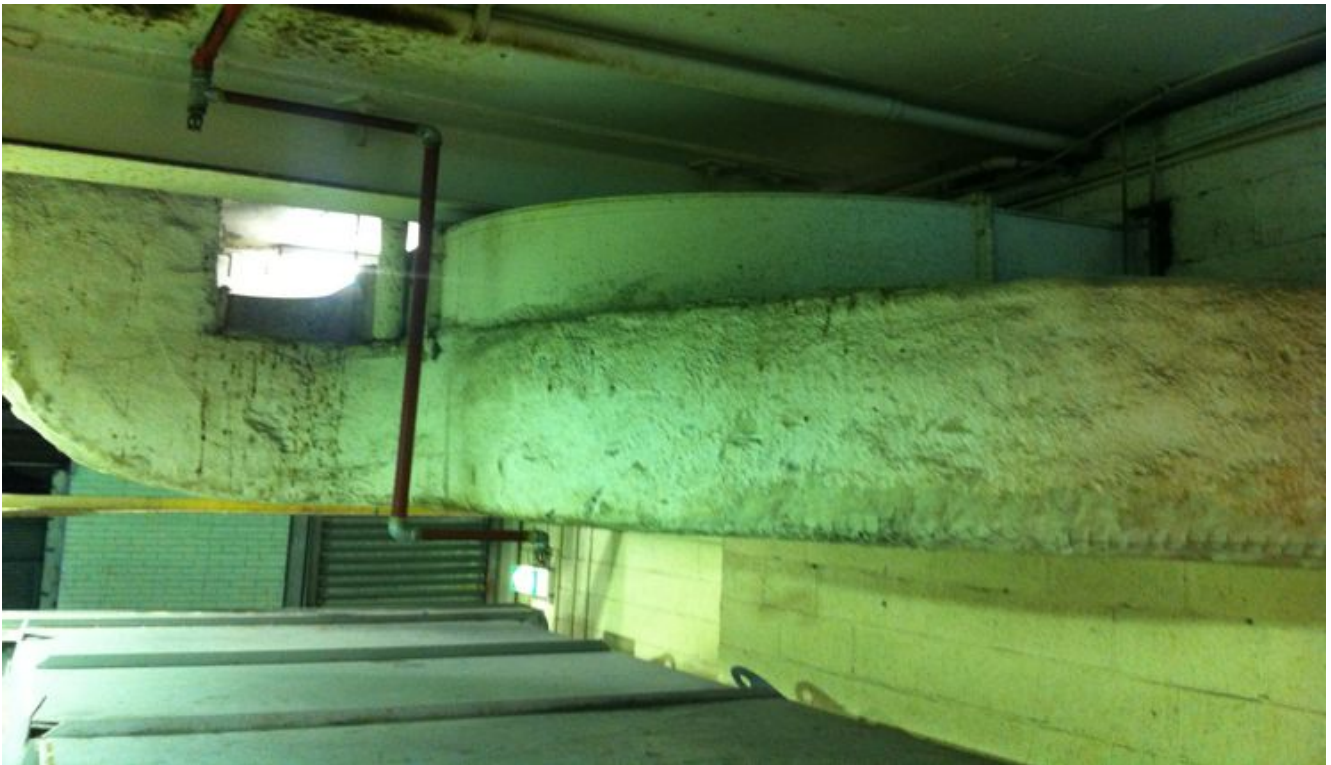
**Photo 59:** SMF insulation on the ductwork within the Loading Dock of 301 George Street, Sydney.

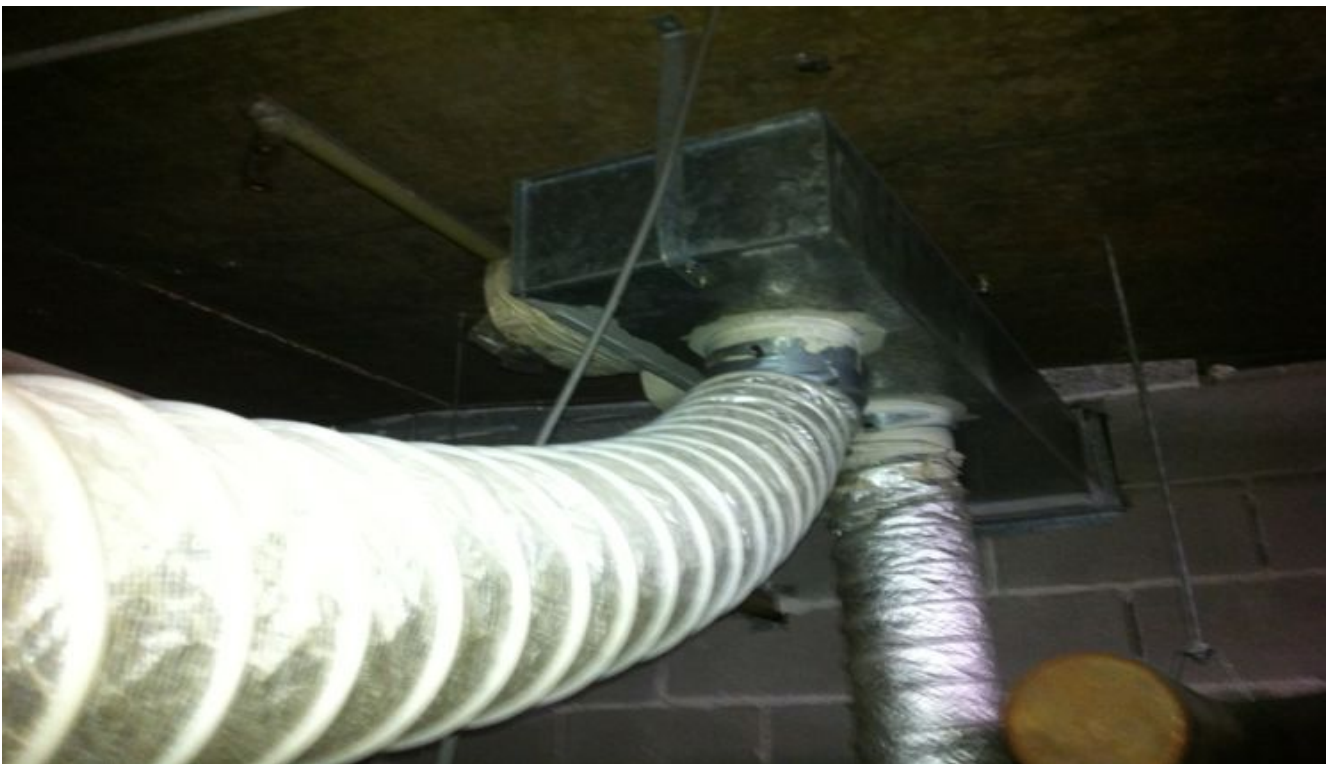
| Location | Material | Photo No. | Form | Condition | Action Required | Action Taken |
|---|---|---|---|---|---|---|
| Throughout – air conditioning duct work – internal insulation | Performed insulation | 60 | Bonded | Stable. Inaccessible. | Procedures and precautions detailed in the National code of Practice for the Safe Use of Synthetic mineral Fibres [NOHSC: 2006 (1990)] should be followed in the management and removal/treatment of all SMF materials. | |

**Photo 60:** SMF insulation within the air conditioning ductwork of the Retail Areas of 301 George Street, Sydney.
