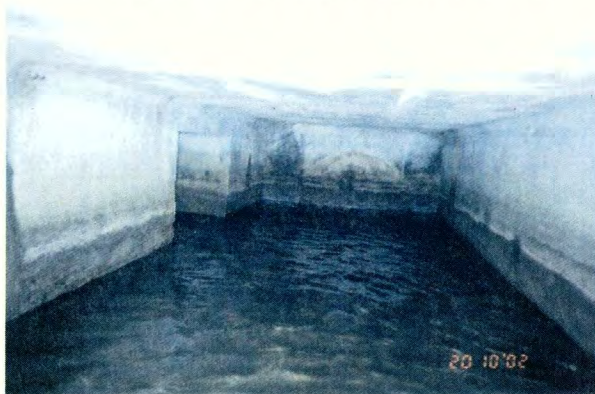
1. DC30A-CP11 (Ch 2.0)  
Cross-connection to parallel channel

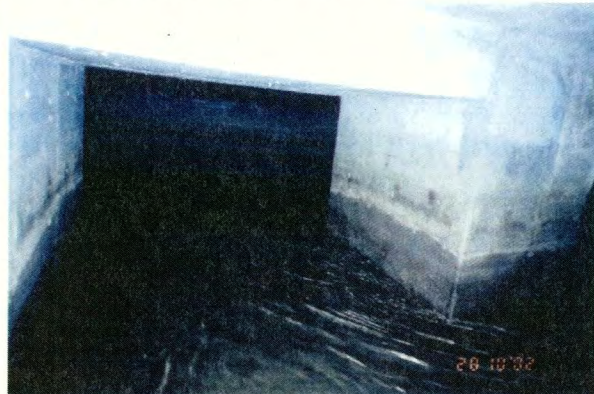
2. DC30A-CP11 (Ch 2.0)  
Cross-connection to parallel channel

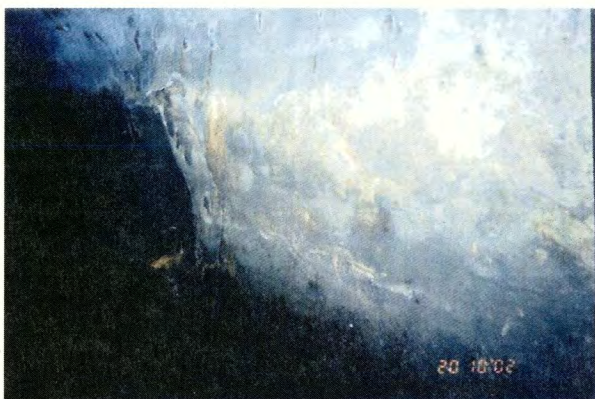
3. DC30A-CP09 to CP10 (Ch 174.0)  
Spalling concrete & exposed reo

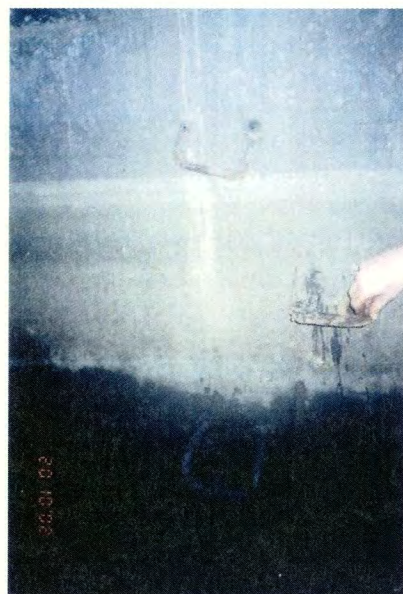
4. DC30A-CP08 (Ch 226.0)  
Deteriorated step-iron

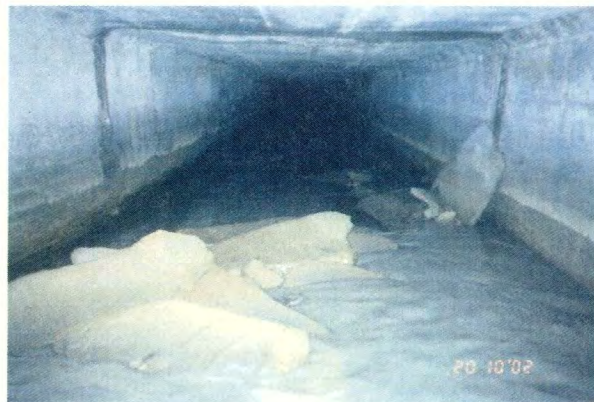
6. DC30A2-CP11 to CP14 (Ch 91.0)  
Debris in channel floor

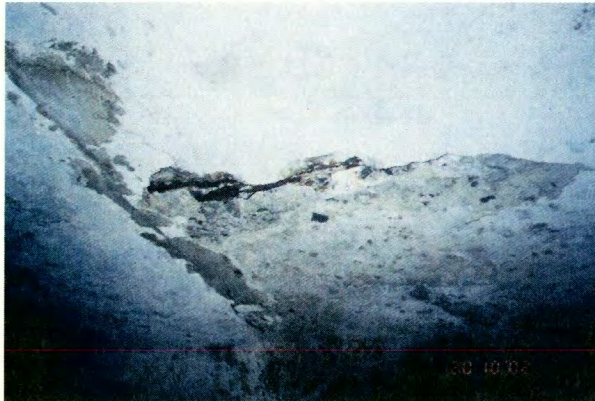
9. DC30P1-CP07 to CP08 (Ch 118.0)  
Spalling concrete & exposed reo

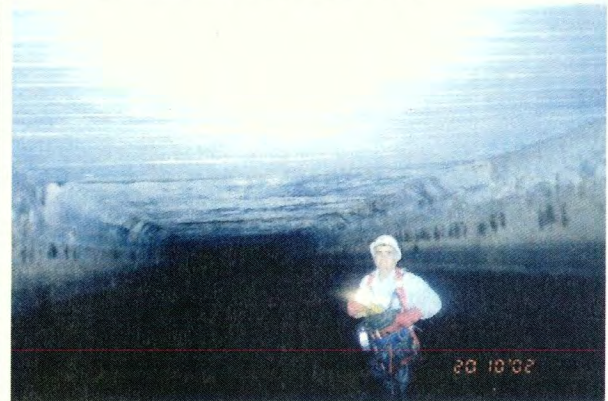
10. DC30P1-CP07 to CP08 (Ch 132.0)  
Aluminium sheeting in roof

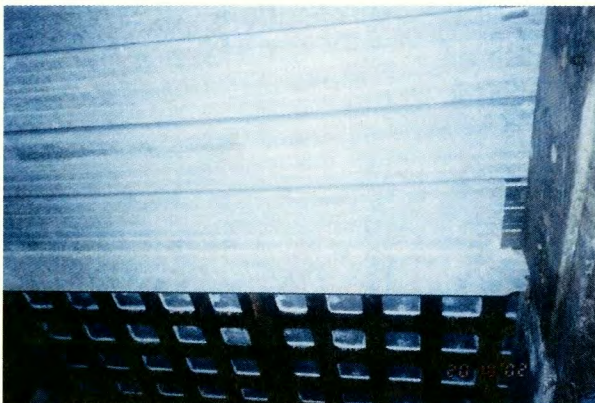
11. DC30P1-CP06 (Ch 183.0)  
Manhole chamber

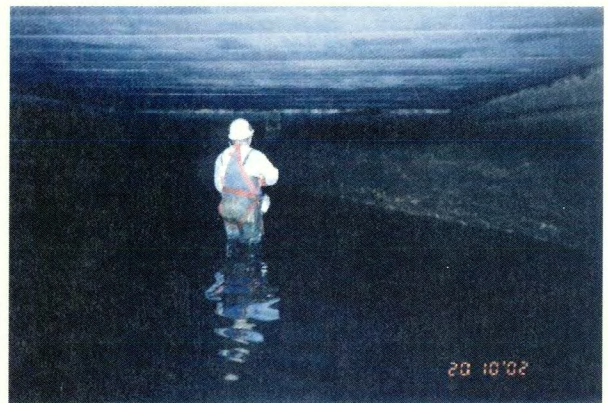
12. DC30P1-CP05 (Ch 332.0)  
Transition & weir across DC30P1

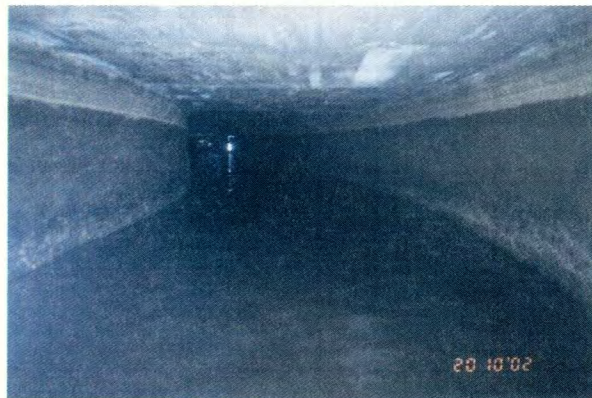
14. DC30P1-CP04 (Ch 0.0)  
Heavy silt just below waterline
