Non-Destructive Hazardous Materials (HAZMAT) Assessment

28 – 32 Bourke Road, Alexandria, NSW 2015

EP2460.001_v1 | 22 December 2021

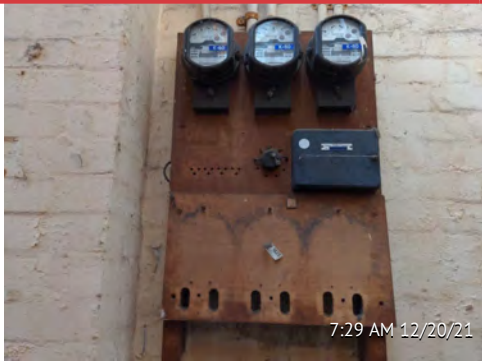
PHOTO 1

Assigned To West Warehouse, West Office Enclosed Western Alleyway, West Wall, EDB Fuses.

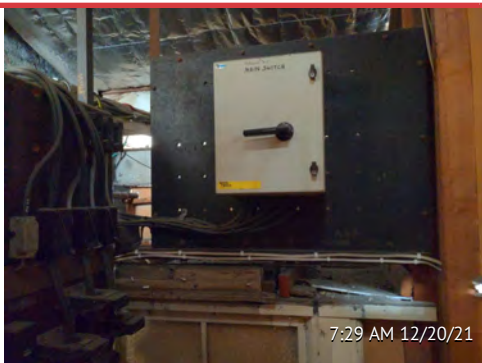
PHOTO 3

Assigned To West Warehouse, West West Office Enclosed Western Alleyway Mezzanine, Central Location, EDB, Resinous Board.

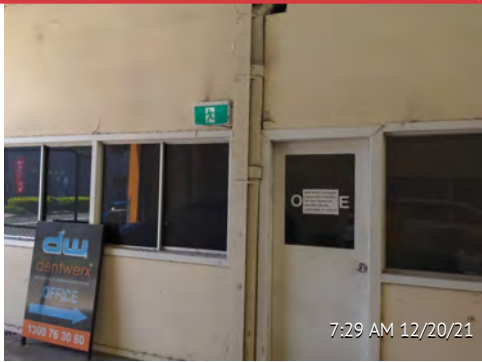
PHOTO 5

Assigned To West Warehouse, West Elevation Office Exterior Façade, Downpipe, Moulded Fibre Cement.
EP2640.003_ASB.003: Chrysotile asbestos detected.

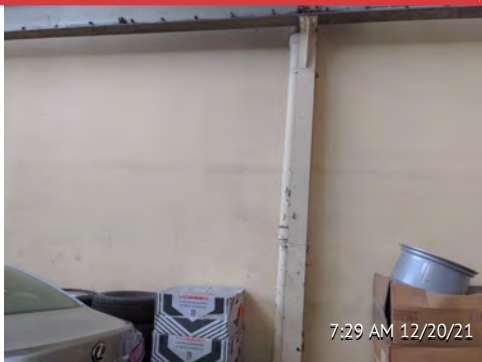
PHOTO 6

Assigned To West Warehouse, East Elevation Office Exterior Façade, Downpipe, Moulded Fibre Cement.
Assumed to contain asbestos.

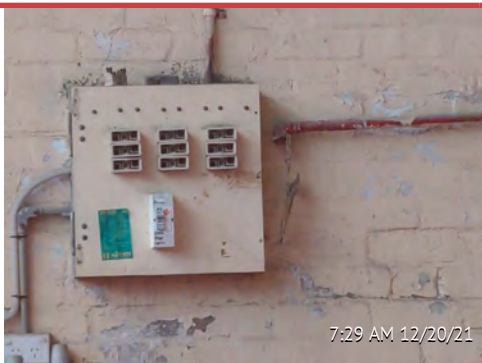
PHOTO 7

Assigned To West Warehouse, West Elevation, Wall, EDB, Fuses.
Assumed to contain asbestos.

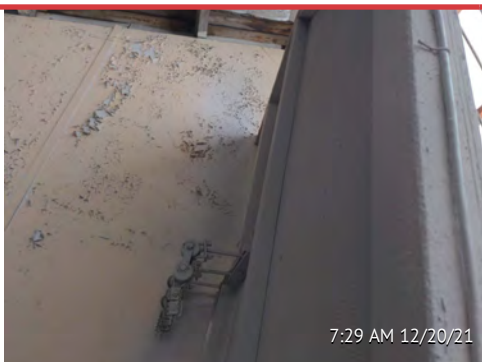
PHOTO 8

Assigned To West Warehouse, South Mezzanine, Exterior West And North Wall Lining, Fibre Cement Sheeting.
EP2640.003_ASB.004: Chrysotile asbestos detected.

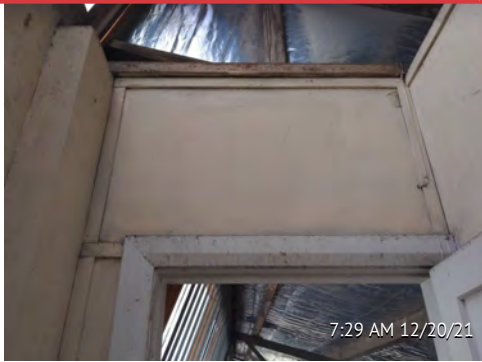
PHOTO 9

Assigned To West Warehouse, West Warehouse, South Mezzanine, Above Entry Door, Infill Panel Fibre Cement Sheeting.

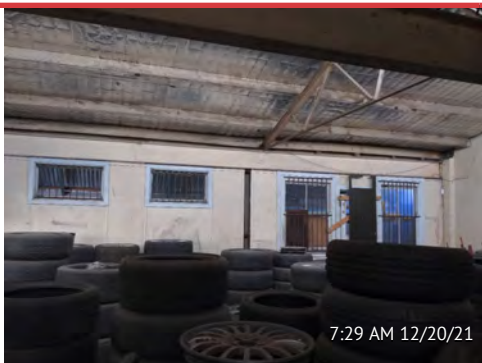
PHOTO 11

Assigned To West Warehouse, South Mezzanine, Main Room, Walls, Wall Lining, Fibre Cement Sheeting.

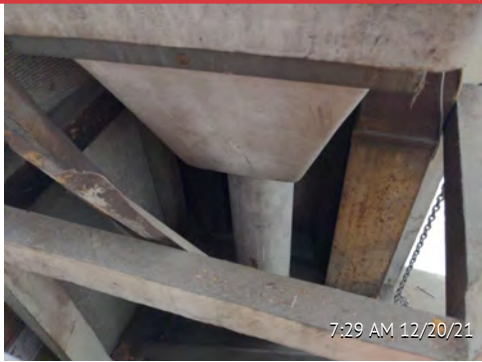
PHOTO 13

Assigned To West Warehouse, South Mezzanine, Main Room, West Wall, Downpipe And Gutter Box, Moulded Fibre Cement.

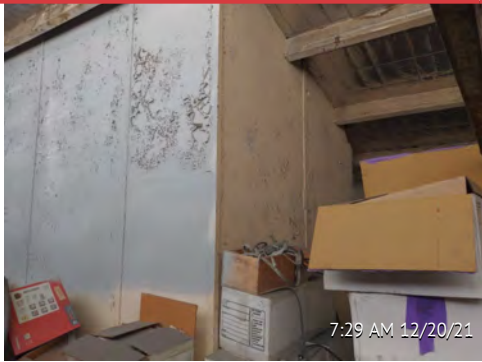
PHOTO 17

Assigned To Central Mezzanine, Wall Lining, Fibre Cement Sheeting.

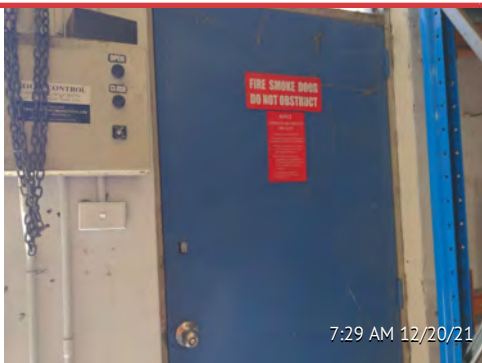
PHOTO 19

Assigned To East Warehouse, North East Elevation, Fire Door.

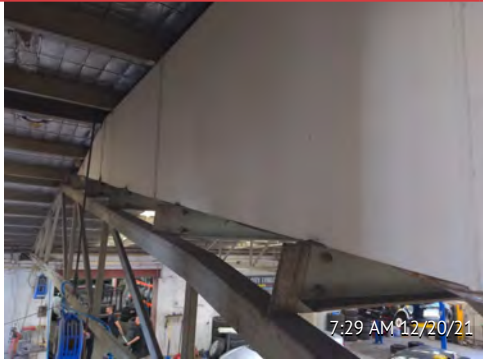
PHOTO 21

Assigned To East Warehouse, Southeast Mezzanine Exterior, North Of Stairway, Wall Lining, Fibre Cement Sheet.

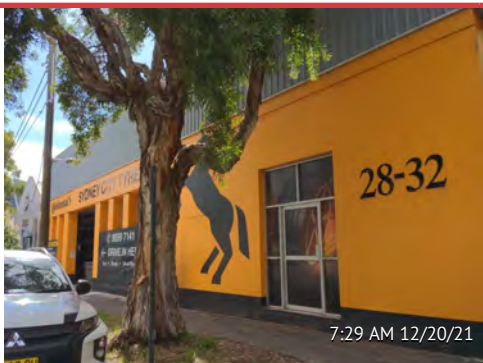
PHOTO 23

Assigned To Exterior, Throughout, Orange Paint

EP2540.003_LCP.001: lead containing paint.

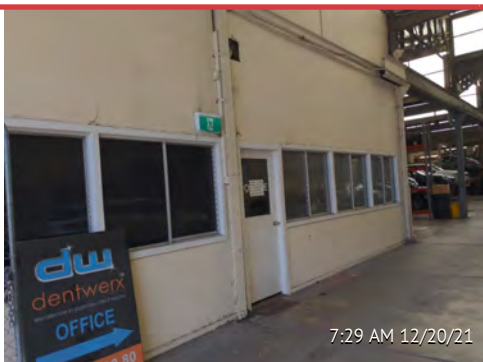
PHOTO 24

Assigned To West Warehouse, West Office Exterior, Door And Door Frame, White Paint.

EP2640.003_LCP.009: Lead containing paint.

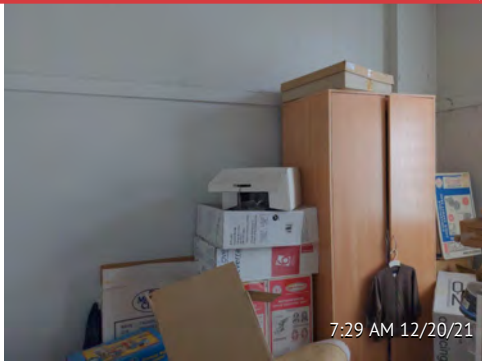
PHOTO 25

Assigned To West Warehouse, West Office Building, North Office Storage Room, Walls Throughout, White Paint.

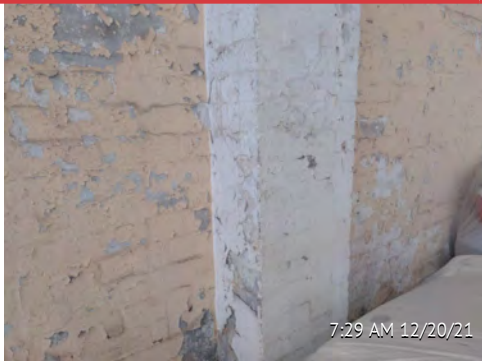
PHOTO 29

Assigned To West Warehouse, Throughout, Walls, White Paint.

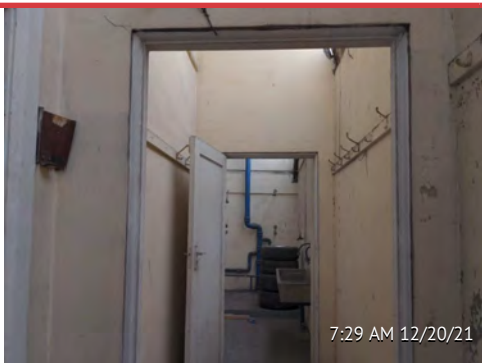
PHOTO 31

Assigned To West Warehouse, South Mezzanine, Entry Door And Door Frame, White Paint.

Assumed lead containing paint.

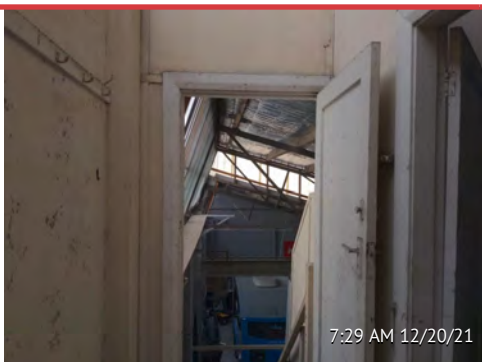
PHOTO 32

Assigned To South Mezzanine Hallway, Walls, Beige Paint.

Assumed lead containing paint.

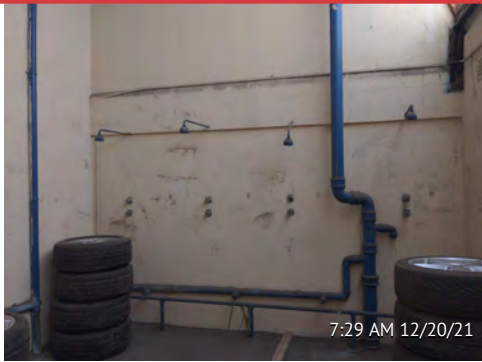
PHOTO 33

Assigned To West Warehouse, South Mezzanine Showers, Walls, Beige Paint.

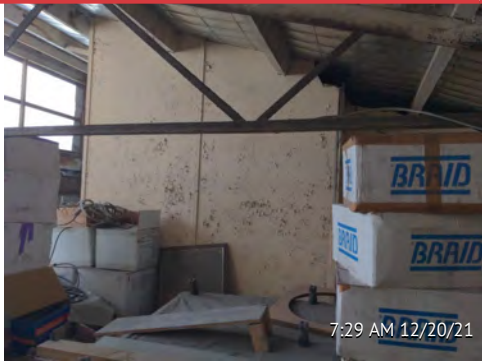
PHOTO 37

Assigned To West Warehouse, Central Mezzanine, Walls, Beige Paint

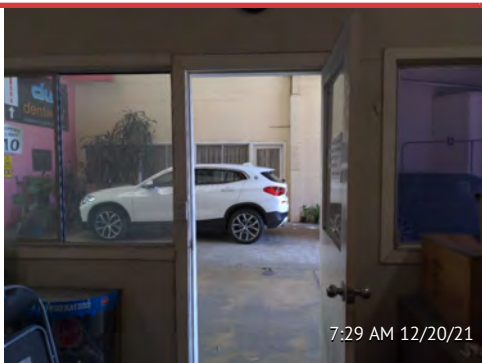
PHOTO 39

Assigned To West Warehouse, East Office Building, Main Area, Door And Door Frame, White Paint.

Assumed lead containing paint.

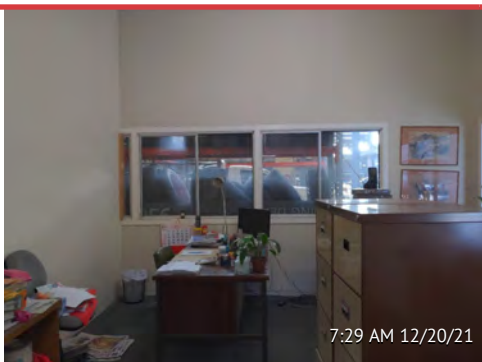
PHOTO 40

Assigned To East Office Building, Main Area, Skirting, White Paint.

Assumed lead containing paint.

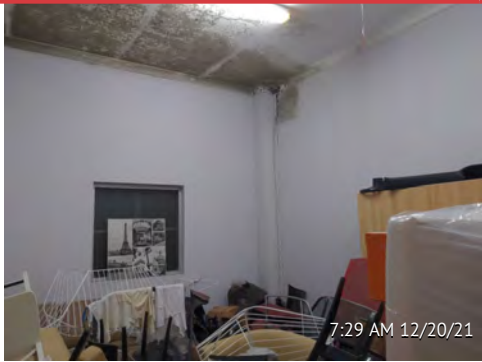
PHOTO 41

Assigned To West Warehouse, East Office Building North Office, Walls, Purple Paint.

EP2640.003_LCP.012: Lead containing paint.

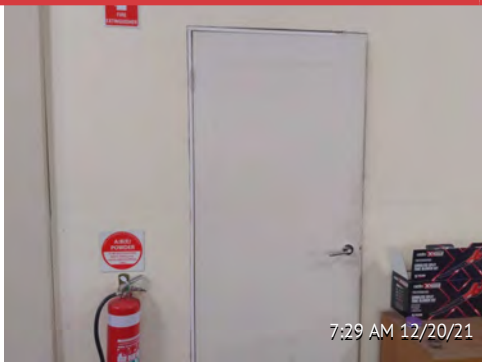
PHOTO 42

Assigned To West Warehouse, East Office Building, North Office, Door And Door Frame, White Paint.

Assumed lead containing paint.

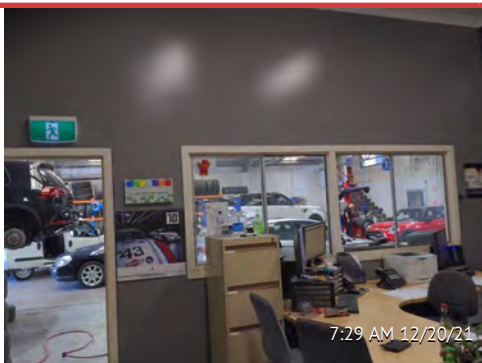
PHOTO 43

Assigned To West Warehouse, East Office Building, South East Office, Door And Door Frame, Beige Paint.

Lead containing paint.

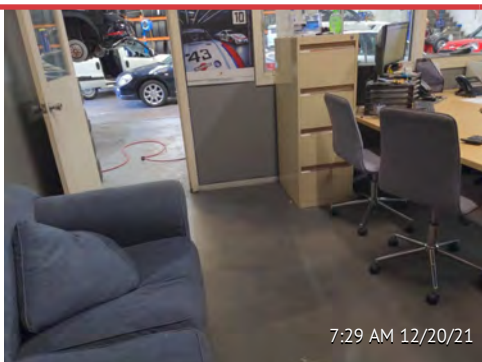
PHOTO 44

Assigned To West Warehouse, East Office Building, South East Office, Window Frame, Beige Paint.

Assumed lead containing paint.

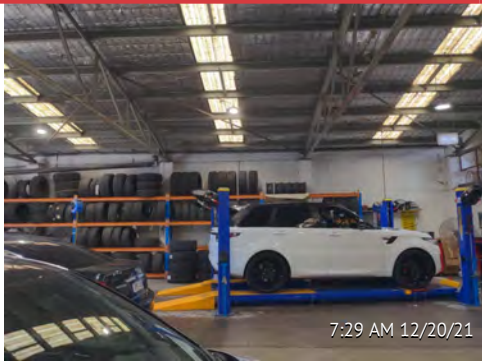
PHOTO 45

Assigned To East Warehouse, Throughout, Walls, White Paint.

EP2540.003_LCP.014: Lead containing paint.

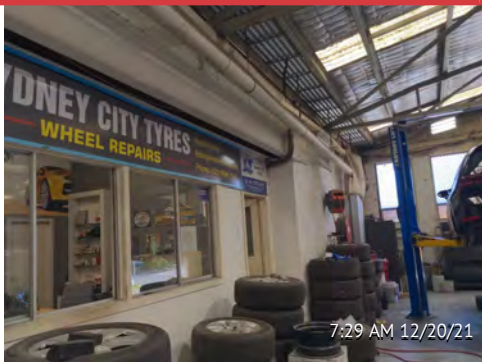
PHOTO 46

Assigned To East Warehouse West Office Exterior, Window Frames, Beige Paint.

Assumed lead containing paint.

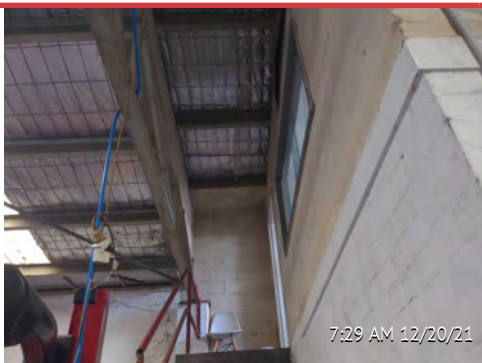
PHOTO 47

Assigned To East Warehouse Southeast Mezzanine, Exterior Walls, Beige Paint.

Assumed lead containing paint.

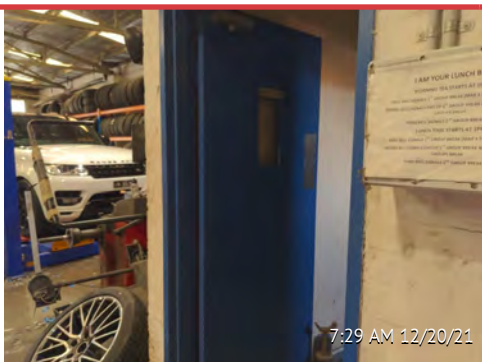
PHOTO 48

Assigned To East Warehouse Male Bathroom, Door And Door Frames, Blue Paint.

EP2640.003_LCP.015: Lead containing paint.

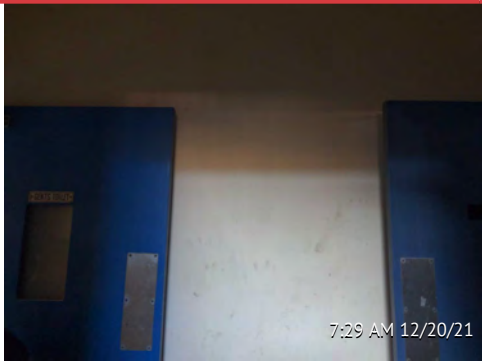
PHOTO 49

Assigned To East Warehouse, Male Bathroom Hallway,
Door And Door Frame, Blue Paint.

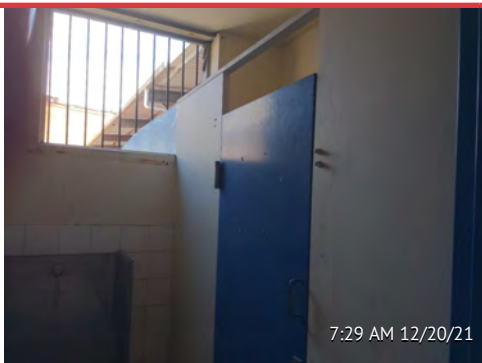
PHOTO 51

Assigned To East Warehouse, Male Bathroom Toilet,
Door, Doorframe And Partition Walls, Blue Paint.

Assumed lead containing paint.

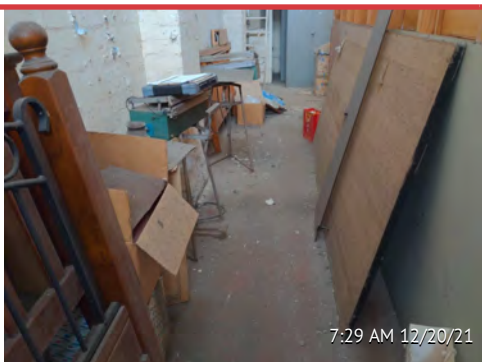
PHOTO 52

Assigned To West Warehouse, West Office Enclosed
Western Alleyway, Floor, Accumulated Dust

Lead containing dust.

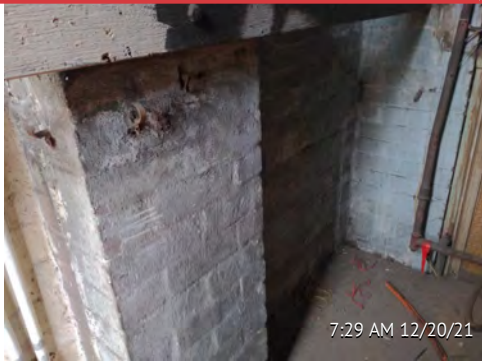
PHOTO 53

Assigned To West Warehouse, West Office Enclosed Western Alleyway Mezzanine, Floor, Accumulated Dust
Lead containing dust.

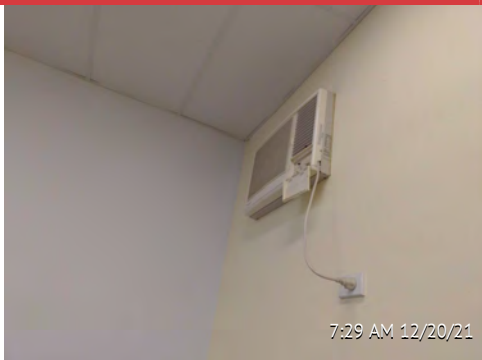
PHOTO 59

Assigned To West Warehouse, West Office Building, South Storage, South Elevation Wall, Air Conditioning Unit.
Suspected R22 refrigerant.

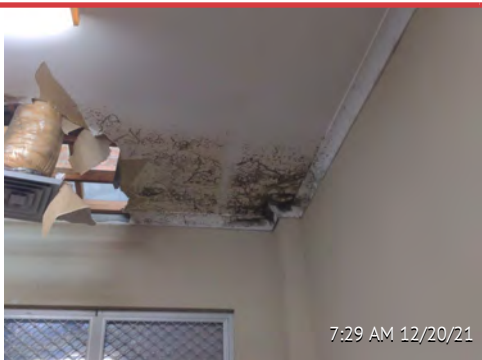
PHOTO 60

Assigned To West Warehouse, East Office Building, Main Office, Ceiling Lining.
Suspected mould.

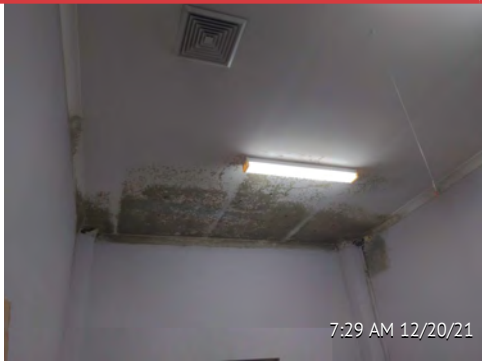
PHOTO 61

Assigned To West Warehouse, East Office Building,
North Office, Ceiling Lining.

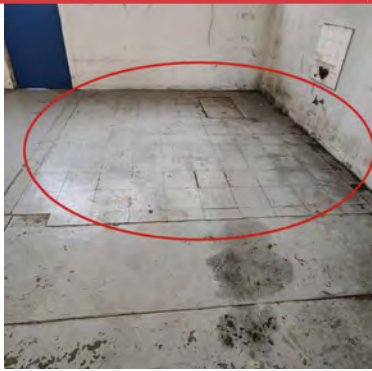
PHOTO 70

Interior west warehouse, northern extent of warehouse, adjacent to entry/exit door to Bourke Road, floor - vinyl floor tiles.
