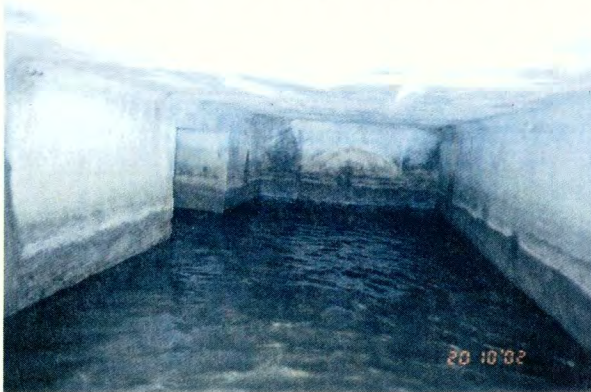
1. DC30A-CP11 (Ch 2.0)  
Cross-connection to parallel channel

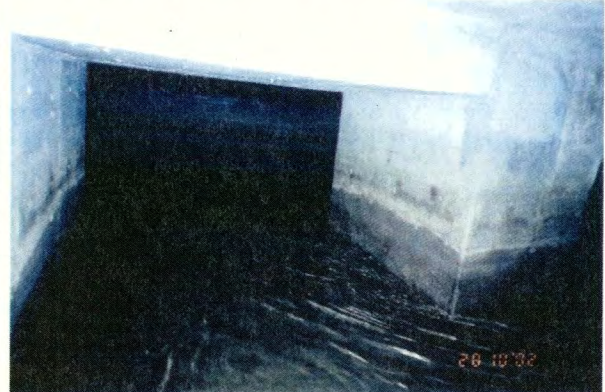
2. DC30A-CP11 (Ch 2.0)  
Cross-connection to parallel channel

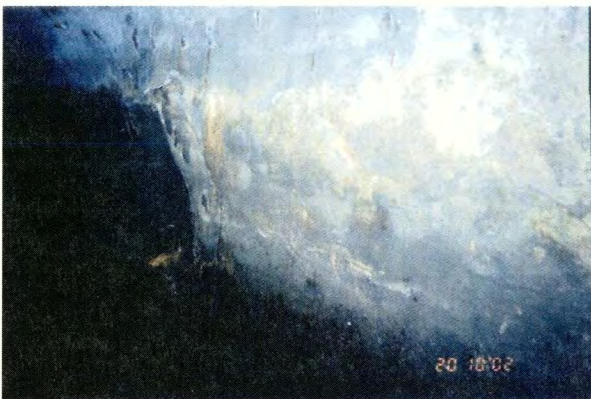
3. DC30A-CP09 to CP10 (Ch 174.0)  
Spalling concrete & exposed reo

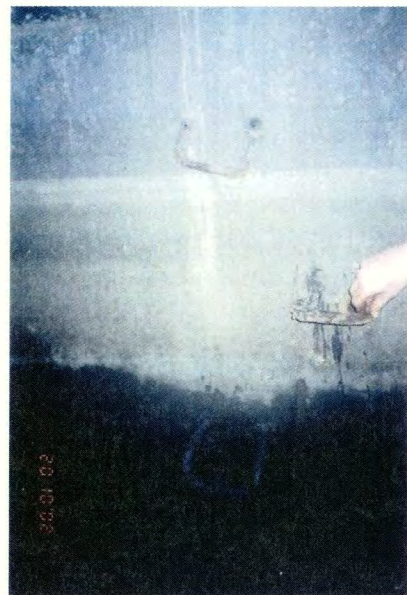
4. DC30A-CP08 (Ch 226.0)  
Deteriorated step-iron

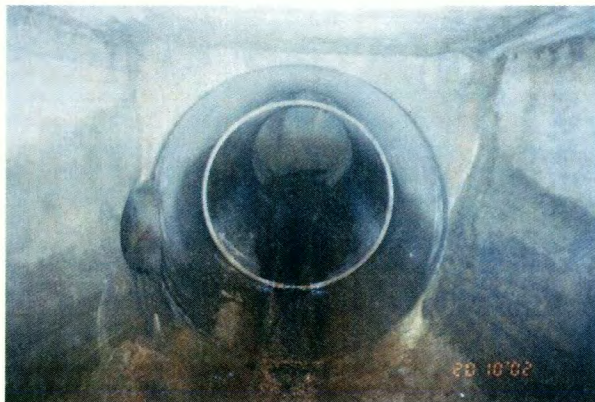
5. DC30A2-CP15 to CP16 (Ch 0.0)  
Transition from circular channel

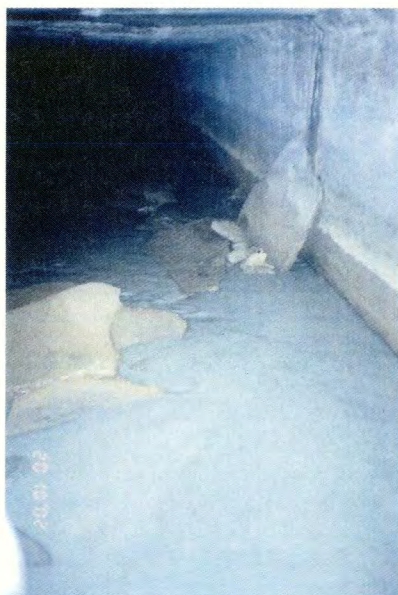
7. DC30A2-CP11 to CP14 (Ch 91.0)  
Debris in channel floor

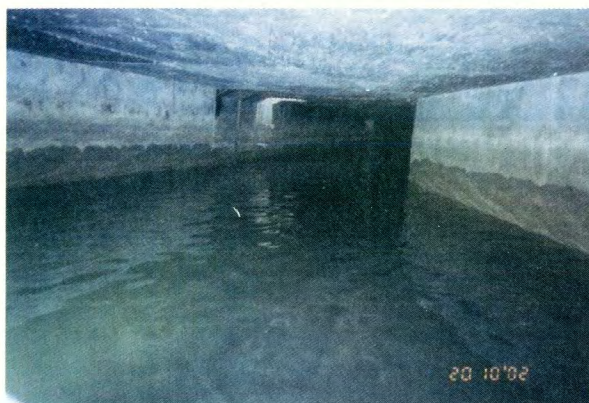
8. DC30A2-CP11 to CP14 (Ch 215.0)  
Transition & increased water depth

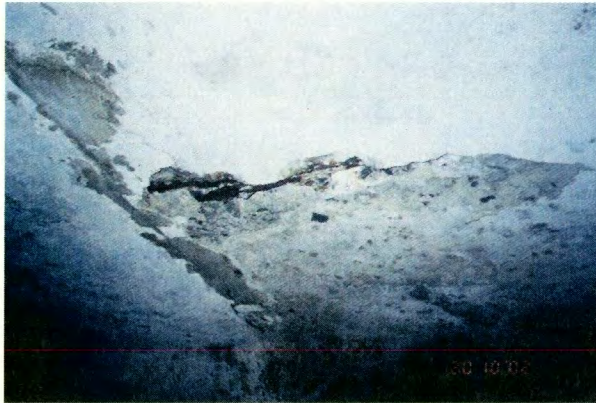
9. DC30P1-CP07 to CP08 (Ch 118.0)  
Spalling concrete & exposed reo

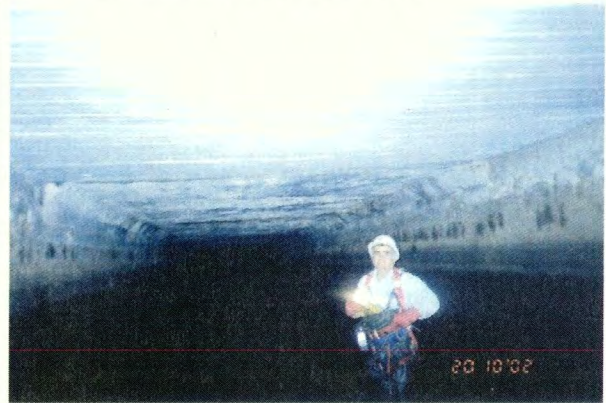
10. DC30P1-CP07 to CP08 (Ch 132.0)  
Aluminium sheeting in roof

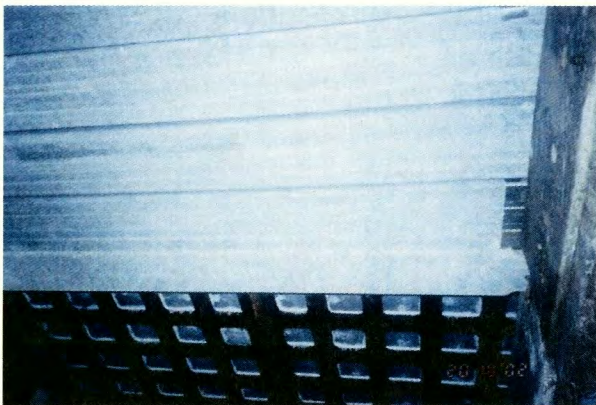
11. DC30P1-CP06 (Ch 183.0)  
Manhole chamber

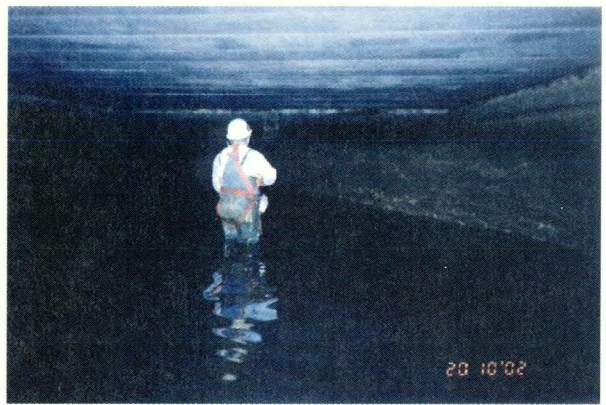
12. DC30P1-CP05 (Ch 332.0)  
Transition & weir across DC30P1

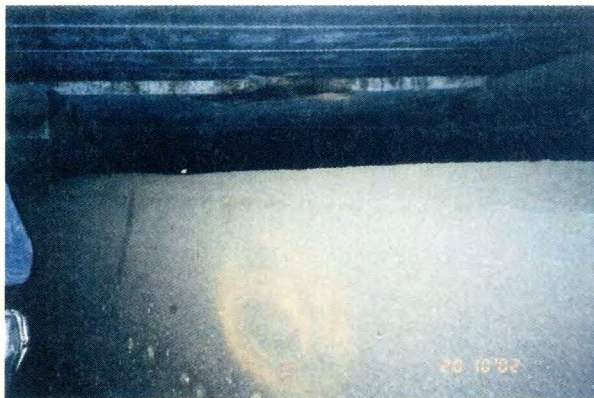
13. DC30P1-CP05 (Ch 332.0)  
Weir across DC30P1

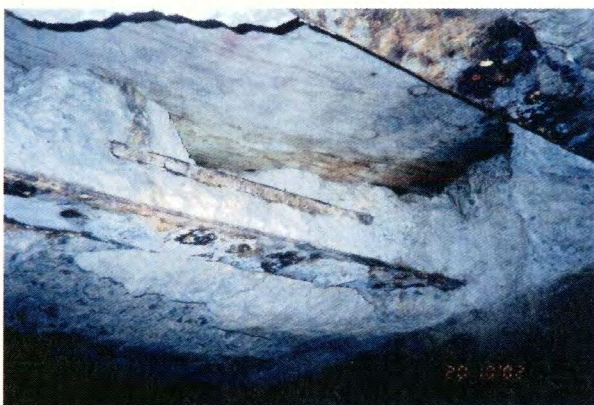
15. DC30P1-CP01 (Ch 104.0)  
Exposed steel beams in roof

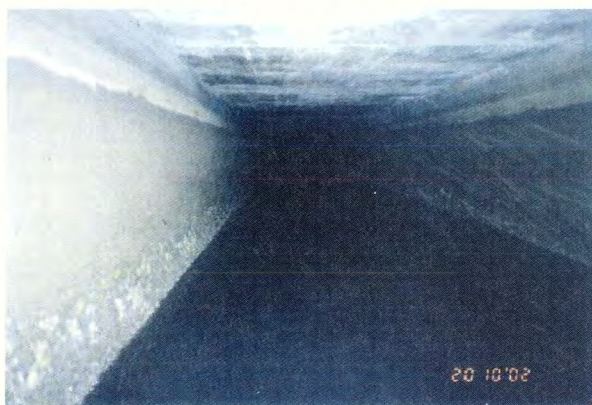
16. DC30P2-CP01 (Ch 0.0)  
Typical channel section
