UNIVERSITY HOUSE: ROOM DATA SHEETS

ROOM: 2.34,2.35,2.36,2.37,2.38,2.39	UNIVERSITY LEGAL CENTRE OFFICES
--	--

LOCATION: SECOND FLOOR NORTH EAST

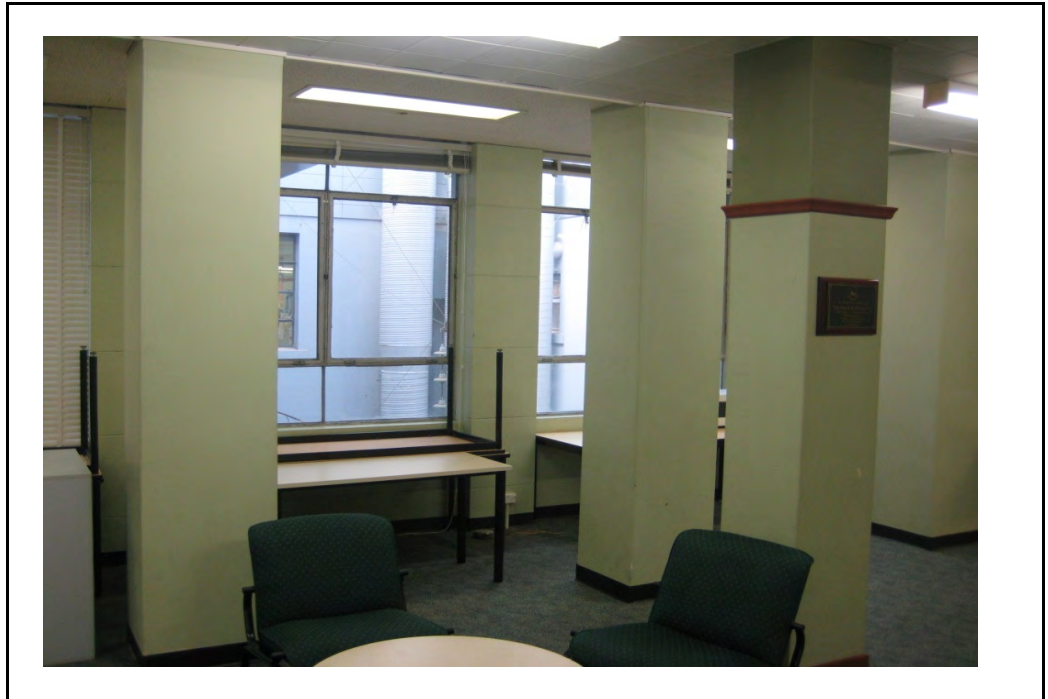
WINDOWS

OVERVIEW	Metal framed windows to south wall, generally fair condition, fixed in closed position.	
HERITAGE SIGNIFICANCE	Heritage Significance Value of the element	Moderate
FUNCTIONALITY	Functional

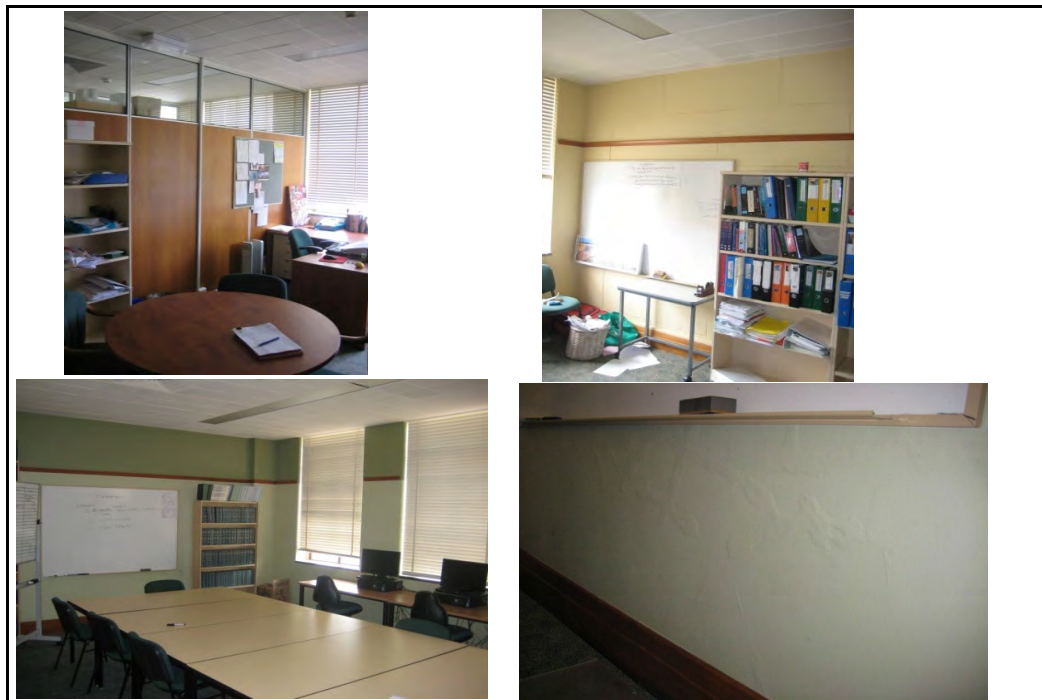
ASSET ELEMENT	WALLS
----------------------	--------------

OVERVIEW	Render and paint finish to external walls, mixture of plasterboard and paint and aluminium framed timber veneer and glazed walls between offices. Generally good condition, external walls showing possible signs of moisture damage - paint bubbling.	
HERITAGE SIGNIFICANCE	Heritage Significance Value of the element	Moderate
	South wall of room 2.34 - rear of original building.	
FUNCTIONALITY	Functional but requiring repair.

OVERVIEW	Investigate and rectify source of moisture, repair and restore wall finishes as required
-----------------	--

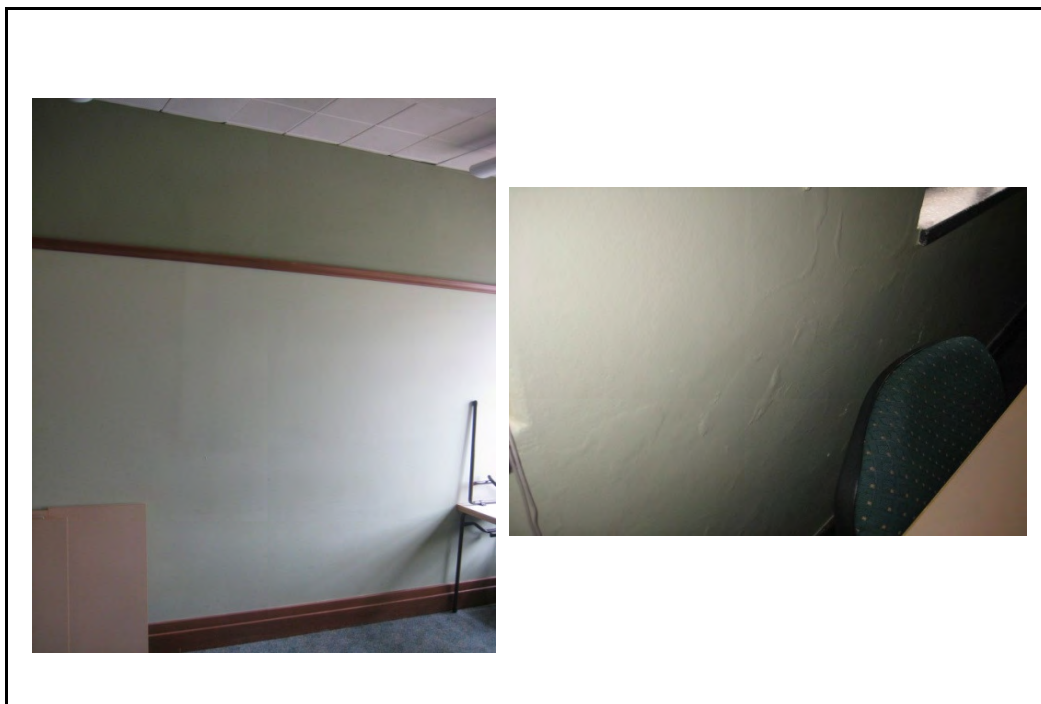
ASSET ELEMENT	WALLS
----------------------	--------------

OVERVIEW	Render and paint finish to north (external) wall, plasterboard and paint finish to remaining walls. Generally good condition, some paint bubbling on the north wall, possible moisture damage behind.	
HERITAGE SIGNIFICANCE	Heritage Significance Value of the element	Mixed
	MODERATE External wall LOW Internal walls	
FUNCTIONALITY	Functional but requiring repair.

OVERVIEW	Investigate and rectify source of moisture, repair and restore wall finishes as required
-----------------	--

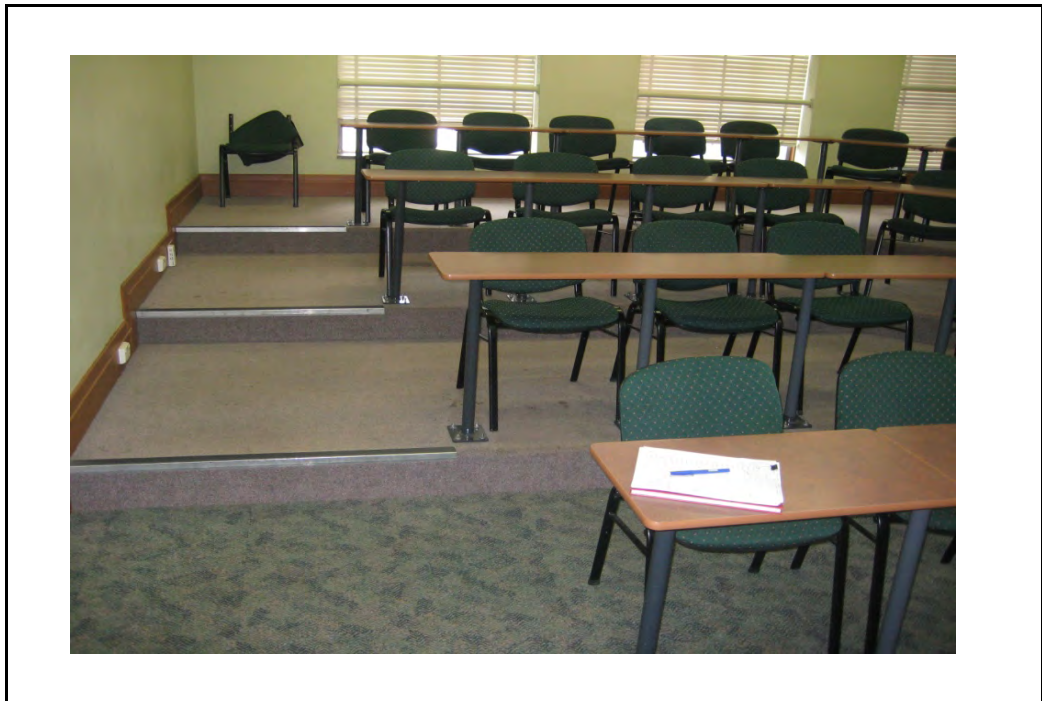
ASSET ELEMENT	FLOOR
---------------	-------

EXISTING CONDITION		
OVERVIEW	Carpet tile flooring to front of room, carpet to tiered flooring, generally good condition.	
HERITAGE SIGNIFICANCE	Heritage Significance Value of the element	Low
	Refers to carpet / carpet tiles only, substrate may hold higher significance.	
FUNCTIONALITY	Functional	
ACTION REQUIRED		
OVERVIEW

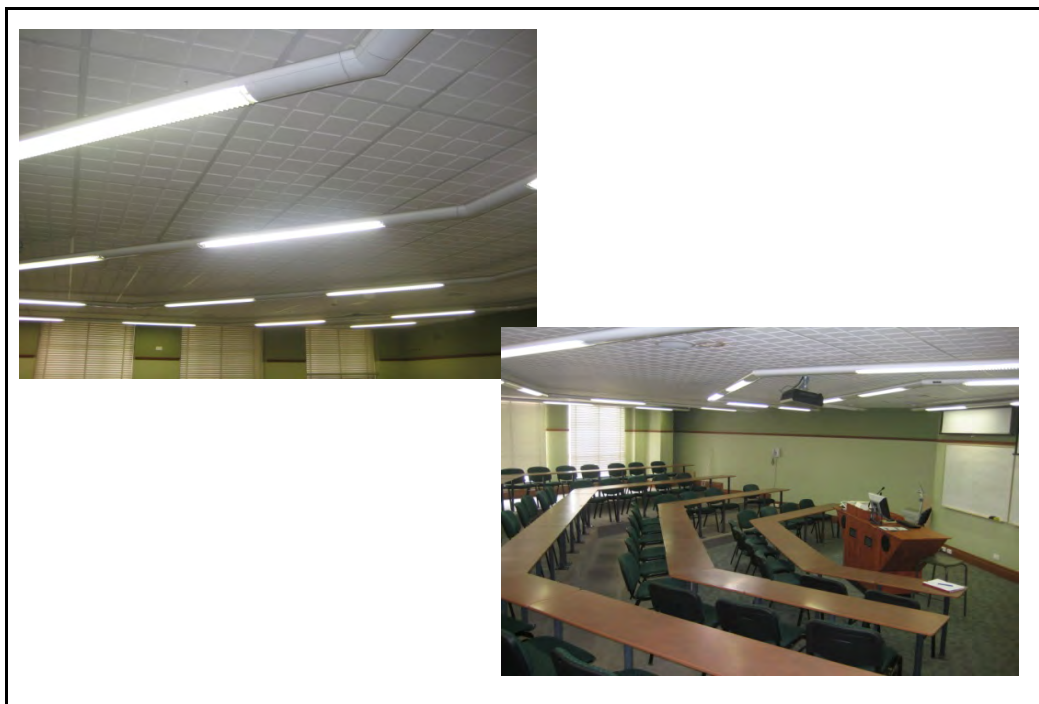
ASSET ELEMENT	CEILING
---------------	---------

OVERVIEW	Suspended tile ceiling, generally good condition, some moisture damage to tiles in western half of room.	
HERITAGE SIGNIFICANCE	Heritage Significance Value of the element	Low
FUNCTIONALITY	Functional, requiring repairs.

OVERVIEW	Investigate and rectify source of moisture, replace tiles as required
----------	---

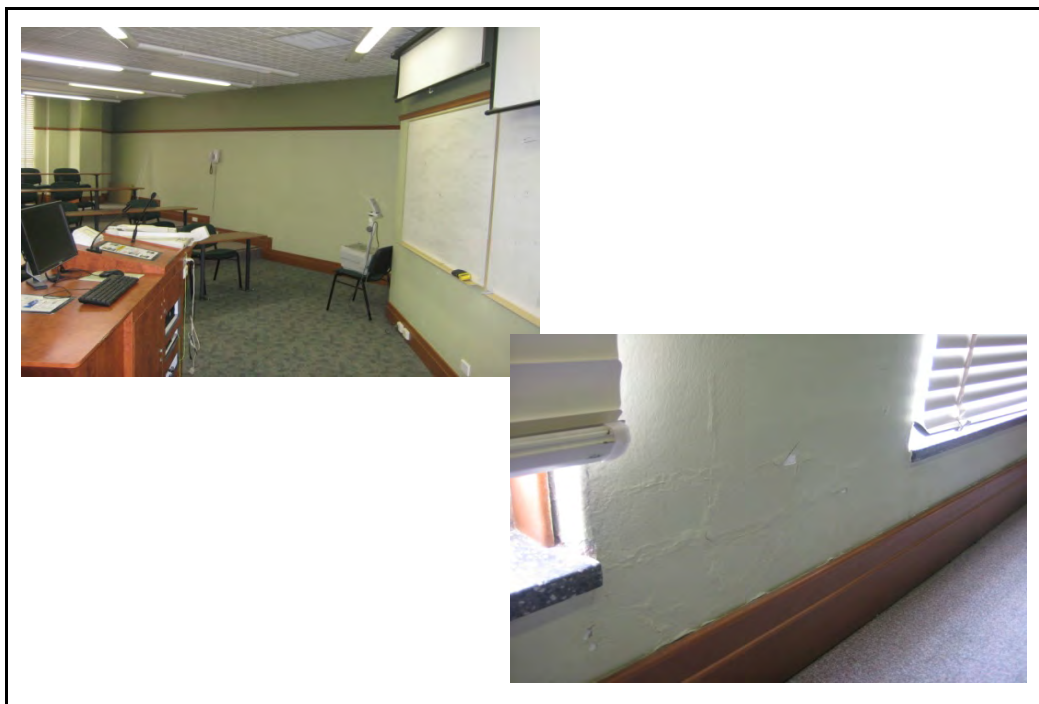
ASSET ELEMENT	WALLS
---------------	-------

OVERVIEW	Render and paint finish to external and part of south walls, plasterboard and paint finish to remaining walls. Generally good condition, some paint bubbling on the north wall, possible moisture damage behind.	
HERITAGE SIGNIFICANCE	Heritage Significance Value of the element	Mixed
	MODERATE External walls LOW Internal walls	
FUNCTIONALITY	Functional but requiring repair.

OVERVIEW	Investigate and rectify source of moisture, repair and restore wall finishes as required
-----------------	--

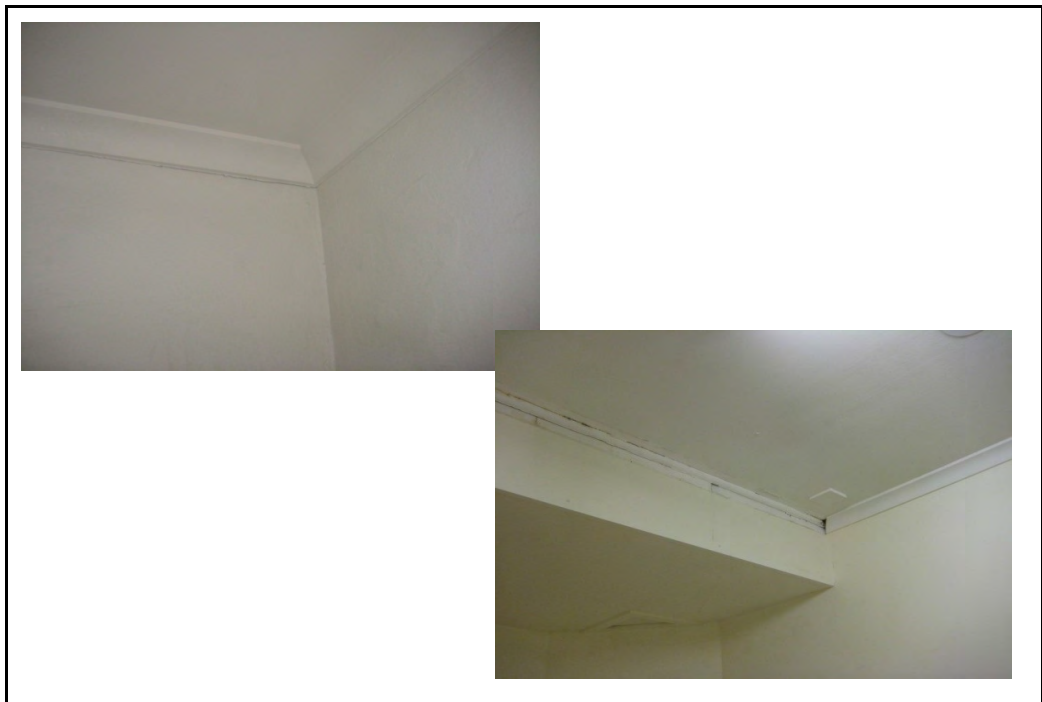
ASSET ELEMENT	CEILING
----------------------	----------------

OVERVIEW	Plasterboard and paint finish - fair condition. Paint cracked, flaking on ceiling in rooms 2.46, 2.47. Section of cornice missing at bulkhead in room 2.45. Gaps at junction with bulkhead at east wall of room 2.46.	
HERITAGE SIGNIFICANCE	Heritage Significance Value of the element	Low
FUNCTIONALITY	Functional, requiring repair

OVERVIEW	Repair and repaint as required.
-----------------	---------------------------------

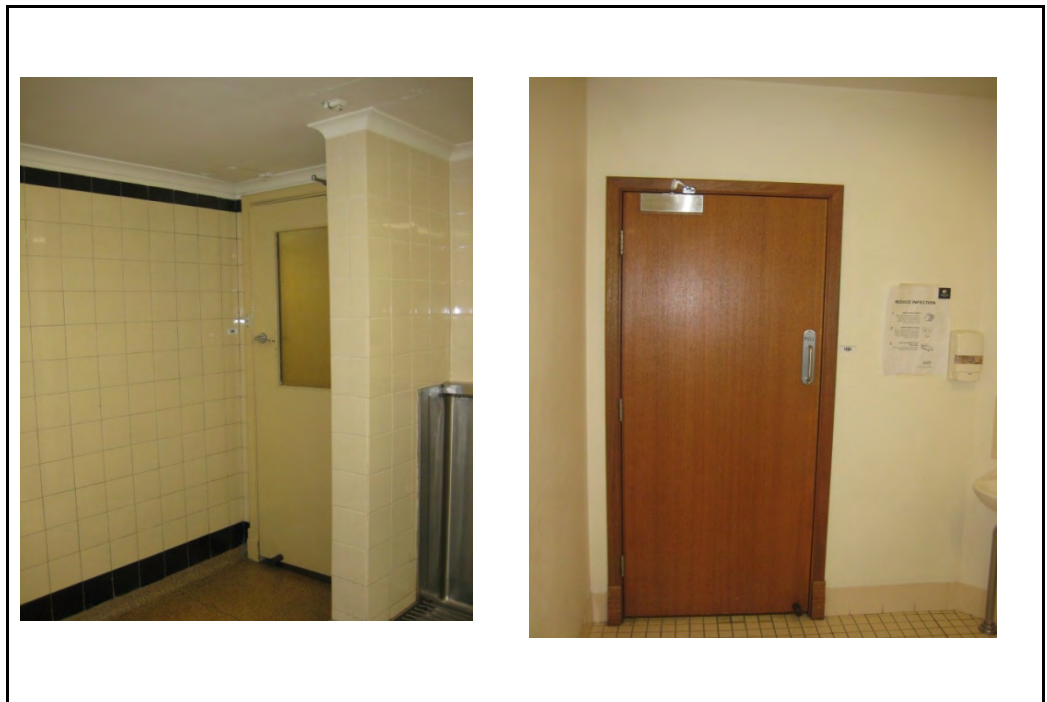
DOORS

OVERVIEW	Painted timber door with glass panel, good condition in room 2.46. Timber door, good condition to room 2.45, painted timber doors to rooms 2.47, 2.48, 2.49, good condition	
HERITAGE SIGNIFICANCE	Heritage Significance Value of the element	
	HIGH Door to 2.46 LOW Other rooms	Mixed
FUNCTIONALITY	Functional.

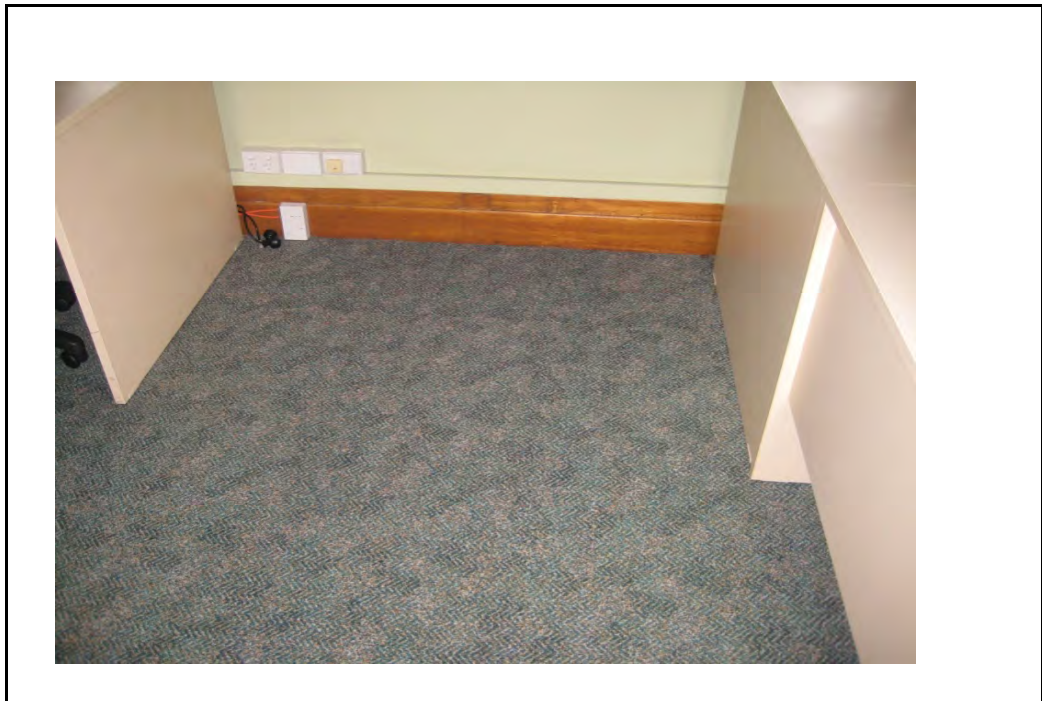
ASSET ELEMENT	FLOOR
---------------	-------

OVERVIEW	Carpet tile flooring, generally good condition.	
HERITAGE SIGNIFICANCE	Heritage Significance Value of the element	Low
	Refers to carpet tiles only, substrate may hold higher significance.	
FUNCTIONALITY	Functional

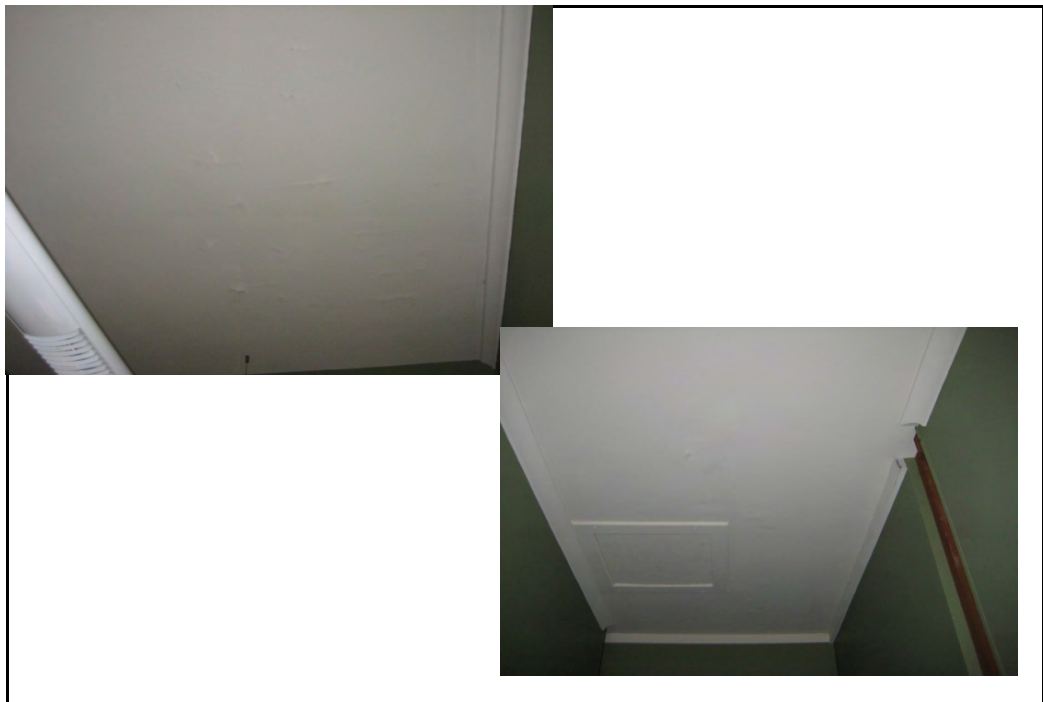
ASSET ELEMENT	CEILING
---------------	---------

OVERVIEW	Painted plasterboard ceiling, generally good condition, cracked, flaking paint in south area of room 2.50 and 2.51, and in northern corridor of 2.51	
HERITAGE SIGNIFICANCE	Heritage Significance Value of the element	High
FUNCTIONALITY	Functional, requiring repairs to paintwork.

OVERVIEW	Remove damaged paintwork and repaint as required.
----------	---

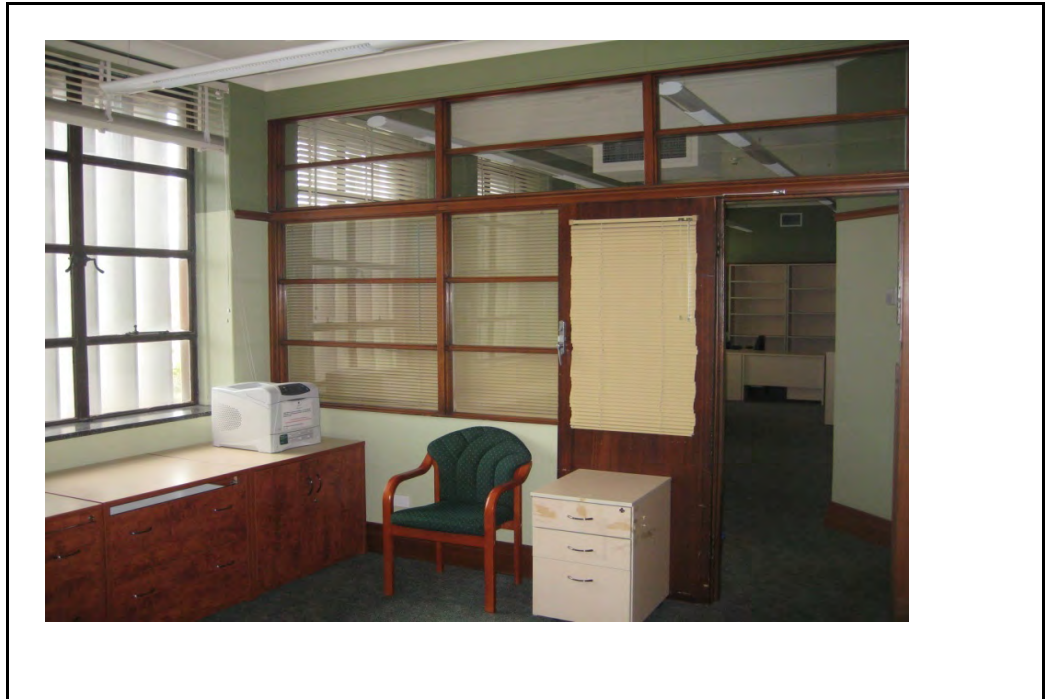
DOORS

OVERVIEW	Timber veneer and glazed doors. Good condition. Timber doors to rooms 2.54 and 2.55.	
HERITAGE SIGNIFICANCE	Heritage Significance Value of the element	Moderate
	HIGH Timber veneer LOW Painted doors	
FUNCTIONALITY	Functional

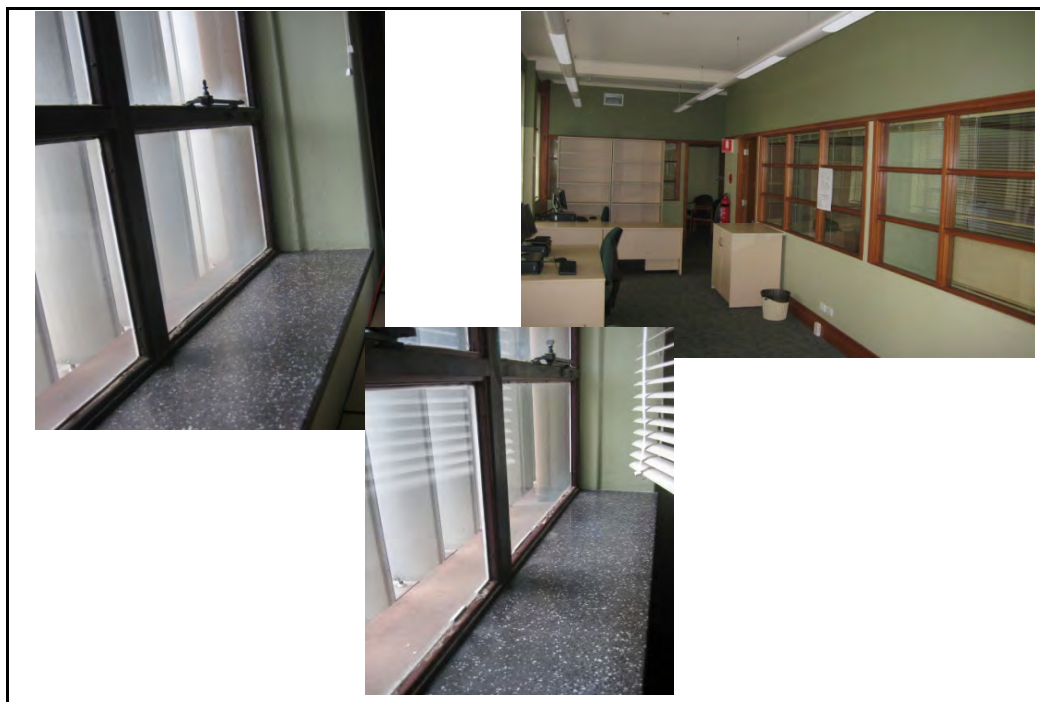
ASSET ELEMENT	WINDOWS
---------------	---------

OVERVIEW	Steel / timber framed casement window to external walls - fair condition, some discolouration to frames, sealant perished, missing externally. Timber frame beads deteriorating. Black stone sills, some cracking and fading evident. Timber framed glazing to internal walls, good condition.	
HERITAGE SIGNIFICANCE	Heritage Significance Value of the element	Mixed
	EXCEPTIONAL External windows HIGH Internal timber framed windows	
FUNCTIONALITY	Functional

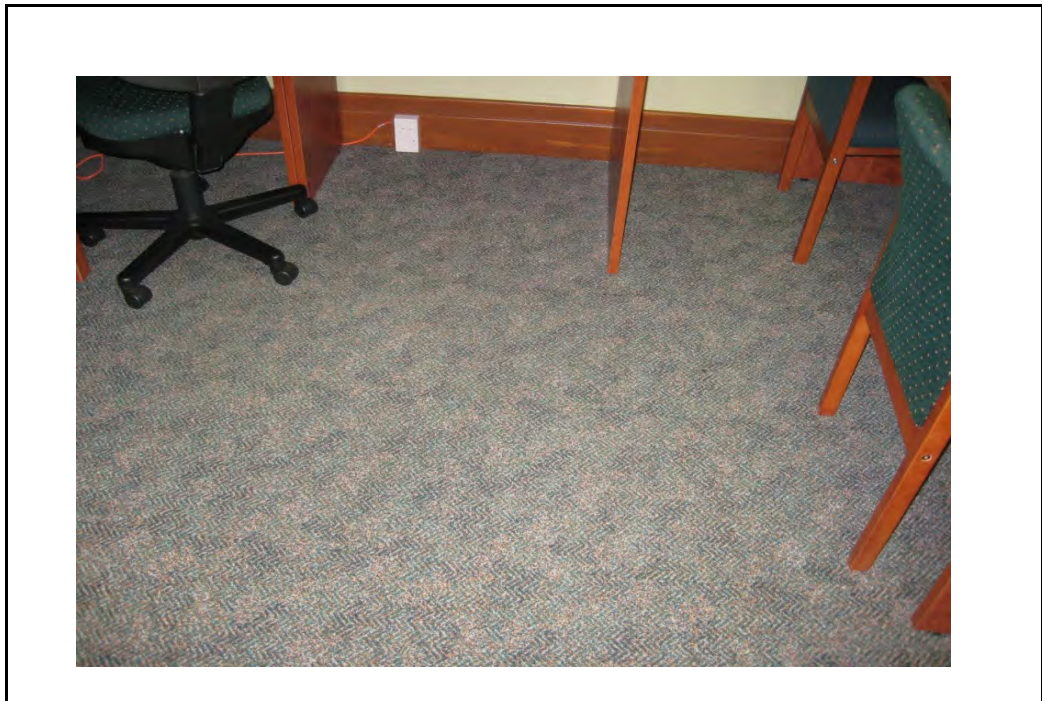
ASSET ELEMENT	FLOOR
---------------	-------

OVERVIEW	Carpet tile flooring, generally good condition.	
HERITAGE SIGNIFICANCE	Heritage Significance Value of the element	
		Low
FUNCTIONALITY	Functional

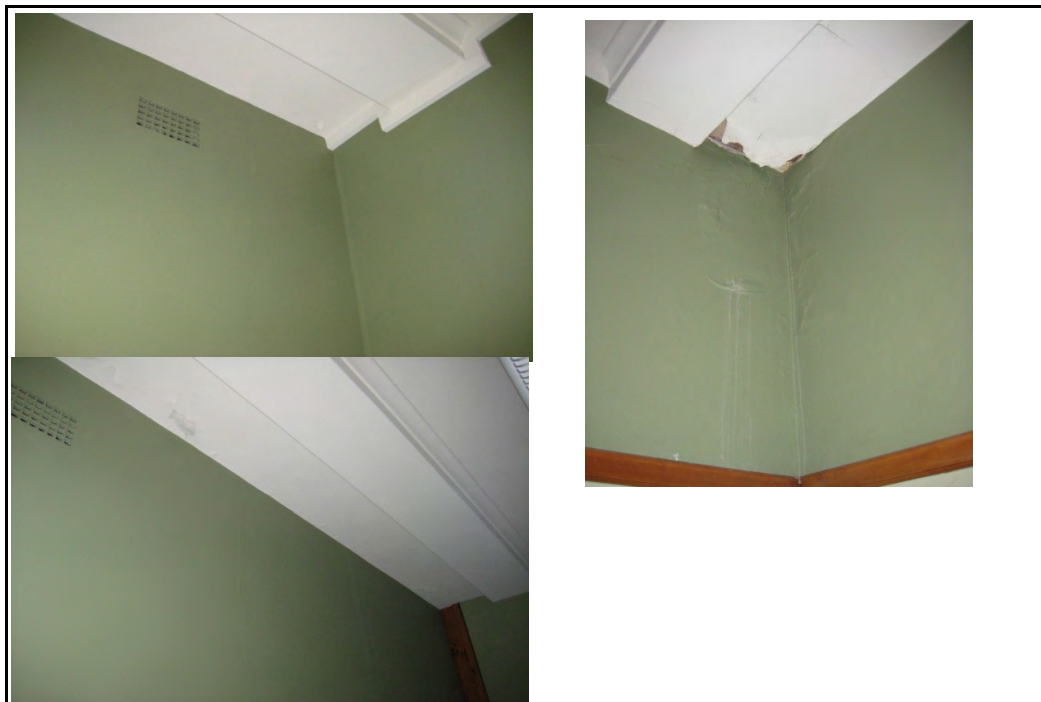
ASSET ELEMENT	CEILING
----------------------	----------------

OVERVIEW	Painted plasterboard ceiling, generally fair condition, crack at cornice on south wall of room 2.52, paint flaking in north east corner of 2.52. Minor flaking in S/E corner of 2.53, crack at south cornice. Major damage to ceiling at north wall, paint bubbling, flaking, peeling, part of ceiling in north west corner of room 2.53. Appears to be moisture damage.	
HERITAGE SIGNIFICANCE	Heritage Significance Value of the element	Low
FUNCTIONALITY	Functional, requiring repairs.

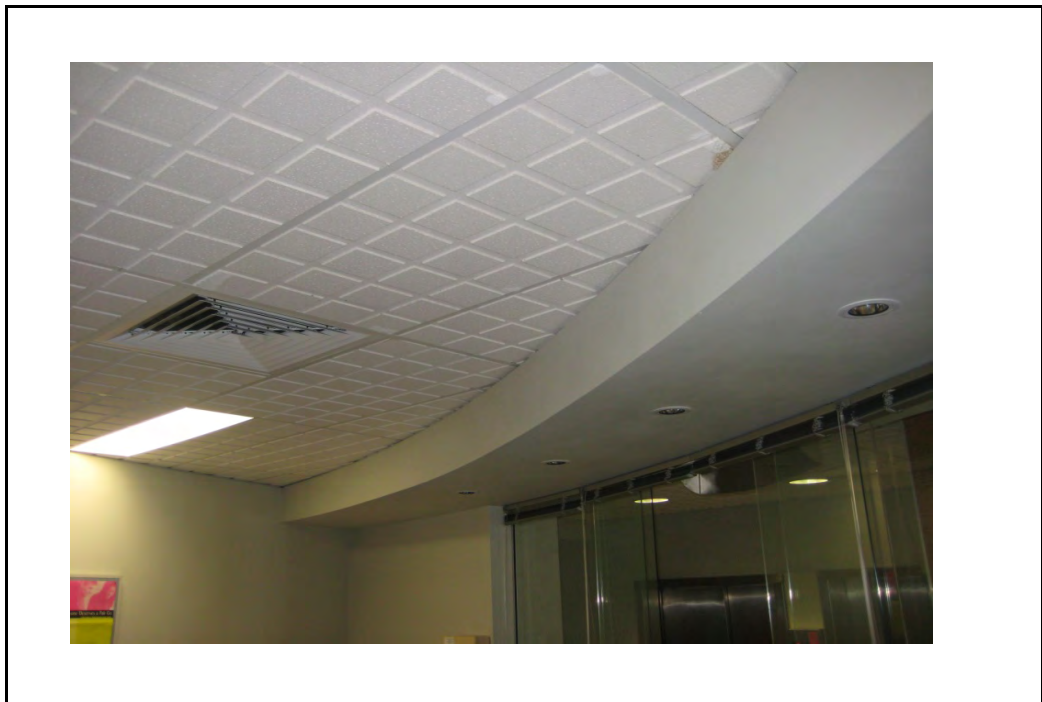
ASSET ELEMENT	CEILING
---------------	---------

EXISTING CONDITION		
OVERVIEW	Suspended ceiling tiles, generally good condition. Some moisture damage to tile at bulkhead.	
HERITAGE SIGNIFICANCE	Heritage Significance Value of the element	Low
FUNCTIONALITY	Functional, requiring minor repair.	
ACTION REQUIRED		
OVERVIEW	Investigate and rectify source of moisture, replace tiles as required.

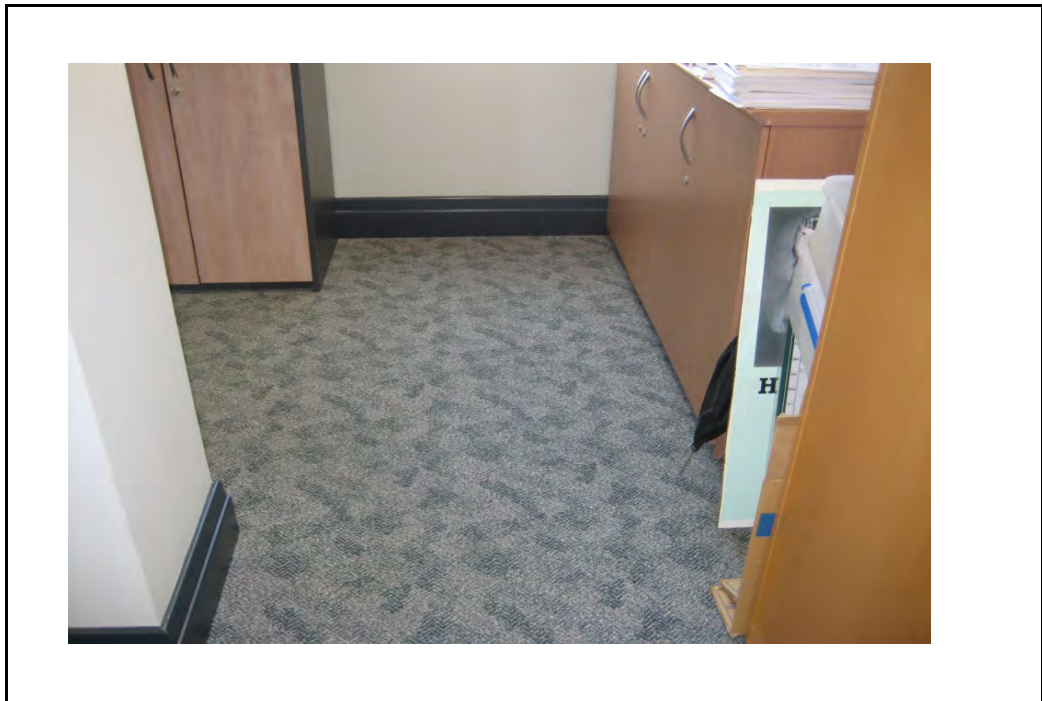
ASSET ELEMENT	FLOOR
---------------	-------

EXISTING CONDITION		
OVERVIEW	Carpet tile flooring, generally good condition.	
HERITAGE SIGNIFICANCE	Heritage Significance Value of the element	Low
	Refers to carpet tiles only, substrate may hold higher significance.	
FUNCTIONALITY	Functional	
ACTION REQUIRED		
OVERVIEW

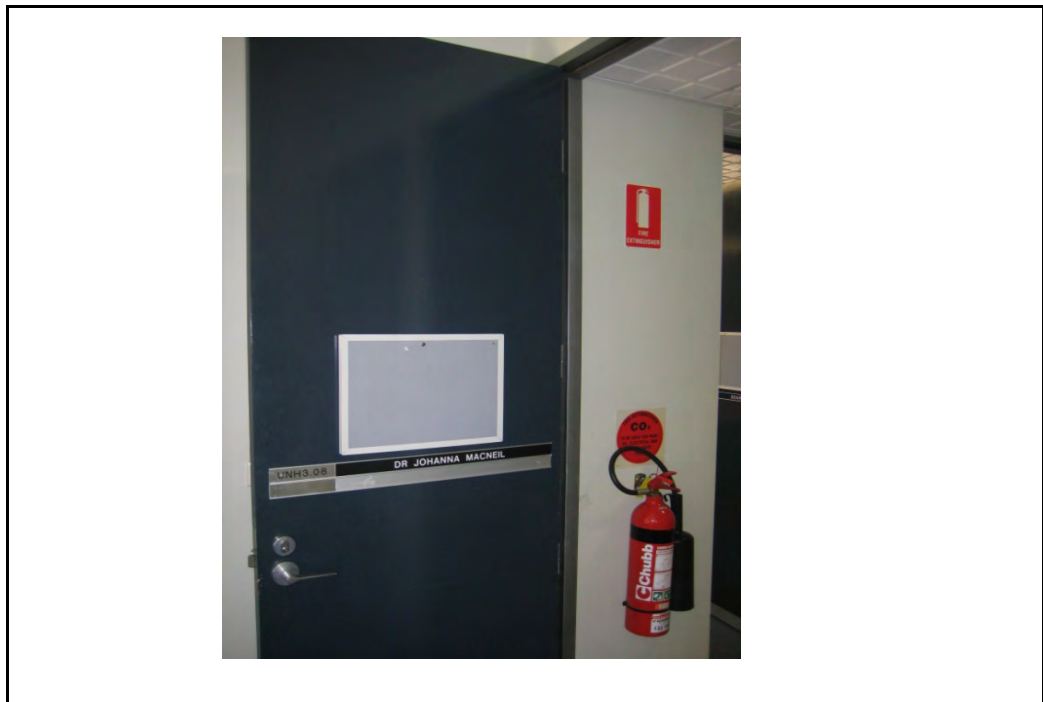
ASSET ELEMENT	DOORS
---------------	-------

EXISTING CONDITION		
OVERVIEW	Timber doors, paint finish, good condition. Powdercoated aluminium framed glazed door to terrace (south wall)	
HERITAGE SIGNIFICANCE	Heritage Significance Value of the element	Low
FUNCTIONALITY	Functional	
ACTION REQUIRED		
OVERVIEW

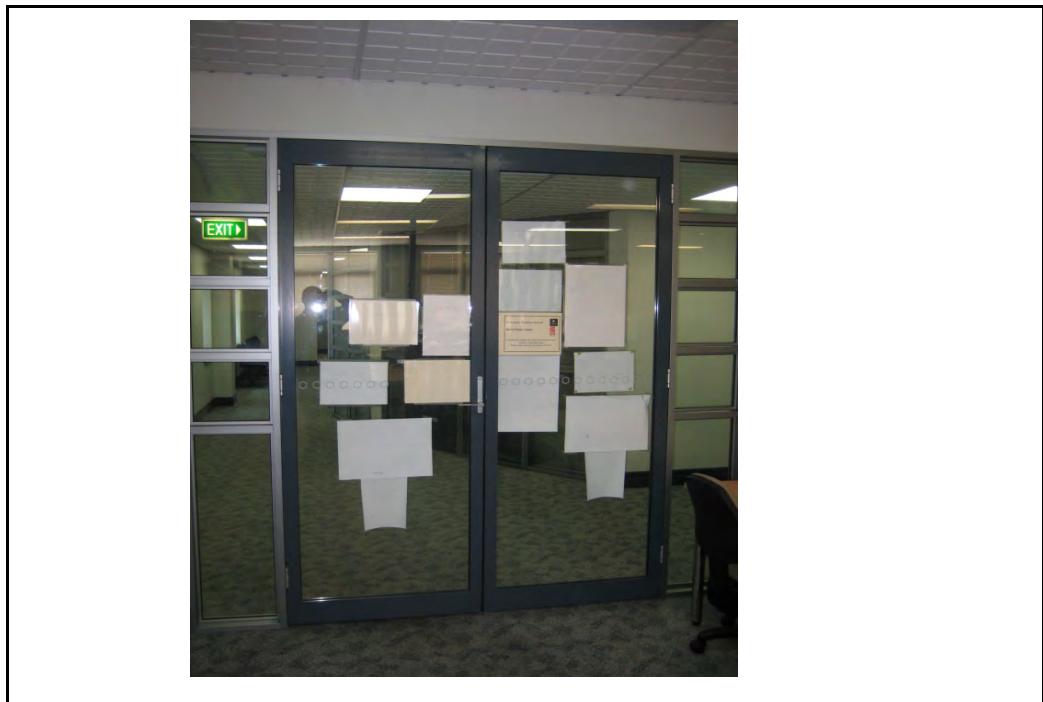
ASSET ELEMENT	DOORS
---------------	-------

EXISTING CONDITION		
OVERVIEW	Powdercoated aluminium framed glazed doors to corridor, painted timber door to common wall. Good condition.	
HERITAGE SIGNIFICANCE	Heritage Significance Value of the element	Low
FUNCTIONALITY	Functional	
ACTION REQUIRED		
OVERVIEW

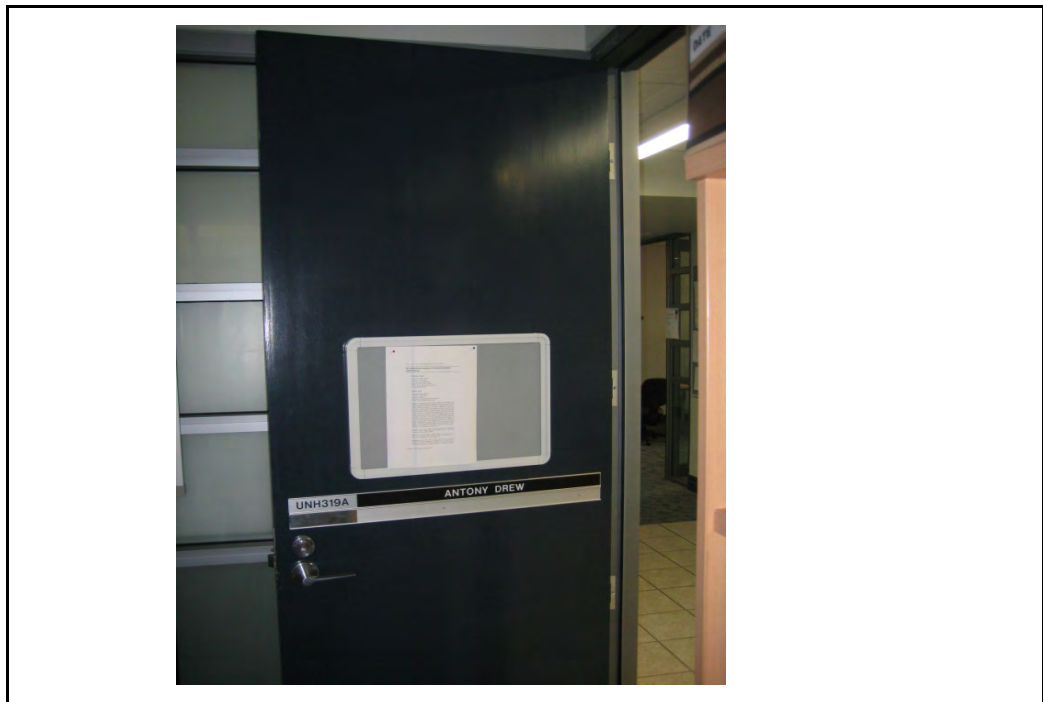
ASSET ELEMENT	DOORS
---------------	-------

EXISTING CONDITION		
OVERVIEW	Timber doors, paint finish, good condition.	
HERITAGE SIGNIFICANCE	Heritage Significance Value of the element	Low
FUNCTIONALITY	Functional	
ACTION REQUIRED		
OVERVIEW

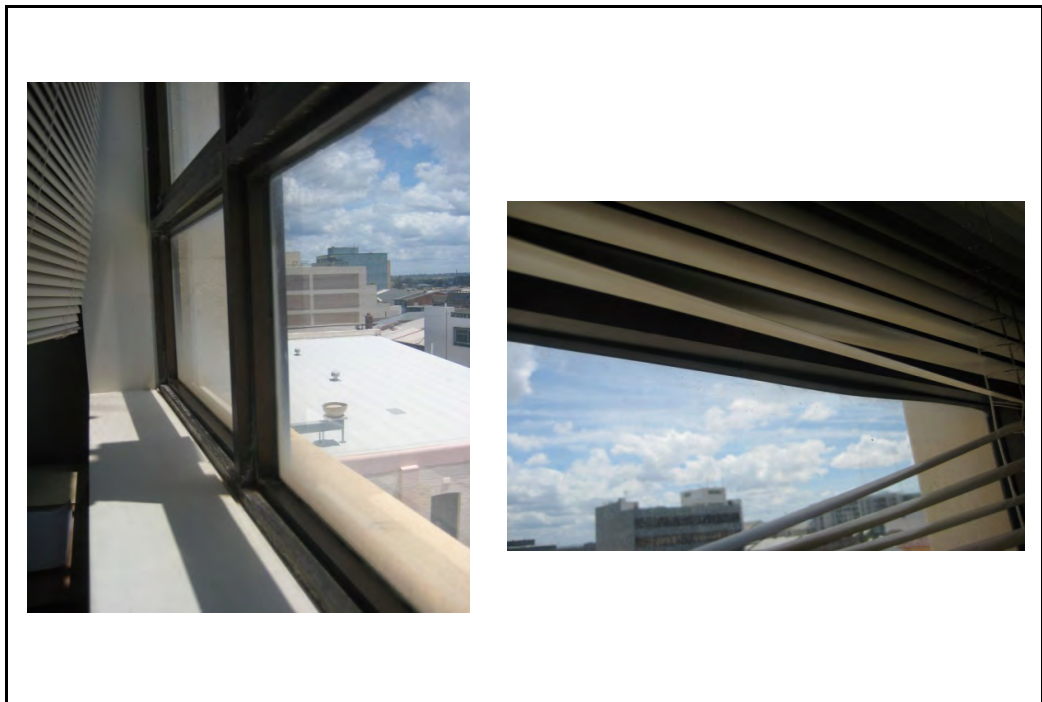
ASSET ELEMENT	WINDOWS
---------------	---------

EXISTING CONDITION		
OVERVIEW	Bronze anodised aluminium framed window to external walls, painted plasterboard sill. Good condition. Rubber seal loose on window in room 3.20	
HERITAGE SIGNIFICANCE	Heritage Significance Value of the element	Low
FUNCTIONALITY	Functional	
ACTION REQUIRED		
OVERVIEW	Refix rubber seals as required.

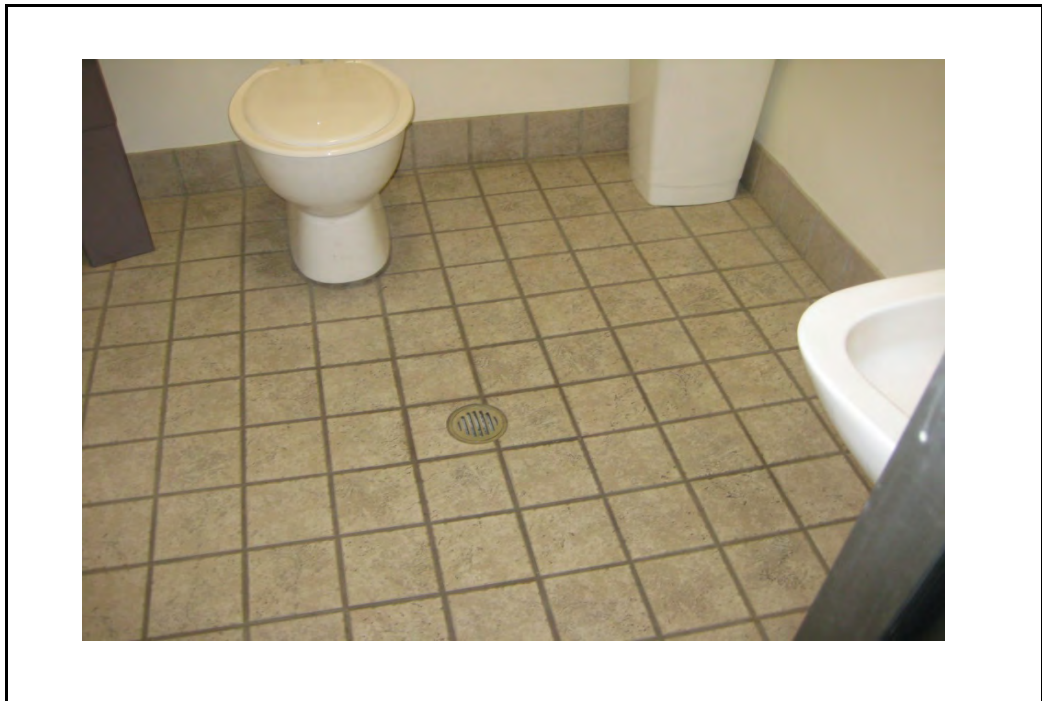
ASSET ELEMENT	FLOOR
---------------	-------

EXISTING CONDITION		
OVERVIEW	Tile flooring, generally good condition.	
HERITAGE SIGNIFICANCE	Heritage Significance Value of the element	Low
FUNCTIONALITY	Functional	
ACTION REQUIRED		
OVERVIEW

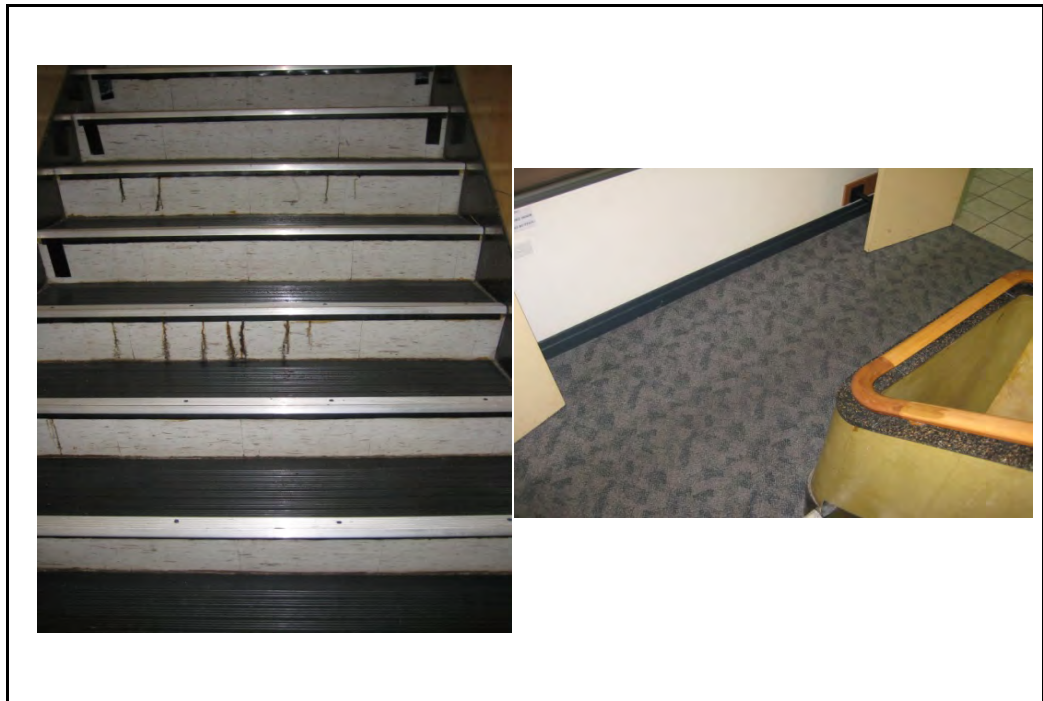
ASSET ELEMENT	FLOOR
---------------	-------

EXISTING CONDITION		
OVERVIEW	Rubber flooring to stair treads, vinyl flooring to intermediate landings, carpet tile flooring to lobby 3.35. Generally good condition.	
HERITAGE SIGNIFICANCE	Heritage Significance Value of the element	Mixed
	HIGH Rubber flooring LOW Carpet tile	
FUNCTIONALITY	Functional.	
ACTION REQUIRED		
OVERVIEW

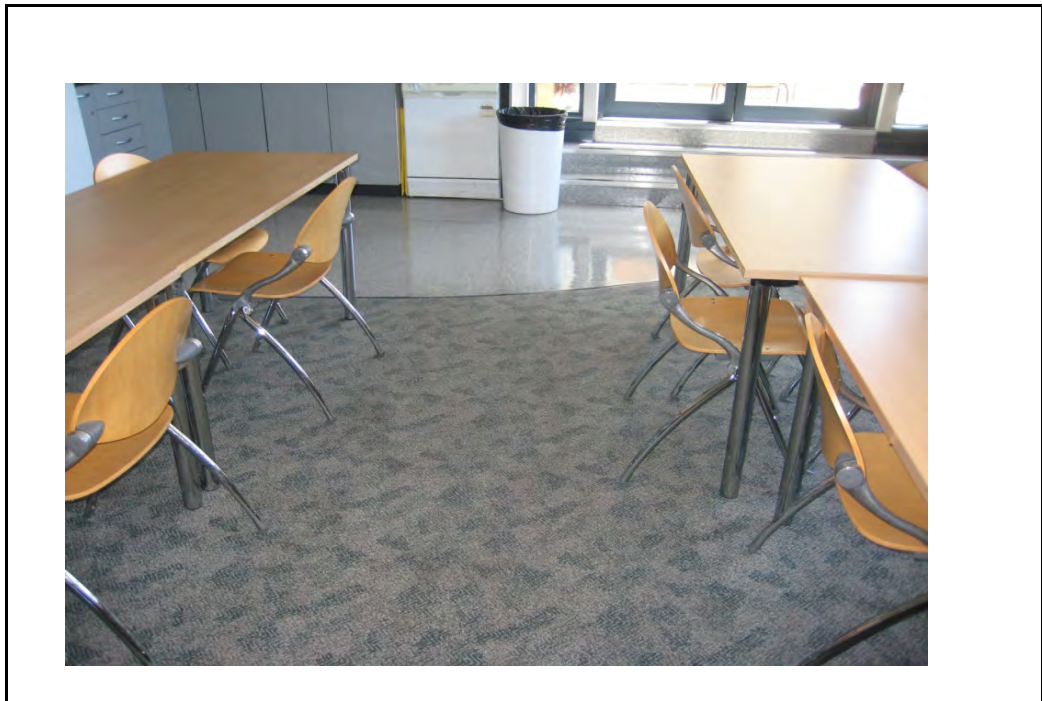
ASSET ELEMENT	FLOOR
---------------	-------

EXISTING CONDITION		
OVERVIEW	Carpet tile and vinyl flooring, good condition	
HERITAGE SIGNIFICANCE	Heritage Significance Value of the element	Low
FUNCTIONALITY	Functional.	
ACTION REQUIRED		
OVERVIEW

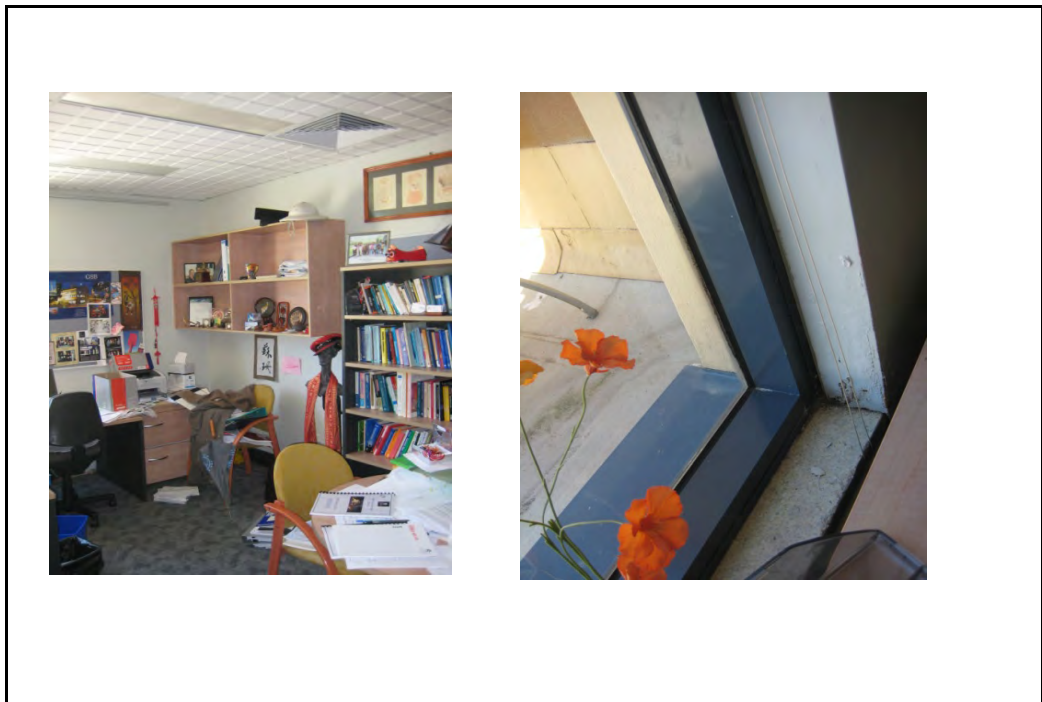
ASSET ELEMENT	WALLS
---------------	-------

EXISTING CONDITION		
OVERVIEW	Plasterboard and paint finish, generally good condition. Some damage at base of window reveals, possible moisture damage.	
HERITAGE SIGNIFICANCE	Heritage Significance Value of the element	Low
FUNCTIONALITY	Functional, requiring minor repairs	
ACTION REQUIRED		
OVERVIEW	Investigate and rectify source of moisture, repair and repaint wall / reveal as required.

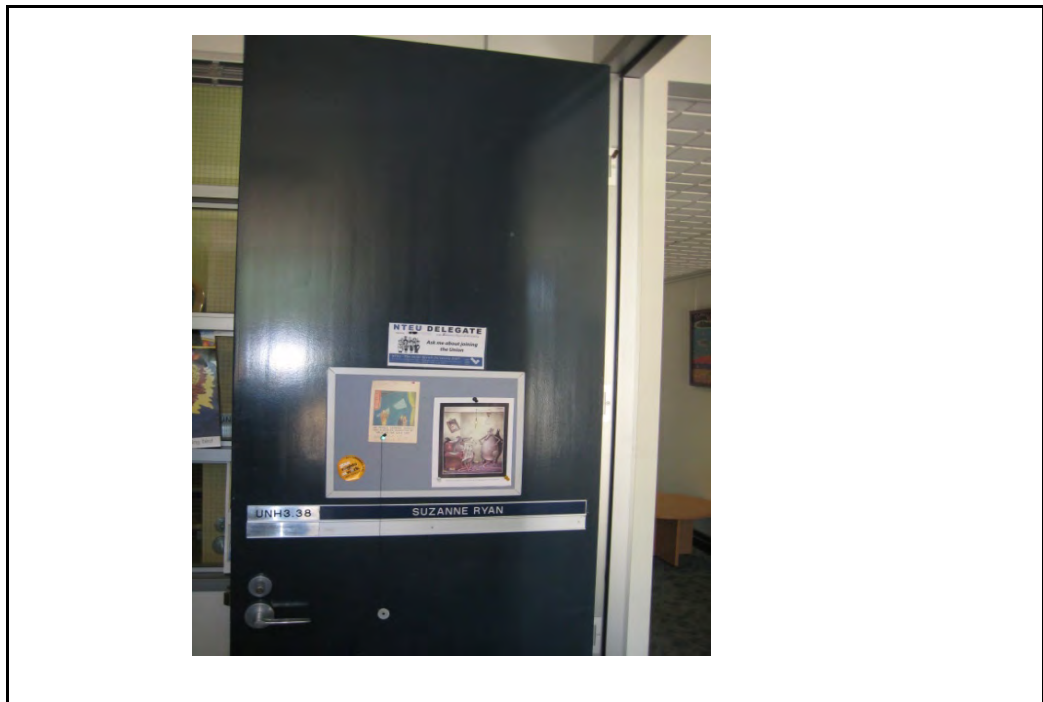
ASSET ELEMENT	DOORS
---------------	-------

EXISTING CONDITION		
OVERVIEW	Timber doors, paint finish, good condition.	
HERITAGE SIGNIFICANCE	Heritage Significance Value of the element	Low
FUNCTIONALITY	Functional	
ACTION REQUIRED		
OVERVIEW

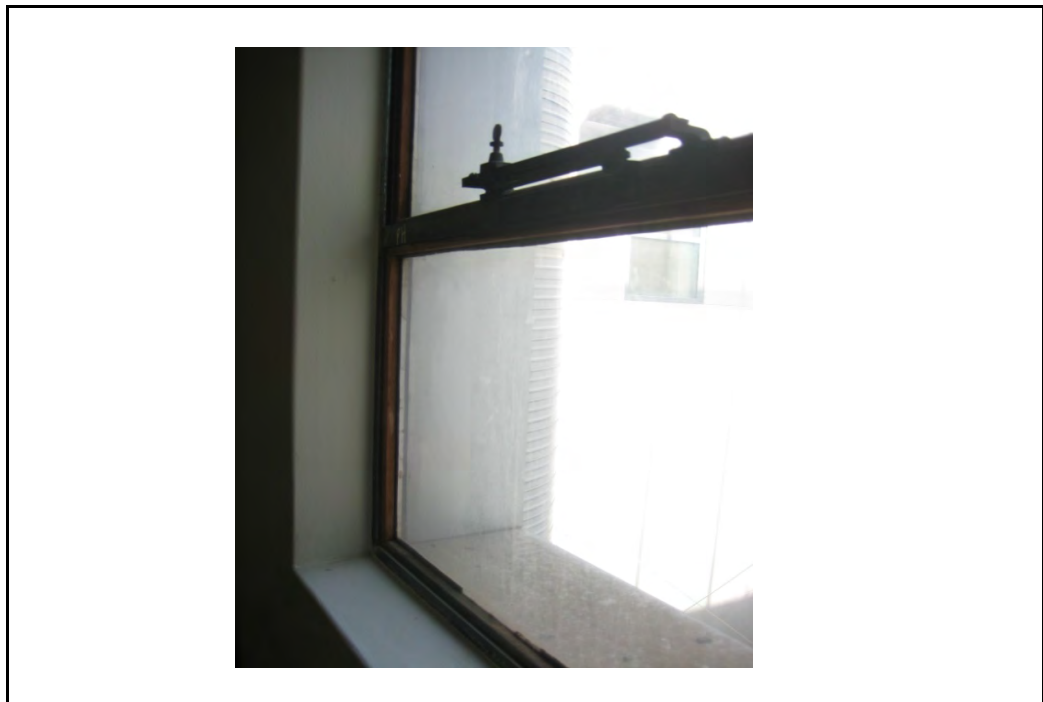
ASSET ELEMENT	WINDOWS
---------------	---------

EXISTING CONDITION		
OVERVIEW	Original metal framed casement window, fair condition - frame discoloured, some sealant perished and missing.	
HERITAGE SIGNIFICANCE	Heritage Significance Value of the element	High
FUNCTIONALITY	Functional, requiring repair	
ACTION REQUIRED		
OVERVIEW	Restore glazing frames and sealant as required.

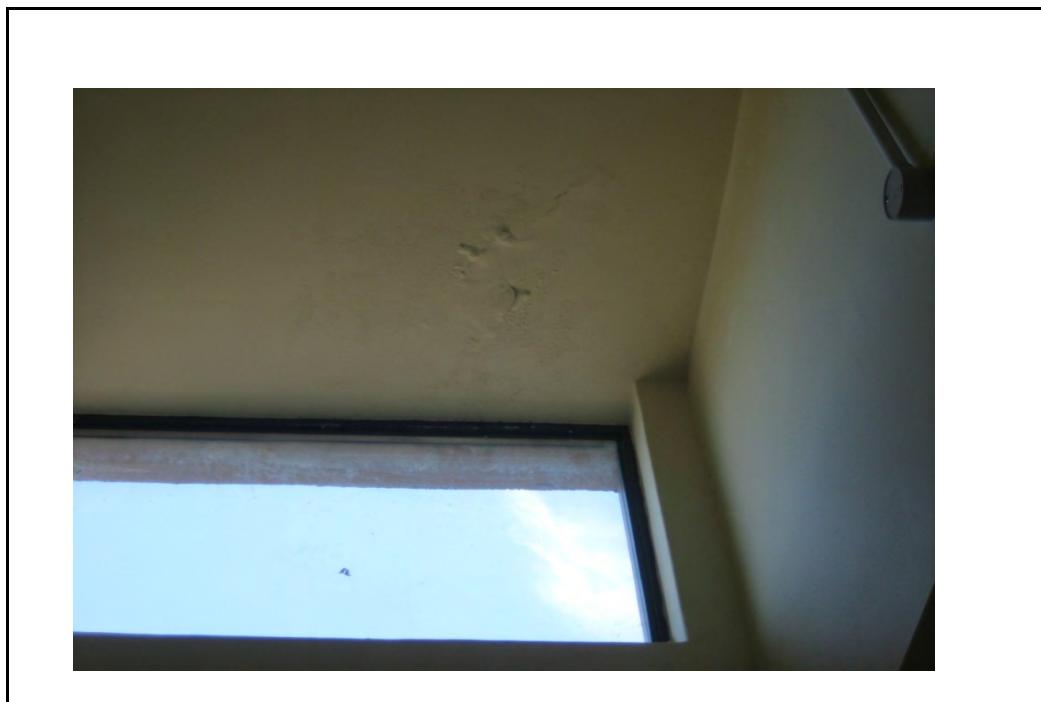
ASSET ELEMENT	CEILING
---------------	---------

EXISTING CONDITION		
OVERVIEW	Painted plasterboard ceiling, generally good condition, paintwork bubbling, flaking at southern corners of room, possible moisture damage.	
HERITAGE SIGNIFICANCE	Heritage Significance Value of the element	High
FUNCTIONALITY	Functional, requiring repair	
ACTION REQUIRED		
OVERVIEW	Investigate and rectify source of moisture, repair and repaint ceiling as required.
