UNIVERSITY HOUSE: ROOM DATA SHEETS

ROOM: 2.34,2.35,2.36,2.37,2.38,2.39	UNIVERSITY LEGAL CENTRE OFFICES
--	--

LOCATION: SECOND FLOOR NORTH EAST

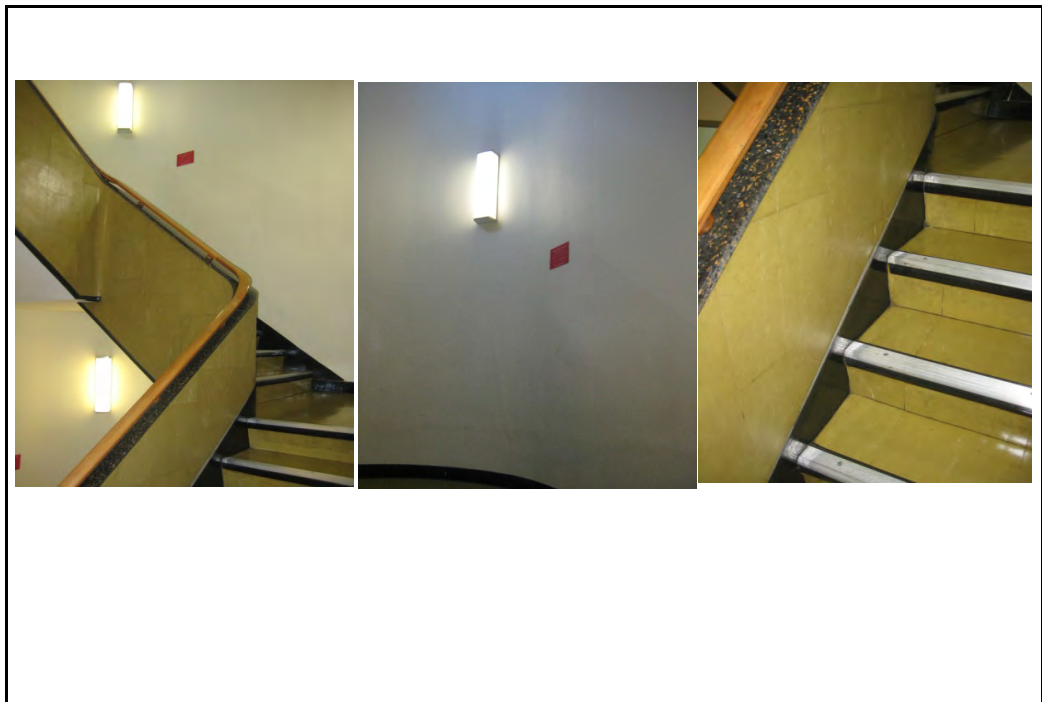
ASSET ELEMENT	WALLS
---------------	-------

EXISTING CONDITION		
OVERVIEW	Vinyl tiles with black vinyl skirting to balustrade, stone capping and timber rail over. Generally good condition, vinyl skirting separating from balustrade near top landing. Render and paint finish to outer walls, good condition, black vinyl skirting - separating from wall near top landing.	
HERITAGE SIGNIFICANCE	Heritage Significance Value of the element	High
FUNCTIONALITY	Functional but requiring repair.	
ACTION REQUIRED		
OVERVIEW	Repair and restore wall finishes as required

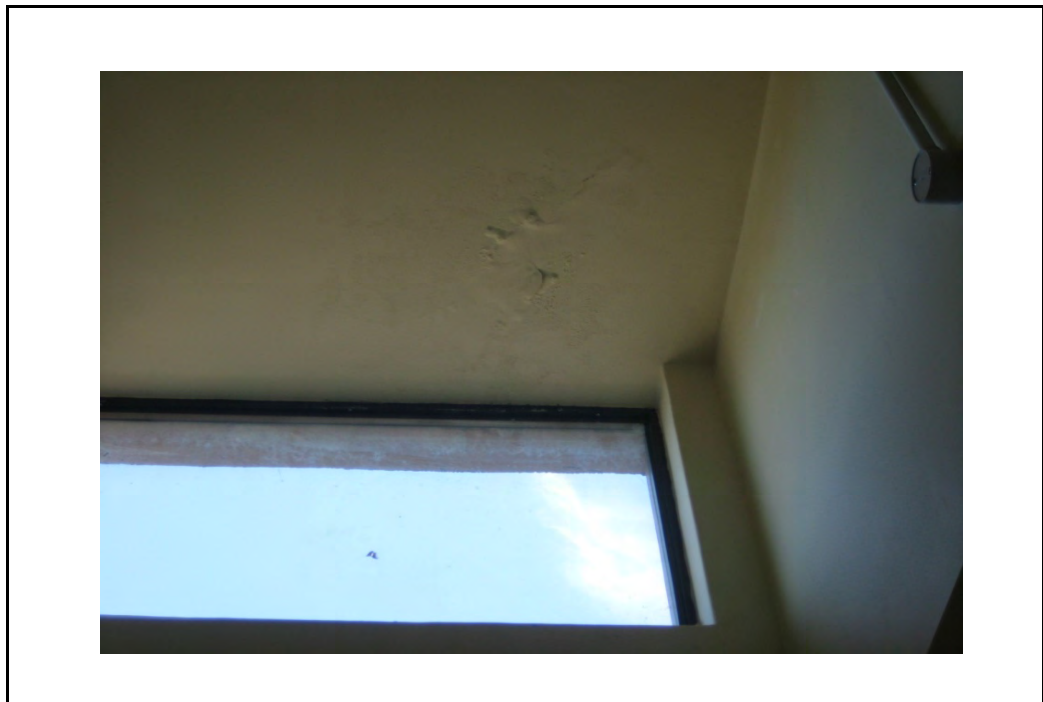
ASSET ELEMENT	WINDOWS
---------------	---------

EXISTING CONDITION		
OVERVIEW	Bronze anodised aluminium framed highlight window to south wall.	
HERITAGE SIGNIFICANCE	Heritage Significance Value of the element	Low
FUNCTIONALITY	Functional	
ACTION REQUIRED		
OVERVIEW

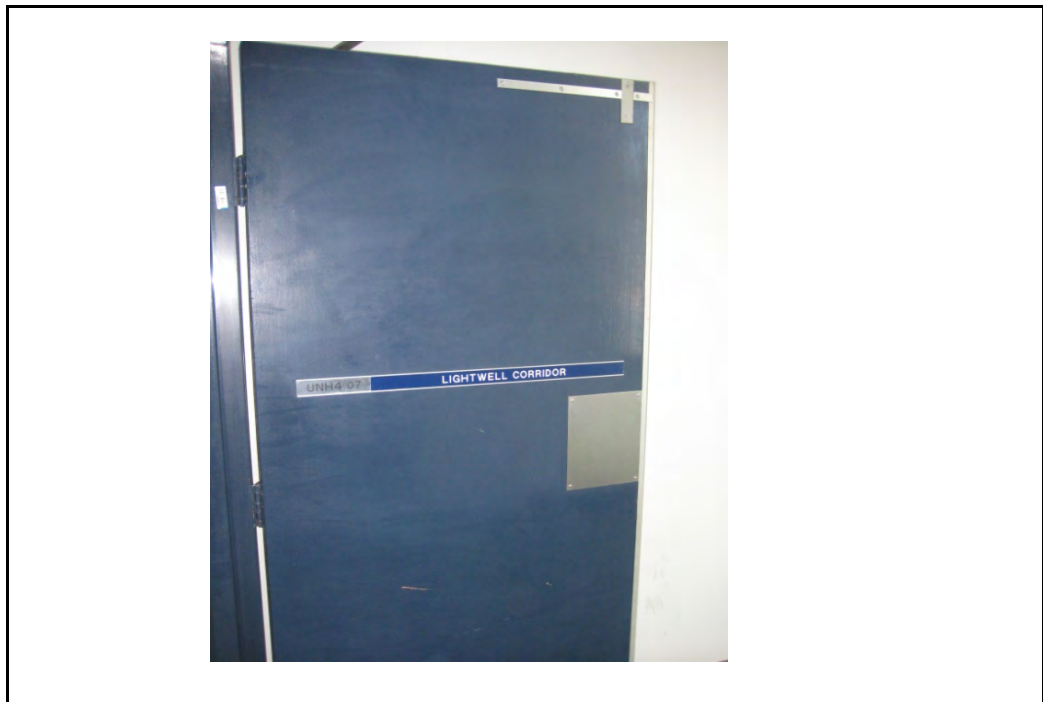
ASSET ELEMENT	DOORS
---------------	-------

EXISTING CONDITION		
OVERVIEW	Painted timber doors. Good condition.	
HERITAGE SIGNIFICANCE	Heritage Significance Value of the element	Low
FUNCTIONALITY	Functional	
ACTION REQUIRED		
OVERVIEW

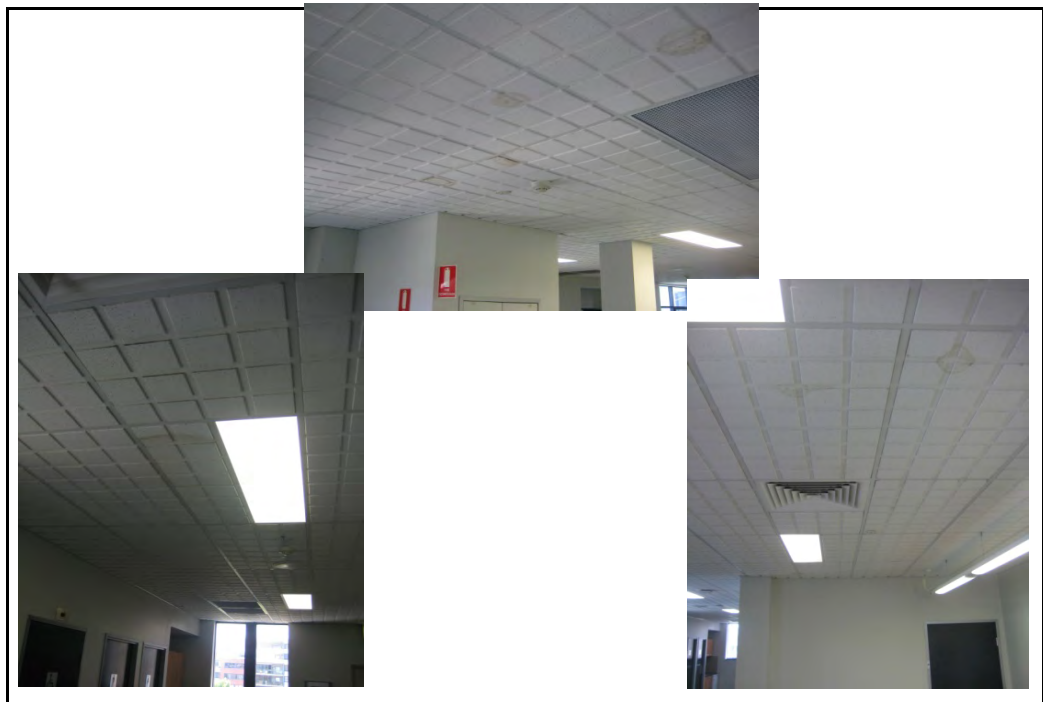
ASSET ELEMENT	CEILING
---------------	---------

EXISTING CONDITION	
OVERVIEW	Suspended ceiling tiles, generally good condition. Some moisture stains in main lobby area and at western end near toilets.
HERITAGE SIGNIFICANCE	Heritage Significance Value of the element Low
FUNCTIONALITY	Functional, requiring repair
ACTION REQUIRED	
OVERVIEW	Investigate and rectify source of moisture, replace tiles as required.

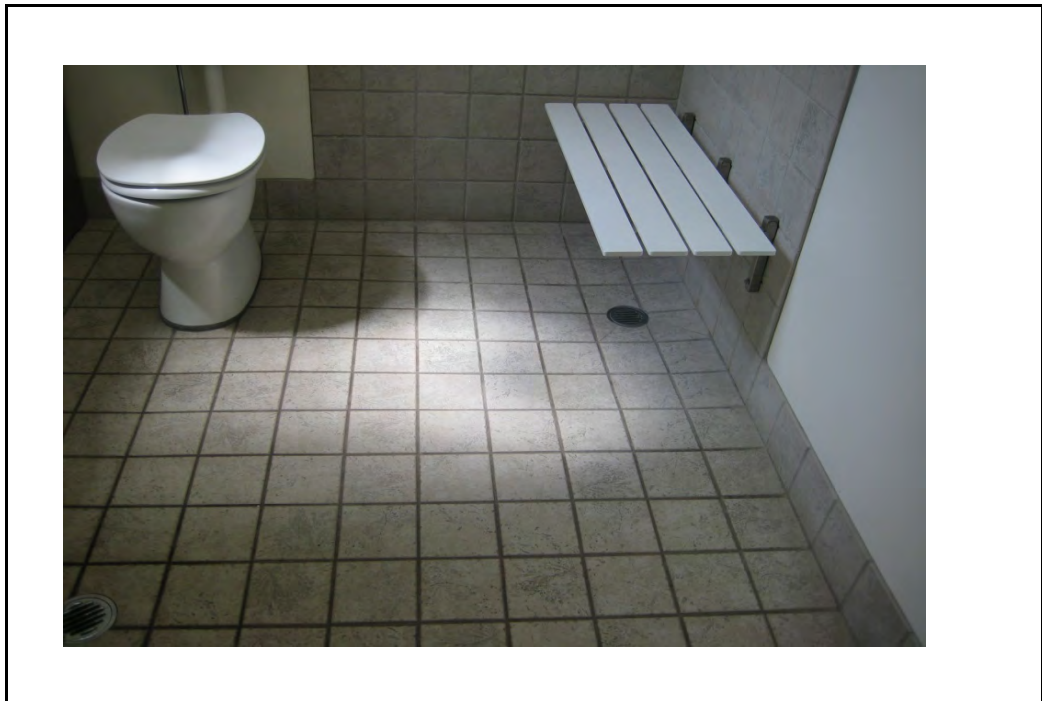
ASSET ELEMENT	FLOOR
---------------	-------

EXISTING CONDITION		
OVERVIEW	Tile flooring, generally good condition.	
HERITAGE SIGNIFICANCE	Heritage Significance Value of the element	Low
FUNCTIONALITY	Functional	
ACTION REQUIRED		
OVERVIEW

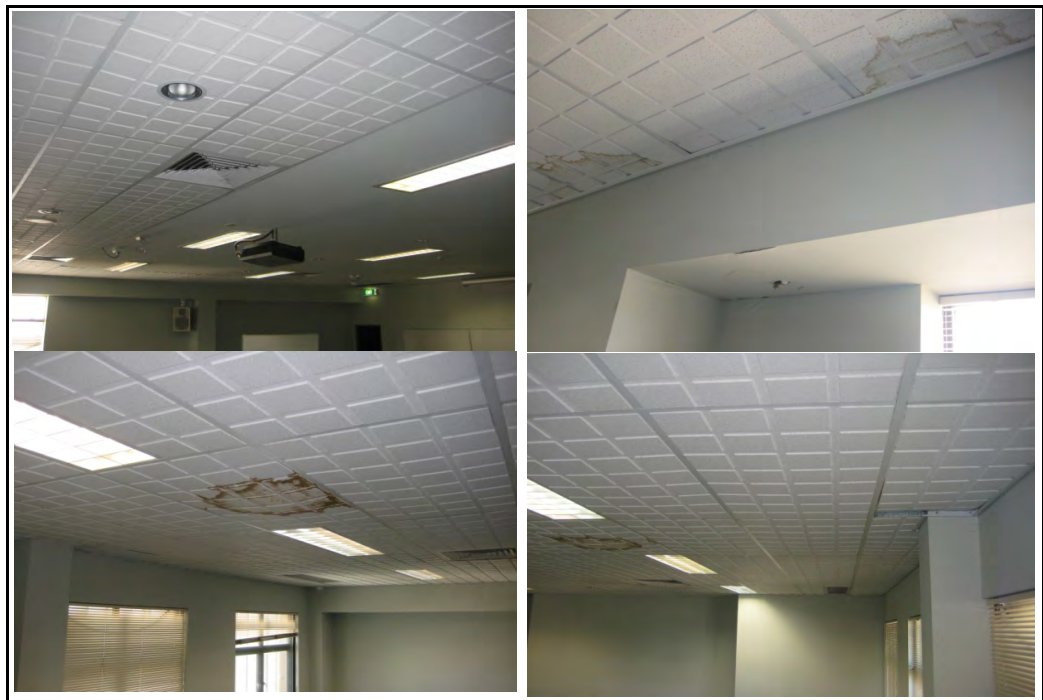
ASSET ELEMENT	CEILING
---------------	---------

EXISTING CONDITION	
OVERVIEW	Suspended ceiling tiles, with area of painted plasterboard at front of the room. Generally good condition, moisture stain on ceiling tiles in western and northern parts of room, paint damage, hole in plasterboard bulkhead in northern part of room.
HERITAGE SIGNIFICANCE	Heritage Significance Value of the element Low
FUNCTIONALITY	Functional, requiring repair
ACTION REQUIRED	
OVERVIEW	Investigate and rectify source of moisture, replace tiles. Patch affected sections of plasterboard bulkhead and repaint as required.

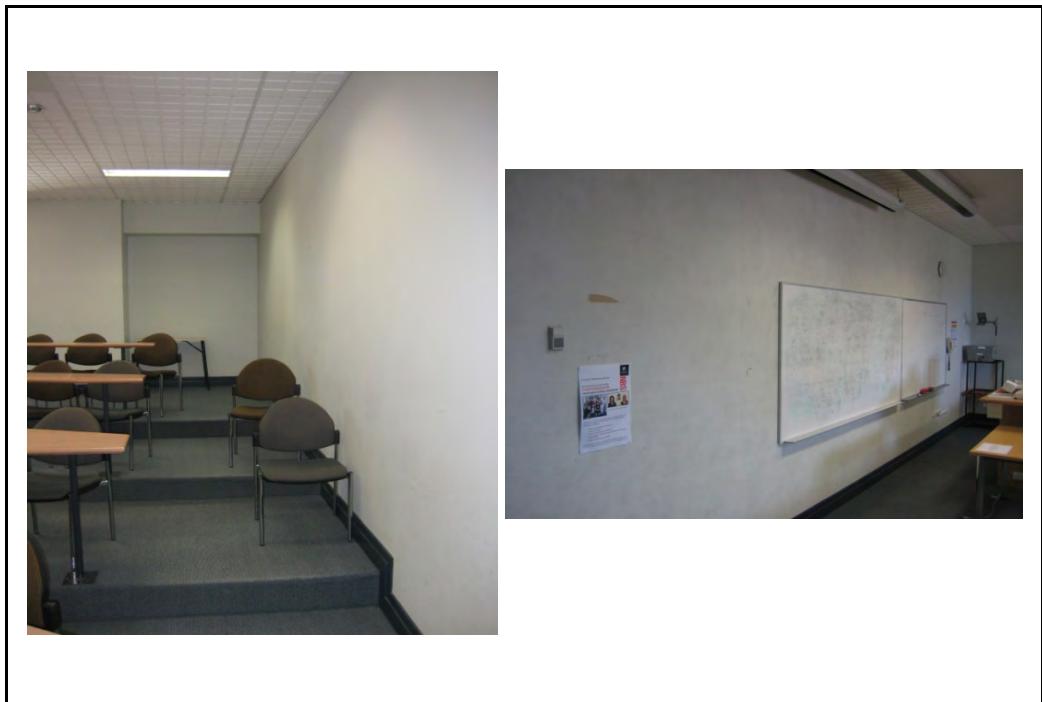
ASSET ELEMENT	WALLS
---------------	-------

EXISTING CONDITION		
OVERVIEW	Plasterboard and paint finish. Generally good condition, some scuff marks.	
HERITAGE SIGNIFICANCE	Heritage Significance Value of the element	Low
FUNCTIONALITY	Functional, requiring minor repair	
ACTION REQUIRED		
OVERVIEW	Repair wall finishes as required.

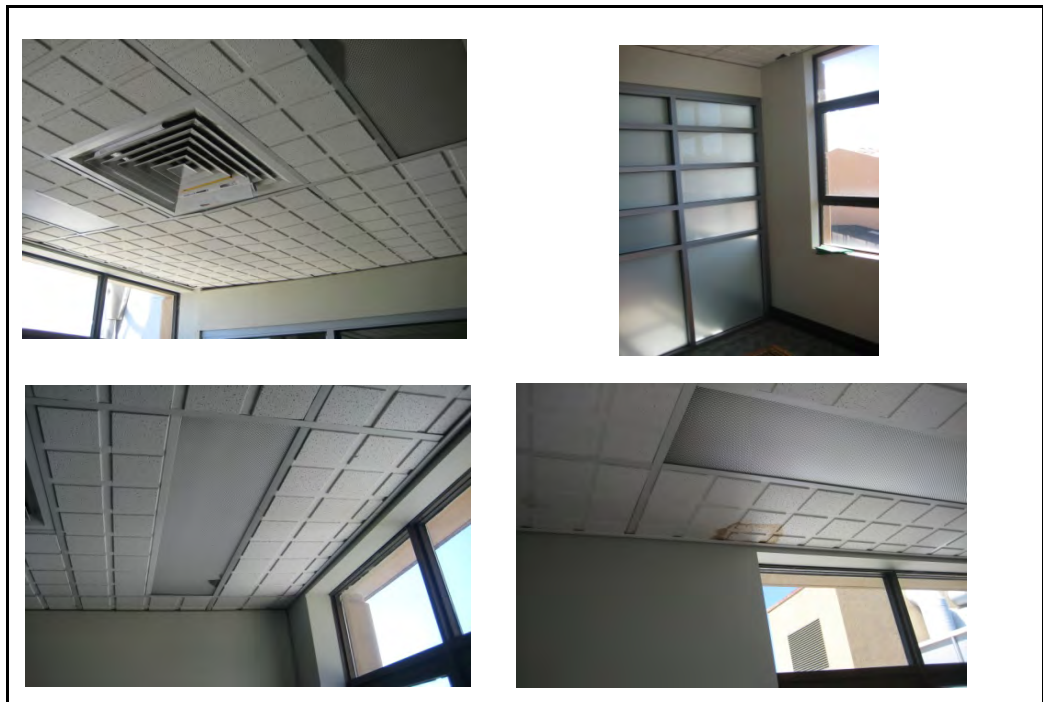
ASSET ELEMENT	CEILING
---------------	---------

EXISTING CONDITION		
OVERVIEW	Suspended ceiling tiles, generally good condition. Some moisture stains at south wall in room 4.25, and damaged tile at north east corner of room 4.25. Paperwork inserted into A/C vent in room 4.23, damaged light diffuser in room 4.24.	
HERITAGE SIGNIFICANCE	Heritage Significance Value of the element	Low
FUNCTIONALITY	Functional, requiring repair	
ACTION REQUIRED		
OVERVIEW	Investigate and rectify source of moisture, replace tiles as required.

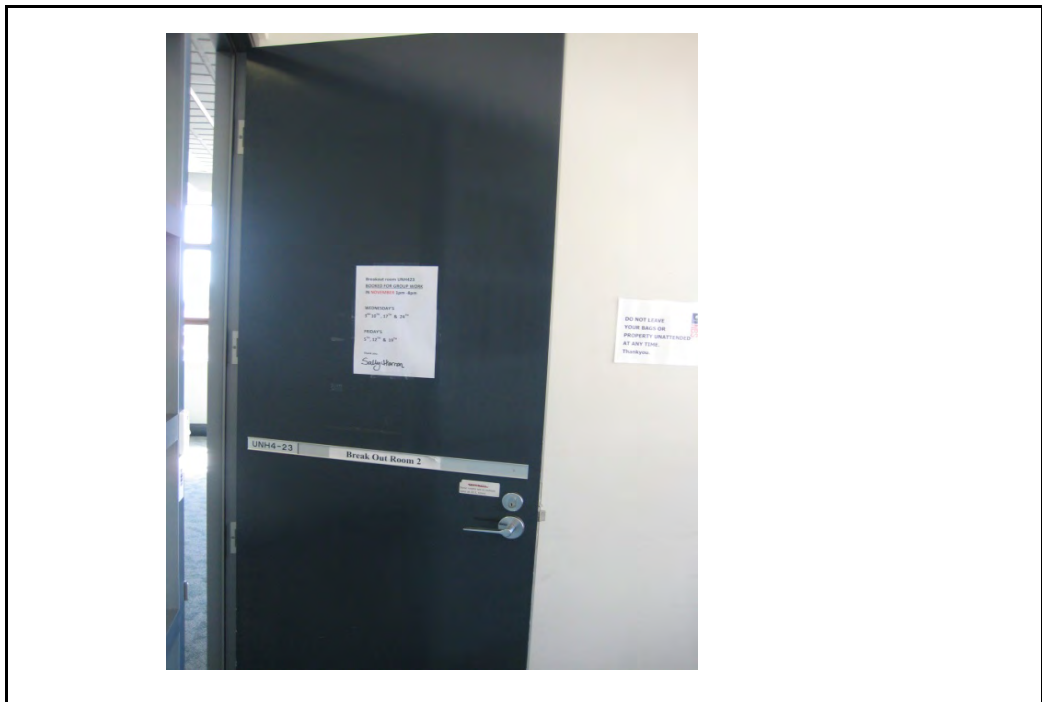
ASSET ELEMENT	DOORS
---------------	-------

EXISTING CONDITION		
OVERVIEW	Painted timber doors. Good condition.	
HERITAGE SIGNIFICANCE	Heritage Significance Value of the element	Low
FUNCTIONALITY	Functional	
ACTION REQUIRED		
OVERVIEW

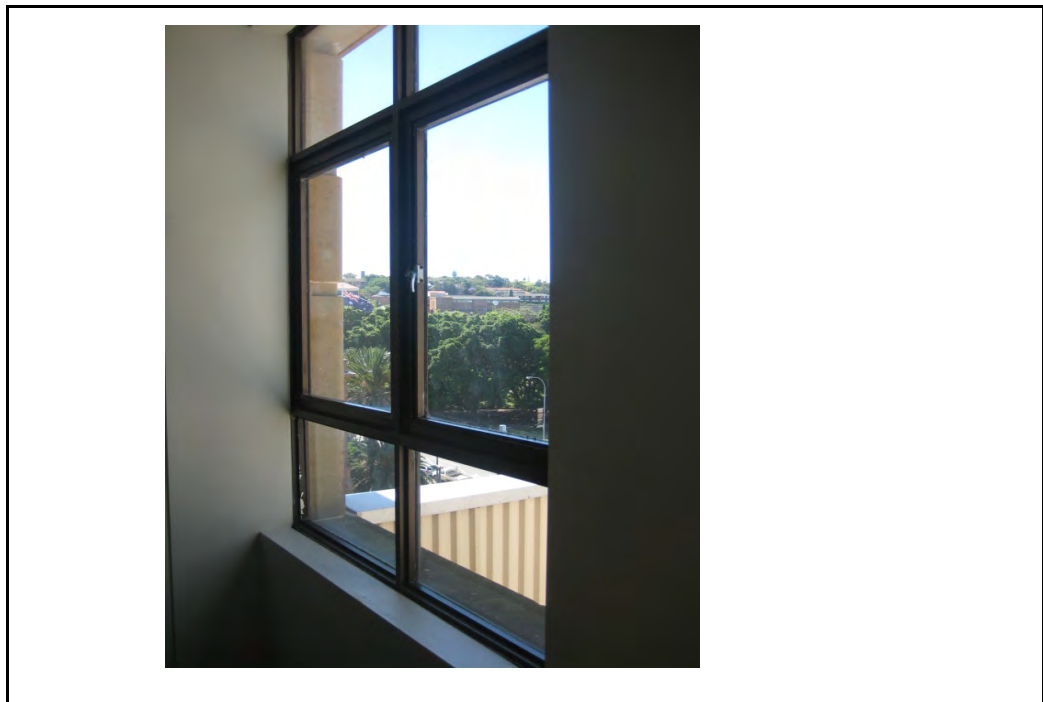
ASSET ELEMENT	WINDOWS
---------------	---------

EXISTING CONDITION		
OVERVIEW	Bronze anodised aluminium windows with painted plasterboard sills. Good condition.	
HERITAGE SIGNIFICANCE	Heritage Significance Value of the element	Low
FUNCTIONALITY	Functional	
ACTION REQUIRED		
OVERVIEW
