CONSERVATION MANAGEMENT PLAN

UNIVERSITY HOUSE FORMERLY N.E.S.C.A HOUSE KING STREET NEWCASTLE

Prepared by EJE Heritage
MARCH 2011
Ref: 8836-CMP-UH-001

APPENDIX H: INVENTORY DATASHEETS

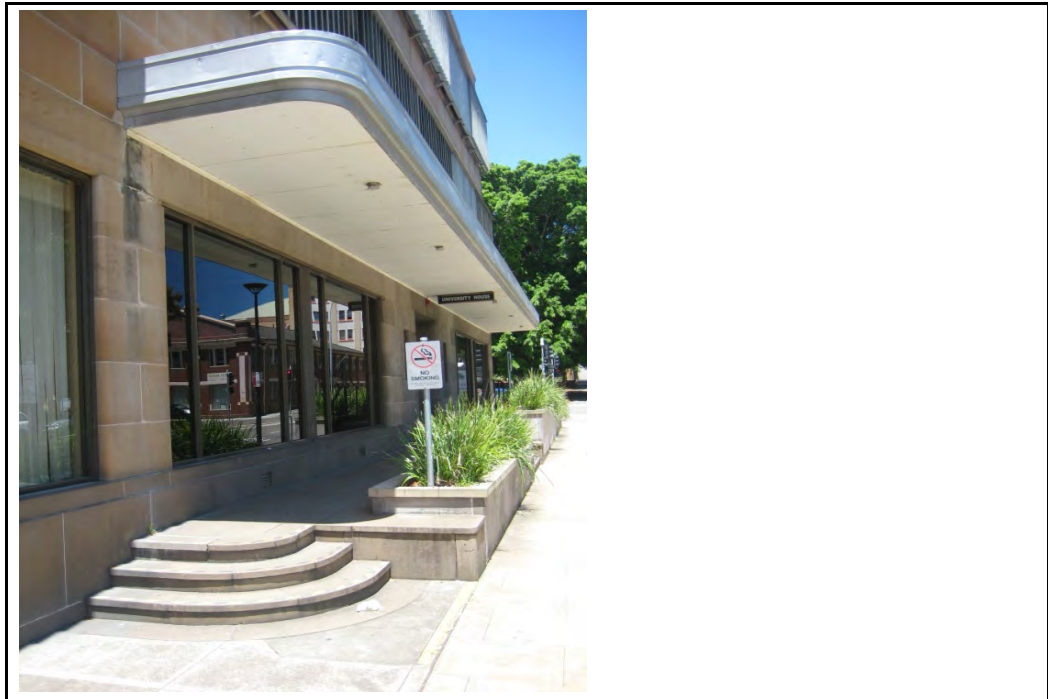
OVERVIEW	Granite paved entrance landing and stairs with matching planters to street boundary.
HERITAGE ELEMENTS	Granite paving
HERITAGE VALUE	High
FUNCTIONALITY	Functional

OVERVIEW	Minor repairs required to stair treads, minor restoration required to stonework generally.
----------	--

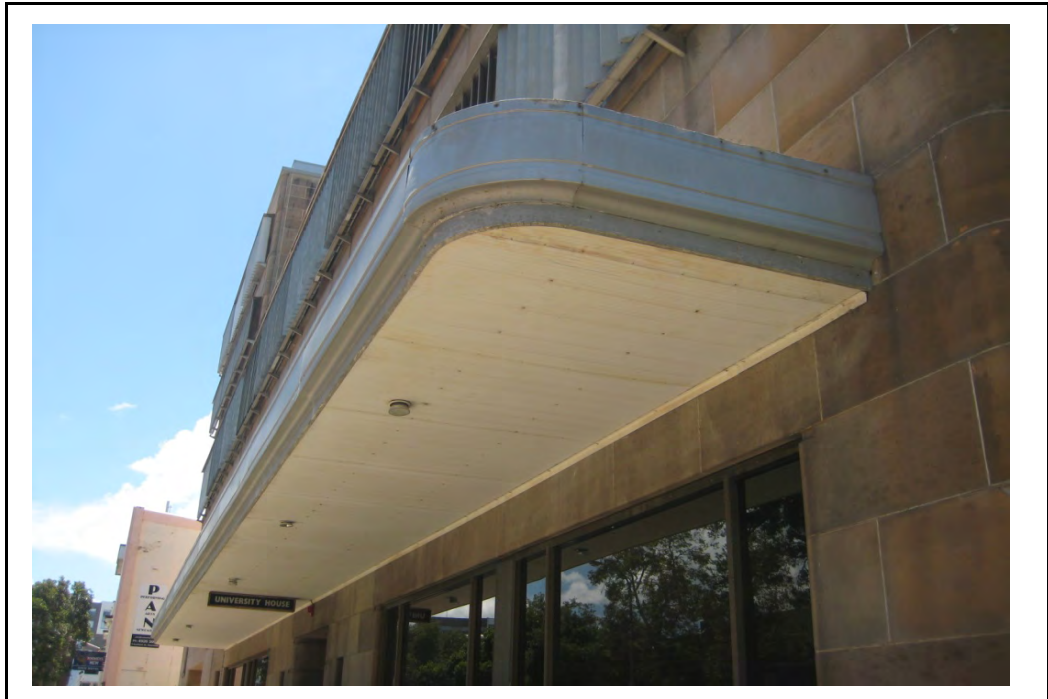
OVERVIEW	Soffit over entry stairs and landing - white profiled metal soffit with pressed metal fascia. Generally good condition, soffit displaying some rust marks, and light fittings separating from soffit. Some minor dents in pressed metal fascia.
HERITAGE ELEMENTS	Pressed metal soffit and fascia
HERITAGE VALUE	High
FUNCTIONALITY	Functional, requiring minor repairs / restoration works.

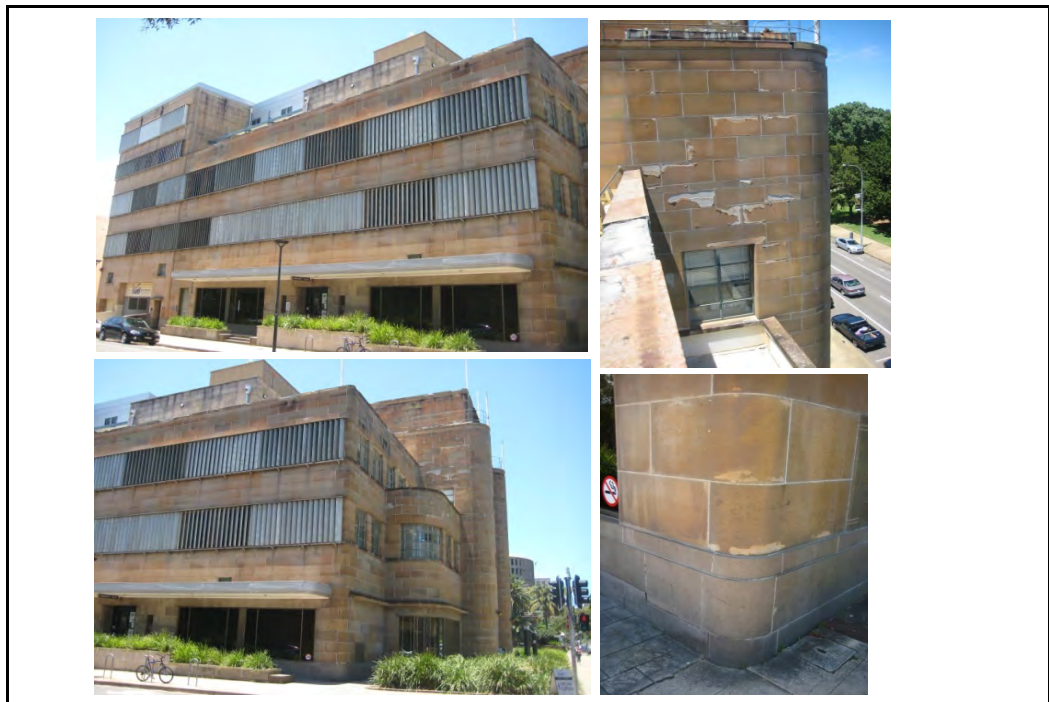
EXISTING CONDITION	
OVERVIEW	Smooth face sandstone blocks over trachyte base, with caulking to bed and perpend joints. Filleted reveals with feature joint detail at entry doors and window heads. Visual bands at window level with recessed joint detail present between windows. Most joints in deteriorating or deteriorated condition. Face of blocks weathered and discoloured, particularly below sill and capping projections. Some physical deterioration to face of blocks. Sandstone cappings in deteriorated condition, with some cappings missing. Parts of level 3 and 4 (recessed back from main building line) clad in modern sandwich panel cladding, small areas visible from street level.
HERITAGE SIGNIFICANCE	Heritage Significance Value of the element Mixed
	EXCEPTIONAL 1939 sandstone and trachyte fabric (South tower all floors, majority of facade below third floor) HIGH 1959 fabric (north end below third floor) MODERATE 1971 sandstone (floors 3, 4) LOW 1998 cladding (floors 3, 4)

FUNCTIONALITY	Functional, but sandstone walls requiring repair.
ACTION REQUIRED	
OVERVIEW	Repair deteriorated facing as required to provide even, consistent restoration of original wall surfaces. Renew stone jointing and replace missing cappings.

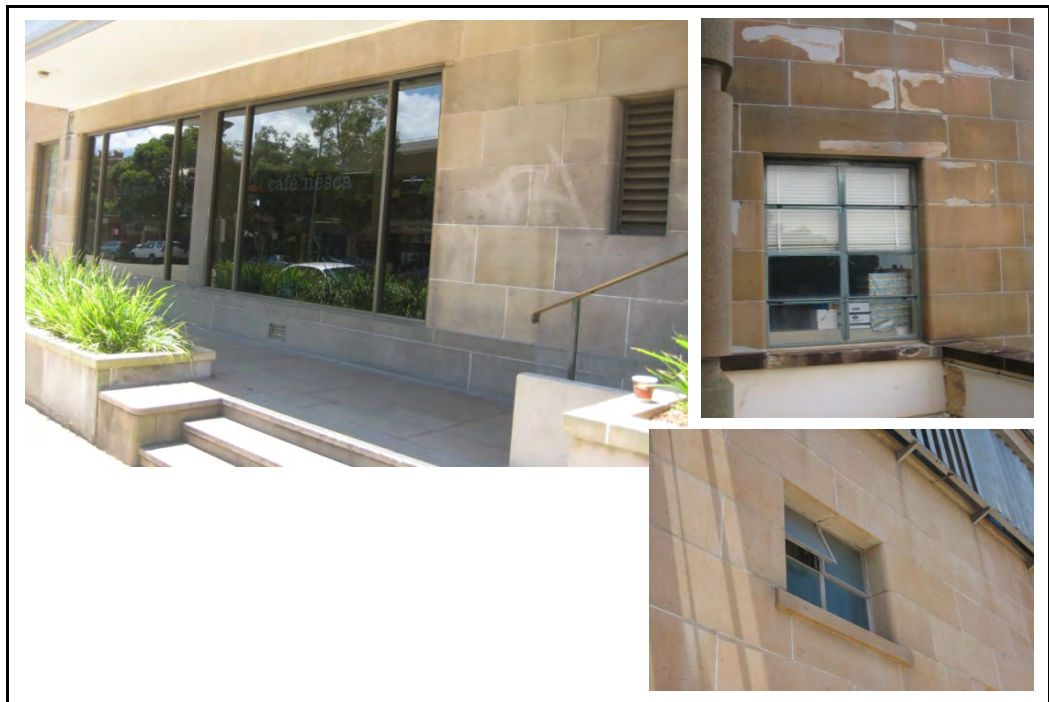
EXISTING CONDITION	
OVERVIEW	Ground floor windows non-original - bronze anodised aluminium framed fixed glazing, good condition. Windows on levels 1 and 2 are metal framed casement windows, with awning windows to stairwell. Generally fair condition - frames weathered and discoloured, some sealant cracked / missing from most windows on these levels. Windows on levels 3 and 4 are bronze anodised aluminium framed casement style, with powdercoated aluminium framed glazing to areas with sandwich panel cladding.
HERITAGE SIGNIFICANCE	Heritage Significance Value of the element Mixed
	EXCEPTIONAL 1939 windows (South tower all floors, majority of facade below third floor) HIGH 1959 windows (north end below third floor) LOW Bronze anodised and powdercoated windows
FUNCTIONALITY	Generally functional, some repairs needed to original windows.
ACTION REQUIRED	
OVERVIEW	Windows to be restored as required.

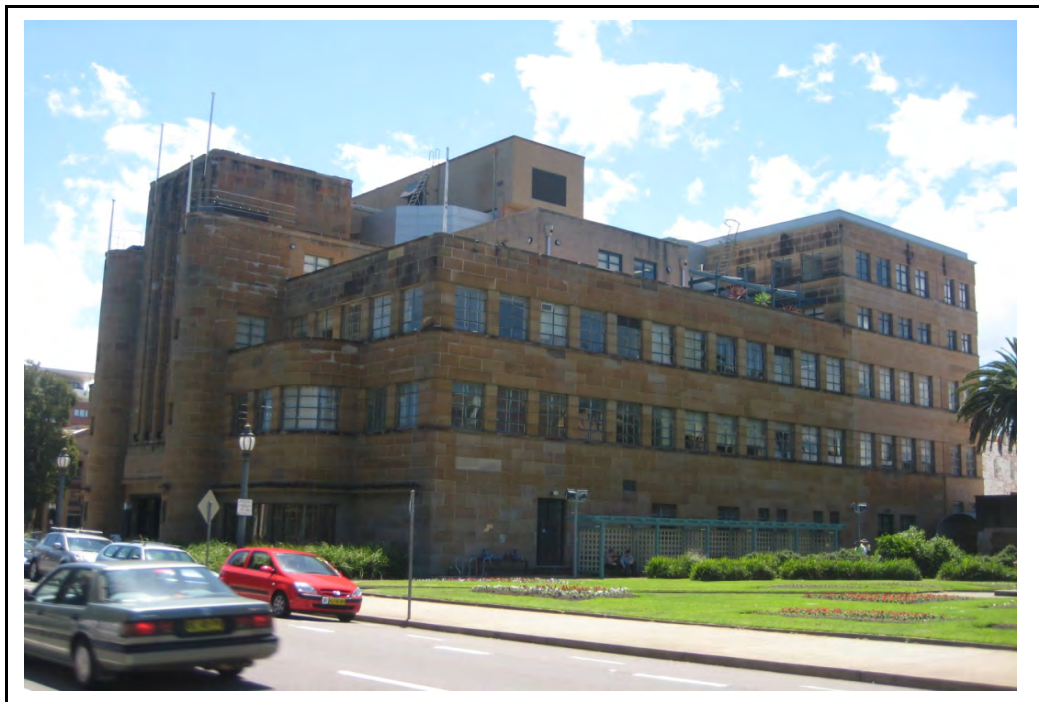
OVERVIEW	Smooth face sandstone blocks over trachyte base, with caulking to bed and perpend joints. Filleted reveals with feature joint detail at entry doors and window heads. Visual bands at window level with recessed joint detail present between windows. Most joints in deteriorating or deteriorated condition. Face of blocks weathered and discoloured. Some physical deterioration to face of blocks - especially at southern end of building. Fragment of block missing on level 1 at junction of 1939 and 1959 works. Sandstone cappings in deteriorated condition, with some cappings missing. Parts of level 3 and 4 (recessed back from main building line) clad in modern sandwich panel cladding, small areas visible from street level.	
HERITAGE SIGNIFICANCE	Heritage Significance Value of the element	Mixed
	EXCEPTIONAL 1939 sandstone and trachyte fabric (South tower all floors, majority of facade below third floor) HIGH 1959 fabric (north end below third floor) MODERATE 1971 sandstone (floors 3, 4) LOW 1998 cladding (floors 3, 4)

FUNCTIONALITY	Functional, but sandstone walls requiring repair.

OVERVIEW	Repair deteriorated facing as required to provide even, consistent restoration of original wall surfaces. Renew stone jointing and replace missing cappings.
-----------------	--

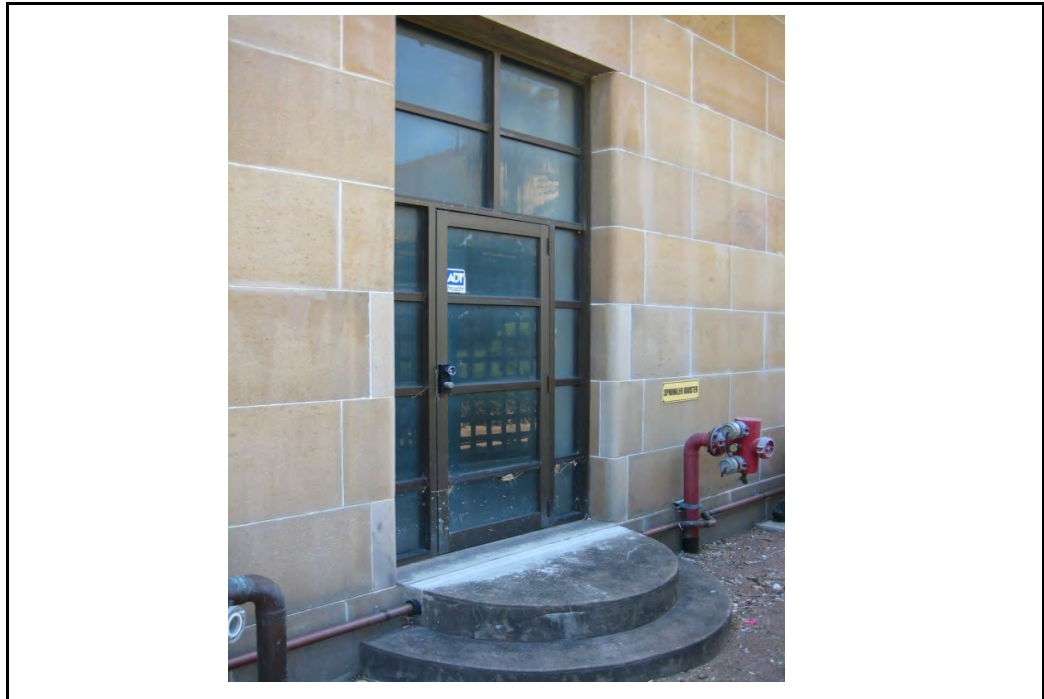
OVERVIEW	Bronze anodised aluminium and glass egress doors. Both doors in good condition.	
HERITAGE SIGNIFICANCE	Heritage Significance Value of the element	Low
FUNCTIONALITY	Functional

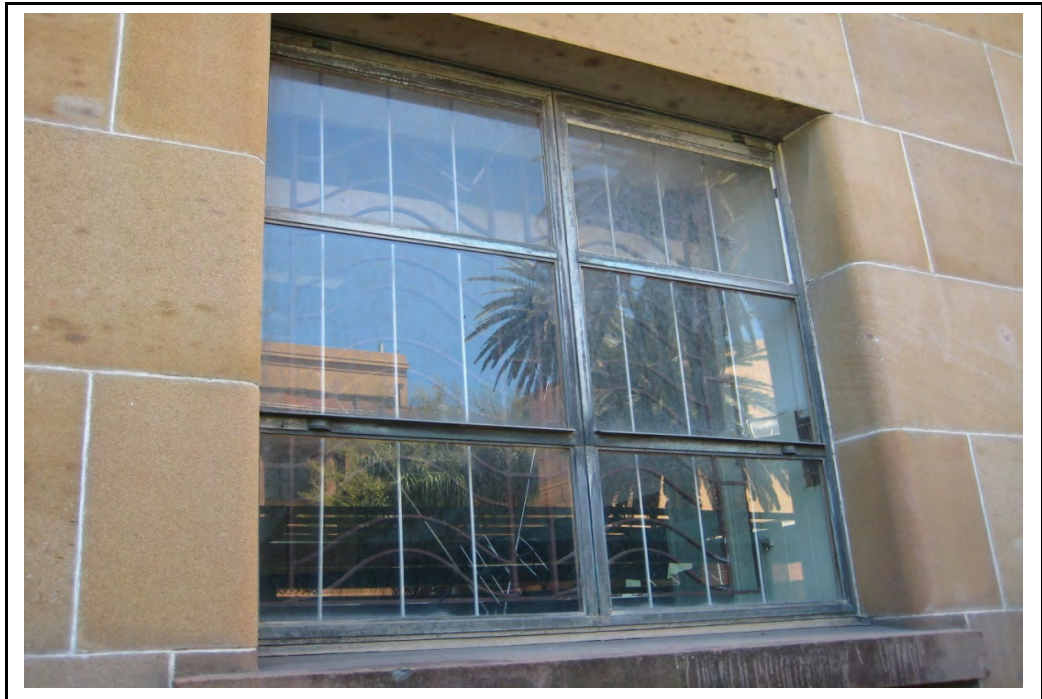
EXISTING CONDITION	
OVERVIEW	Windows are original metal framed casement windows.. Generally fair condition - frames weathered and discoloured, some sealant cracked / missing from most windows. Windows on levels 3 and 4 are bronze anodised aluminium framed casement style, with powdercoated aluminium framed glazing to areas with sandwich panel cladding.
HERITAGE SIGNIFICANCE	Heritage Significance Value of the element Mixed
	EXCEPTIONAL 1939 windows (South tower all floors, majority of facade below third floor) HIGH 1959 windows (north end below third floor) LOW Bronze anodised and powdercoated windows.
FUNCTIONALITY	Generally functional, some repairs needed to original windows.
ACTION REQUIRED	
OVERVIEW	Windows to be restored as required.

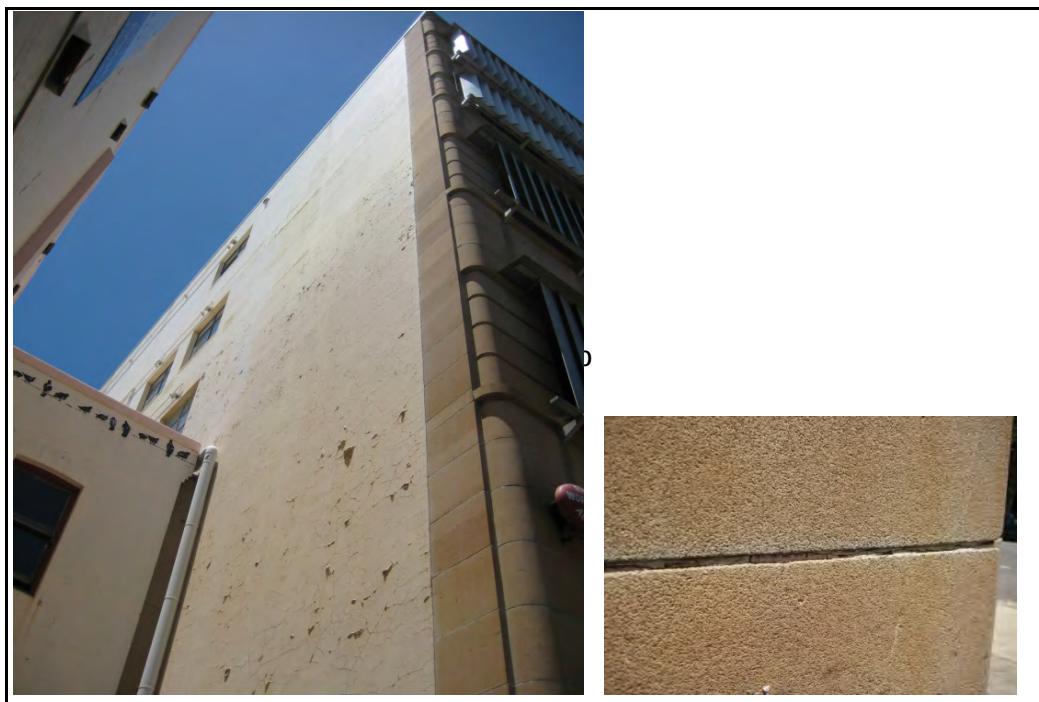
OVERVIEW	Render and paint finish with smooth faced sandstone blocks over trachyte base at eastern and western ends. Render and paint finish cracked, peeling generally across facade. Paintwork extremely faded at top of building, different shades of the same colour graduation along the height of the wall. Graffiti on wall at base. Joints to stonework deteriorated - hardened, cracked and in some locations missing.	
HERITAGE SIGNIFICANCE	Heritage Significance Value of the element	Moderate
FUNCTIONALITY	Functional but requiring minor repairs

OVERVIEW	Work to restore facade - rectify cracking render and paint to majority of facade, renew stonework and jointing at corners of building.
----------	--

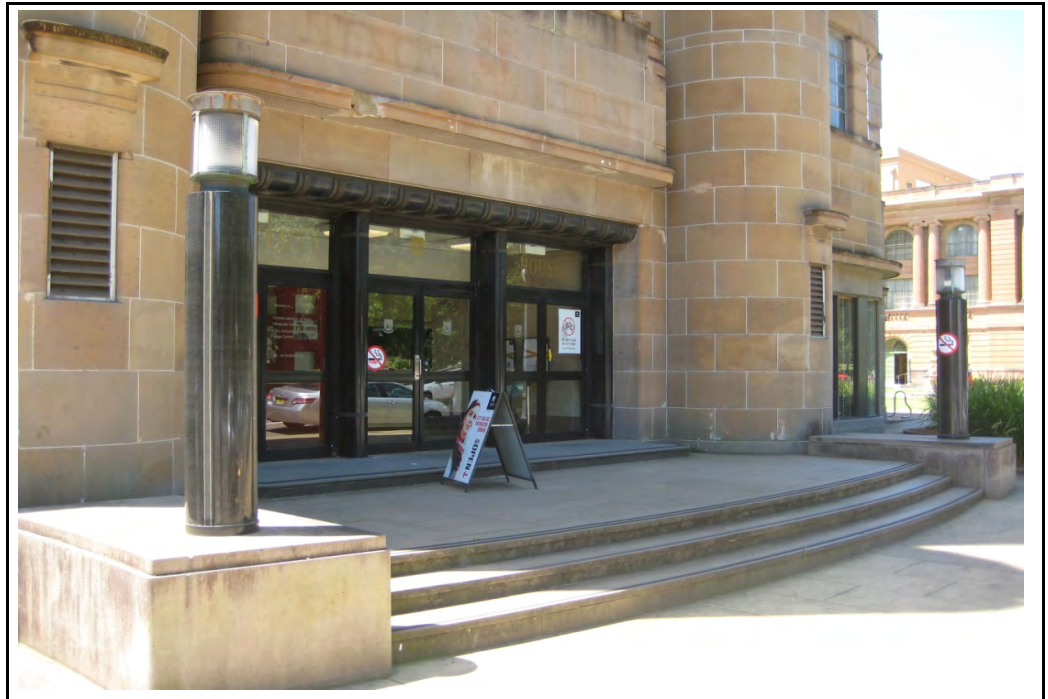
OVERVIEW	Stone entrance landing and stairs with matching plinths each side. Two parts of the top tread are loose and require attention.	
HERITAGE SIGNIFICANCE	Heritage Significance Value of the element	High
FUNCTIONALITY	Functional, with some repair required.

OVERVIEW	Minor repairs required to stair treads, minor restoration required to stonework generally.
----------	--

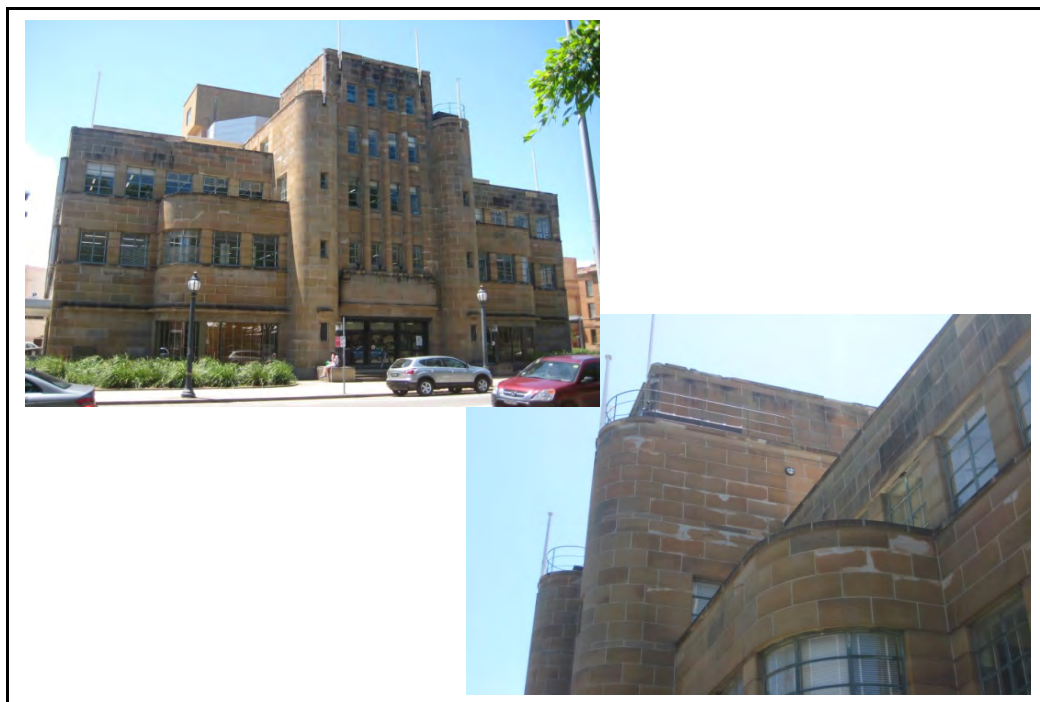
OVERVIEW	Smooth face sandstone blocks over trachyte base, with caulking to bed and perpend joints. Filleted reveals with feature joint detail at entry doors and window heads. Visual bands at window level with recessed joint detail present between windows. Most joints in deteriorating or deteriorated condition. Face of blocks weathered and discoloured, particularly below sill and capping projections and at top of building. Extensive physical deterioration to face of blocks. Sandstone cappings in deteriorated condition, with some cappings missing. Some cracking at eastern end of building. Damage to underside of ledges, especially panel over main doors. Some cracking and evidence of moisture on undersides of sills and window heads. Sub-floor vent missing at western end of building. Third and fourth floor additions each side of main tower (1971) - sandstone blocks, good condition.	
HERITAGE SIGNIFICANCE	Heritage Significance Value of the element	Mixed

EXCEPTIONAL 1939 sandstone and trachyte fabric (main tower all floors, east and west wings below third floor) MODERATE 1971 additions (floors 3 and 4 on east and west wings).	
FUNCTIONALITY	Functional, but requiring repair.

OVERVIEW	Repair deteriorated facing as required to provide even, consistent restoration of original wall surfaces. Renew stone jointing and replace missing cappings. Replace missing sub-floor vent.
-----------------	--

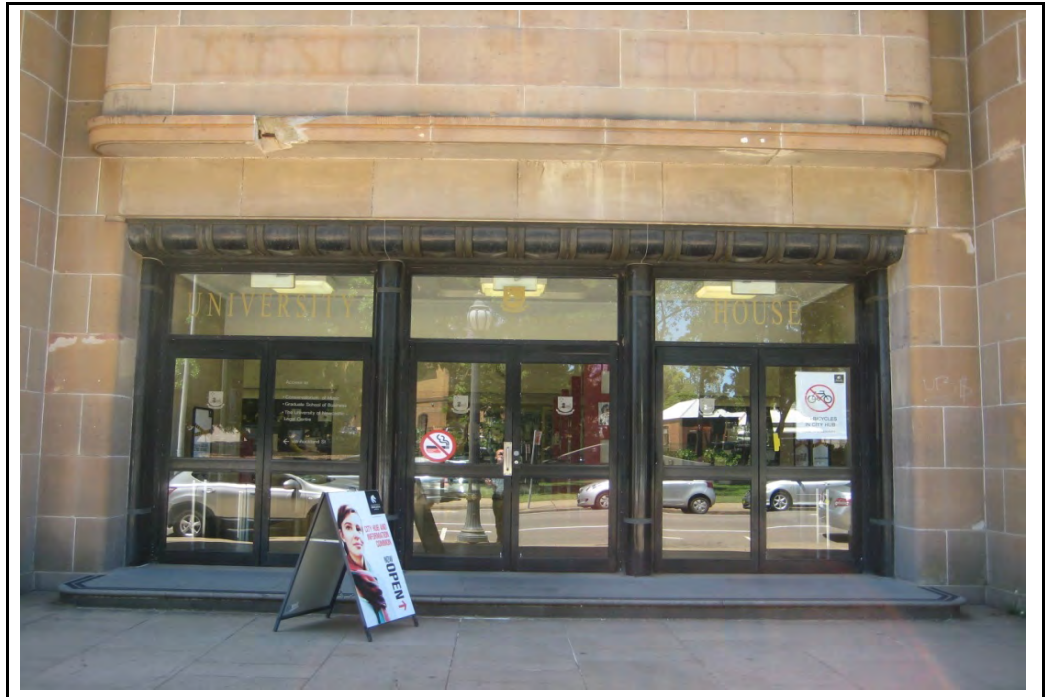
OVERVIEW	Powdercoated aluminium and glass entry doors. Doors and frames in good condition. Decorative stone feature jambs, mullions and door head - weathered but otherwise in good condition.	
HERITAGE SIGNIFICANCE	Heritage Significance Value of the element	Mixed
	EXCEPTIONAL Stonework LOW Doors	
FUNCTIONALITY	Functional

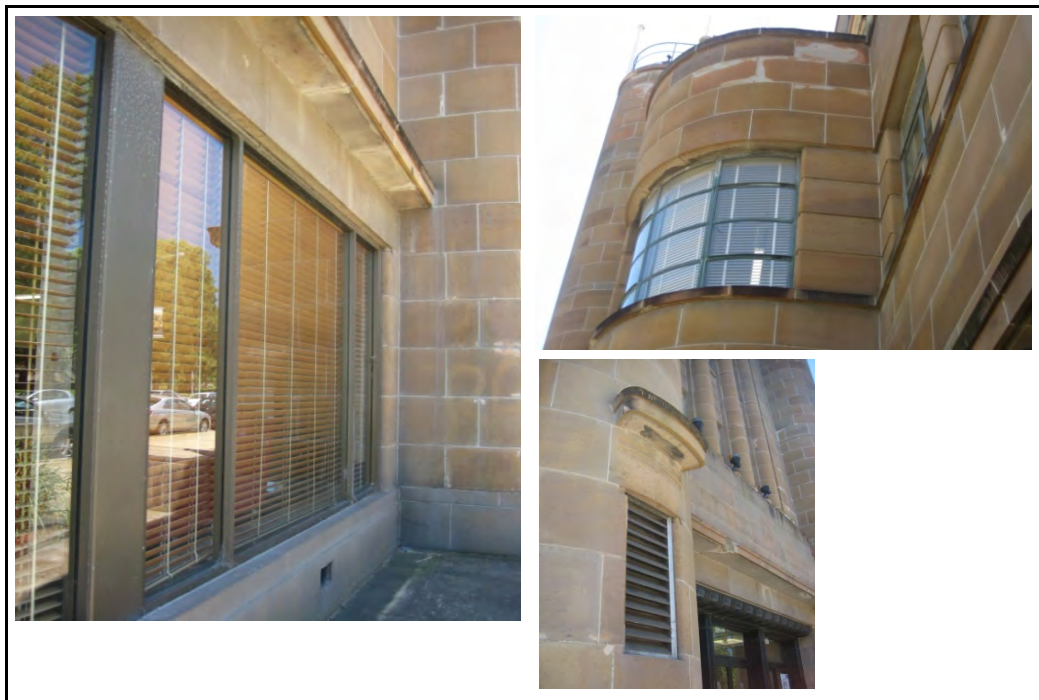
OVERVIEW	Ground floor windows non-original - bronze anodised aluminium framed fixed glazing, good condition. Windows from level 1 upwards are original metal framed casement windows, with curved frames and glass at curved walls on level 1. Generally fair condition - frames weathered and discoloured, some sealant cracked / missing from most windows on these levels. Coated steel louvers at ground floor level of risers - paint coating deteriorated.	
HERITAGE SIGNIFICANCE	Heritage Significance Value of the element	Mixed
	EXCEPTIONAL Original metal framed casement windows INTRUSIVE Aluminium framed windows Facetted aluminium glazing in curved walls on ground floor.	
FUNCTIONALITY	Generally functional, some repairs needed to original windows.

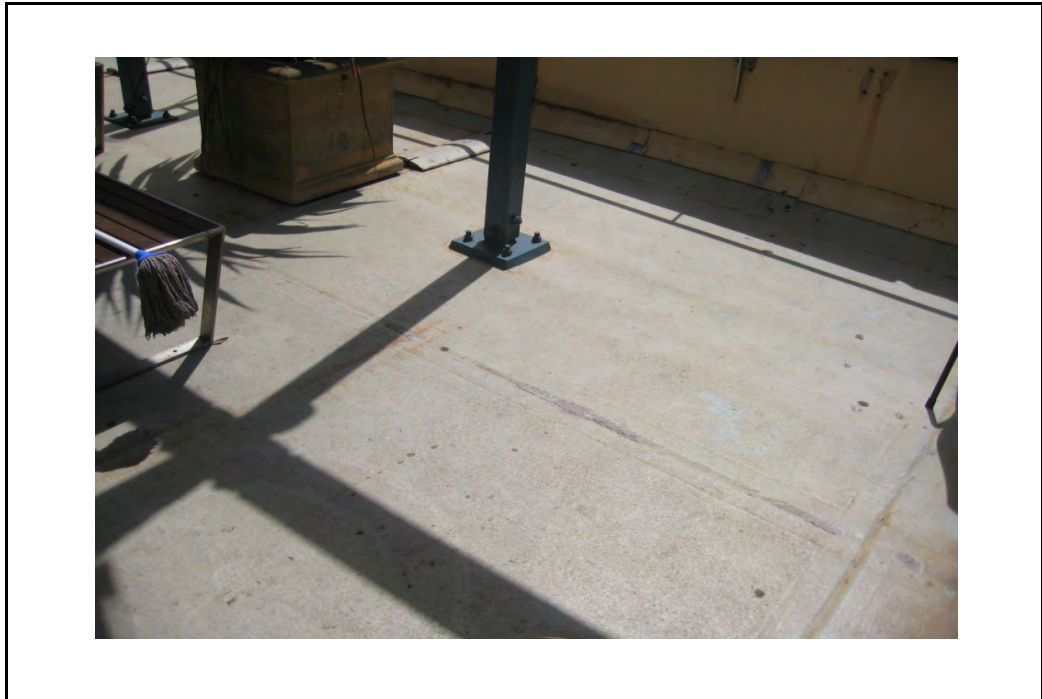
EXISTING CONDITION		
OVERVIEW	Concrete slab with waterproofing membrane over, coved at walls. Fall toward balustrade along east side. Generally good condition, some staining, particularly at irrigation pipe crossovers.	
HERITAGE SIGNIFICANCE	Heritage Significance Value of the element	Moderate
FUNCTIONALITY	Functional.	
ACTION REQUIRED		
OVERVIEW

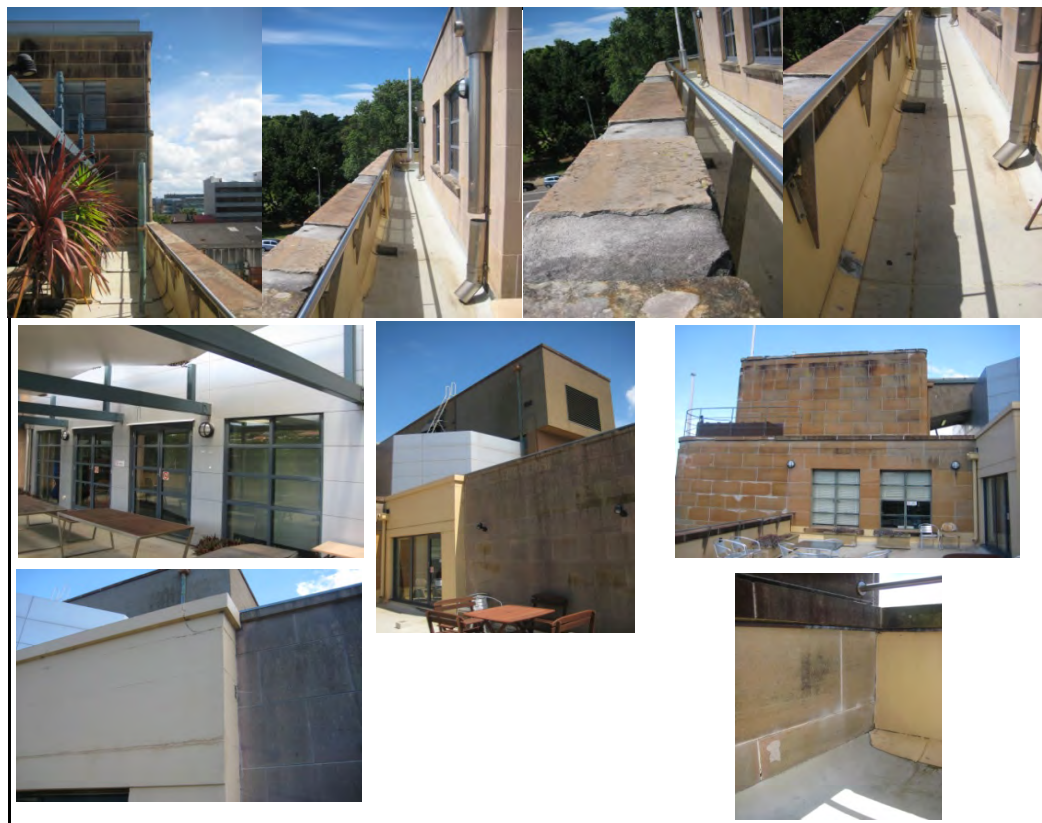
OVERVIEW	Render and paint finish to inside face of balustrade wall, generally good condition, some cracking along top of flashing. Stone capping to balustrade in fair - poor condition - sections of capping missing, others badly chipped and weathered. Sandstone blocks to original wall at south western area of terrace extremely weathered, with similar capping issues as balustrade wall. Sandstone blocks to northern section of building and surrounding room 3.36 also weathered, discoloured, not to same degree as original fabric. Metal sandwich panel cladding to western wall of north area of terrace, good condition. Render and paint to area of access to southern area of terrace, generally good condition, crack at top of eastern end of rendered wall. Flashing missing from base of some areas of wall, grout missing from sandstone joints at junction with balustrade wall in north east corner of terrace.

HERITAGE SIGNIFICANCE	Heritage Significance Value of the element	Mixed
	EXCEPTIONAL Original sandstone MODERATE 1971 additions LOW Sandwich panels low	
FUNCTIONALITY	Functional but requiring repair.	
ACTION REQUIRED		
OVERVIEW	Repair and restore wall finishes as required

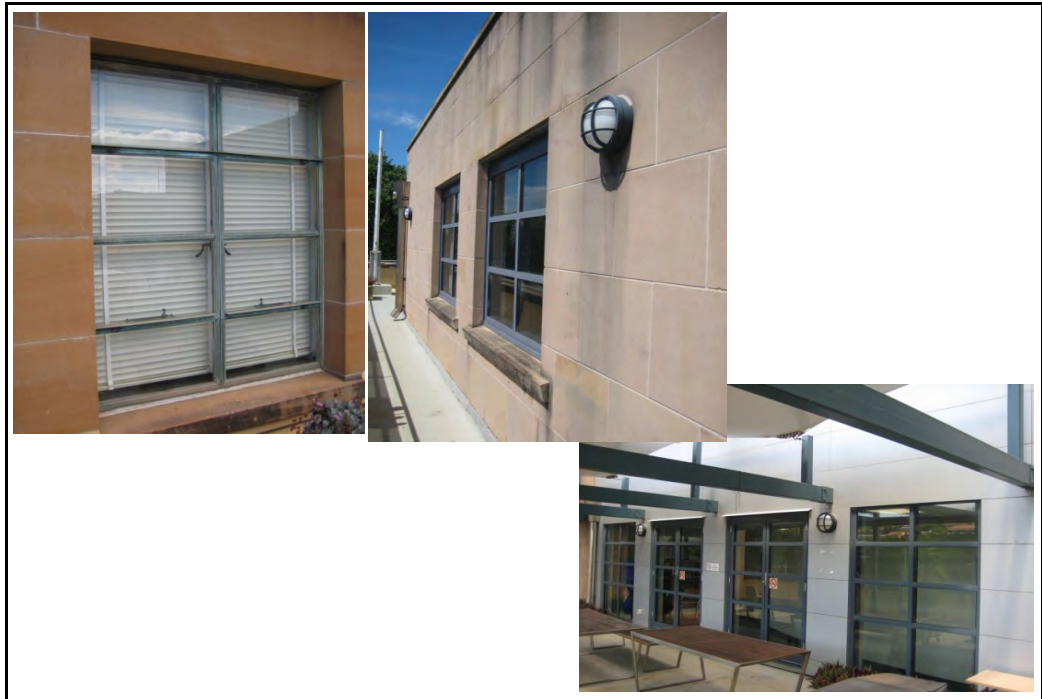
OVERVIEW	Metal framed casement windows, original, to southern facades of building, generally fair condition - discoloured and weathered, some sealant missing from some panes. Powdercoated aluminium framed windows to eastern most facade and southern and western walls of north area of terrace, good condition. Bronze anodised aluminium framed windows to north wall of north area of terrace, good condition, some cracking and sealant missing at head of eastern most window.	
HERITAGE SIGNIFICANCE	Heritage Significance Value of the element	Mixed
	EXCEPTIONAL Original windows LOW Anodised and powdercoated glazing	
FUNCTIONALITY	Functional

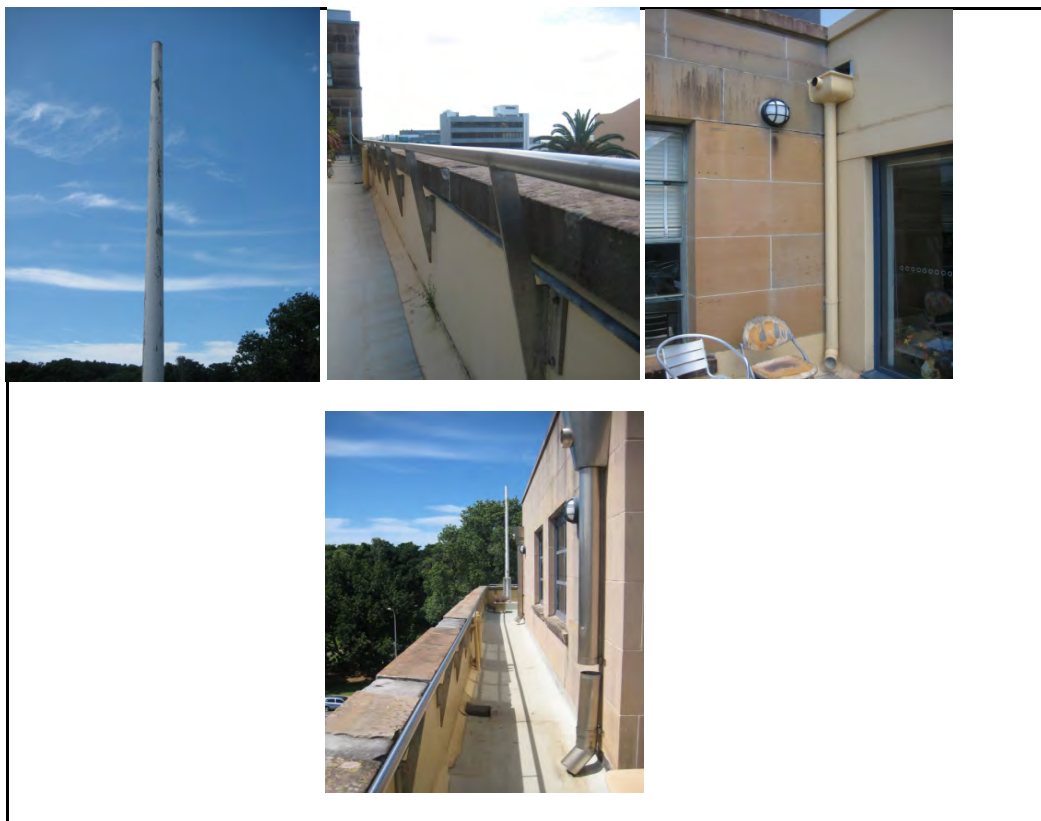
OVERVIEW	Flagpole in south-east corner of terrace, weathered and missing capstan. Stainless rail fixed to balustrade wall, good condition. Bulkhead style light fittings, good condition. Original painted rainwater head and downpipe in north-west corner of southern area of terrace, good condition, discharges onto slab. Stainless rainwater heads and downpipes fixed to eastern facades, some dented, one with break toward base. All discharge onto slab.	
HERITAGE SIGNIFICANCE	Heritage Significance Value of the element	Mixed
	HIGH Original rainwater head / downpipe LOW Handrail, light fittings and stainless downpipes INTRUSIVE Flagpole at south east corner of terrace.	
FUNCTIONALITY	Functional

OVERVIEW	Repair fittings as required.
----------	------------------------------

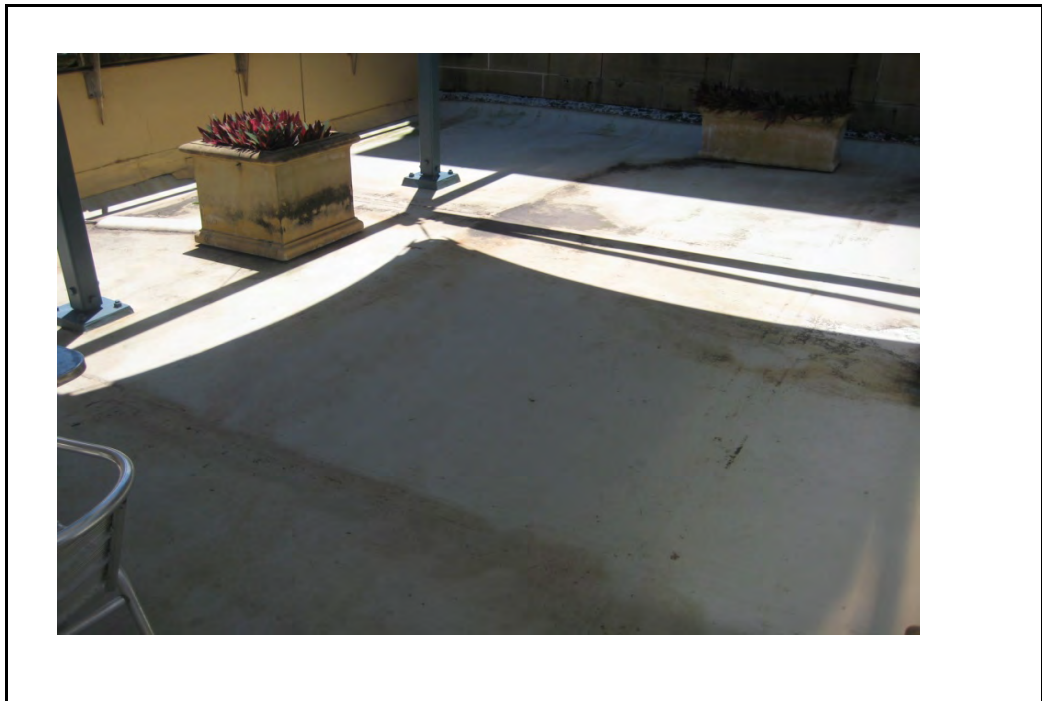
EXISTING CONDITION		
OVERVIEW	Concrete slab with waterproofing membrane over, coved at walls. Fall toward balustrade along east side. Generally good condition, some staining, particularly at irrigation pipe crossovers and path of flow from downpipes to sunps	
HERITAGE SIGNIFICANCE	Heritage Significance Value of the element	Moderate
FUNCTIONALITY	Functional.	
ACTION REQUIRED		
OVERVIEW

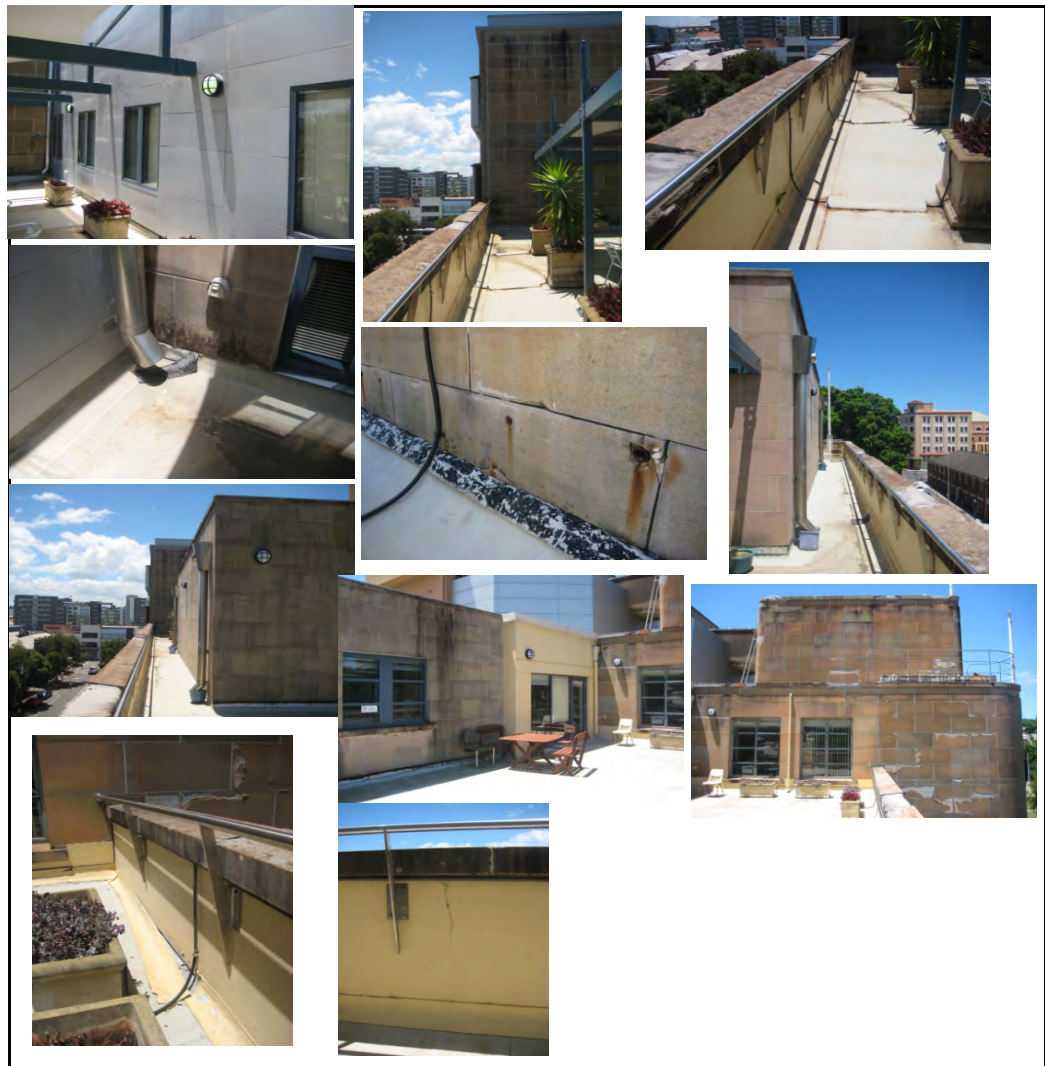
EXISTING CONDITION		
OVERVIEW	<p>Render and paint finish to inside face of balustrade wall, generally good condition, some cracking along top of flashing and at various points along wall. Stone capping to balustrade in fair - poor condition - sections of capping missing, others badly chipped and weathered. Sandstone blocks to original wall at south eastern area of terrace extremely weathered, with similar capping issues as balustrade wall. Sandstone blocks to northern section of building and surrounding room 3.09 also weathered, discoloured, not to same degree as original fabric. Metal sandwich panel cladding to eastern wall of north area of terrace, good condition. Render and paint to area of access to southern area of terrace, generally good condition. Flashing missing from base of some areas of wall, separating from base of balustrade wall near south eastern-most corner of terrace. Grout missing from sandstone joints at base of north wall of terrace.</p>

HERITAGE SIGNIFICANCE	Heritage Significance Value of the element	Mixed
	<p>EXCEPTIONAL Original sandstone MODERATE 1971 additions LOW Sandwich panels</p>	
FUNCTIONALITY	Functional but requiring repair.

ACTION REQUIRED	
OVERVIEW	Repair and restore wall finishes as required

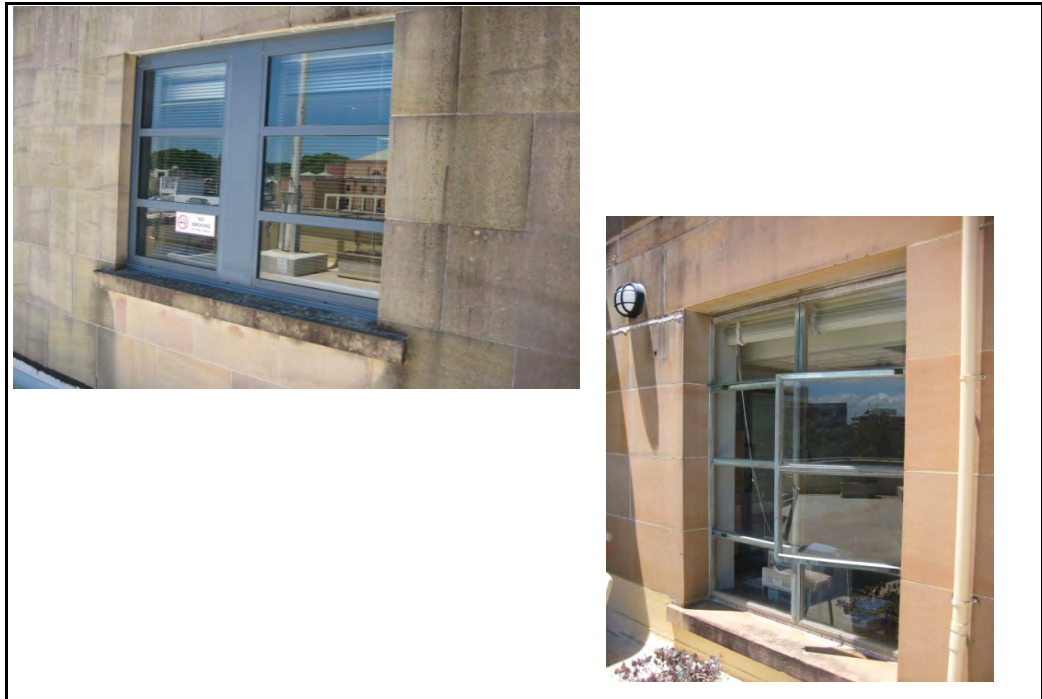
OVERVIEW	Metal framed casement windows, original, to original facade of building, generally fair condition - discoloured and weathered, some sealant missing from some panes. Powdercoated aluminium framed windows to eastern most facade, north wall of southern area of terrace and southern and eastern walls of north area of terrace, good condition.	
HERITAGE SIGNIFICANCE	Heritage Significance Value of the element	Mixed
	EXCEPTIONAL Original windows LOW Powdercoated glazing	
FUNCTIONALITY	Functional

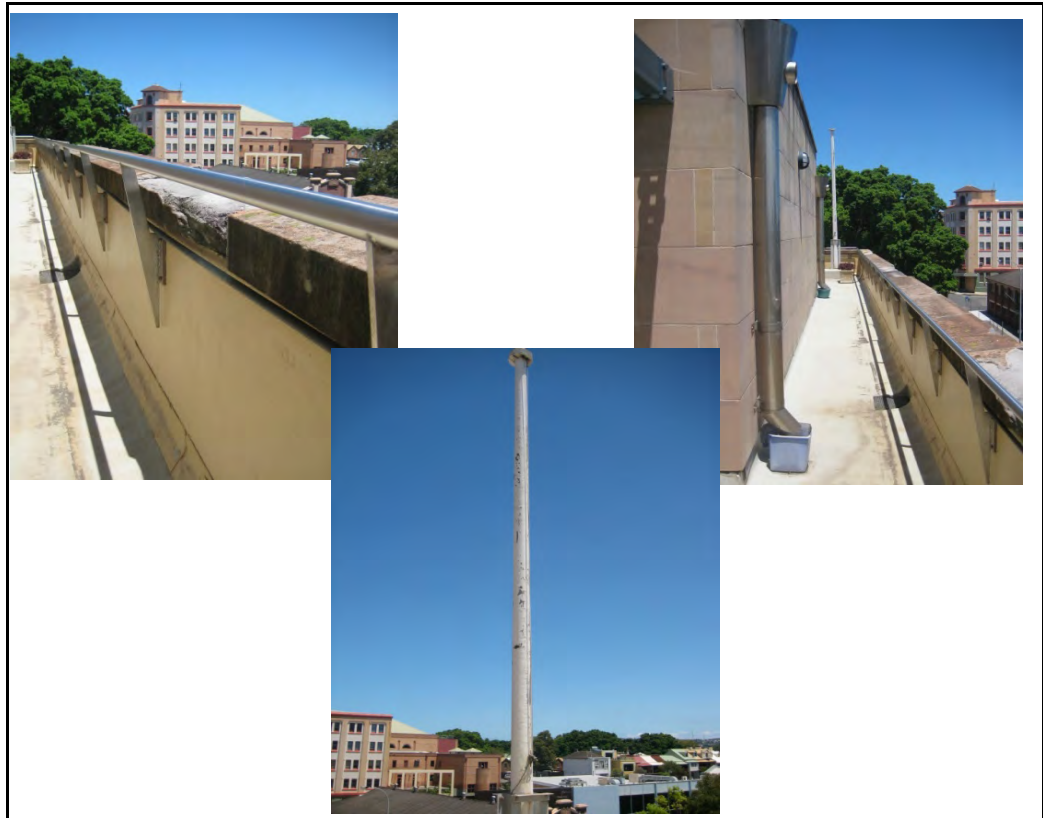
EXISTING CONDITION		
OVERVIEW	Flagpole in south-west corner of terrace, weathered. Stainless rail fixed to balustrade wall, good condition. Bulkhead style light fittings, good condition. Stainless rainwater heads and downpipes, generally good condition, discharge either directly onto slab or into buckets on the slab.	
HERITAGE SIGNIFICANCE	Heritage Significance Value of the element	Mixed
	LOW Handrail, light fittings and stainless downpipes INTRUSIVE Flagpole at south west corner of terrace	
FUNCTIONALITY	Functional	
ACTION REQUIRED		
OVERVIEW	Repair fittings as required.

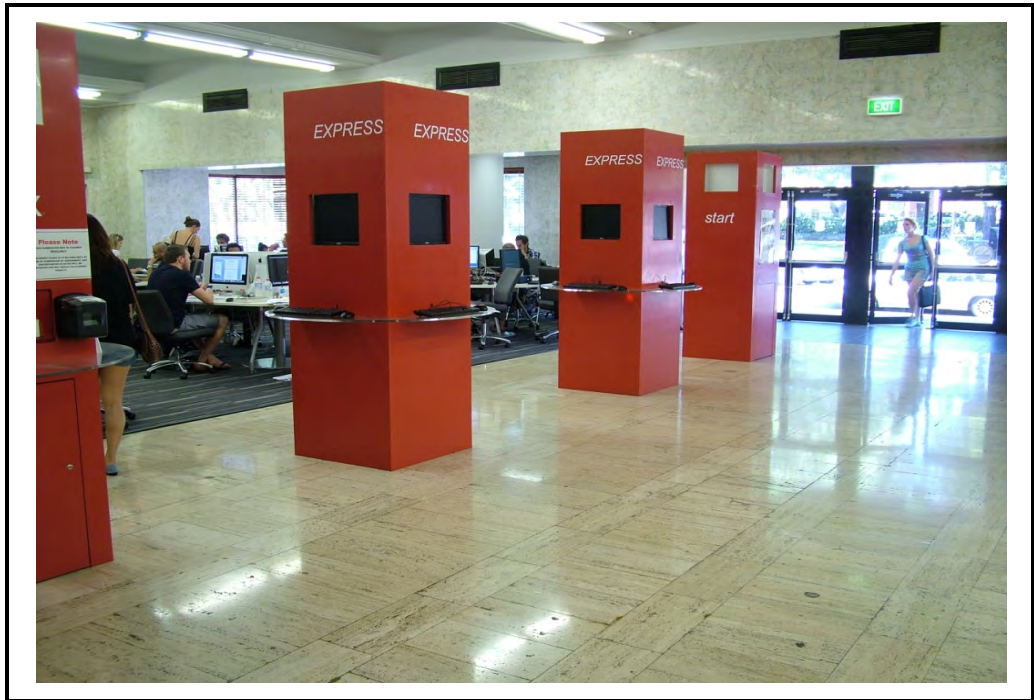
OVERVIEW	Combination of original travertine flooring and new carpet over. Black tiles at southern entry doors. General condition of all surfaces good, some minor areas of damage to travertine, notably at doors to corridor (Room G6) at western end - section of brass expansion joint missing, flooring chipped / cracked.	
HERITAGE SIGNIFICANCE	Heritage Significance Value of the element	Mixed
	HIGH 1939 original finishes, Travertine INTRUSIVE Carpet	
FUNCTIONALITY	Functional

OVERVIEW	Repair and restore original flooring as required.
----------	---

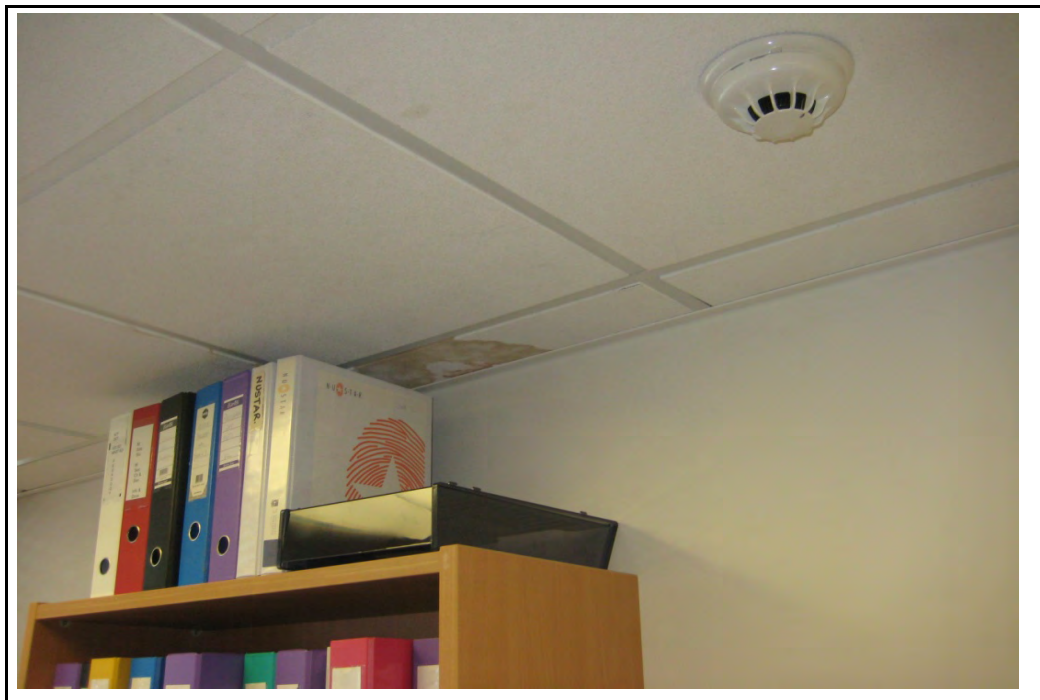
OVERVIEW	Modern suspended ceiling tiles, good condition. Moisture damage to ceiling tiles in two locations in room G1B	
HERITAGE SIGNIFICANCE	Heritage Significance Value of the element	Low
FUNCTIONALITY	Functional, requiring minor repair

OVERVIEW	Source of moisture to be investigated and rectified, new ceiling tiles installed as required.
----------	---

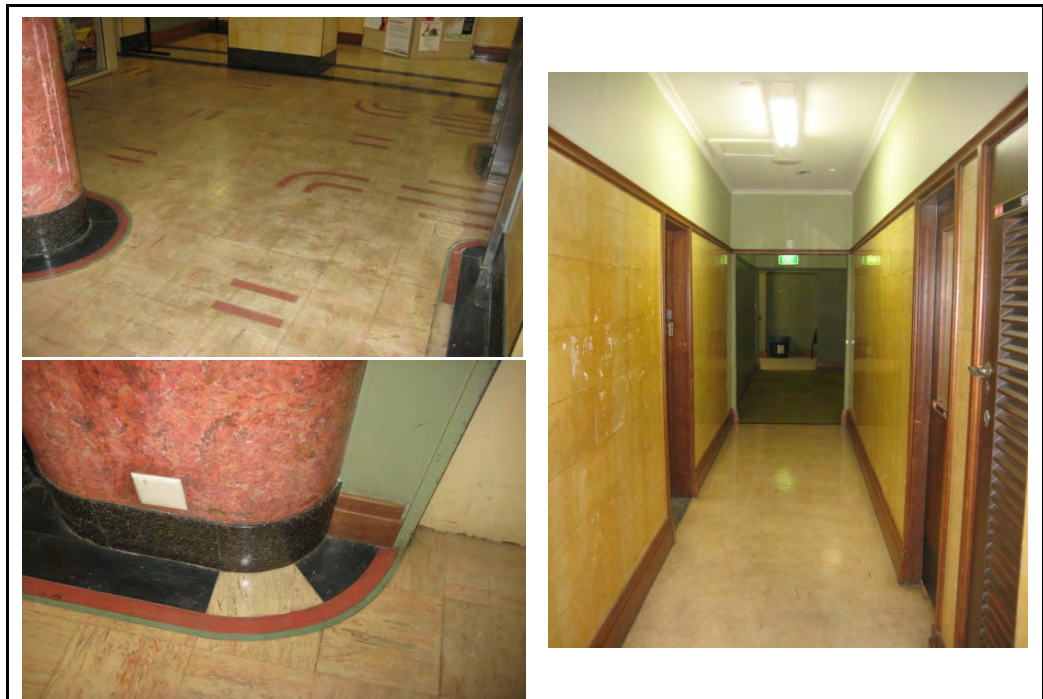
EXISTING CONDITION		
OVERVIEW	Inlaid vinyl flooring to lobby 1.01, sheet vinyl flooring to corridor, carpet tile at north end of corridor. Generally good condition, some scuff marks to flooring in lobby 1.01, section of border inlay missing at east end of room 1.01.	
HERITAGE SIGNIFICANCE	Heritage Significance Value of the element	Mixed
	HIGH Inlaid vinyl LOW Sheet vinyl and carpet tiles	
FUNCTIONALITY	Functional, requiring minor repairs	
ACTION REQUIRED		
OVERVIEW	Rectify marking to lobby floor, infill missing section of inlay.

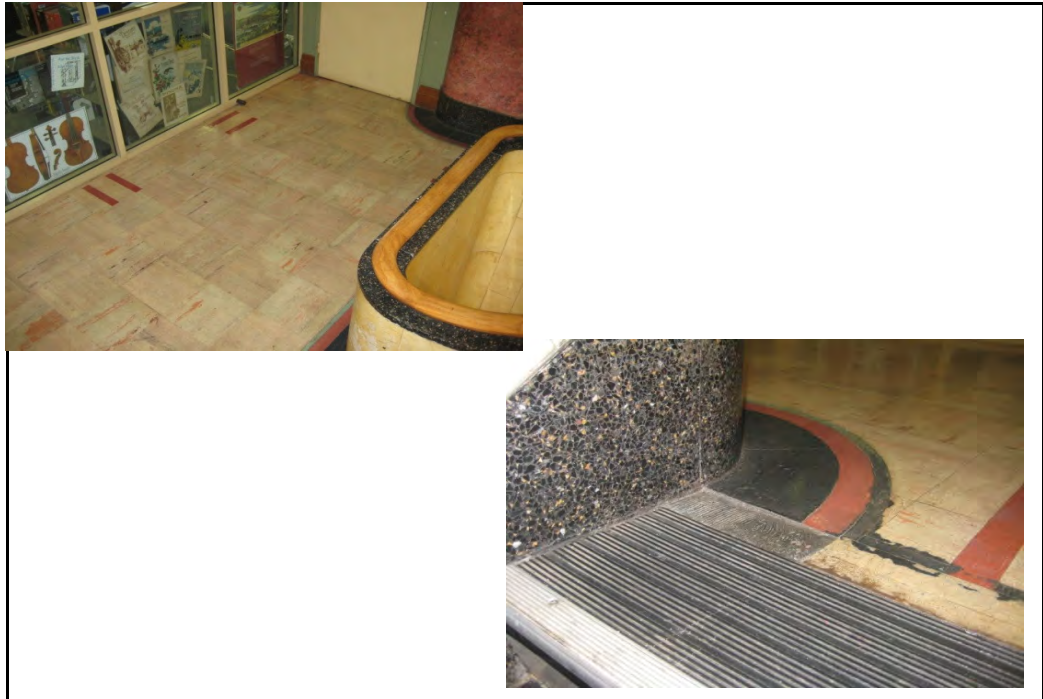
EXISTING CONDITION		
OVERVIEW	Rubber flooring to stair treads, vinyl flooring to intermediate landings, inlayed vinyl flooring to lobby 1.16. Generally good condition, some scuff marks to flooring in lobby 1.16, section of border inlay missing at top of stair.	
HERITAGE SIGNIFICANCE	Heritage Significance Value of the element	High
FUNCTIONALITY	Functional.	
ACTION REQUIRED		
OVERVIEW	Rectify marking to lobby floor, infill missing section of inlay.
