CONSERVATION MANAGEMENT PLAN

VOLUME 3 OF 3

UNIVERSITY HOUSE FORMERLY N.E.S.C.A HOUSE KING STREET NEWCASTLE

Prepared by EJE Heritage
MARCH 2011
Ref: 8836-CMP-UH-001

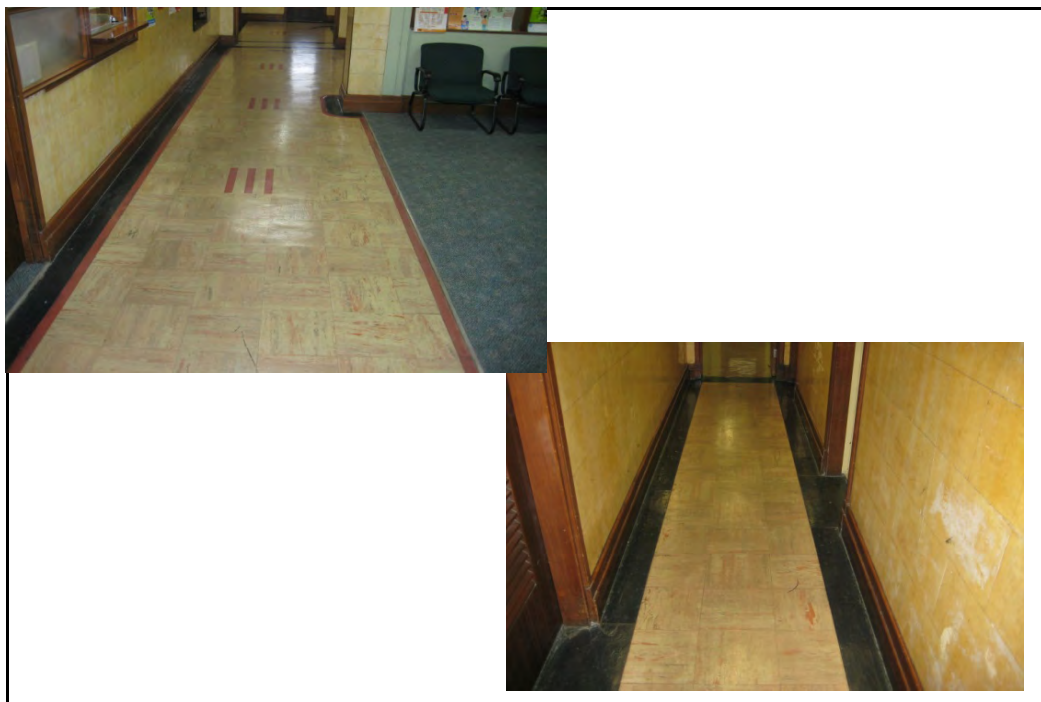
ASSET ELEMENT	FLOOR
---------------	-------

OVERVIEW	Inlaid vinyl flooring to lobby 2.1 and south end of corridor, sheet vinyl flooring to middle part of corridor, carpet at north end of corridor. Generally good condition, some scuff marks to flooring in lobby at junction with western corridor.	
HERITAGE SIGNIFICANCE	Heritage Significance Value of the element	
		Mixed
	HIGH Inlaid vinyl LOW Sheet vinyl and carpet	
FUNCTIONALITY	Functional, requiring minor repairs

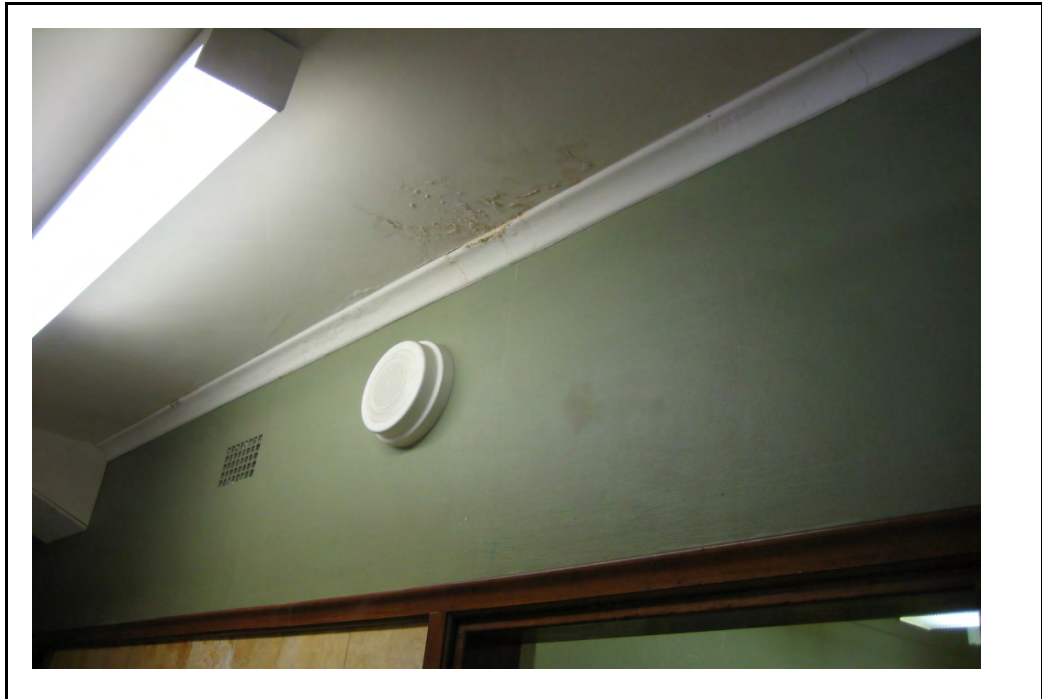
ASSET ELEMENT	CEILING
---------------	---------

EXISTING CONDITION		
OVERVIEW	Painted plasterboard ceiling to lobby and most of corridor, suspended ceiling tiles to northern end of corridor. Generally good condition, some moisture staining to eastern side of ceiling in corridor near entry to toilets.	
HERITAGE SIGNIFICANCE	Heritage Significance Value of the element	Low
FUNCTIONALITY	Functional, requiring repair.	
ACTION REQUIRED		
OVERVIEW	Investigate source of moisture above, repair and restore ceiling as required.

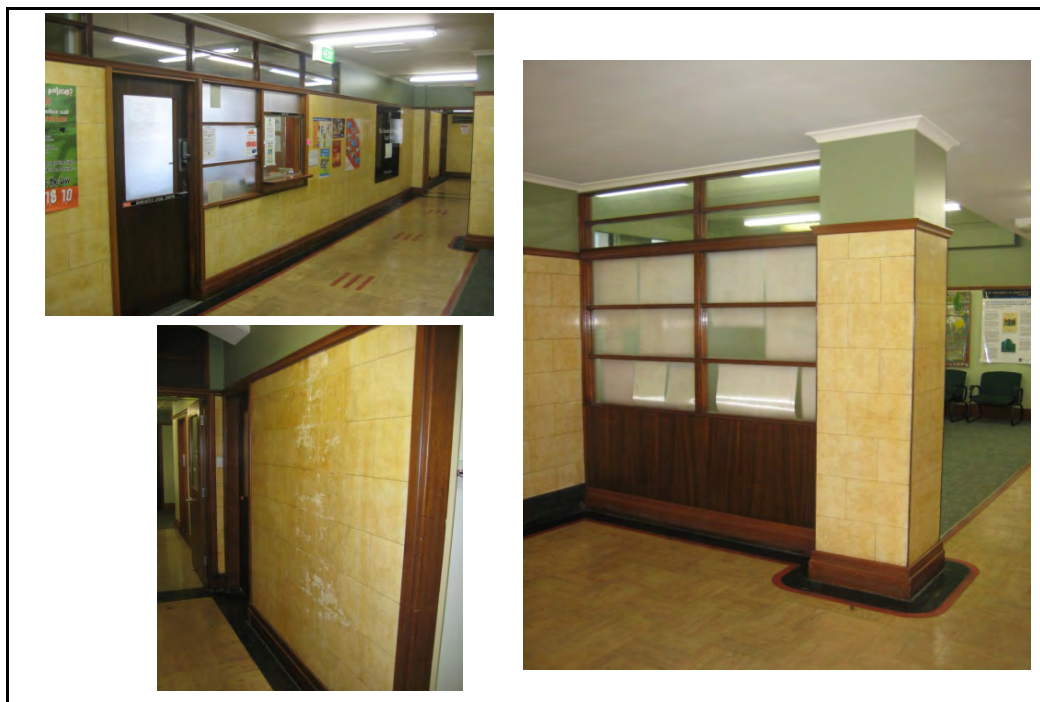
ASSET ELEMENT	WALLS
---------------	-------

EXISTING CONDITION			
OVERVIEW	<p>Scagliola tiles, with stepped timber skirting to most of lobby and southern end of corridor - fair condition, with fine cracks extensively across surface of scagliola tiles. Black stone skirting to lift walls. Some tiles in corridor and lobby have surface colour deteriorating / falling off. All scagliola tiled walls drummy in some areas, particularly adjacent to larger crack locations. Decorative timber rail at 2100 AFFL, paint finish over. Render and paint to walls in north part of lobby (waiting room), generally good condition, some chips in paintwork at window reveals. Timber veneer and glazed wall to lift entry screen wall, good condition. Northern part of corridor combination of render or plasterboard with paint finish, generally good condition with some cuff marks, scratches, etc.</p>		
HERITAGE SIGNIFICANCE	<table border="1" style="width: 100%;"> <tr> <td style="width: 70%;">Heritage Significance Value of the element</td> <td style="text-align: center;">Mixed</td> </tr> </table>	Heritage Significance Value of the element	Mixed
	Heritage Significance Value of the element	Mixed	
<p>EXCEPTIONAL Scagliola tiles, skirtings HIGH Timber veneer / glazed wall LOW Painted plasterboard / render</p>			
FUNCTIONALITY	Functional but requiring repair.		
ACTION REQUIRED			
OVERVIEW	Repair and restore wall finishes as required

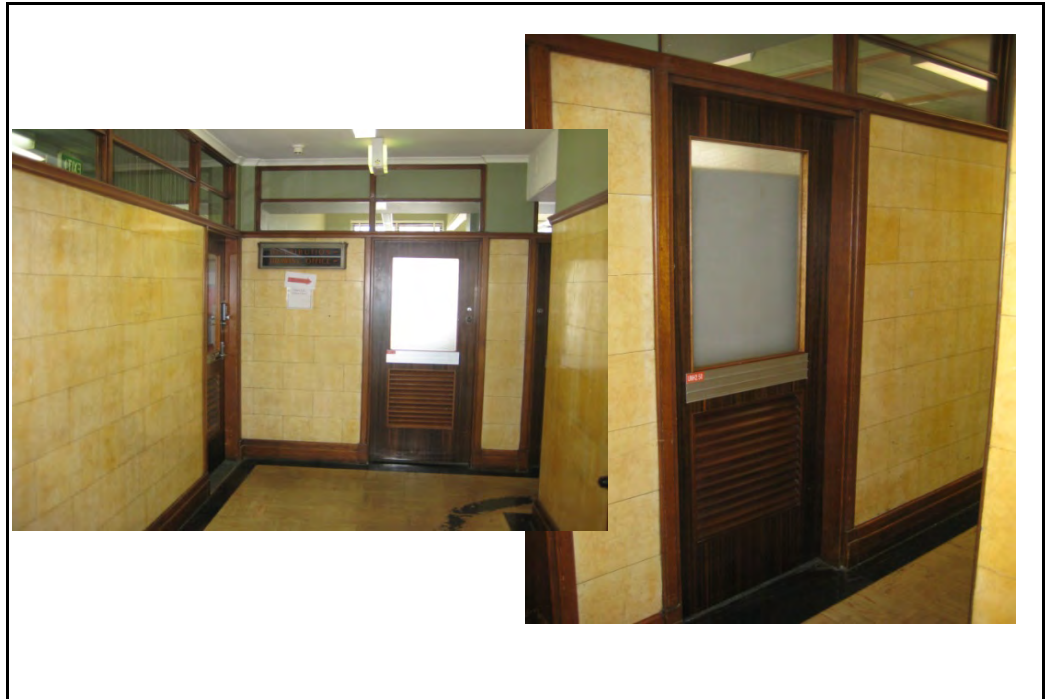
DOORS

OVERVIEW	Mostly timber veneer doors with glazed panels, some with timber louvres in lower half of door. Some doors newer timber veneer. Generally good condition to all.	
HERITAGE SIGNIFICANCE	Heritage Significance Value of the element	High
FUNCTIONALITY	Functional

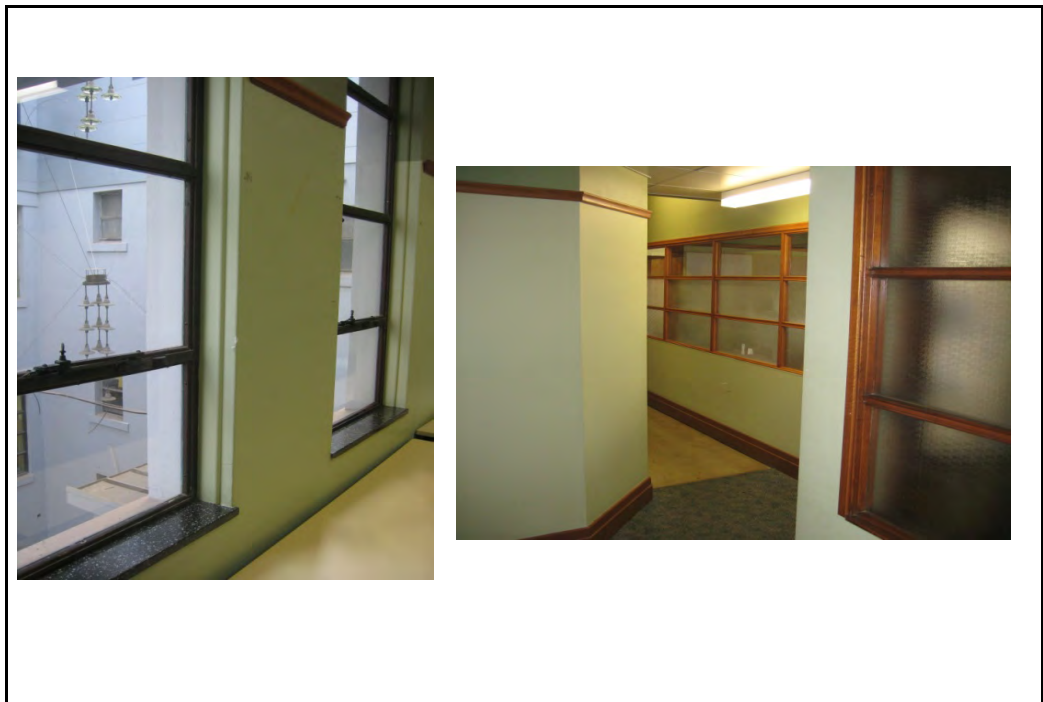
ASSET ELEMENT	WINDOWS
---------------	---------

OVERVIEW	Steel / timber framed casement window to external light well - fair condition, some discolouration to frame. Black stone sills, some minor cracking evident. Timber framed glazing to walls surrounding lobby and at each side of corridor, and on screen wall at lift entry. Good condition.	
HERITAGE SIGNIFICANCE	Heritage Significance Value of the element	Mixed
	HIGH Original metal window and timber framed highlight window LOW Powdercoated aluminium framed glazing	
FUNCTIONALITY	Functional

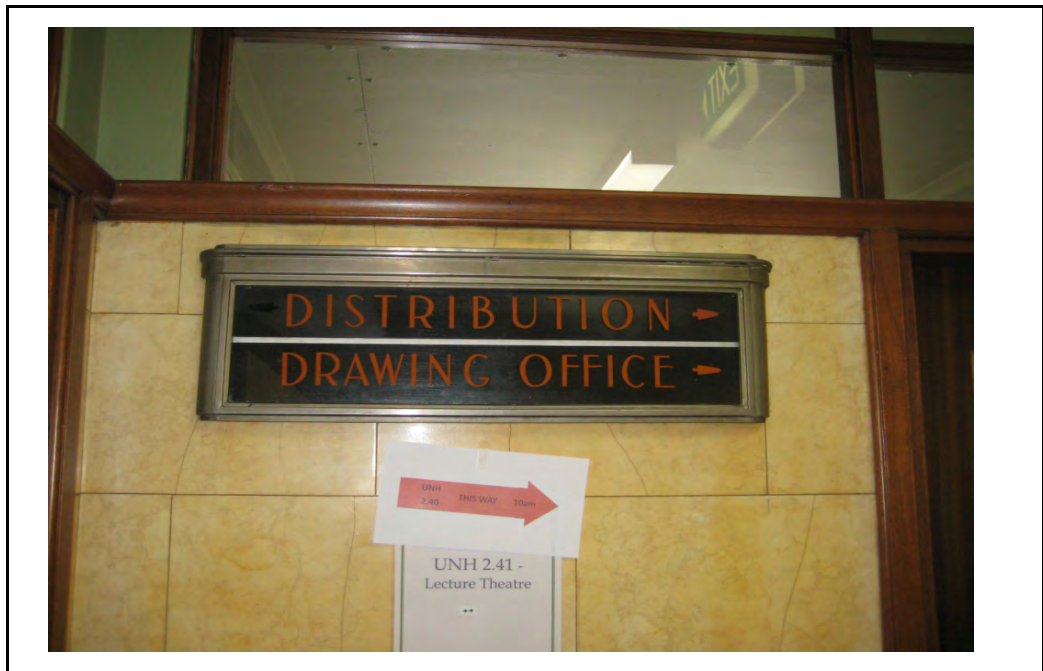
ASSET ELEMENT	FITTINGS
---------------	----------

EXISTING CONDITION		
OVERVIEW	Original directional signage from NESCA occupancy. Good condition.	
HERITAGE SIGNIFICANCE	Heritage Significance Value of the element	High
FUNCTIONALITY	Functional	
ACTION REQUIRED		
OVERVIEW

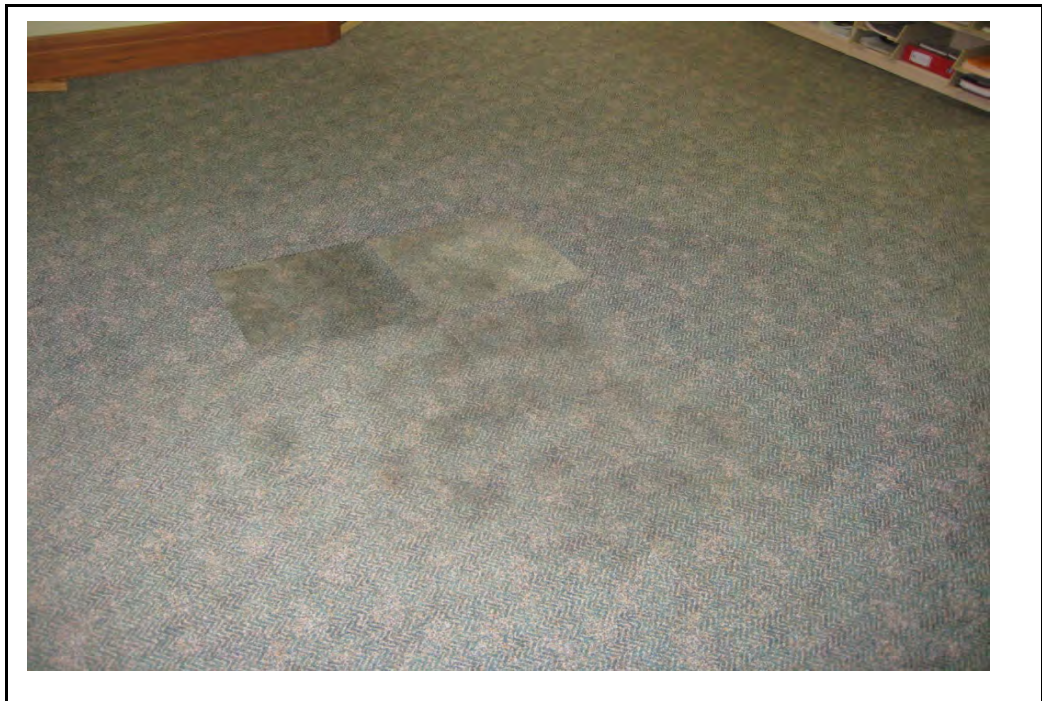
ASSET ELEMENT	FLOOR
---------------	-------

OVERVIEW	Carpet tile flooring, generally good condition, some staining in middle of room 2.2	
HERITAGE SIGNIFICANCE	Heritage Significance Value of the element	Low
	Refers to carpet tiles only, substrate may hold higher significance.	
FUNCTIONALITY	Functional

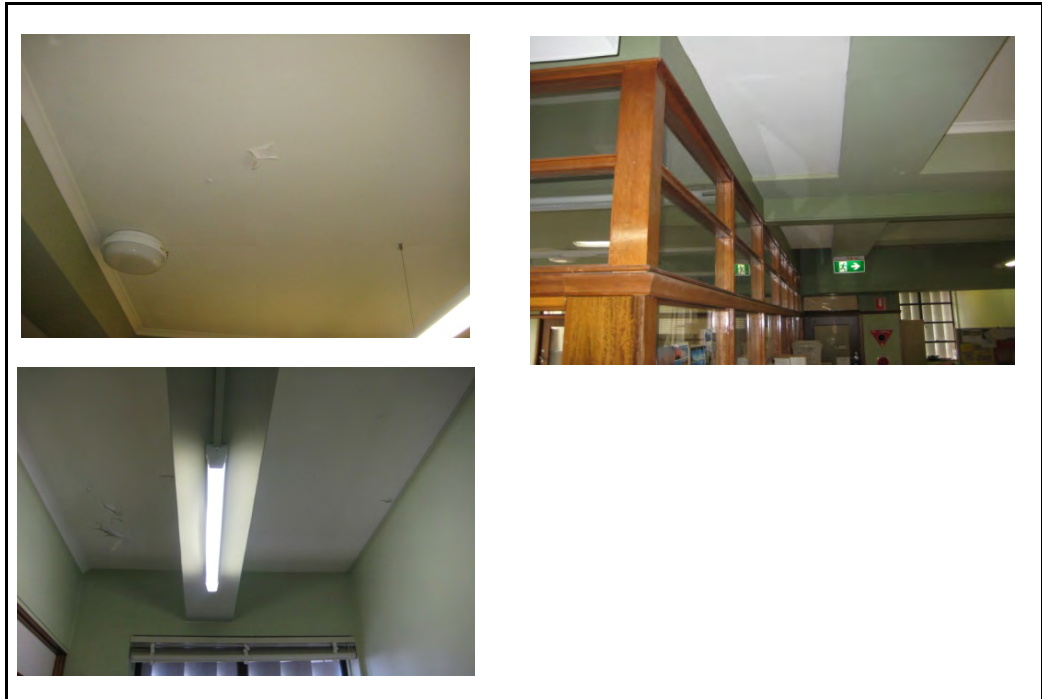
ASSET ELEMENT	CEILING
---------------	---------

OVERVIEW	Painted plasterboard ceiling, generally good condition, some areas of flaking paint.	
HERITAGE SIGNIFICANCE	Heritage Significance Value of the element	Moderate
FUNCTIONALITY	Functional, requiring repairs to paintwork.

OVERVIEW	Remove damaged paintwork and repaint as required.
----------	---

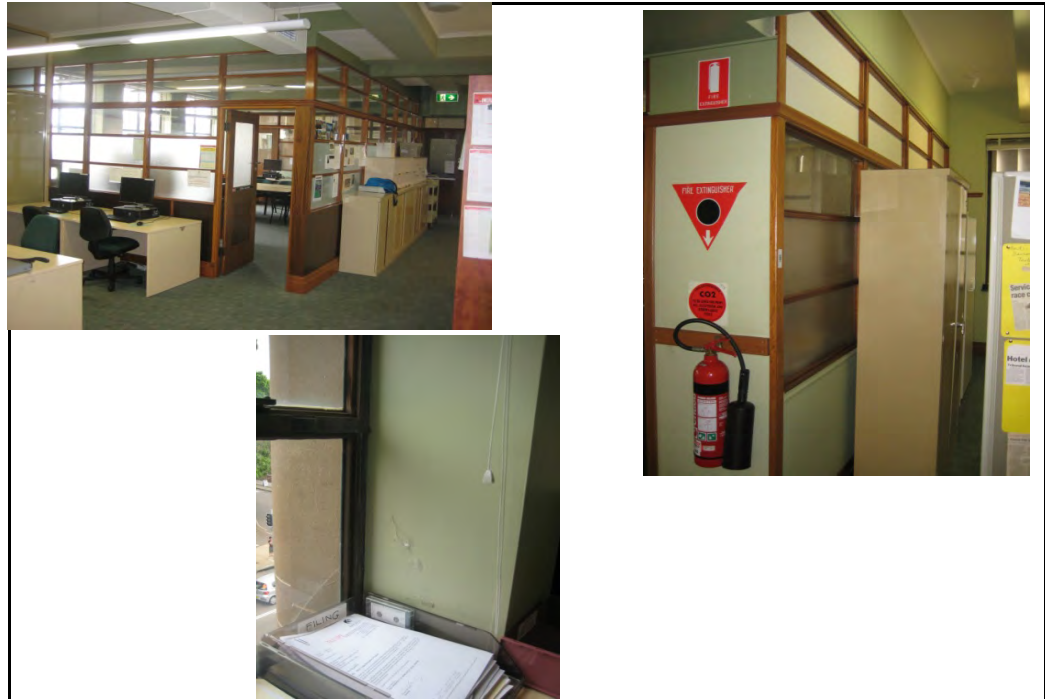
ASSET ELEMENT	WALLS
---------------	-------

EXISTING CONDITION		
OVERVIEW	Mixture of wall types - render and painted, plasterboard / FC and paint, timber veneer and glass, and masonite / paint with timber framed glazing. Generally good condition, some paint flaking, peeling on external wall, particularly at window reveals.	
HERITAGE SIGNIFICANCE	Heritage Significance Value of the element	Mixed
	HIGH Timber veneer and glass and painted masonite and glass LOW Painted plasterboard / render	
FUNCTIONALITY	Functional but requiring repair.	
ACTION REQUIRED		
OVERVIEW	Repair and restore wall finishes as required

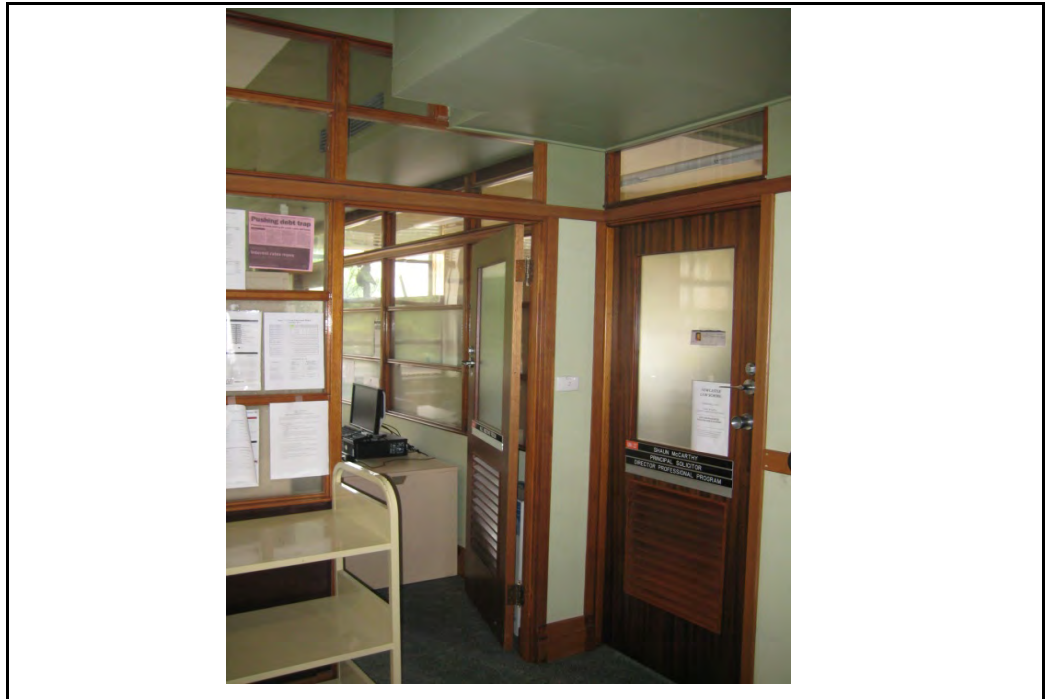
DOORS

OVERVIEW	Timber veneer and glass doors, good condition. Timber doors, also good condition.	
HERITAGE SIGNIFICANCE	Heritage Significance Value of the element	Mixed
	<p>HIGH Timber veneer and glass doors</p> <p>LOW Other timber doors</p>	
FUNCTIONALITY	Functional

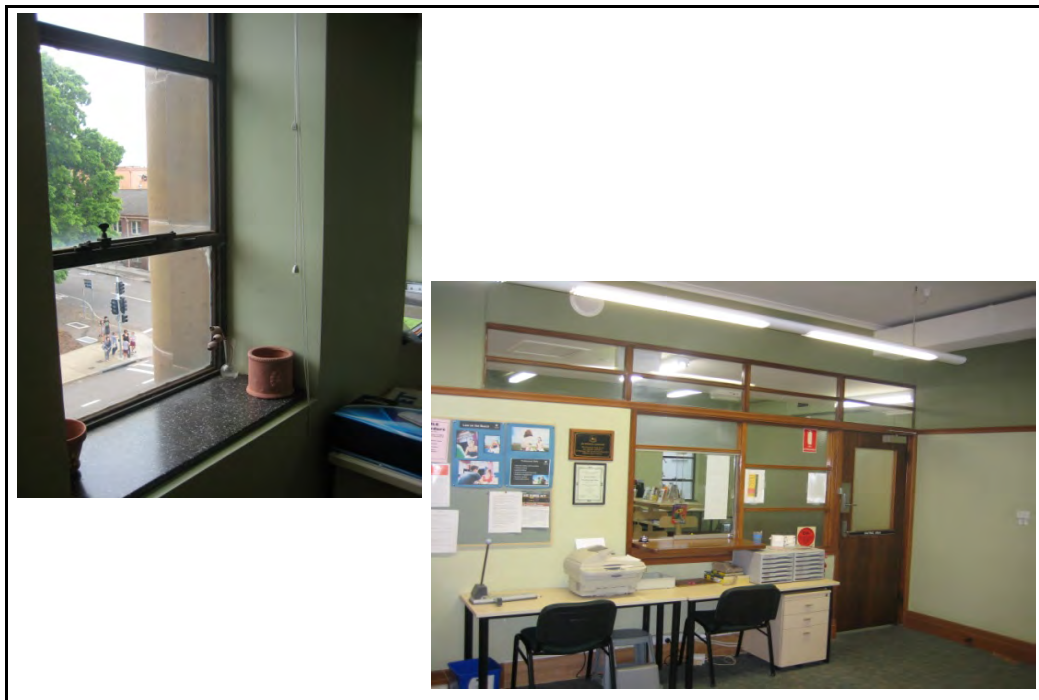
ASSET ELEMENT	WINDOWS
---------------	---------

OVERVIEW	Steel / timber framed casement window to external walls - fair condition, some discolouration to frames. Black stone sills, some cracking evident. Powdercoated aluminium framed glazed walls to internal offices. Timber framed glazing to lobby and to rooms 2.6 and 2.7.	
HERITAGE SIGNIFICANCE	Heritage Significance Value of the element	Mixed
	EXCEPTIONAL Original metal window HIGH Timber framed windows LOW Powdercoated aluminium framed glazing	
FUNCTIONALITY	Functional

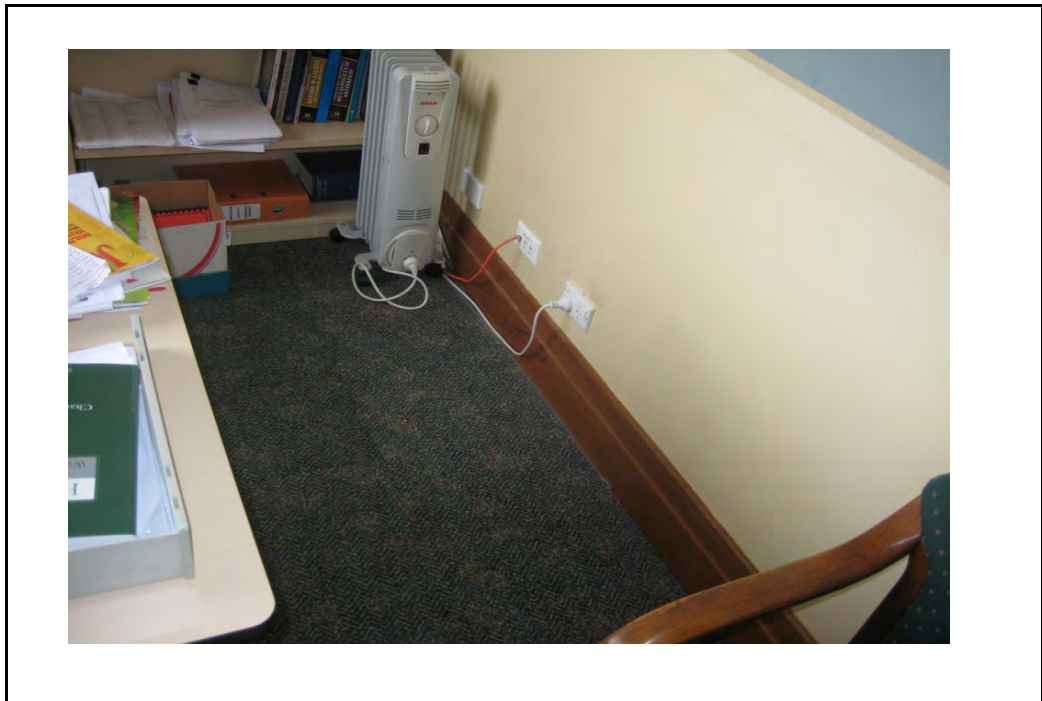
ASSET ELEMENT	FLOOR
---------------	-------

OVERVIEW	Carpet tile flooring, generally good condition.	
HERITAGE SIGNIFICANCE	Heritage Significance Value of the element	Low
	Refers to carpet tiles only, substrate may hold higher significance.	
FUNCTIONALITY	Functional

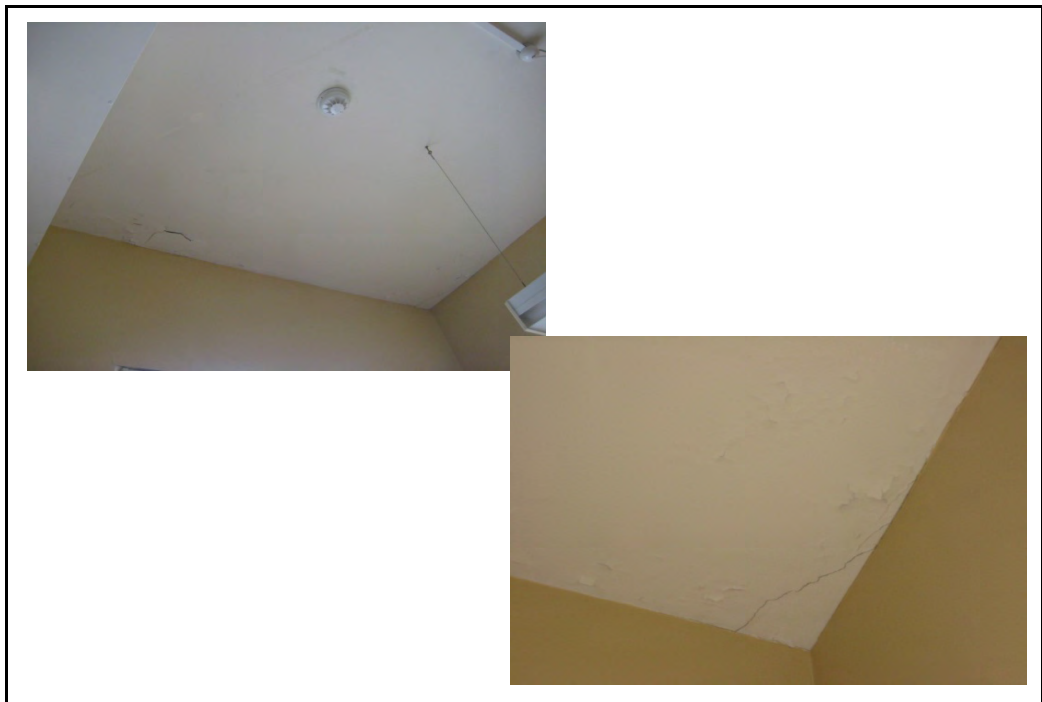
ASSET ELEMENT	CEILING
---------------	---------

OVERVIEW	Painted plasterboard ceiling, generally good condition, cracked, flaking paint on underside of beams, and ceiling at external walls.	
HERITAGE SIGNIFICANCE	Heritage Significance Value of the element	Low
FUNCTIONALITY	Functional, requiring repairs to paintwork.

OVERVIEW	Remove damaged paintwork and repaint as required.
----------	---

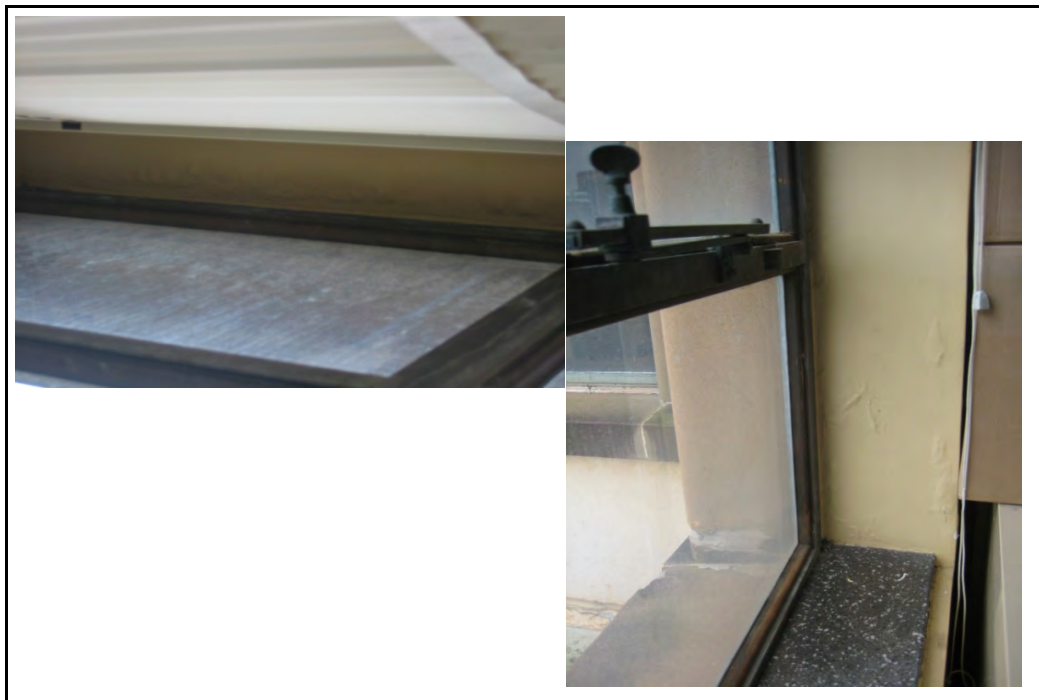
ASSET ELEMENT	WALLS
---------------	-------

OVERVIEW	Plasterboard and paint finish, fair - good condition. Paint bubbling below window heads and on window reveals. Possible moisture damage. Corners of columns chipped.	
HERITAGE SIGNIFICANCE	Heritage Significance Value of the element	Medium
	HIGH External walls LOW Internal walls	
FUNCTIONALITY	Functional but requiring repair.

OVERVIEW	Investigate and rectify source of moisture, repair and restore wall finishes as required
-----------------	--

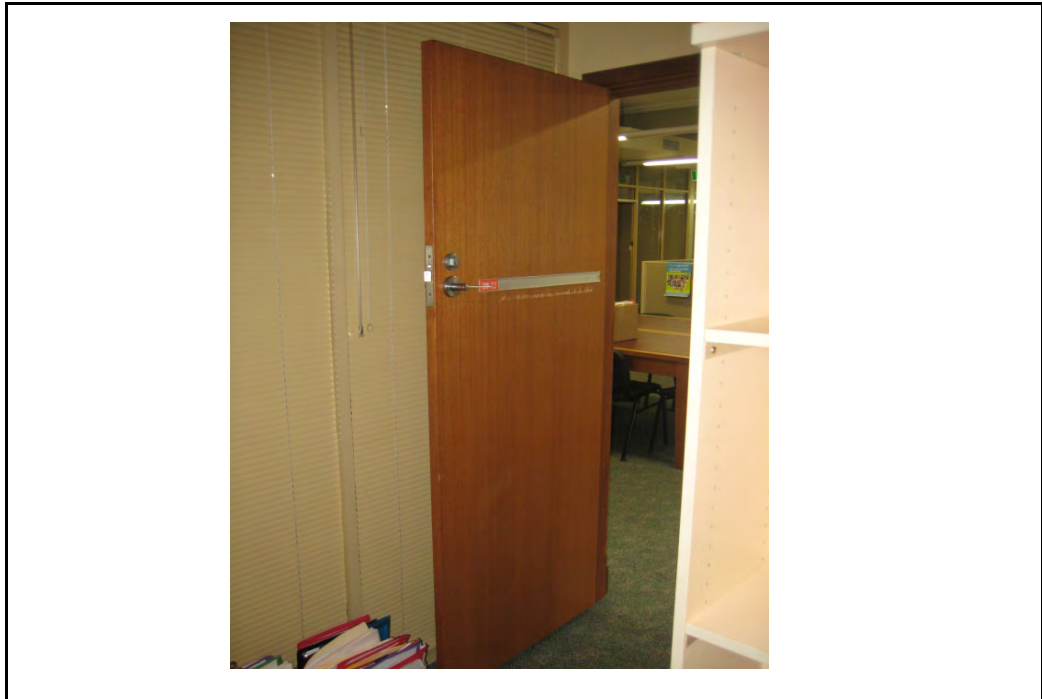
ASSET ELEMENT	DOORS
---------------	-------

EXISTING CONDITION		
OVERVIEW	Timber doors, good condition.	
HERITAGE SIGNIFICANCE	Heritage Significance Value of the element	Low
FUNCTIONALITY	Functional	
ACTION REQUIRED		
OVERVIEW

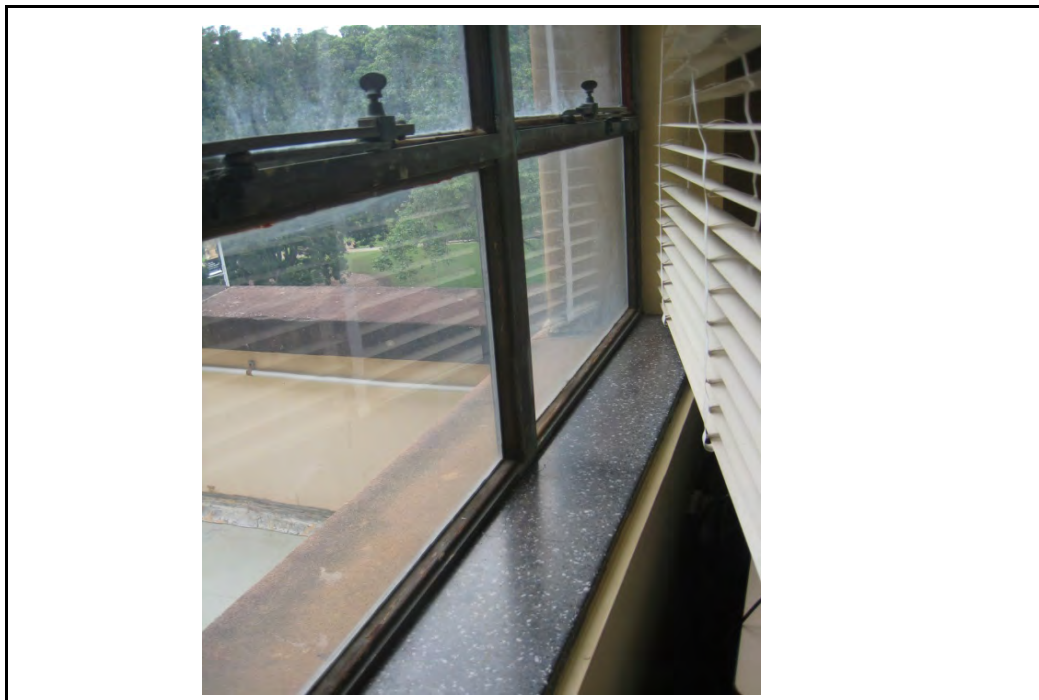
ASSET ELEMENT	WINDOWS
---------------	---------

OVERVIEW	Steel / timber framed casement window to external walls - fair condition, some discolouration to frames, sealant perished, missing externally. Timber frame beads deteriorating. Black stone sills, some cracking and fading evident.	
HERITAGE SIGNIFICANCE	Heritage Significance Value of the element	Exceptional
FUNCTIONALITY	Functional

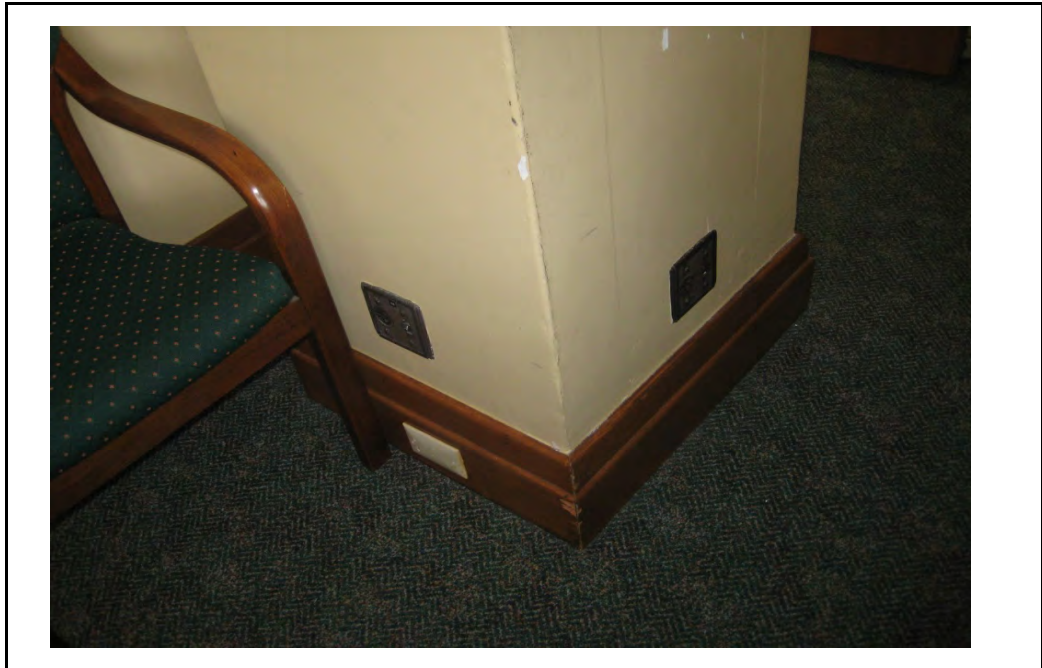
ASSET ELEMENT	FITTINGS
---------------	----------

EXISTING CONDITION		
OVERVIEW	Original power outlets on column in room 2.4.	
HERITAGE SIGNIFICANCE	Heritage Significance Value of the element	High
FUNCTIONALITY	Not assessed, assumed functional	
ACTION REQUIRED		
OVERVIEW

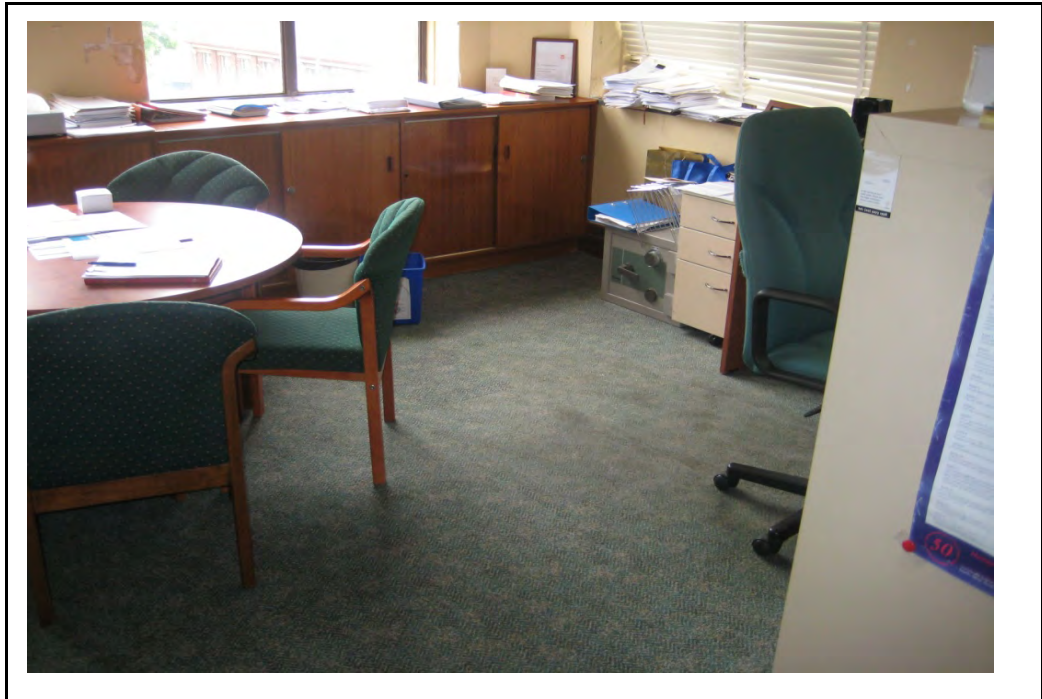
ASSET ELEMENT	FLOOR
---------------	-------

EXISTING CONDITION		
OVERVIEW	Carpet tile flooring, generally good condition, showing some signs of wear.	
HERITAGE SIGNIFICANCE	Heritage Significance Value of the element	Low
	Refers to carpet tiles only, substrate may hold higher significance.	
FUNCTIONALITY	Functional	
ACTION REQUIRED		
OVERVIEW

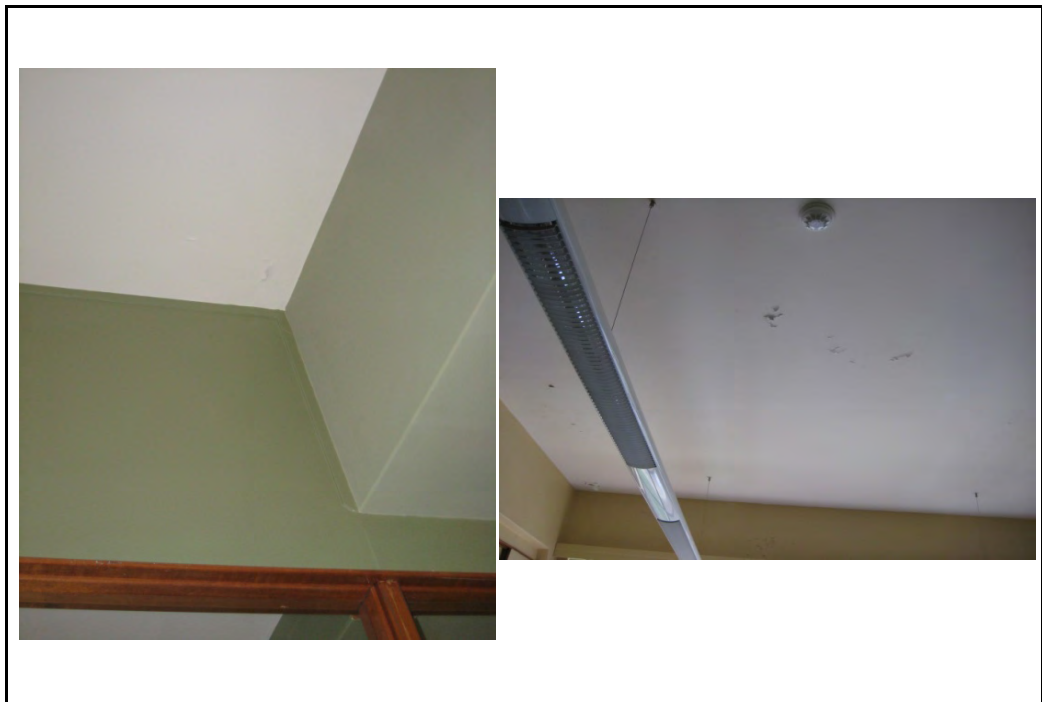
ASSET ELEMENT	CEILING
---------------	---------

OVERVIEW	Painted plasterboard ceiling, generally good condition, cracked, flaking paint in middle and south areas of rooms.	
HERITAGE SIGNIFICANCE	Heritage Significance Value of the element	Low
FUNCTIONALITY	Functional, requiring repairs to paintwork.

OVERVIEW	Remove damaged paintwork and repaint as required.
----------	---

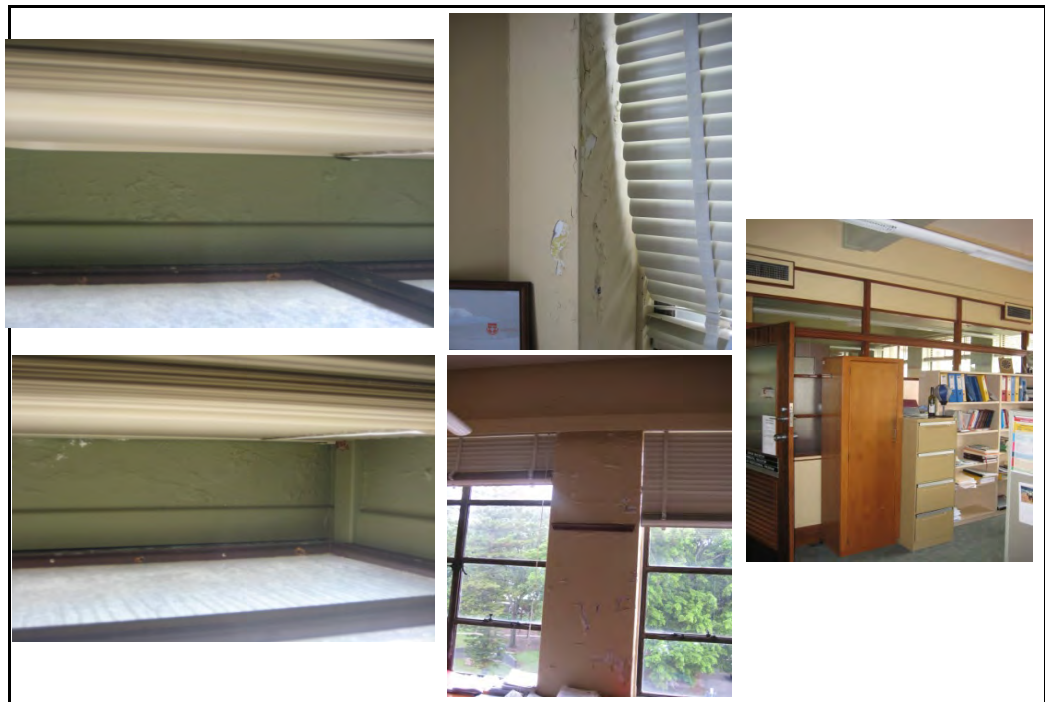
ASSET ELEMENT	WALLS
---------------	-------

OVERVIEW	Plasterboard and paint finish, fair condition. Extensive paint bubbling, flaking and peeling, particularly in room 2.7. Generally flaking, bubbling on window reveals and underside of window heads. Possible moisture damage. Painted masonite wall with timber framed glazing - internal wall. Good condition.	
HERITAGE SIGNIFICANCE	Heritage Significance Value of the element	Mixed
	HIGH External walls and internal walls with original timber framed windows LOW All other internal walls	
FUNCTIONALITY	Functional but requiring repair.

OVERVIEW	Investigate and rectify source of moisture, repair and restore wall finishes as required.
-----------------	---

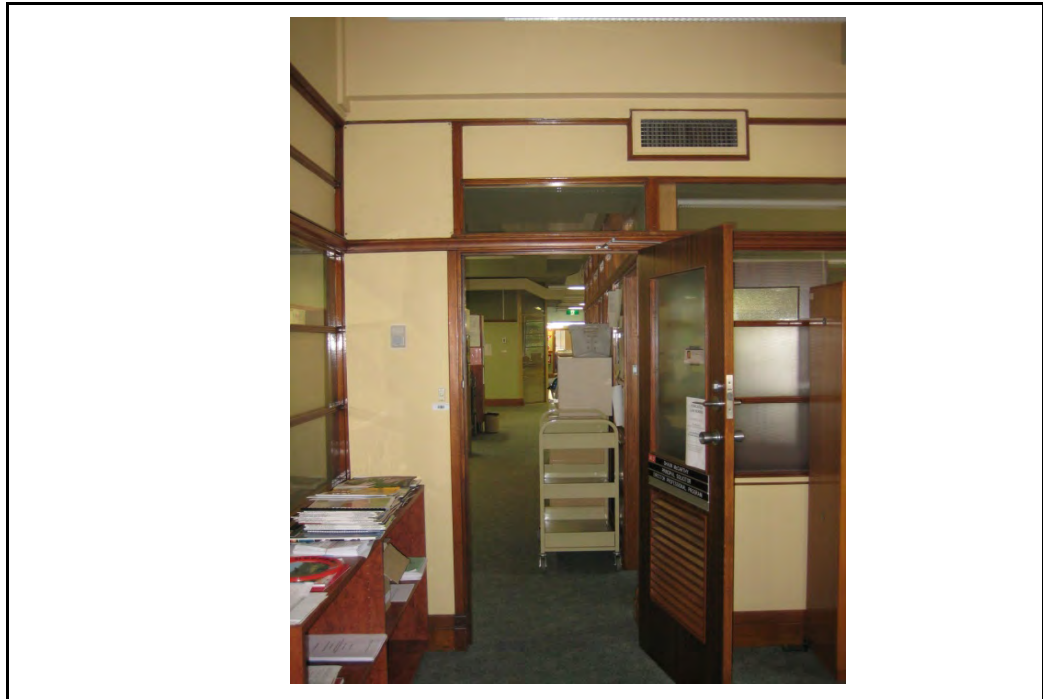
ASSET ELEMENT	DOORS
---------------	-------

EXISTING CONDITION		
OVERVIEW	Timber veneer and glazed doors, with timber louvres. Good condition.	
HERITAGE SIGNIFICANCE	Heritage Significance Value of the element	High
FUNCTIONALITY	Functional	
ACTION REQUIRED		
OVERVIEW

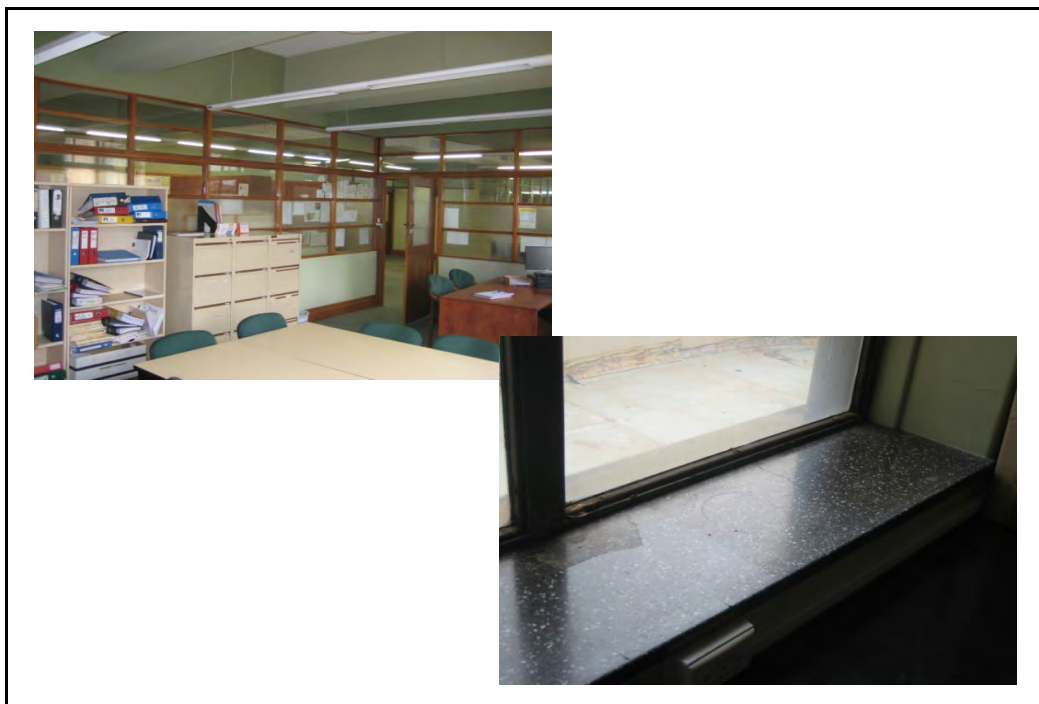
ASSET ELEMENT	WINDOWS
---------------	---------

OVERVIEW	Steel / timber framed casement window to external walls - fair condition, some discolouration to frames, sealant perished, missing externally. Timber frame beads deteriorating. Black stone sills, some cracking and fading evident. Discoloured area of sill in room 2.6. Timber framed glazing to internal walls, good condition.	
HERITAGE SIGNIFICANCE	Heritage Significance Value of the element	Mixed
	EXCEPTIONAL External windows HIGH Internal timber framed windows	
FUNCTIONALITY	Functional

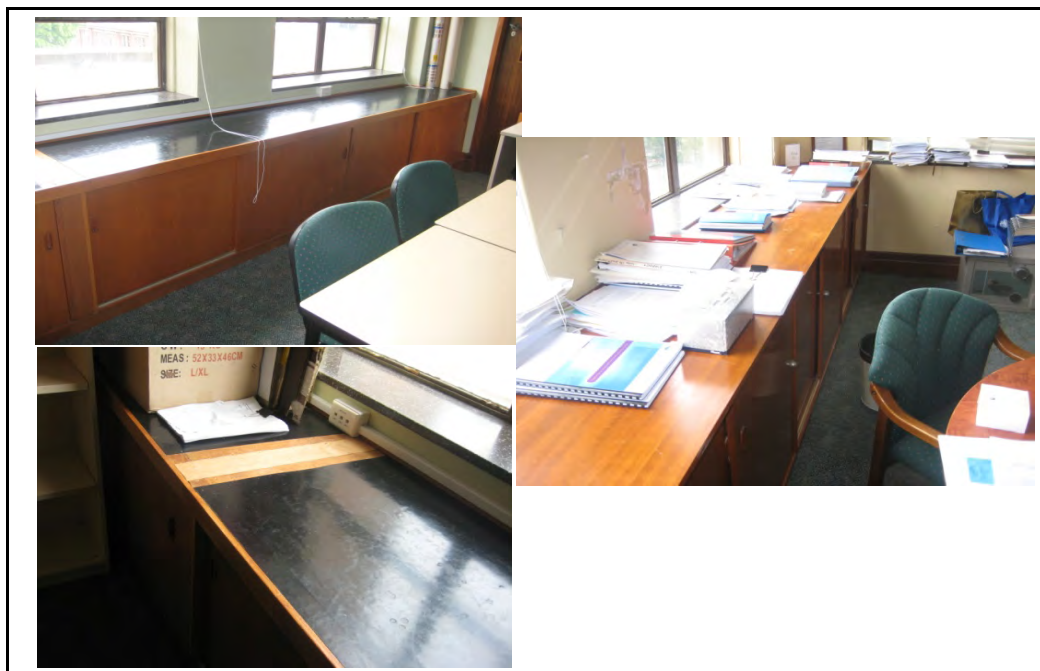
ASSET ELEMENT	FITTINGS
---------------	----------

EXISTING CONDITION		
OVERVIEW	Timber veneer joinery along south wall of both rooms. Good condition, section of vinyl top missing in room 2.6	
HERITAGE SIGNIFICANCE	Heritage Significance Value of the element	High
FUNCTIONALITY	Functional, requiring repair	
ACTION REQUIRED		
OVERVIEW	Repair benchtop to joinery in room 2.6.

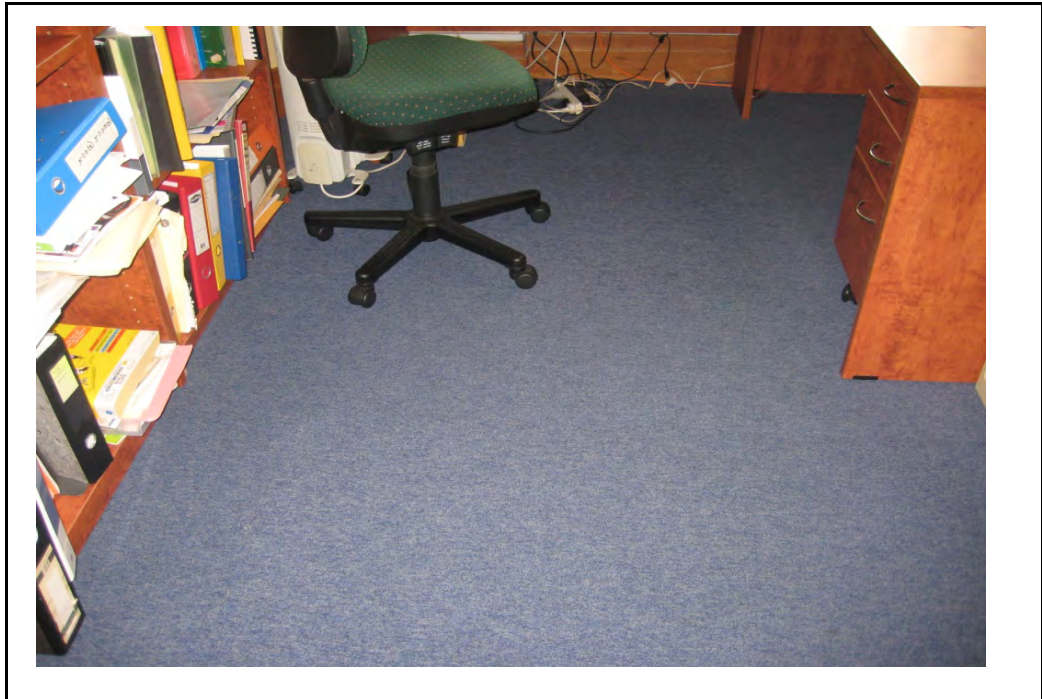
ASSET ELEMENT	FLOOR
---------------	-------

OVERVIEW	Carpet flooring, generally good condition.	
HERITAGE SIGNIFICANCE	Heritage Significance Value of the element	Low
	Refers to carpet only, substrate may hold higher significance.	
FUNCTIONALITY	Functional

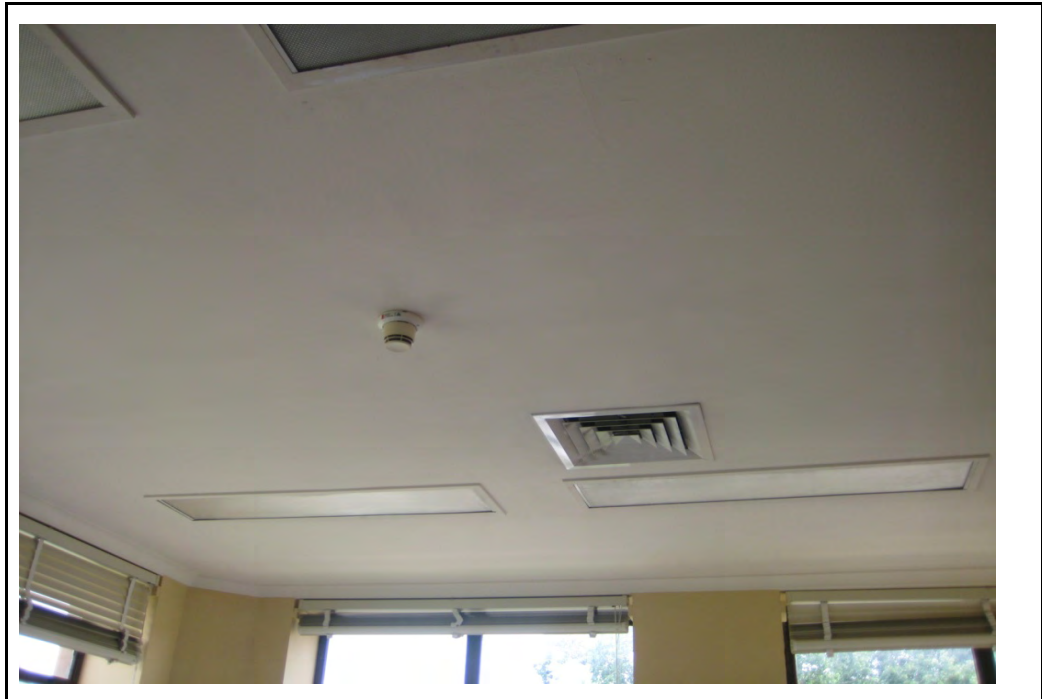
ASSET ELEMENT	CEILING
---------------	---------

OVERVIEW	Painted plasterboard ceiling, generally good condition, some areas of flaking paint.	
HERITAGE SIGNIFICANCE	Heritage Significance Value of the element	Low
FUNCTIONALITY	Functional, requiring repairs to paintwork.

OVERVIEW	Remove damaged paintwork and repaint as required.
----------	---

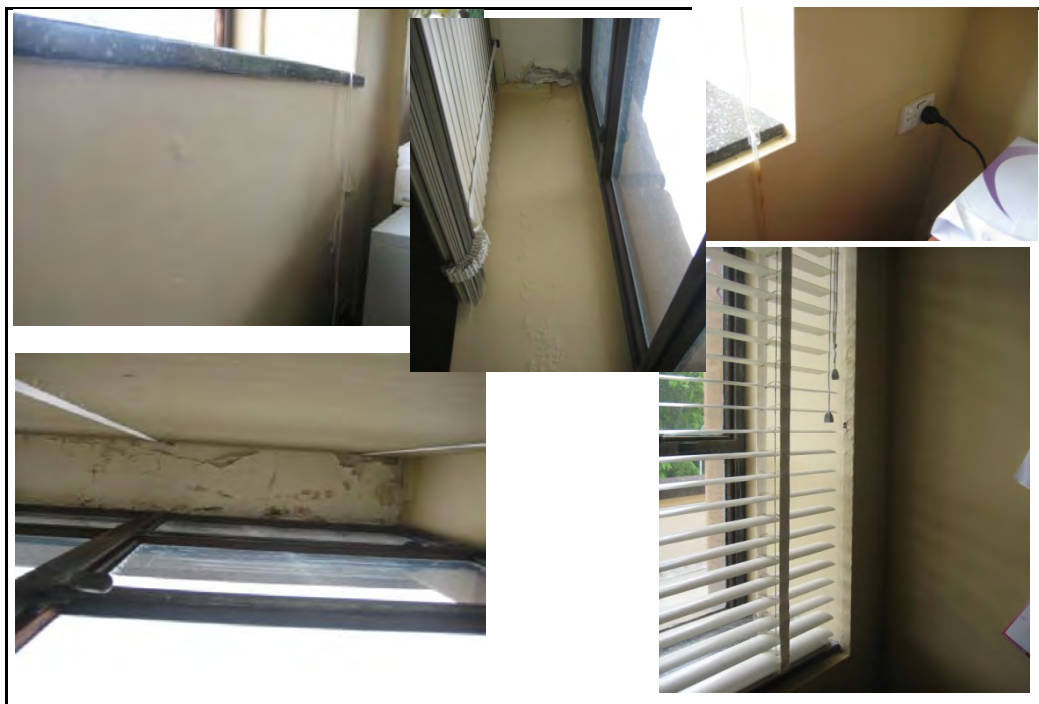
ASSET ELEMENT	WALLS
---------------	-------

OVERVIEW	Plasterboard and paint to external walls and party walls, powdercoated aluminium framed glazed walls to corridor in rooms 2.11, 2.13 and 2.15. Some painted areas in all rooms in poor condition - paint flaking, bubbling, peeling, appears moisture affected. Particularly evident on window reveals and underside of window heads.	
HERITAGE SIGNIFICANCE	Heritage Significance Value of the element	Mixed
	HIGH External walls LOW Internal walls	
FUNCTIONALITY	Functional but requiring repair.

OVERVIEW	Investigate and rectify source of moisture, repair and restore wall finishes as required
-----------------	--

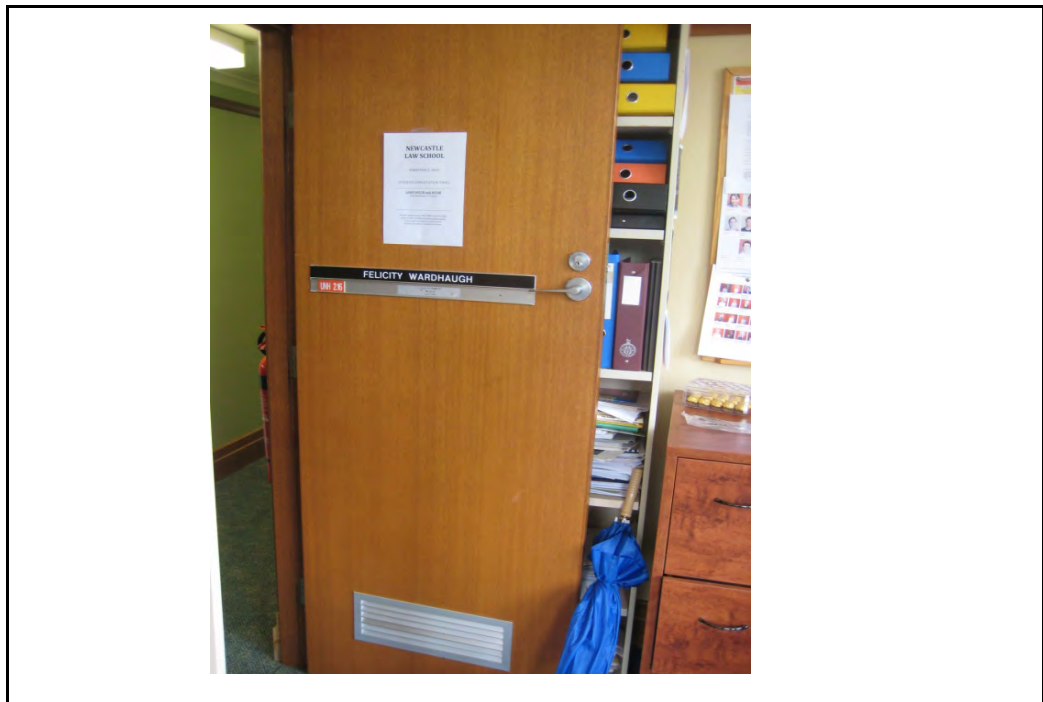
ASSET ELEMENT	DOORS
---------------	-------

EXISTING CONDITION		
OVERVIEW	Timber doors, good condition.	
HERITAGE SIGNIFICANCE	Heritage Significance Value of the element	Low
FUNCTIONALITY	Functional	
ACTION REQUIRED		
OVERVIEW
