CONSERVATION MANAGEMENT PLAN

VOLUME 3 OF 3

UNIVERSITY HOUSE FORMERLY N.E.S.C.A HOUSE KING STREET NEWCASTLE

Prepared by EJE Heritage
MARCH 2011
Ref: 8836-CMP-UH-001

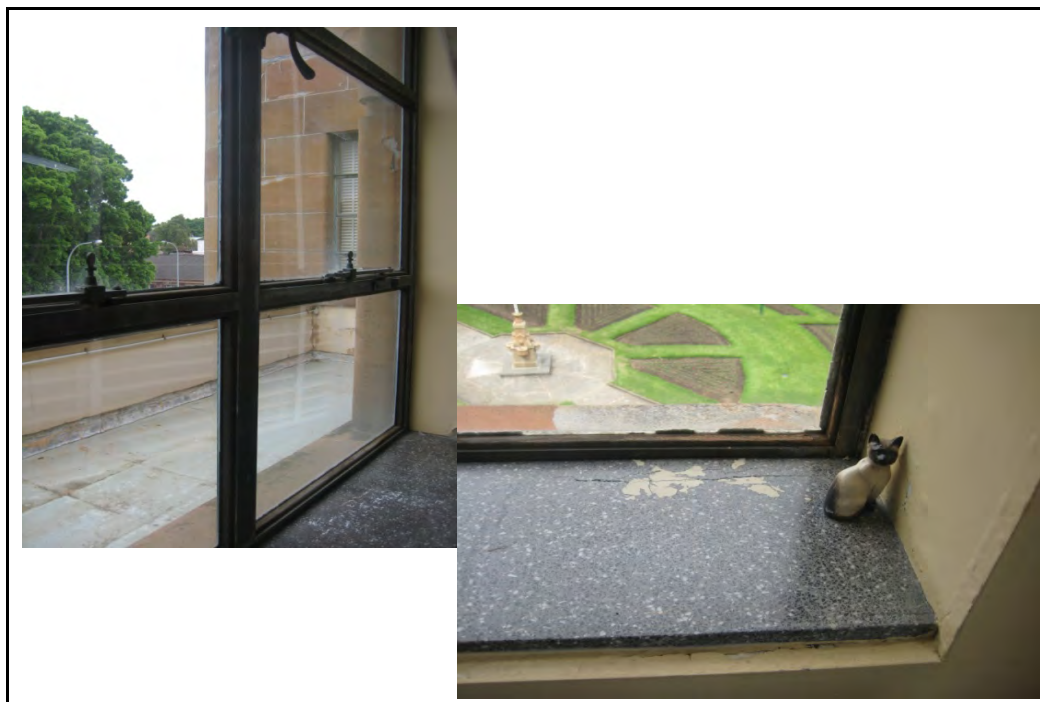
ASSET ELEMENT	WINDOWS
---------------	---------

OVERVIEW	Steel / timber framed casement window to external walls - fair condition, some discolouration to frames, sealant perished, missing externally. Cracked pane in room 2.13. Black stone sills, some cracking and fading evident. Powdercoated aluminium framed glazed walls to corridor.	
HERITAGE SIGNIFICANCE	Heritage Significance Value of the element	Mixed
	EXCEPTIONAL Original metal window and timber framed windows LOW Powdercoated aluminium framed glazing	
FUNCTIONALITY	Functional

OVERVIEW	Restore original glazing frames and sill as required. Replace cracked pane.
-----------------	---

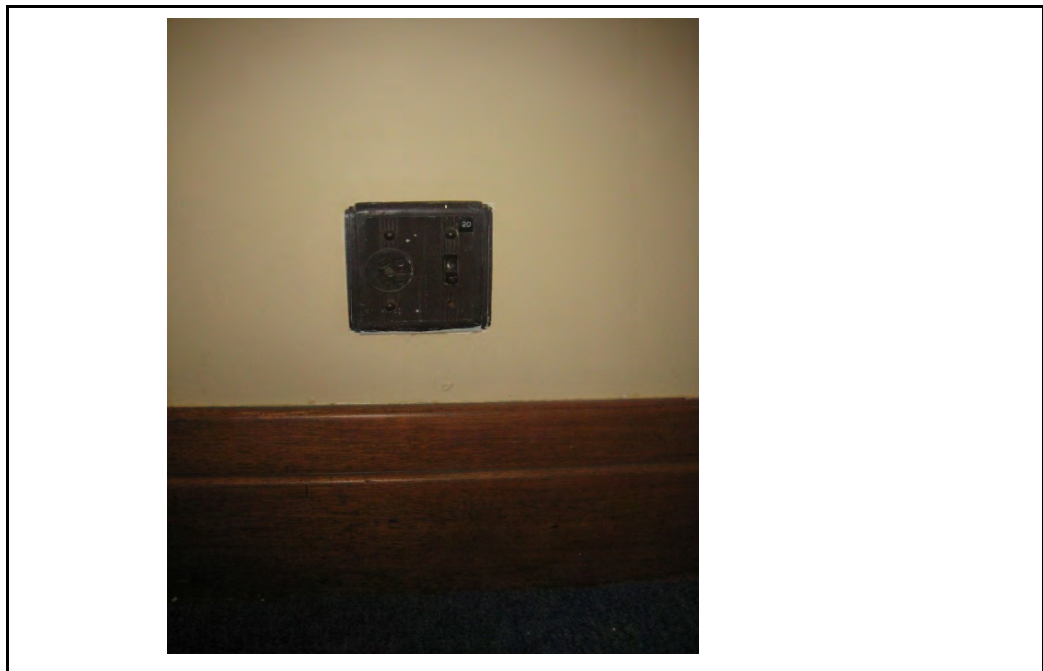
ASSET ELEMENT	FITTINGS
---------------	----------

EXISTING CONDITION		
OVERVIEW	Original power outlet on wall in room 2.16.	
HERITAGE SIGNIFICANCE	Heritage Significance Value of the element	High
FUNCTIONALITY	Not assessed, assumed functional	
ACTION REQUIRED		
OVERVIEW

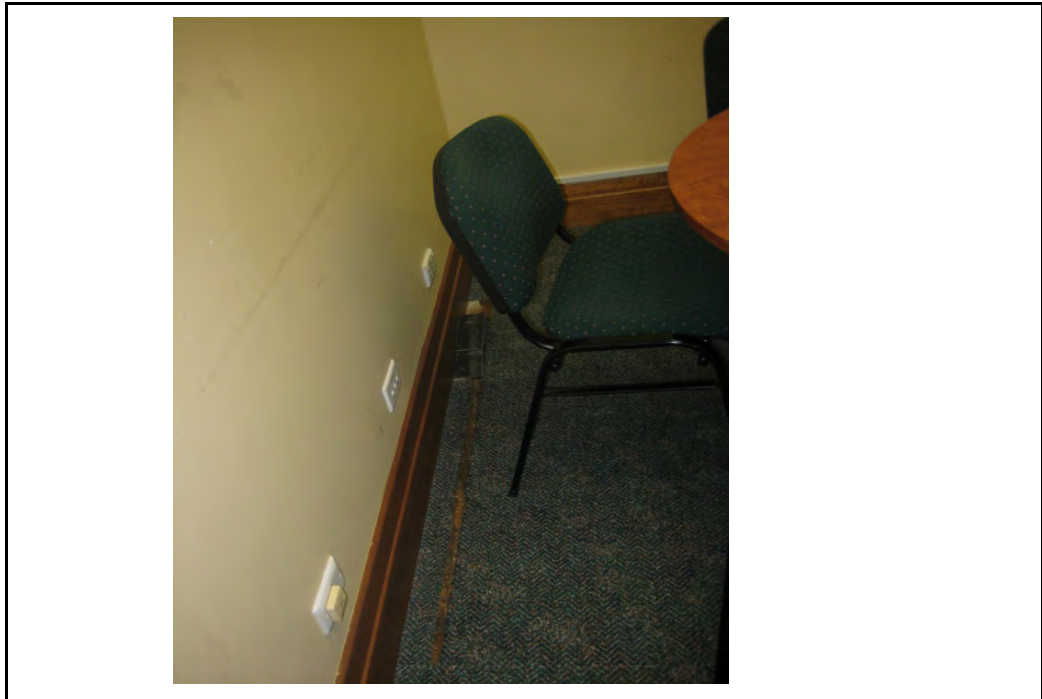
ASSET ELEMENT	FLOOR
---------------	-------

OVERVIEW	Carpet tile flooring, generally good condition, tiles loose at west wall in room 2.9.	
HERITAGE SIGNIFICANCE	Heritage Significance Value of the element	Low
	Refers to carpet tiles only, substrate may hold higher significance.	
FUNCTIONALITY	Functional

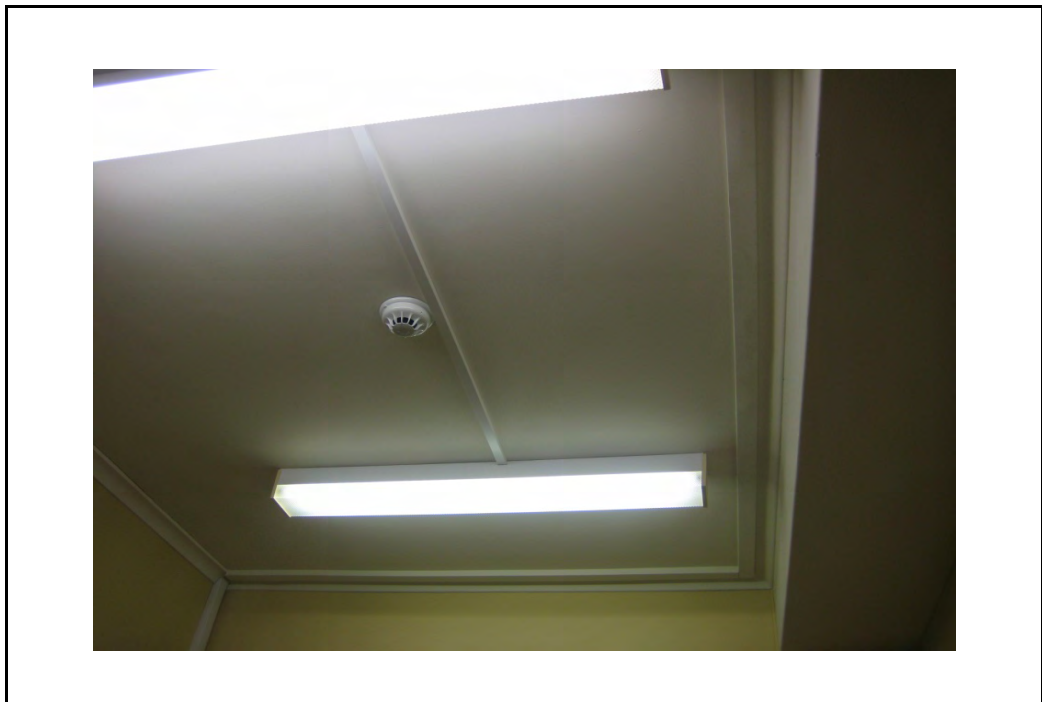
ASSET ELEMENT	CEILING
---------------	---------

OVERVIEW	Painted plasterboard ceiling, generally good condition.	
HERITAGE SIGNIFICANCE	Heritage Significance Value of the element	Low
FUNCTIONALITY	Functional

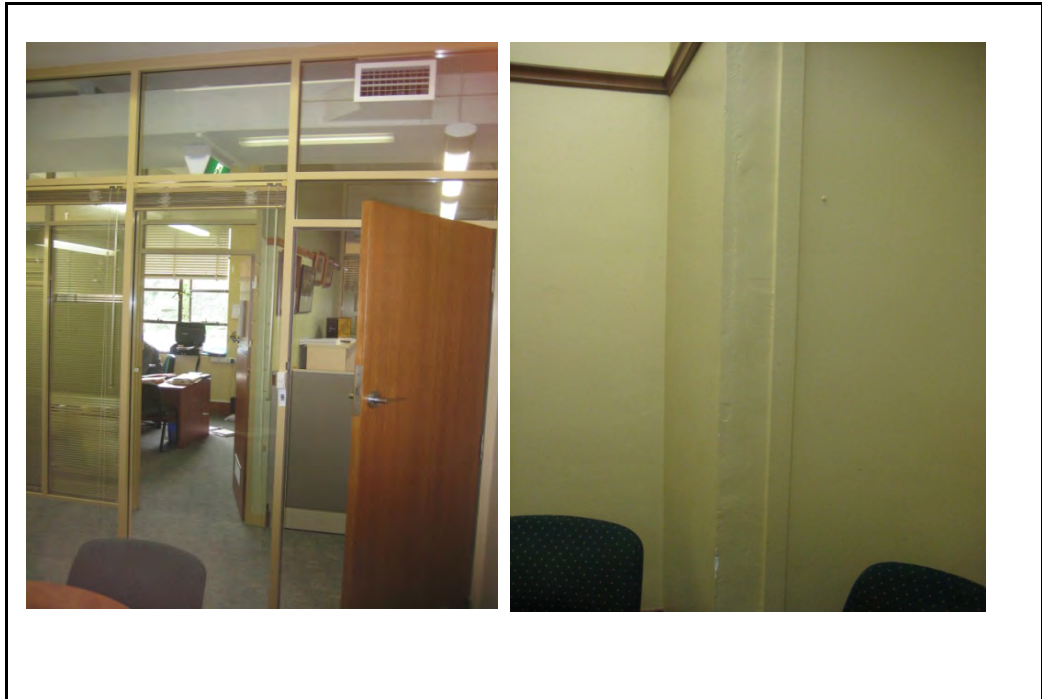
ASSET ELEMENT	WALLS
---------------	-------

OVERVIEW	Plasterboard and paint finish, generally good condition. Powdercoated aluminium framed glazed wall to corridor.	
HERITAGE SIGNIFICANCE	Heritage Significance Value of the element	Mixed
	HIGH North wall (excluding powdercoated aluminium glass partition) LOW Other walls	
FUNCTIONALITY	Functional.

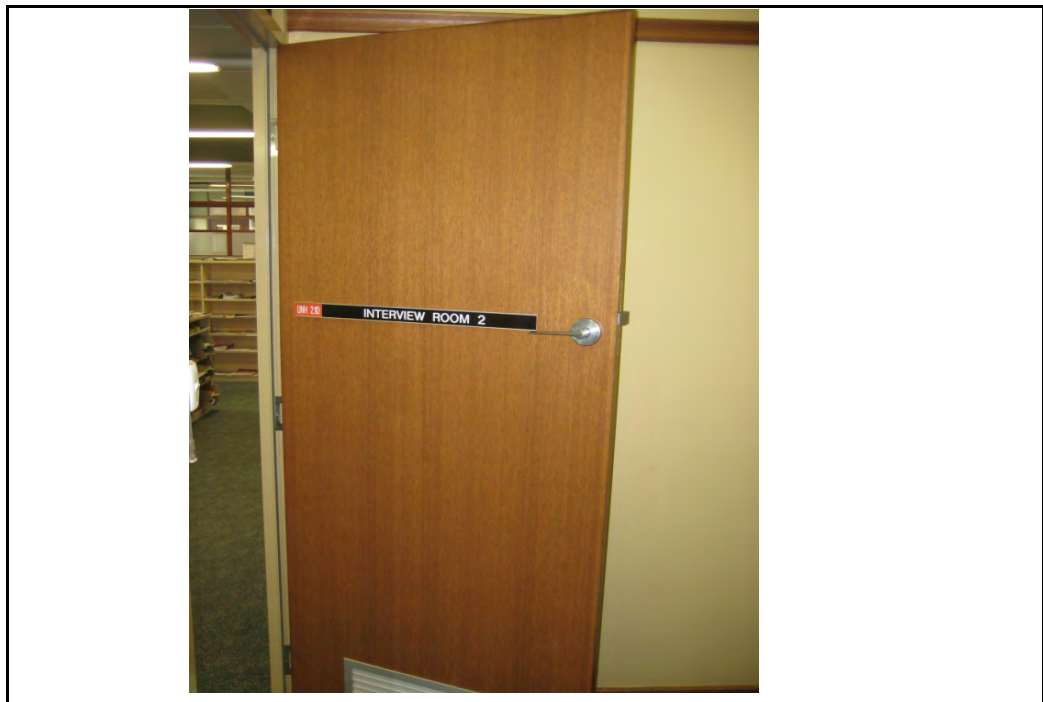
ASSET ELEMENT	DOORS
---------------	-------

EXISTING CONDITION		
OVERVIEW	Timber doors Good condition.	
HERITAGE SIGNIFICANCE	Heritage Significance Value of the element	Low
FUNCTIONALITY	Functional	
ACTION REQUIRED		
OVERVIEW

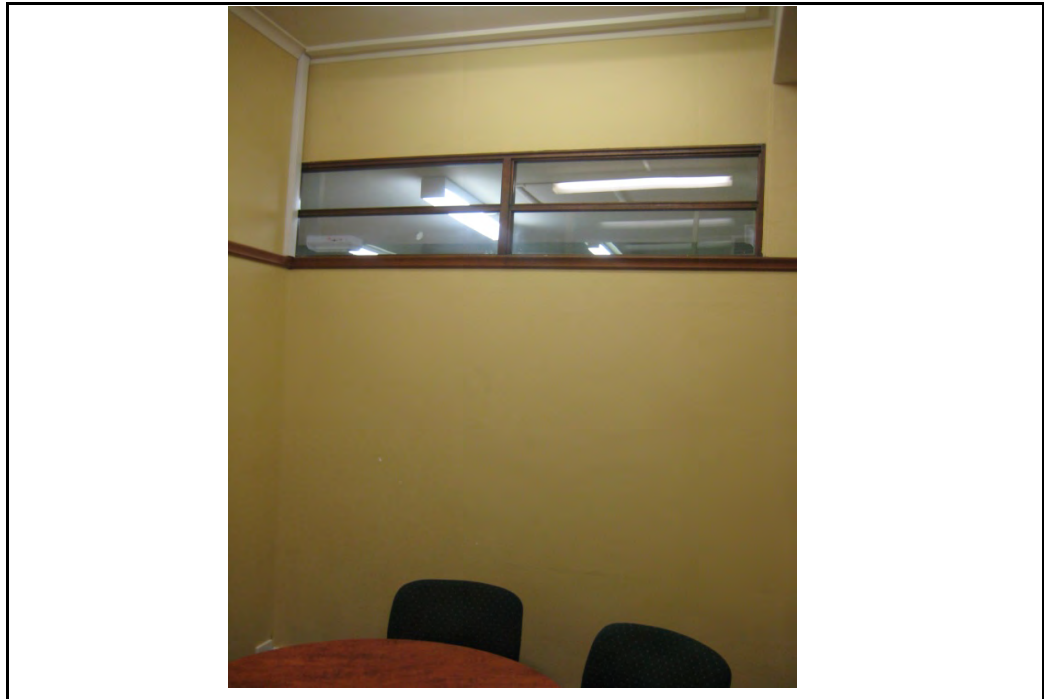
ASSET ELEMENT	WINDOWS
---------------	---------

EXISTING CONDITION		
OVERVIEW	Timber framed highlight glazing in room 2.9	
HERITAGE SIGNIFICANCE	Heritage Significance Value of the element	High
FUNCTIONALITY	Functional	
ACTION REQUIRED		
OVERVIEW

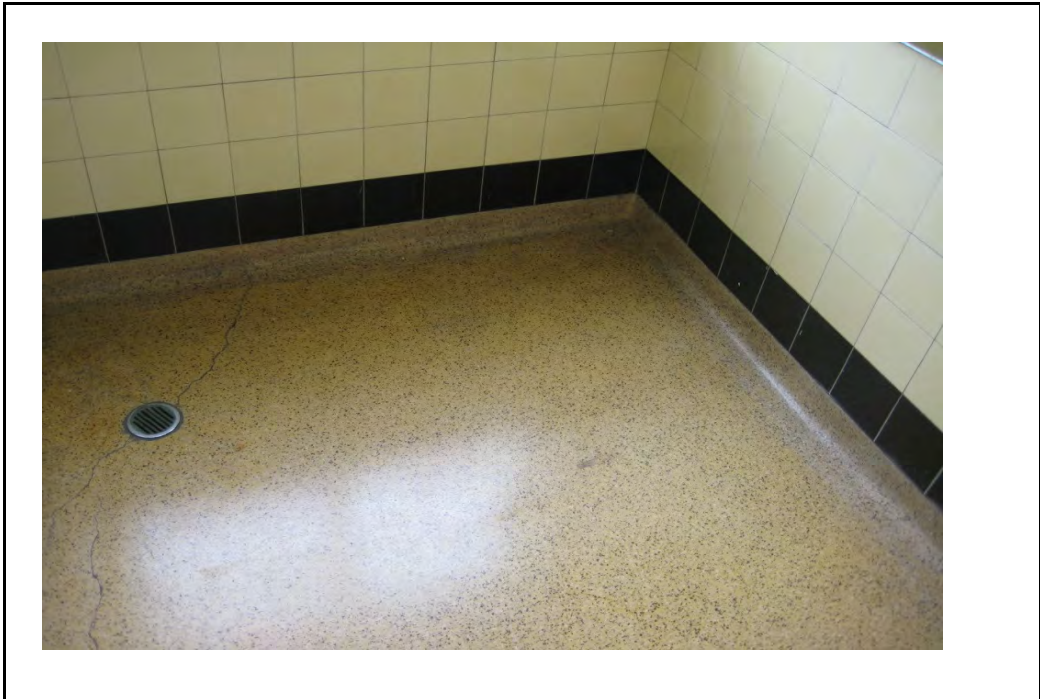
ASSET ELEMENT	FLOOR
----------------------	--------------

EXISTING CONDITION		
OVERVIEW	Terrazzo flooring, coved at walls in. Generally fair condition, some cracks and discolouration present.	
HERITAGE SIGNIFICANCE	Heritage Significance Value of the element	High
FUNCTIONALITY	Functional, requiring minor repair.	
ACTION REQUIRED		
OVERVIEW	Repair and restore flooring as required

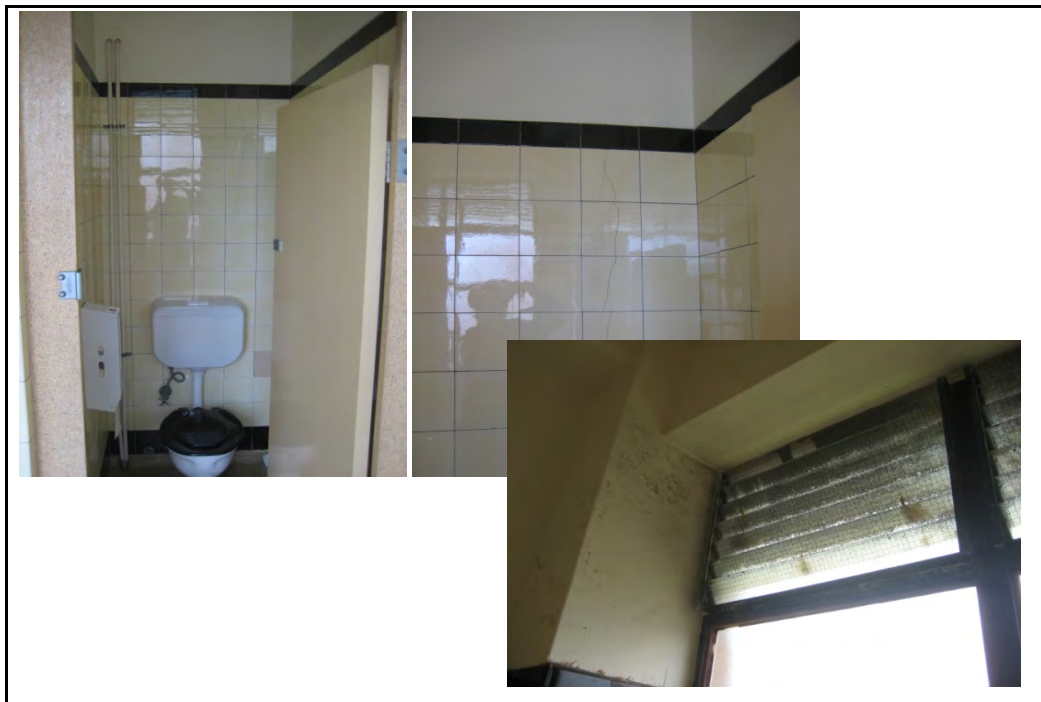
ASSET ELEMENT	WALLS
----------------------	--------------

OVERVIEW	Tiles to approx. 2200 AFFL, appear to be original and generally in fair condition. Some cracked tiles. Paintwork above appears in good condition, some moisture damage at window - paint flaking.	
HERITAGE SIGNIFICANCE	Heritage Significance Value of the element	High
FUNCTIONALITY	Functional, requiring minor repairs

OVERVIEW	Repair and restore wall finishes as required
-----------------	--

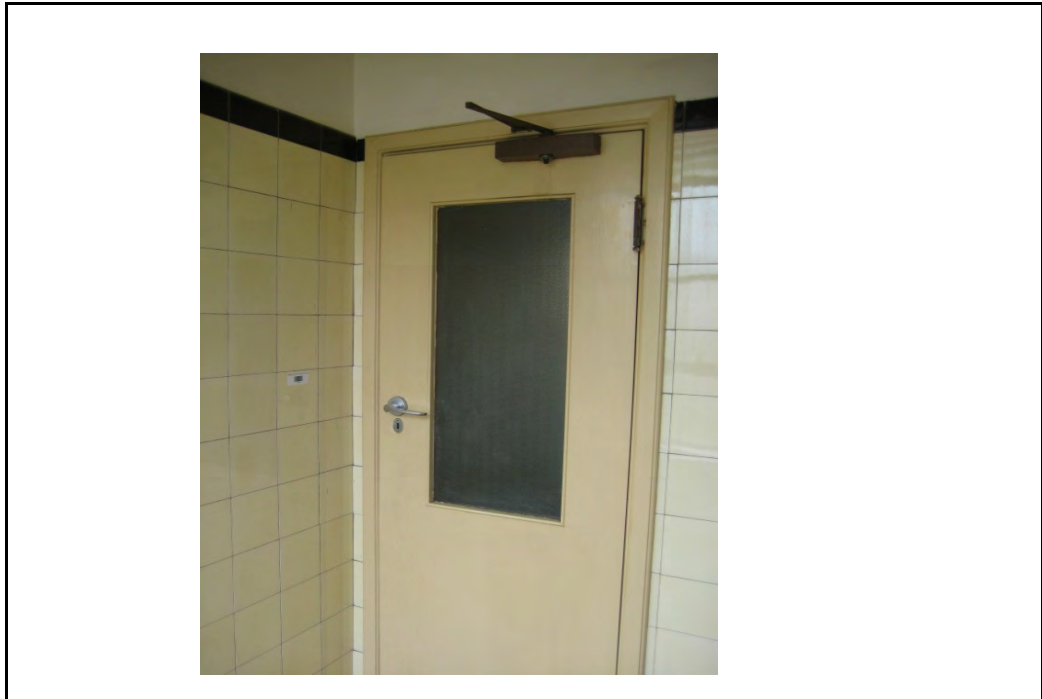
ASSET ELEMENT	DOORS
----------------------	--------------

OVERVIEW	Timber and glass door, painted. Good condition.	
HERITAGE SIGNIFICANCE	Heritage Significance Value of the element	High
FUNCTIONALITY	Functional.

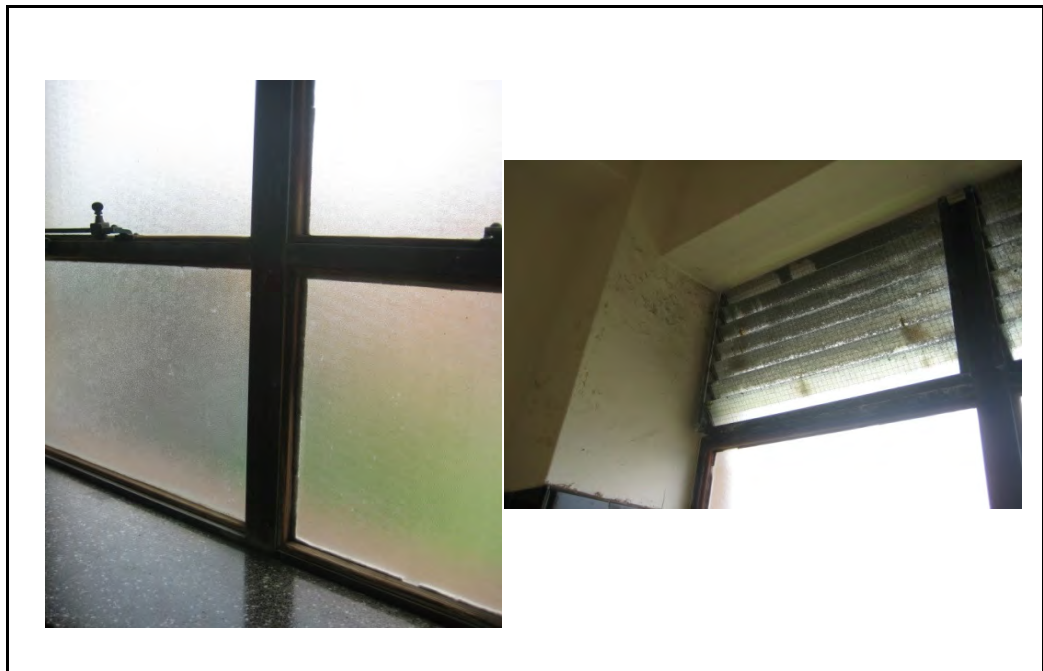
ASSET ELEMENT	WINDOWS
----------------------	----------------

EXISTING CONDITION		
OVERVIEW	Original metal framed windows - casement at base, louvres above, fair condition. Frame discoloured, sealant perished, missing externally. Black stone sill.	
HERITAGE SIGNIFICANCE	Heritage Significance Value of the element	High
FUNCTIONALITY	Functional.	
ACTION REQUIRED		
OVERVIEW

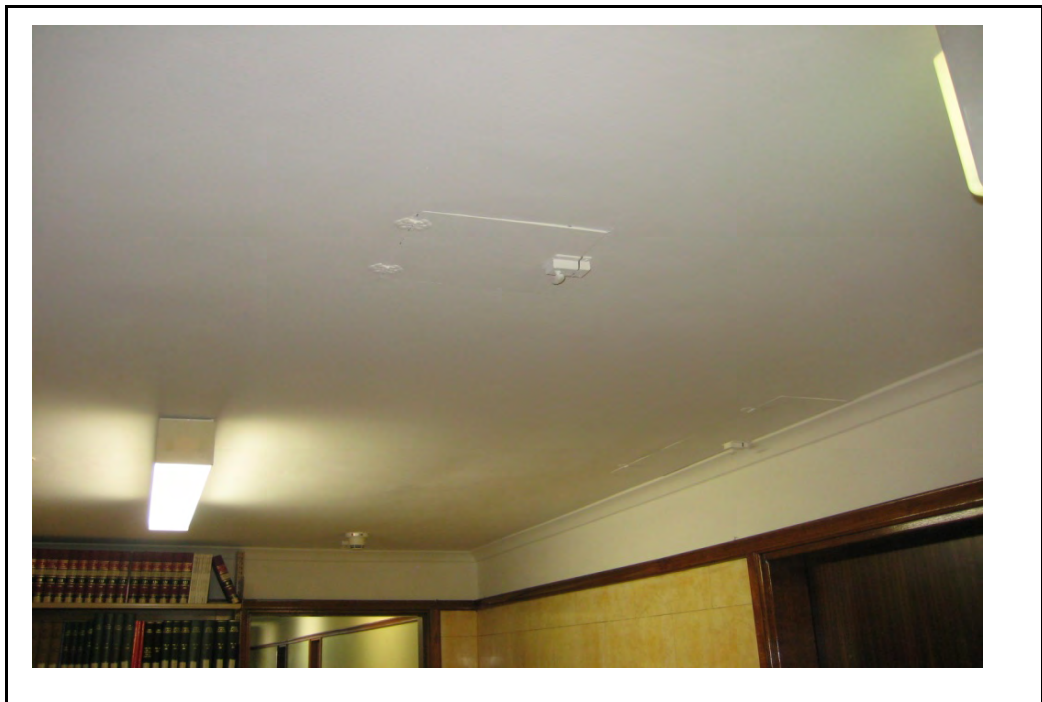
ASSET ELEMENT	CEILING
---------------	---------

OVERVIEW	Plasterboard ceiling, paint finish, generally good condition.	
HERITAGE SIGNIFICANCE	Heritage Significance Value of the element	Moderate
FUNCTIONALITY	Functional.

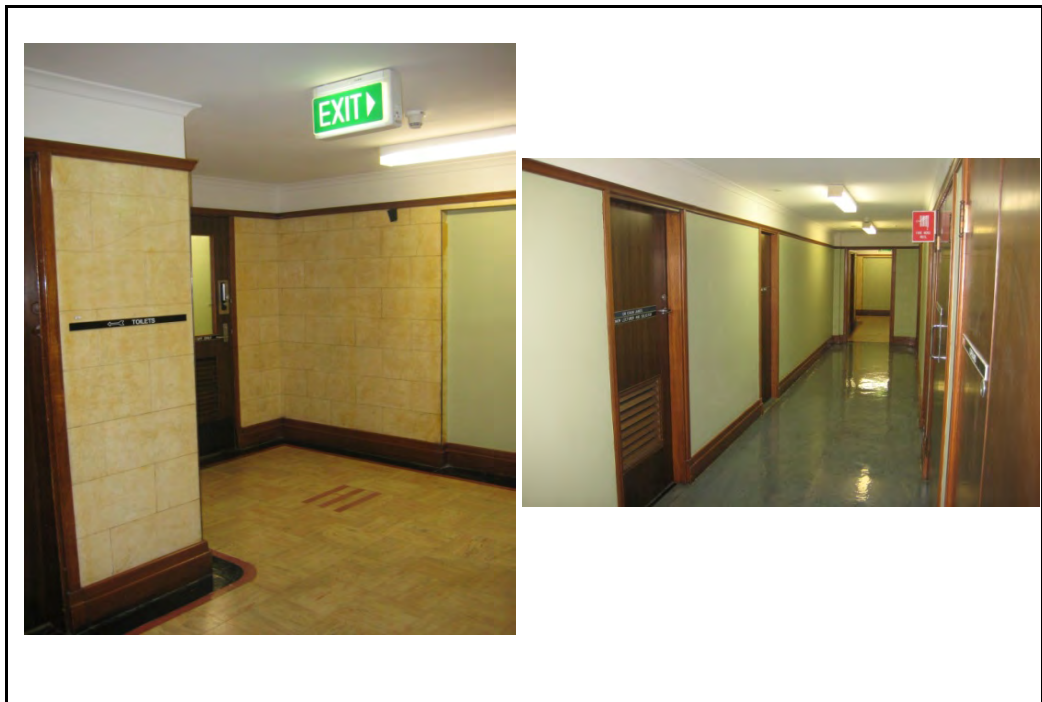
ASSET ELEMENT	WALLS
---------------	-------

EXISTING CONDITION	
OVERVIEW	Scagliola tiles to lobby at south end - extensively covered in fine cracks, drummy areas. Corridor painted plasterboard, generally good condition. Decorative timber rail at 2100 AFFL and steeped timber skirtings throughout.
HERITAGE SIGNIFICANCE	Heritage Significance Value of the element Mixed
	EXCEPTIONAL Scagliola tiles LOW Painted plasterboard
FUNCTIONALITY	Functional
ACTION REQUIRED	
OVERVIEW	Repair and restore wall finishes as required

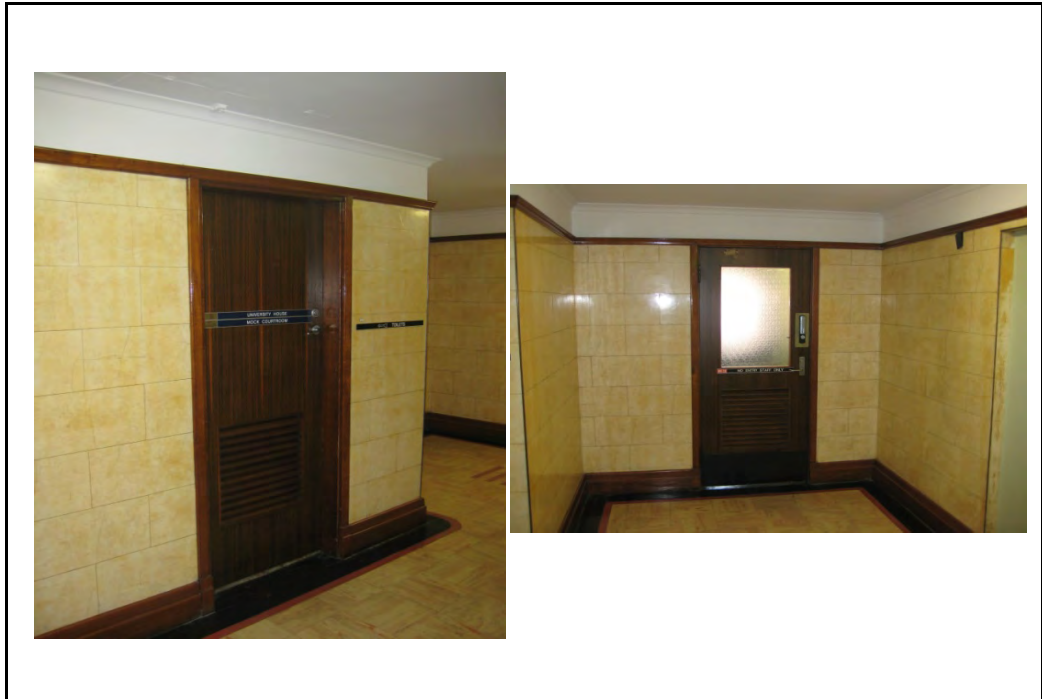
ASSET ELEMENT	DOORS
---------------	-------

OVERVIEW	Timber veneer doors with timber frames throughout, 1 door with glazed panel, some with timber louvres. Door to stair lobby room 2.22 is painted timber with steel framed. All generally good condition.	
HERITAGE SIGNIFICANCE	Heritage Significance Value of the element	Mixed
	HIGH Timber veneer doors LOW Painted doors	
FUNCTIONALITY	Functional

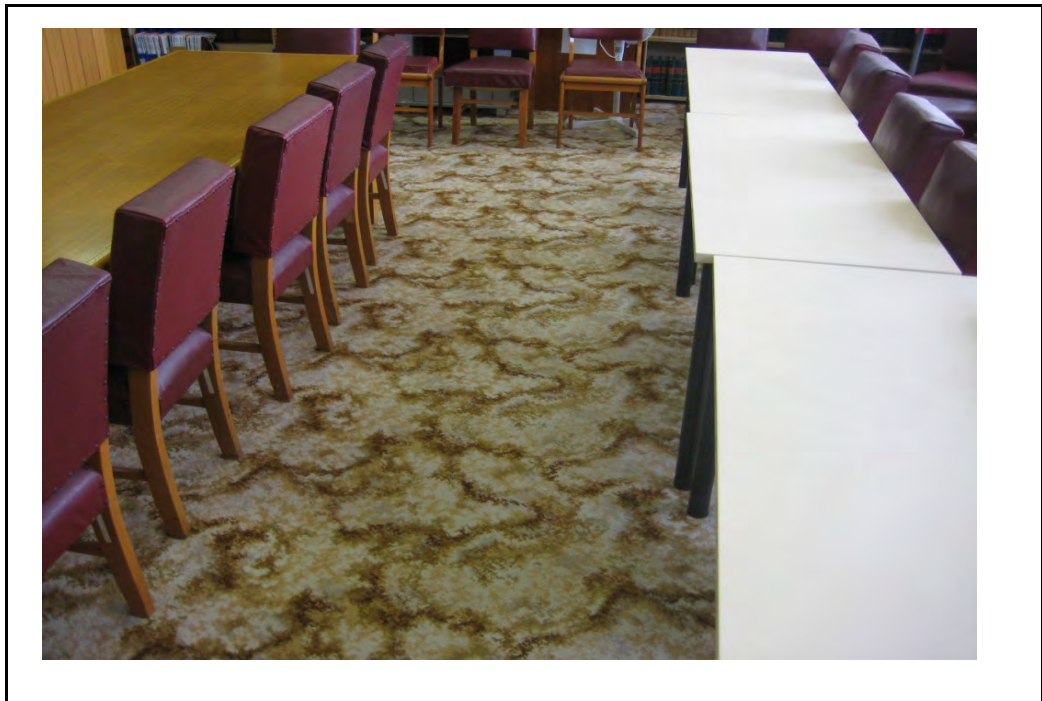
ASSET ELEMENT	FLOOR
---------------	-------

EXISTING CONDITION		
OVERVIEW	Carpet flooring, possibly dating back to NESCA occupancy, good condition.	
HERITAGE SIGNIFICANCE	Heritage Significance Value of the element	High
FUNCTIONALITY	Functional	
ACTION REQUIRED		
OVERVIEW

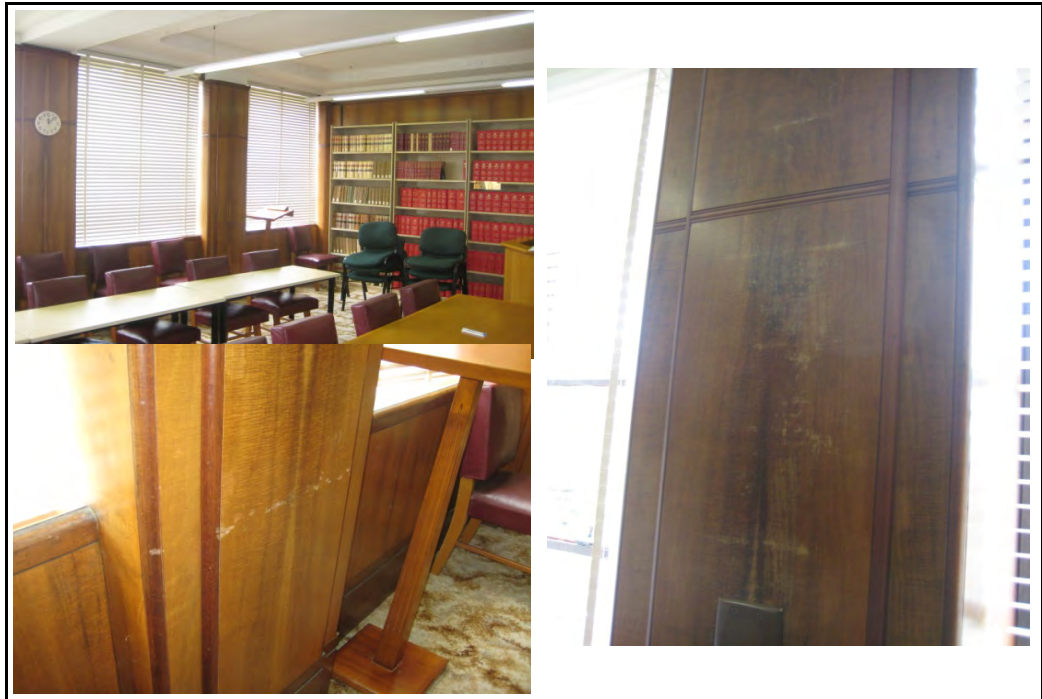
ASSET ELEMENT	WALLS
---------------	-------

EXISTING CONDITION		
OVERVIEW	Timber veneer panelling, generally good condition, some scratches and areas where veneer scuffed.	
HERITAGE SIGNIFICANCE	Heritage Significance Value of the element	High
FUNCTIONALITY	Functional but requiring repair.	
ACTION REQUIRED		
OVERVIEW	Repair and restore wall finishes as required.

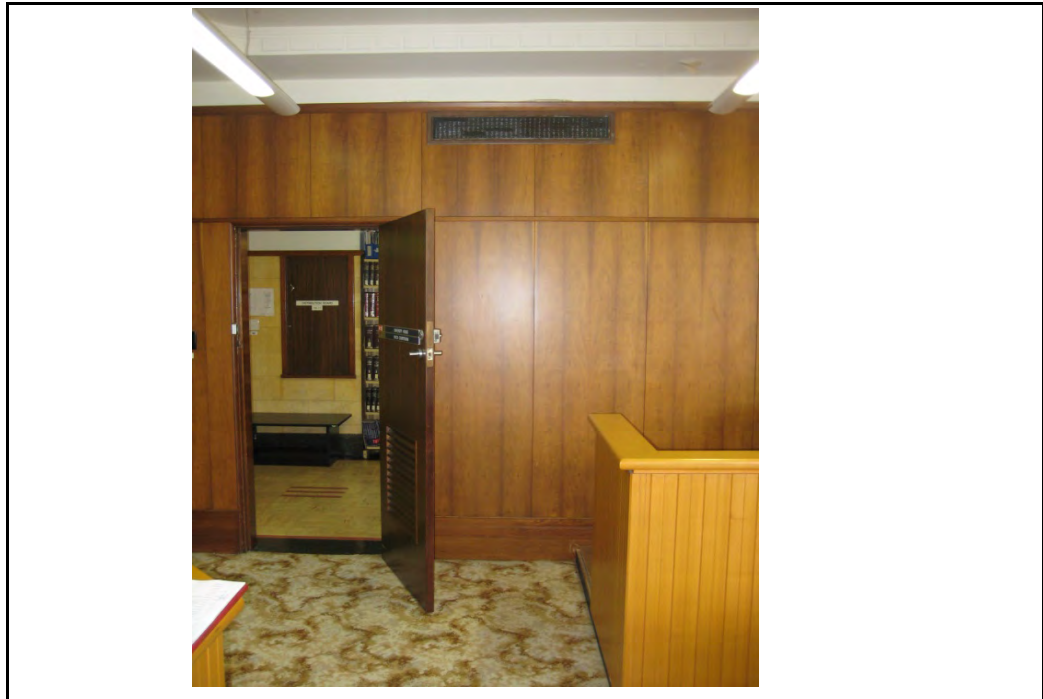
ASSET ELEMENT	DOORS
---------------	-------

EXISTING CONDITION		
OVERVIEW	Timber veneer doors with timber louvres. Good condition.	
HERITAGE SIGNIFICANCE	Heritage Significance Value of the element	High
FUNCTIONALITY	Functional	
ACTION REQUIRED		
OVERVIEW

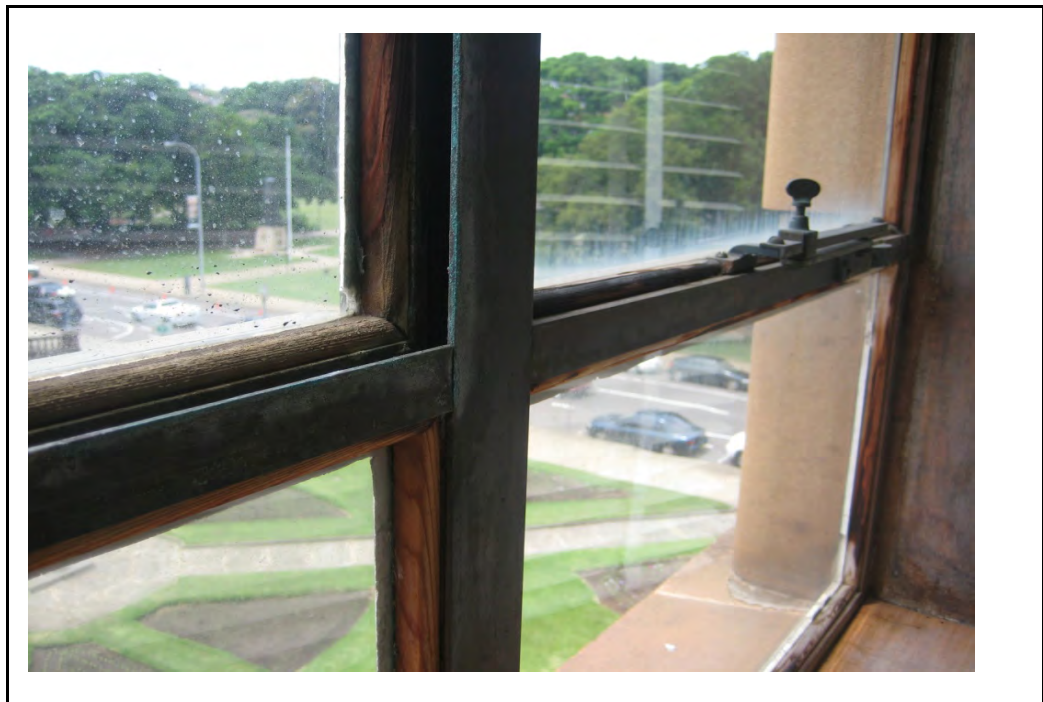
ASSET ELEMENT	WINDOWS
---------------	---------

EXISTING CONDITION		
OVERVIEW	Steel / timber framed casement window to external walls - fair condition, some discolouration to frames, sealant perished, missing externally. Timber frame beads deteriorating. Timber sills and reveals, faded.	
HERITAGE SIGNIFICANCE	Heritage Significance Value of the element	Exceptional
FUNCTIONALITY	Functional	
ACTION REQUIRED		
OVERVIEW	Restore original glazing frames and sills as required.

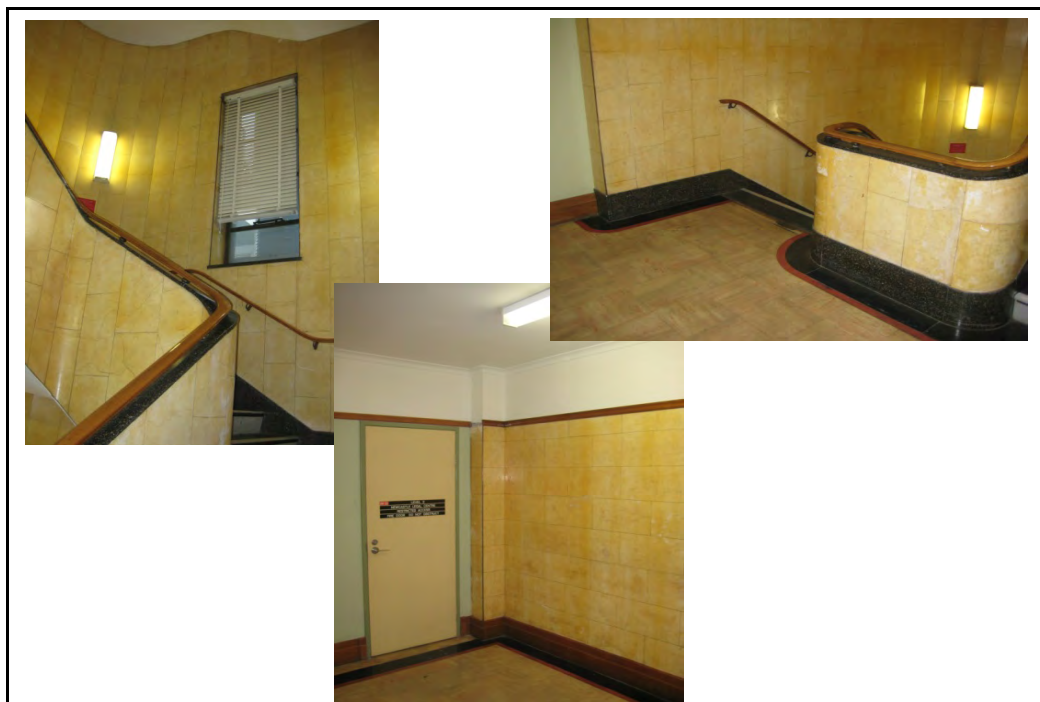
ASSET ELEMENT	WALLS
---------------	-------

EXISTING CONDITION	
OVERVIEW	Scagliola tiles with black stone skirting to stair wall and balustrade - fair condition, with fine cracks extensively across surface of scagliola tiles. Black stone capping to balustrade. Painted plasterboard with stepped timber skirting, scagliola tiles with black stone skirting to room 2.22. Similar condition to stair walls - fine cracking extensively across surface, all scagliola tiled walls drummy in some areas, particularly adjacent to larger crack locations. Section of skirting missing at corner of room near door to 2.1. Section of timber rail missing near door to 2.20.
HERITAGE SIGNIFICANCE	Heritage Significance Value of the element
	Mixed
EXCEPTIONAL	Scagliola tiles, skirtings
LOW	Painted plasterboard
FUNCTIONALITY	Functional but requiring repair.
ACTION REQUIRED	
OVERVIEW	Repair and restore wall finishes as required

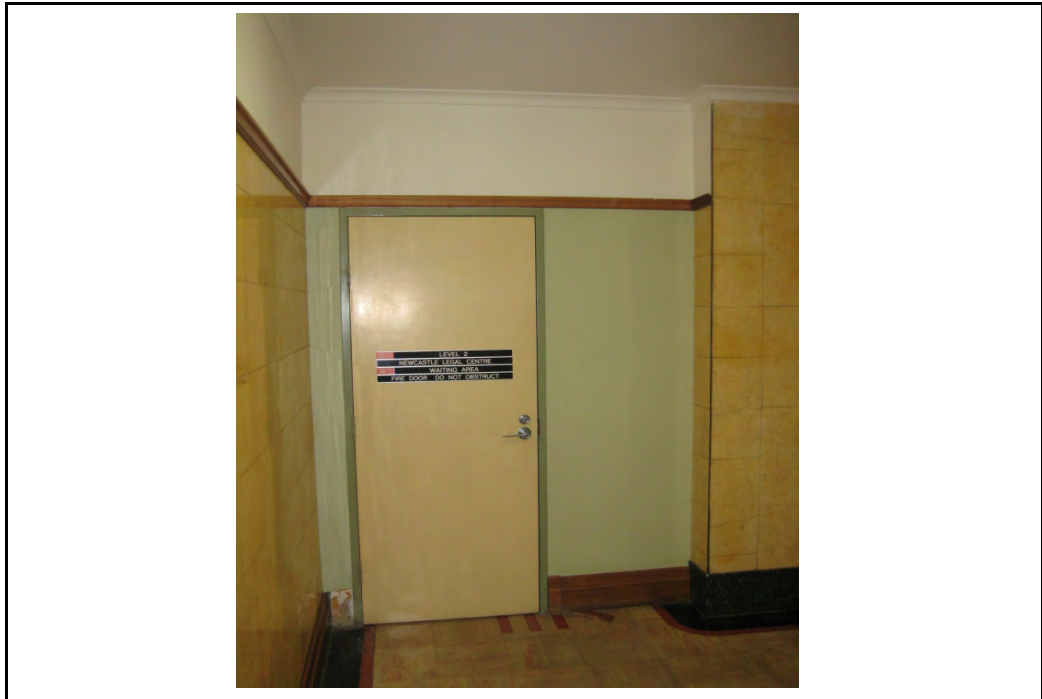
ASSET ELEMENT	DOORS
---------------	-------

EXISTING CONDITION		
OVERVIEW	Painted timber with painted steel frames. All good condition.	
HERITAGE SIGNIFICANCE	Heritage Significance Value of the element	Low
FUNCTIONALITY	Functional	
ACTION REQUIRED		
OVERVIEW

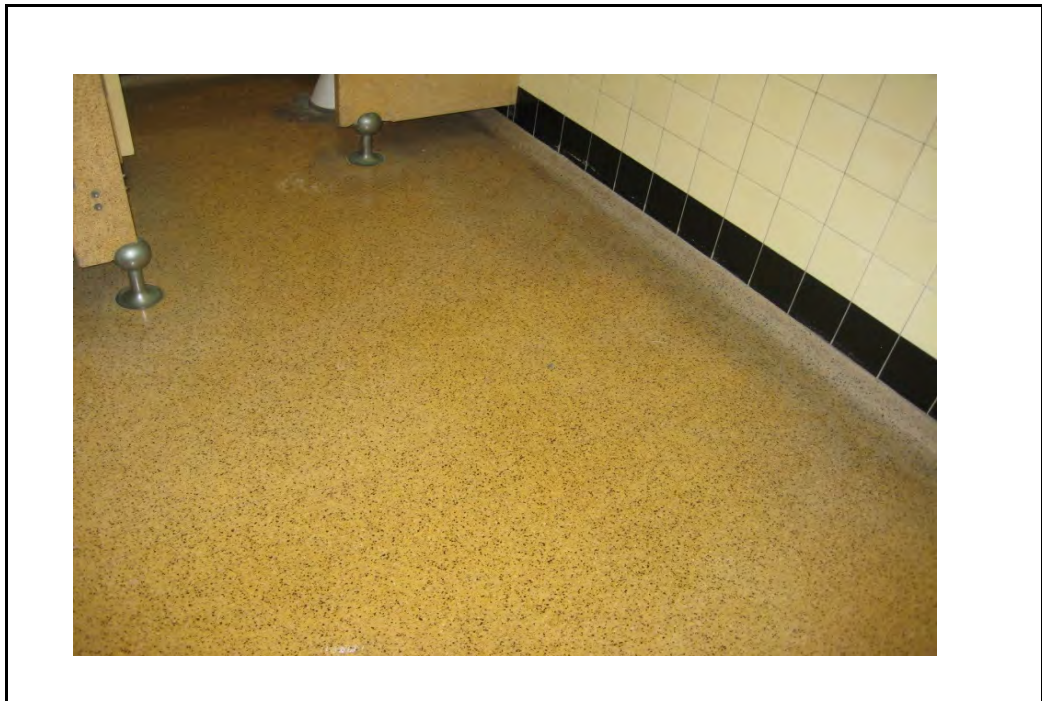
ASSET ELEMENT	FLOOR
----------------------	--------------

EXISTING CONDITION		
OVERVIEW	Terrazzo flooring, coved at walls in. Generally good condition, some minor cracks and discolouration present.	
HERITAGE SIGNIFICANCE	Heritage Significance Value of the element	High
FUNCTIONALITY	Functional, requiring minor repair.	
ACTION REQUIRED		
OVERVIEW	Repair and restore flooring as required

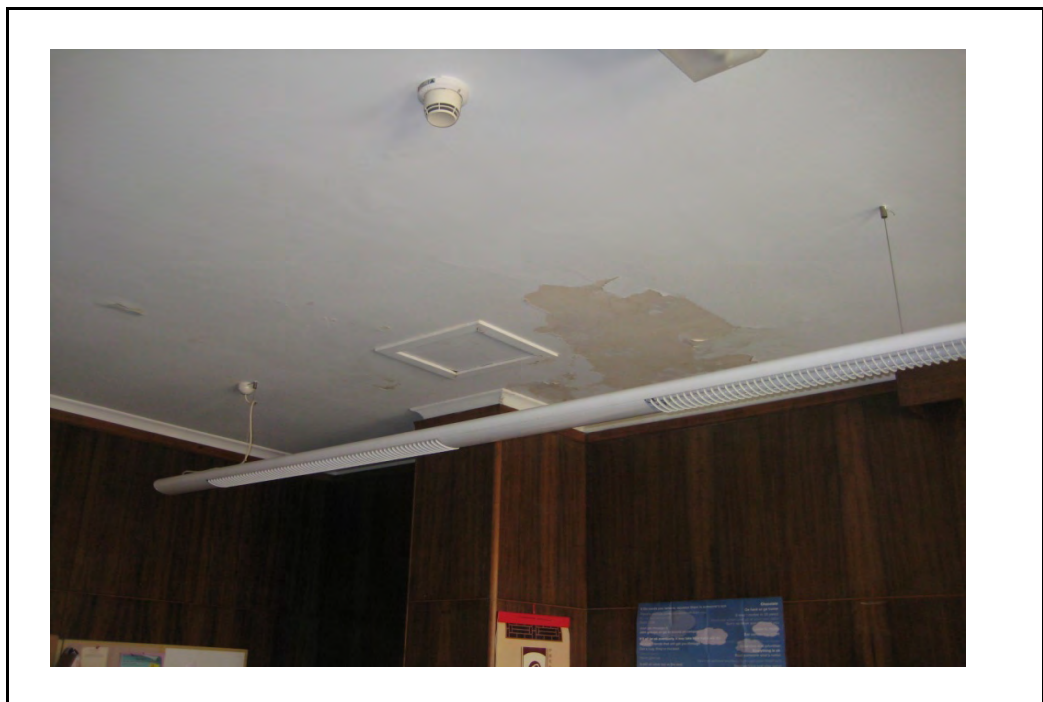
ASSET ELEMENT	CEILING
---------------	---------

EXISTING CONDITION		
OVERVIEW	Painted plasterboard ceiling, generally fair condition, area of ceiling in north-west part of room poor condition, moisture damage and paint flaking.	
HERITAGE SIGNIFICANCE	Heritage Significance Value of the element	Moderate
FUNCTIONALITY	Functional, requiring repairs to paintwork.	
ACTION REQUIRED		
OVERVIEW	Investigate and rectify source of moisture, remove damaged paintwork and repaint as required.

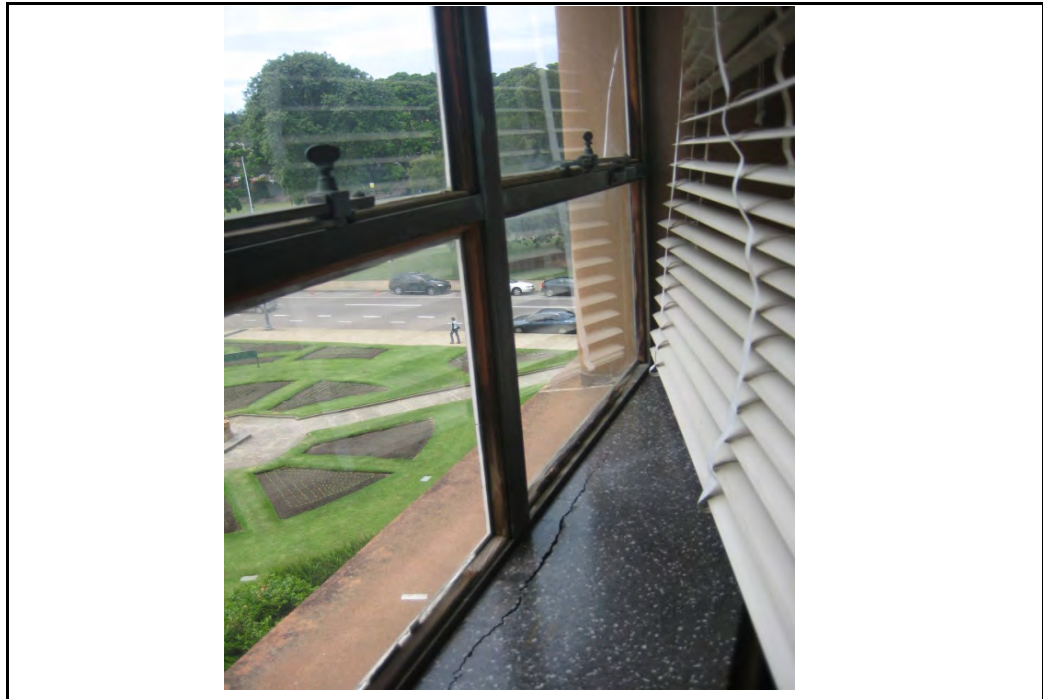
ASSET ELEMENT	WINDOWS
---------------	---------

EXISTING CONDITION		
OVERVIEW	Steel / timber framed casement window to external walls - fair condition, some discolouration to frames, sealant perished, missing externally. Cracked pane on northern-most window. Black stone sills, fading and cracking evident. Large crack to sill on northern-most window.	
HERITAGE SIGNIFICANCE	Heritage Significance Value of the element	Exceptional
FUNCTIONALITY	Functional	
ACTION REQUIRED		
OVERVIEW	Restore original glazing frames and sills as required.
