# Mount Thorley Warkworth

## 2025 Annual Review

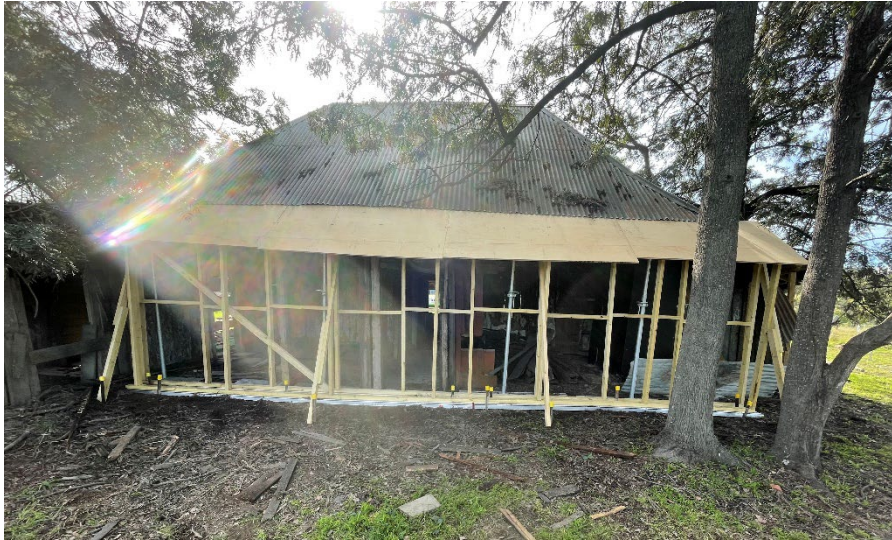
**FIGURE 24: TEMPORARY ROOFING EXTENSION AND SUPPORTING FRAMEWORK AT REAR OF SPRINGWOOD HOMESTEAD**

During the reporting period routine area maintenance works were undertaken at Springwood Homestead, the Red Brick House, and the RAAF Cook House. Inspection by a heritage builder was undertaken at Springwood and the Red Brick House and at Springwood Homestead an area of temporary roofing extension to shed roof runoff away from the building was subsequently constructed (**Figure 24**). Roofing repairs were undertaken at the Red Brick House following damage by a severe storm in late November in addition to minor repairs on several occasions to re-attach hoarding boards following break-ins by persons unknown. Works planned for the period at Springwood Homestead and the RAAF Cook House were again disrupted by access constraints due to periods of wet weather however at the end of the period construction of alternate all weather access to Springwood Homestead had been completed and upgrade completed of the initial track sections to the RAAF Cook House, including mulching to realign track sections and replacement of a washed out culvert.

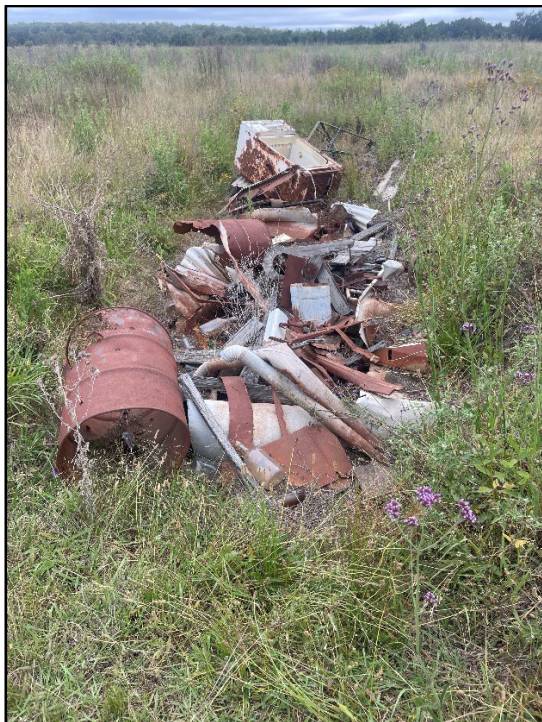
The presence of historic, farming related debris and scrap was noted in the immediate vicinity of two ACH sites inspected. It should be noted that this rubbish was not located within the site boundaries, nor had it disturbed any recorded ACH material. The majority of the material consisted of scrap metal – a likely deliberate dump at MTW-141 and an individual water tank ring at MTW-176. Access to these areas and the removal of the rubbish would be able to be accomplished while also avoiding all ACH sites in the area.

***Scrap metal dump near MTW-141***

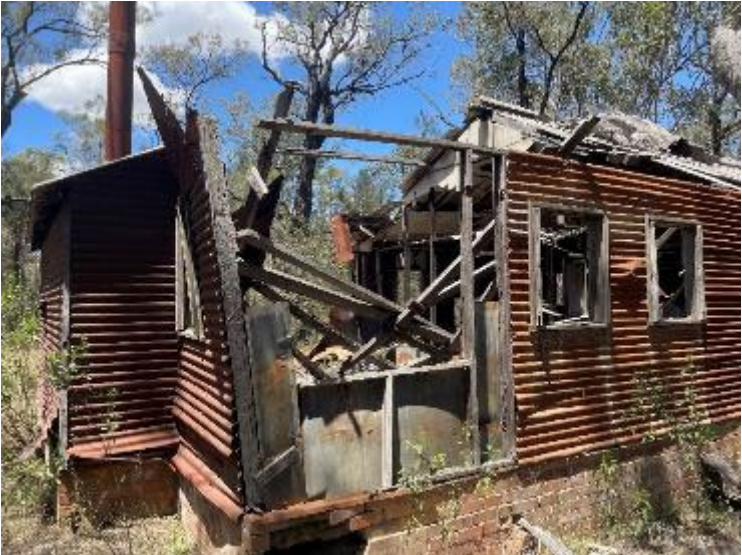
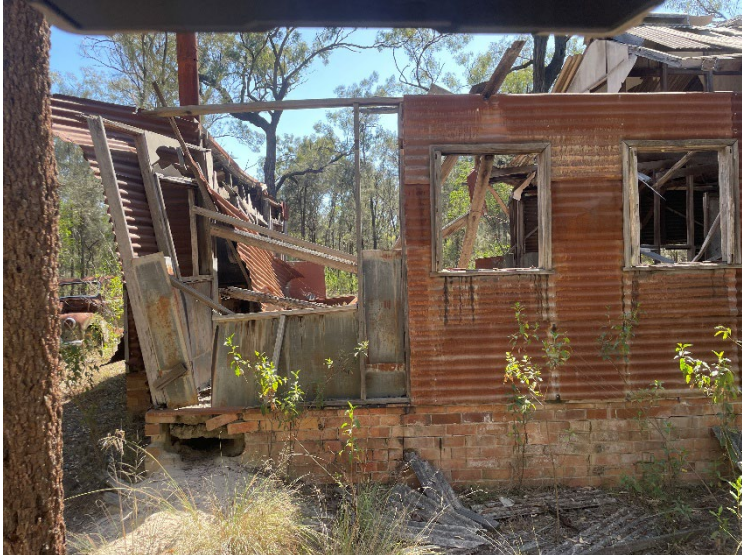
**Detail of north-west elevation**

- 2012-18: shows increased collapse over open kitchen area, as well as new damage to brick foundation at north-west corner.
- 2018-20 (Mar): shows fallen top of north wall plus increased (animal?) damage to brick foundation at north-western corner.
- Mar 2020 – Dec 2020: no discernible change.
- Dec 2020 – 2021: detachment of north wall from western beam.
- 2021-2022: no discernible change
- 2022-2023: some internal timbers have fallen further.
- 2023-2024: no discernible change.
- 2024-2025: further collapse of interior members; northern wall slumping out.

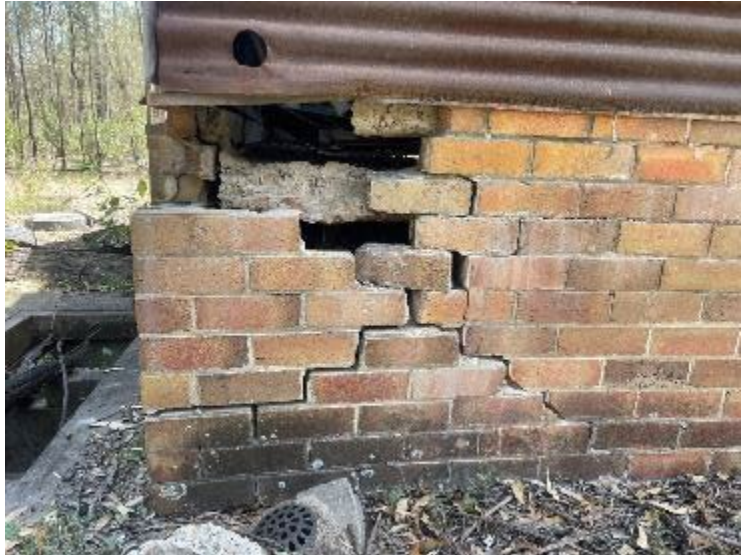
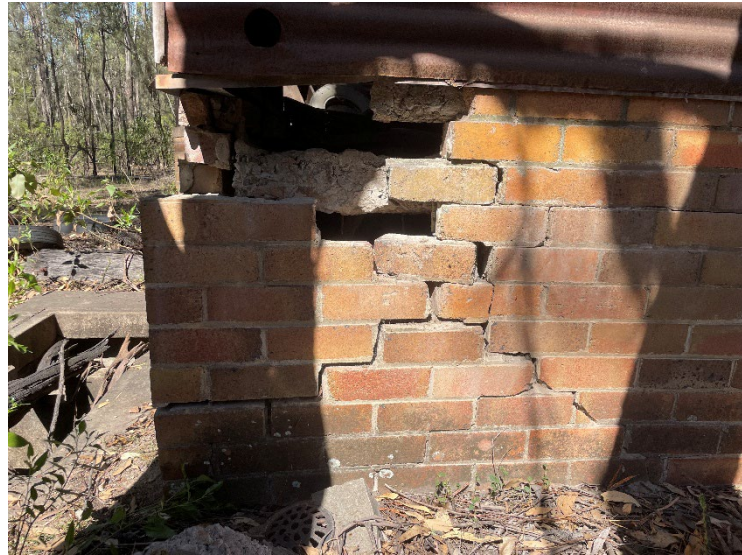
#### Detail of damaged brick foundation (east view)

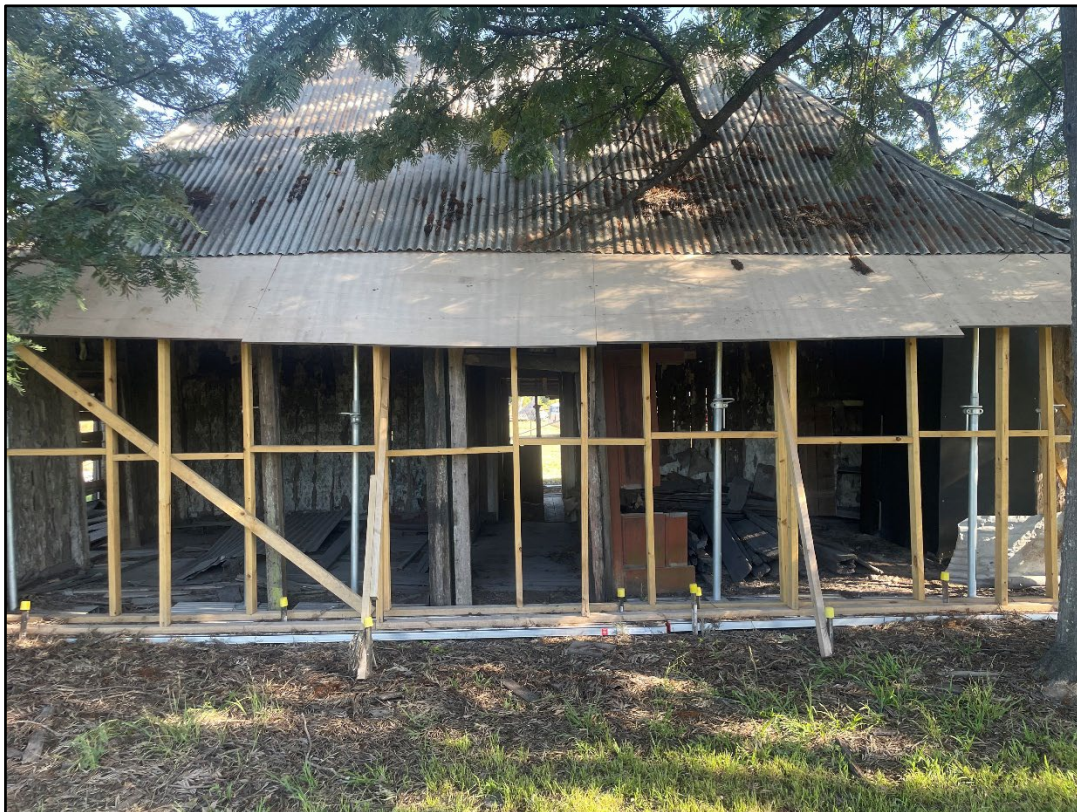
***Recent temporary roof extension and supporting framework installed along southern elevation within the last 12 months***

- Pruning of the tree impacting the eastern elevation
- Clearing and stacking of all historic items of building fabric that have previously collapsed, fallen or have otherwise been arrayed across the site
- Strapping and propping of eastern edge beam as well as propping of internal roofing rafters along this section
- Installation of supporting framework under the southern elevation roof line
- Cladding and propping of sandstone chimney
- Northern veranda edge beam propped
- Temporary roof extension installed at southern elevation. Extension is diverting roof runoff away from rear of building and protecting exposed shingles.

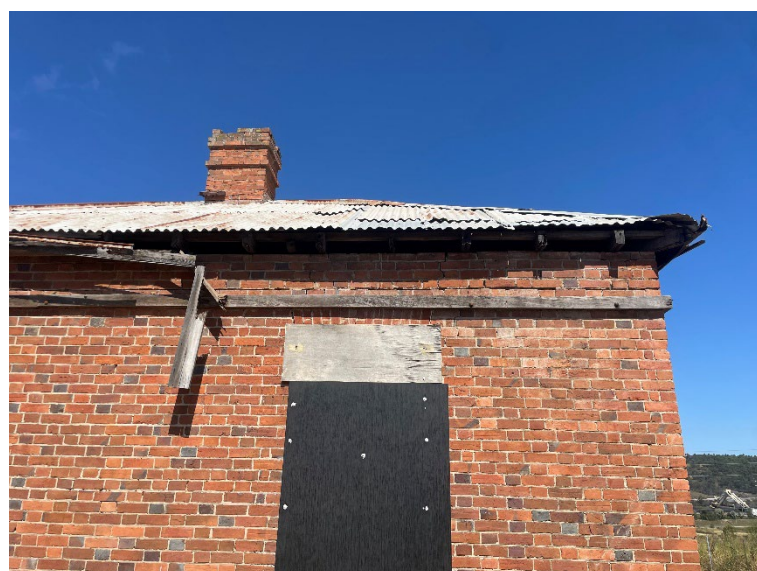
#### View of north-west roof corner (focus on damaged roof)

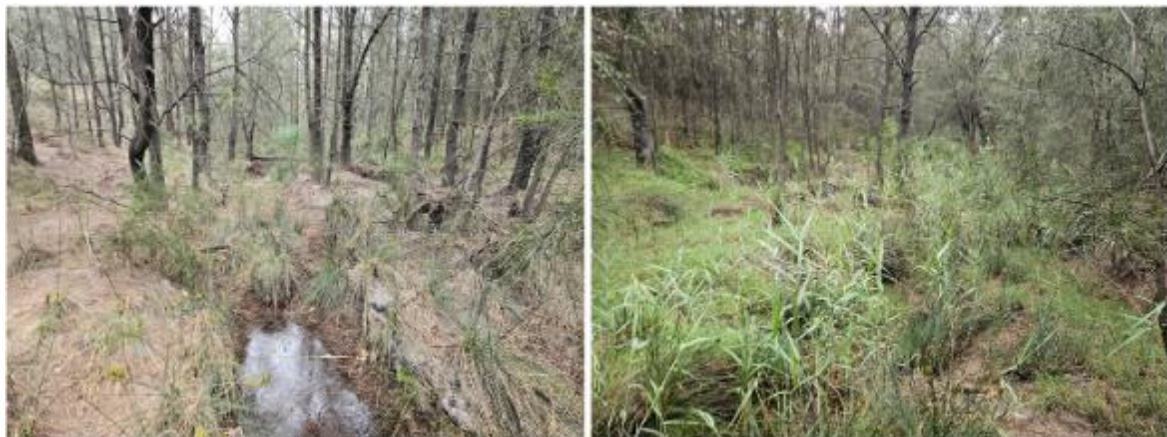
The exposed erosion scar along the upper southern (right hand) bank (**Figure 7**) is unchanged but continues to act as a source of active erosion. Along with animal tracks dissecting the site, this feature contributes fine sediment inputs to the creek line. The extent of settled colluvial sediments at the base of the channel valley walls and colonisation by couch grass noted in previous reports remained unchanged in 2025.

**Figure 5:** Loder Creek site BM35 looking upstream (left) and downstream (right).

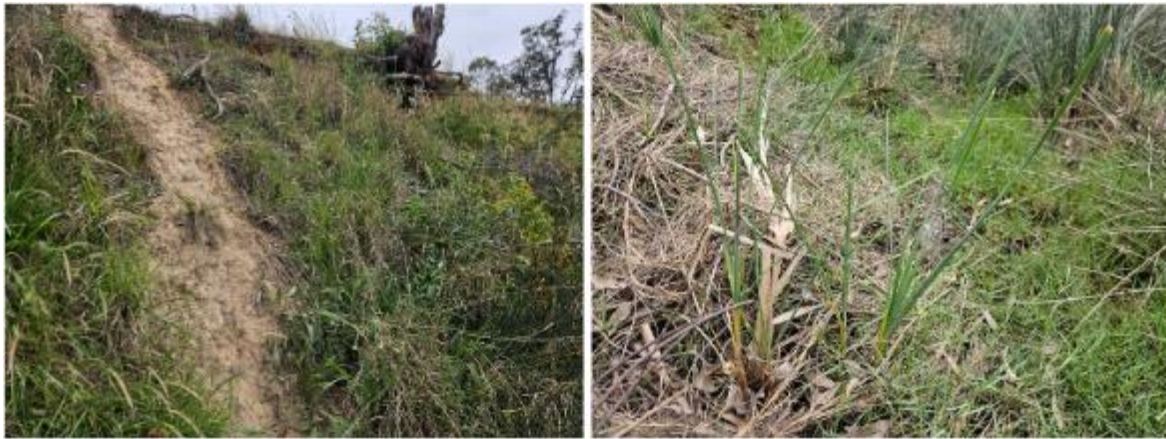
Riparian vegetation showed strong growth and vigour, maintaining a healthy and thriving conditions throughout the site. Pre-existing erosion features along the upper left bank remained stable, with compacted sands continuing to be the dominant exposed sediment type. There was no evidence of increased sediment loss from historical scars or any significant contribution of fine material to the channel bed. A small, recently formed erosion scar was observed along the left bank, contributing a minor amount of sediment (**Figure 21**).

**Figure 21:** Animal tracks and active erosion blocked via felled trees.

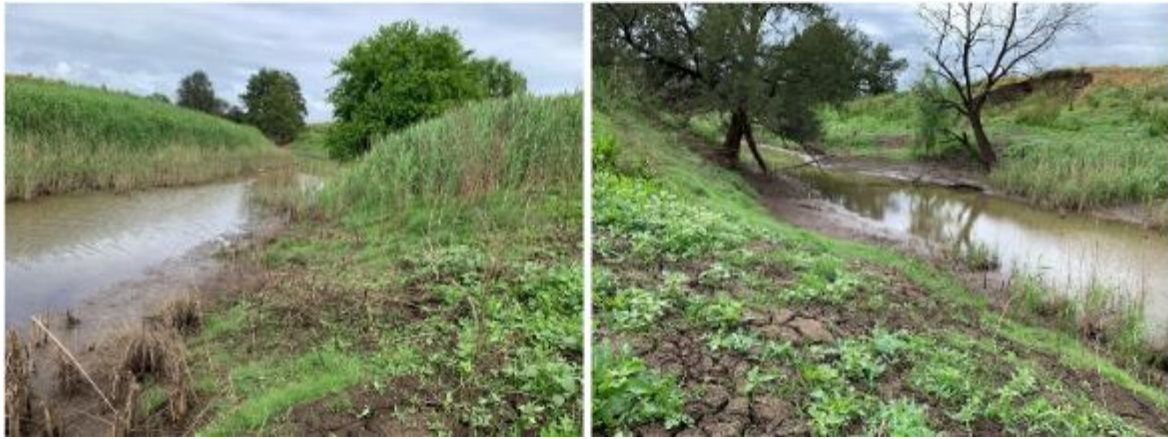
The LC16 channel is considered highly susceptible to flood-driven scouring and potential exacerbation of existing erosion, largely due to the absence of a well-developed wooded riparian corridor. Site conditions showed no substantial change in 2025, and accordingly, the CSIRO ESA rating for LC16 remained classified as *Active*.

**Figure 47:** Looking upstream (left) and downstream (right) at site LC16 in 2025.
