# Mount Thorley Warkworth Aboriginal Heritage Management Plan 2020 Compliance Audit Inspection

Report prepared for  
Yancoal Australia, Mount Thorley Warkworth

February 2021

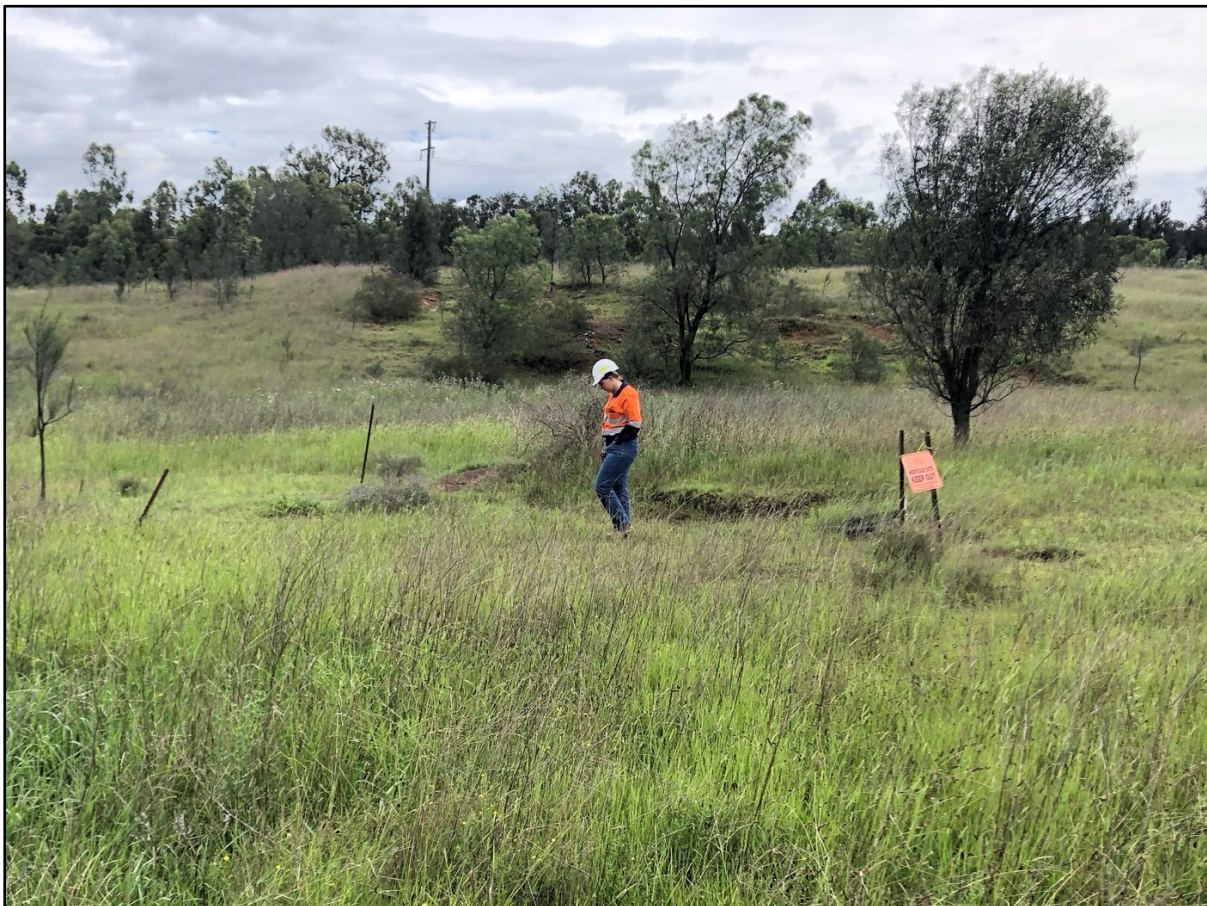
| Site Name | Date | Mine | Site re-identified? | Site intact? | Site fenced/barricaded? | Fencing/barricading intact? | Natural erosion | Livestock damage | Human disturbance | Animal disturbance | Pests & weeds | General observations | Management recommendations |
|---|---|---|---|---|---|---|---|---|---|---|---|---|---|
| MTW-506 | 22/12/20 | WML | Yes | Yes | Yes | No | Yes | No | No | No | No | Within WBACHCA | Rebarricade site |

***Example of dilapidated barricading (at MTW-506)***

As a general observation, most of the barricading, where installed at ACH sites, was in a good state of repair. Some new barricading has been recommended as a protective measure for sites located in proximity to access or activity areas. Barricading should consist of hi-vis string line and signage delineating the area as an ACH site to be avoided.

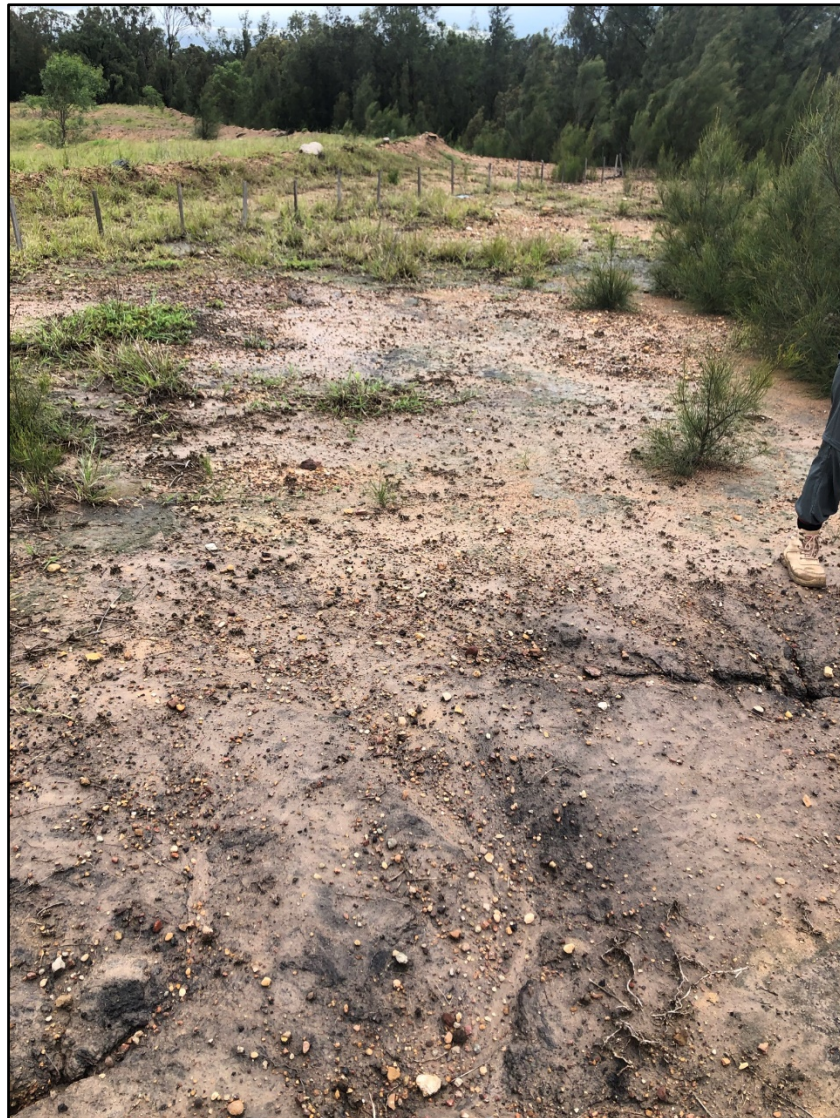
| Site Name | Date | Mine | Site re-identified? | Site intact? | Site fenced/barricaded? | Fencing/barricading intact? | Natural erosion | Livestock damage | Human disturbance | Animal disturbance | Pests & weeds | General observations | Management recommendations |
|---|---|---|---|---|---|---|---|---|---|---|---|---|---|
| MTW-548 | 22/12/20 | MTO | No | Yes | No | - | Sheet wash | No | Dam construction | No | No | AHIP is in place over area. Site was recorded after dam construction | Consider salvaging site to prevent loss through erosion |

The two sites located at Mount Thorley (MTW-547 and 548) are located on the banks of Loders Creek and are at risk of being washed away by sheet wash and erosion. Their condition should be discussed with the CHWG with a view to salvaging them prior to them being lost to erosion.

***Sheet wash erosion at MTW-548***

There are a number of sites that are located within future planned disturbance areas or are already in close proximity to work areas. These sites should be salvaged prior to works in the area to prevent inadvertent disturbance. There were no objections raised to this recommendation by the RAPs in the field, and further planning and salvage should be done in conjunction with the CHWG.

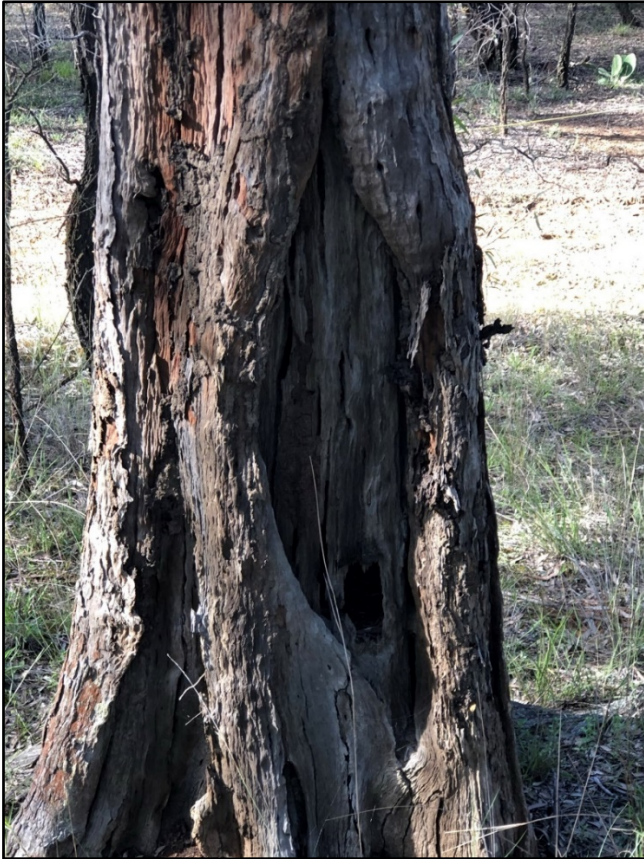
**Scarred tree MTW-8**

| Site Name | Date | Mine | Site re-identified? | Site intact? | Site fenced/barricaded? | Fencing/barricading intact? | Natural erosion | Livestock damage | Human disturbance | Animal disturbance | Pests & weeds | General observations | Management recommendations |
|---|---|---|---|---|---|---|---|---|---|---|---|---|---|
| MTW-8 | 23/12/20 | WML | Yes | Yes | Yes | Yes | No | No | No | No | No | Scarred tree in very deteriorated state. Track has been diverted as avoidance buffer | Relocation to be attempted in consultation with CHWG |

Four scarred trees are located within the approved future mining area at MTW. With the exception of MTW-70, these trees have been assessed by an arborist regarding the best method of removal and relocation. MTW-70 should also be assessed for removal and relocation. These scarred trees have been visited by RAPs during this compliance inspection and during other inspections and assessments. Their removal and the arborist's plans should be discussed with the CHWG, as well as the location to where they will be relocated – the WBACHCA has been suggested. The three dead trees (MTW-8, 70 and 523) are in a poor condition however and may not be able to be successfully relocated.

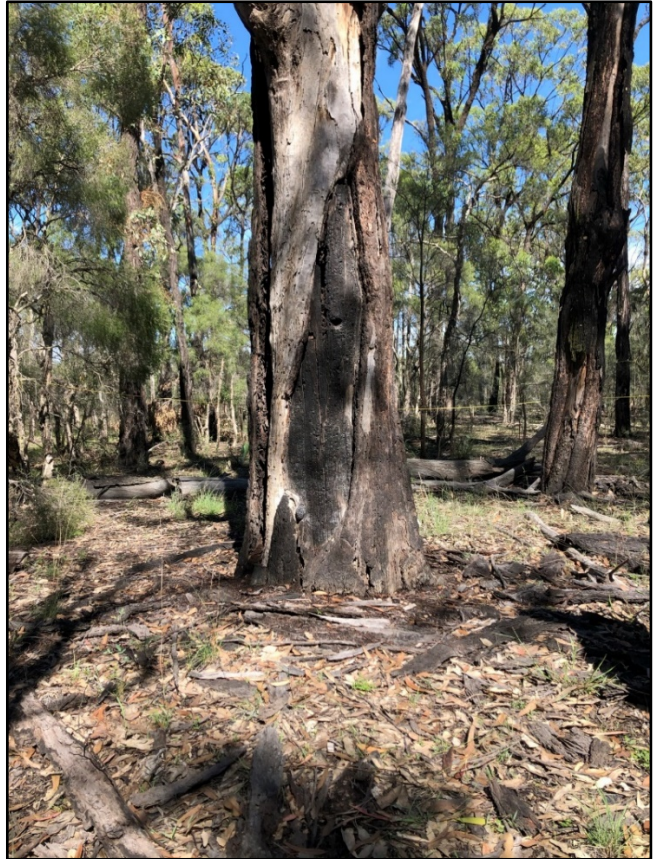
**Scarred tree MTW-70**

| Site Name | Date | Mine | Site re-identified? | Site intact? | Site fenced/barricaded? | Fencing/barricading intact? | Natural erosion | Livestock damage | Human disturbance | Animal disturbance | Pests & weeds | General observations | Management recommendations |
|---|---|---|---|---|---|---|---|---|---|---|---|---|---|
| MTW-70 | 23/12/20 | WML | Yes | Yes | Yes | Yes | No | No | No | No | No | - | Have arborist assess for removal options |

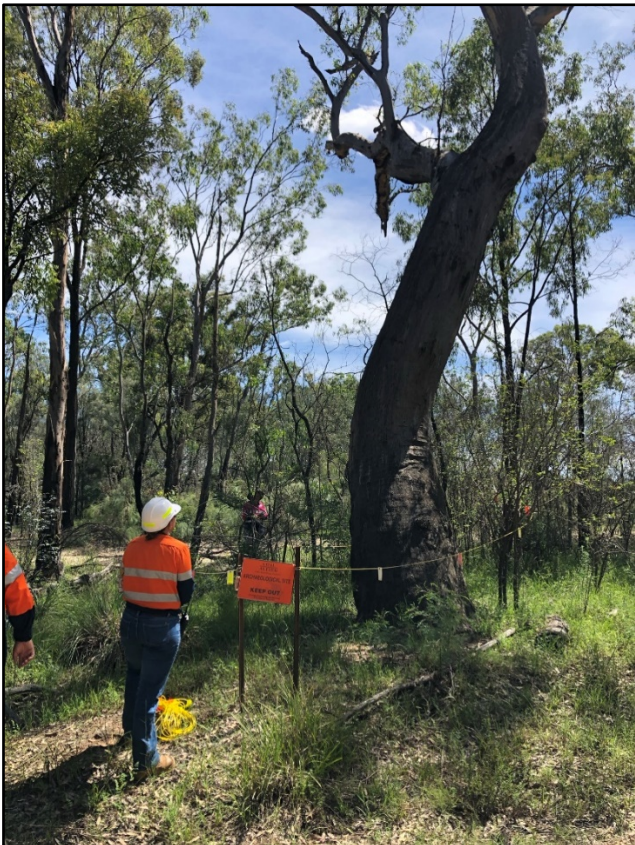
**Scarred tree MTW-80**

| Site Name | Date | Mine | Site re-identified? | Site intact? | Site fenced/barricaded? | Fencing/barricading intact? | Natural erosion | Livestock damage | Human disturbance | Animal disturbance | Pests & weeds | General observations | Management recommendations |
|---|---|---|---|---|---|---|---|---|---|---|---|---|---|
| MTW-80 | 23/12/20 | WML | Yes | Yes | Yes | Yes | No | No | No | No | No | Tree in good health | Relocate in consultation with CHWG |

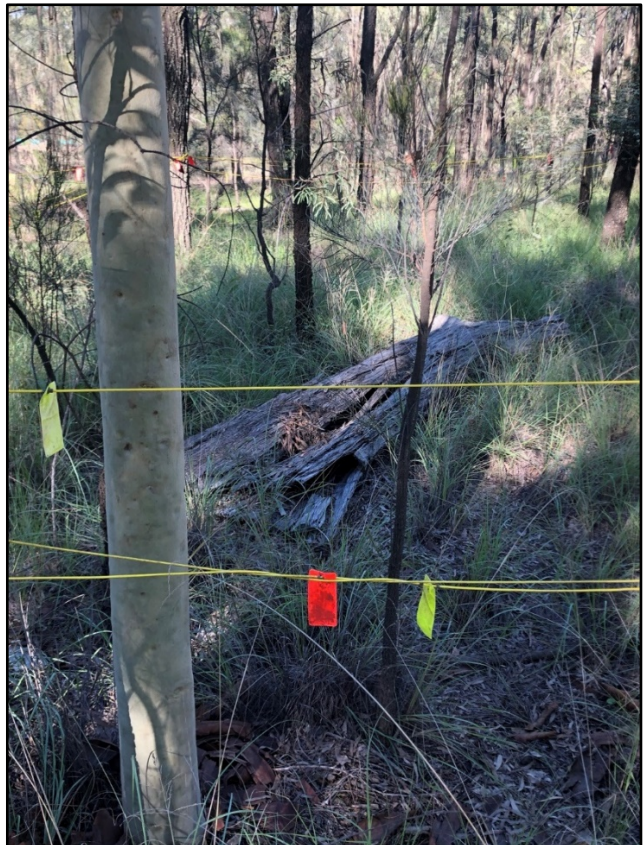
**Scarred tree MTW-523**

| Site Name | Date | Mine | Site re-identified? | Site intact? | Site fenced/barricaded? | Fencing/barricading intact? | Natural erosion | Livestock damage | Human disturbance | Animal disturbance | Pests & weeds | General observations | Management recommendations |
|---|---|---|---|---|---|---|---|---|---|---|---|---|---|
| MTW-523 | 23/12/20 | WML | Yes | Yes | Yes | Yes | No | No | No | No | No | Fallen scarred tree in very deteriorated state | Relocation to be attempted in consultation with CHWG |
