# Mount Thorley Warkworth Historic Heritage Management Plan 2020 Compliance Audit Inspection

Report prepared for

Yancoal Australia, Mount Thorley Warkworth

January 2021

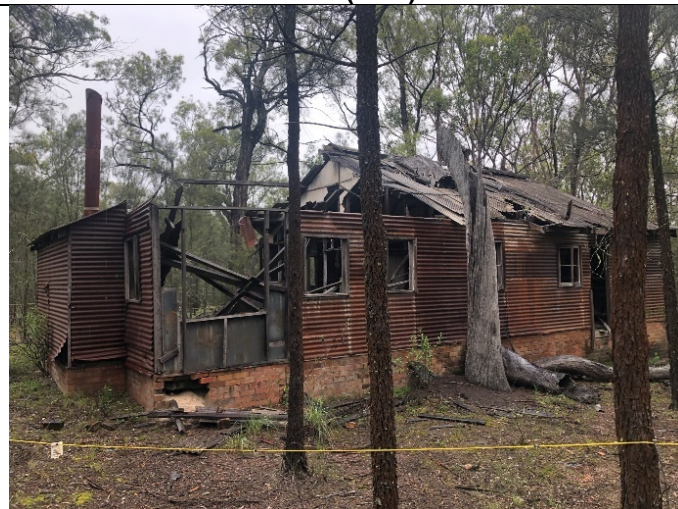
| 2012 | 2018 | 2020 (Mar) | 2020 (Dec) |
|---|---|---|---|
| <b>West elevation</b><br><b>2012-18:</b> shows deterioration of roofing members above open kitchen area and leaning north wall, and further collapse of asbestos roof due to fallen dead tree.<br><b>2018-20 (Mar):</b> top of north wall now collapsed, further damage to roof with branch now fallen to ground.<br><b>Mar 2020 – Dec 2020:</b> no discernible change. | | | |

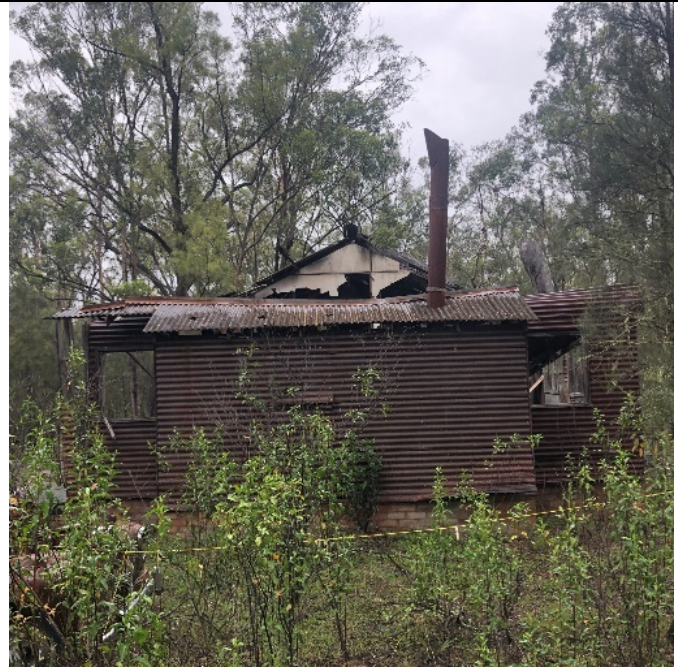
| 2012 | 2018 | 2020 (Mar) | 2020 (Dec) |
|---|---|---|---|
| <b>North elevation</b><br><b>2012-18:</b> no discernible change.<br><b>2018-20 (Mar):</b> top of north wall now collapsed.<br><b>Mar 2020 – Dec 2020:</b> no discernible change. | | | |

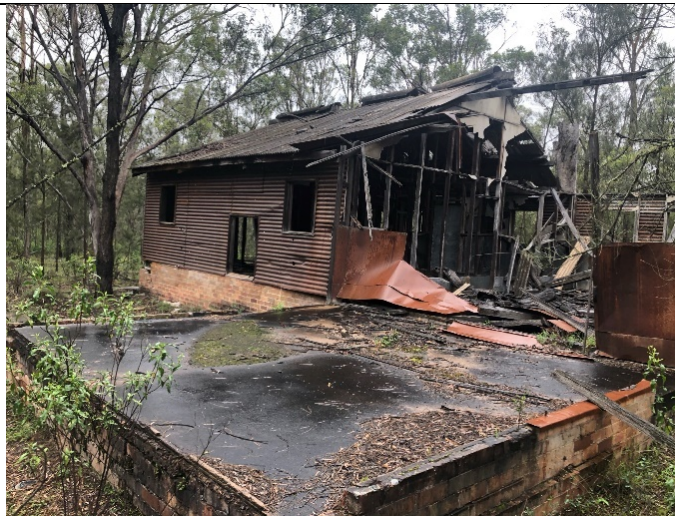
| 2012 | 2018 | 2020 (Mar) | 2020 (Dec) |
|---|---|---|---|
| <b>Concrete and brick foundation at east side of building</b><br><b>2012-18:</b> difficult to discern change.<br><b>2018-20 (Mar):</b> no discernible change.<br><b>Mar 2020 – Dec 2020:</b> no discernible change. | | | |

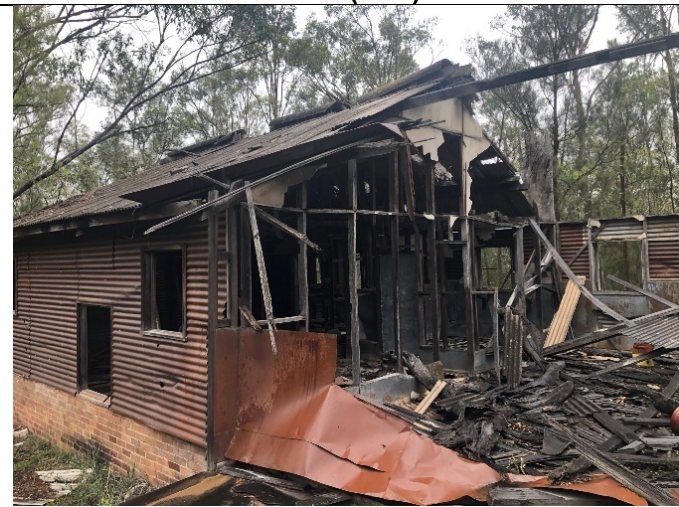
| 2012 | 2018 | 2020 (Mar) | 2020 (Dec) |
|---|---|---|---|
| <p><b>View to building interior from north-east</b><br/> <b>2012-18:</b> shows collapse of remnant roofing members above open kitchen area.<br/> <b>2018-20 (Mar):</b> further minor deterioration of asbestos sheeting panelling.<br/> <b>Mar 2020 – Dec 2020:</b> no discernible change.</p> | | | |

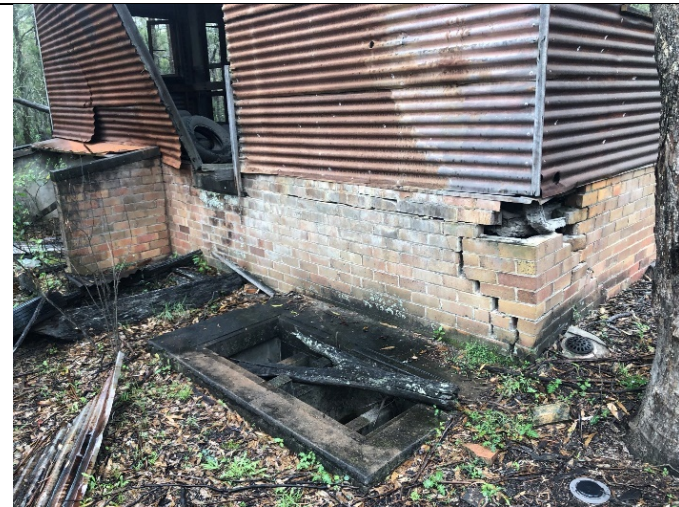
| 2012 | 2018 | 2020 (Mar) | 2020 (Dec) |
|---|---|---|---|
| <p><b>Grease trap at south end of building</b><br/> <b>2012-18:</b> shows bow to south wall.<br/> <b>2018-20 (Mar):</b> shows increased bow to south wall.<br/> <b>Mar 2020 – Dec 2020:</b> shows increasing bowing of south wall, and example of new termite monitoring system in bottom right of picture.</p> | | | |

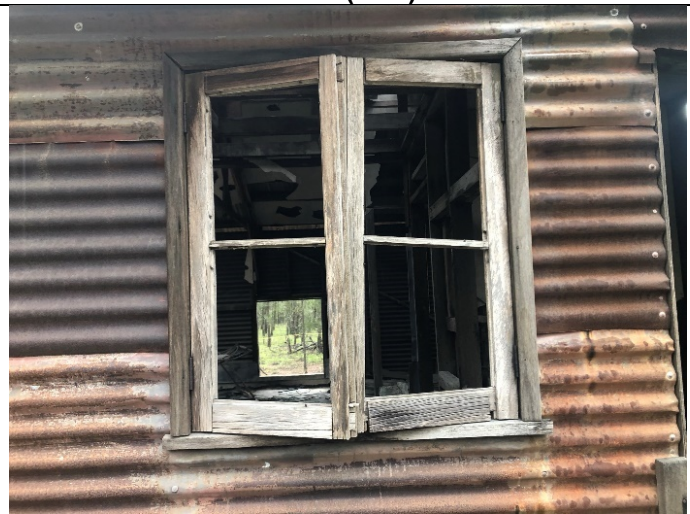
| 2012 | 2018 | 2020 (Mar) | 2020 (Dec) |
|---|---|---|---|
| <b>Timber window detail, west elevation</b><br><b>2012-18:</b> no discernible change.<br><b>2018-20 (Mar):</b> no discernible change.<br><b>Mar 2020 – Dec 2020:</b> no discernible change. | | | |

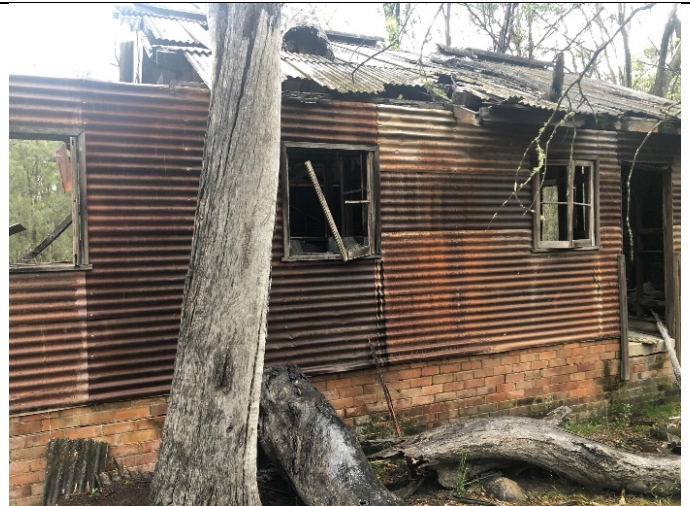
| 2012 | 2018 | 2020 (Mar) | 2020 (Dec) |
|---|---|---|---|
| <b>Showing cylindrical ventilator and damage to roof, view from west</b><br><b>2012-18:</b> shows significant roof damage from fallen dead tree, including to ventilator.<br><b>2018-20 (Mar):</b> shows increased damage to roof edge sheeting from fallen branch.<br><b>Mar 2020 – Dec 2020:</b> no discernible change. | | | |

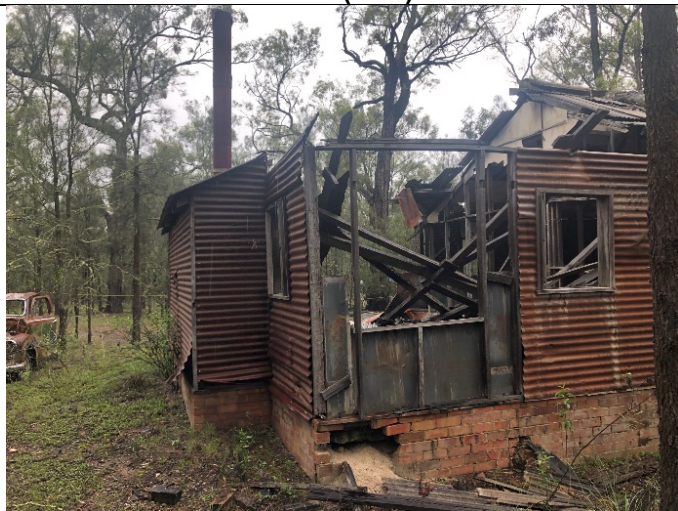
| 2012 | 2018 | 2020 (Mar) | 2020 (Dec) |
|---|---|---|---|
| <p><b>Detail of north-west elevation</b><br/> <b>2012-18:</b> shows increased collapse over open kitchen area, as well as new damage to brick foundation at north-west corner.<br/> <b>2018-20 (Mar):</b> shows fallen top of north wall plus increased (animal?) damage to brick foundation at north-western corner.<br/> <b>Mar 2020 – Dec 2020:</b> no discernible change.</p> | | | |

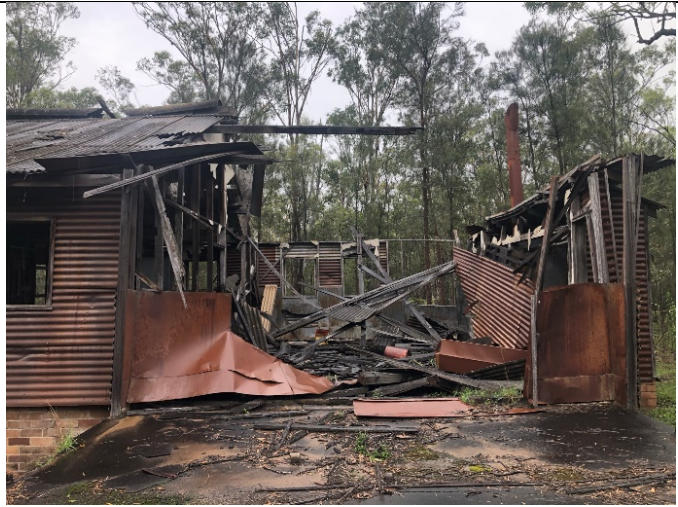
| 2012 | 2018 | 2020 (Mar) | 2020 (Dec) |
|---|---|---|---|
| <p><b>Showing interior damage at kitchen at north end of building</b><br/> <b>2012-18:</b> shows increased collapse over and accumulation of debris within open kitchen area. Note also severe lean to north wall.<br/> <b>2018-20 (Mar):</b> shows collapsed top of north wall and collapse of remaining full cross-beam.<br/> <b>Mar 2020 – Dec 2020:</b> no discernible change.</p> | | | |

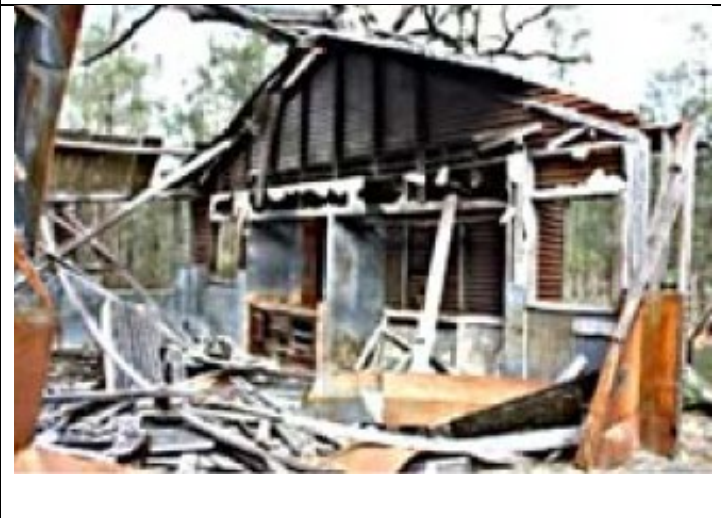
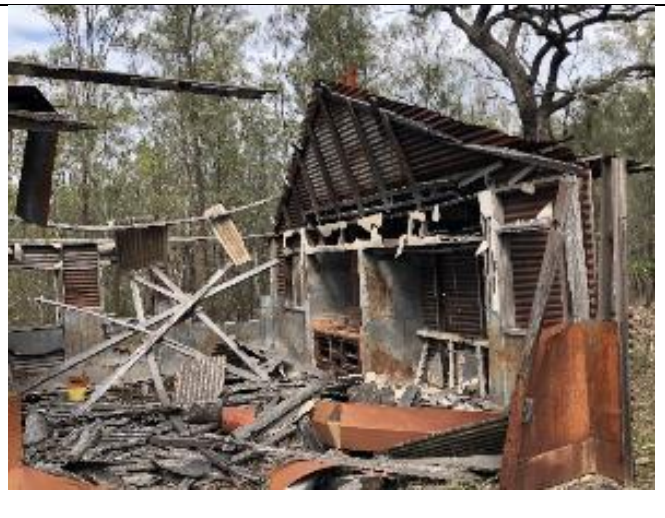
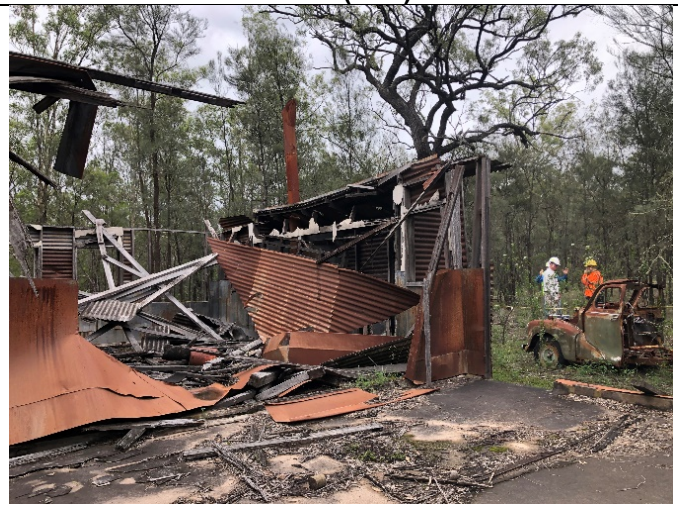
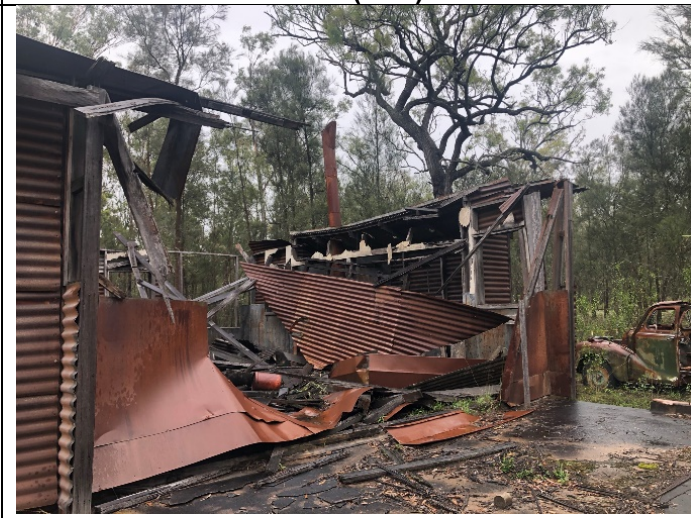
| 2012 | 2018 | 2020 (Mar) | 2020 (Dec) |
|---|---|---|---|
| <p><b>Showing interior damage at kitchen at north end of building</b><br/> <b>2012-18:</b> shows increased collapse over and accumulation of debris within open kitchen area. Note also severe lean to north wall.<br/> <b>2018-20 (Mar):</b> shows collapsed top of north wall and collapse of remaining full cross-beam.<br/> <b>Mar 2020 – Dec 2020:</b> no discernible change.</p> | | | |

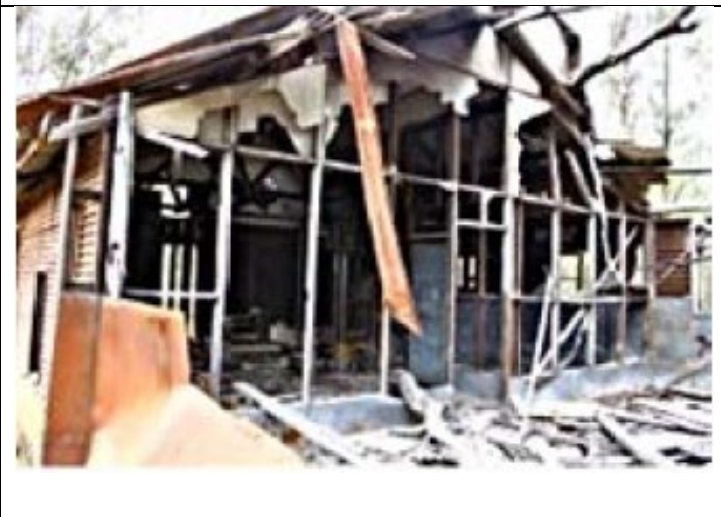
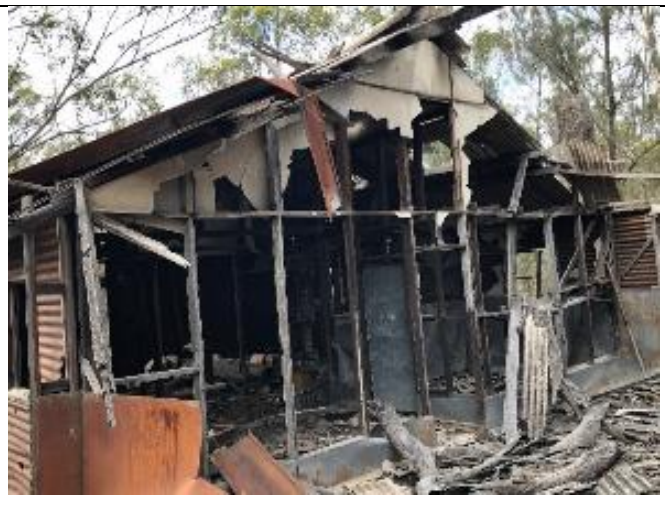
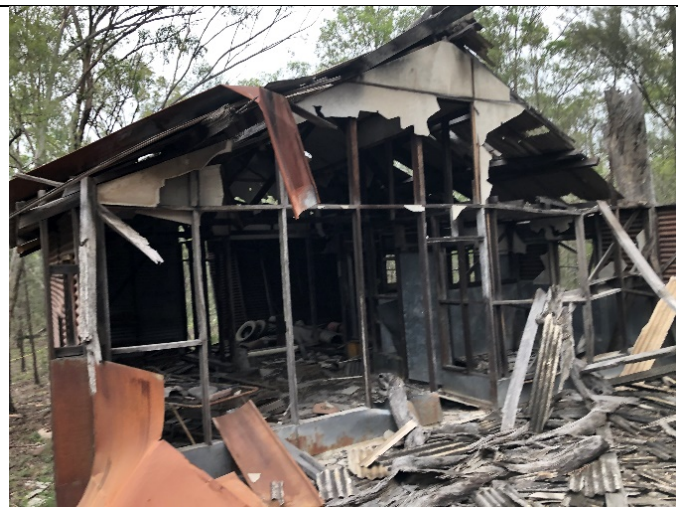
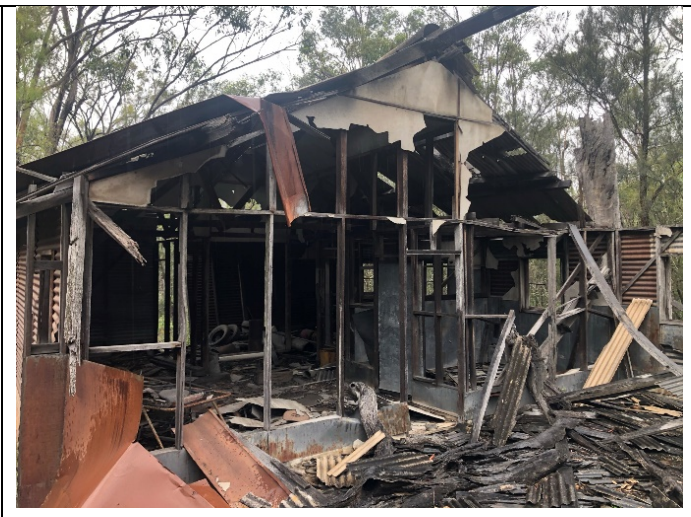
| 2012 | 2018 | 2020 (Mar) | 2020 (Dec) |
|---|---|---|---|
| <p><b>View to interior of south end of building, view from east</b><br/> <b>2012-18:</b> shows increased collapse over open kitchen area.<br/> <b>2018-20 (Mar):</b> shows further minor deterioration of asbestos panelling.<br/> <b>Mar 2020 – Dec 2020:</b> no discernible change.</p> | | | |

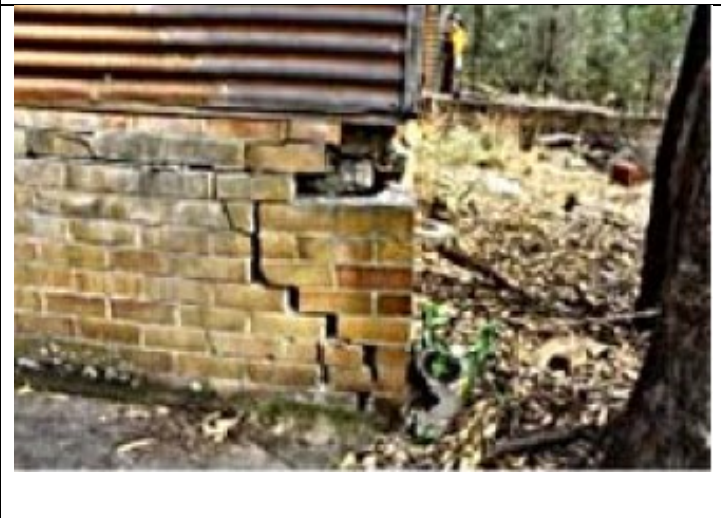
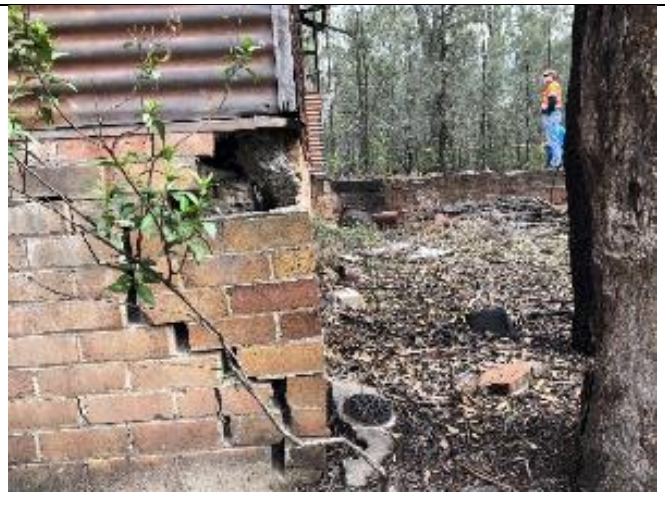
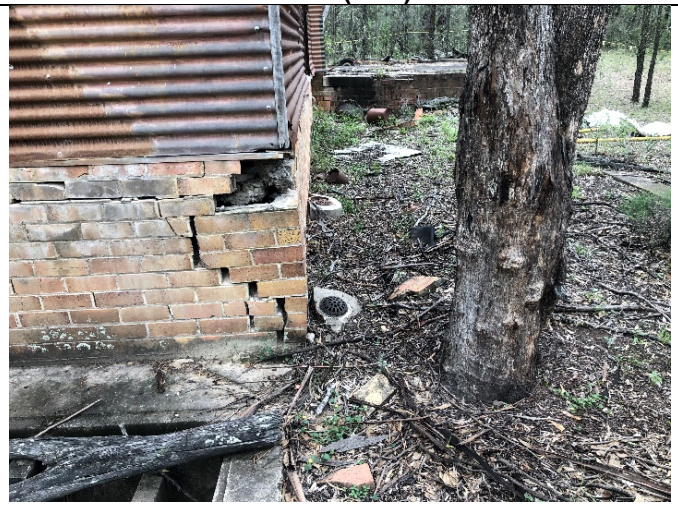
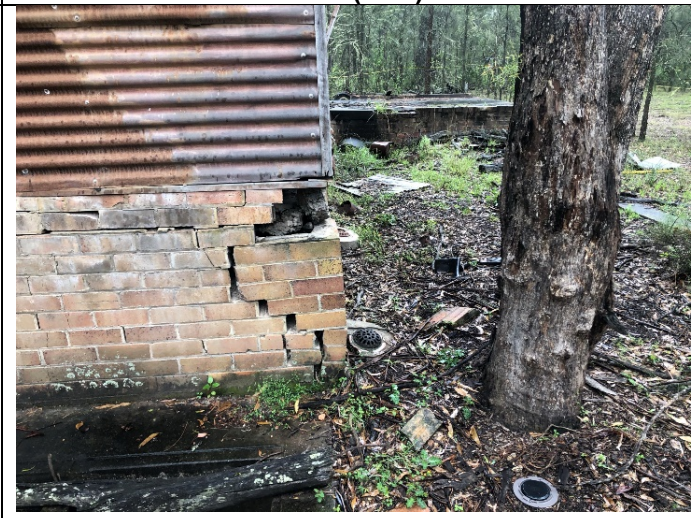
| 2012 | 2018 | 2020 (Mar) | 2020 (Dec) |
|---|---|---|---|
| <p><b>Damaged brick foundation at south-east corner</b><br/> <b>2012-18:</b> no discernible increase to cracked brick foundation.<br/> <b>2018-20 (Mar):</b> further cracking of foundation (to left of shot) and some slumping of corner bricks.<br/> <b>Mar 2020 – Dec 2020:</b> some slight potential further movement in cracked section (also note termite management system in bottom right hand corner of photograph).</p> | | | |

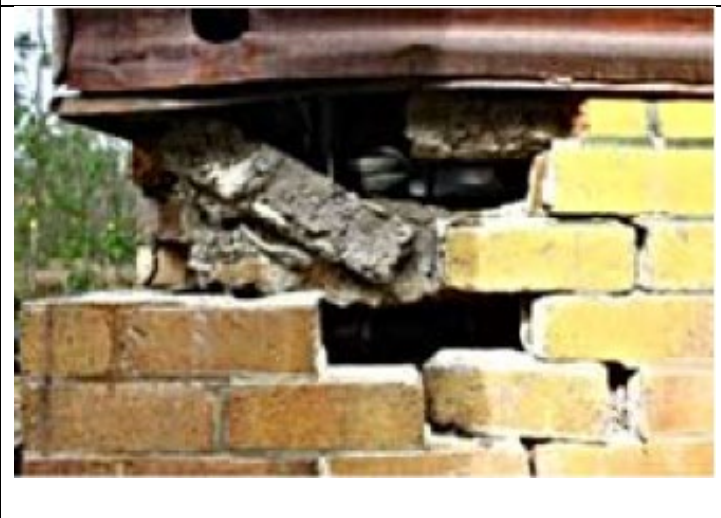
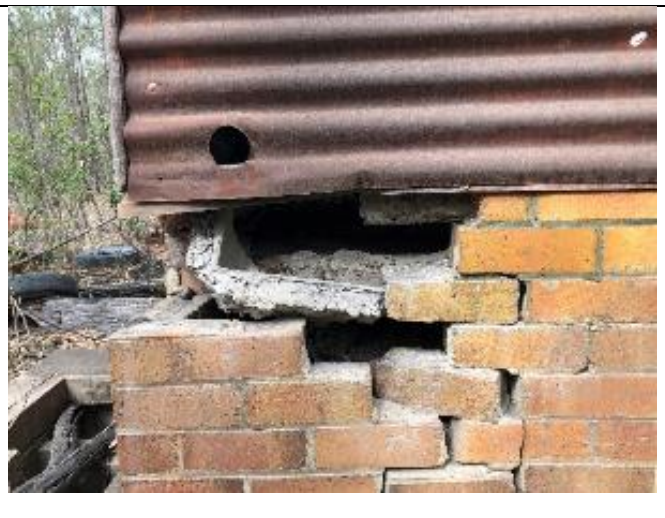
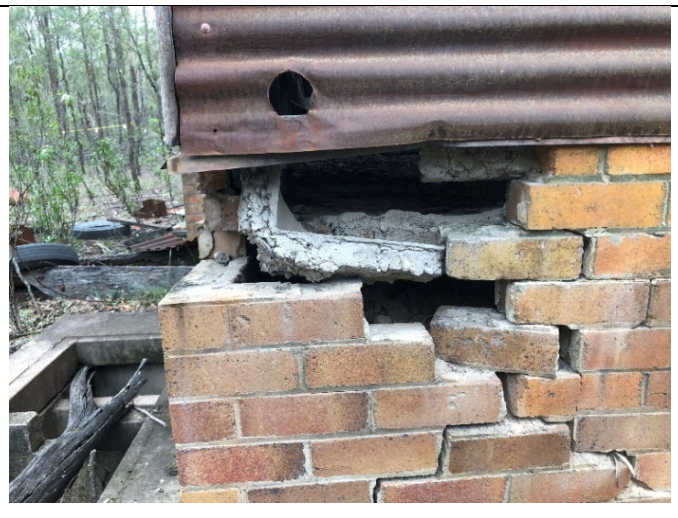
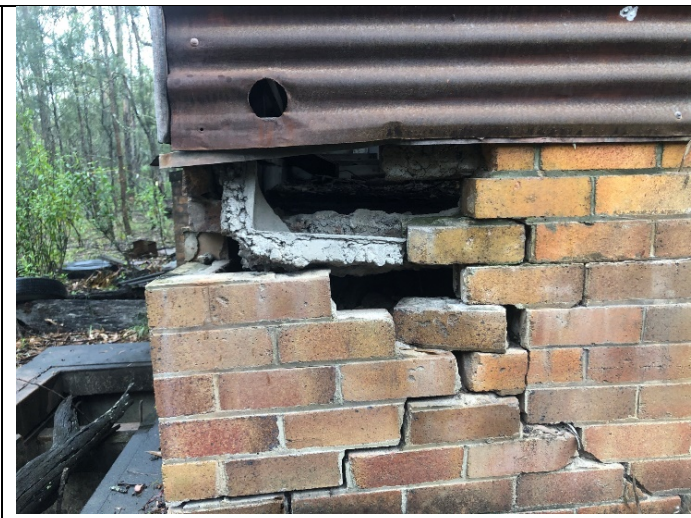
| 2012 | 2018 | 2020 (Mar) | 2020 (Dec) |
|---|---|---|---|
| <p><b>Detail of damaged brick foundation</b><br/> <b>2012-18:</b> some further collapse of concrete/cement above brick foundation.<br/> <b>2018-20 (Mar):</b> some slumping outwards of corner brick foundation.<br/> <b>Mar 2020 – Dec 2020:</b> no discernible change.</p> | | | |

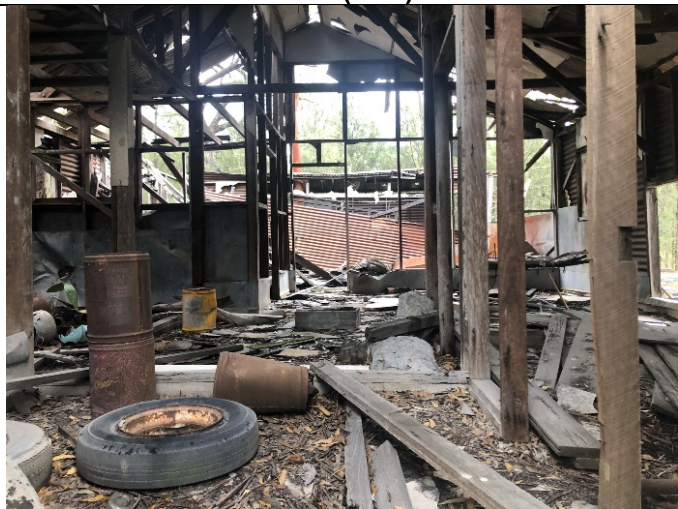
| 2012 | 2018 | 2020 (Mar) | 2020 (Dec) |
|---|---|---|---|
| <p><b>View to interior of building, looking north from south entry</b><br/> <b>2012-18:</b> no discernible change.<br/> <b>2018-20 (Mar):</b> no discernible interior change, but shows collapsed north wall.<br/> <b>Mar 2020 – Dec 2020:</b> no discernible change.</p> | | | |

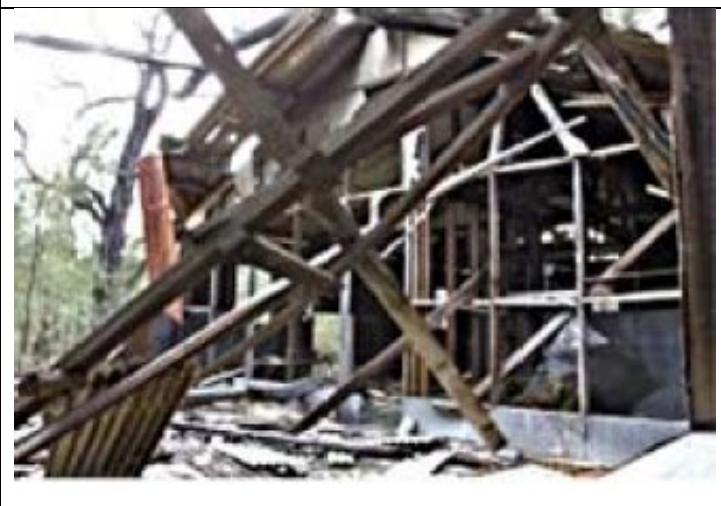
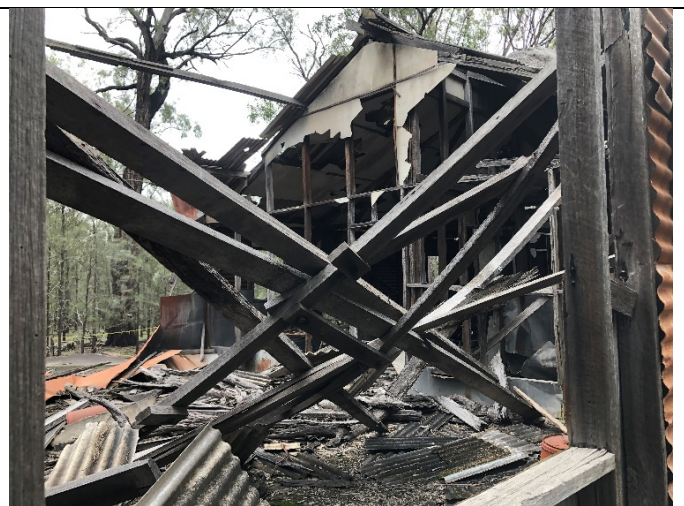
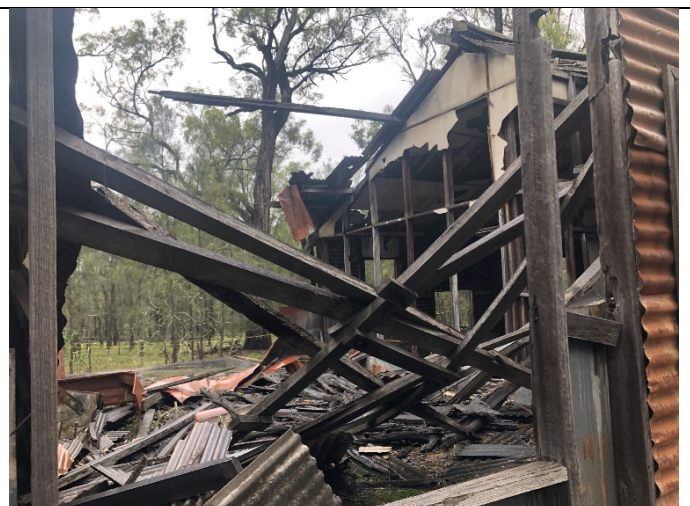
| 2012 | 2018 | 2020 (Mar) | 2020 (Dec) |
|---|---|---|---|
| <p><b>Showing interior of building, viewed from north-west corner</b><br/> <b>2012-18:</b> shows collapsed roofing members above open kitchen area and accumulation of debris.<br/> <b>2018-20 (Mar):</b> shows additional collapsed roofing member.<br/> <b>Mar 2020 – Dec 2020:</b> no discernible change.</p> | | | |

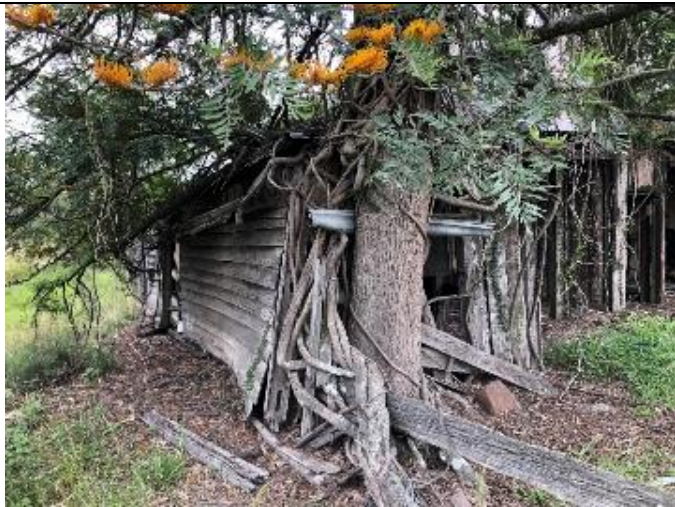
| 2014 | 2018 | 2020 (Mar) | 2020 (Dec) |
|---|---|---|---|
| <p><b>Looking towards south-west corner from south-west</b><br/><b>2014-8:</b> no discernible change to tree impact, but note missing vertical slabs from southern wall.<br/><b>2018-20 (Mar):</b> no discernible change, but vine still growing.<br/><b>Mar 2020-Dec 2020:</b> no discernible change.</p> | | | |

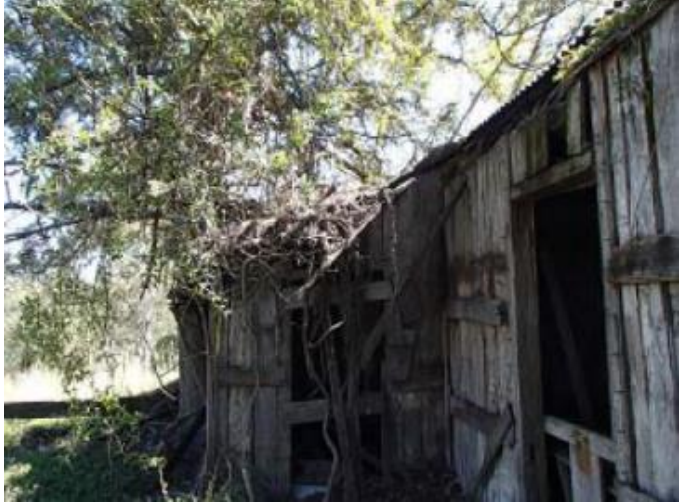
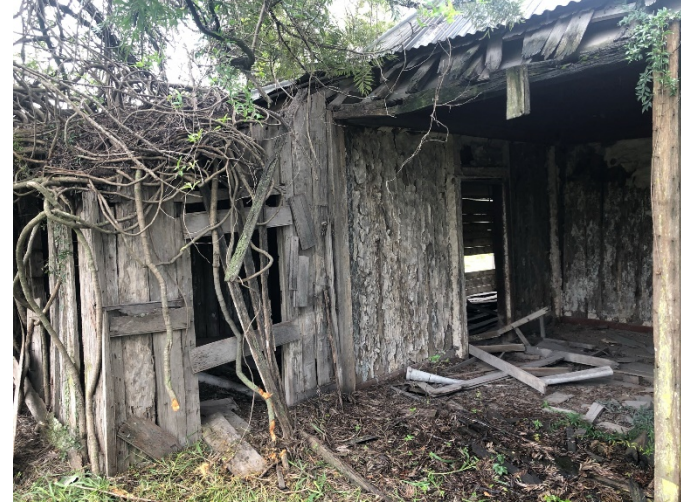
| 2014 | 2018 | 2020 (Mar) | 2020 (Dec) |
|---|---|---|---|
| <p><b>South-west corner</b><br/> <b>2014-8:</b> shows removal of vertical slabs from southern wall.<br/> <b>2018-20 (Mar):</b> no discernible change.<br/> <b>Mar 2020-Dec 2020:</b> no discernible change.</p> | | | |

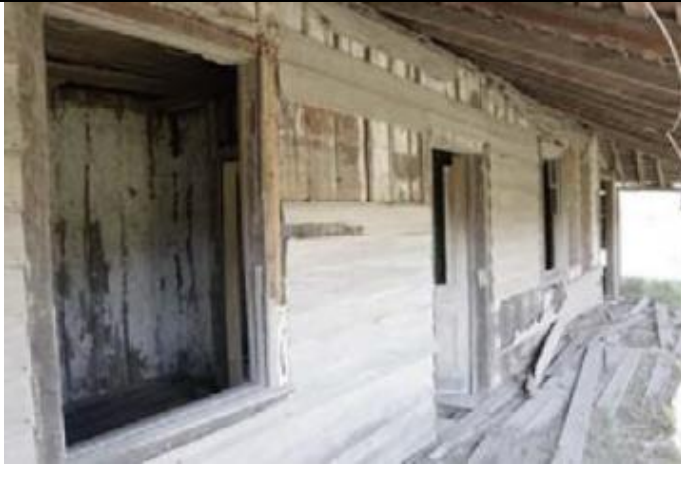
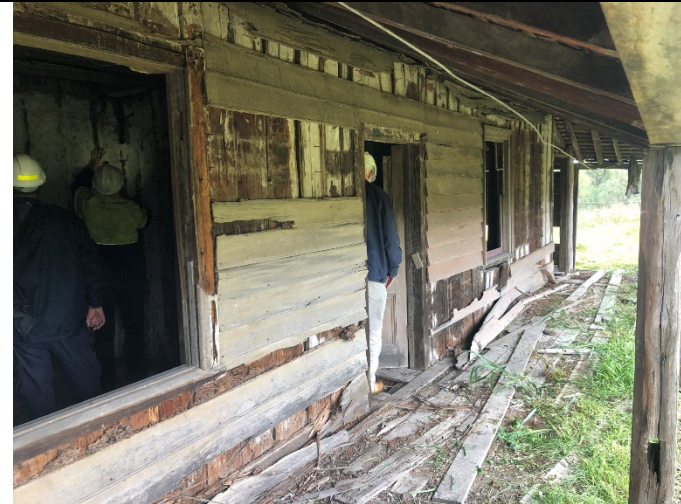
| 2014 | 2018 | 2020 (Mar) | 2020 (Dec) |
|---|---|---|---|
| <p><b>Northern elevation</b><br/> <b>2014-8:</b> further deterioration of weatherboard panelling.<br/> <b>2018-20 (Mar):</b> no discernible change, though termite activity present.<br/> <b>Mar 2020-Dec 2020:</b> grass/weed growth encroaching over verandah floor.</p> | | | |

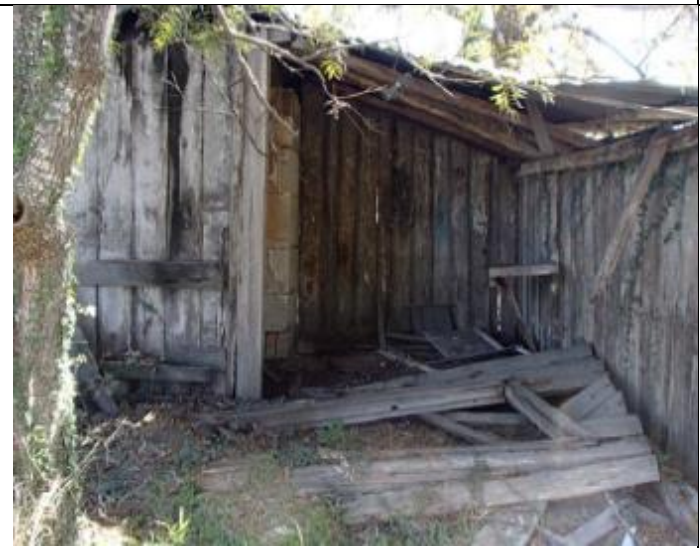
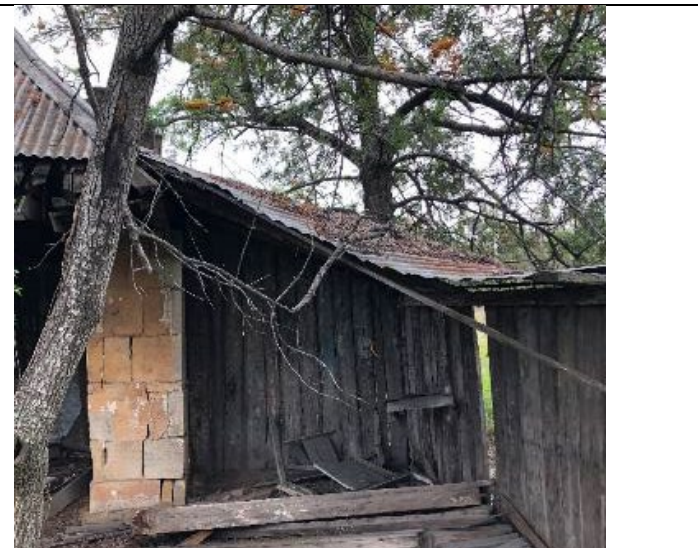
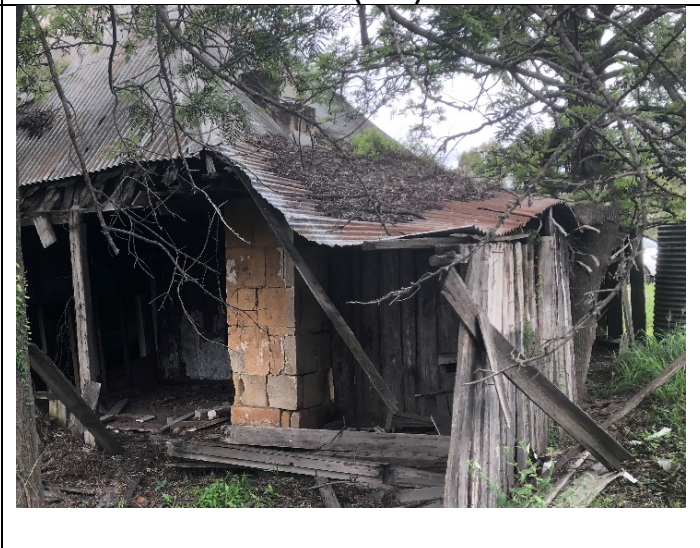
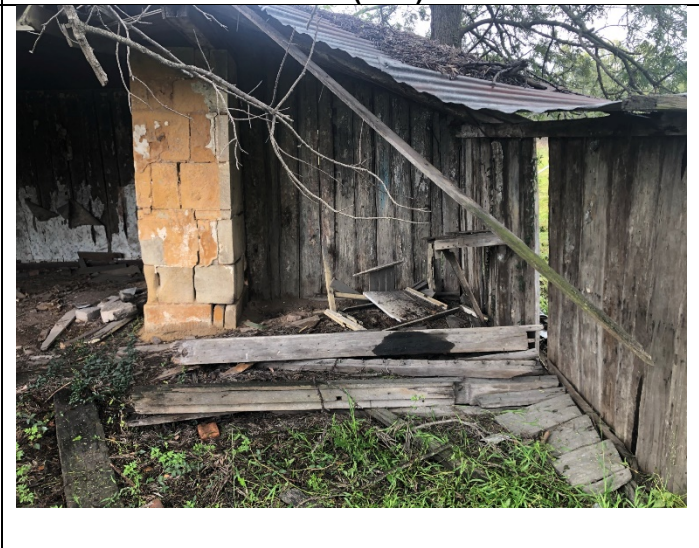
| 2014 | 2018 | 2020 (Mar) | 2020 (Dec) |
|---|---|---|---|
| <b>South-east corner</b><br><b>2014-8:</b> shows removal of vertical slabs from southern wall, and some from eastern wall, and further collapse of roof.<br><b>2018-20 (Mar):</b> further roof slumping and deterioration of eastern wall.<br><b>Mar 2020-Dec 2020:</b> no discernible change. | | | |

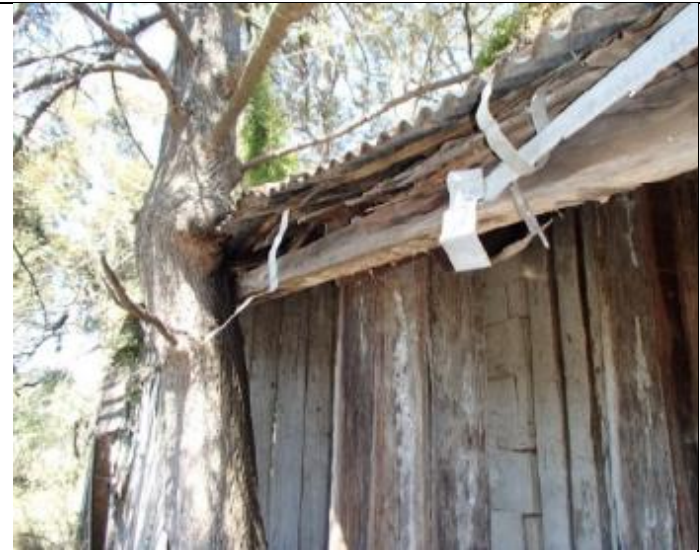
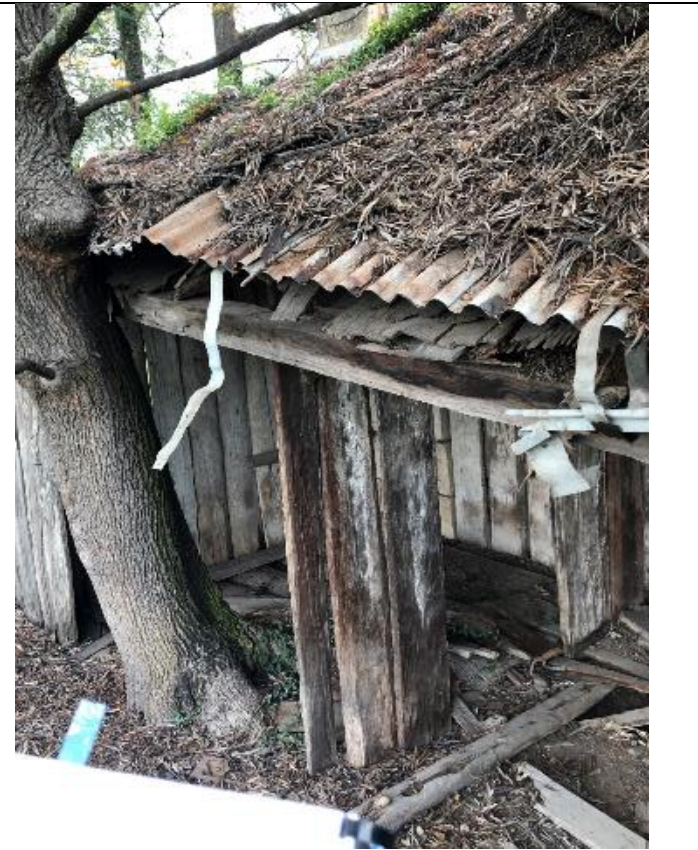
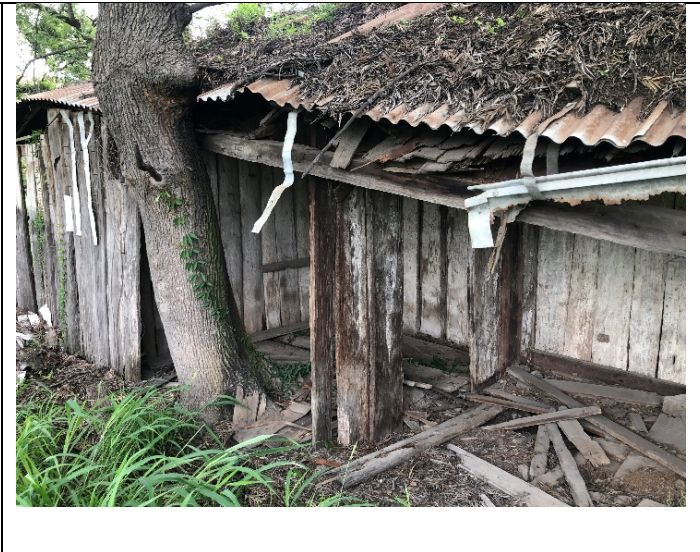
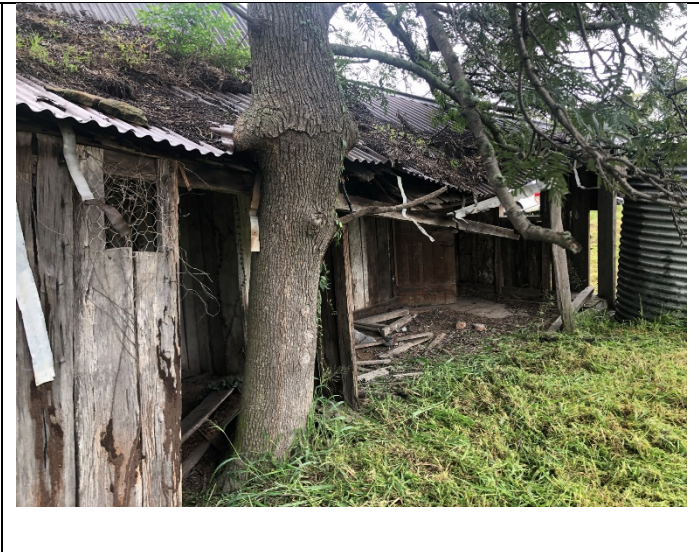
| 2014 | 2018 | 2020 (Mar) | 2020 (Dec) |
|---|---|---|---|
| <b>Eastern elevation</b><br><b>2014-8:</b> possible further collapse of crossbeam and guttering.<br><b>2018-20 (Mar):</b> tree continues to impact eastern roof line.<br><b>Mar 2020-Dec 2020:</b> increased impact on roofline by tree branches. | | | |

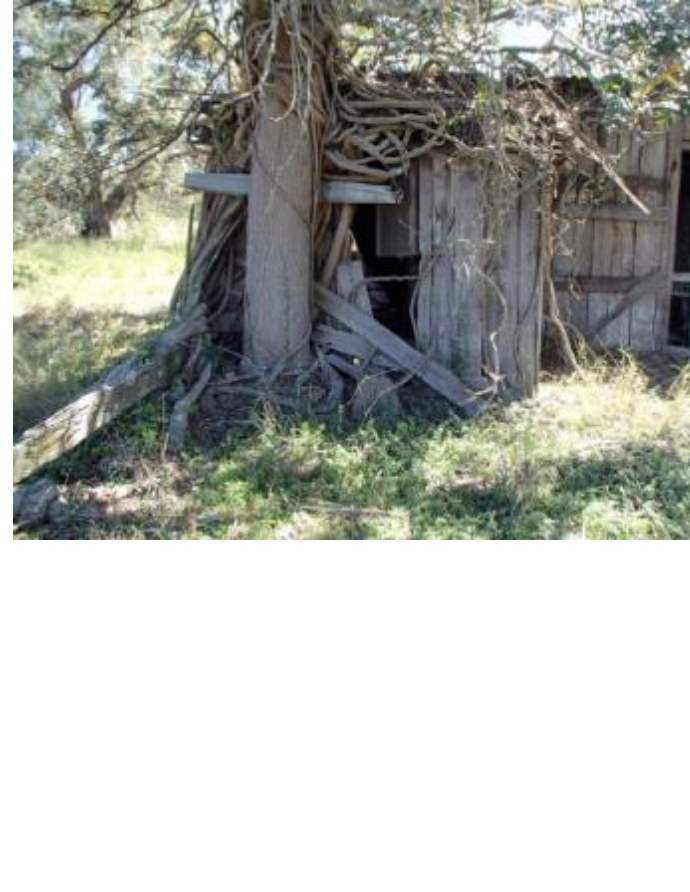
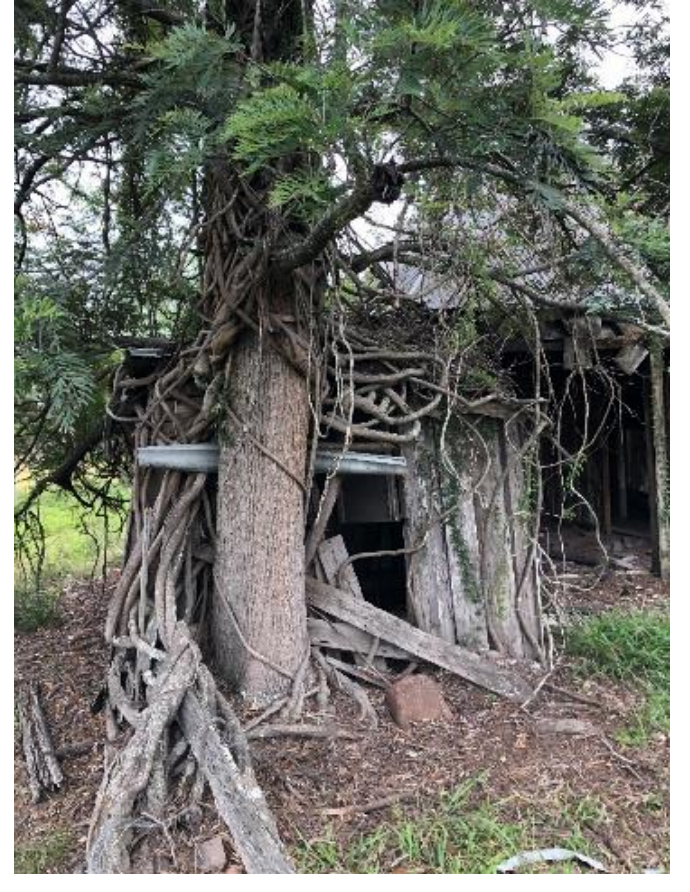
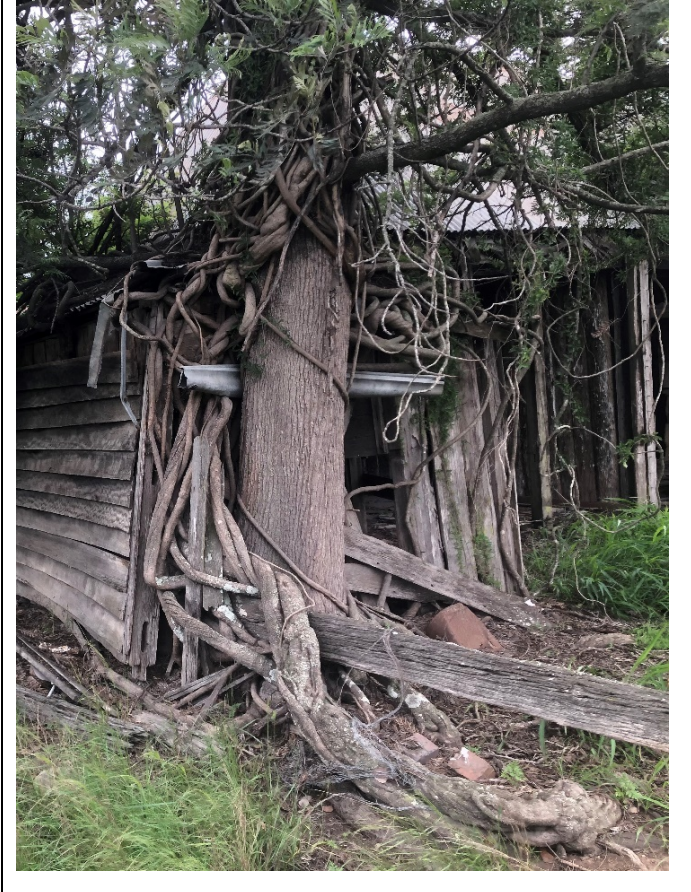
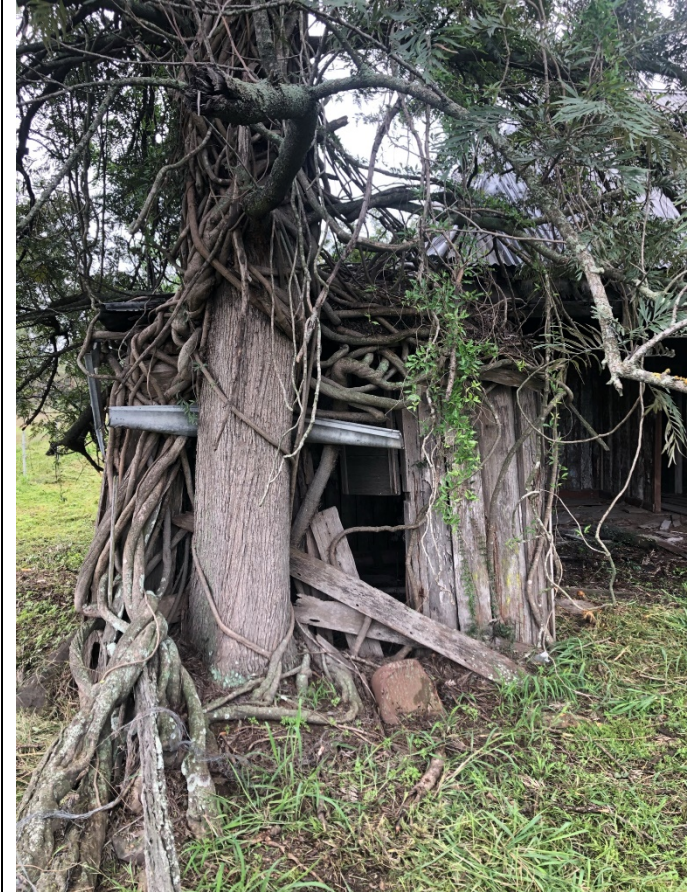
| 2014 | 2018 | 2020 (Mar) | 2020 (Dec) |
|---|---|---|---|
| <p><b>View of south-west corner from south</b><br/> <b>2014-8:</b> shows removal of vertical slabs from southern wall as well as some increase in vegetation growth.<br/> <b>2018-20 (Mar):</b> no discernible change but continuing vegetation impacts.<br/> <b>Mar 2020-Dec 2020:</b> Apparent increased vine growth.</p> | | | |

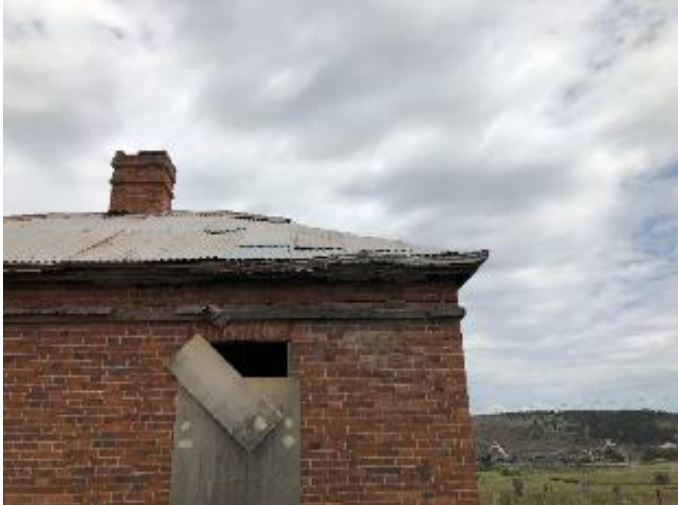
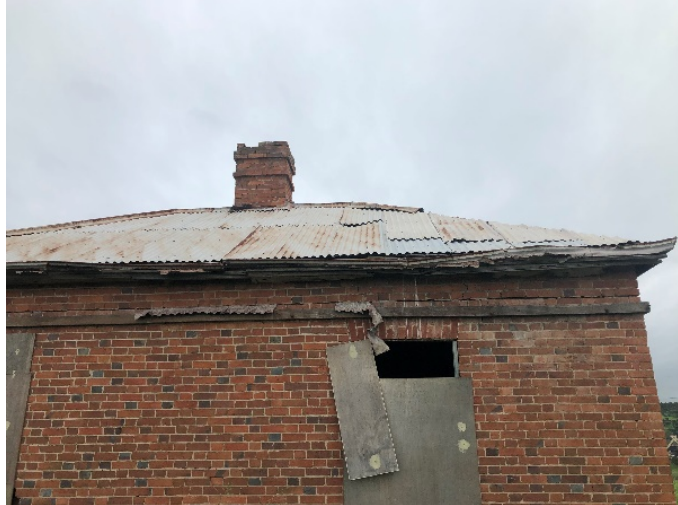
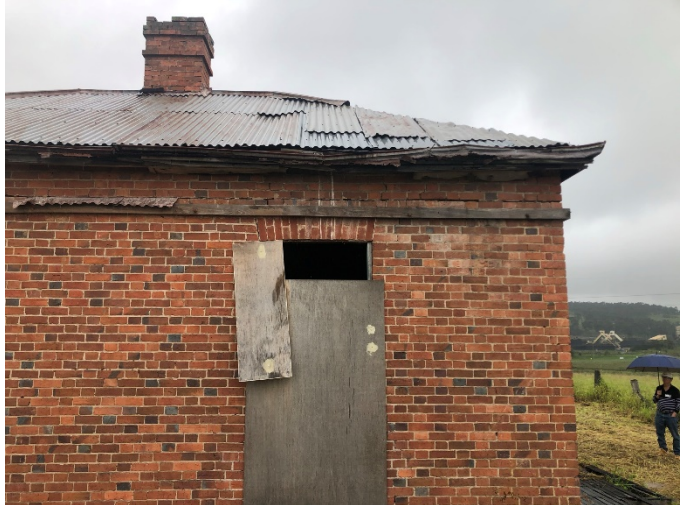
| 2015 | 2018 | 2020 (Mar) | 2020 (Dec) |
|---|---|---|---|
| <p><b>View of north-west roof corner (focus on damaged roof)</b><br/><b>2015-8:</b> roofing sheets have been replaced and holes patched<br/><b>2018-20 (Mar):</b> some minor roof holes and lifted sheeting noted<br/><b>Mar 2020-Dec 2020:</b> some verandah flashing fallen, panel above door requires refixing.</p> | | | |

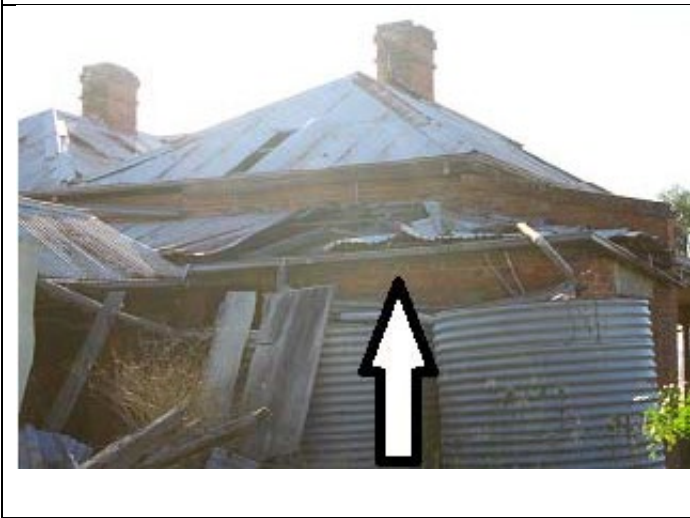
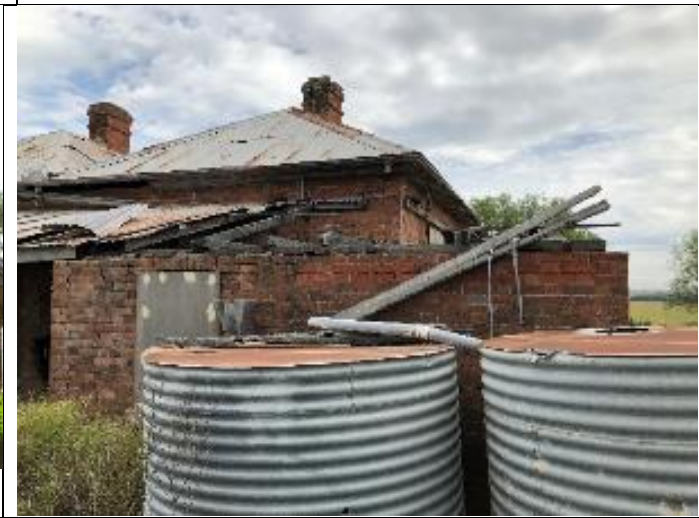
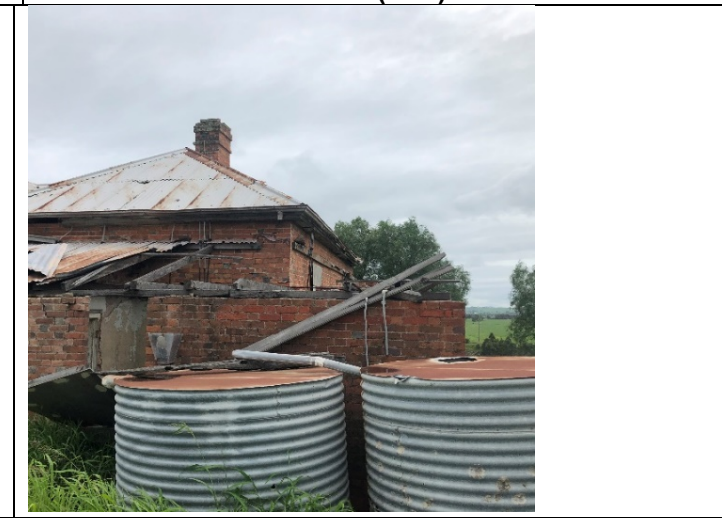
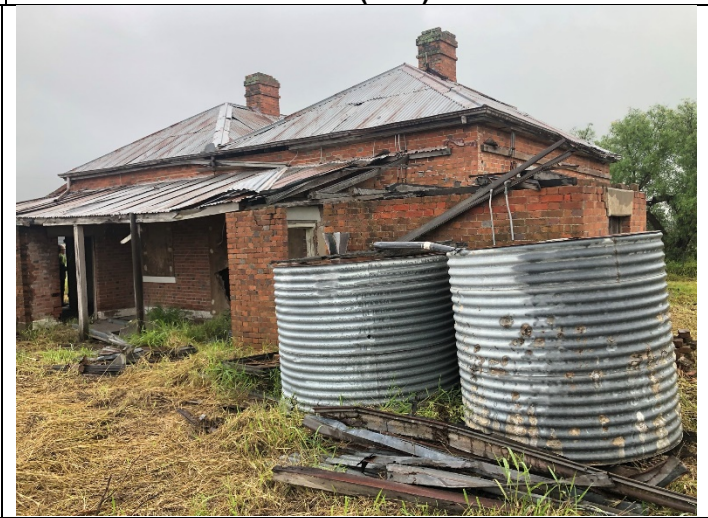
| 2015 | 2018 | 2020 (Mar) | 2020 (Dec) |
|---|---|---|---|
| <p><b>View of rear of building (focus on roof)</b><br/><b>2015-8:</b> skillion roof, guttering and rafters have collapsed; main roof holes repaired<br/><b>2018-20 (Mar):</b> no discernible change<br/><b>Mar 2020-Dec 2020:</b> some minor holes in roofing require repair</p> | | | |
