# Mount Thorley Warkworth Historic Heritage Management Plan 2020 Compliance Audit Inspection

Report prepared for

Yancoal Australia, Mount Thorley Warkworth

January 2021

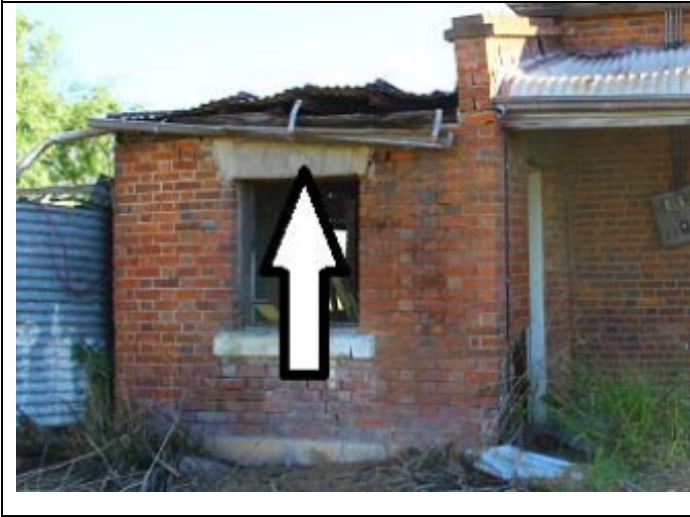
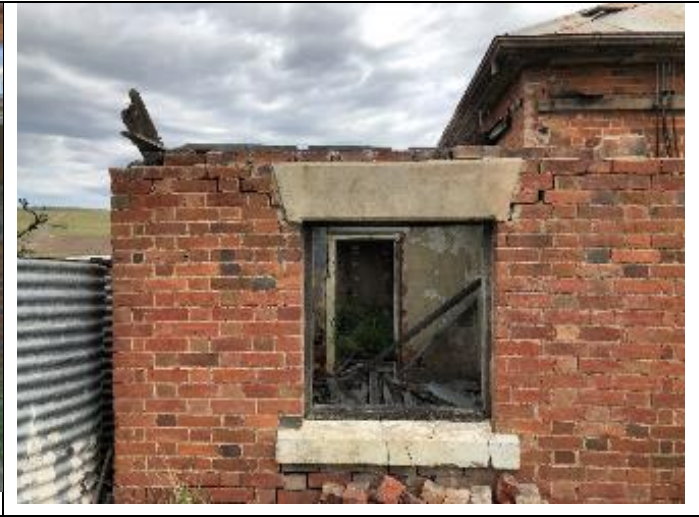
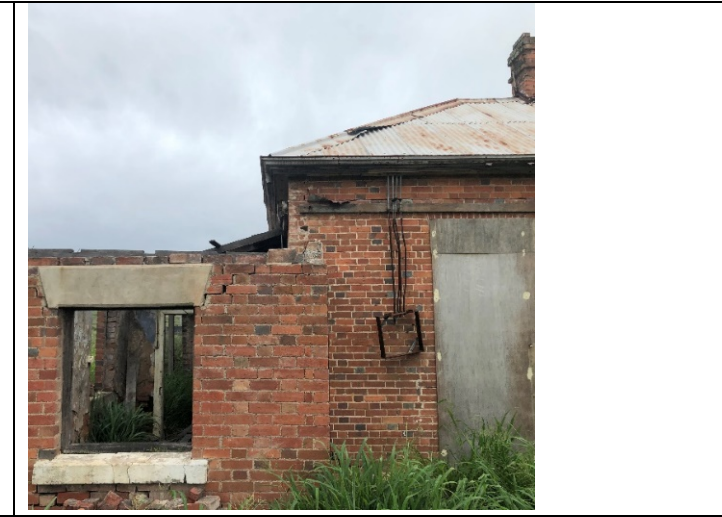
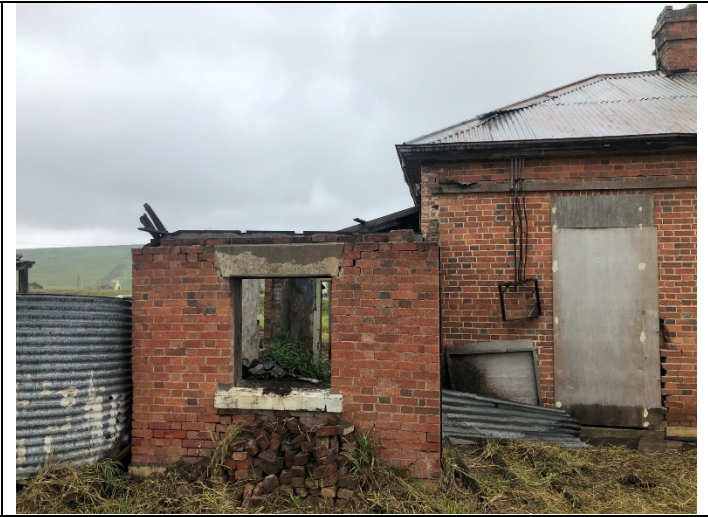
| 2015 | 2018 | 2020 (Mar) | 2020 (Dec) |
|---|---|---|---|
| <p><b>View of north-east of building</b><br/><b>2015-8:</b> wall element has collapsed (bricks stacked under window); roof framing, sheeting and guttering has collapsed<br/><b>2018-20 (Mar):</b> no discernible change<br/><b>Mar 2020-Dec 2020:</b> no discernible change</p> | | | |

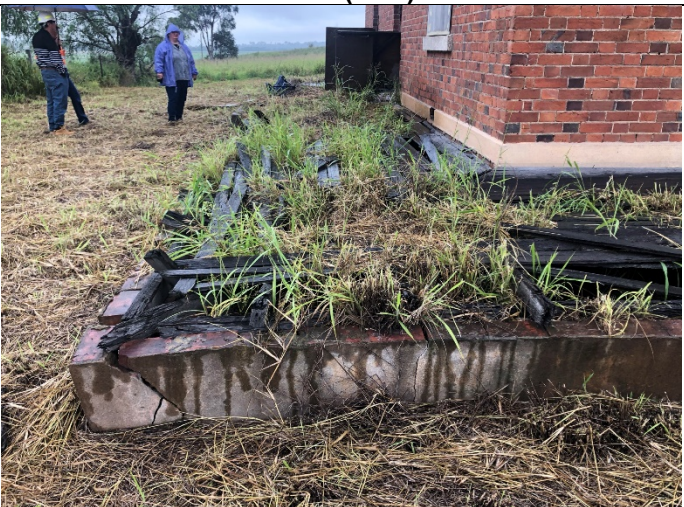
| 2015 | 2018 | 2020 (Mar) | 2020 (Dec) |
|---|---|---|---|
| <b>View of eastern verandah (focus on dwarf wall wall)</b><br><b>2015-8:</b> debris cleared from verandah, no change to dwarf wall<br><b>2018-20 (Mar):</b> no discernible change<br><b>Mar 2020-Dec 2020:</b> cracking to wall evident | | | |

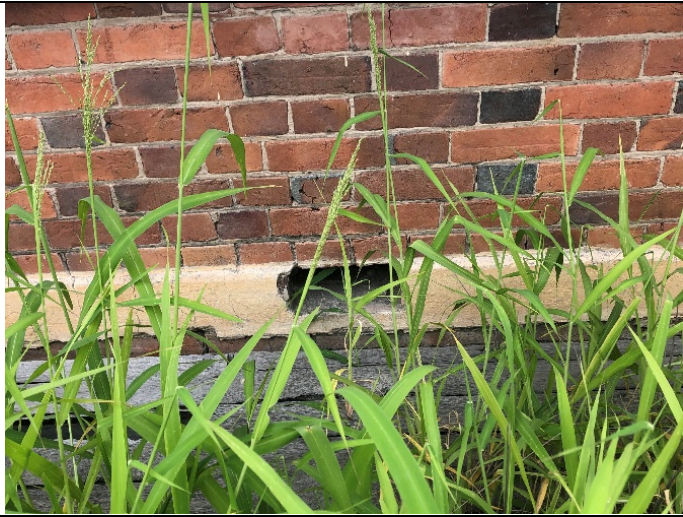
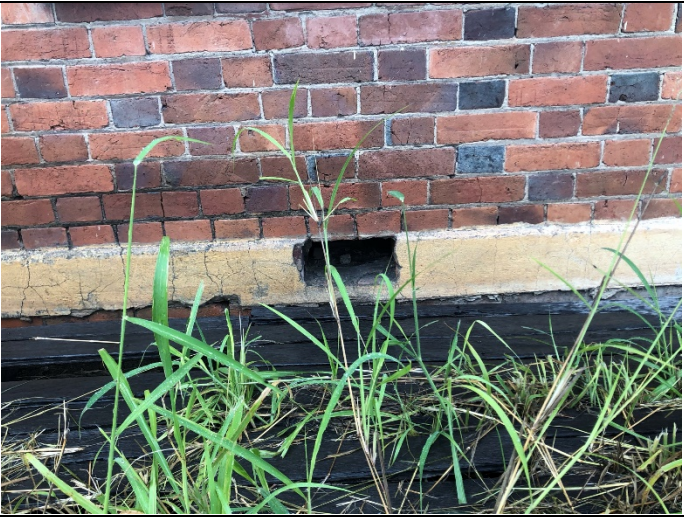
| 2015 | 2018 | 2020 (Mar) | 2020 (Dec) |
|---|---|---|---|
| <b>View of ventilation grilles</b><br><b>2015-8:</b> grilles not replaced<br><b>2018-20 (Mar):</b> no discernible change<br><b>Mar 2020-Dec 2020:</b> grilles remain open | | | |

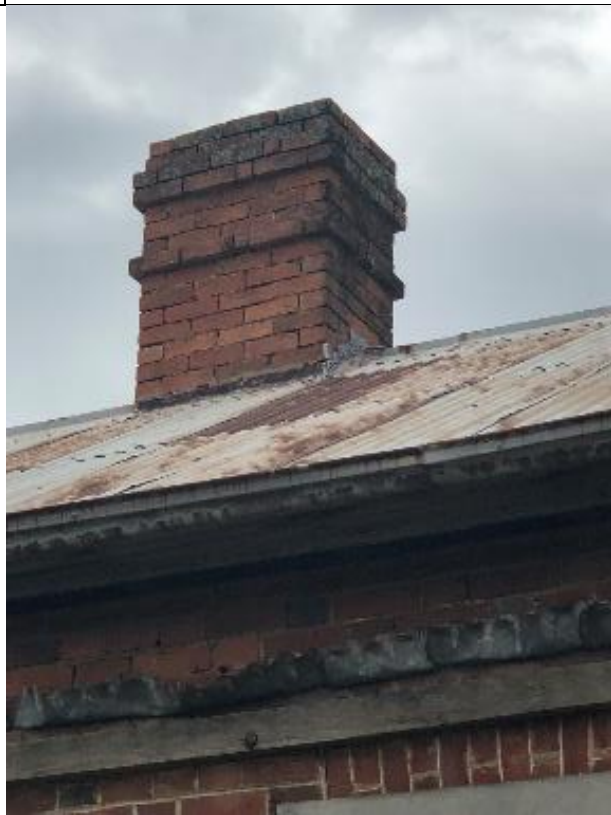
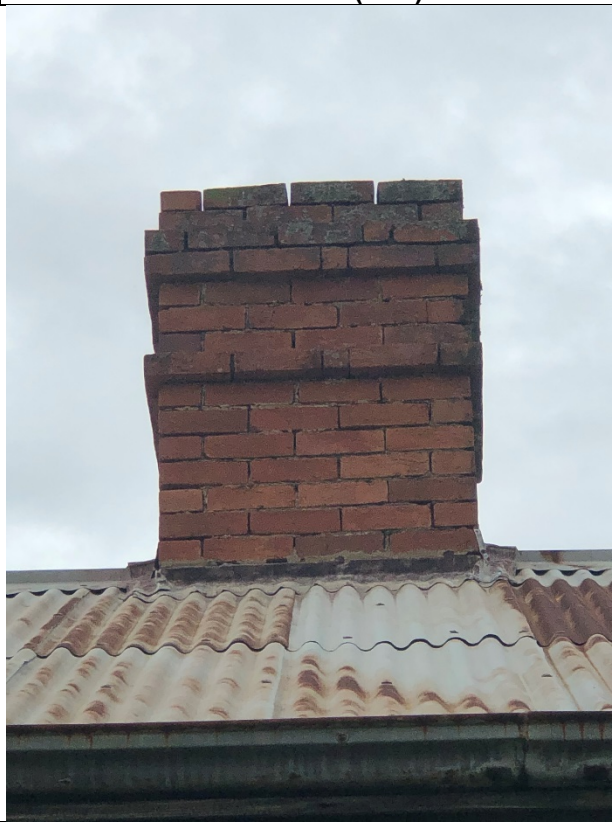
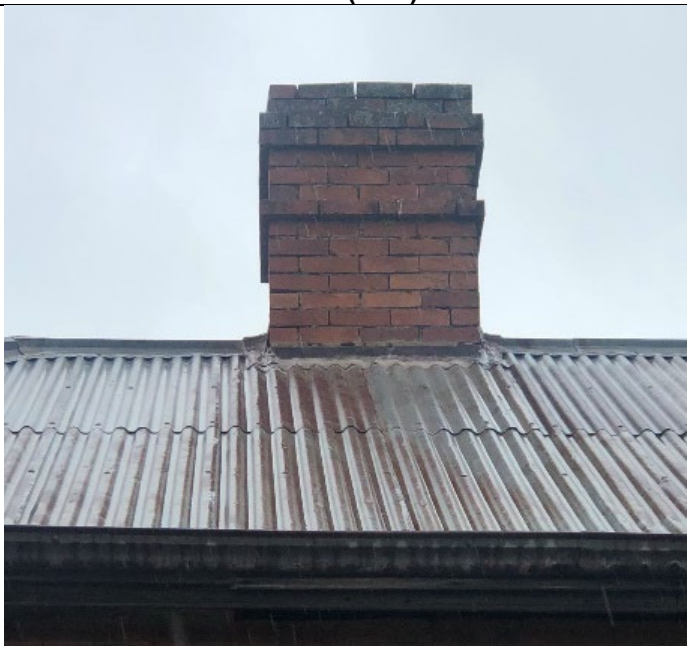
| 2015 | 2018 | 2020 (Mar) | 2020 (Dec) |
|---|---|---|---|
| <p><b>View of southern chimney</b><br/> <b>2015-8:</b> no discernible change<br/> <b>2018-20 (Mar):</b> no discernible change<br/> <b>Mar 2020-Dec 2020:</b> no discernible change</p> | | | |
