# 2020 STREAM HEALTH AND STABILITY REPORT

Mount Thorley Warkworth

SLR Ref: 630.30119-R01  
Version No: -v0.2  
February 2021

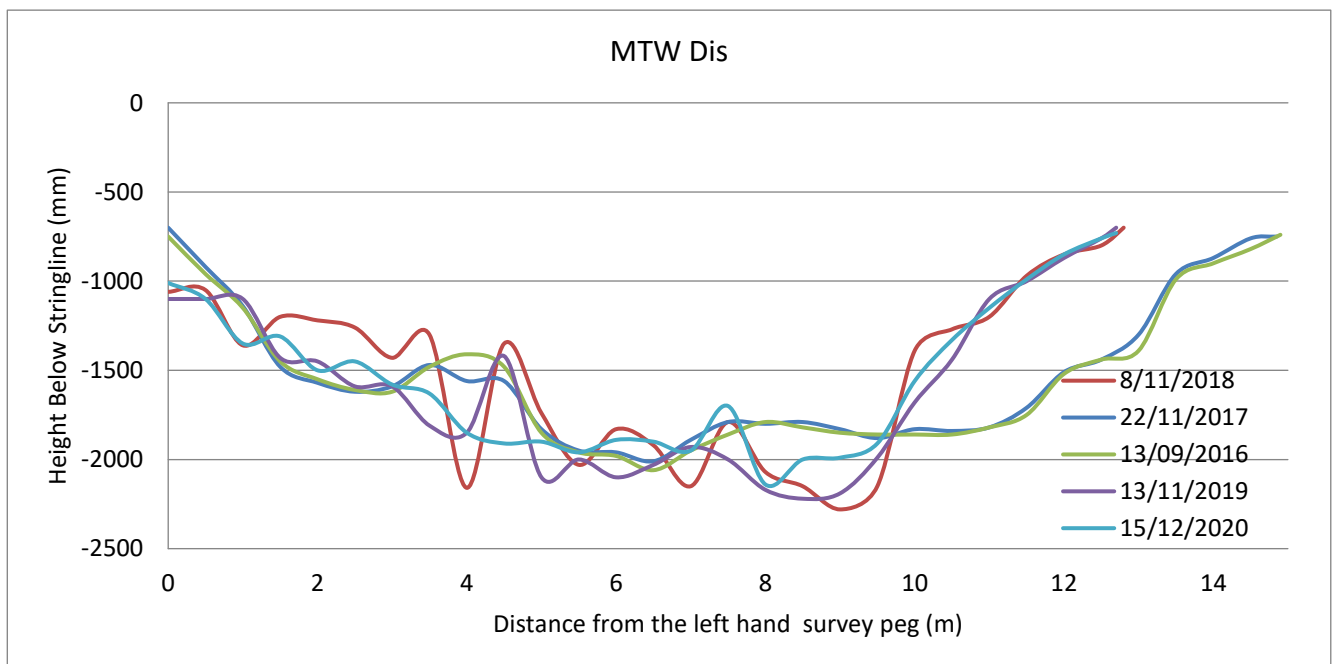
**Figure 2** MTW Dis Transect Results

For the purpose of monitoring any changes to the creek, a creek line transect was established. The transect is shown in **Figure 2** and was taken from left to right looking downstream. It can be seen from this transect that the channel hasn't changed significantly since the previous monitoring cycle. It should also be noted that as part of the upgrade works, the peg on the left bank was removed which explains why this round of monitoring shows a shorter length of transect. Difference in the data appears to be within the expected transect accuracy tolerances, it is not possible to discern if there has been bed erosion across at transect location.

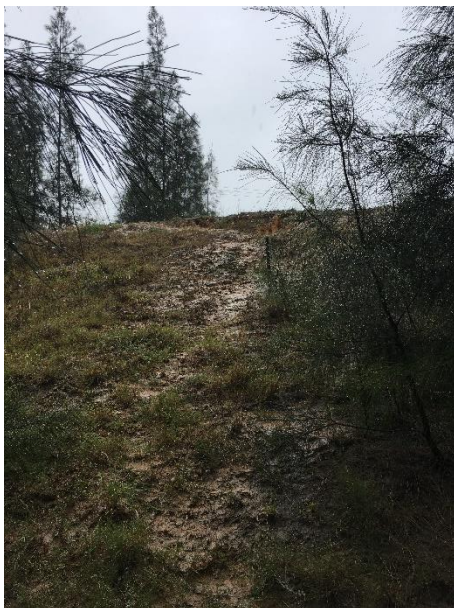
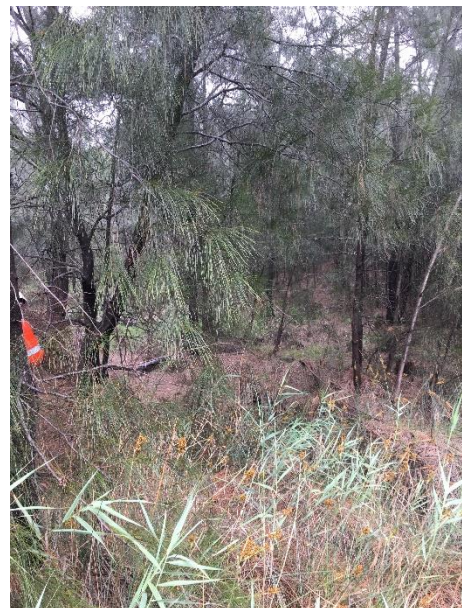
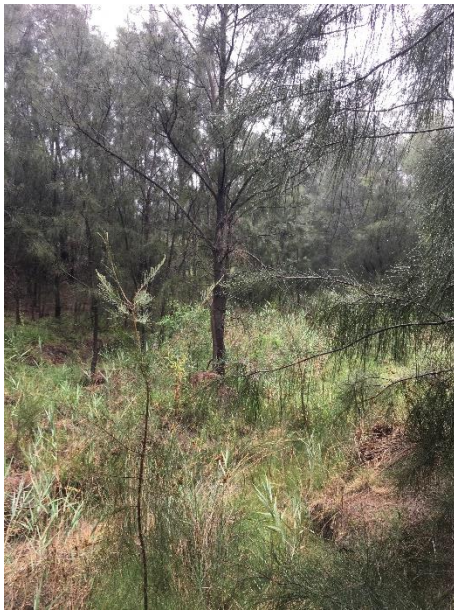
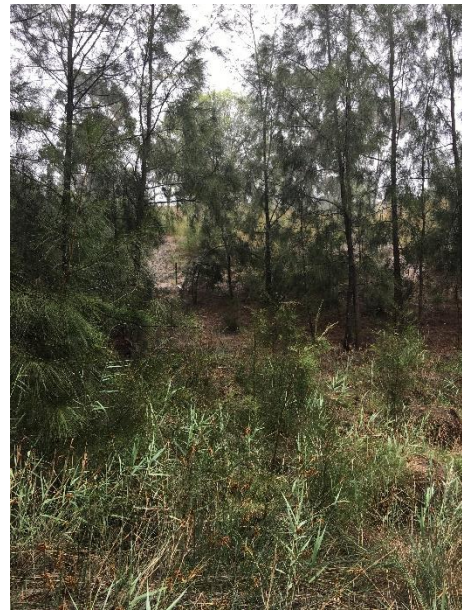
The channel at this location was observed to have a good coverage of long grass across the bed. The left bank also appears stable with good grass coverage. The right bank contains some lateral erosion (approximately 0.5m high) at the top of the bank. The lateral erosion is forming some rill/gully erosion down this bank, however the rest of the right bank appears to be stable with good grass coverage. Overall, this location shows similar conditions to the previous monitoring cycle.

CSIRO Ephemeral Stream Assessment Classification – **Active**

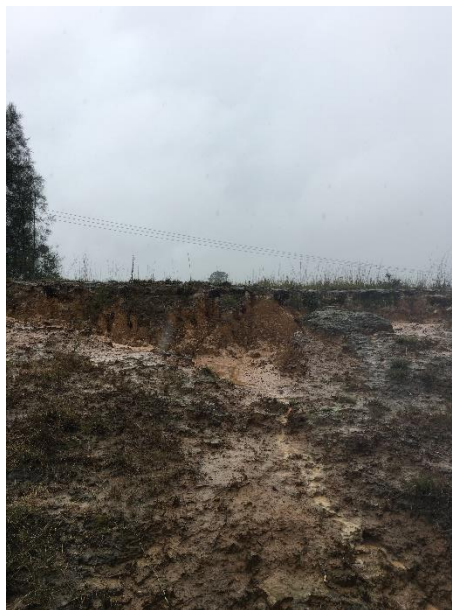
Plate 9 Erosion (top of right bank)

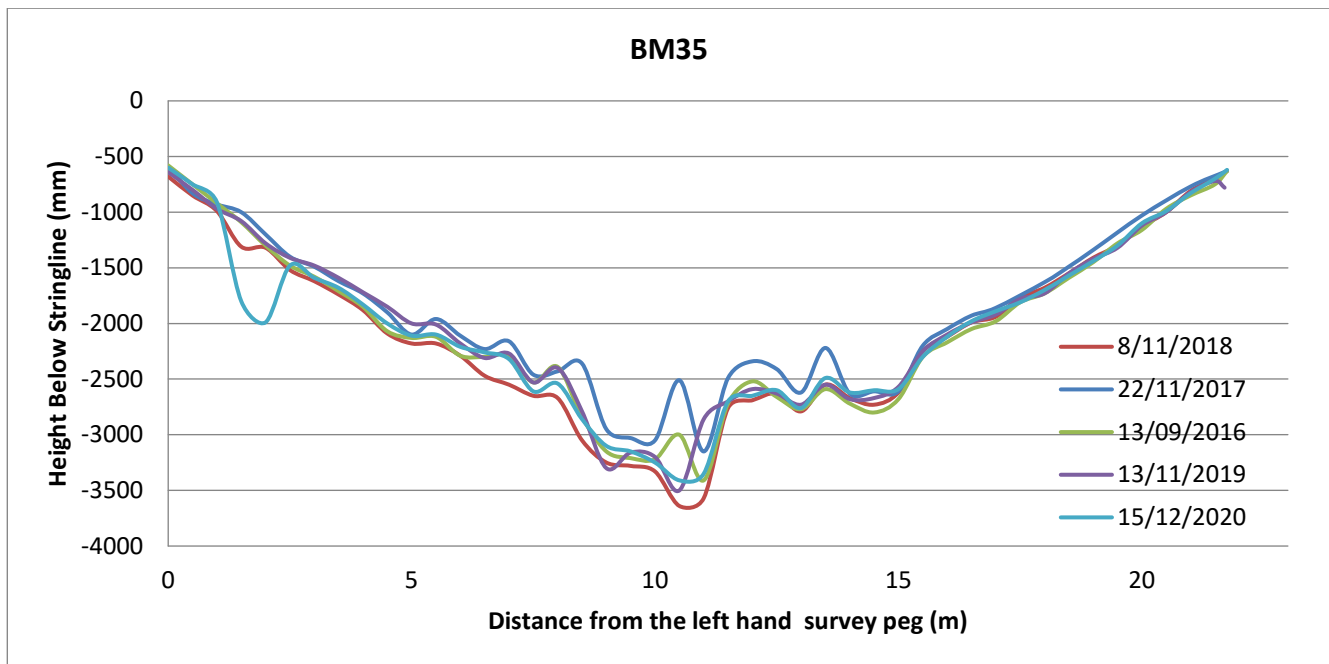
**Figure 3 BM35 Transect Results**

For the purpose of monitoring any changes of the creek, a creek line transect was established. The transect is shown in **Figure 3** and was taken from left to right looking downstream. It suggests that no significant scouring has occurred on the banks or creek bed since the previous monitoring cycles. A slight dip in the 2020 data at the 2m mark was caused by tussock vegetation and any other difference in the data appears to be within the expected transect accuracy tolerances.

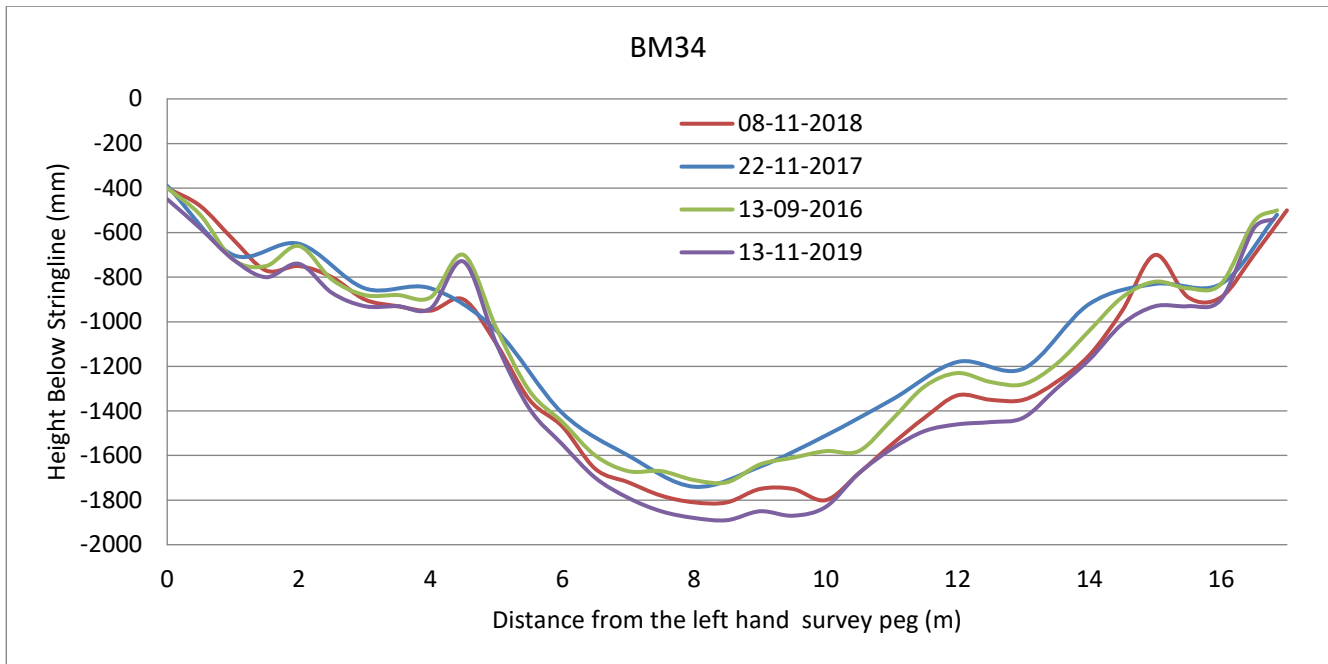
**Figure 4 BM34 Transect Results**

For the purpose of monitoring any changes of the creek, a creek line transect was established. The transect is shown in **Figure 4** and was taken from left to right looking downstream for previous rounds of monitoring. Due to flowing water in the creek, SLR was unable to undertake the 2020 transect. Visual inspection of the monitoring location suggested that the creek cross section hasn't changed since the 2019 monitoring cycle.

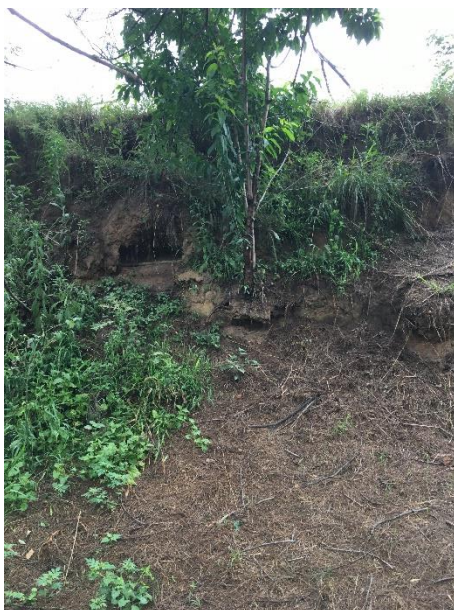
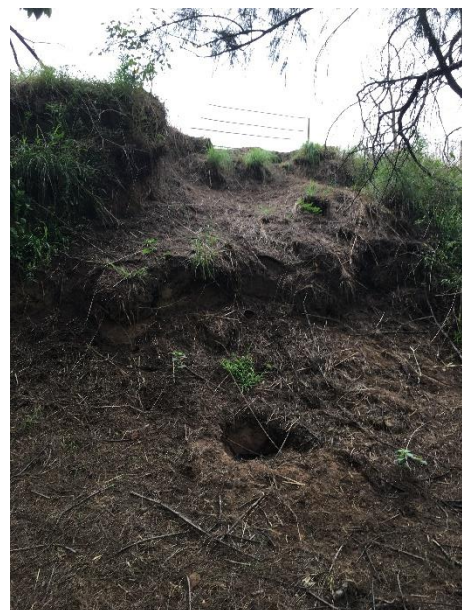
Monitoring point BM37 is the only monitoring point that is located on Wollombi Brook. Wollombi Brook is a large tributary of the Hunter River, with channel widths ranging from 10m to 60m. Generally, Wollombi Brook has flowing water in it except during extreme drought periods. Water was observed to be flowing at the time of the inspection. Both the left and right banks appeared to be generally stable with both banks containing trees. The right bank is steeper than the left bank with a moderate slope and a height of approximately 2m. A pipe outlet exists immediately downstream of the monitoring point on the eastern bank and has scoured out the bank slightly with some exposed moderately dispersive soils (approximately 0.3m high). Some wombat holes were also observed on the eastern bank. Overall, this location has remained the same as the previous monitoring cycle conditions.

Plate 18 Erosion

Plate 19 Erosion

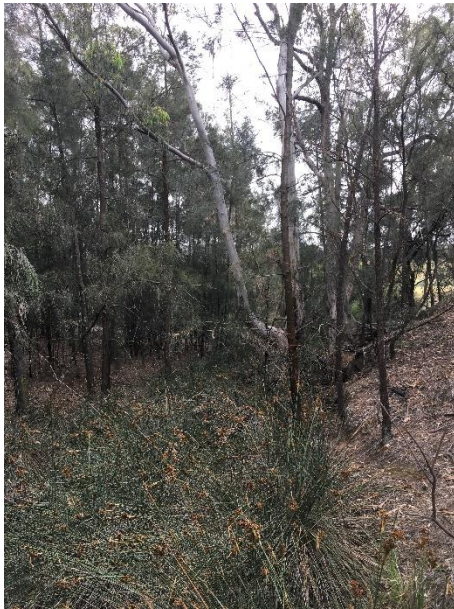
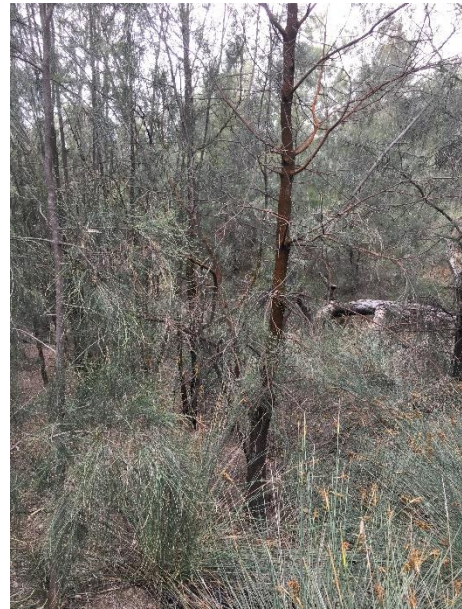
The erosion observed at LC2 included a steep near vertical section of exposed dispersive material (approximately 2m high) on the right bank. This area appeared to be actively eroding including some areas immediately downstream. The erosion at this monitoring location appears to be similar to what was observed in the 2018 survey. A tree was observed to have fallen over at this section of the exposed creek bank. The creek bed and left bank appear to be stable at this location.

### CSIRO Ephemeral Stream Assessment Classification – **Active**

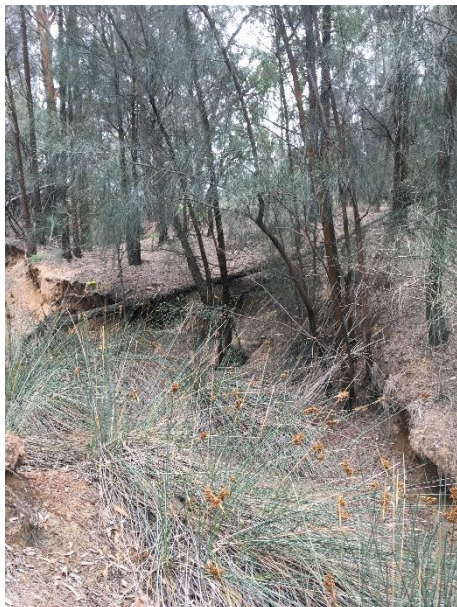
### CSIRO Ephemeral Stream Assessment Classification – **Very Active**

Plate 29 Erosion

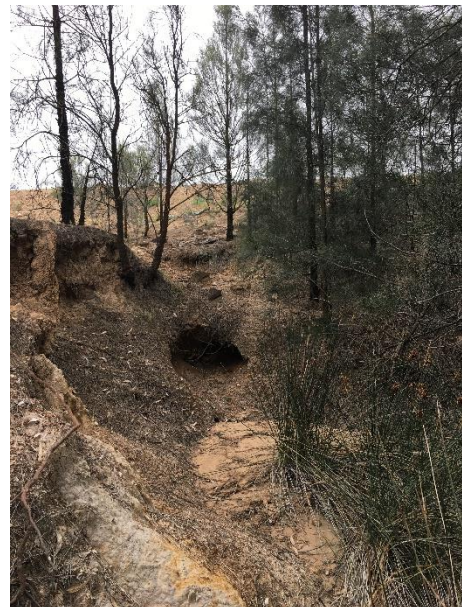
Plate 30 Tunnel Erosion

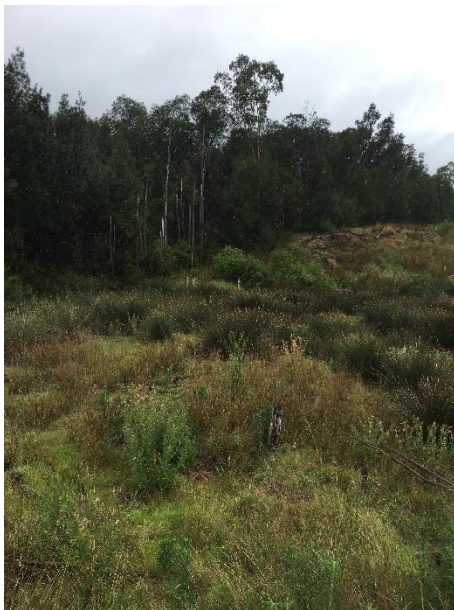
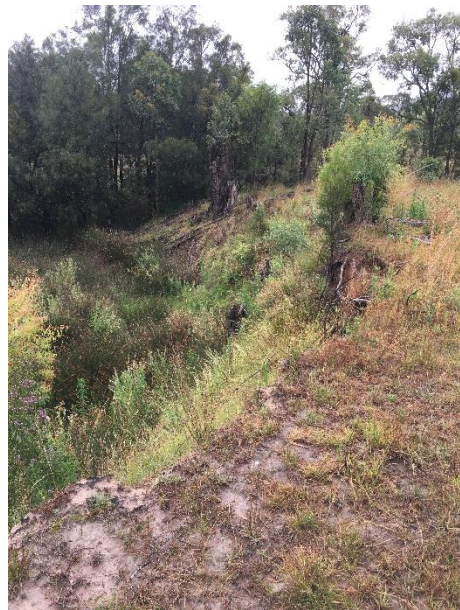
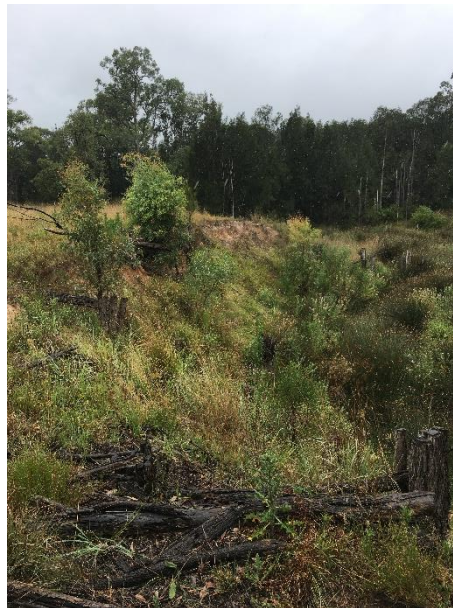
LC4 is located under a powerline in an area where it appears that vegetation has been maintained within the powerline easement. The near vertical left bank on the outside of the creek meander is about 4-5m high and has some exposed dispersive material (approximately 1m high) near the top of the bank however this erosion has shown signs of potentially stabilising. The right bank is much flatter and appears to be stable, as does the creek bed. Overall, this monitoring location has shown similar conditions to the previous monitoring cycle.

CSIRO Ephemeral Stream Assessment Classification – **Potentially Stabilising**

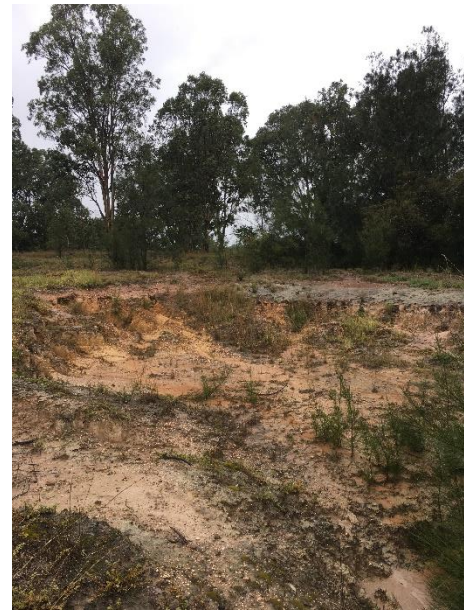
LC5 is located in a historic diversion of Loders Creek. The erosion observed at LC5 included erosion extending up the right bank approximately 20-30m. The area has 0.5-1.0m high steep exposed walls surrounding 5m of exposed soil. The creek bed and left bank appear to be stable. Overall, this monitoring location has shown similar conditions to the previous monitoring cycle.

CSIRO Ephemeral Stream Assessment Classification – **Active**

Plate 37 Erosion (top of right bank)

For example, erosion caused by lateral flows and unstable wall materials may be remediated by re-grading the batter slope (as required) to a maximum gradient of 3(H):1(V), ripping the soil and then seeding with a suitable vegetation species. Gypsum may also be used as a soil ameliorant and applied at a rate of 1kg/m<sup>2</sup>. Bunding may also be used to control upslope lateral flows. Creek erosion caused by the shear stresses associated with the upstream flows may be remediated by armouring of the creek bed / banks (i.e. rock, jute mesh, erosion blanket etc), as was observed to have been implemented by MTW at location MTW Discharge Point during the 2018 survey.

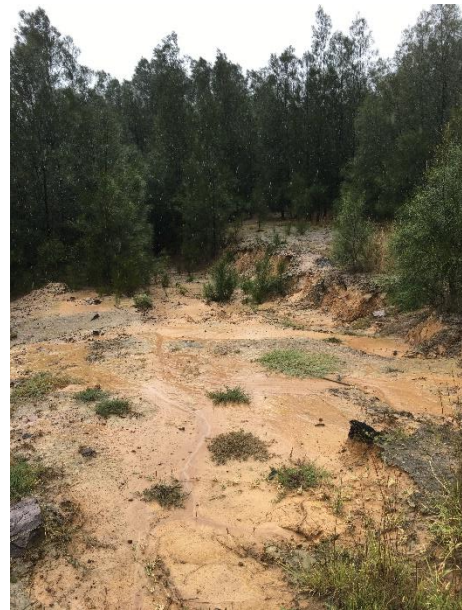
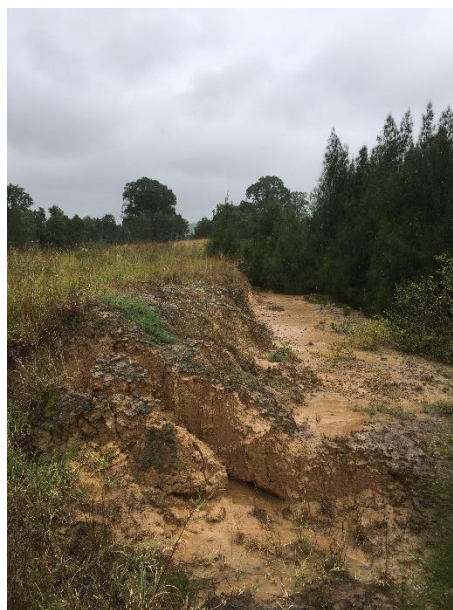
The erosion observed at LC6 included significant lateral erosion near the top of the right bank. This erosion was approximately 1m high with an alluvial fan extending approximately 2m from the near vertical bank. The rest of the right bank appears to be stable as does the creek bed and the left bank. Overall, this monitoring location appears similar to the previous monitoring cycle. The active erosion appears to be primarily the result of a historic disturbance of the top of the right bank which has exposed the highly dispersive soils at this location.

CSIRO Ephemeral Stream Assessment Classification – **Active**

Plate 39 Erosion

Plate 40 Erosion

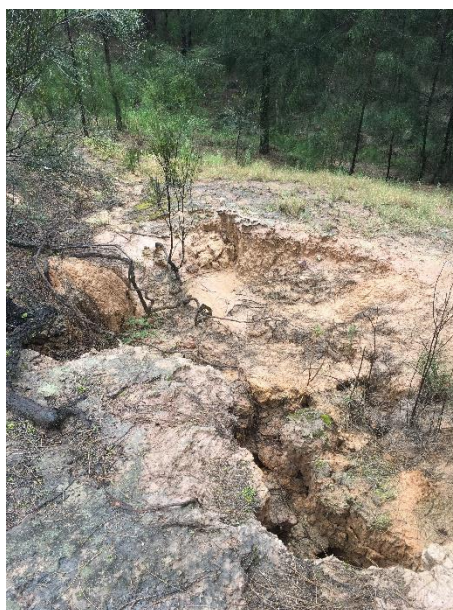
The erosion observed at LC7 included an area of active erosion of a steep comprising exposed dispersive clay material (approximately 0.8m high) on the right bank, however this erosion is not laterally extensive. The erosion appears to have been caused by lateral flow across the bare banks in the area. The right bank appears to be stable downslope of the eroded area, as does the creek bed and the left bank. Overall, this monitoring location has shown similar conditions to the previous monitoring cycle.

CSIRO Ephemeral Stream Assessment Classification – **Active**

Plate 43 Erosion

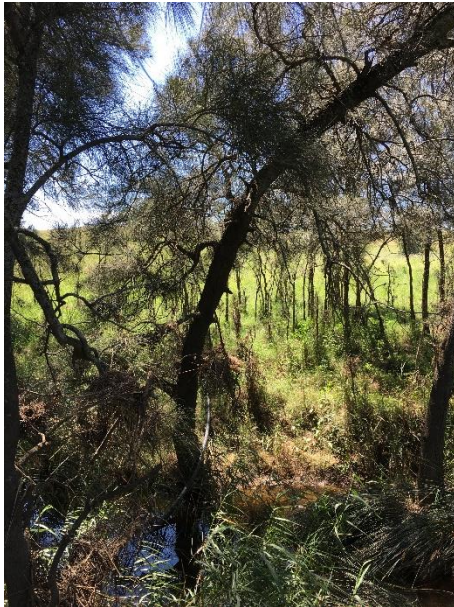
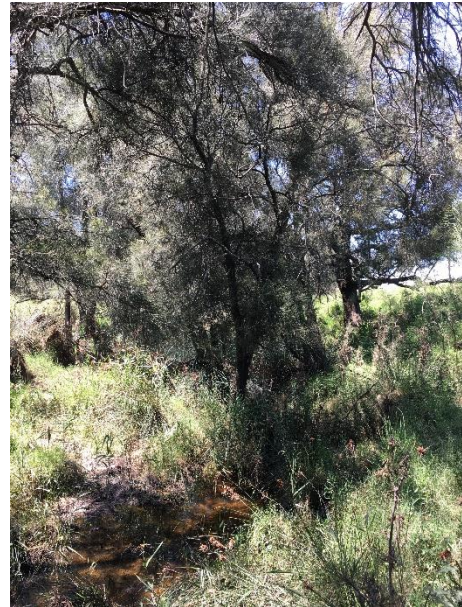
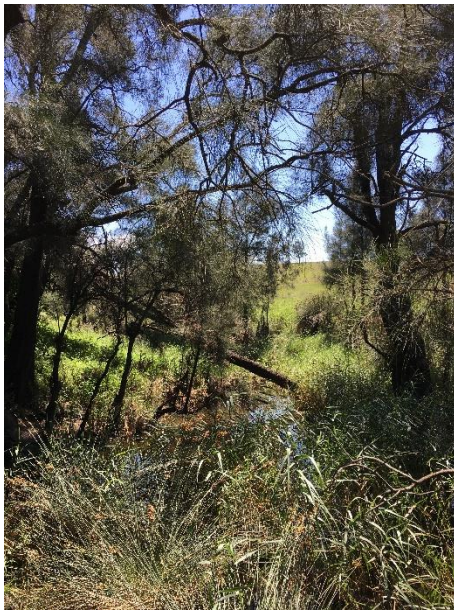
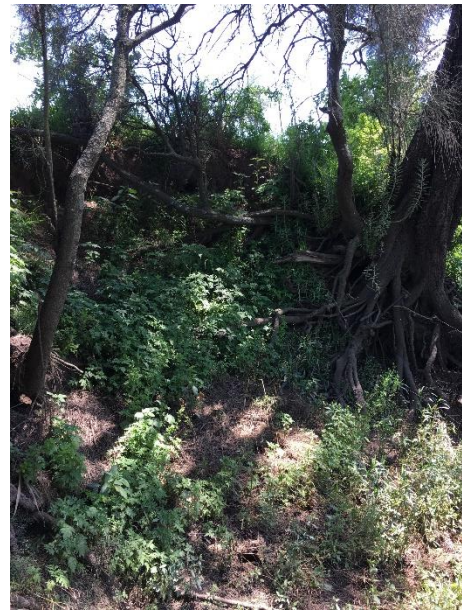
The erosion observed at LC8 included significant erosion of the left bank (approximately 1m high with the overall bank at approximately 2.5m high) at a location with a slight meander in the creek. The erosion has some minor undercutting with a section of vertical banks partly stabilised by tree roots. Vegetation growth at this location appears to have increased since the last round of monitoring. This is most likely linked to the alluvial nature of the soil as well as the continuous rainfall observed in the region in the last few months. Trees at this location are at risk of falling over due to loss of support. The creek bed and right bank appear to be stable. Overall, this monitoring location has shown similar conditions to the previous monitoring cycle.

CSIRO Ephemeral Stream Assessment Classification – **Potentially Stabilising**

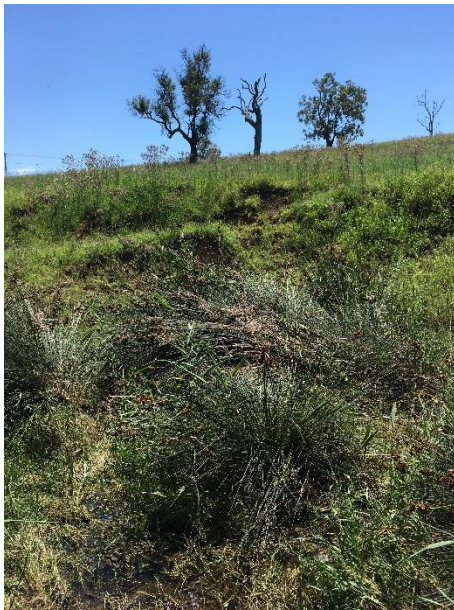
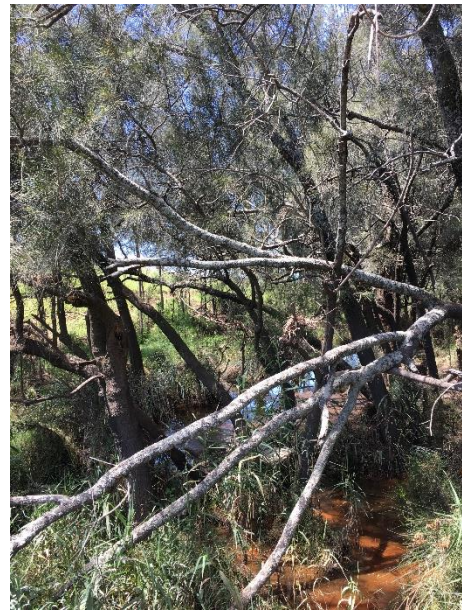
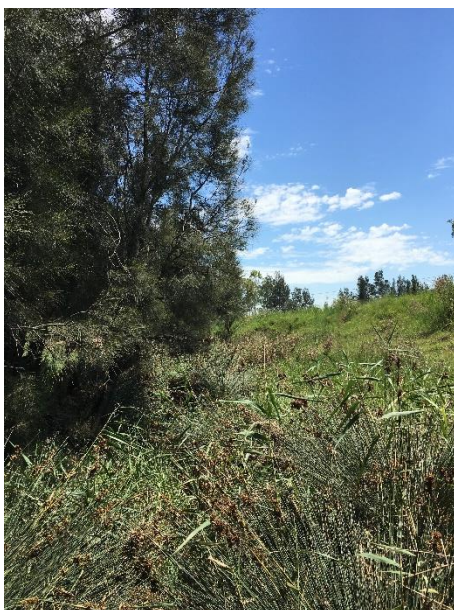
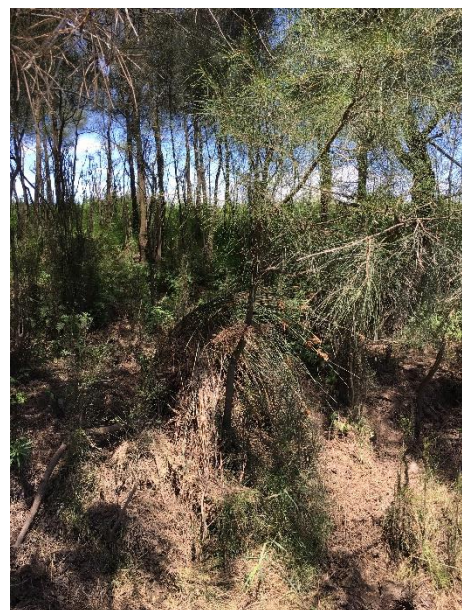
The erosion observed at LC9 included some loss of exposed slightly dispersive material on the right bank which may have been caused by livestock in the area. This bank is about 2m high and has about 0.8m of exposed soil. The area appears to be stabilising and this round of monitoring has shown an increase in vegetation growth. This is most likely linked to the continuous rainfall observed in the region in the last few months. The creek bed and the left bank appear to be stable. Overall, this monitoring location has shown similar conditions to the previous monitoring cycle.

CSIRO Ephemeral Stream Assessment Classification – **Potentially Stabilising**

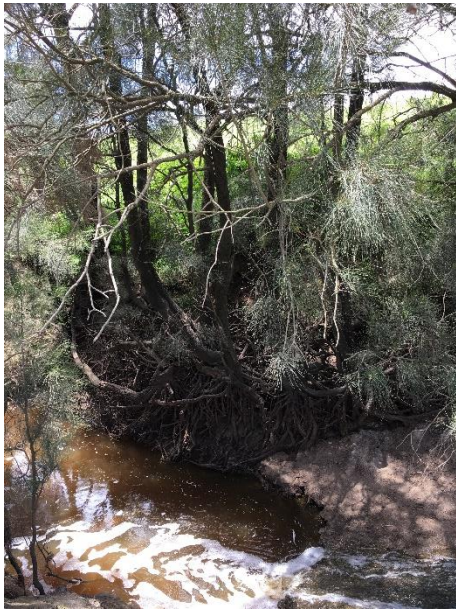
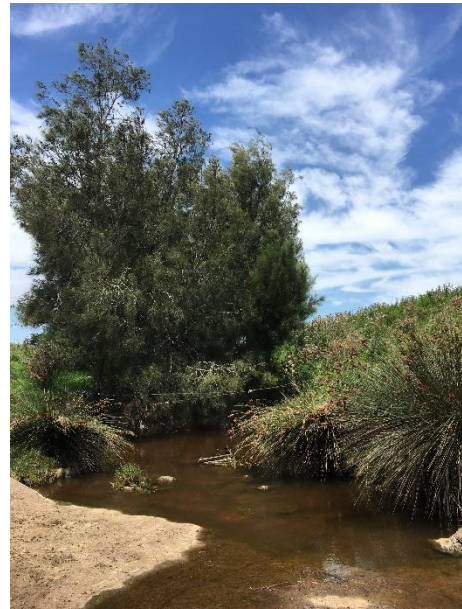
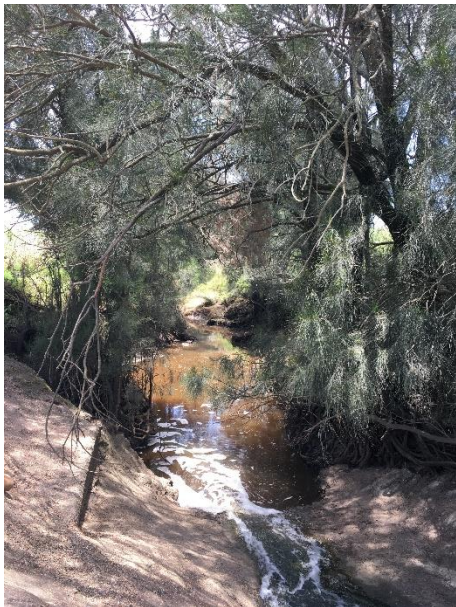
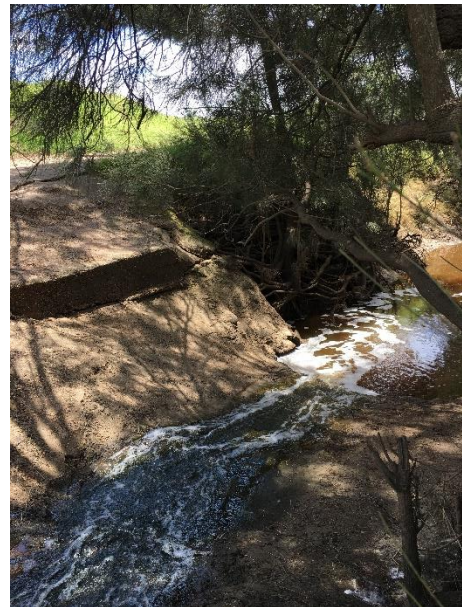
The erosion observed at LC10 is located immediately downstream of a concrete lined chute. The soil is alluvial and non-dispersive. The erosion has been created from scouring of the right bank during large flow events with the upstream chute increasing the velocity of the water to this downstream section of channel. This scouring has exposed some tree roots of some of the trees that line the creek bank. The creek has steep slopes on both banks (approximately 3m high) and was observed flowing at the time of monitoring. The creek is generally stable upstream and downstream except for some cattle tracks immediately upstream on the right bank. Overall, this monitoring location has shown similar conditions to the previous monitoring cycle.

### CSIRO Ephemeral Stream Assessment Classification – **Active**

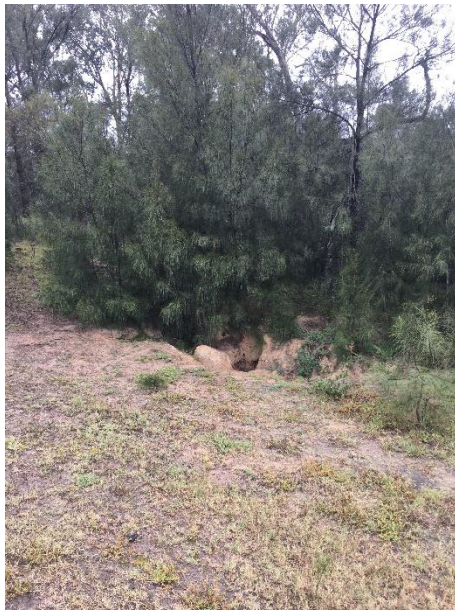
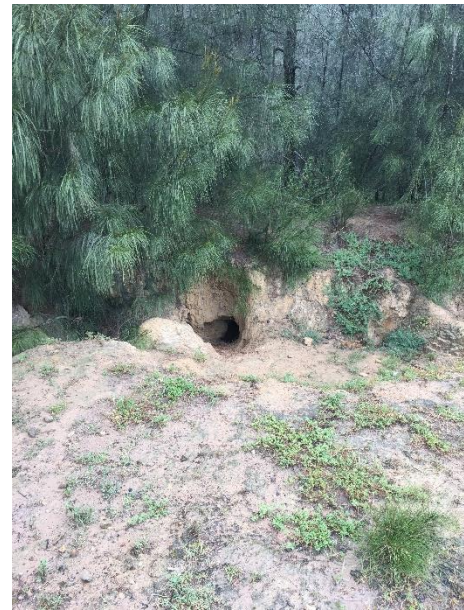
The erosion observed at LC11 includes some significant tunnelling and active erosion on the left bank with exposed vertical dispersive soil. Potential causes for this erosion include wombat holes as well as the presence of a contour bank overflow (which is located immediately upslope of the erosion). Trees were observed on both banks and creek bed. The creek bed and the right bank both show stable conditions. Overall, this monitoring location has shown similar conditions to the previous monitoring cycle.

CSIRO Ephemeral Stream Assessment Classification – **Active**

Plate 58 Erosion

Plate 59 Erosion

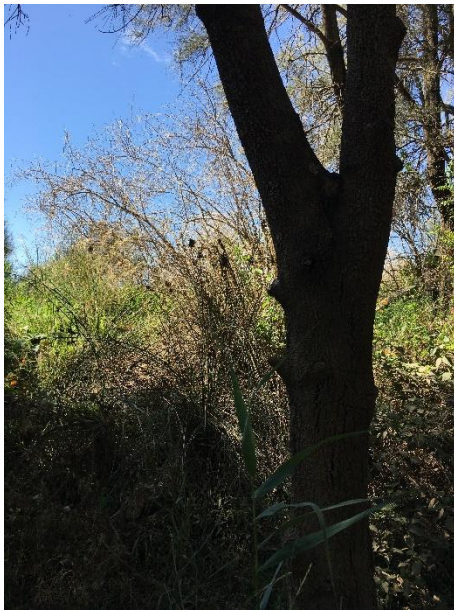
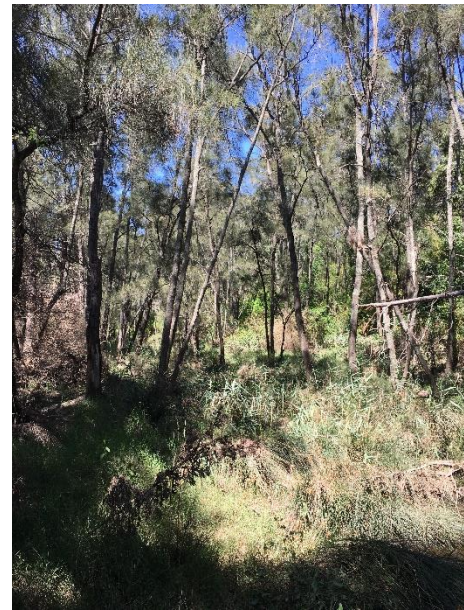
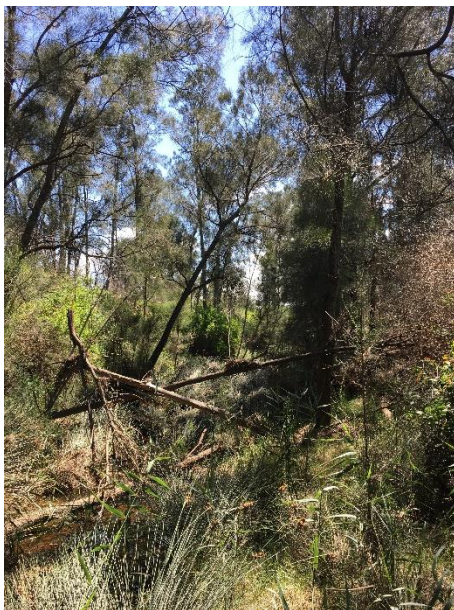
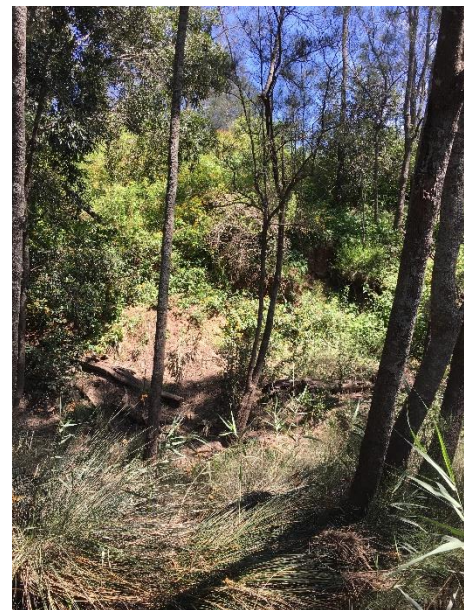
The erosion observed at LC12 includes some erosion (approximately 2m high) on the left bank. It is likely that this erosion was at least partially caused by a fallen tree at the monitoring point location. The 2020 monitoring cycle shows this erosion partially vegetated. This is most likely linked to the continuous rainfall observed in the region in the last few months. The left bank at the monitoring point is significantly higher than the right bank. The creek bed and the right bank both show stable conditions.

CSIRO Ephemeral Stream Assessment Classification – **Potentially Stabilising**

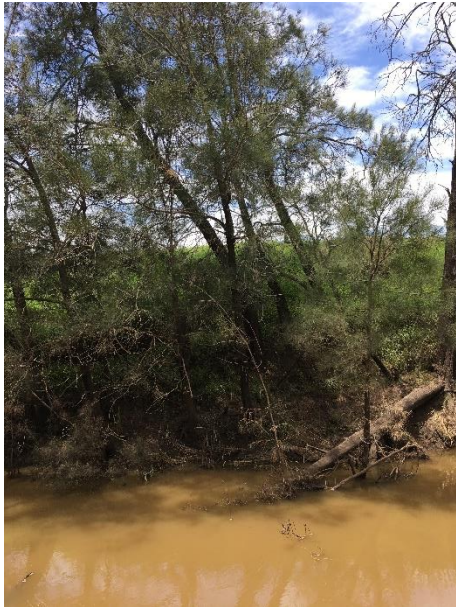
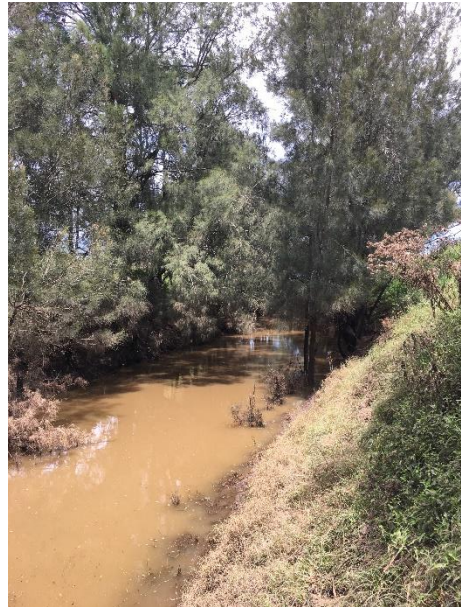
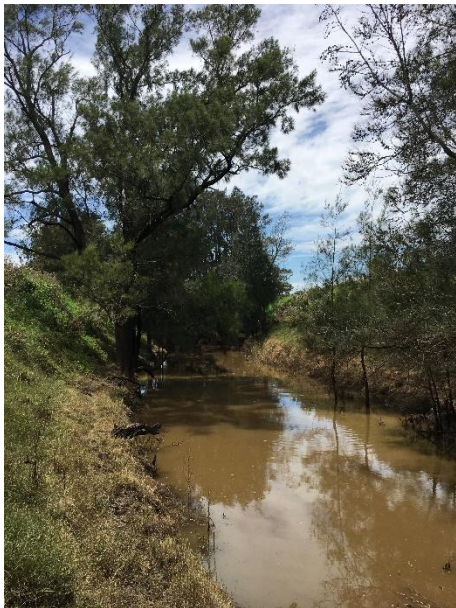
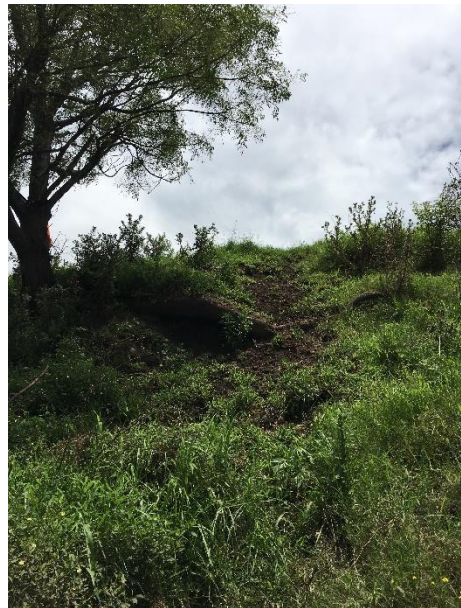
LC13 includes some erosion extending for approximately 5m on the steep left bank with exposed soil which doesn't appear to be highly dispersive. This erosion was most likely caused by livestock tracks observed upstream and downstream of the monitoring location or a localised slope failure. Other than more vegetation as a result of continuous rainfall in the region, this monitoring location has shown similar conditions to the previous monitoring cycle.

CSIRO Ephemeral Stream Assessment Classification – **Potentially Stabilising**
