# MOUNT THORLEY WARKWORTH

## 2020 Annual Groundwater Review

SLR Ref: 620.30305.00000-R01  
Version No: -v2.0  
March 2021

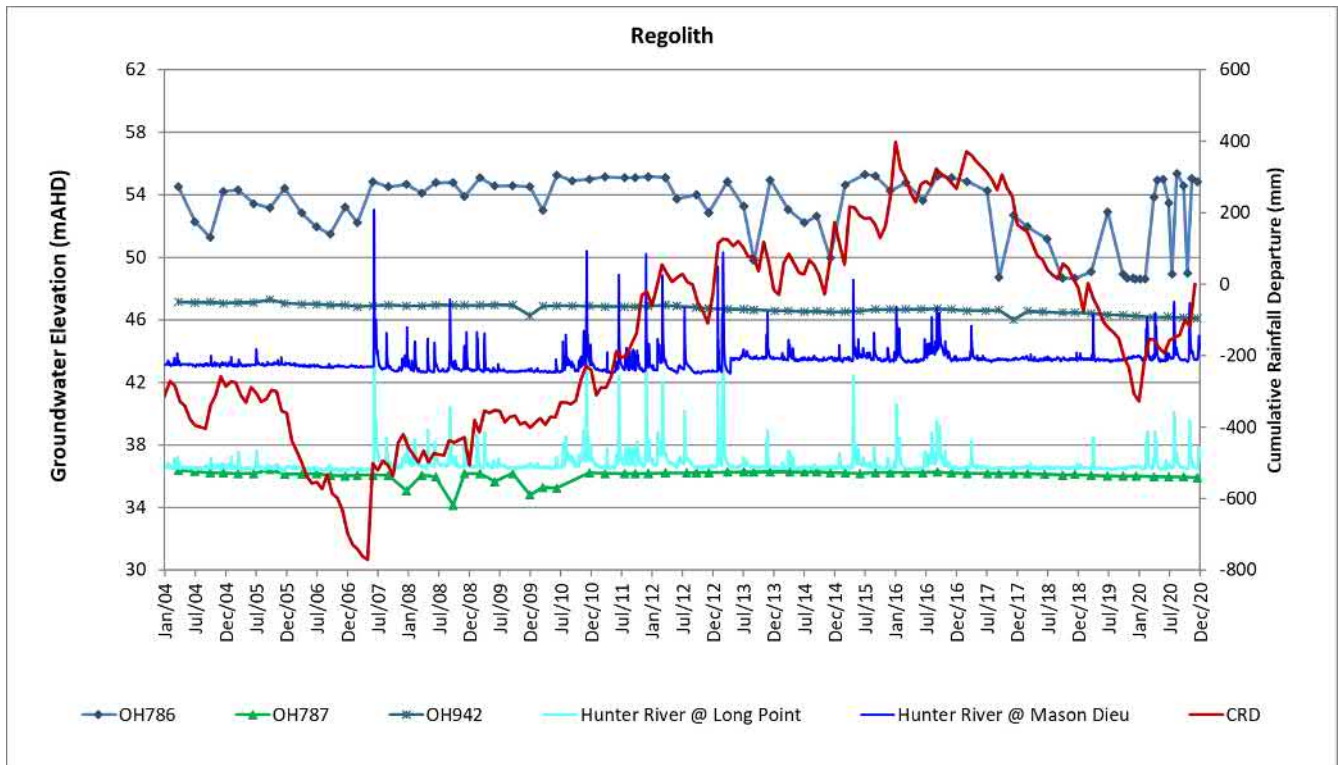
Figure 6-1 Groundwater Levels – Regolith

OH787 exhibited a decreasing trend in groundwater elevation during 2020, despite the above average rainfall received early and later in the year. There appears to be historical influence from pumping of nearby bores (large drawdown fluctuations from 2007 to 2010) and a lack of response or delayed response to rainfall. This is possibly due to the lack of connection with alluvium and low permeability of the weathered material in which this bore is screened (identified in SLR, 2019).

Similar to OH787, OH942 has declined in water level over the long term (since 2014), with minor seasonal fluctuations as a delayed response to recharge. Over 2020, despite the above average rainfall, only a 2 cm rise in groundwater level occurred between March 2020 and June 2020, before a decline in groundwater level continued (an additional 9 cm of decrease from June to December 2020).

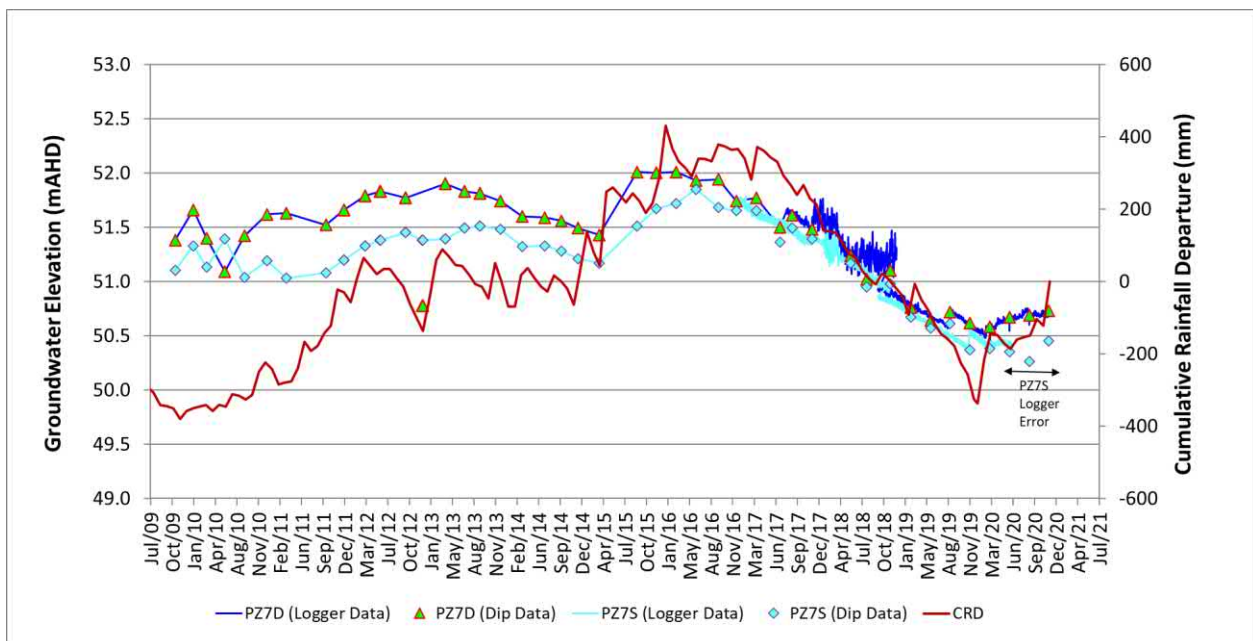
**Figure 6-2 Groundwater Levels – Warkworth Sands Bore PZ7S and PZ7D**

Bore PZ7 is a nested bore of two separate standpipes, with PZ7S constructed within the Warkworth Sands to 11.1 m depth bgl (screened interval unknown), and PZ7D constructed within the shallow overburden material to a total depth of 30.5 m bgl (screened interval unknown). Historical water level data for the bores is presented in **Figure 6-2**. **Figure 6-2** shows that groundwater elevations within the coal measures at PZ7D have historically been slightly higher than levels in the overlying Warkworth Sands, indicating a potential upward gradient. Between 2016 and 2019 this gradient has reduced, with levels within the Warkworth Sands and shallow overburden showing similar elevations and longer-term declining trends. **Figure 6-2** shows that during 2020 groundwater levels within the Warkworth Sands and shallow overburden material at PZ7S and PZ7D, respectively started to recover, likely in response to above average rainfall received in February and March 2020. A delayed recovery response is seen in the manually measured water level at PZ7S. The data collected by the logger in PZ7S was erroneous from June 2020 onwards; therefore, the short-term water level response to rainfall was not able to be examined. As recommended in the previous annual review, further investigation into the local ground conditions bore construction details and condition of the nested bore should be undertaken, to understand the interaction between the two bore depths. The logger in PZ7S should be replaced with an operating logger.

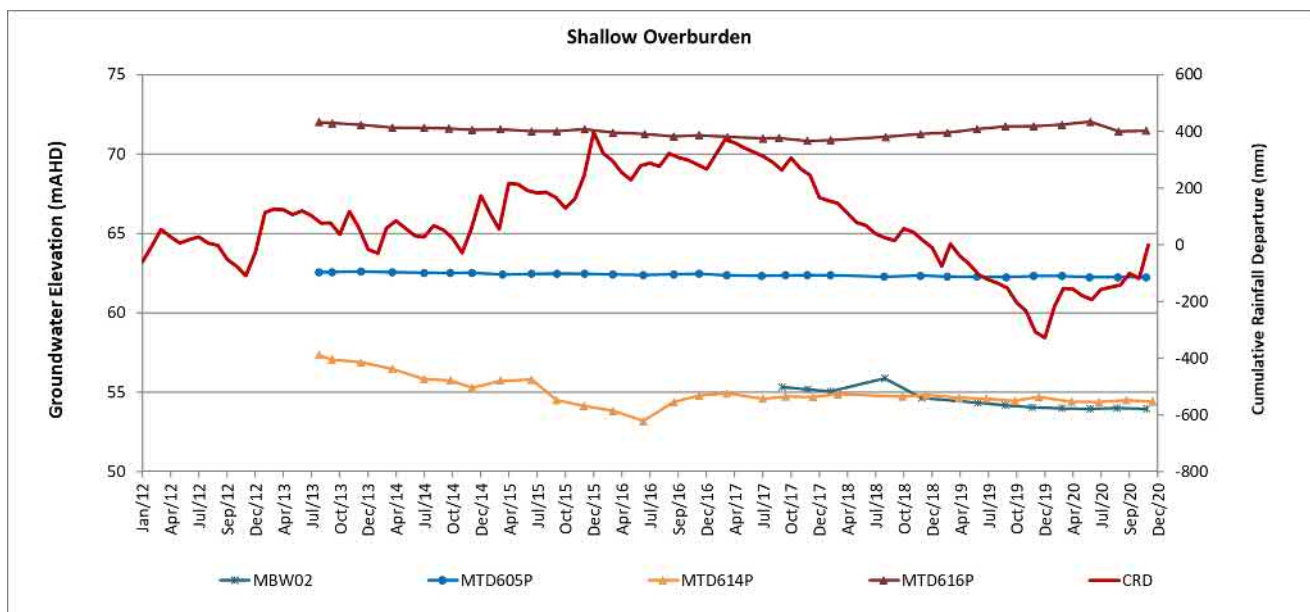
**Figure 6-6 Hydrograph of Shallow Permian Coal Measures**

Groundwater elevation trends for bores MTD605P, MTD614P, MTD616P, and MBW02 are presented in **Figure 6-6**. **Figure 6-6** shows stable to slightly declining groundwater levels within the shallow overburden material. The exception to this is bore MTD616P in which slightly increasing groundwater levels were recorded between January 2018 and May 2020. Subsequent groundwater elevations have declined and stabilised at approximately 71.4 mAHD. Given the CRD generally declined from 2017 to 2019, it would not be expected that groundwater elevations would rise. As reported in the previous annual review, no land use changes, or activities are known to have occurred near the bore that may have caused this rising trend. Further investigation into site conditions around MTD616P should be undertaken to confirm this.

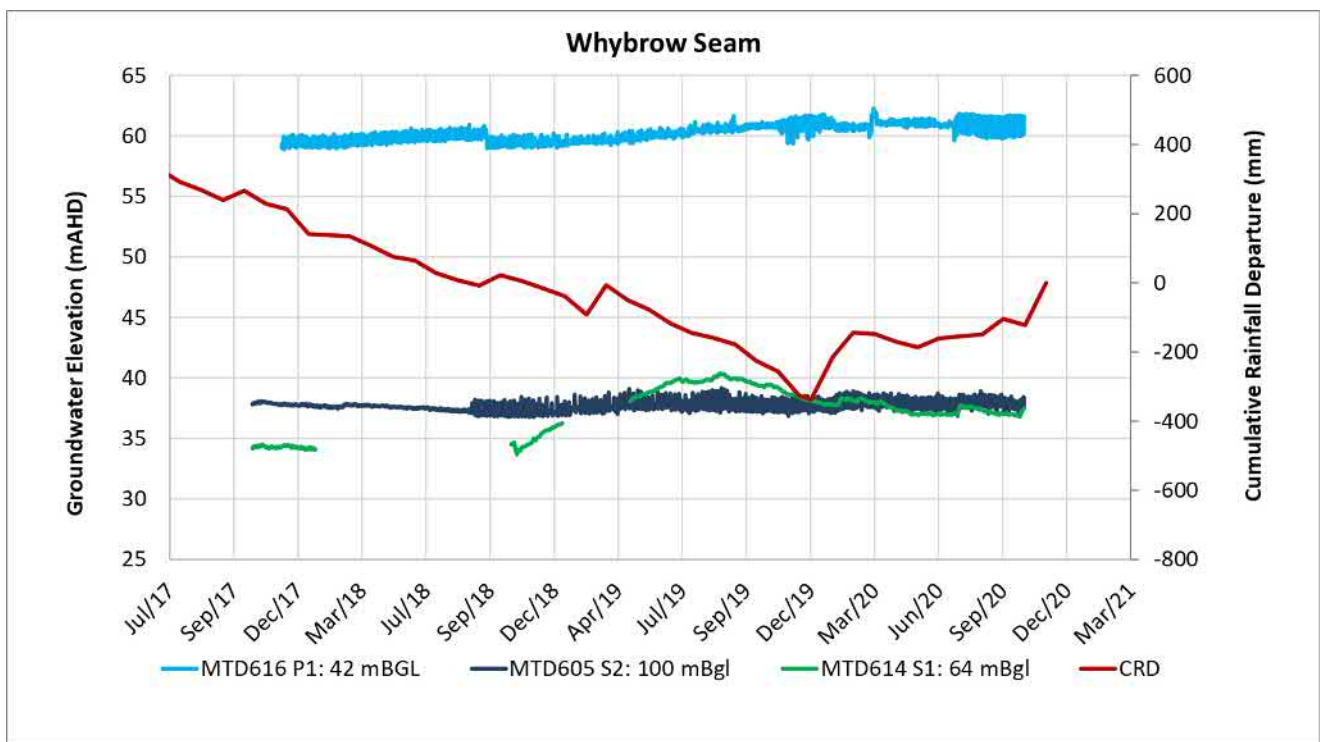
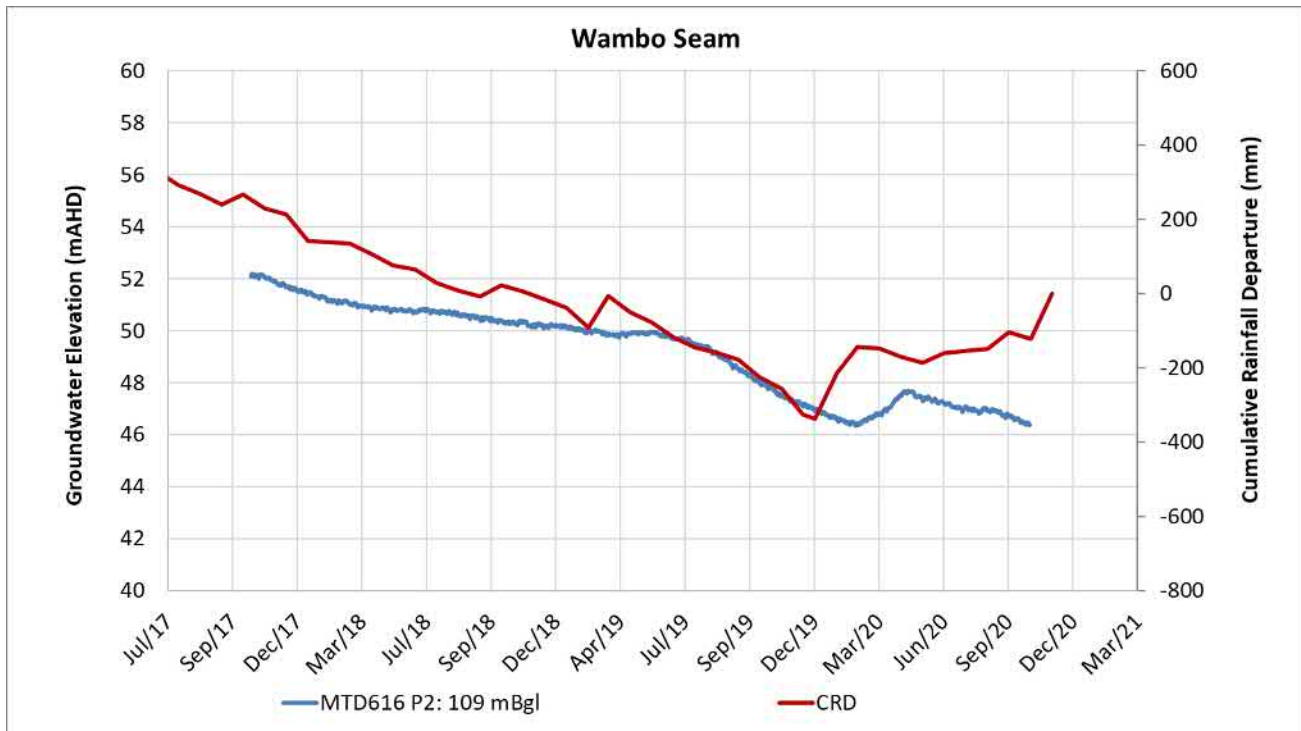
Groundwater elevation trends for VWP sensors installed within the Whybrow and Wambo seams are presented in **Figure 6-8** and **Figure 6-9**, respectively. The Whybrow Seam hydrograph shows that groundwater elevations have remained relatively stable throughout 2020, with the exception of a minor decline in MTD614 S1 of ~1 m. These trends are similar to those observed in the Whybrow Seam standpipe monitoring bores mentioned above. Groundwater elevations in the Wambo Seam recovered temporarily following above average rainfall in February and March 2020. Despite this temporary relief, the declining trends continued over the rest of the year as a result of coal seam depressurisation. It should be noted that 'noise' (short-term fluctuations of up to 2 m) observed in water level data from MTD605 Sensor 2 since mid-2018 and MTD616 P1 over the entire dataset may indicate faulty VWP sensors. This is especially likely since MTD614 Sensor 1 located approximately 800 m to the east of MTD605 does not exhibit the same fluctuations, and such frequent fluctuations would not be related to rainfall or stream water level fluctuations. Further investigation into the condition of MTD616 P1 and MTD605 S2 sensors should be undertaken before the sensor should be replaced.

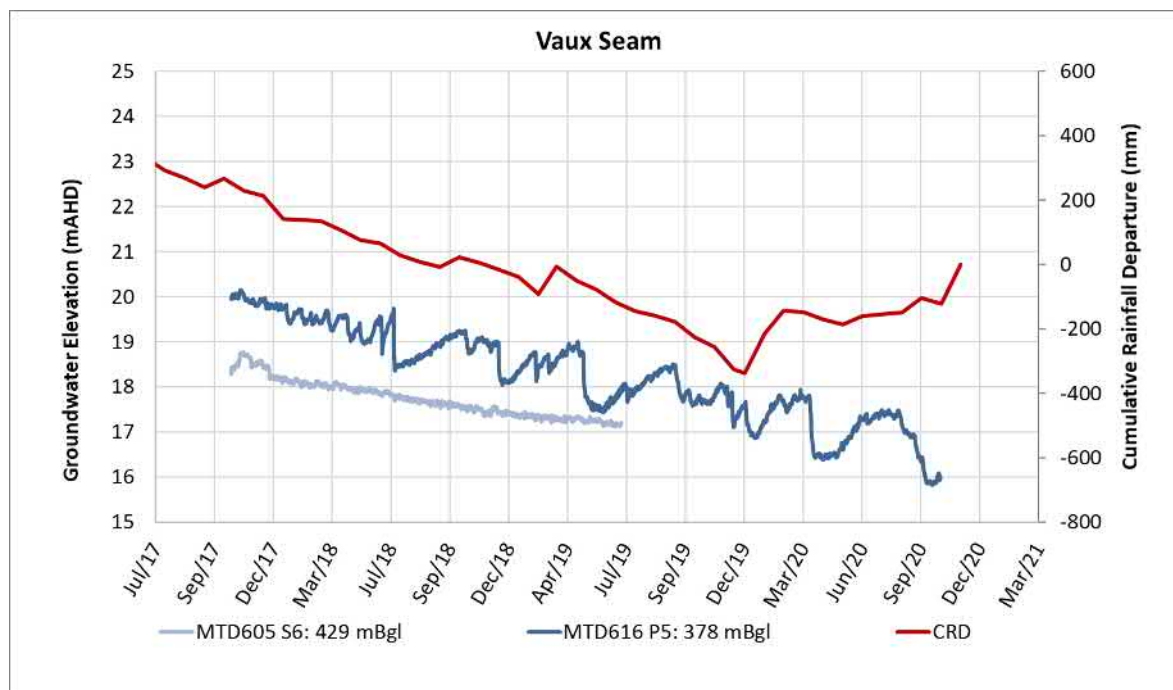
**Figure 6-18 VWP hydrograph of MTD616 P5 and MTD605 S6 (Vaux Seam)**

The sensor for MTD605 (S6) appears to have failed in June 2016 and the logger stopped in June 2019 according to the summary notes provided to SLR. It is recommended that this sensor is replaced. MTD616 P5 has declined approximately 4 m between 2017 and 2020 (**Figure 6-18**). The overall rate of decline appears to be at a steady rate; however, water levels exhibit sinusoidal fluctuations that are likely related to pumping and recovery of water levels in the Vaux Seam. The water level in MTD605 S6 was also following a declining trend, but not dropping at the same rate (approximately 1.6 m between 2017 and 2019). The overall trends observed at these two VWPs are similar to those seen in OH1126 and OH1137 (mentioned above). Therefore, it is also likely that these bores are influenced by surrounding mine operations that target the Vaux Seam. The VWP data from WD625 S3 indicates that only 12 cm of decline has been recorded in the Vaux Seam over the three years of monitoring at this location (**Figure 6-19**).

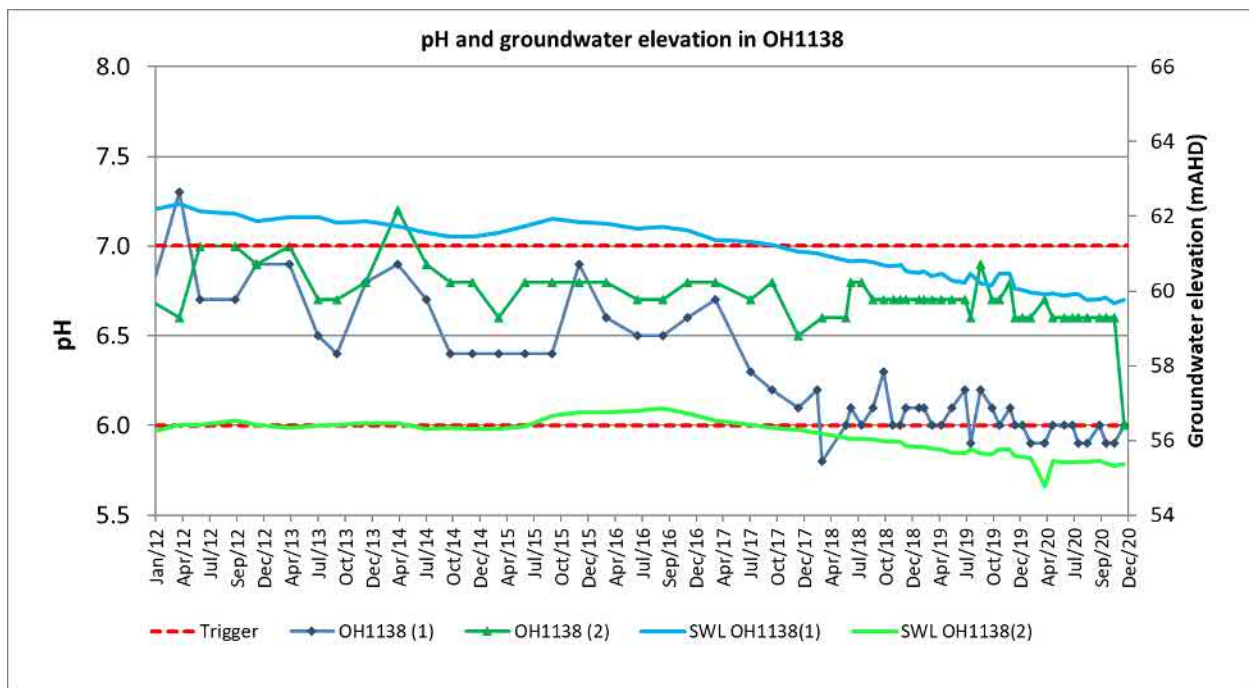
**Figure 6-26 Water Quality Trends at OH1138(1) and OH1138(2)**

Exceedances of the lower trigger level for pH (6.3) has been ongoing since September 2017. Measured pH values during 2020 have remained relatively stable, although slightly lower than those recorded in 2019. Apart from the historical shift in pH values below the lower trigger level, there are no discernible ongoing trends. A comparison of groundwater elevations in OH1138(1) and OH1138 (2) indicate a potential downwards flow gradient at this location. This means there is potential for flow between the two depths within the Warkworth Seam; however, it does not indicate potential for impact to occur from a source at the ground surface. As discussed previously in the annual review for 2019, assessment of water quality data from the adjacent surface water dam 27N resulted in no clear correlation to trends in OH1138. Further assessment of groundwater flow directions and a detailed assessment of pH measurements in other monitoring bores in the network and within the Warkworth Seam could help in better understanding the changes that have occurred to the water quality in this bore. Additionally, the triggers for OH1138(1) should be revised to allow for detection of new trends and potential impact.
