Mount Thorley Warkworth

Aboriginal Heritage Management Plan

2019 Compliance Audit Inspection

Report prepared for
Yancoal Australia, Mount Thorley Warkworth

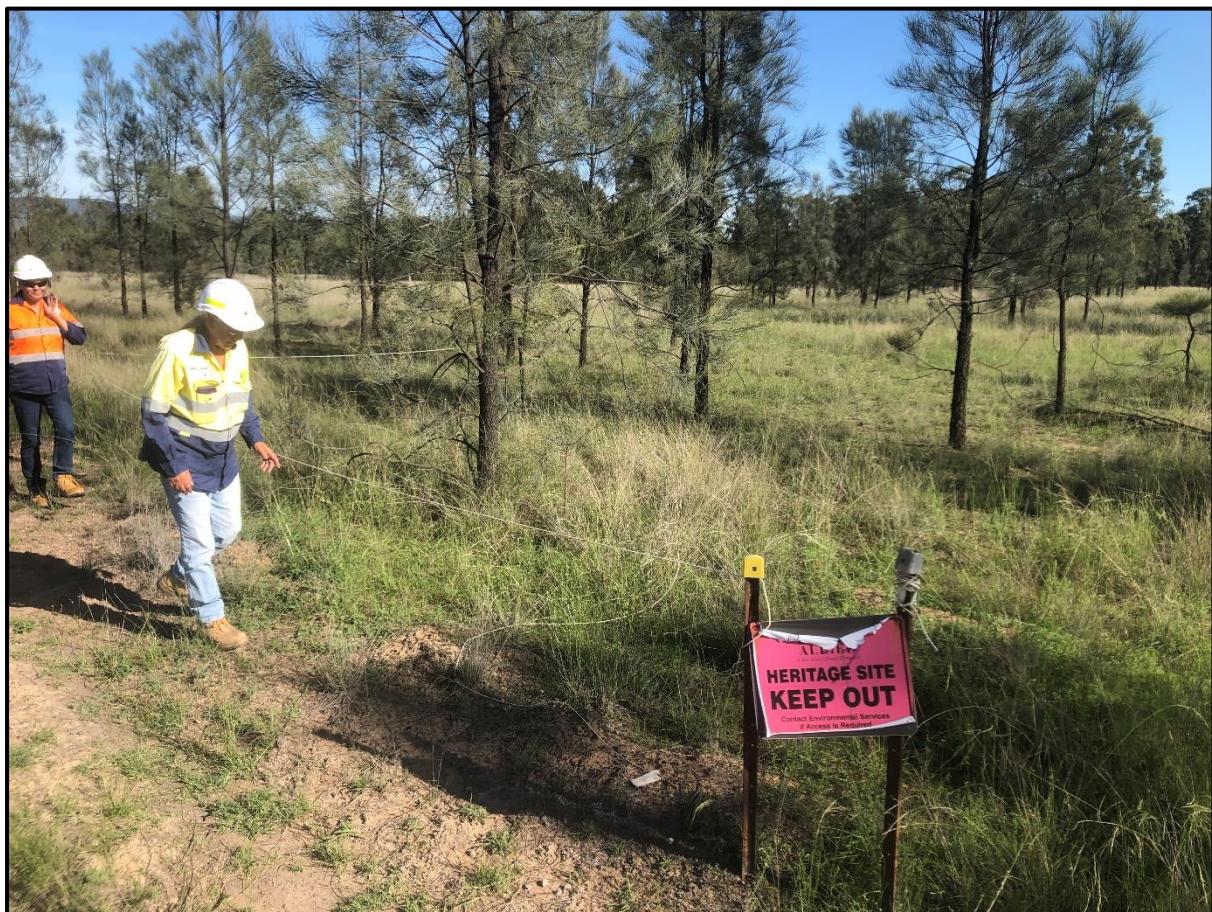
The majority of ACH sites inspected had barricading installed that had deteriorated and required mending or reinstalling. It is recommended that barricading, fencing and signage at these sites be re-installed/repaired to prevent inadvertent disturbance.

Example of dilapidated barricading

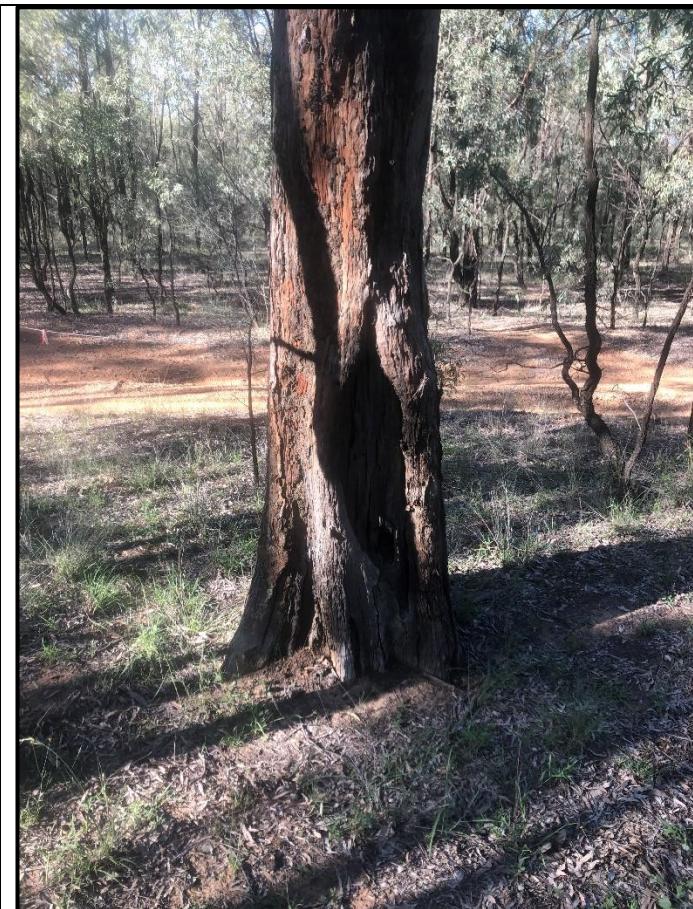
Scarred tree MTW-8

Four scarred trees are located within the approved future mining area at MTW. With the exception of MTW-70, these trees have been visited by an arborist to assess the best method of removal and relocation, and general plans developed. MTW-70 should also be assessed for removal and relocation. These scarred trees have been visited by RAPs during this compliance inspection and during other inspections and assessments. Their removal and the arborist's plans should be discussed with the CHWG, as well as the location to where they will be relocated – the Wollombi Brook ACH Conservation Area has been suggested.

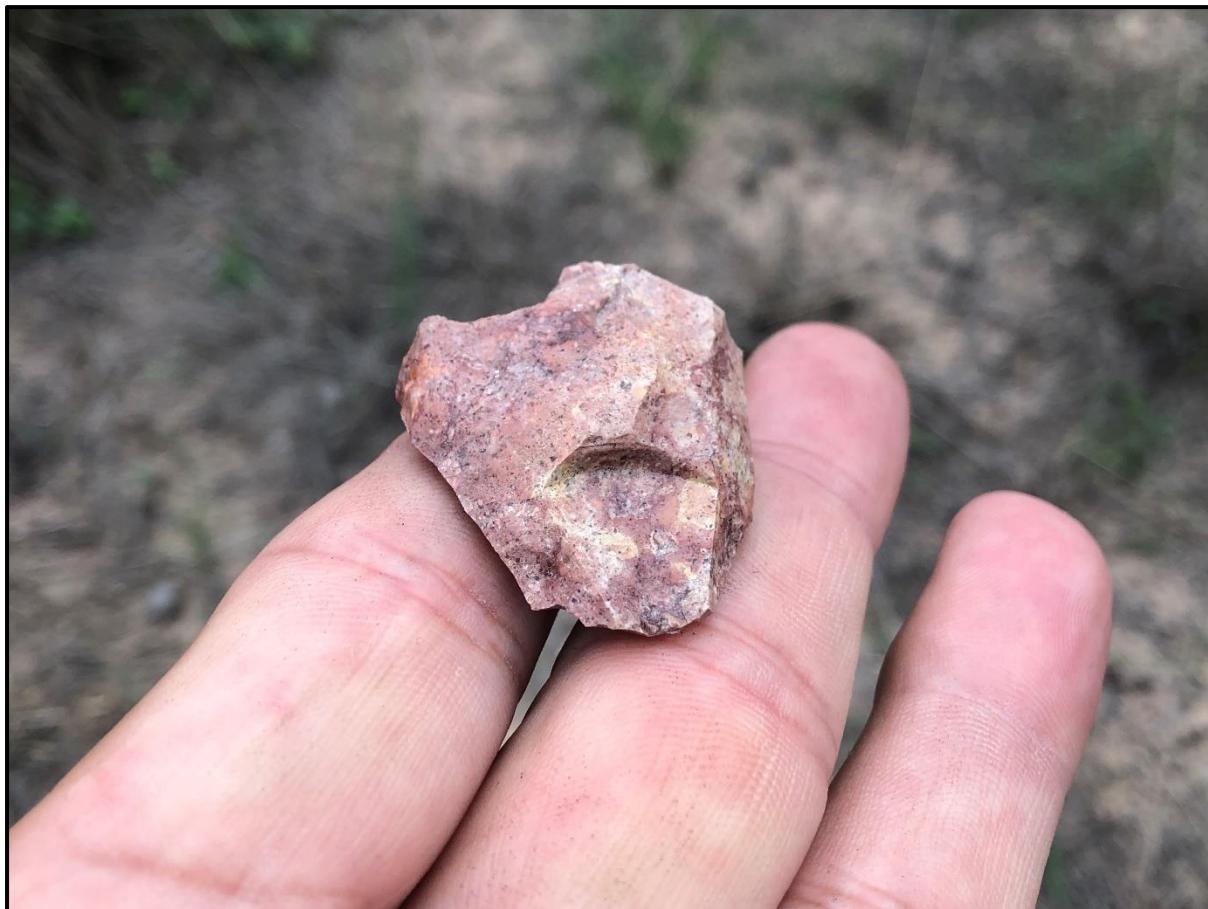
Limited information is on file regarding ACH site WB3, which was recorded off Charlton Rd several decades ago when GIS/GPS equipment was less advanced and accurate than today. Previous inspections have failed to relocate the site, however, during the current compliance inspection a silcrete flaked piece was identified near to the registered co-ordinates (317593e 6385352n). It is recommended that the site record be relocated to these co-ordinates within the MTW GIS system.

Silcrete flaked piece from WB3
