2019 STREAM HEALTH AND STABILITY REPORT

Mount Thorley Warkworth

SLR Ref: 630.12941-R01
Version No: -v0.2
March 2020

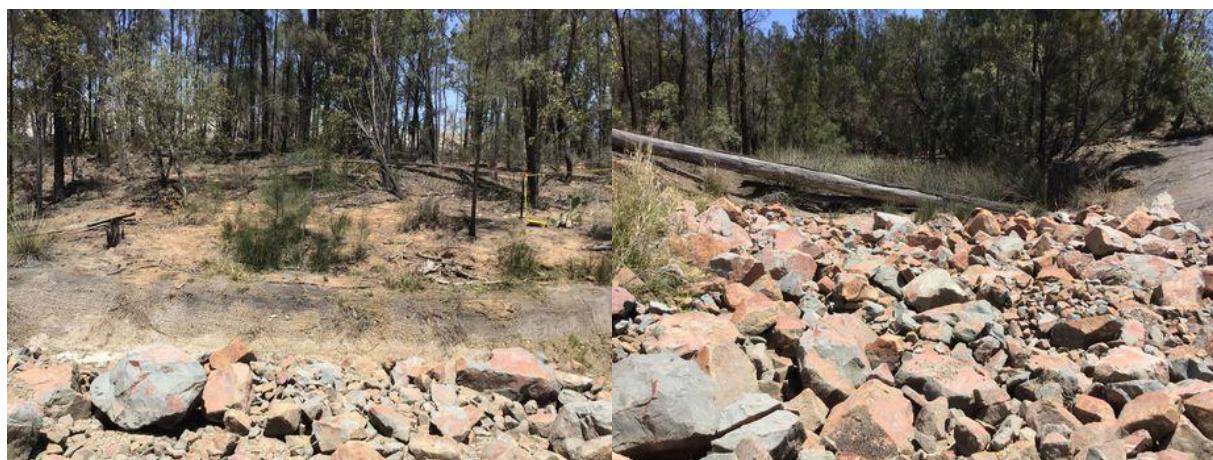
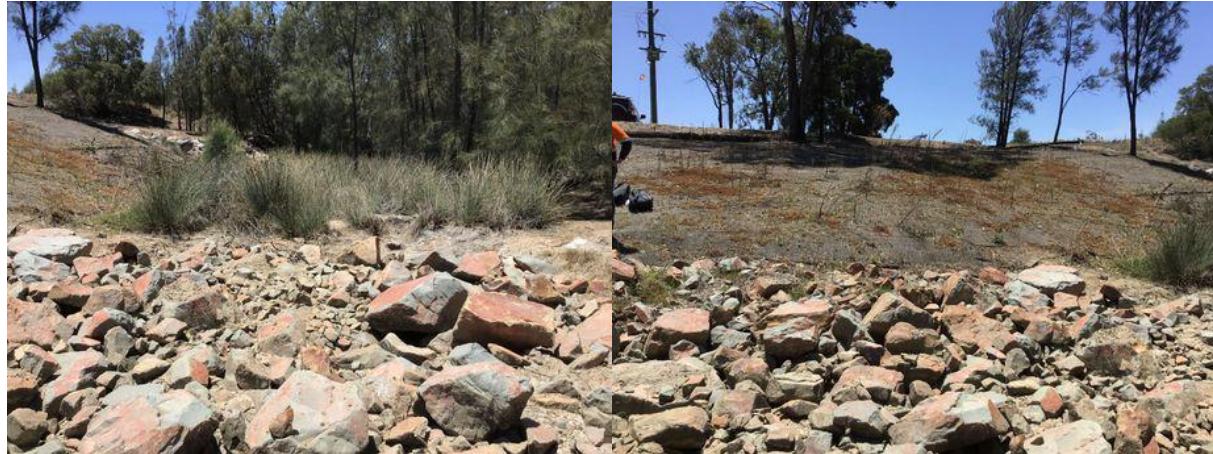
CSIRO Ephemeral Stream Assessment Classification – **Potentially Stabilising**

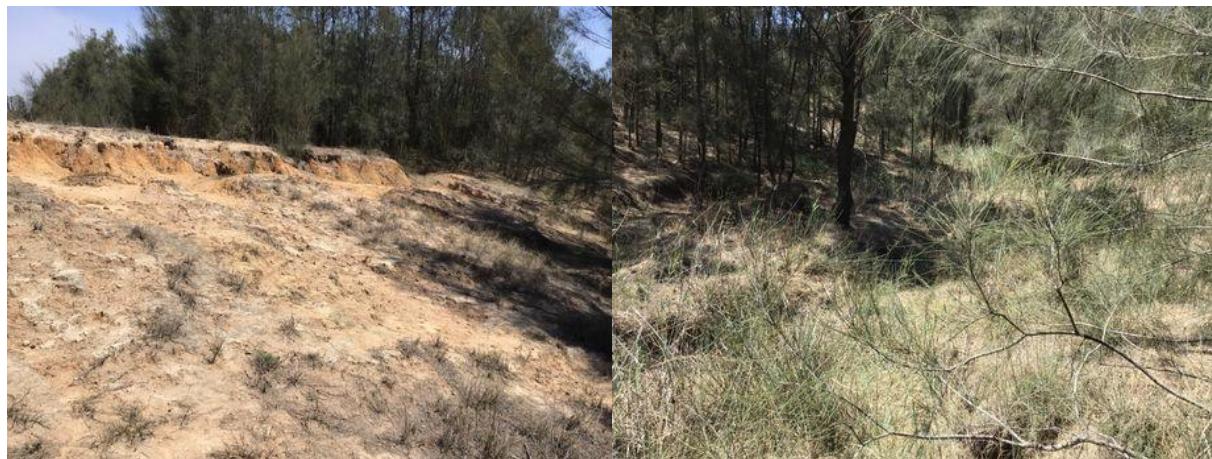
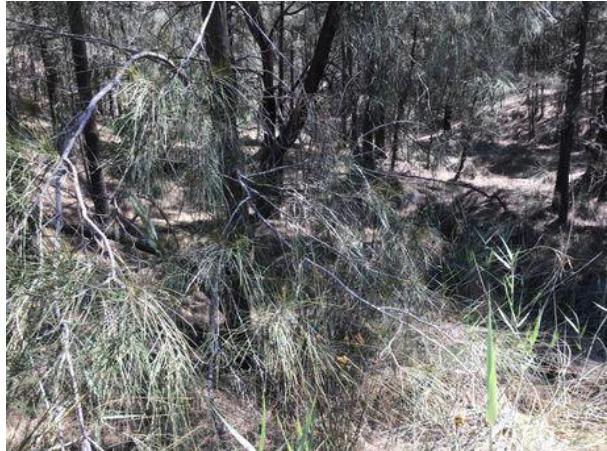
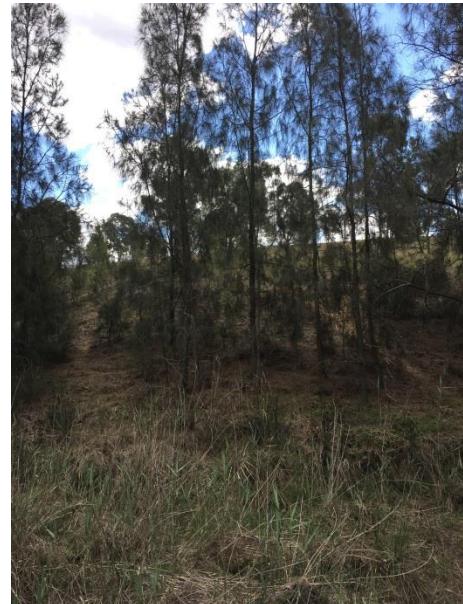
The channel at this location was observed to have a good coverage of long grass across the bed. The left bank also appears stable with good grass coverage. The right bank contains some lateral erosion (approximately 0.5m

high) at the top of the bank. The lateral erosion is forming some rill/gully erosion down this bank, however the rest of the right bank appears to be stable with good grass coverage. Overall, this location shows similar conditions to the previous monitoring cycle.

CSIRO Ephemeral Stream Assessment Classification – **Active**

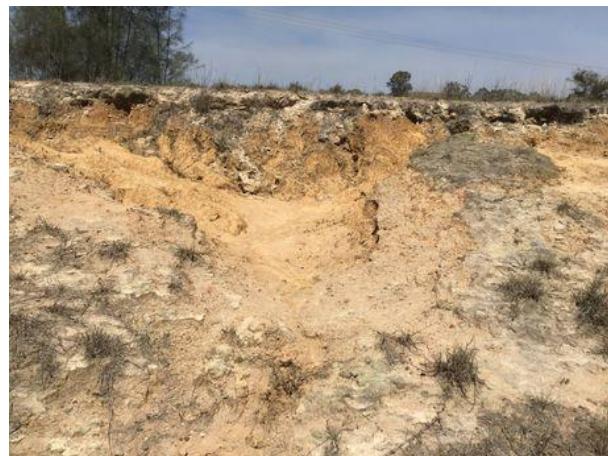
Plate 9 Erosion (top of right bank)

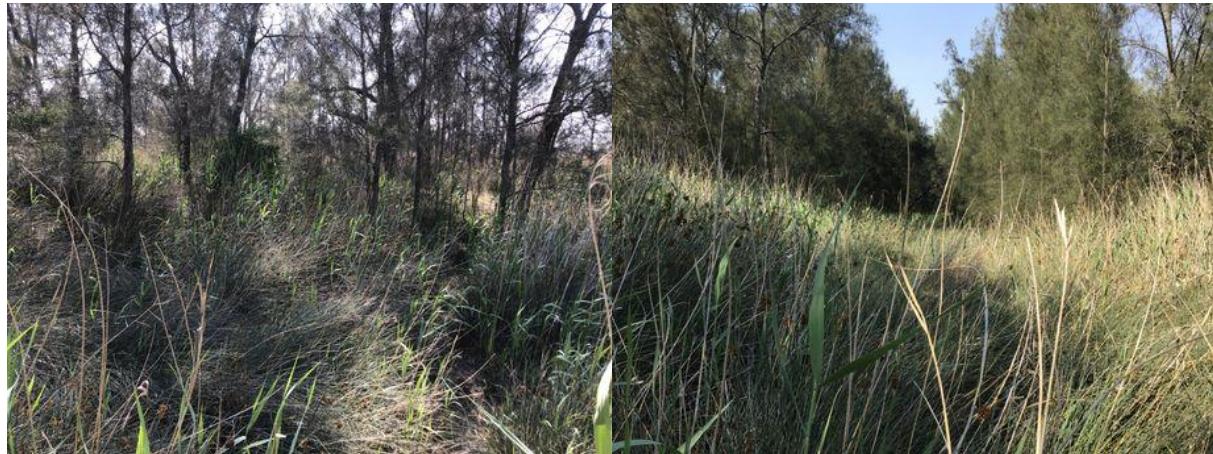
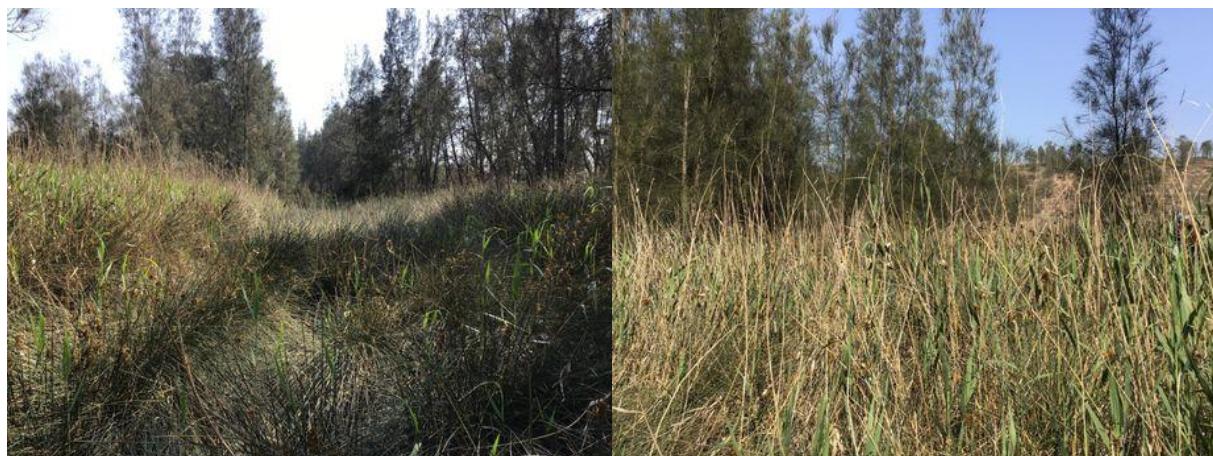
The creek bed at this monitoring point is covered by reeds and is stable. Both the left and right banks have good grass coverage and appear to be stable with gentle-moderate slopes. The creek upstream and downstream of the monitoring point also appears to be stable. The creek has a very slight meander at this monitoring point. Overall this location has remained the same as the previous monitoring cycle conditions.

CSIRO Ephemeral Stream Assessment Classification – **Stable**

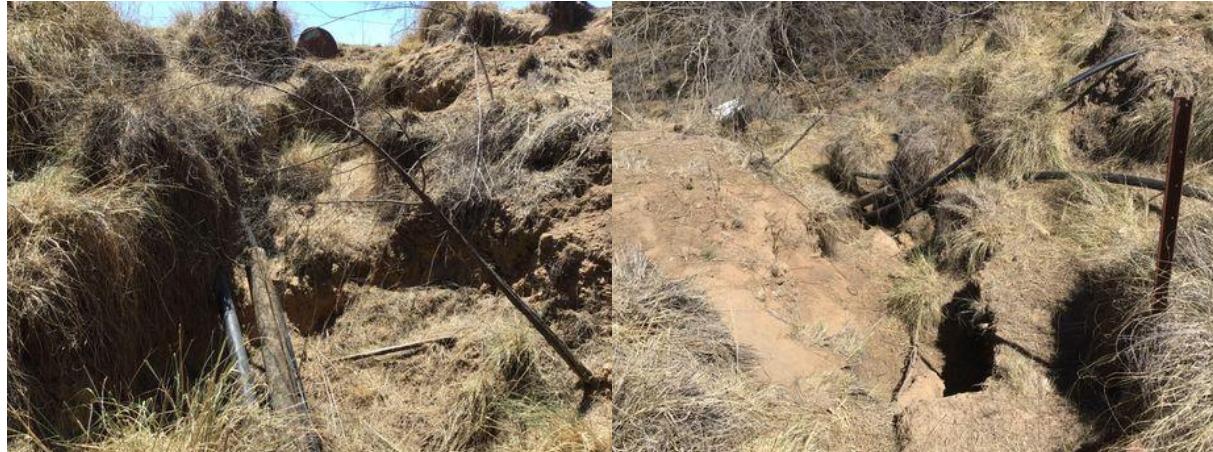
CSIRO Ephemeral Stream Assessment Classification – **Potentially Stabilising**

Plate 18 Erosion

Plate 19 Erosion

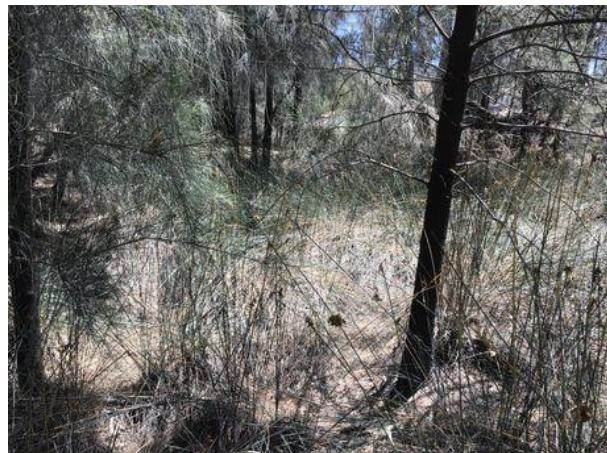
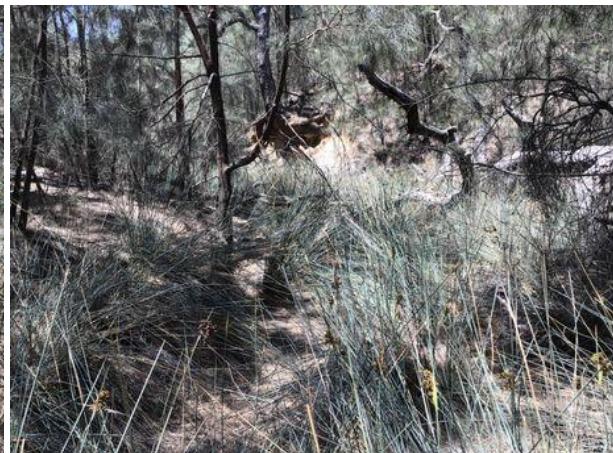
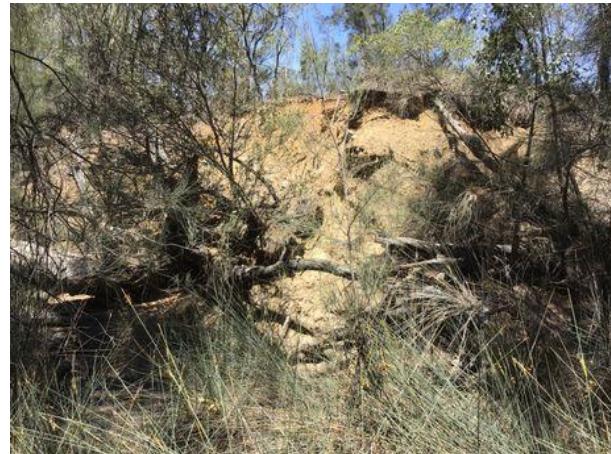
The erosion observed at LC2 included a steep near vertical section of exposed dispersive material (approximately 2m high) on the right bank. This area appeared to be actively eroding including some areas immediately downstream. However, this monitoring location appears to be similar to what was observed in the 2018 survey. A tree was observed to have fallen over at this section of the exposed creek bank. The creek bed and left bank appear to be stable at this location.

CSIRO Ephemeral Stream Assessment Classification – **Active**

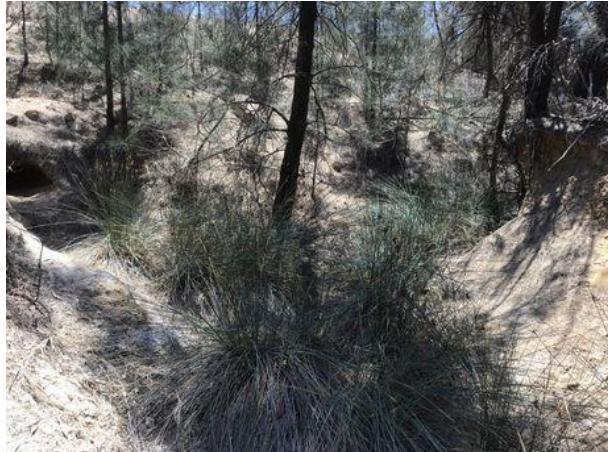
Plate 29 Erosion

CSIRO Ephemeral Stream Assessment Classification – **Very Active**

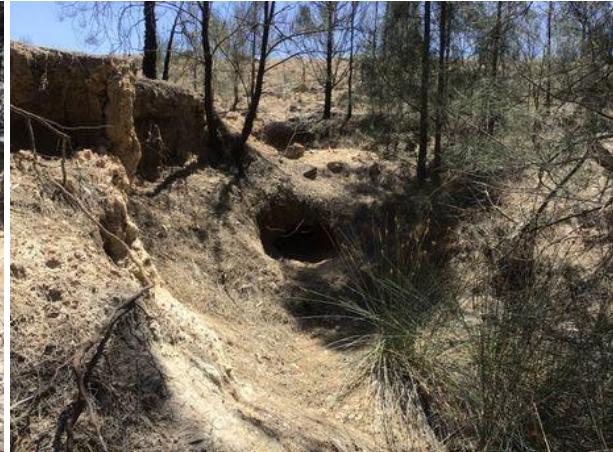
Plate 30 Tunnel Erosion

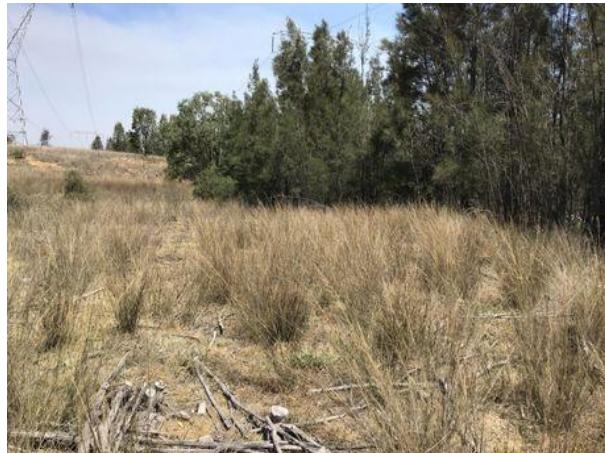
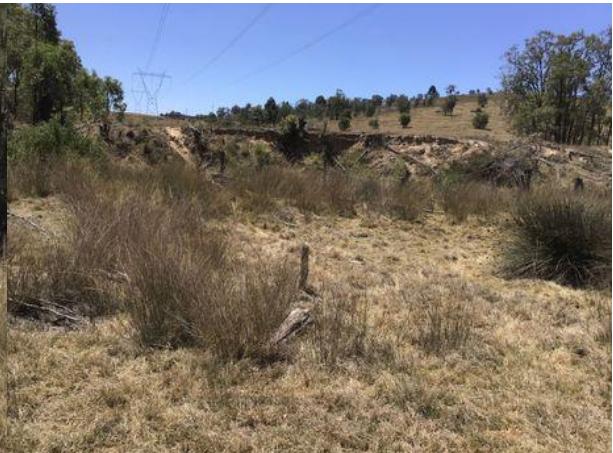
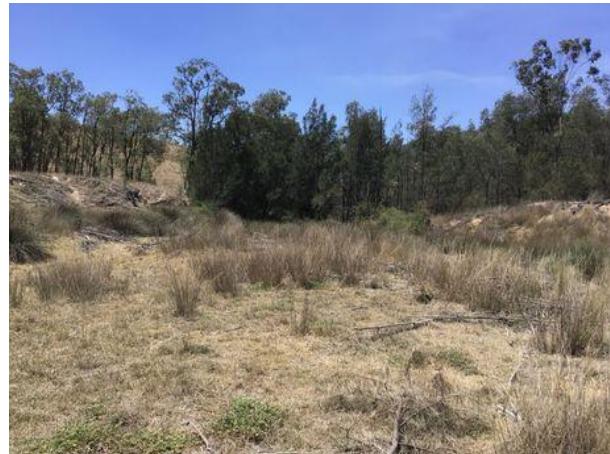
LC4 is located under a powerline in an area where it appears that vegetation has been maintained within the powerline easement. The near vertical left bank on the outside of the creek meander is about 4-5m high and has some exposed dispersive material (approximately 1m high) near the top of the bank however this erosion has shown signs of potentially stabilising. The right bank is much flatter and appears to be stable, as does the creek bed. Overall, this monitoring location has shown similar conditions to the previous monitoring cycle.

CSIRO Ephemeral Stream Assessment Classification – **Potentially Stabilising**

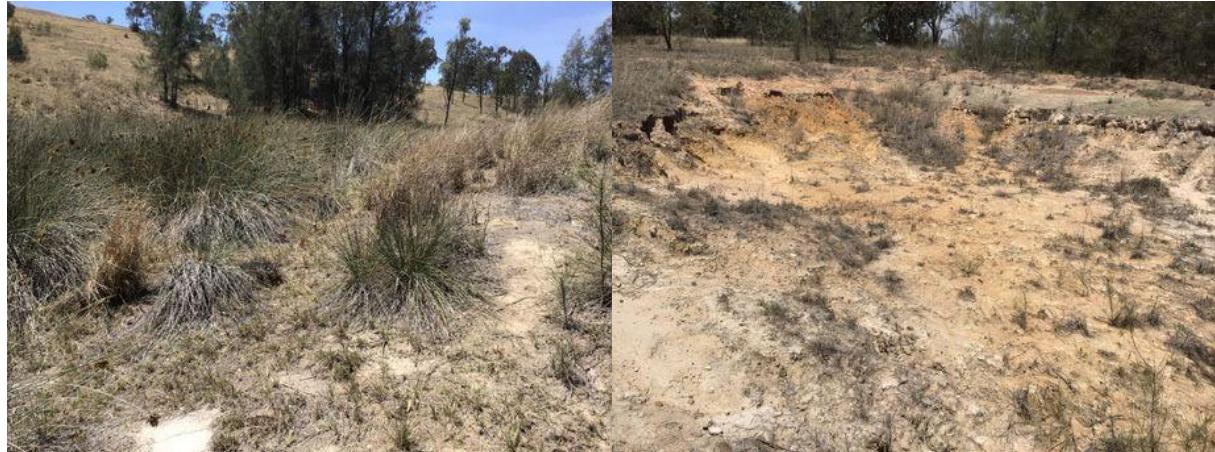
LC5 is located in a historic diversion of Loders Creek. The erosion observed at LC5 included erosion extending up the right bank approximately 20-30m. The area has 0.5-1.0m high steep exposed walls surrounding 5m of exposed soil. The creek bed and left bank appear to be stable. Overall, this monitoring location has shown similar conditions to the previous monitoring cycle.

CSIRO Ephemeral Stream Assessment Classification – **Active**

Plate 37 Erosion (top of right bank)

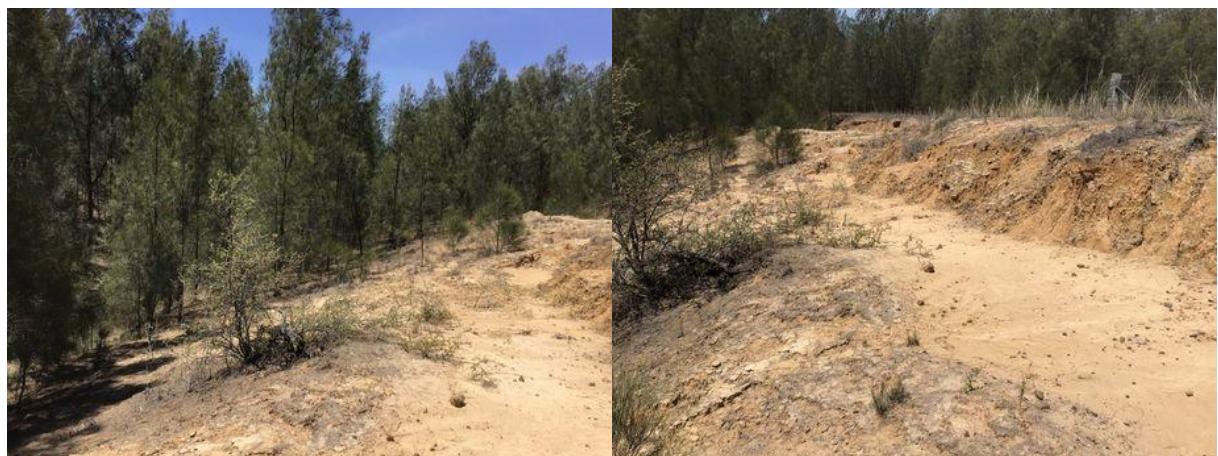
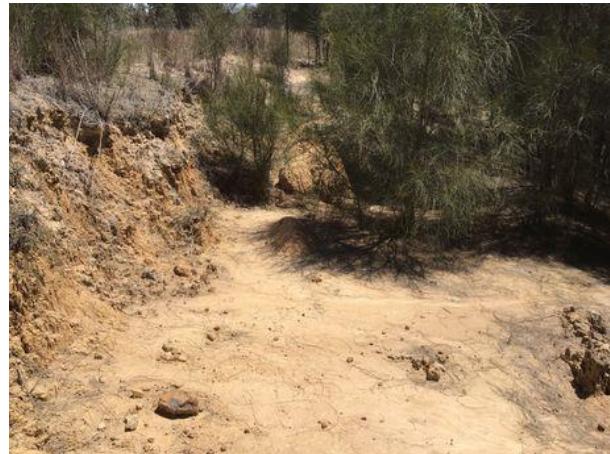
The erosion observed at LC6 included significant lateral erosion near the top of the right bank. This erosion was approximately 1m high with an alluvial fan extending approximately 2m from the near vertical bank. The rest of the right bank appears to be stable as does the creek bed and the left bank. Overall, this monitoring location appears similar to the previous monitoring cycle. The active erosion appears to be primarily the result of a historic disturbance of the top of the right bank which has exposed the highly dispersive soils at this location.

CSIRO Ephemeral Stream Assessment Classification – **Active**

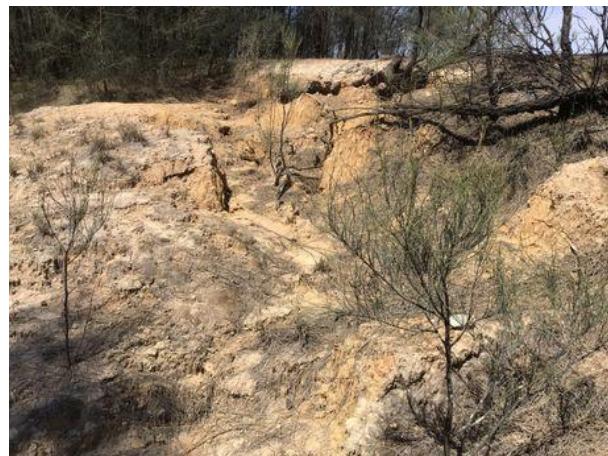
Plate 45 Erosion

The erosion observed at LC7 included an area of active erosion of a steep comprising exposed dispersive clay material (approximately 0.8m high) on the right bank, however this erosion is not laterally extensive. The erosion appears to have been caused by lateral flow across the bare banks in the area. The right bank appears to be stable downslope of the eroded area, as does the creek bed and the left bank. Overall, this monitoring location has shown similar conditions to the previous monitoring cycle.

CSIRO Ephemeral Stream Assessment Classification – **Active**

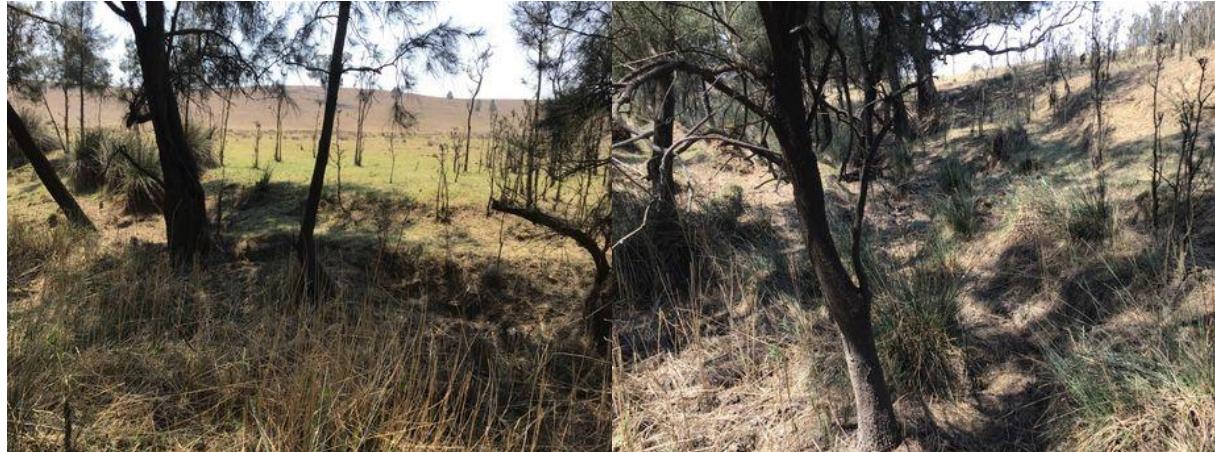
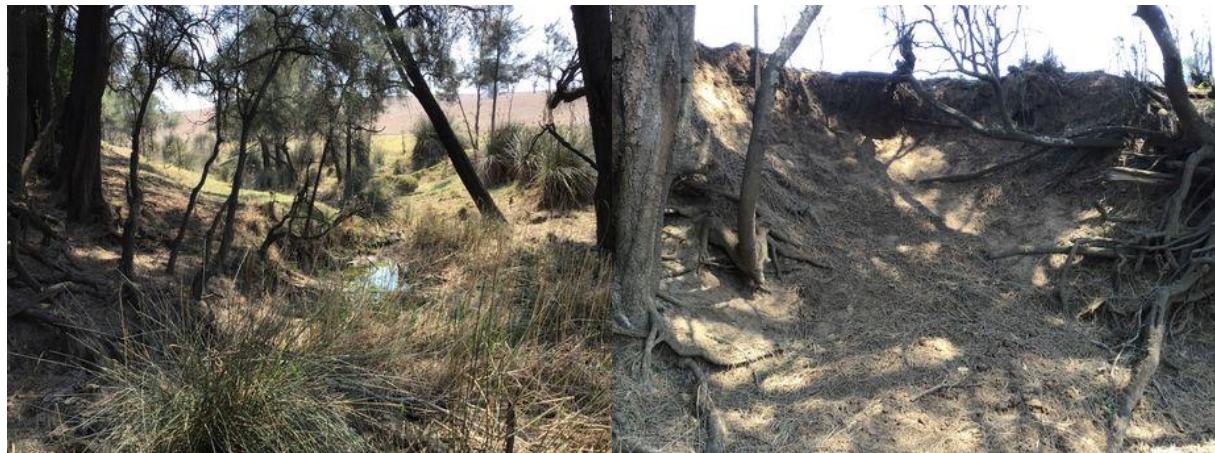
The erosion observed at LC8 included significant erosion of the left bank (approximately 0.8m high with the overall bank at approximately 2.5m high) at a location with a slight meander in the creek as shown on Plate 57. The erosion has some minor undercutting with a section of vertical banks partly stabilised by tree roots. The soil appears be alluvial and not particularly dispersive. Trees at this location are at risk of falling over due to loss of support. The creek bed and right bank appear to be stable. Overall, this monitoring location has shown similar conditions to the previous monitoring cycle.

CSIRO Ephemeral Stream Assessment Classification – **Potentially Stabilising**

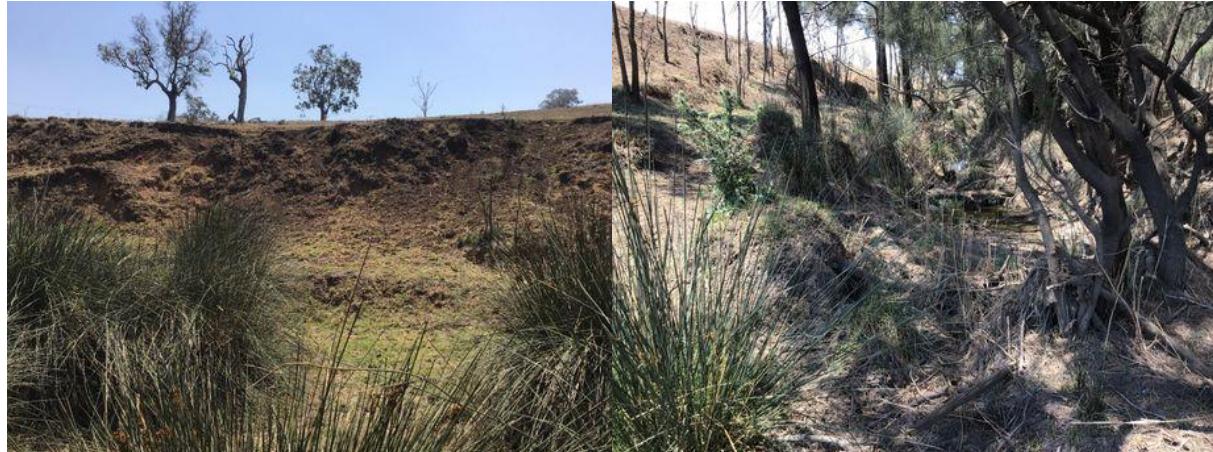
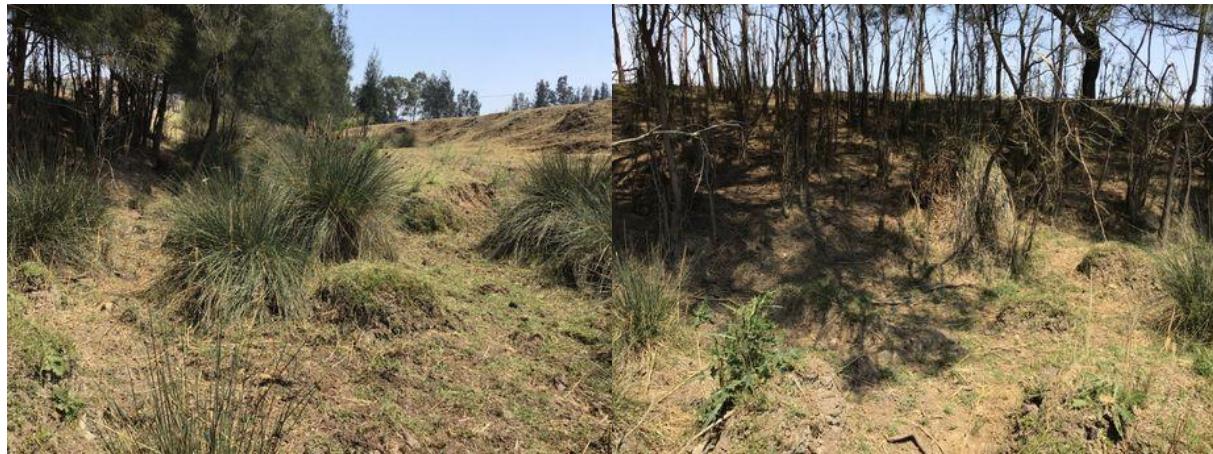
The erosion observed at LC9 included some loss of exposed slightly dispersive material on the right bank which may have been caused by livestock in the area. This bank is about 2m high and has about 0.8m of exposed soil. The area appears to be stabilising. The creek bed and the left bank appear to be stable. Overall, this monitoring location has shown similar conditions to the previous monitoring cycle.

CSIRO Ephemeral Stream Assessment Classification – **Potentially Stabilising**

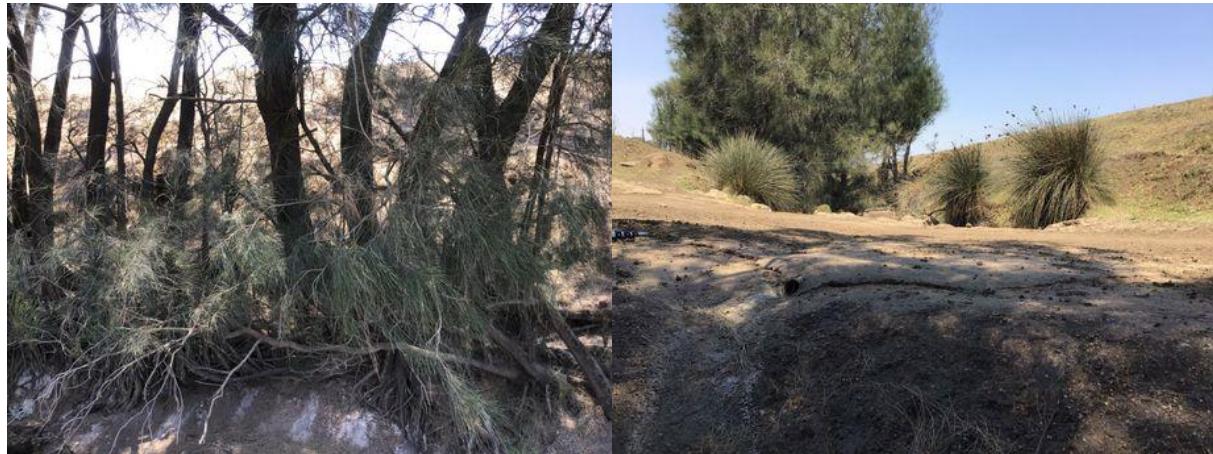
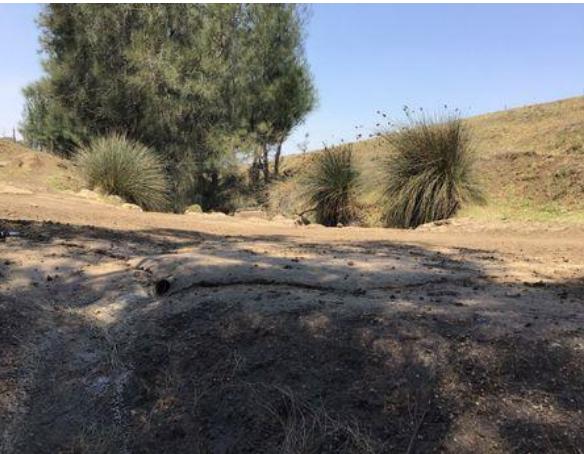
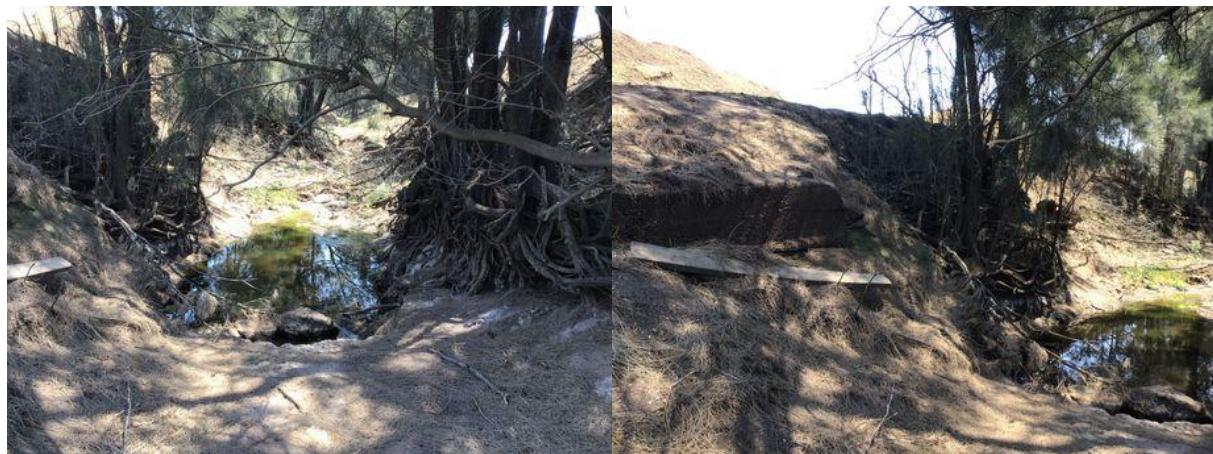
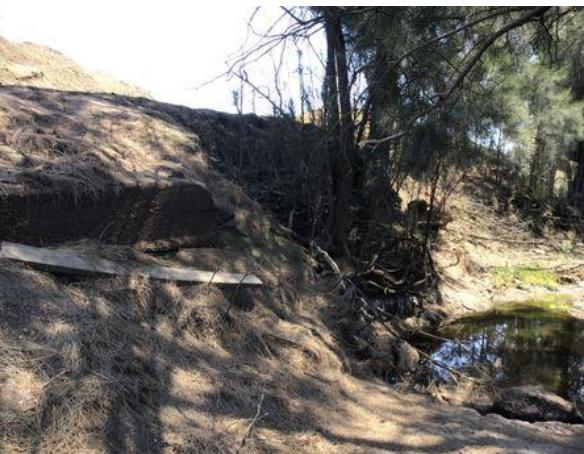
The erosion observed at LC10 is located immediately downstream of a concrete lined chute. The soil is alluvial and non-dispersive. The erosion has been created from scouring of the right bank during large flow events with the upstream chute increasing the velocity of the water to this downstream section of channel. This scouring has exposed some tree roots of some of the trees that line the creek bank. The creek has steep slopes on both banks (approximately 4m high). The creek is generally stable upstream and downstream except for some cattle tracks immediately upstream on the right bank. Limited vegetation exists in the creek bed. Overall, this monitoring location has shown similar conditions to the previous monitoring cycle.

CSIRO Ephemeral Stream Assessment Classification – **Potentially Stabilising**

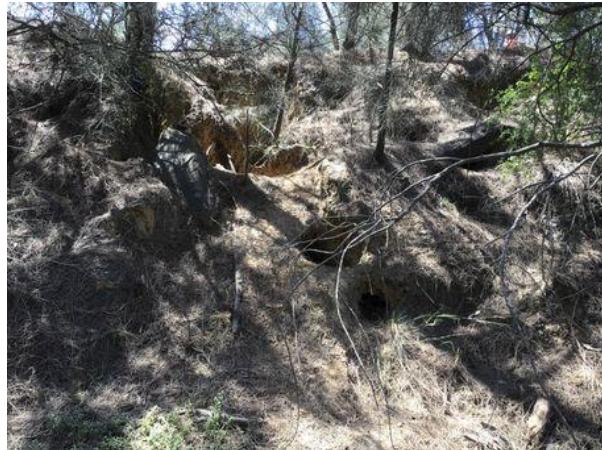
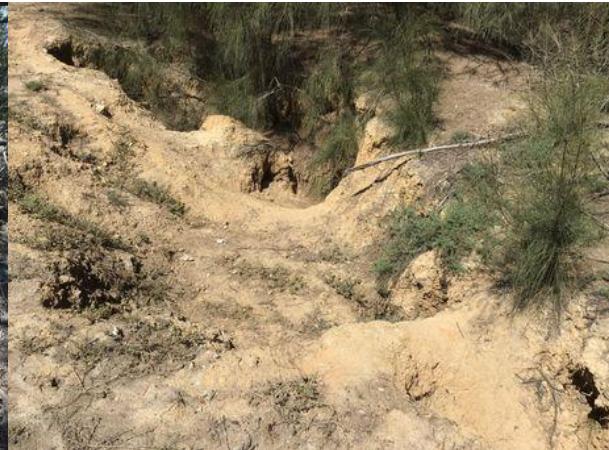
The erosion observed at LC11 includes some significant tunnelling and active erosion on the left bank with exposed vertical dispersive soil. Potential causes for this erosion include wombat holes as well as the presence of a contour bank overflow (which is located immediately upslope of the erosion). Trees were observed on both banks and creek bed. The creek bed and the right bank both show stable conditions. Overall, this monitoring location has shown similar conditions to the previous monitoring cycle.

CSIRO Ephemeral Stream Assessment Classification – **Active**

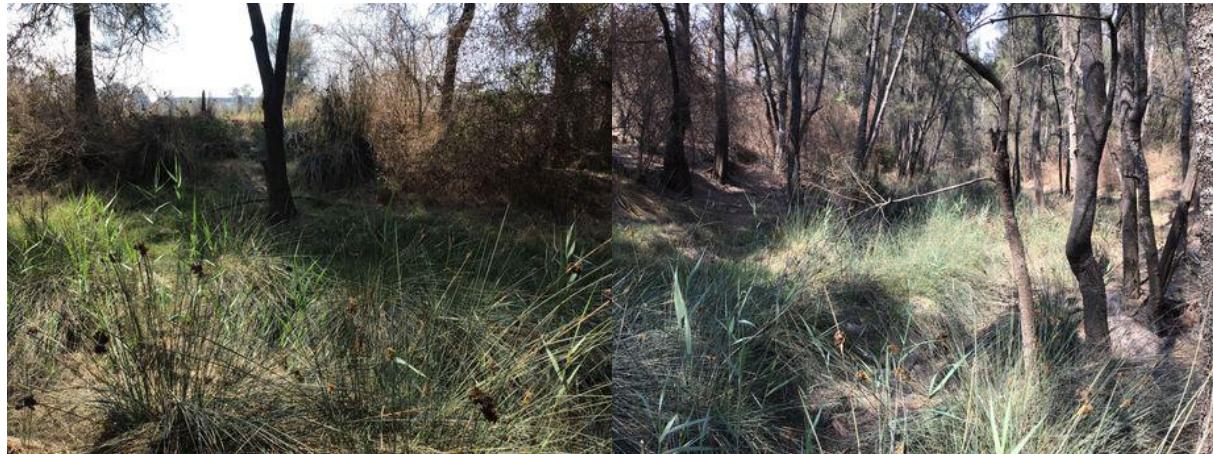
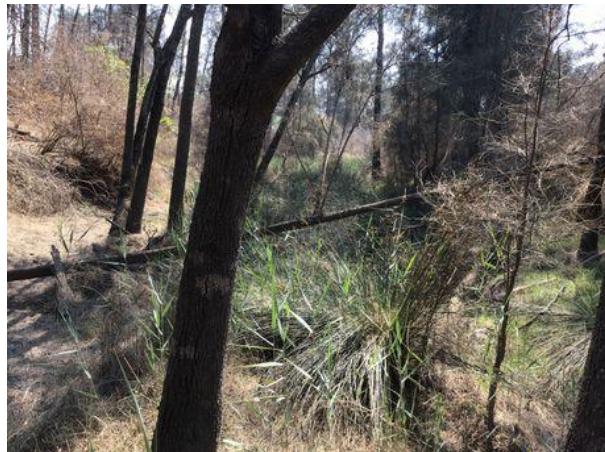
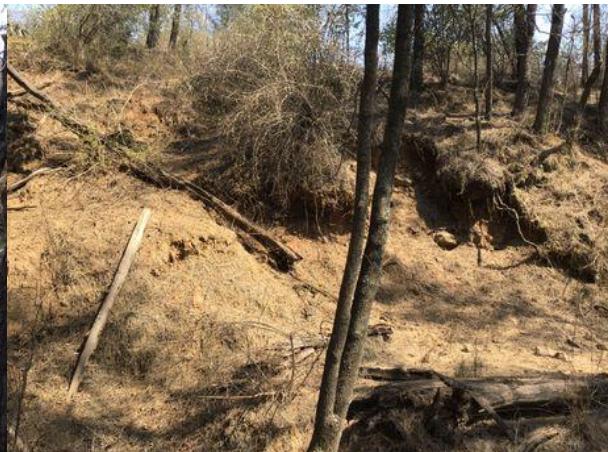
The erosion observed at LC12 includes some erosion (approximately 2m high) on the left bank with exposed vertical dispersive soil. It is likely that this erosion was at least partially caused by a fallen tree at the monitoring point location. The left bank at the monitoring point is significantly higher than the right bank. The creek bed and the right bank both show stable conditions. Overall, this monitoring location has shown similar conditions to the previous monitoring cycle.

CSIRO Ephemeral Stream Assessment Classification – **Potentially Stabilising**

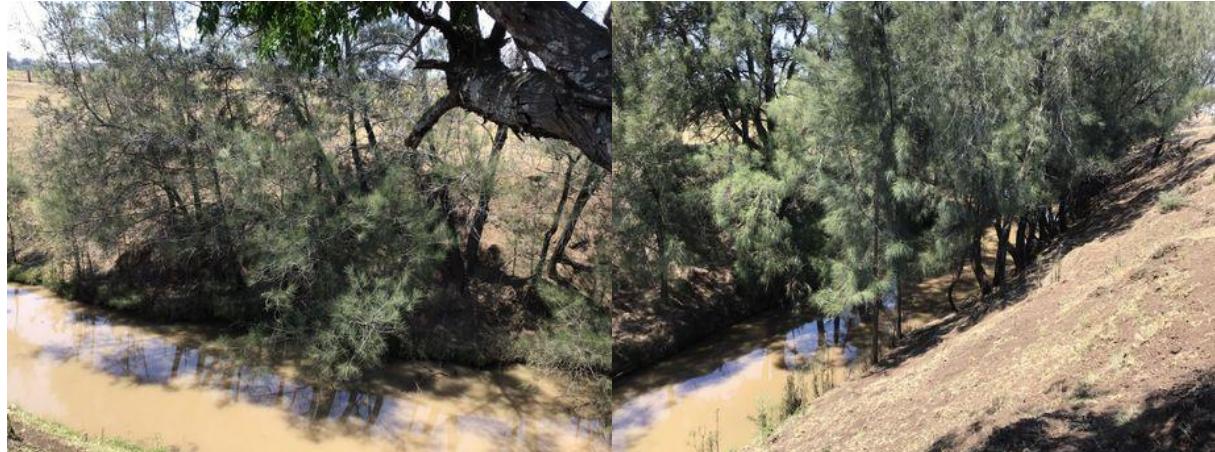
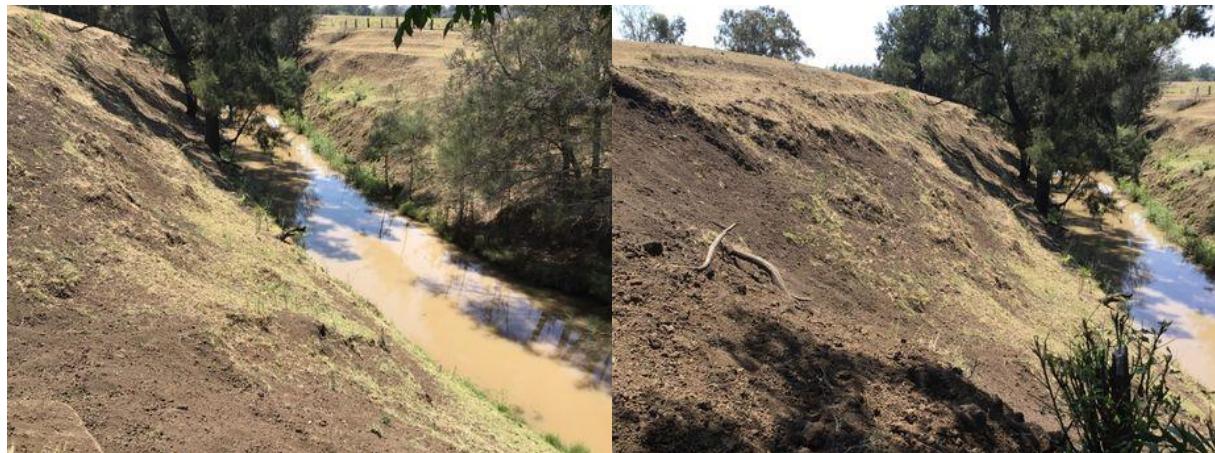
LC13 includes some erosion extending for approximately 5m on the steep left bank with exposed soil which doesn't appear to be highly dispersive. This erosion was most likely caused by livestock tracks observed upstream and downstream of the monitoring location or a localised slope failure. The creek and the right bank both show stable conditions. Overall, this monitoring location has shown similar conditions to the previous monitoring cycle.

CSIRO Ephemeral Stream Assessment Classification – **Active**
