Mount Thorley Warkworth Historic Heritage Management Plan 2019 Compliance Audit Inspection

Report prepared for

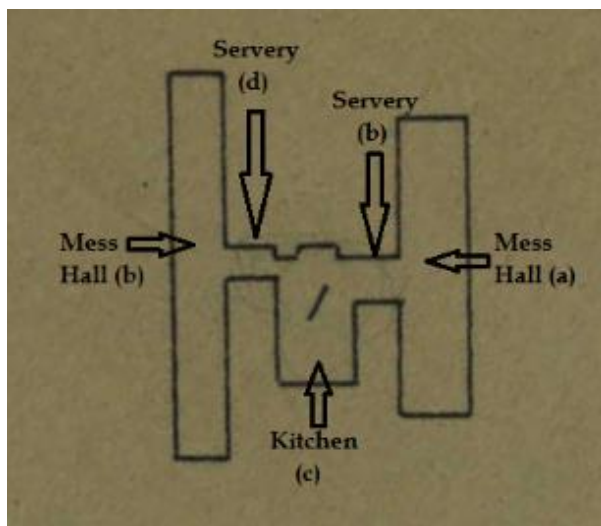
Original layout of building

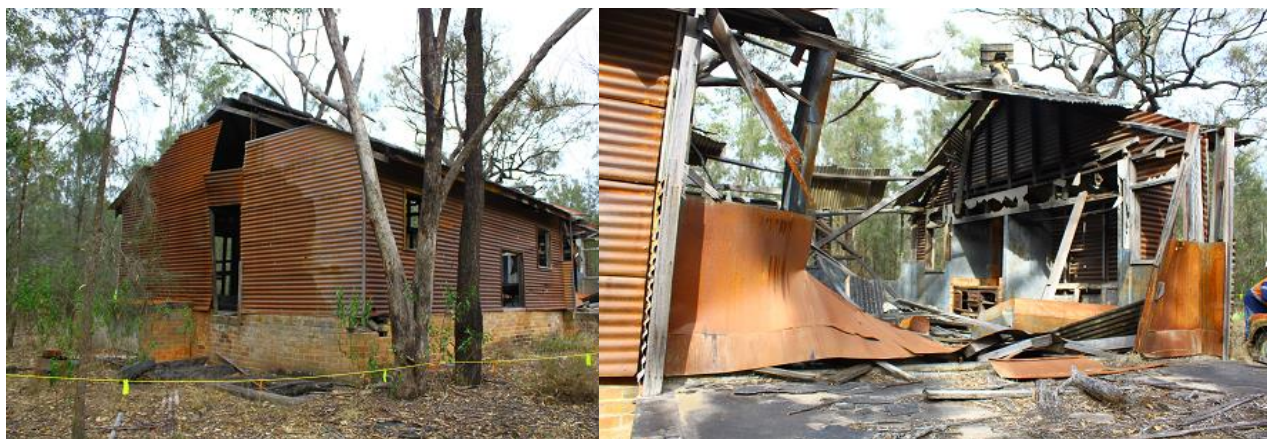
View to mess from south-east (2012)

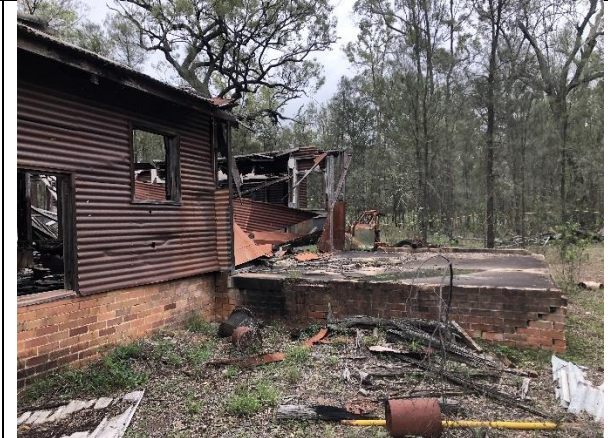
View to north-east elevation

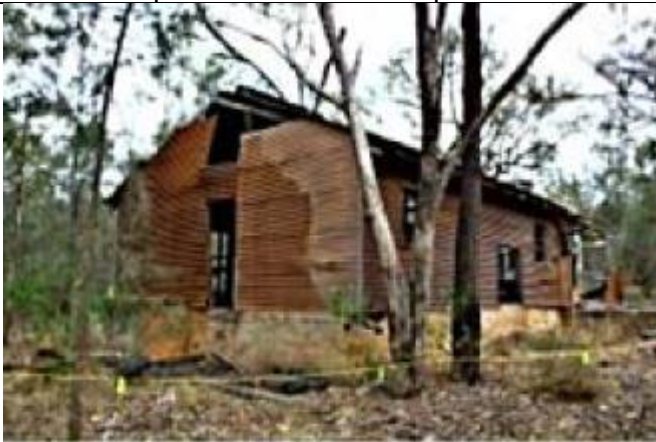
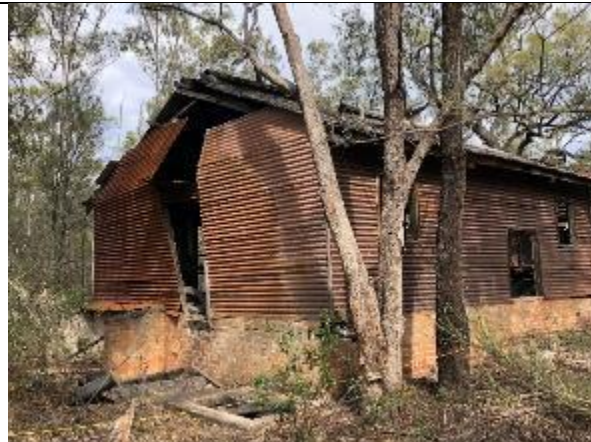
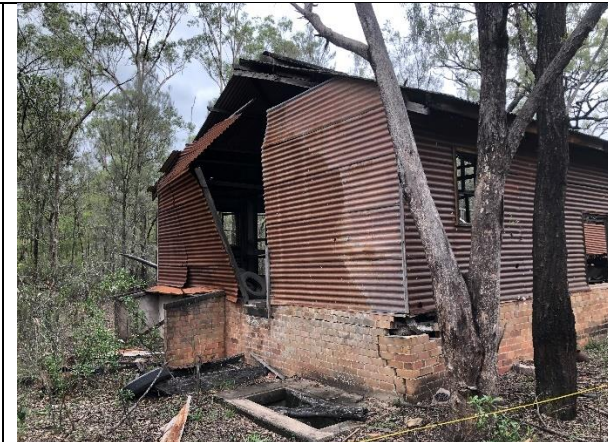
South-east elevation

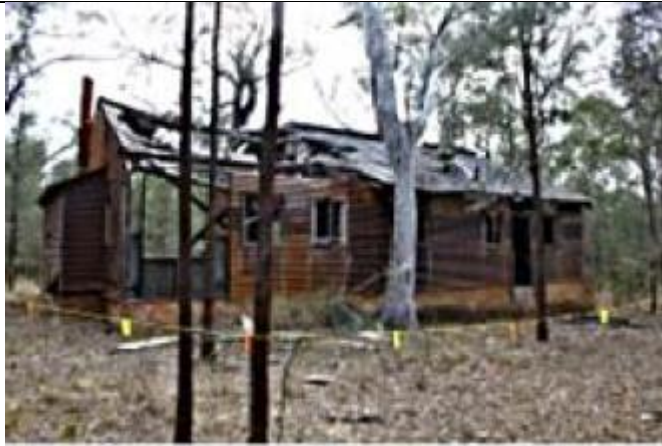
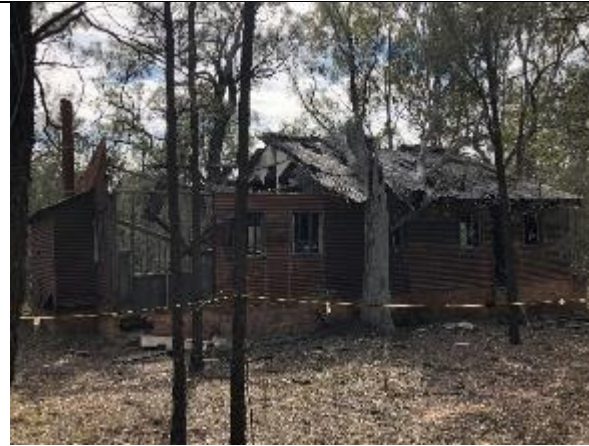
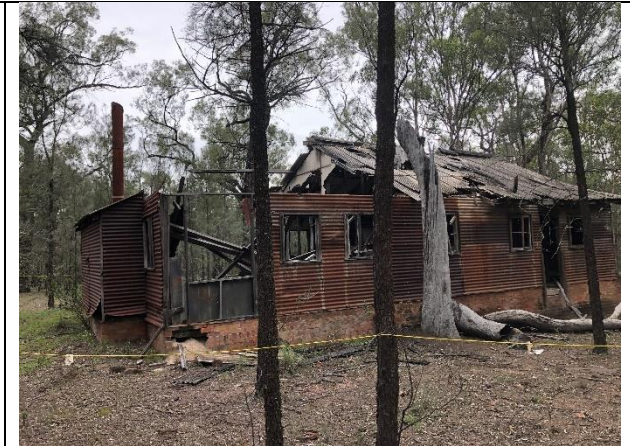
2018-20: increased bow to southern wall.

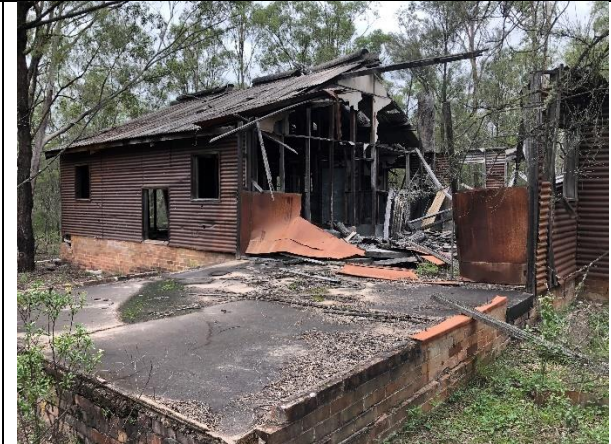
Concrete and brick foundation at east side of building

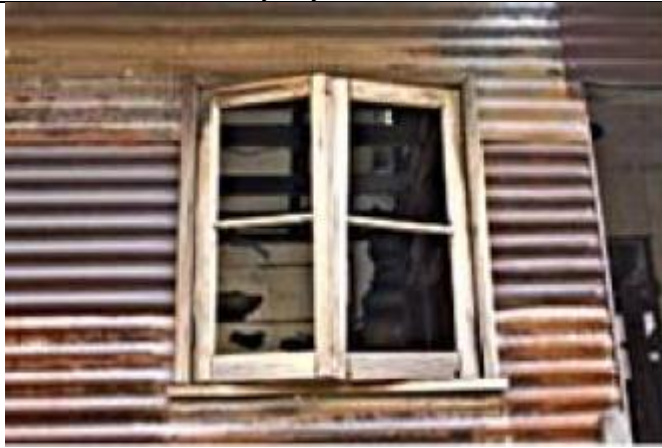
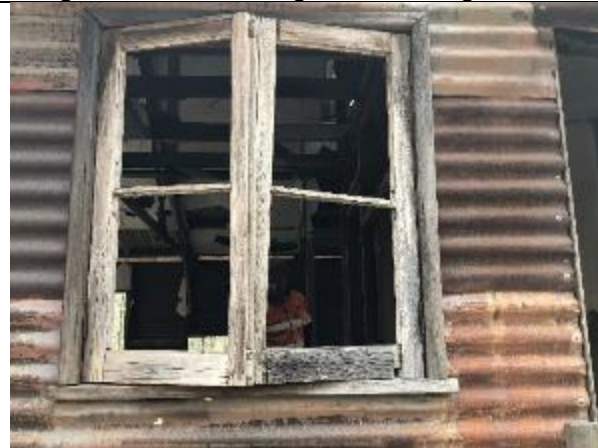
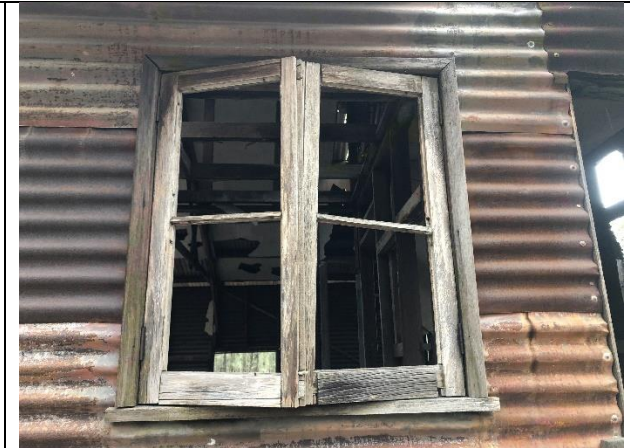
Timber window detail, west elevation

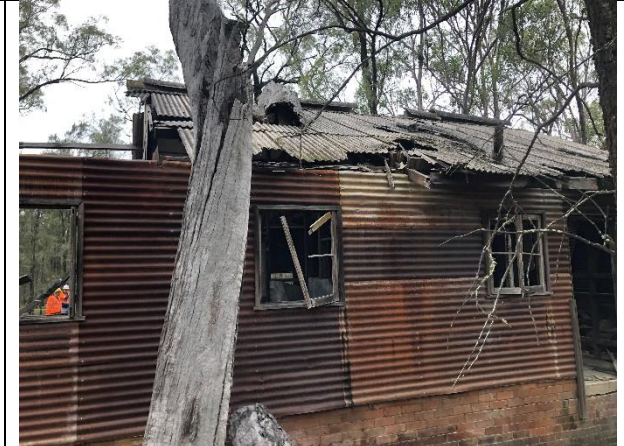
Showing cylindrical ventilator and damage to roof, view from west

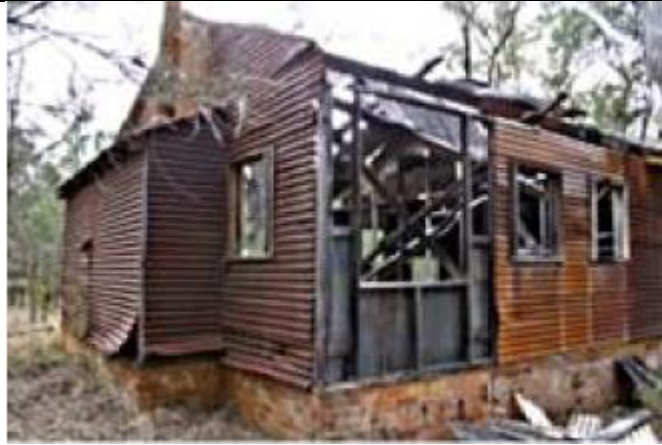
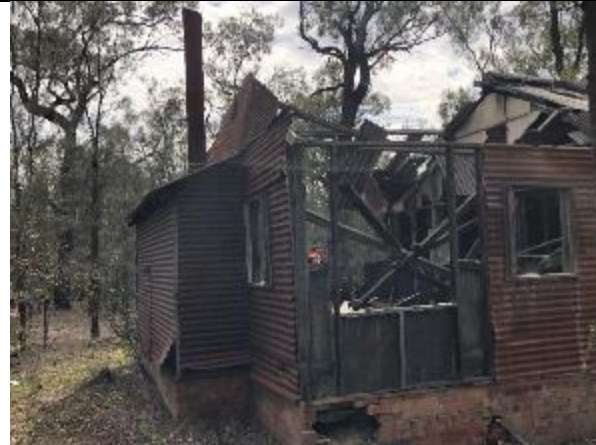
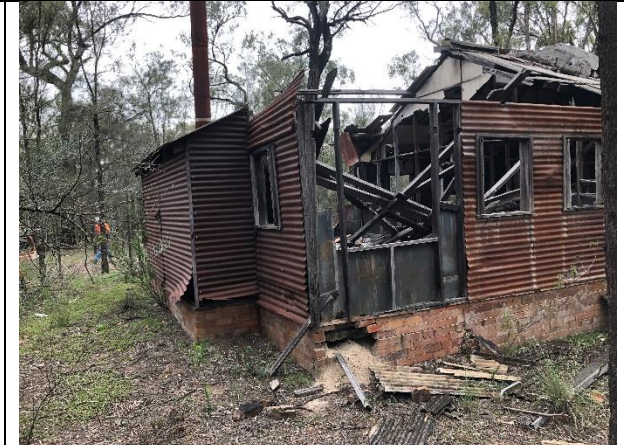
Detail of north-west elevation

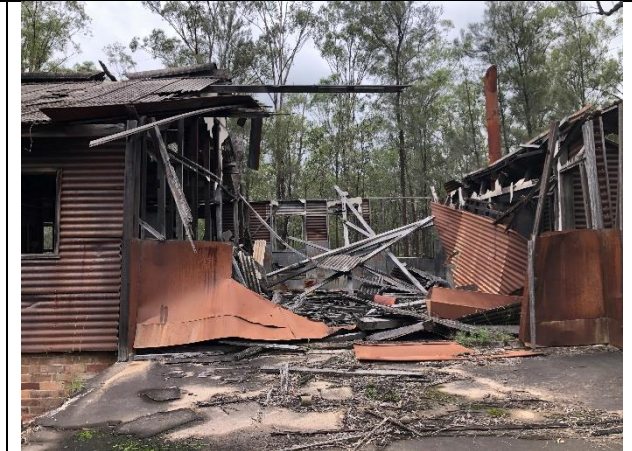
Showing interior damage at kitchen at north end of building

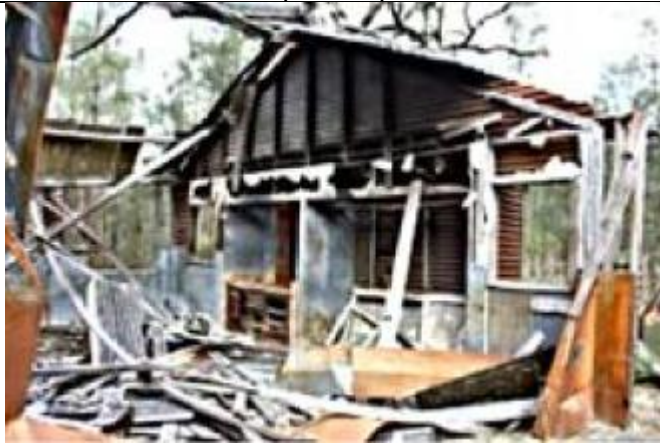
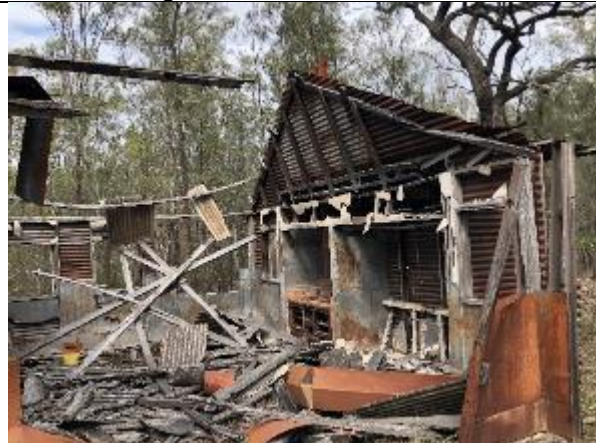
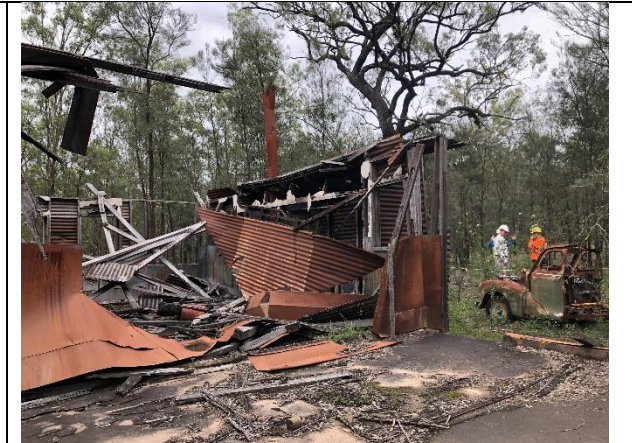
Showing interior damage at kitchen at north end of building

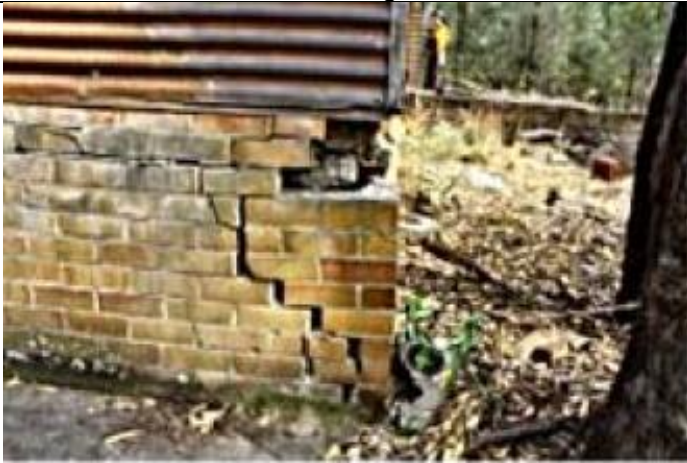
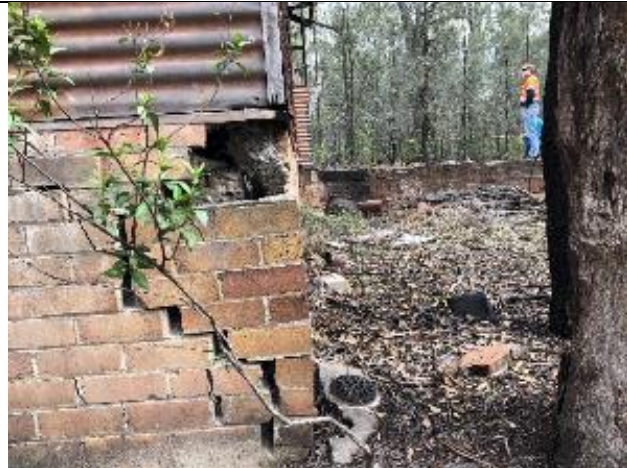
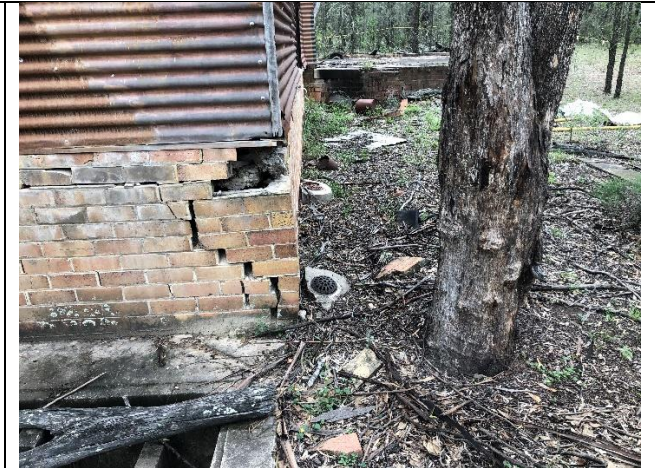
Damaged brick foundation at south-east corner
2012-18: no discernible increase to cracked brick foundation.
2018-20: further cracking of foundation (to left of shot) and some slumping of corner bricks.

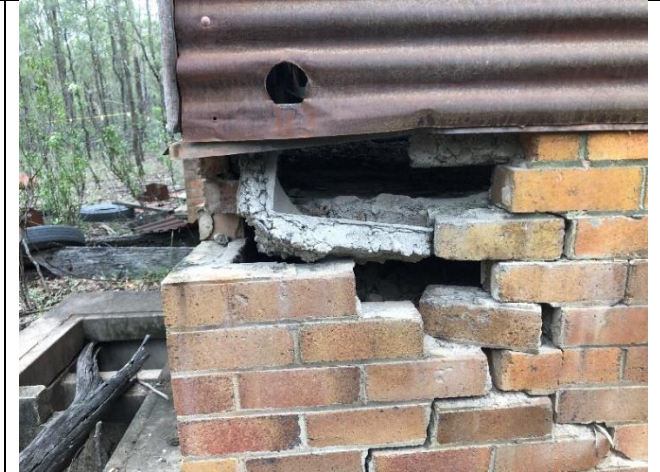
Detail of damaged brick foundation

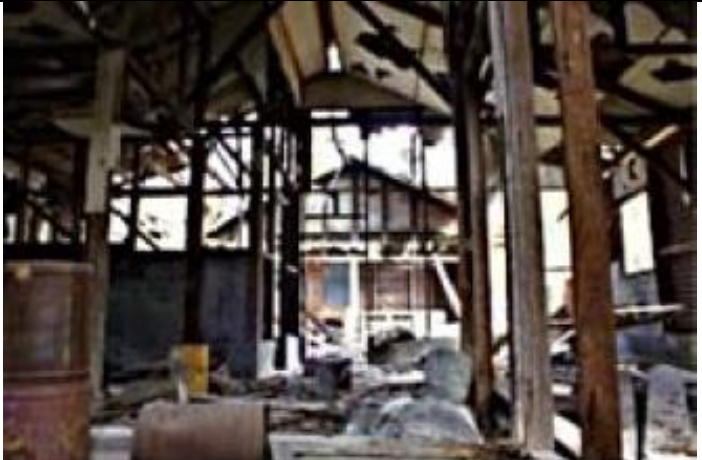
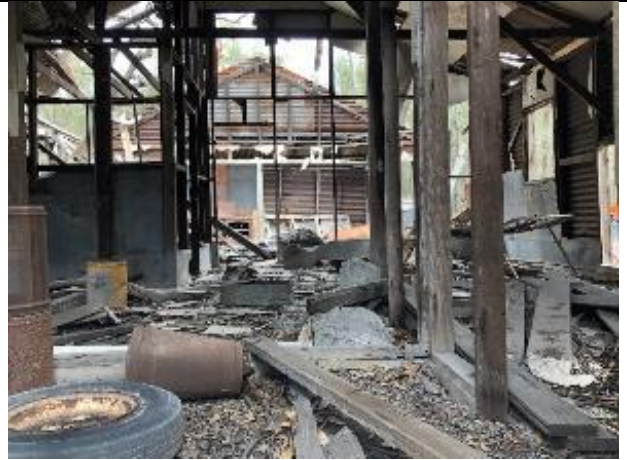
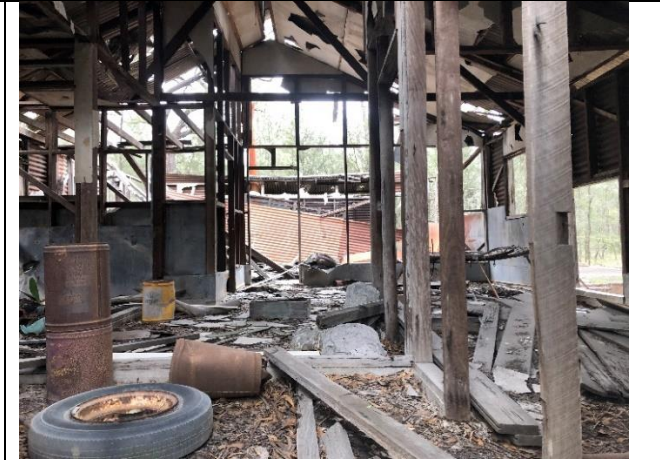
View to interior of building, looking north from south entry

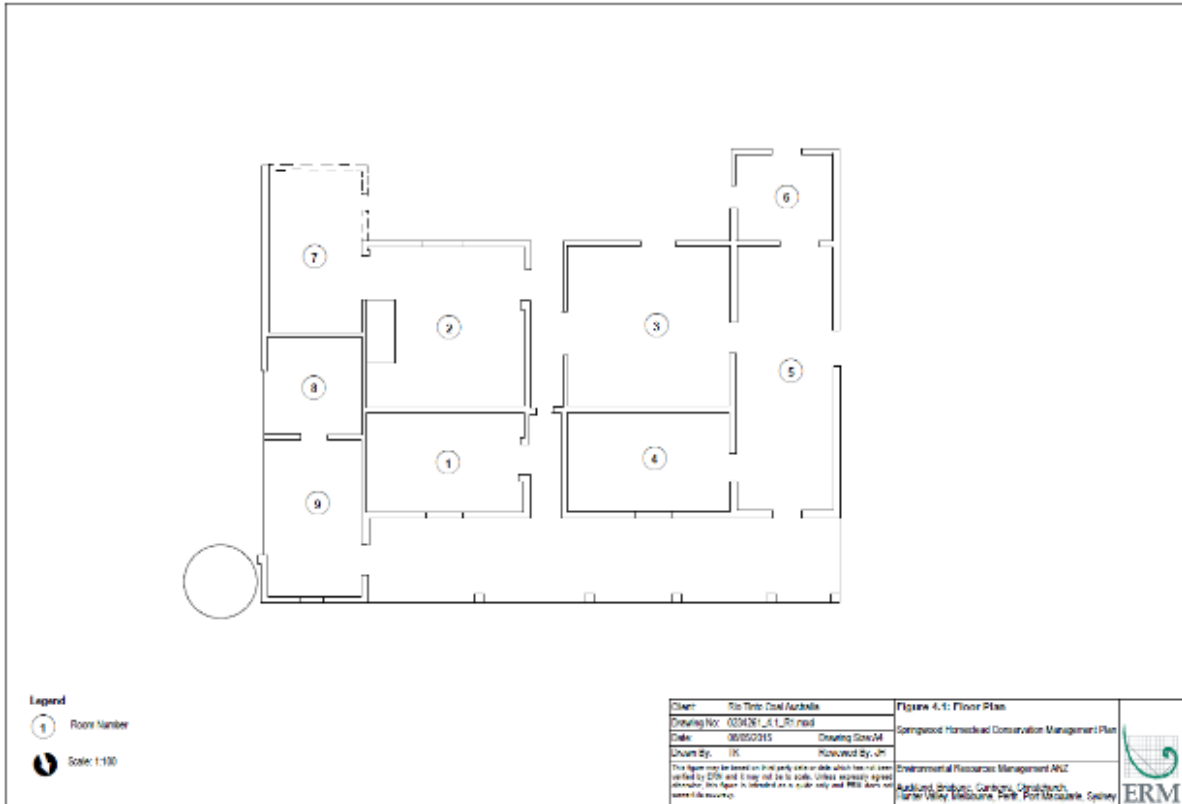
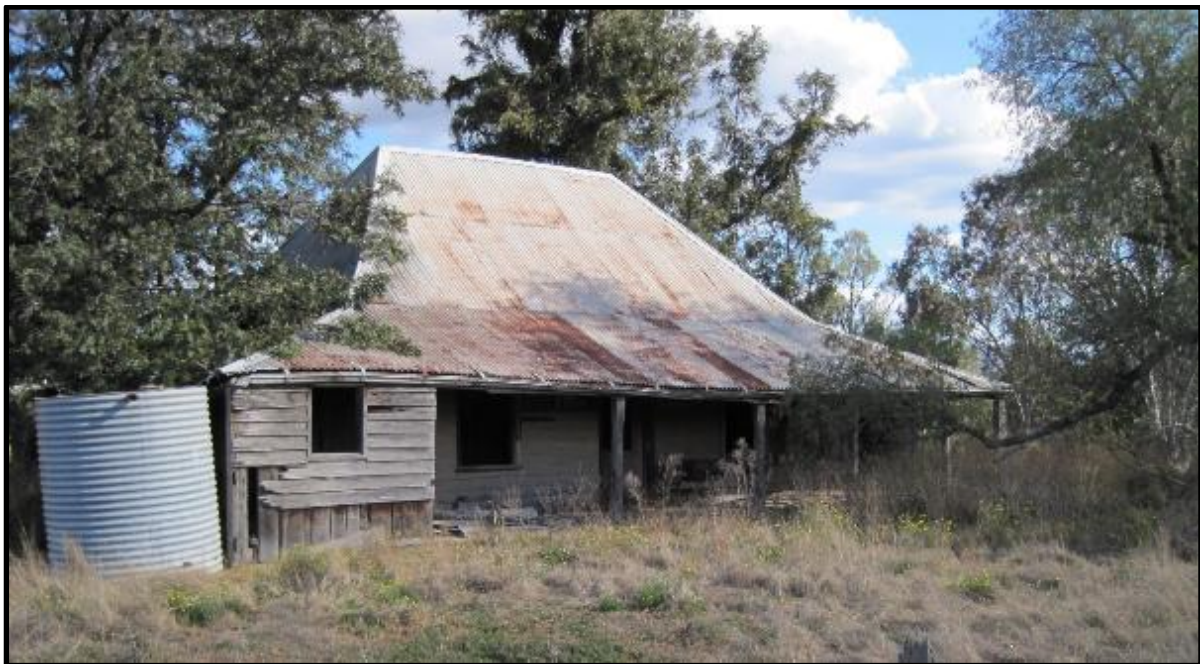
Springwood Homestead in 2012

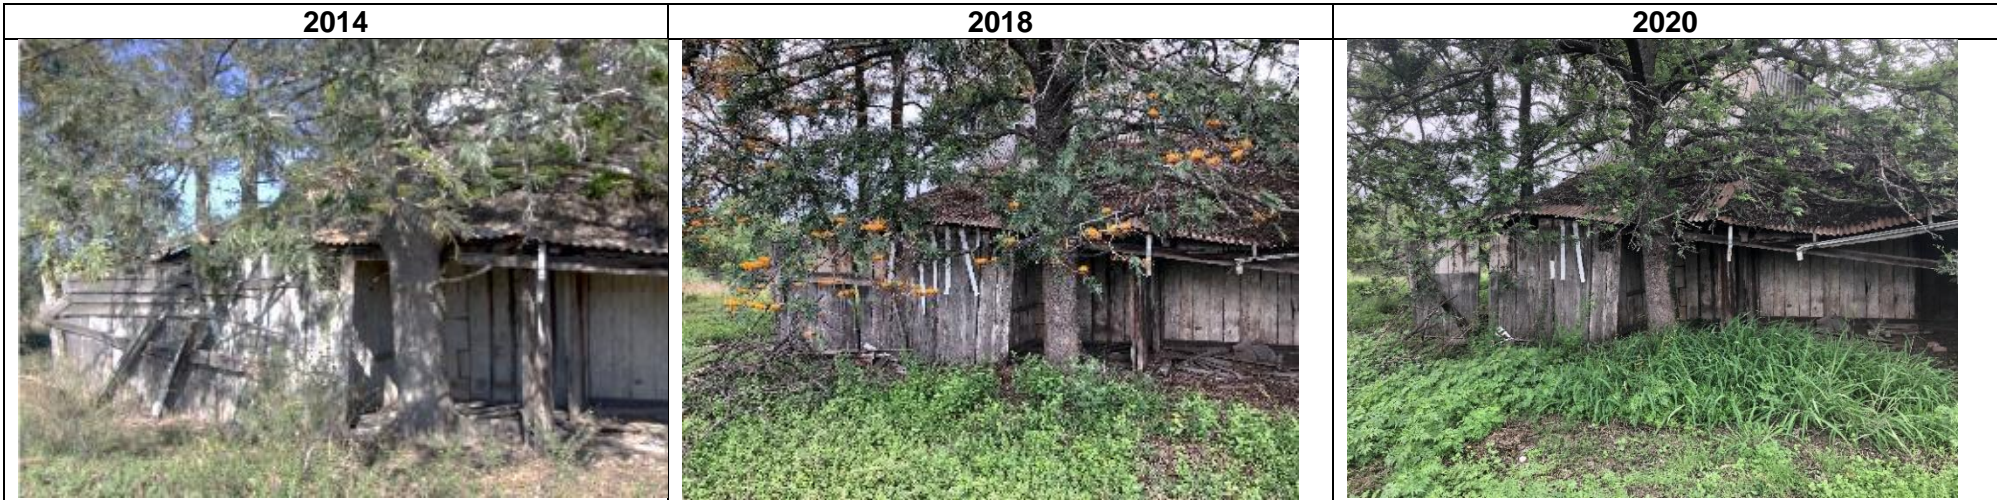
<p>Northern entrance 2014-8: further deterioration of overlaid weatherboard. 2018-20: No major increase in deterioration.</p>

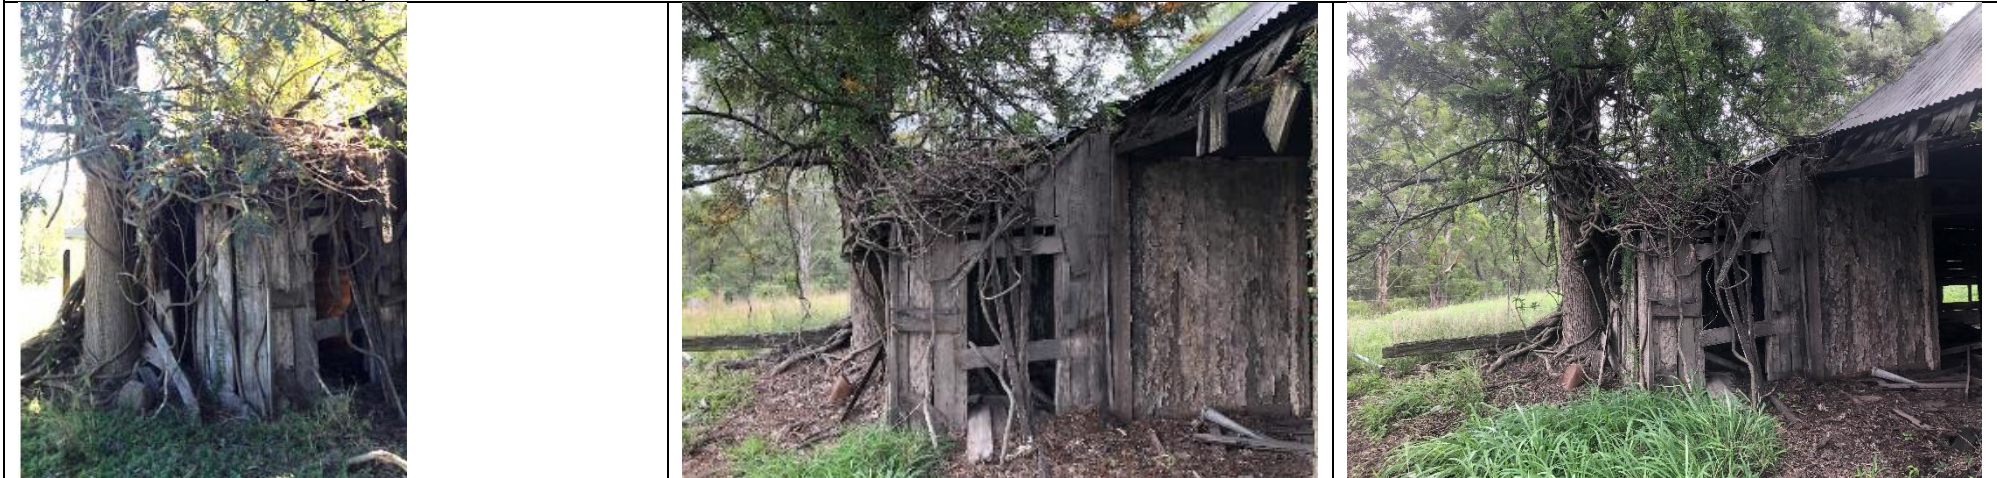
Looking towards south-west corner from east

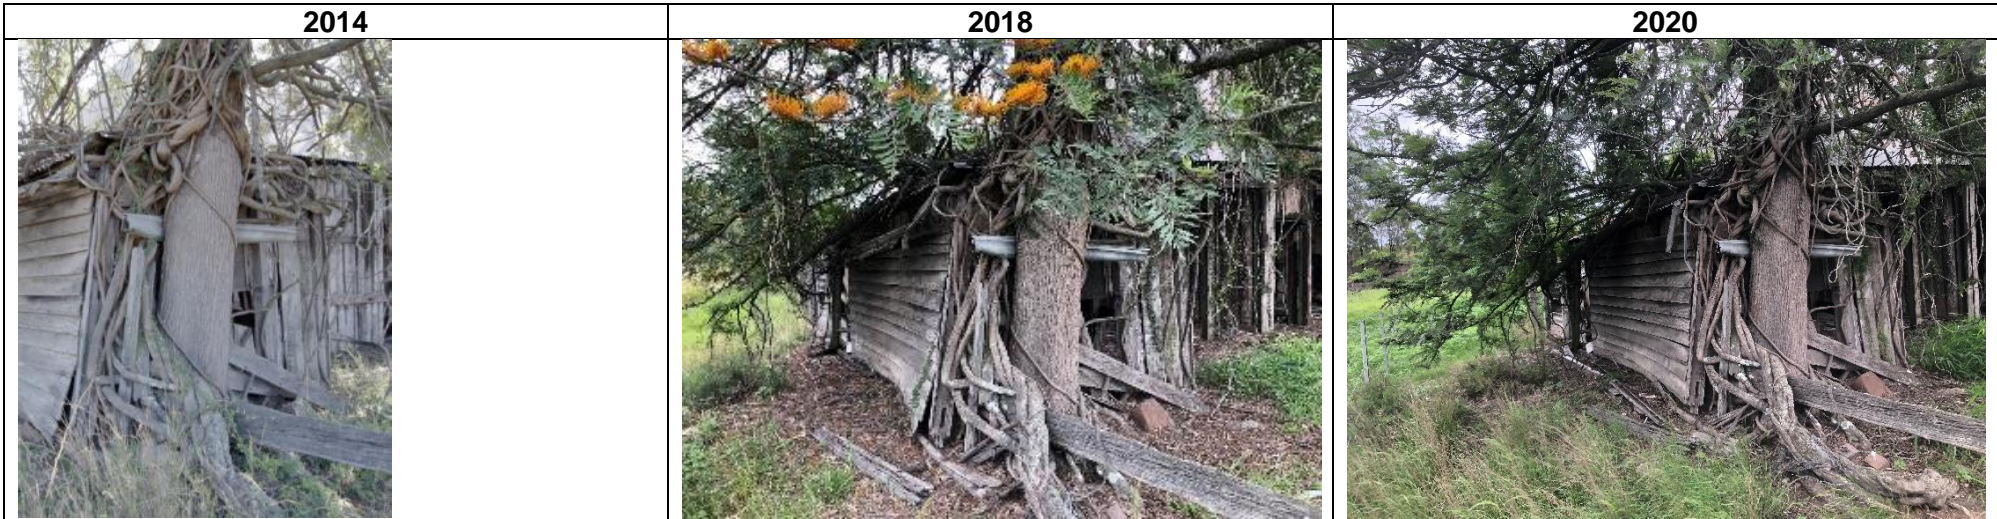
Looking towards south-west corner from south-west

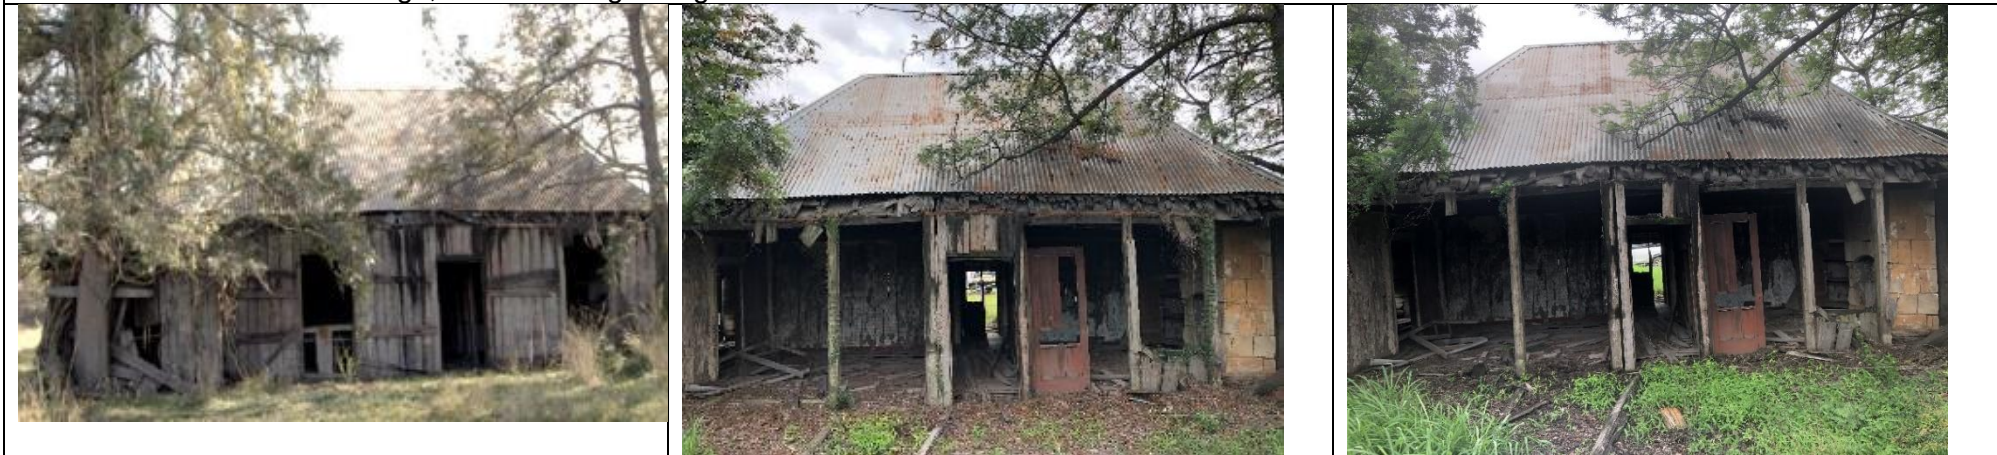
2018-20: no discernible change, but vine still growing.

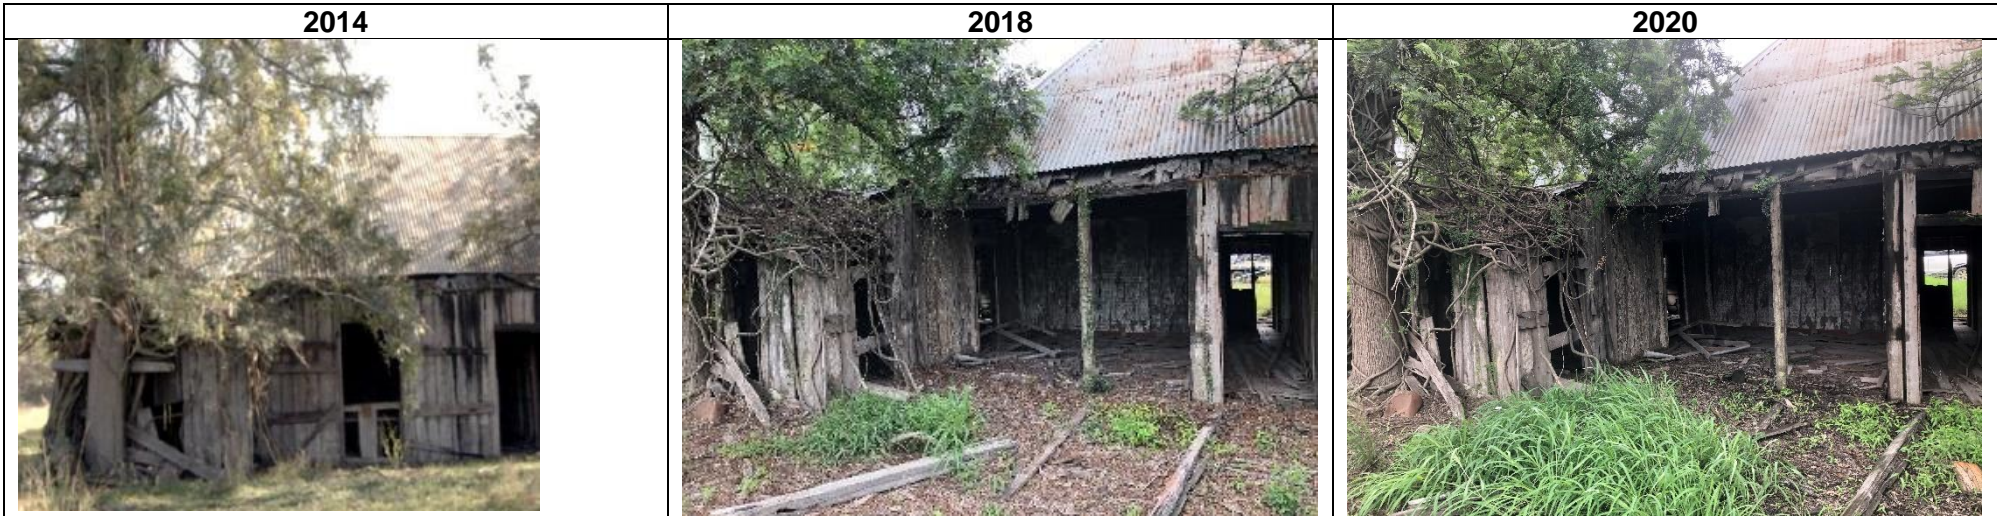
2018-20: possible deterioration of shingles at roof edge, and missing panels from above back door.

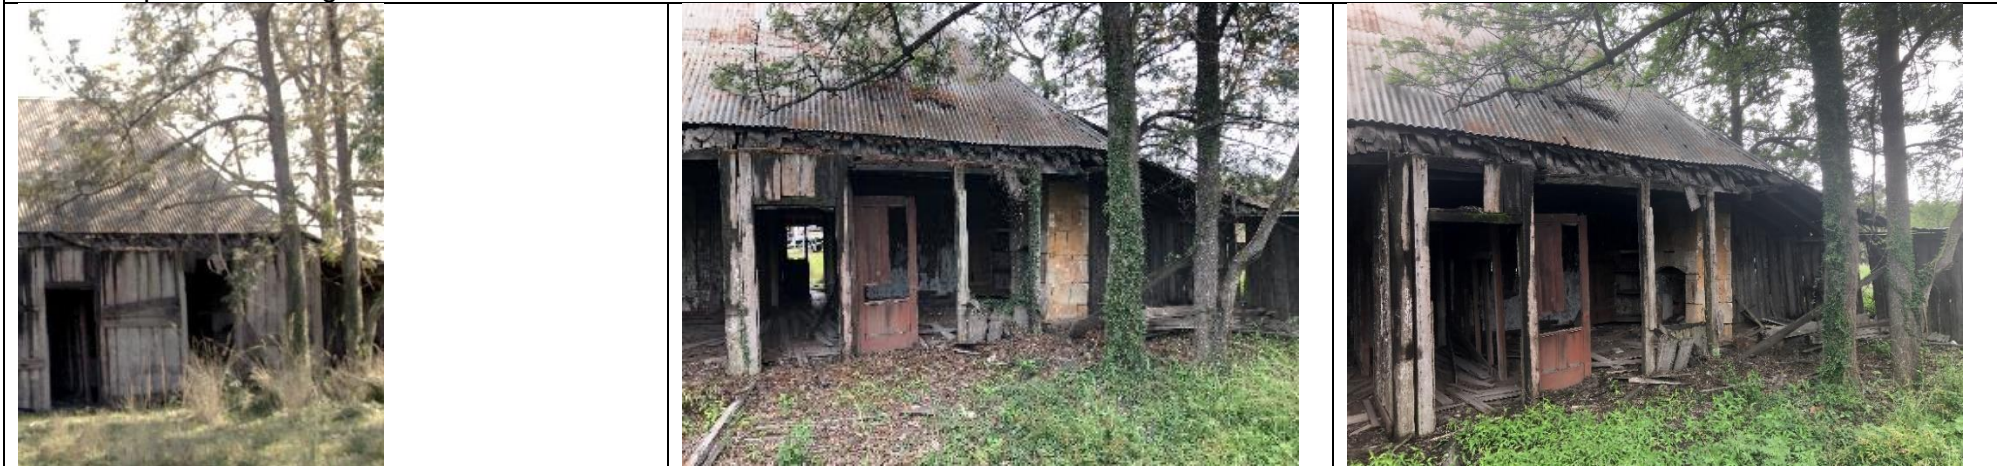
2018-20: panels missing from above back door.

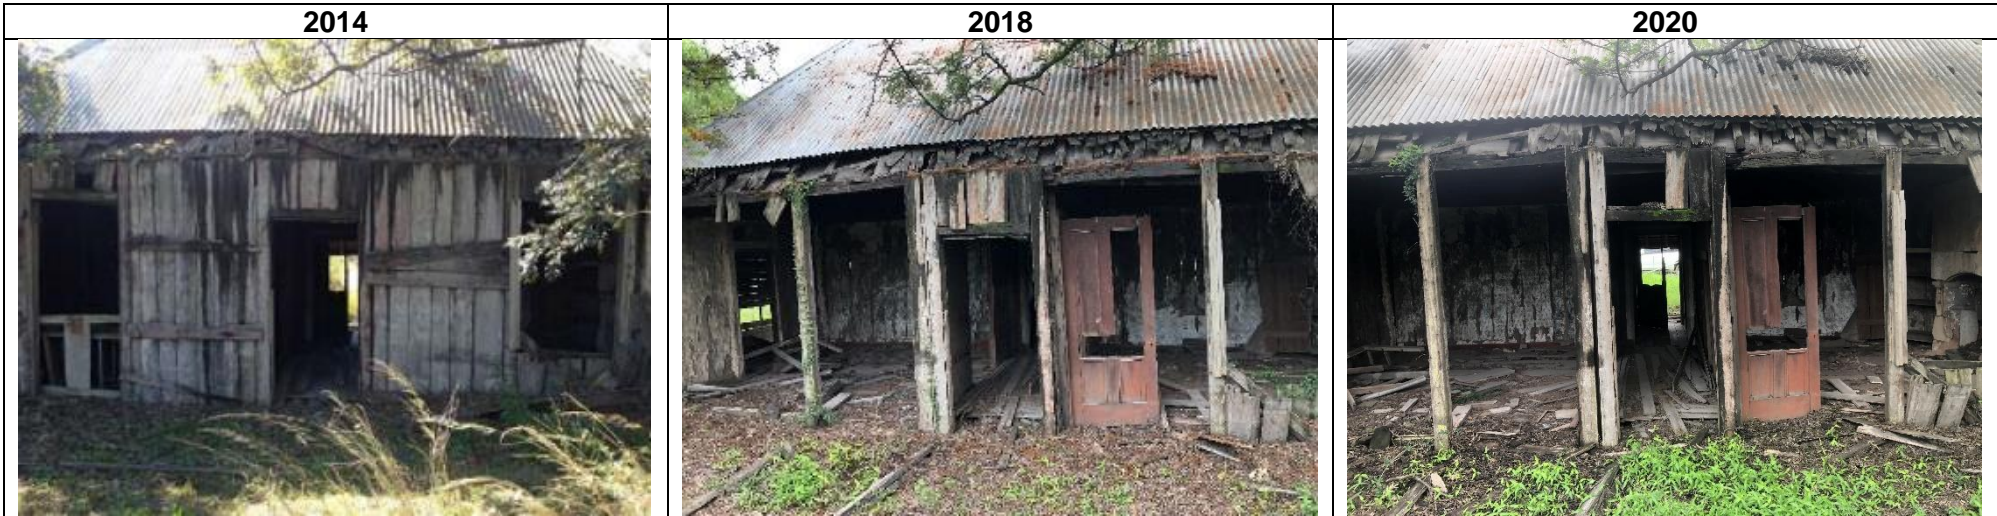
2018-20: possible deterioration of shingles at roof edge, and missing panels from above back door.

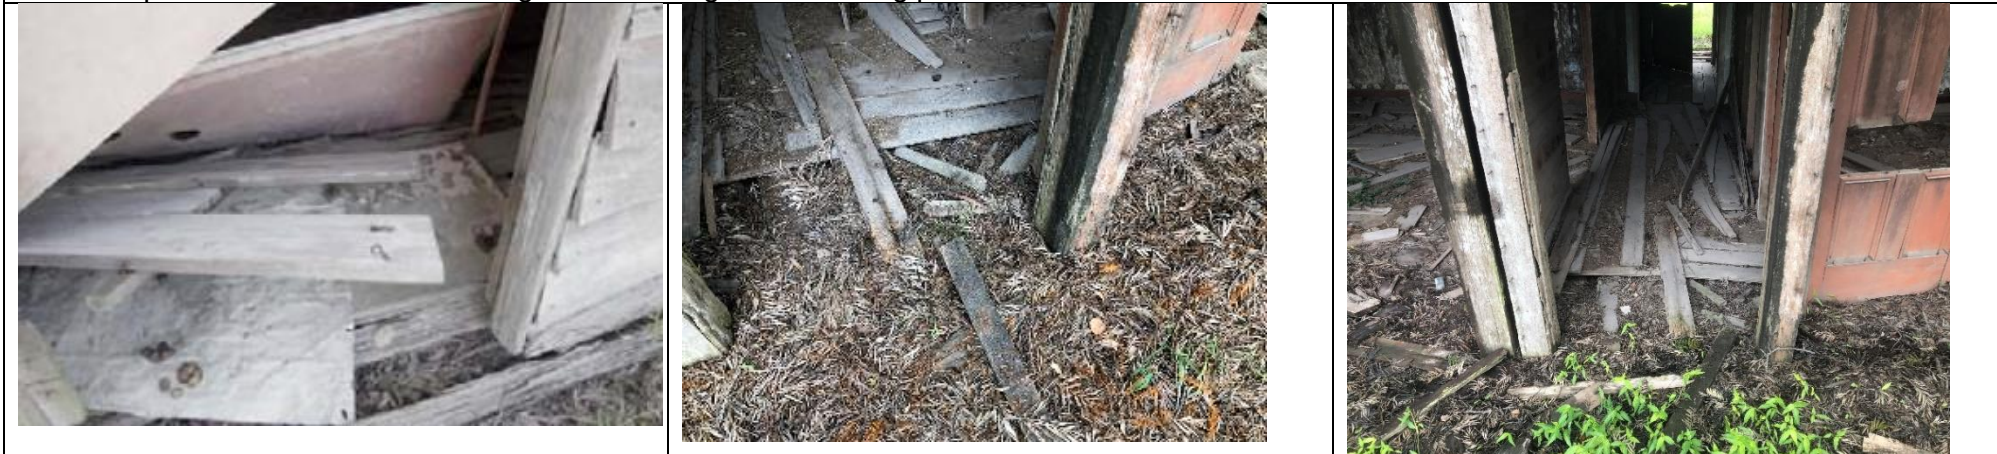
Southern elevation doorway

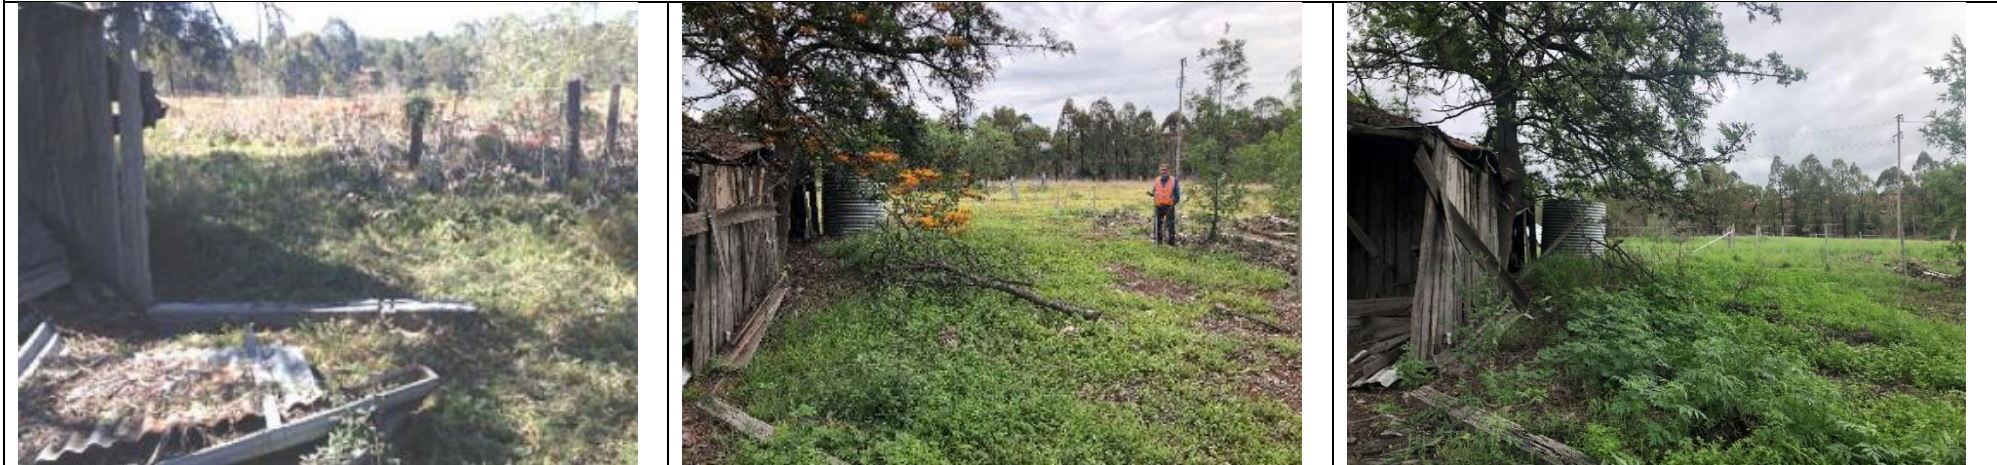
2018-20: further deterioration of eastern wall.

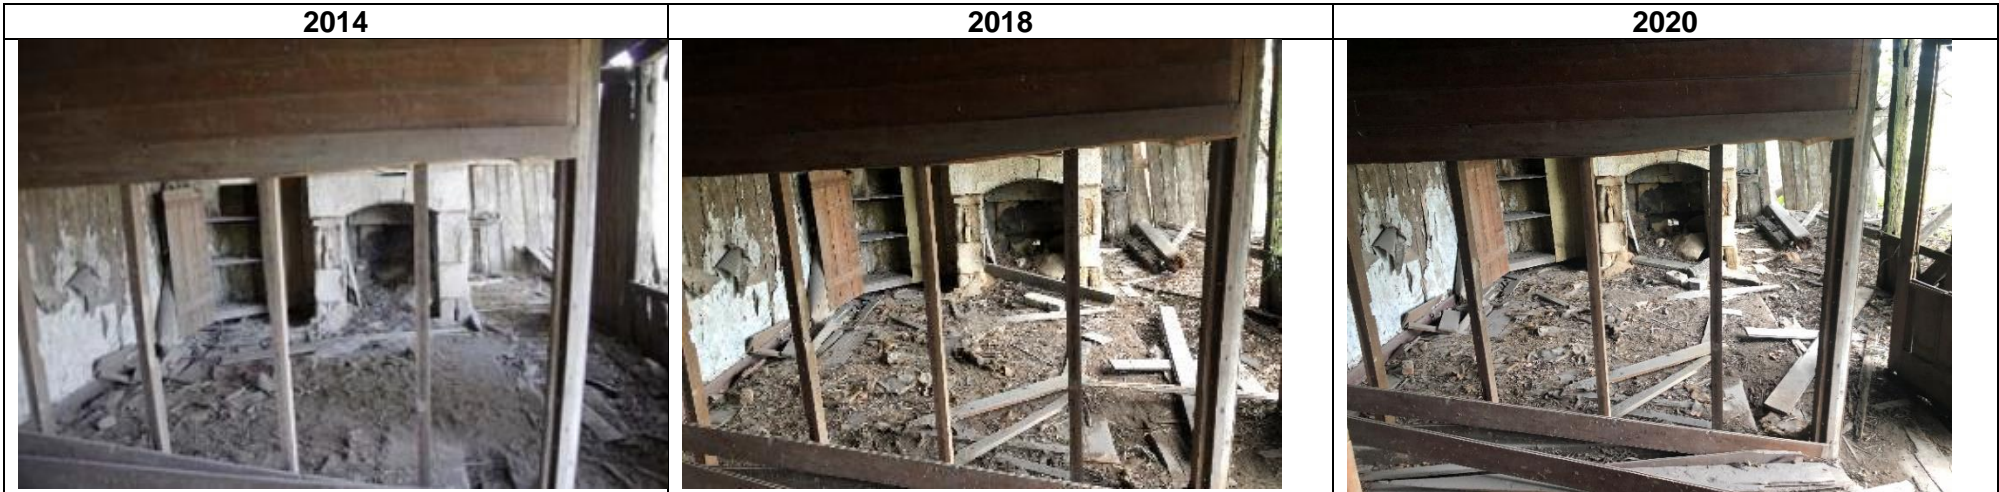
2018-20: further deterioration of eastern wall and regrowth of weeds.

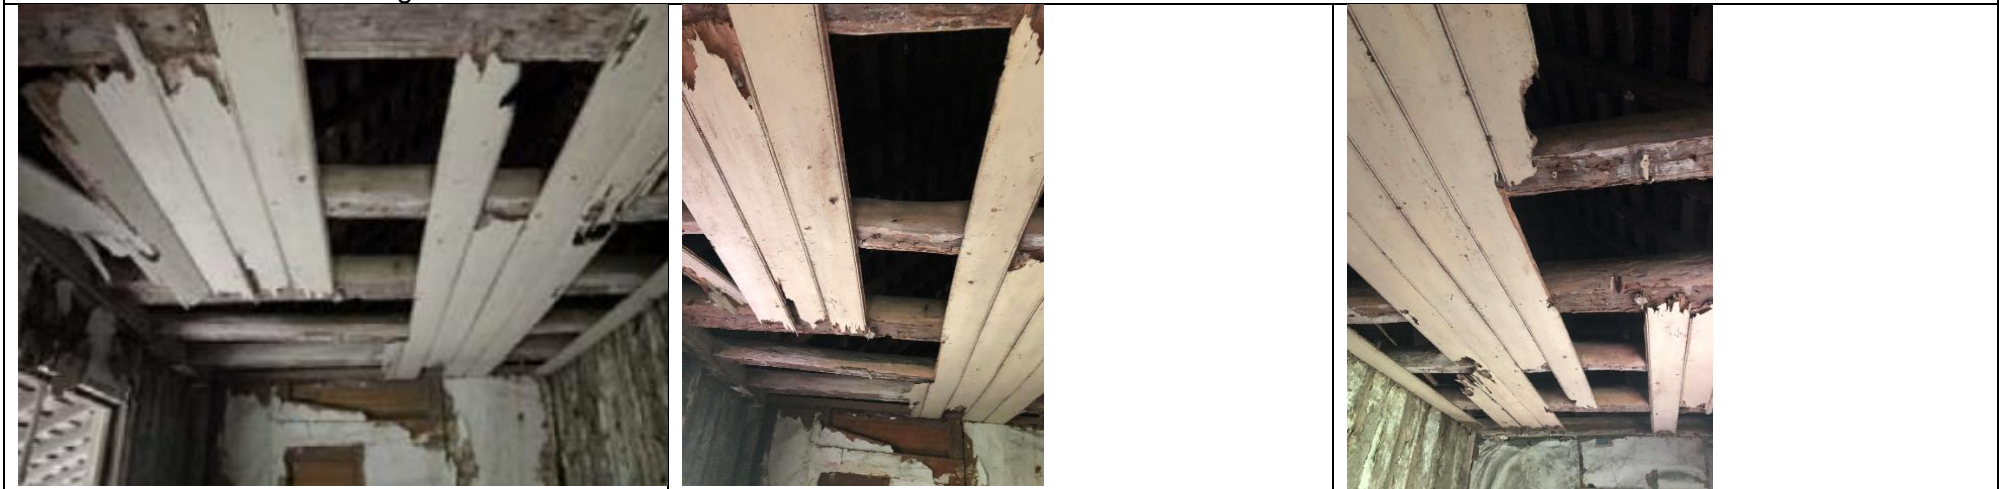
2018-20: no discernible change.

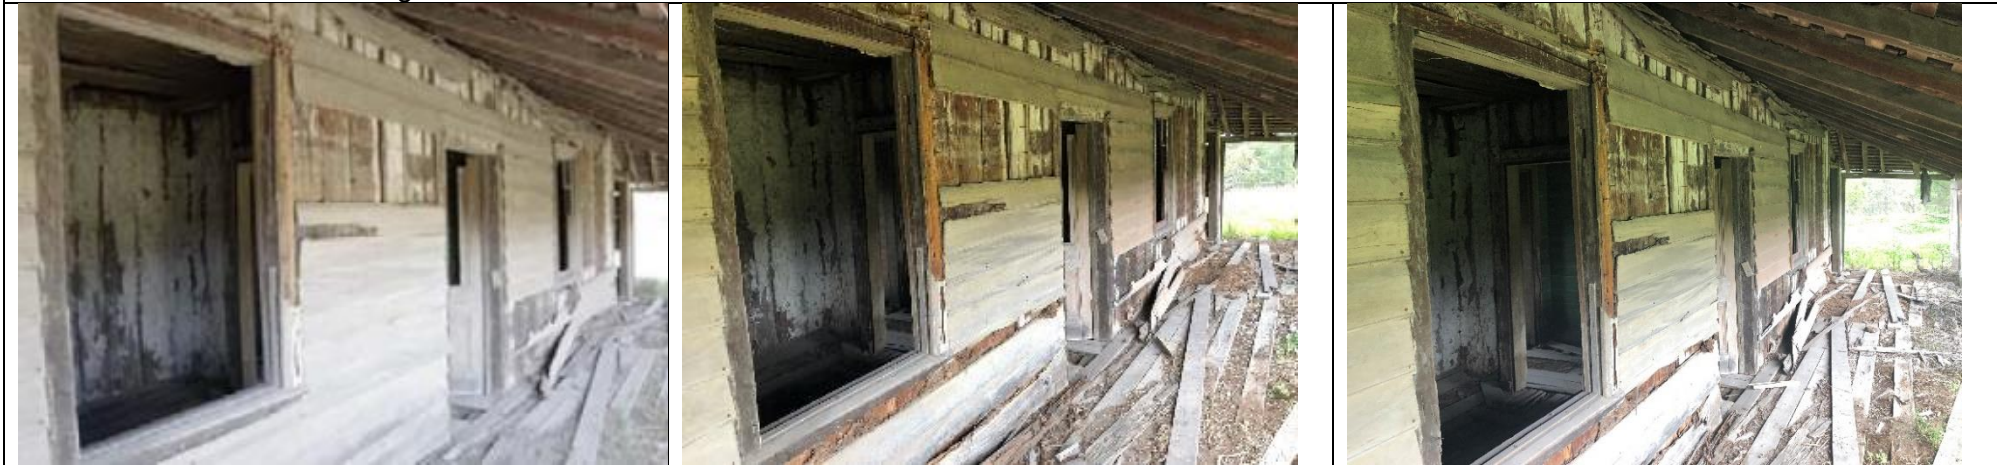
2018-20: no discernible change.

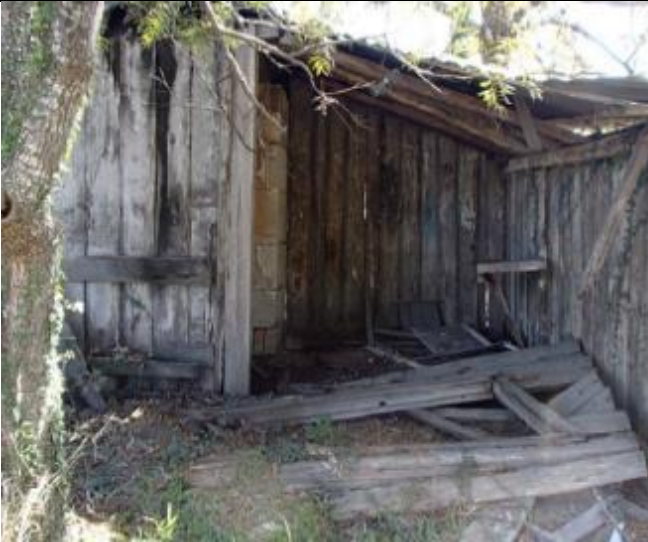
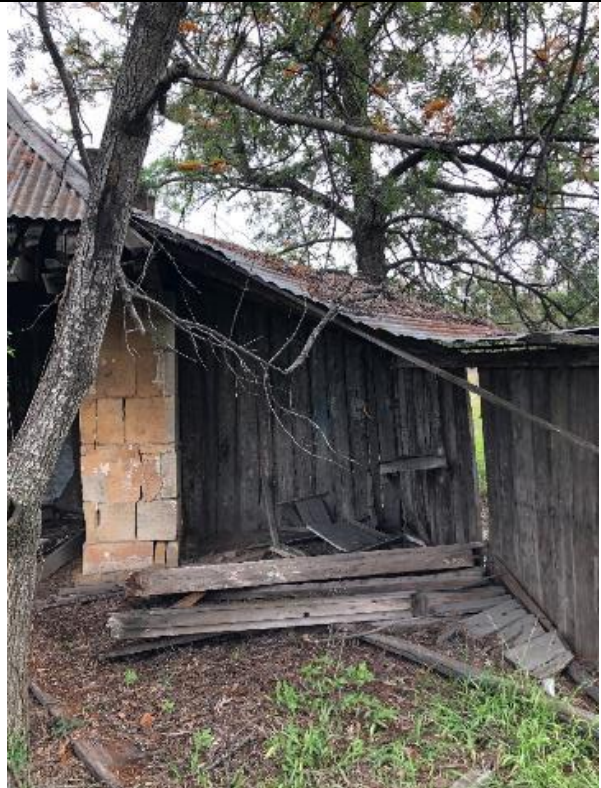
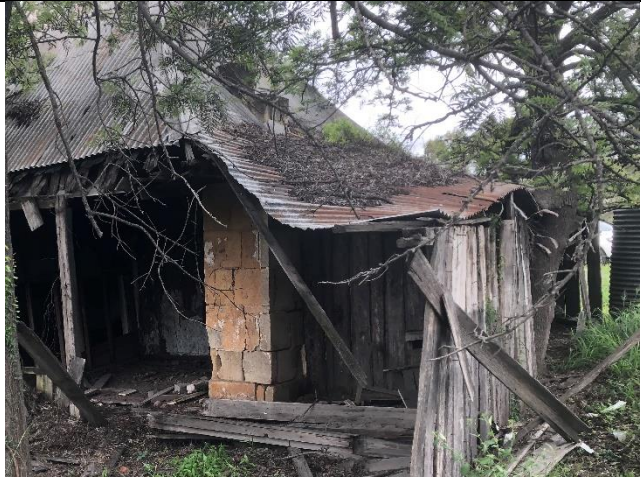
<p>South-east corner 2014-8: shows removal of vertical slabs from southern wall and further collapse of roof. 2018-20: further roof slumping and deterioration of eastern wall.</p>
