Mount Thorley Warkworth Historic Heritage Management Plan 2019 Compliance Audit Inspection

Report prepared for

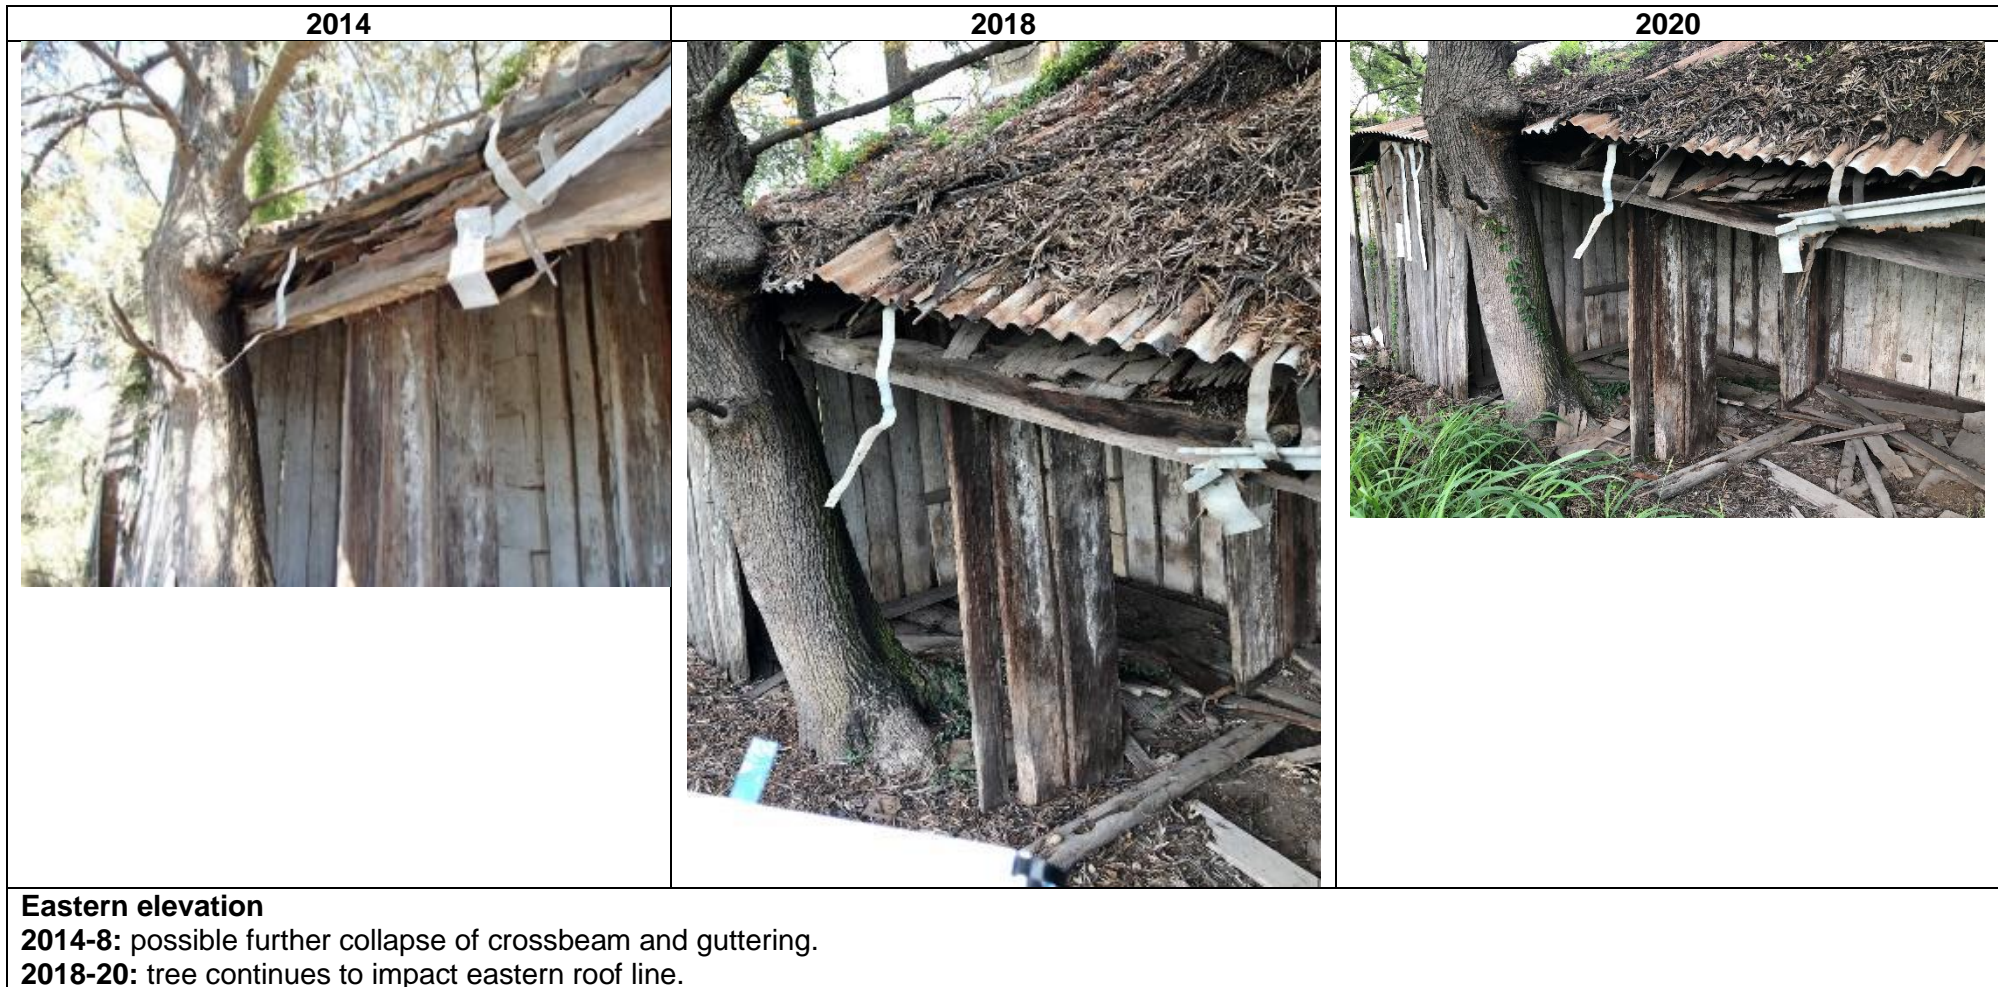
<p>South-east corner 2014-8: shows removal of vertical slabs from southern wall and further collapse of roof. 2018-20: further roof slumping and deterioration of eastern wall.</p>

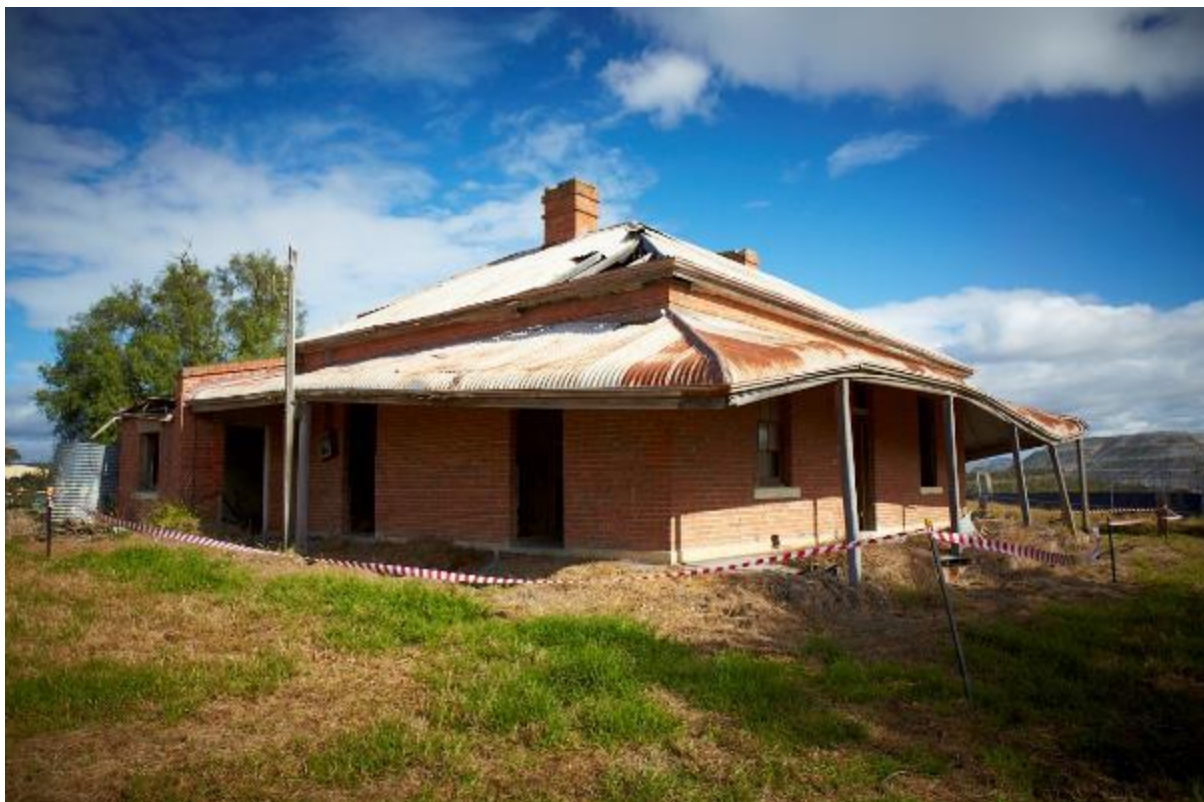
Mount Thorley Brick Farm House (2012)

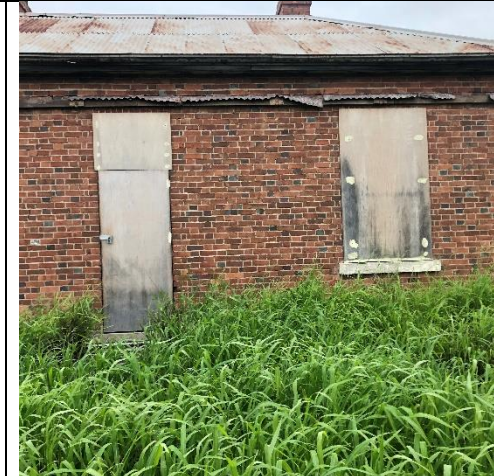
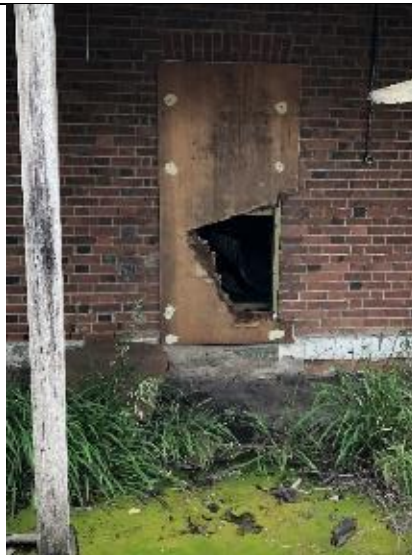
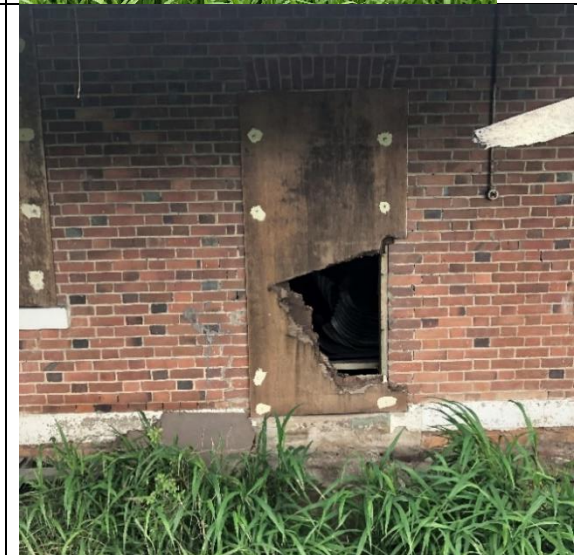
View of door and window panelling

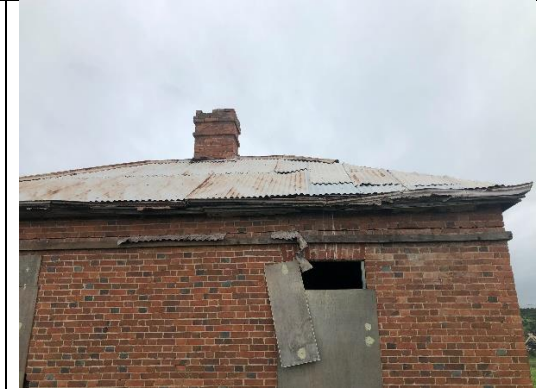
View of north-west roof corner (focus on damaged roof)

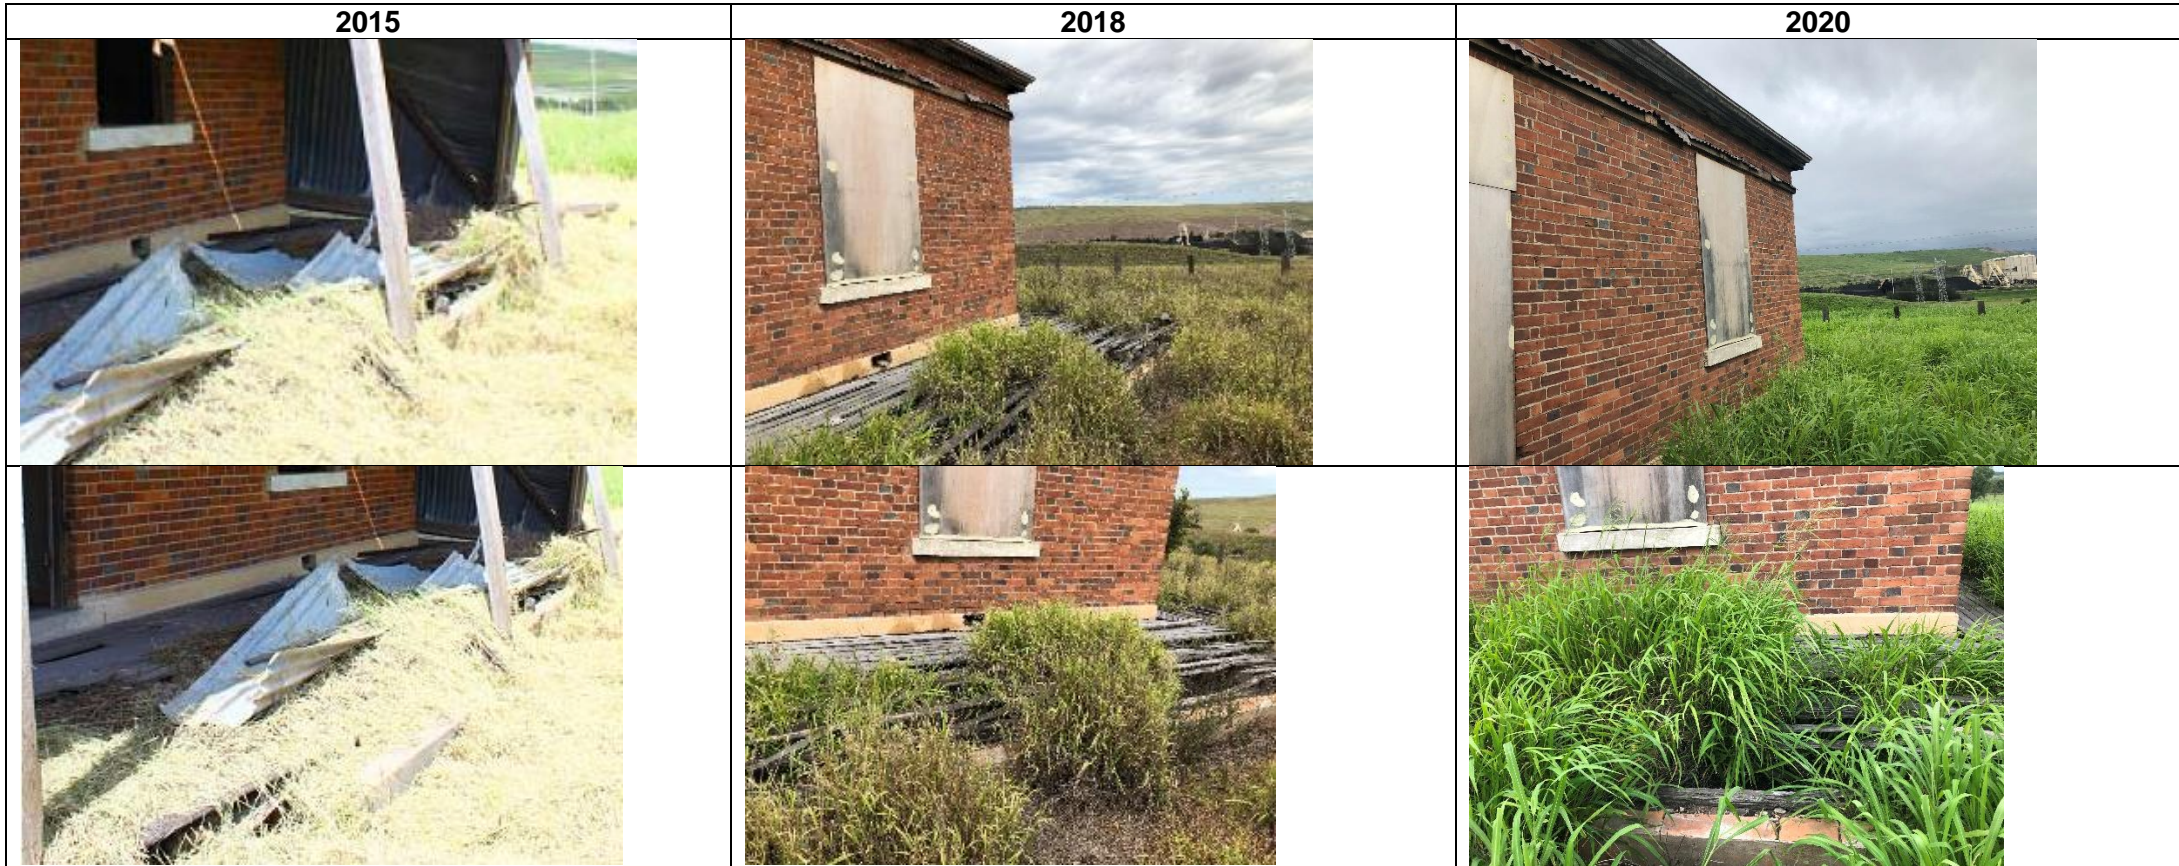
View of eastern verandah (focus on verandah floor)

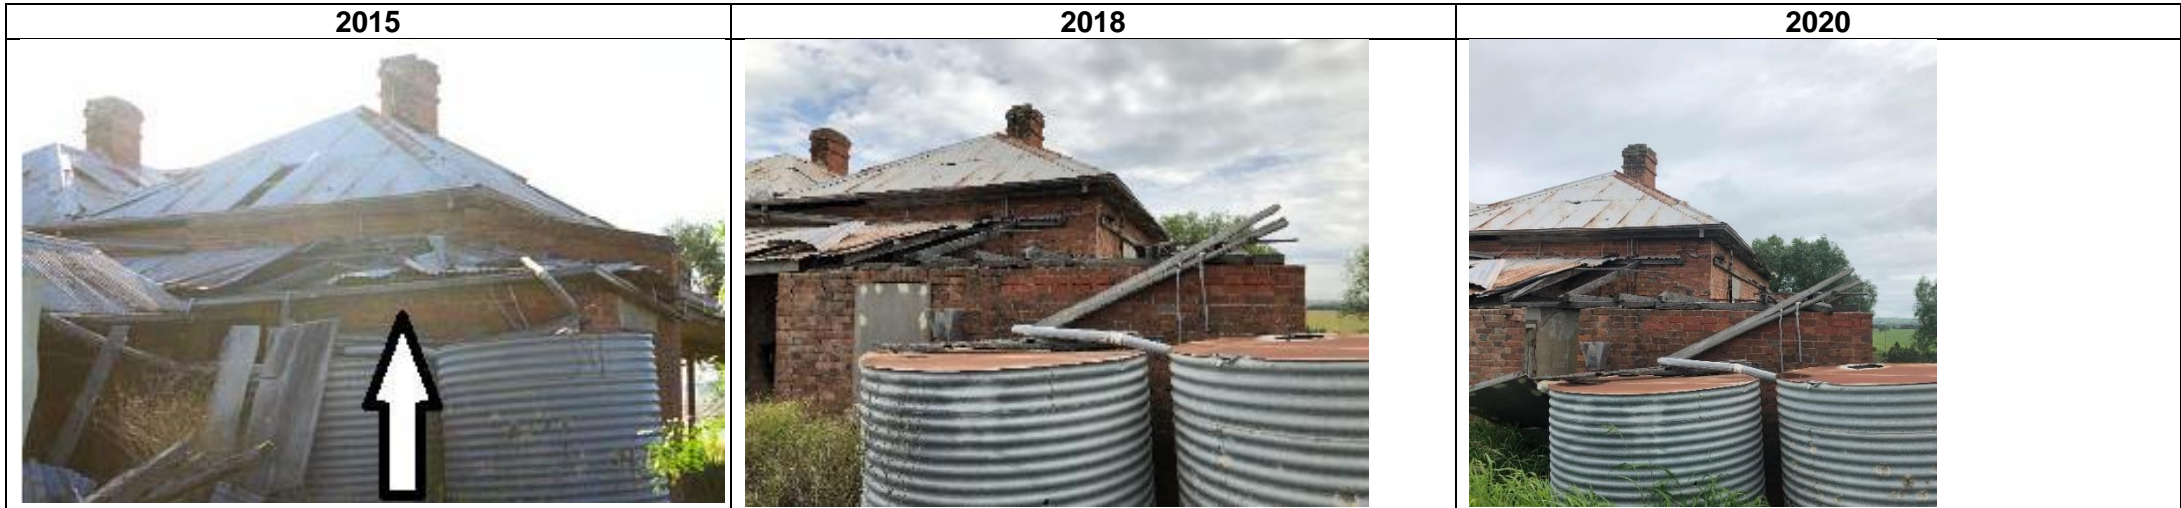
View of rear of building (focus on skillion roof)
2015-8: skillion roof and rafters have collapsed
2018-20: no discernible change

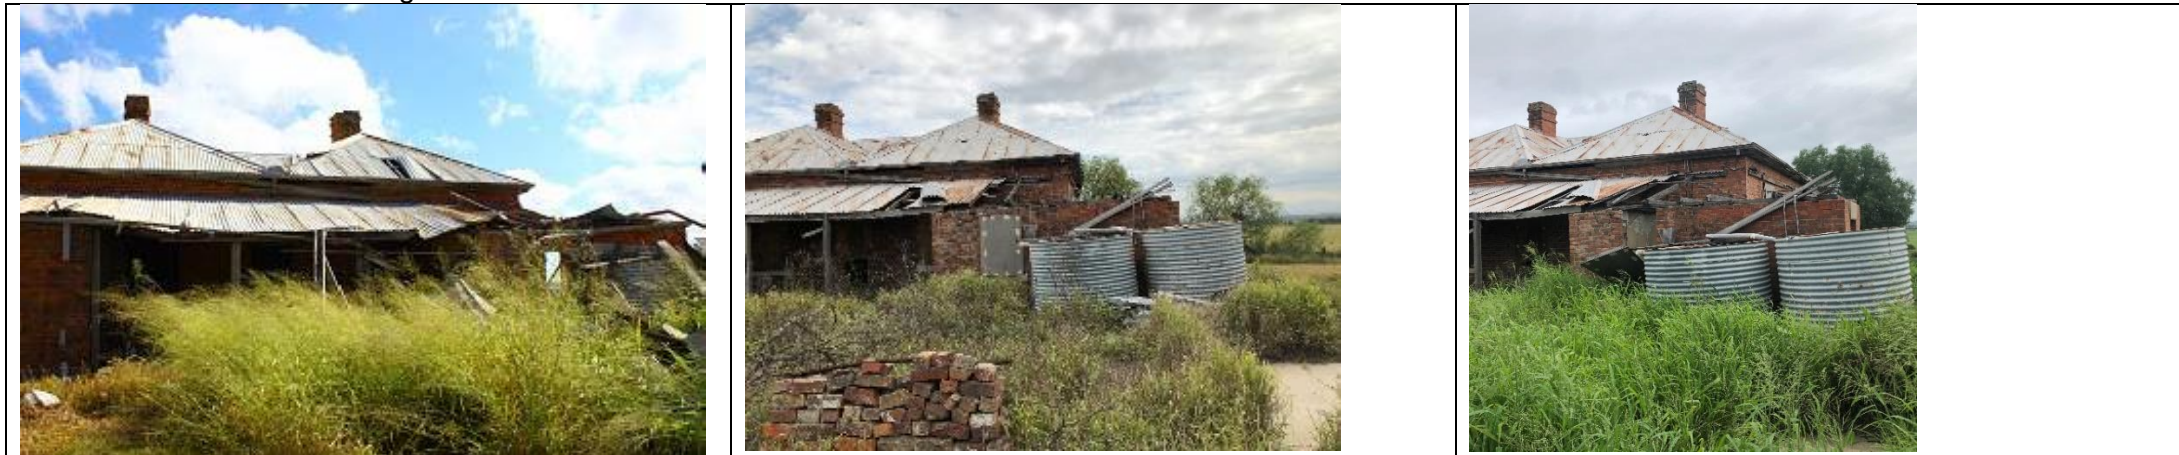
View of rear of building (focus on guttering)
 2015-8: main roof holes repaired but northern section of skillion roof collapsed and guttering unchanged
 2018-20: no discernible change, however vegetation regrowth evident

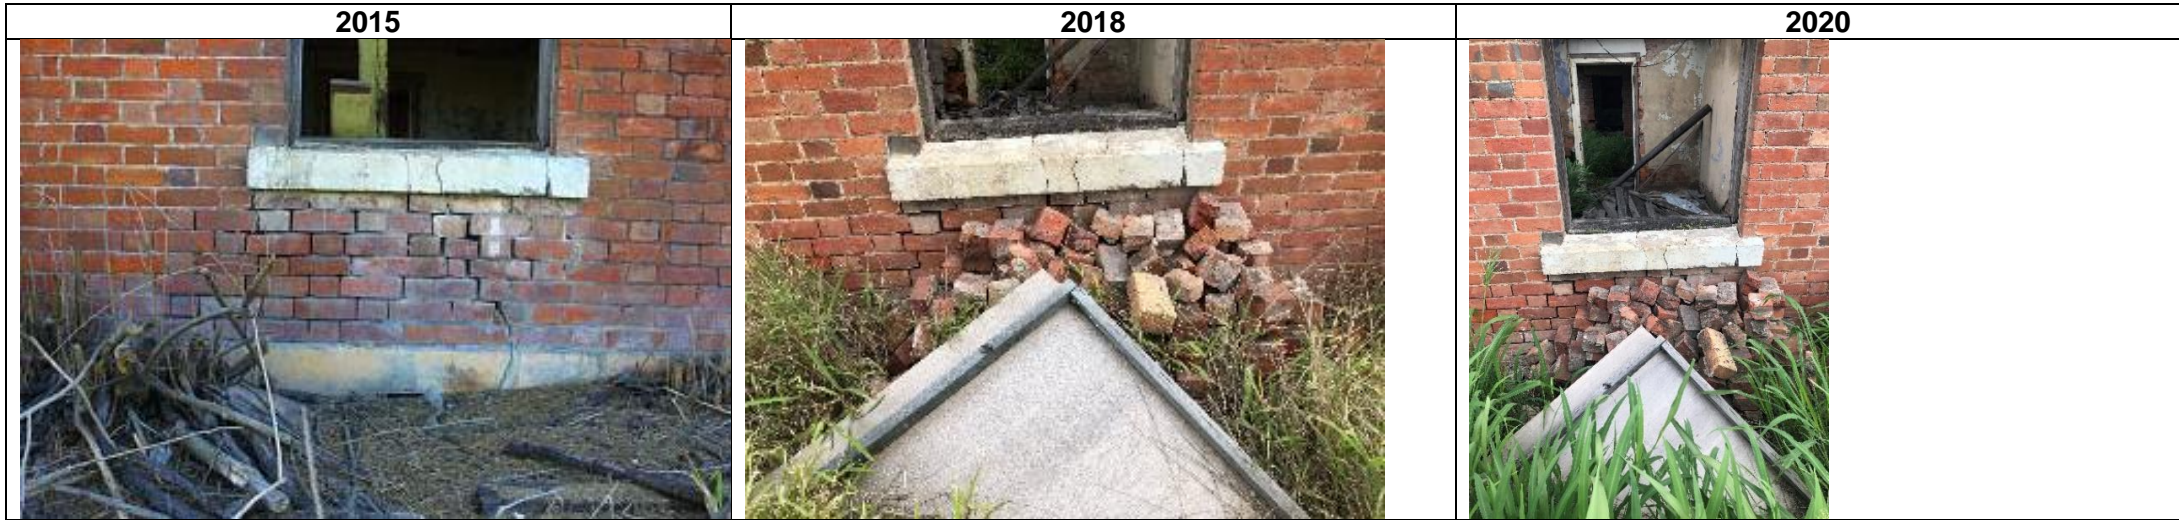
View of north-east corner of building (focus wall below window)
 2015-8: bricks from roof above stacked in front of required repointing, window sheeting removed
 2018-20: no discernible change

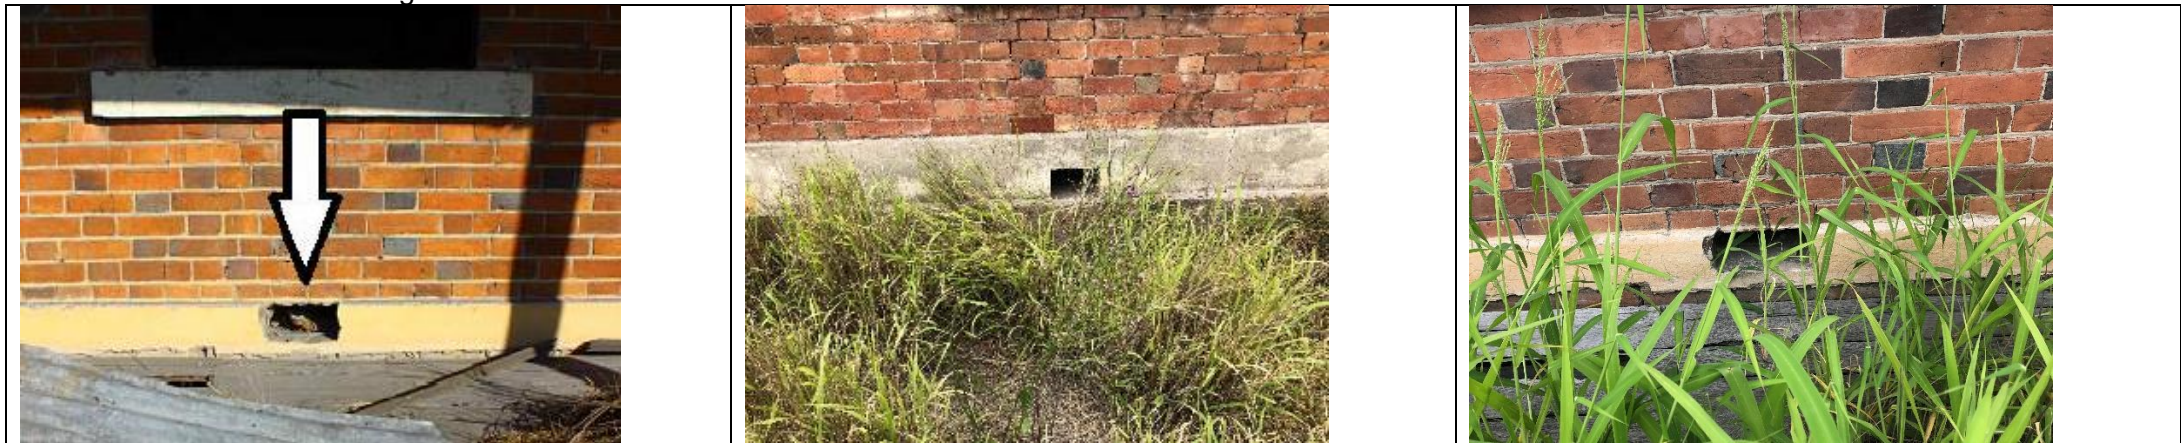
View of ventilation grilles

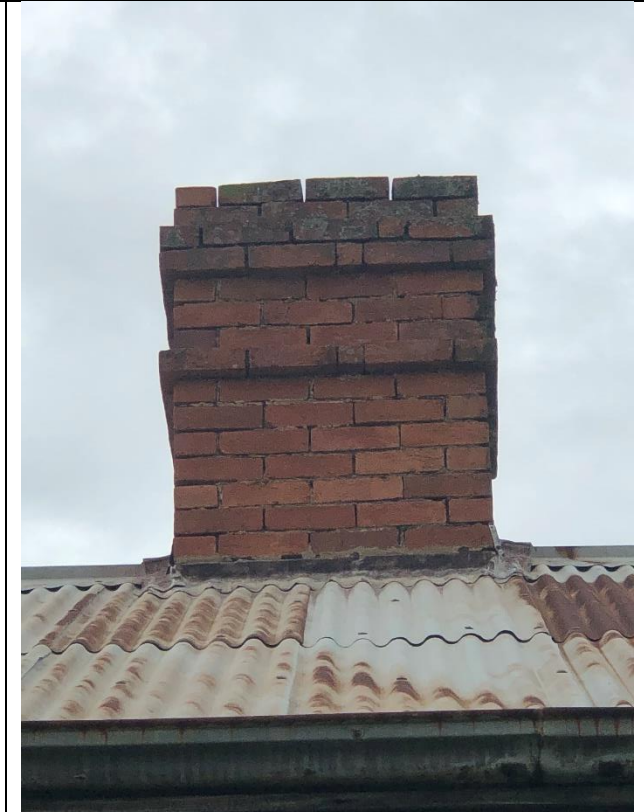
View of southern chimney
2015-8: no discernible change
2018-20: no discernible change
