# Mount Thorley Warkworth

## 2023 Annual Review

| <b>Name of Operations</b> | Mount Thorley Warkworth |

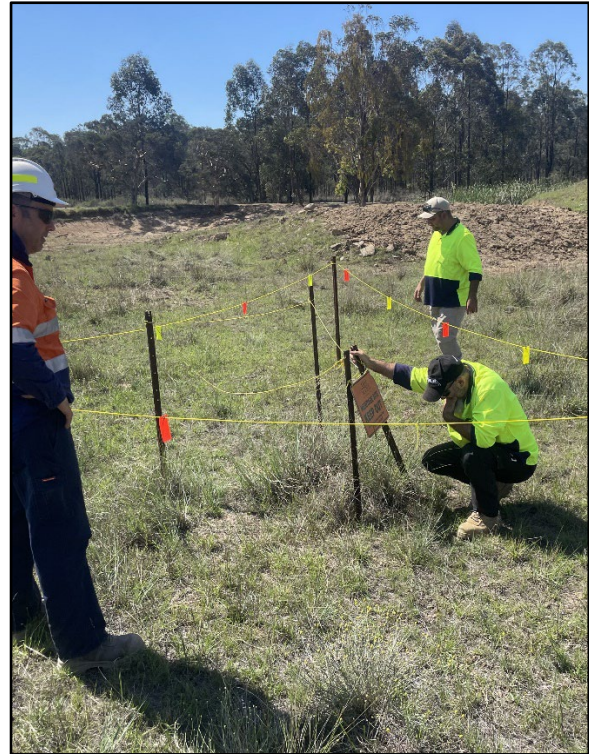
Barricading should consist of hi-vis string line and signage delineating the area as an ACH site to be avoided. There are some areas, however, where hi-vis delineation posts minus string line are an appropriate demarcation method.

***Examples of barricading in need of repair (left) and newly reinstated (right)***

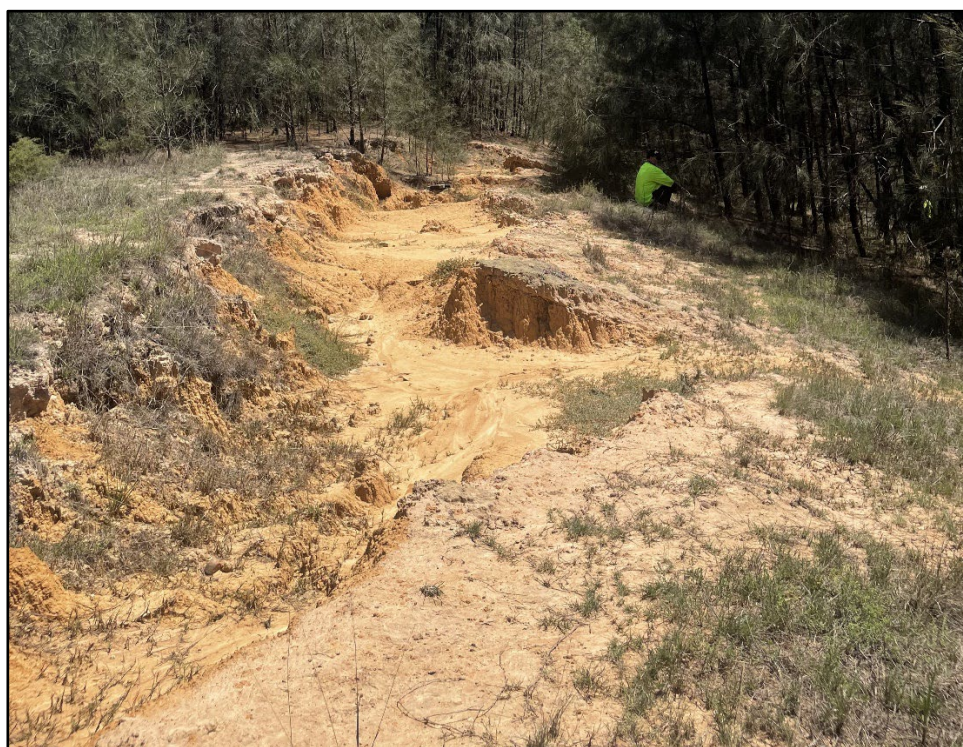
Sites: MTW-631, MTW-632, MTW-665

***Erosion scour along Loder Creek***

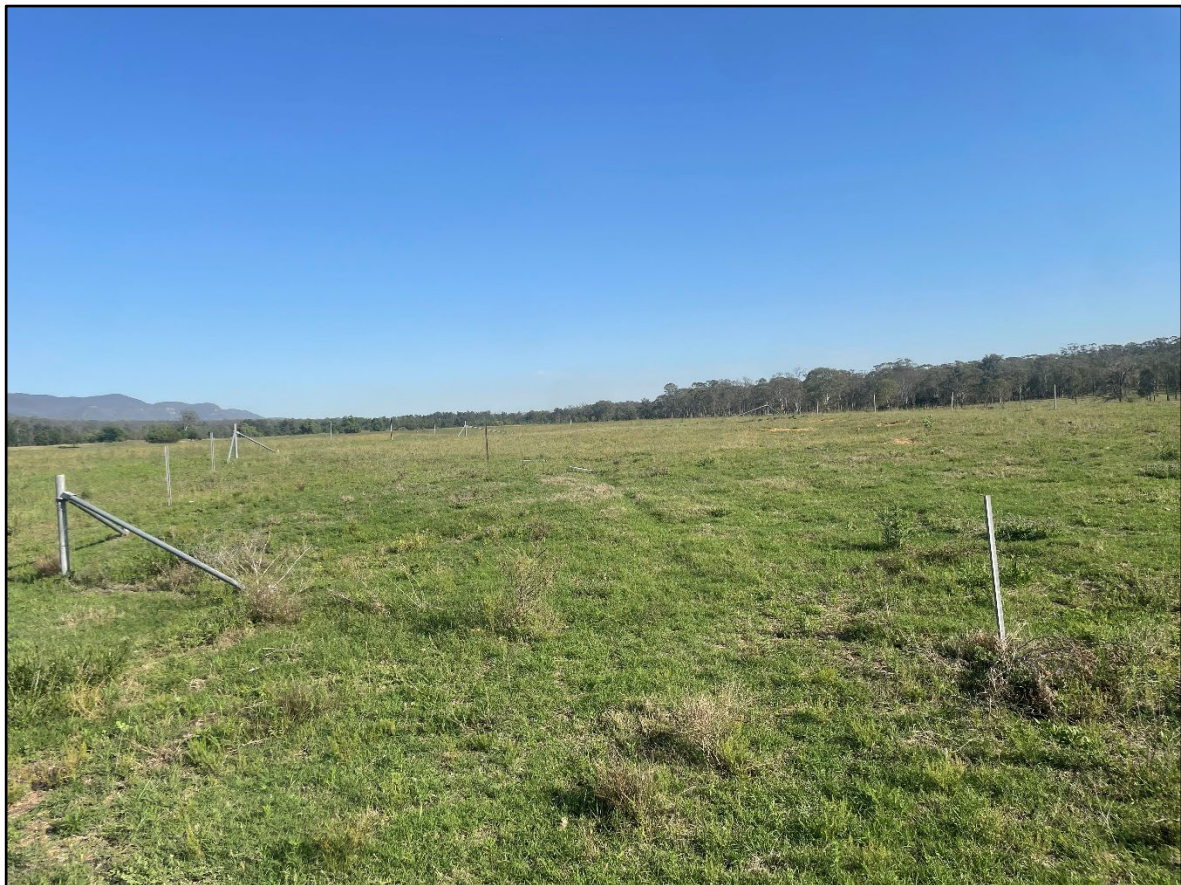
This site is located on land bounded by Wollombi Brook, Putty Rd and the WBACHCA. Upon inspection the site was found to have been fenced in the past but as it was not recorded for MTW, its contents are unknown. The site was covered in thick ground cover and no artefacts were located during the inspection. It is recommended that the AHIMS site card be requested in order to add relevant details to the MTW ACH sites database that will better assist relocation attempts during a future audit.

***View north across WB2 fenced area***

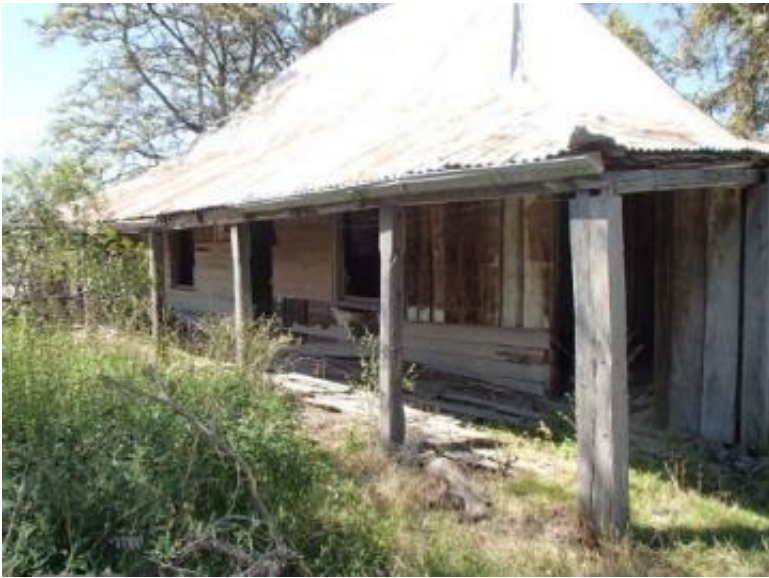
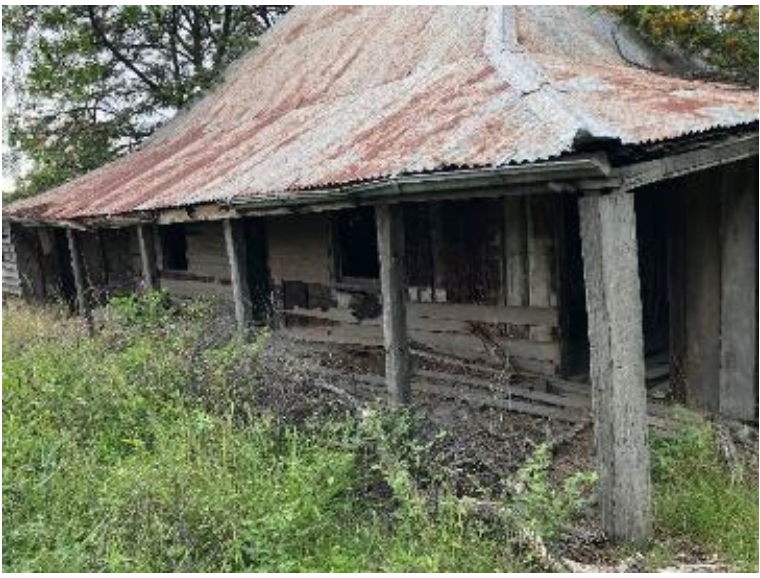
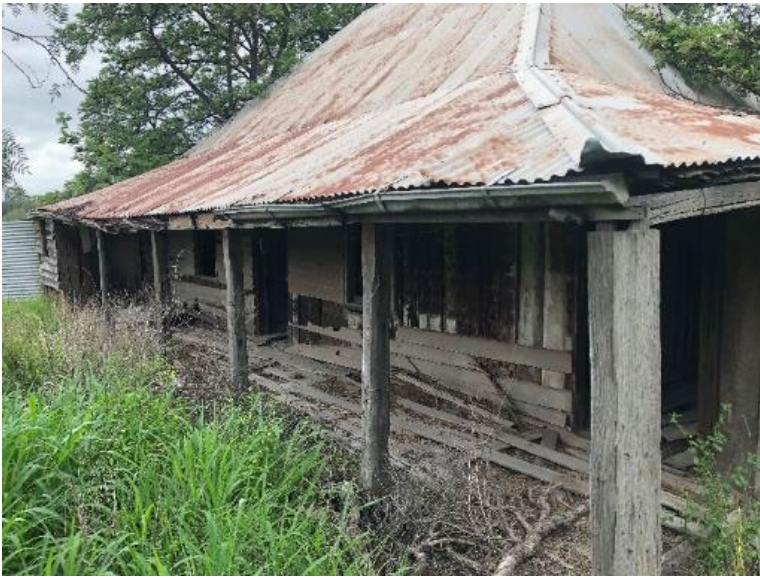
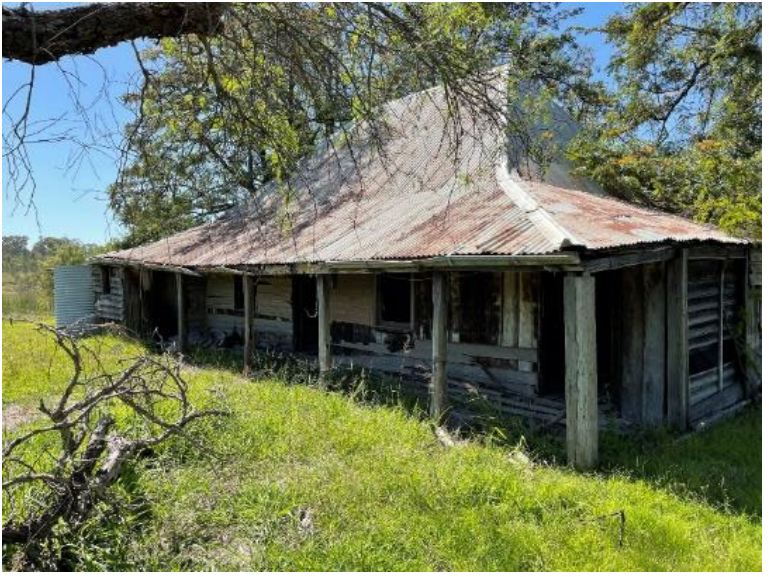
| 2014 | 2018 | 2020 (Mar) | 2020 (Dec) |
|---|---|---|---|
| | | | <p><b>2014-8:</b> <a href="#">slumping of veranda along edge beam.</a></p> <p><b>2018-20 (Mar):</b> no discernible change.</p> <p><b>Mar 2020-Dec 2020:</b> <a href="#">grass/weed growth encroaching over veranda floor.</a></p> <p><b>Dec 2020 – 2021:</b> no discernible change.</p> <p><b>2021-2022:</b> peppercorn has been pruned; <a href="#">termite damage is increased within veranda uprights.</a></p> <p><b>2022-2023:</b> <a href="#">increased splitting to fourth verandah post from right</a></p> |

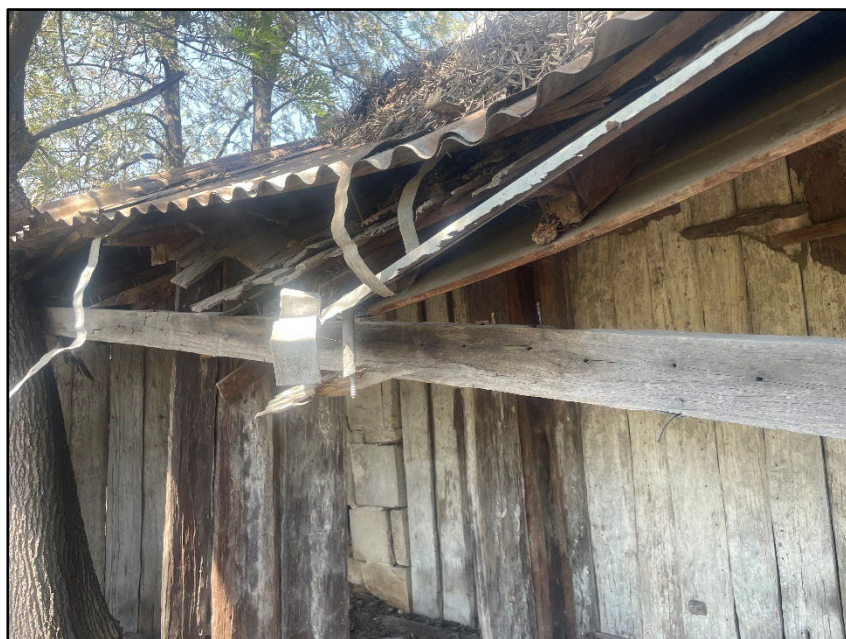
***Increased slumping along eastern wall***

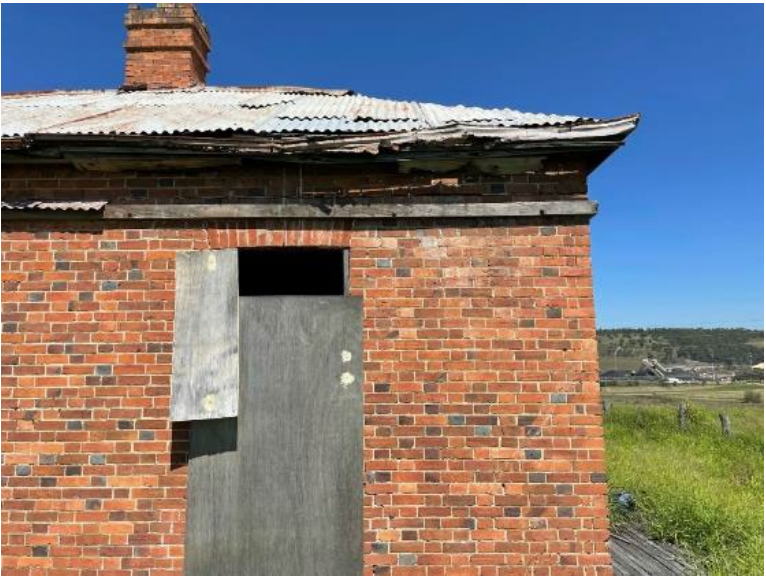
| 2015 | 2018 | 2020 (Mar) | 2020 (Dec) |
|---|---|---|---|
| | | | <p><b>2015-8:</b> roofing sheets have been replaced and holes patched.</p> <p><b>2018-20 (Mar):</b> some minor roof holes and lifted sheeting noted.</p> <p><b>Mar 2020-Dec 2020:</b> some veranda flashing fallen, panel above door requires refixing.</p> <p><b>Dec 2020 – 2021:</b> panel above door requires re-affixing and guttering remains in disrepair.</p> <p><b>2021-2022:</b> panel above door fixed, guttering in disrepair.</p> <p><b>2022-2023:</b> Deterioration of guttering and roof edge.</p> |

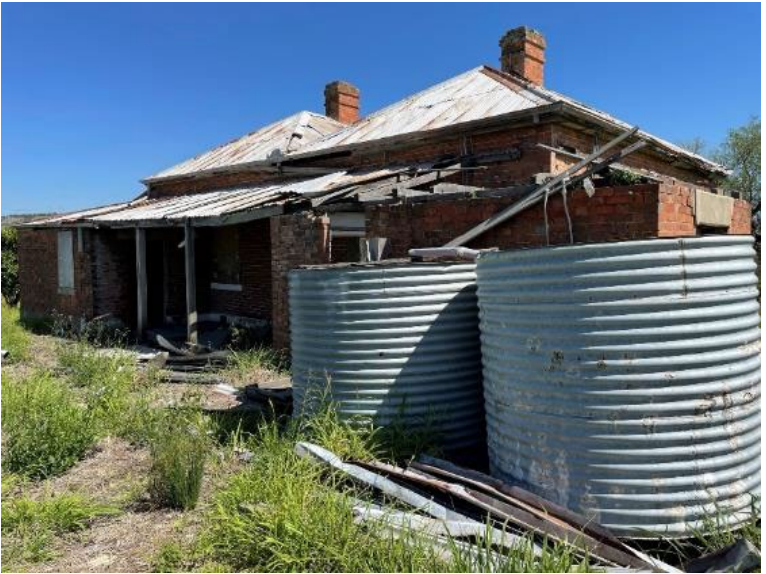
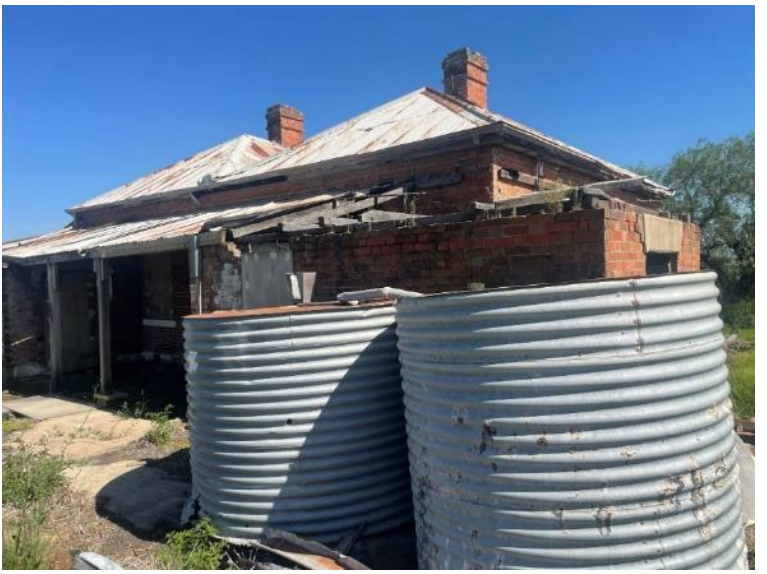
| 2015 | 2018 | 2020 (Mar) | 2020 (Dec) |
|---|---|---|---|
| | | | <p><b>2015-8:</b> debris has been cleared and stacked.</p> <p><b>2018-20 (Mar):</b> vegetation has regrown around building and stacked debris.</p> <p><b>Mar 2020-Dec 2020:</b> vegetation cleared and debris restacked.</p> <p><b>Dec 2020 – 2021:</b> vegetation management required.</p> <p><b>2021-2022:</b> vegetation managed; collapsed roofing members tidied and stacked inside building; <b>broken fascia removed but not repaired.</b></p> <p><b>2022-2023:</b> no discernible change.</p> |

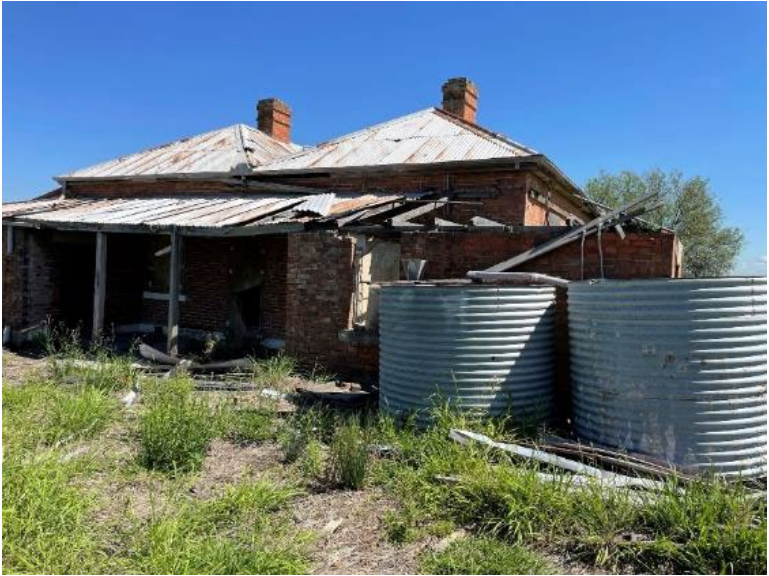
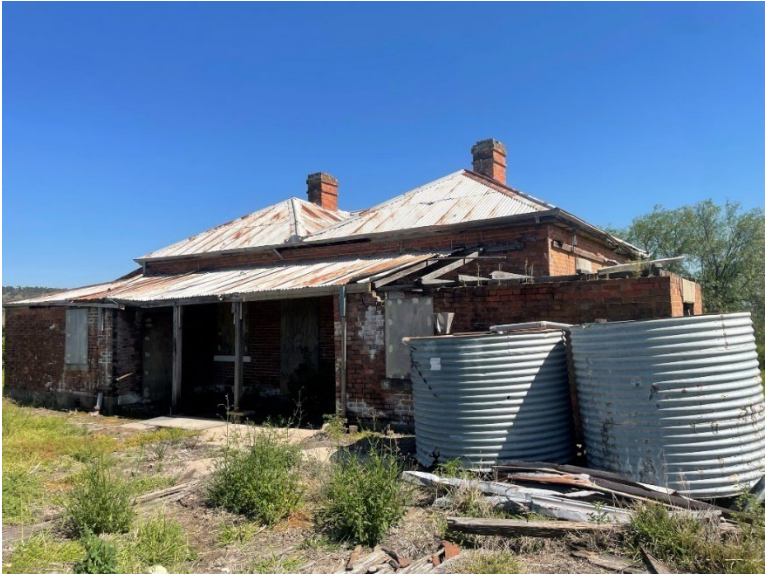
| 2015 | 2018 | 2020 (Mar) | 2020 (Dec) |
|---|---|---|---|
| | | | <p><b>2015-8:</b> skillion roof, guttering and rafters have collapsed; main roof holes repaired.</p> <p><b>2018-20 (Mar):</b> no discernible change.</p> <p><b>Mar 2020-Dec 2020:</b> some minor holes in roofing require repair.</p> <p><b>Dec 2020 – 2021:</b> minor roofing holes remain.</p> <p><b>2021-2022:</b> veranda uprights propped, loose members tidied; roofing appears patched.</p> <p><b>2022-2023:</b> shows fallen guttering with lifting of roof sheeting behind.</p> |

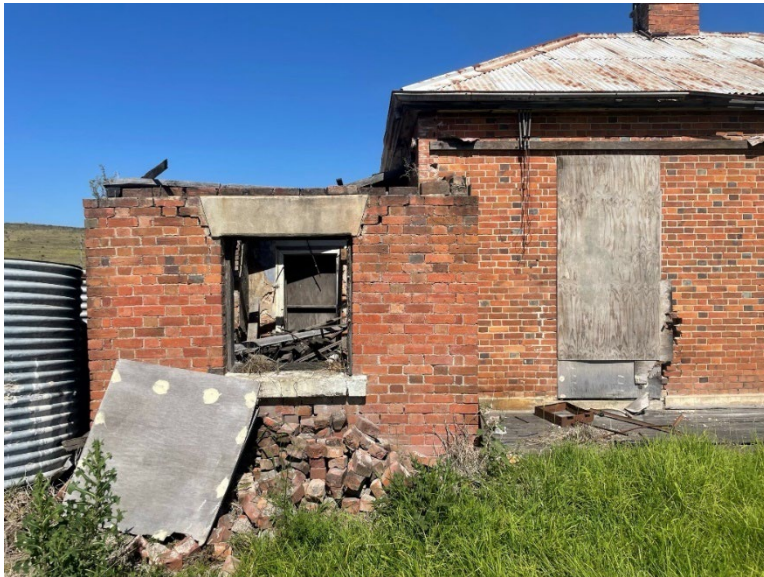
| 2015 | 2018 | 2020 (Mar) | 2020 (Dec) |
|---|---|---|---|
| | | | <p><b>2015-8:</b> wall element has collapsed (bricks stacked under window); roof framing, sheeting and guttering has collapsed.</p> <p><b>2018-20 (Mar):</b> no discernible change.</p> <p><b>Mar 2020-Dec 2020:</b> no discernible change.</p> <p><b>Dec 2020 – 2021:</b> rafter collapse from above window.</p> <p><b>2021-2022:</b> redundant electrical box fallen; increased vandal activity at doorway; roof capping repaired; redundant panel can be removed.</p> <p><b>2022-2023:</b> window opening cover replaced and door panel repaired.</p> |

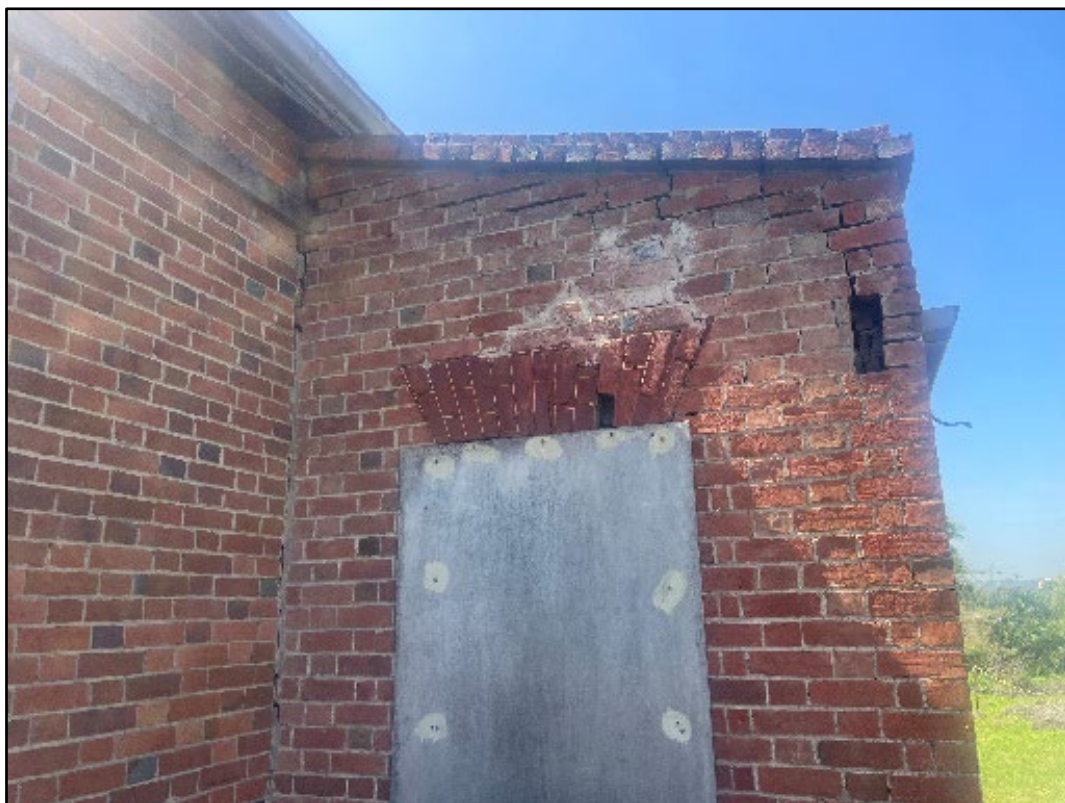
A section of wall at the end of the verandah where it meets Room 5 on the house's south-east corner also requires attention (see picture below). The mortar between the brick work on this wall, particularly on the southern edge, has deteriorated, with fretting on some bricks also apparent. This has created some slight bowing/deformation to the top of the southern side of this wall, which poses a risk of collapse of this section. Repointing attention is required in this area, as it is in other sections of the building.

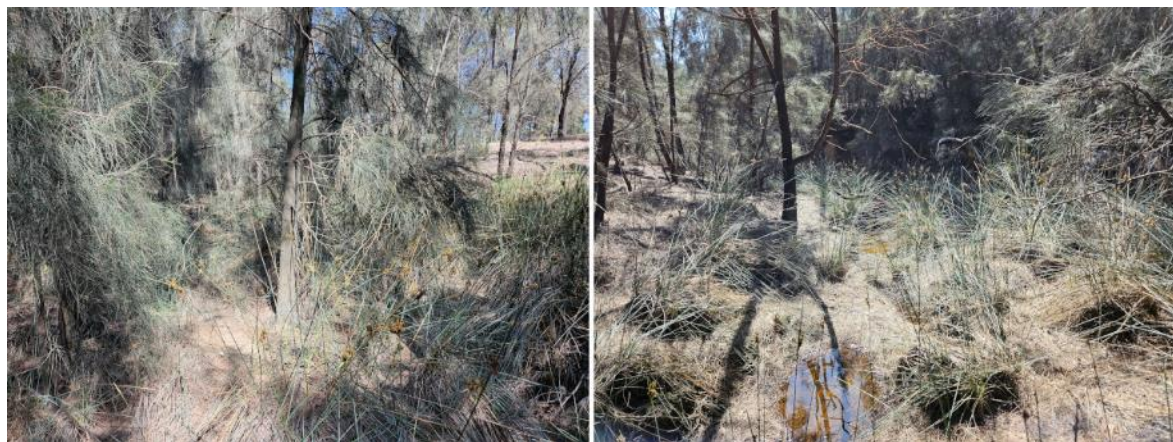
**Figure 15:** Site LC2 looking upstream (left) and looking downstream (right).

The composition of the vegetation growing on the drainage line walls resulted in an improved category score. There was also an improved category score for ‘Particle size of materials on the drainage floor’ owing to the presence of gravels in the channel basin, and re-assessment of the ‘Shape of drainage line cross-section’ resulted in an improved category score. Overall, there was an improvement in the CSIRO ESA score and rating which shifted from *Active* to *Potentially stable*.

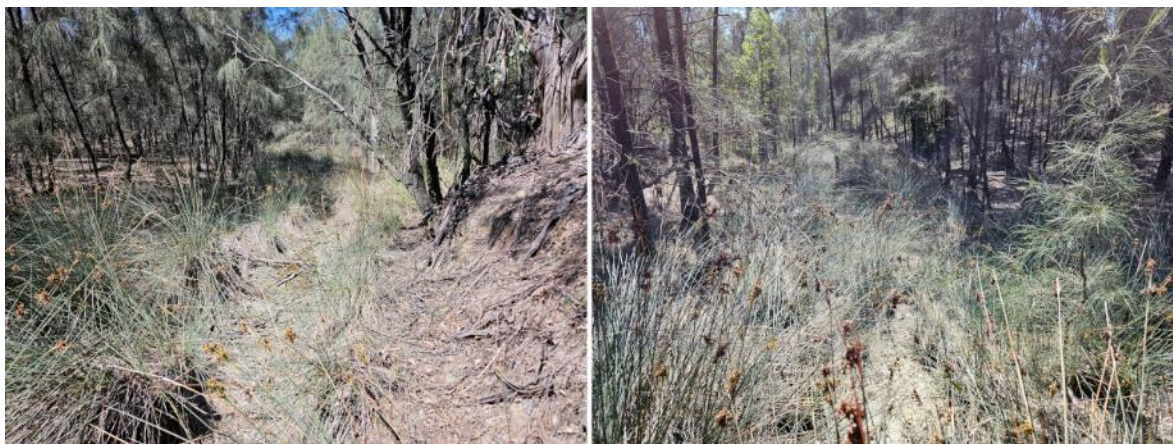
**Figure 18:** Site LC3 looking upstream (left) and looking downstream (right).

There was an improved category score recorded for 'Particle size of materials on the drainage floor' owing to the presence of gravels in the channel basin, and re-assessment of the 'Shape of drainage line cross-section' and 'Longitudinal morphology' resulted in an improved category score. Overall, there was an improvement in the CSIRO ESA score between 2022 and 2023 which shifted the band rating from *Very Active* to *Active*.

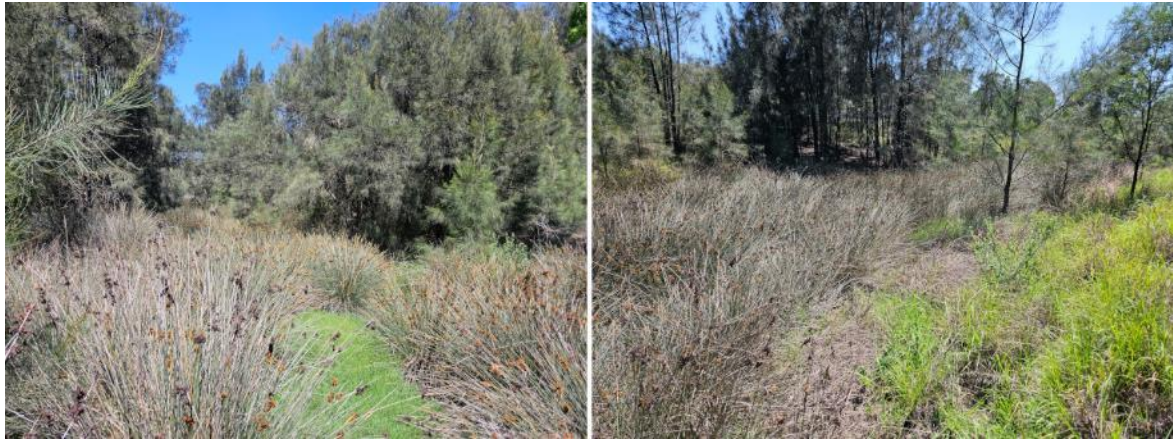
**Figure 22:** Looking upstream (left) and downstream (right) at LC5.

There was an improved category score recorded for ‘Nature of drainage line wall materials’ owing to reduced estimate of exposed soils along drainage line walls, and re-assessment of the ‘Shape of drainage line cross-section’ and ‘Longitudinal morphology’ resulted in an improved scores their respective categories, resulting in an improved CSIRO rating of *Potentially Stabilising* in 2023.

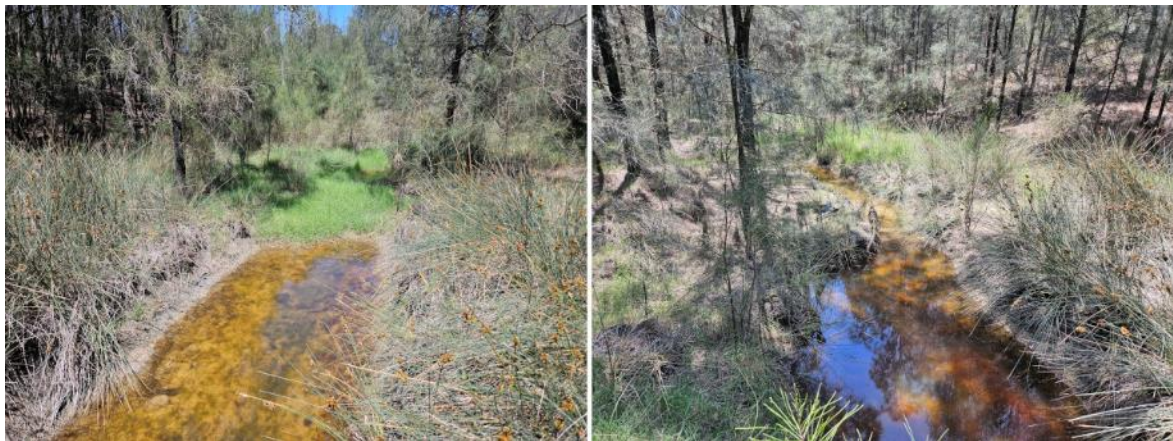
**Figure 25:** Looking upstream at site LC6 (left) and looking downstream (right).

Notwithstanding, there were no changes to the LC6 site CSIRO ESA rating which remained as *Active* in 2023.

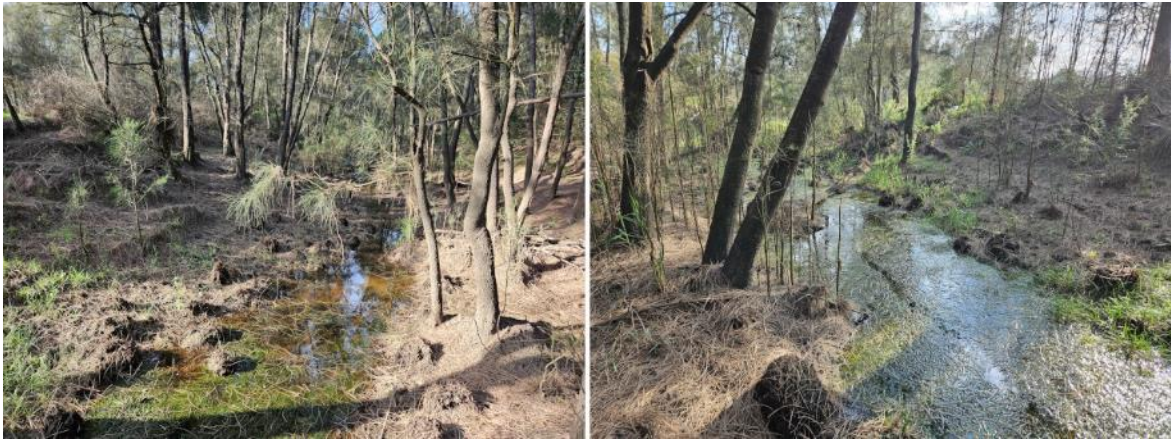
**Figure 32:** Looking upstream at LC12 (left) and looking downstream (right).

The previous monitoring round in 2022 noted that spiny rushes and common reeds at LC12 had died back, and while there was no indication of recovery for the 2023 survey, the reduction was insufficient to warrant reducing the category score for ‘Vegetation on drainage line floor’. Couch grasses and streaked arrow grass (*Triglochin striatum*) showed signs of localised renewed growth, however much of the drainage line floor and walls comprised bare ground smothered in a layer of swamp-oak needles during the 2023 survey (**Figures 32 and 33**). Cattle access the creekline at LC12 contributes to exposure of soil profiles through trampling, and there was a reduction in category score for ‘Nature of drainage line wall materials’ owing to an increase in the estimate of exposed soils along drainage line walls, and as a result, the LC12 CSIRO ESA score declined, and the overall site rating shifted from the lower limits of *Potentially Stabilising* to the upper limits of *Active* in 2023.

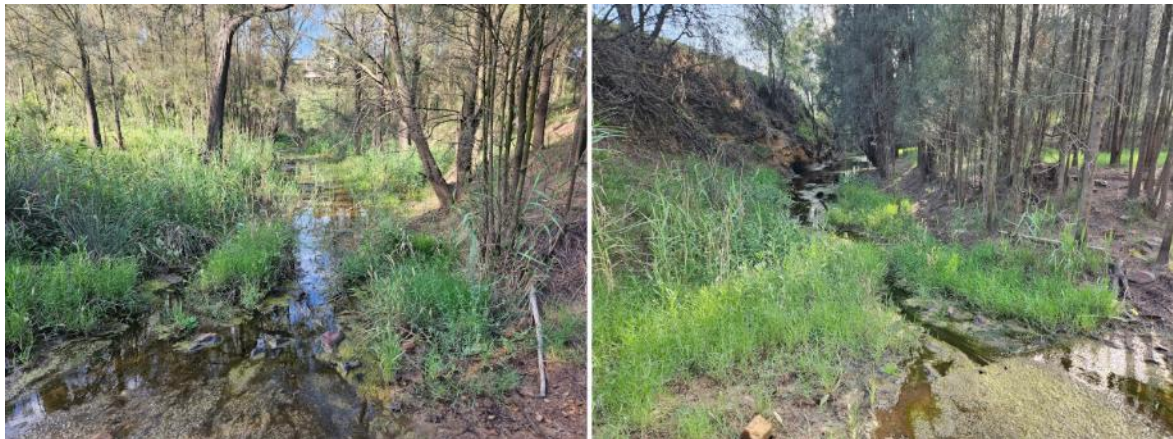
**Figure 34:** Looking upstream at LC14 (left) and looking downstream (right) in 2023.

Overall, the site drainage channel condition appears consistent with the previous monitoring round and there were no changes to the CSIRO ESA rating, maintaining its rating within the upper limits of *Active* in 2023.

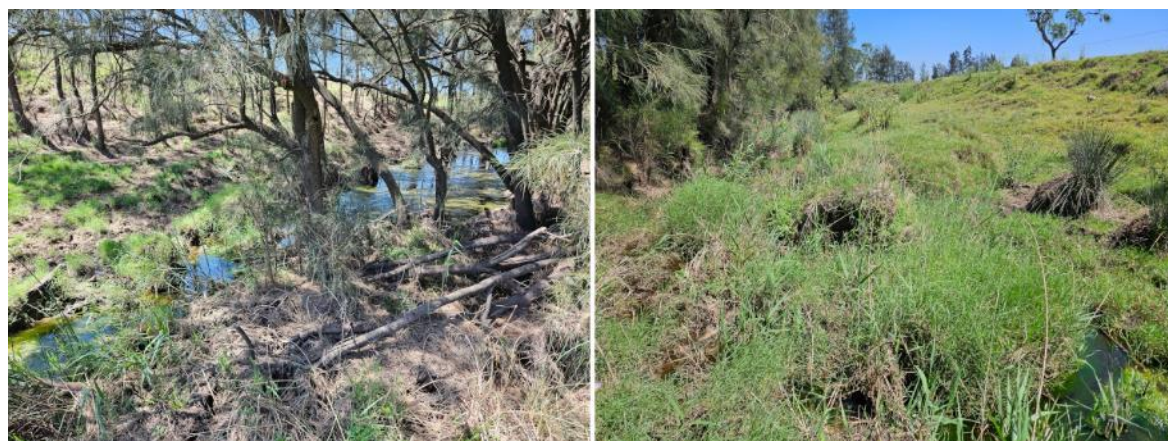
**Figure 38:** Looking upstream (left) and downstream (right) at LC9.

The creek waters were clear and flowing throughout the site length for the 2023 survey. The instream and edge bank couch grasses, common reed and spiny rush growths showed signs of minor growth since the 2022 survey, and the erosion points along the right-hand bank appeared more vegetated (with pasture grasses) despite signs of recent cattle usage of the area (tracks, scats). The left-hand bank riparian corridor remains in good condition with a dense coverage of small to medium sized swamp-oaks and saplings (<1m height). There were no changes to the LC9 site CSIRO ESA rating which has remained within the upper half of *Potentially Stabilising* since 2018.

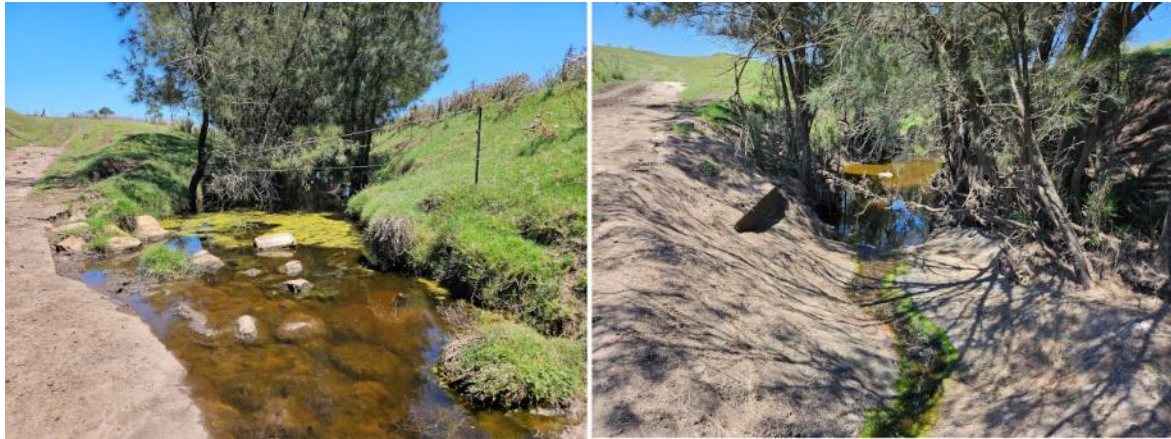
**Figure 40:** Site LC10 looking upstream from causeway (left) and looking downstream (right).

Surface waters were clear for the 2023 survey and flow was continuous throughout the site length. The condition of the riparian bank vegetation and erosional features (mostly restricted to flow induced bank undercutting and stepped bank profiles from livestock access) remained unchanged from the previous survey. There was an increase in category score for ‘Particle size of materials on drainage line floor’ due to observations made of coarser materials on the substrates up and downstream of the causeway. As a result, the overall LC10 CSIRO ESA rating increased from *Active* to *Potentially Stabilising* for the 2023 survey.

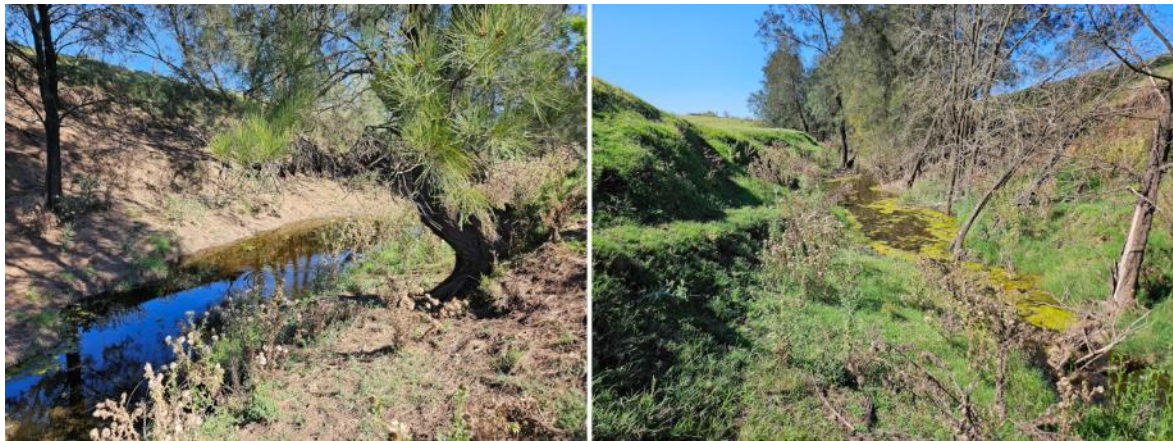
**Figure 42:** Site LC15 looking upstream (left) and looking downstream (right).

Despite the groundcover vegetation (pasture grasses and weeds) showing a recovery from the degraded condition encountered in 2022, the 'Vegetation on drainage line' category score was reduced for the 2023 survey (from 3 to 2), as the 2023 condition was more suited to the relevant category description. A re-assessment of the 'Shape of drainage line cross-section' resulted in an improved category score, which resulted in an unchanged overall CSIRO ESA score and rating which remained as *Stable* in 2023.

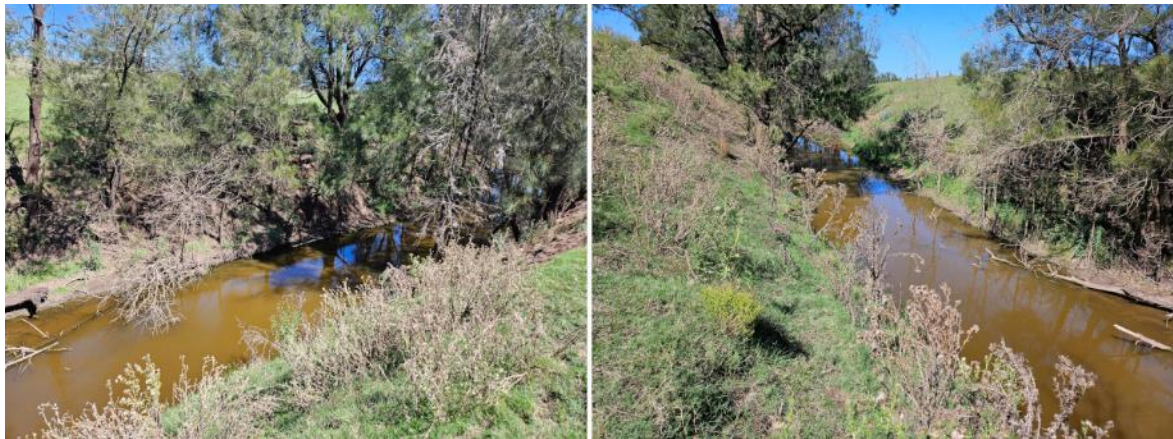
**Figure 44:** Looking upstream (left) and downstream (right) at site LC13 in 2023.

The channel form at LC13 is similar to that noted for LC10, and consists of a V-shaped channel, deeply incised (7 to 10m) into the surrounding catchment area with fragmented riparian corridor consisting of mature she-oak and eucalypts (**Figures 44 and 45**). Surface waters were turbid and continuous through the site, and carp (*Cyprinus carpio*) were observed.
