**Addendum 2 to Arboricultural Impact Assessment Report  
Art Gallery of NSW Expansion Project – Sydney Modern [SSD 14\_6471]  
Consistency with the objectives of the *Royal Botanic Gardens and Domain Trust Act 1980*.**

# PICUS SONIC TOMOGRAPH REPORT

### **Re – Arborist Inspection - Picus Sonic Tomograph Testing**

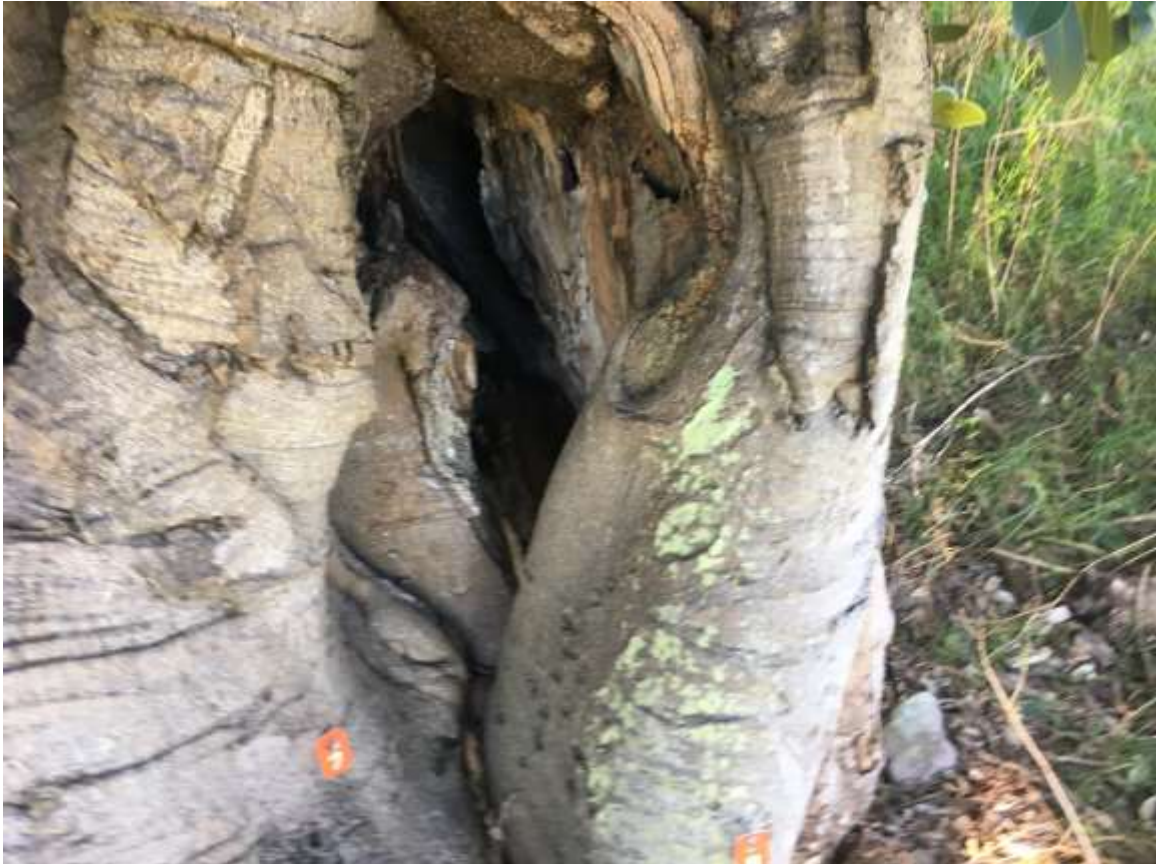
The Picus test was undertaken on a *Ficus macrophylla* (Moreton Bay Fig) identified as requiring further investigation to determine the structural condition of the tree at the site of a large lower trunk cavity.

Photo 1. Main cavity at base of the tree which was the main area of concern.

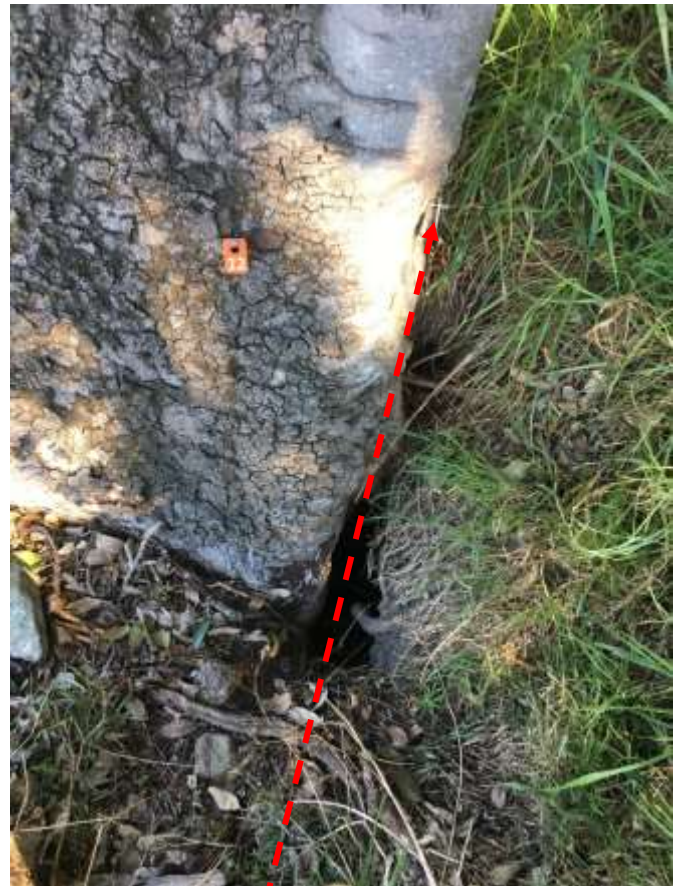
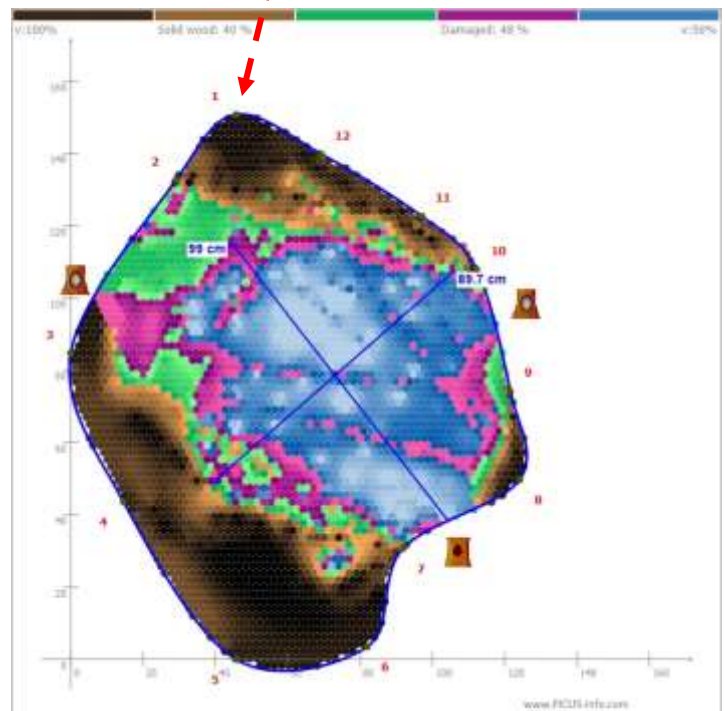
The Picus© Sonic Tomograph (Series 3) test shows (lower right insert) that this *Ficus macrophylla* tree has extensive active fungus, decay and altering wood within the test location.

The test results indicate 40% of the test area is sound wood (brown areas), 12% consists of altering wood i.e. wood being altered by the fungus (green area) and 48% active fungus and decay (pink and blue areas).

The fungal activity and decay appears to have initially entered the trunk through past lower trunk damage. The active fungal pathogen, decay and altering wood have breached the outer trunk between sensors 2 – 3, 7 – 8 and 9 – 10.

The active fungal pathogen is progressing through the remaining sound wood at a moderate rate, as shown by the amount of altering wood, (green colouration).

The fungal activity measured 99 cm in a north-south direction and 89.7 cm in an east-west direction. The decayed section has trisected the tree from sensors 2 – 3, 7 – 8 and 9 – 10.

New incremental wood growth was recorded at sensors 1, 3 – 6, 8 and 11 – 12.

The Picus test was undertaken at 300 mm above ground level at the location of the lower trunk cavity site. The Picus Tomograph test showed that there is a moderate amount of altering wood 12% surrounding an extensive amount of fungal activity and decay 48% with only 40% of sound wood remaining at the site of the test location.

The active fungal pathogen is progressing through the sound wood at a moderate rate, as shown by the amount of altering wood (green colouration) and has breached the outer trunk between sensors 2 – 3, 7 – 8 and 9 – 10. The active decayed section has trisected the tree.

At the time of testing the Picus test results show that the structural integrity of the lower trunk has been compromised by the active fungal pathogen.

- Based on the results of the Picus test combined with Visual Tree Assessment as well as a WHS/OH&S assessment and usage of the site at the time of testing the tree was considered to be structurally compromised at the test location and should be considered for removal.
- If the tree is to be retained then it would require the fall area of the tree to be barricaded off from public access. Native grasses could be grown under the tree as they will not require regular mowing. Signage could state that the tree is being left and no access to the area is permitted.
- The management of the tree should be based on this Picus report as well as any other recent and, or, current Arboricultural reports or Visual Tree Assessments.
