ASBESTOS CLEARANCE CERTIFICATE

REMOVAL OF ASBESTOS CONTAINING EXTERNAL AND INTERNAL MATERIALS TO THE REDUNDANT AUSGRID SUBSTATION, SYDNEY MODERN PROJECT, ART GALLERY ROAD, SYDNEY NSW 2000

Report Date: 30th June 2020

Project Ref: SYDGE234348

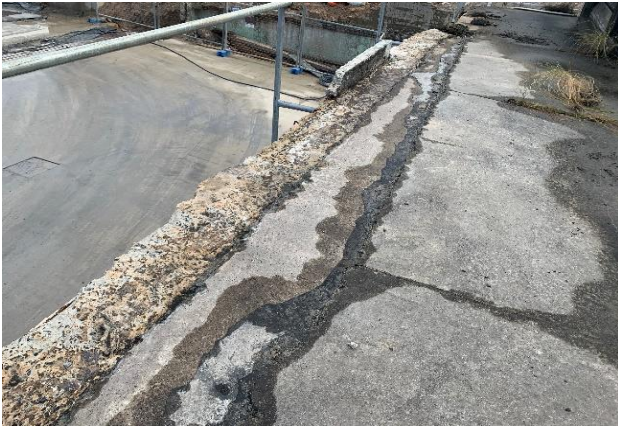
Photograph 1: Exterior, roof, following removal of remnant asbestos-containing bituminous membrane.

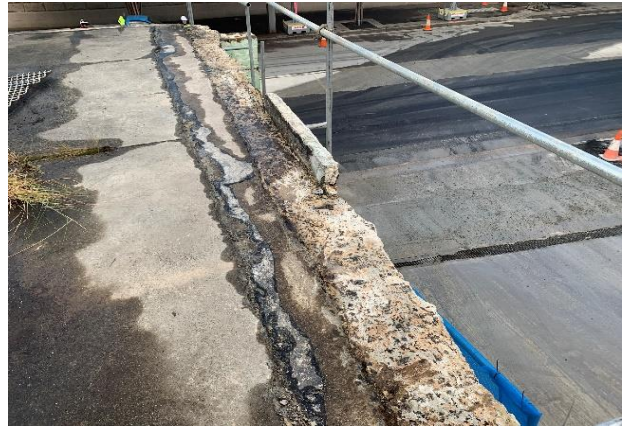
Photograph 2: Exterior, roof, following removal of remnant asbestos-containing bituminous membrane.

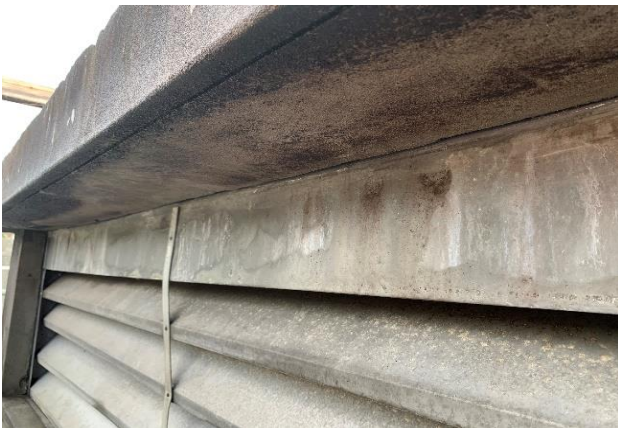
Photograph 3: Exterior, upper roof, following removal of remnant asbestos-containing white/beige caulking to louvres.

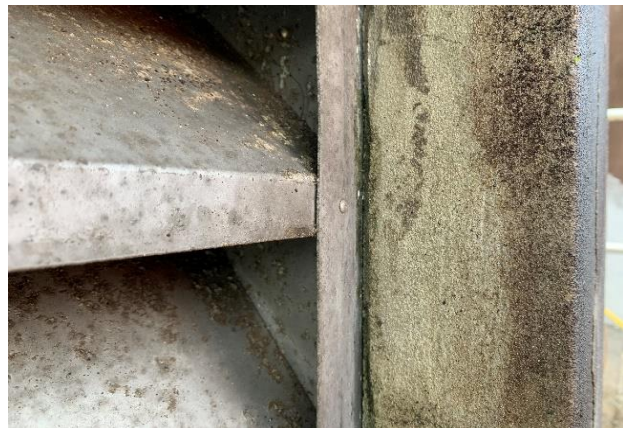
Photograph 4: Exterior, upper roof, following removal of remnant asbestos-containing white/beige caulking to louvres.

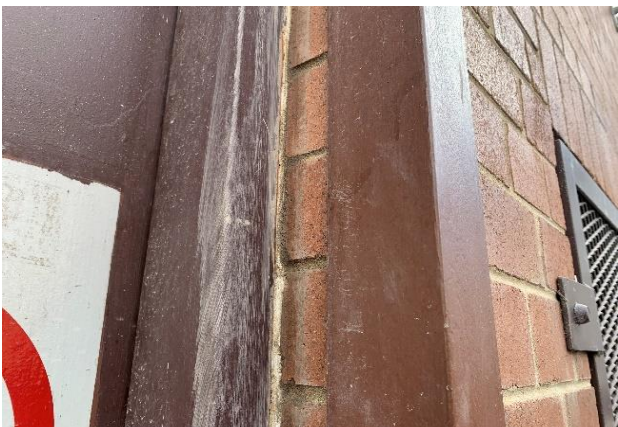
Photograph 5: Exterior, doorway following removal of asbestos-containing caulking.

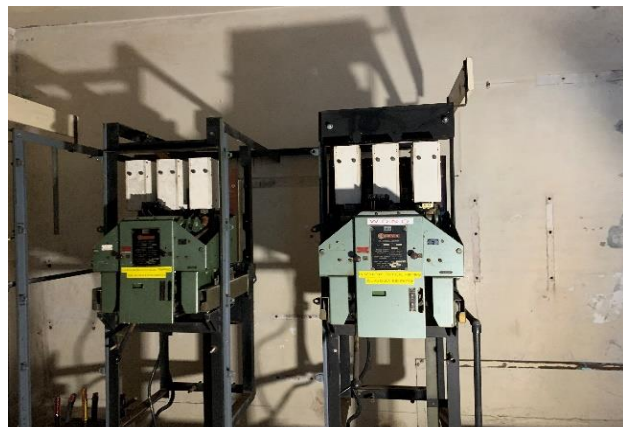
Photograph 6: Interior, switchboard structure following removal works.

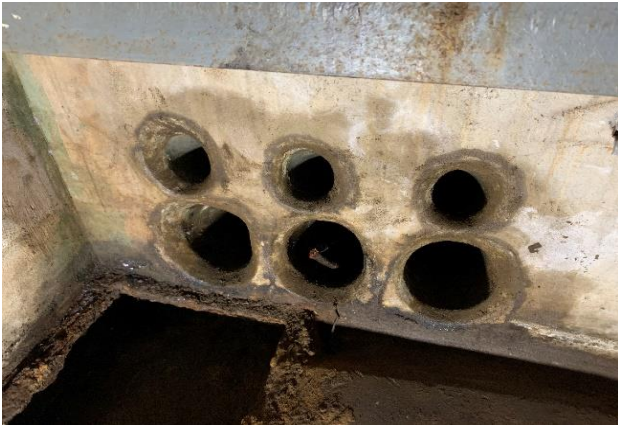
Photograph 7: Interior, substation pit, conduit penetrations following removal of asbestos-containing NC compound/caulking.

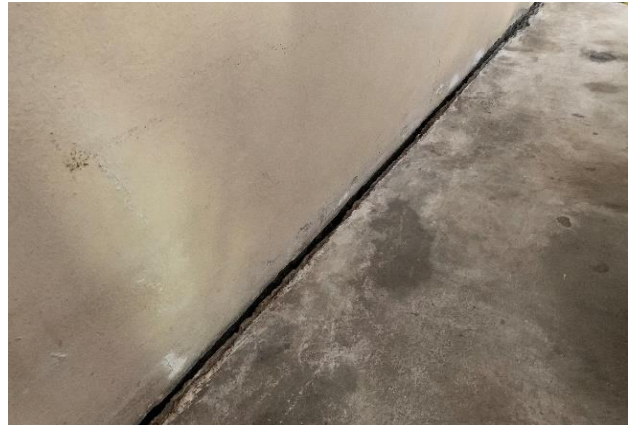
Photograph 8: Interior, base of walls following removal of asbestos-containing flexible grey compound/caulking.

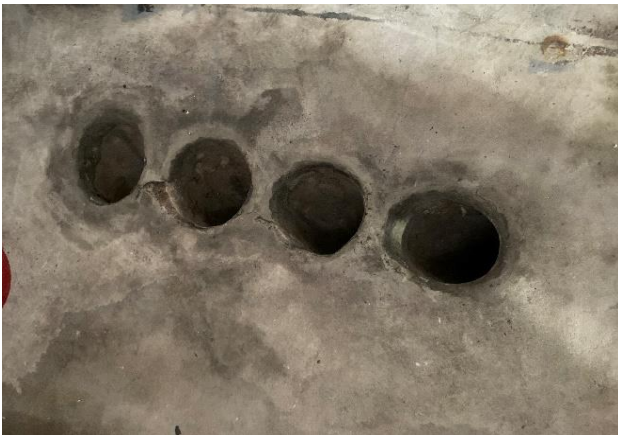
Photograph 9: Interior, substation floor, conduit penetrations following removal of asbestos-containing NC compound/caulking.

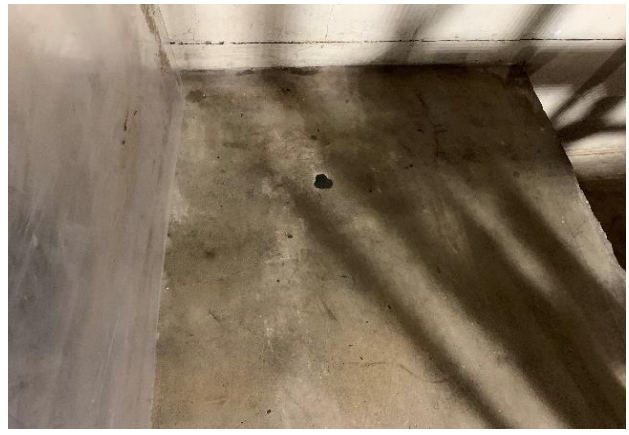
Photograph 10: Interior, substation floor following removal of asbestos-containing HRC fuses.
