Hazardous Materials Survey

Prepared for:	Pariter
Prepared by:	Alex Tam Licensed Asbestos Assessor 001241 Trinitas Group
Site	Cumberland Country Golf Club
Address:	248 Old Prospect Road, Greystanes NSW 2145
Date:	04/02/2024
Version:	3

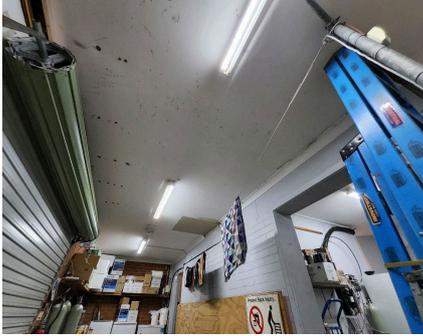
Photo No: 231218-093208
 Result: PCB - Presumed Positive
 Location-Level: Interior - Ground Floor
 Room-Location: Loading dock - fluorescent light fitting
 Feature-Material: Double capacitor
 Item No - Risk Rating: 4 - Low

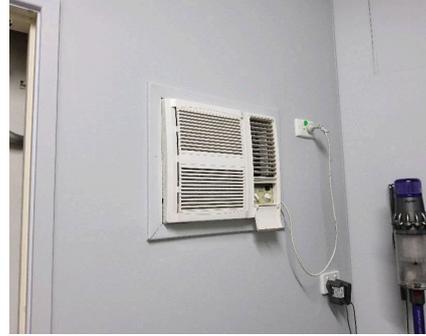
Photo No: 231218-093414
 Result: ODS - Presumed Positive
 Location-Level: Interior - Ground Floor
 Room-Location: Staff room - AC unit
 Feature-Material: Unknown refrigerant
 Item No - Risk Rating: 6 -

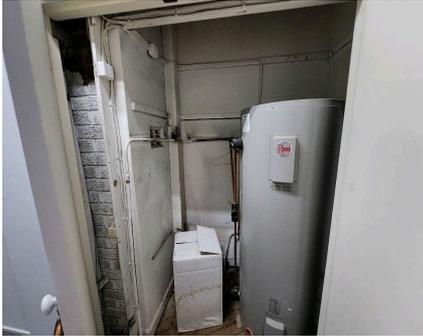
Photo No: 231218-094820
 Result: Lead in Paint - Positive
 Location-Level: Interior - Ground Floor
 Room-Location: Staff room - original door frames, downpipe and walls
 Feature-Material: Lower colour paint system
 Item No - Risk Rating: 7 -

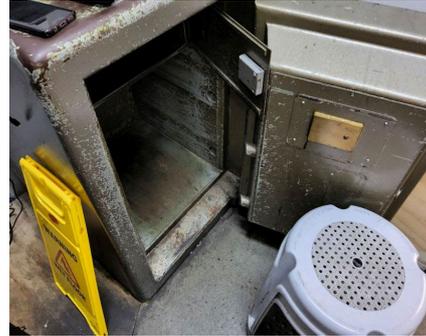
Photo No: 231218-100929
 Result: Asbestos - Presumed Positive
 Location-Level: Interior - Ground Floor
 Room-Location: Adj to bar - safe
 Feature-Material: Internal insulation
 Item No - Risk Rating: 14 - Low

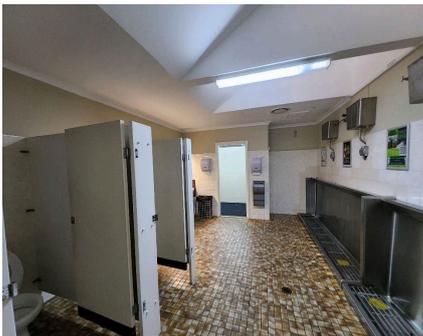
Photo No: 231218-101618
 Result: PCB - Presumed Positive
 Location-Level: Interior - Basement
 Room-Location: Male toilet - fluorescent light fitting
 Feature-Material: Double capacitor
 Item No - Risk Rating: 21 - Low

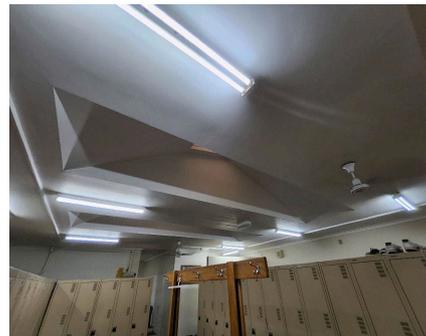
Photo No: 231218-102334
 Result: PCB - Presumed Positive
 Location-Level: Interior - Basement
 Room-Location: Male shower and changing room - fluorescent light fitting
 Feature-Material: Double capacitor
 Item No - Risk Rating: 27 -

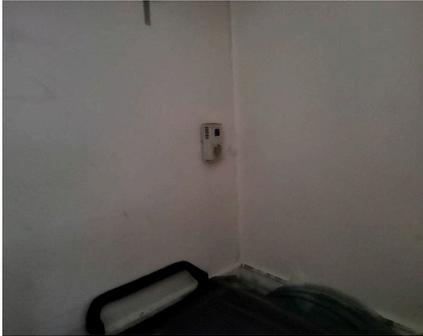
Photo No: 231218-103121
 Result: Asbestos - Presumed Positive
 Location-Level: Interior - Ground Floor
 Room-Location: Cupboard next to Unisex toilet - power switch
 Feature-Material: Internal insulation
 Item No - Risk Rating: 30 - Low

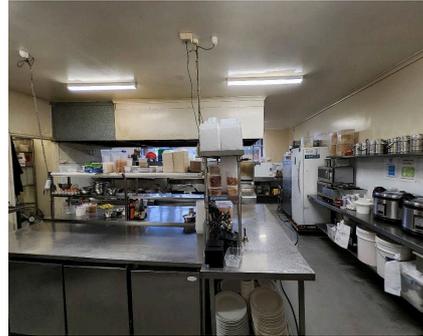
Photo No: 231218-103517
 Result: PCB - Presumed Positive
 Location-Level: Interior - Ground Floor
 Room-Location: Kitchen - fluorescent light fitting
 Feature-Material: Double capacitor
 Item No - Risk Rating: 31 -

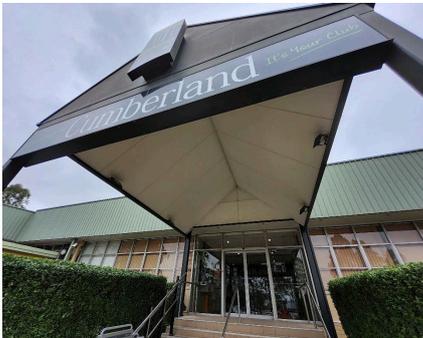
Photo No: 231218-103809
 Result: Asbestos - Presumed Positive
 Location-Level: Exterior - Ground Floor
 Room-Location: Above main entrance - awning and gable
 Feature-Material: FC sheeting
 Item No - Risk Rating: 35 - Low

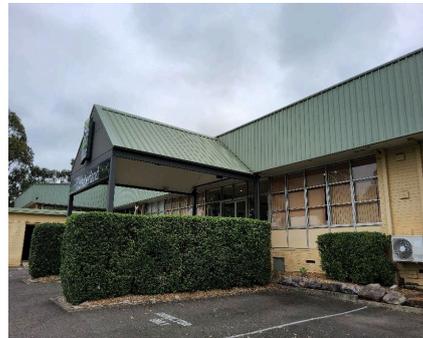
Photo No: 231218-104454
 Result: Lead in Paint - Positive
 Location-Level: Exterior - Ground Floor
 Room-Location: All elevation of the building - roof system, downpipe, and vertical support
 Feature-Material: Lower colour paint system
 Item No - Risk Rating: 37 -

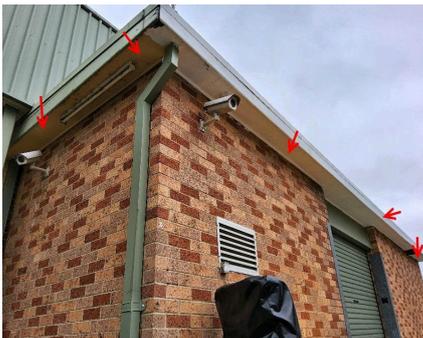
Photo No: 231218-104600
 Result: Asbestos - Presumed Positive
 Location-Level: Exterior - Ground Floor
 Room-Location: Loading dock - eaves
 Feature-Material: FC sheeting
 Item No - Risk Rating: 39 - Medium

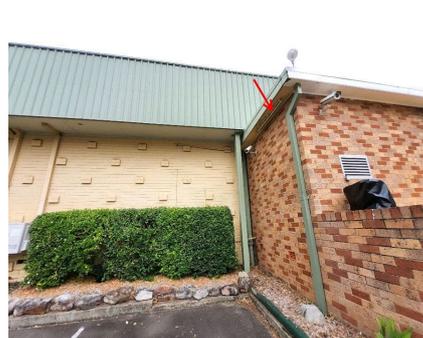
Photo No: 231219-210357
 Result: PCB - Presumed Positive
 Location-Level: Exterior - Ground Floor
 Room-Location: Next to loading dock entrance - fluorescent light fitting
 Feature-Material: Single capacitor
 Item No - Risk Rating: 40 - Low

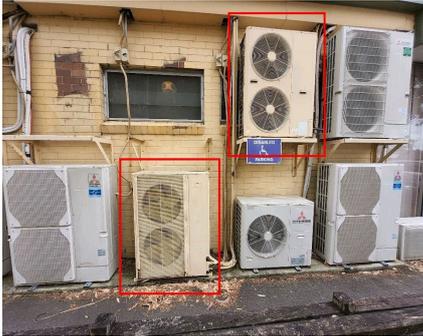
Photo No: 231218-105227
 Result: ODS - Presumed Positive
 Location-Level: Exterior - Ground Floor
 Room-Location: Southern elevation of the building - AC unit
 Feature-Material: Unknown refrigerant
 Item No - Risk Rating: 41 -

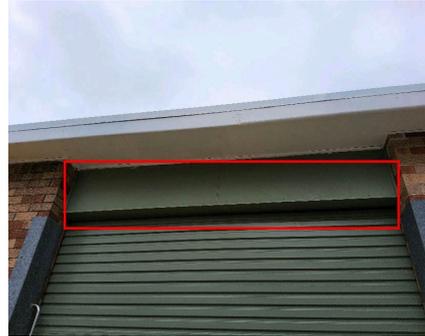
Photo No: 231218-112751
 Result: Asbestos - Presumed Positive
 Location-Level: Exterior - Ground Floor
 Room-Location: Above loading dock entrance - infill panels
 Feature-Material: FC sheeting
 Item No - Risk Rating: 43 - Low

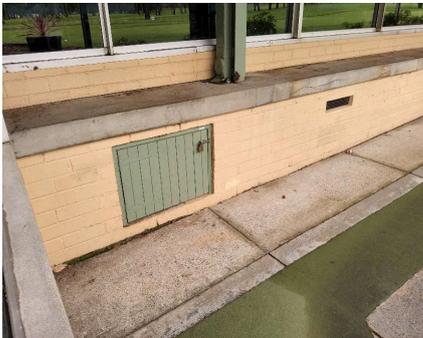
Photo No: 231219-104905
 Result: Lead in Paint - Presumed Positive
 Location-Level: Exterior - Ground Floor
 Room-Location: All elevation of the building - entrance door to subfloor
 Feature-Material: Lower colour paint system
 Item No - Risk Rating: 50 - Low

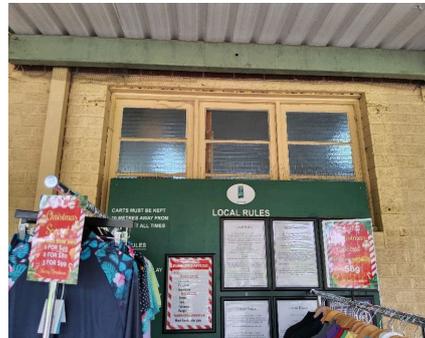
Photo No: 231219-105138
 Result: Asbestos - Presumed Positive
 Location-Level: Exterior - Ground Floor
 Room-Location: Western elevation of the building (next to male changing room entrance) window frame sealant
 Feature-Material: Mastic-like material
 Item No - Risk Rating: 51 - Low

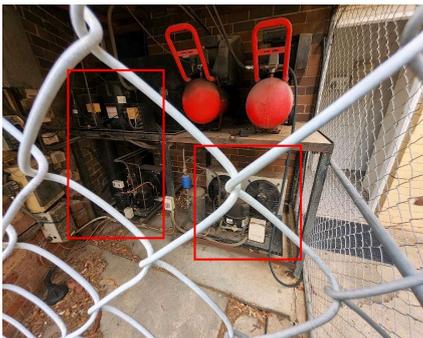
Photo No: 231219-105321
 Result: ODS - Presumed Positive
 Location-Level: Exterior - Ground Floor
 Room-Location: Northern elevation of the building (next to external toilet) - AC units
 Feature-Material: Unknown refrigerant
 Item No - Risk Rating: 52 -

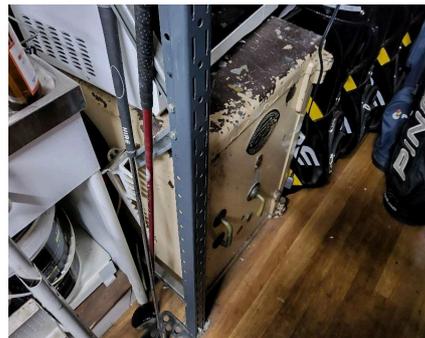
Photo No: 231218-111134
 Result: Asbestos - Presumed Positive
 Location-Level: Interior - Ground Floor
 Room-Location: Worship - safe
 Feature-Material: Internal insulation
 Item No - Risk Rating: 3 - Low

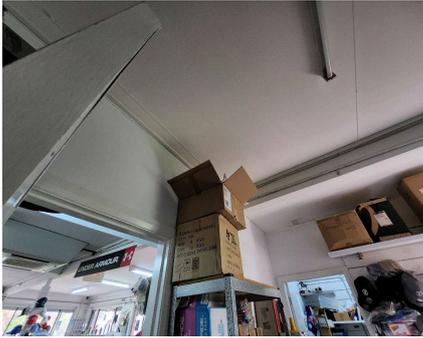
Photo No: 231218-111344
 Result: Asbestos - Presumed Positive
 Location-Level: Interior - Ground Floor
 Room-Location: All elevation of the floor - fluorescent light fitting
 Feature-Material: Single capacitor
 Item No - Risk Rating: 4 - Low

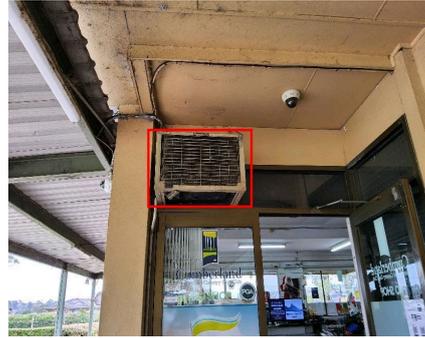
Photo No: 231218-111501
 Result: Asbestos - Presumed Positive
 Location-Level: Exterior - Ground Floor
 Room-Location: Above entrance - AC unit
 Feature-Material: Unknown refrigerant
 Item No - Risk Rating: 6 - Low

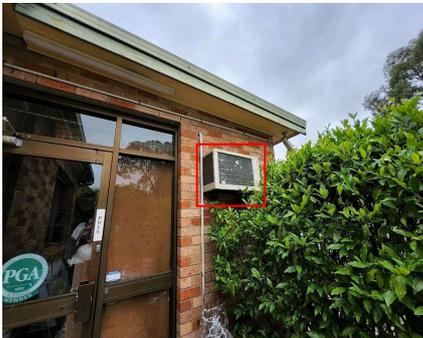
Photo No: 231218-112140
 Result: PCB - Presumed Positive
 Location-Level: Exterior - Ground Floor
 Room-Location: Southern elevation of the shop - AC unit
 Feature-Material: Unknown refrigerant
 Item No - Risk Rating: 7 -

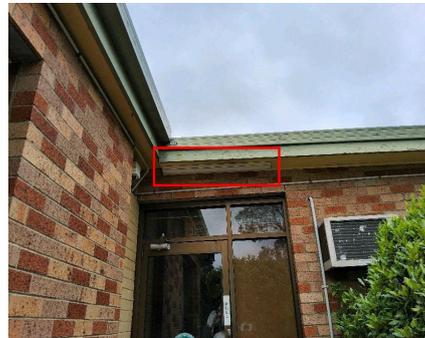
Photo No: 231219-212552
 Result: PCB - Presumed Positive
 Location-Level: Exterior - Ground Floor
 Room-Location: Southern elevation of the shop - fluorescent light fitting
 Feature-Material: Single capacitor
 Item No - Risk Rating: 11 - Low

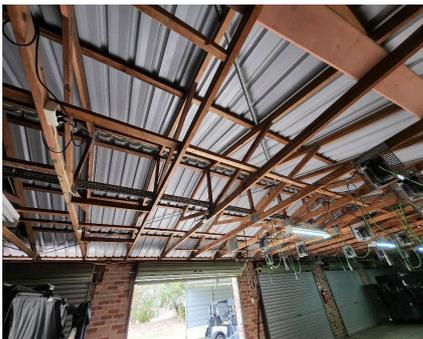
Photo No: 231218-113354
 Result: Asbestos - Presumed Positive
 Location-Level: Interior - Ground Floor
 Room-Location: All elevation of the floor - fluorescent light fitting
 Feature-Material: Double capacitor
 Item No - Risk Rating: 2 - Low
